**CBC Asbestos Refurbishment Survey Report
Neville House, George Street, Corby
22nd – 24th March 2016**

Reference:					
Issue			Prepared by	Verified by	
V1	Apr 16	JQ

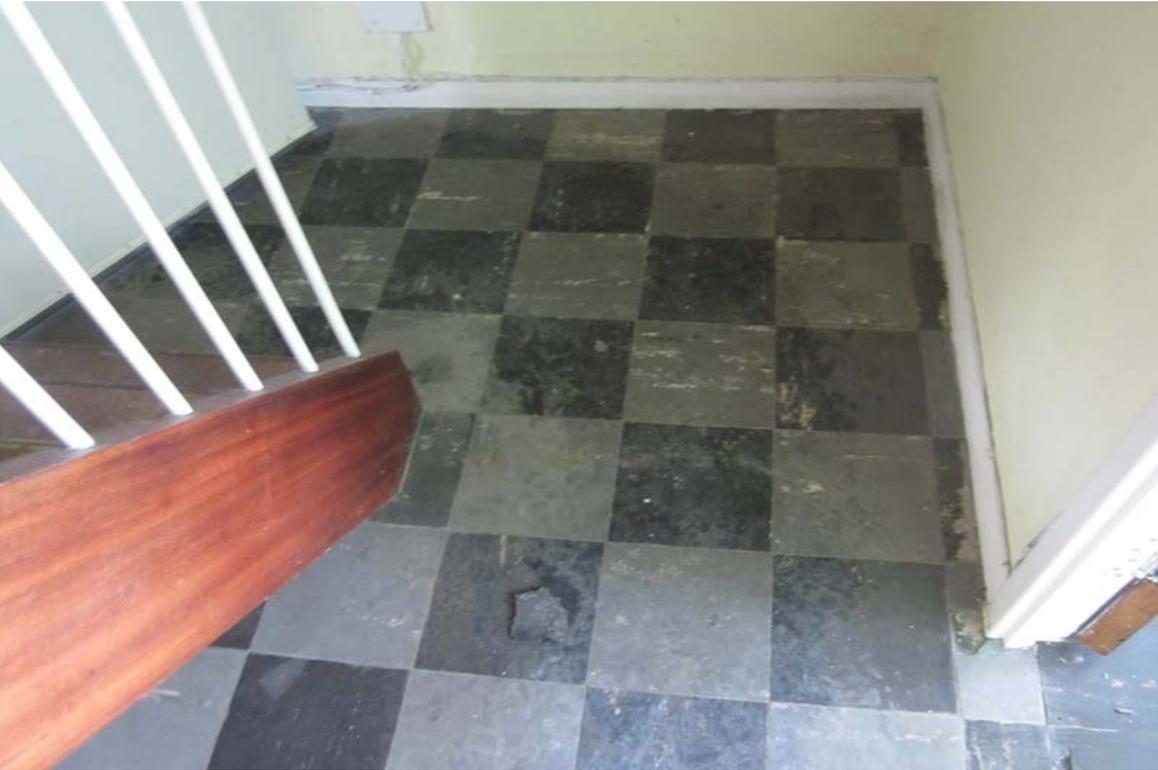
Photo Number	147	Reference number	230316MW155
Inspection / Sample	Inspection	Inspection Cross Reference / Visual I.D.	230316MW72

Notes	ACM: Asbestos Containing Material

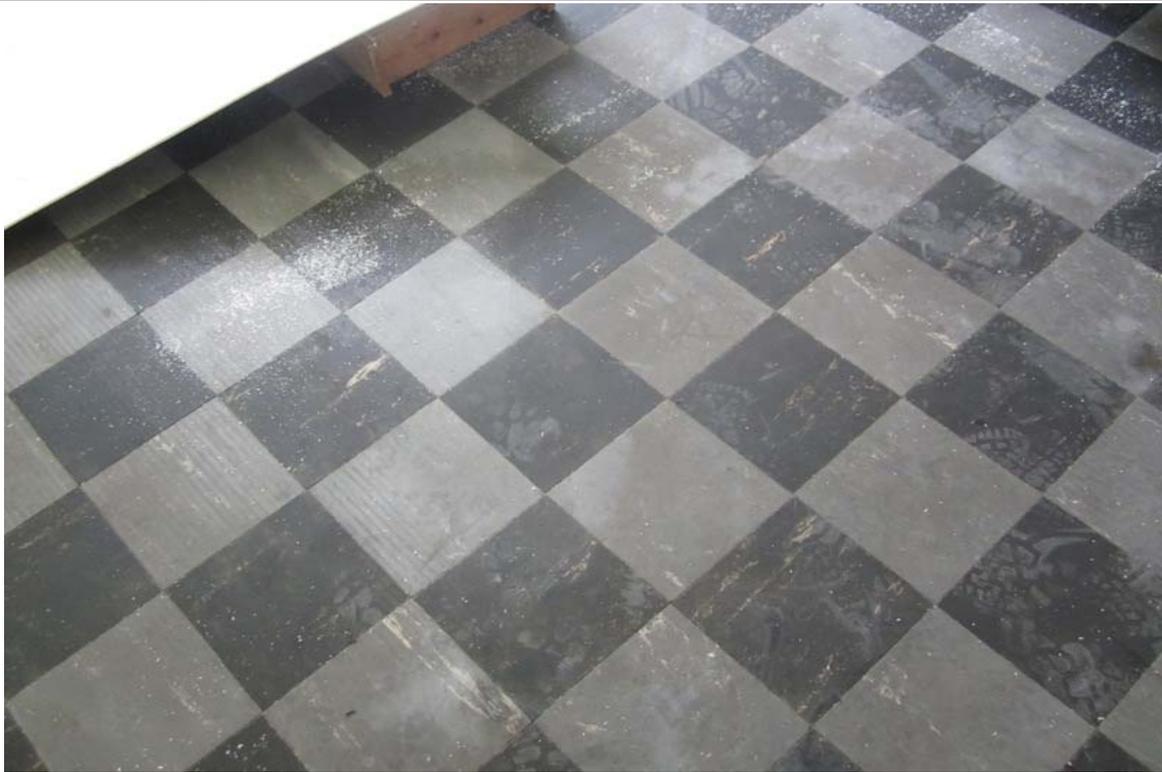
Photo Number	148	Reference number	230316MW156
Inspection / Sample	Inspection	Inspection Cross Reference / Visual I.D.	230316MW72

Notes	ACM: Asbestos Containing Material

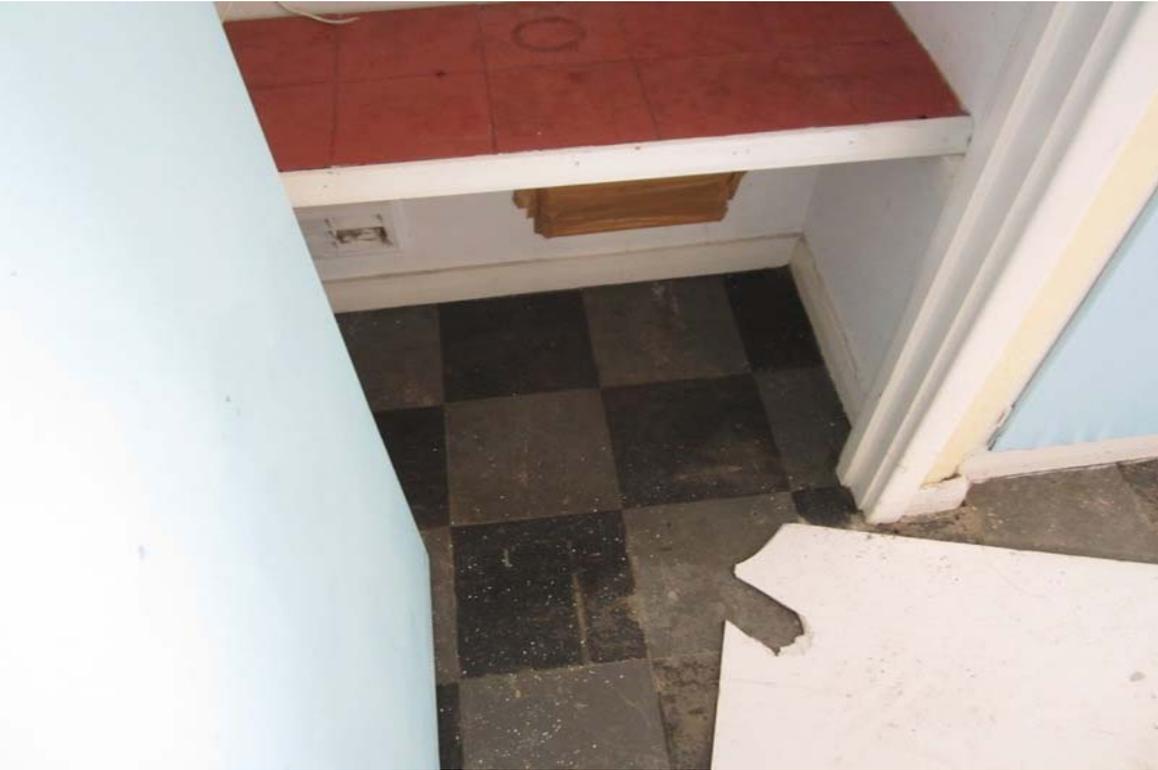
Photo Number	149	Reference number	230316MW157
Inspection / Sample	Inspection	Inspection Cross Reference / Visual I.D.	230316MW72

Notes	ACM: Asbestos Containing Material

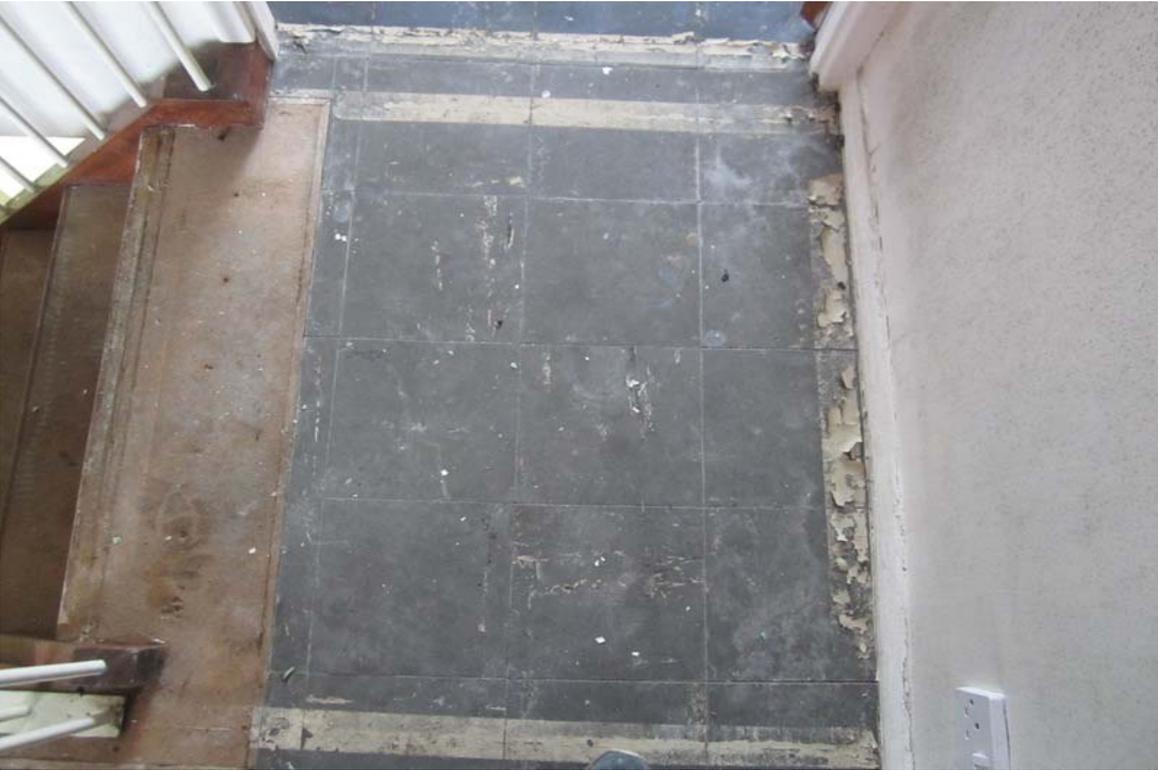
Photo Number	151	Reference number	230316MW159
Inspection / Sample	Inspection	Inspection Cross Reference / Visual I.D.	230316MW72

Notes	ACM: Asbestos Containing Material

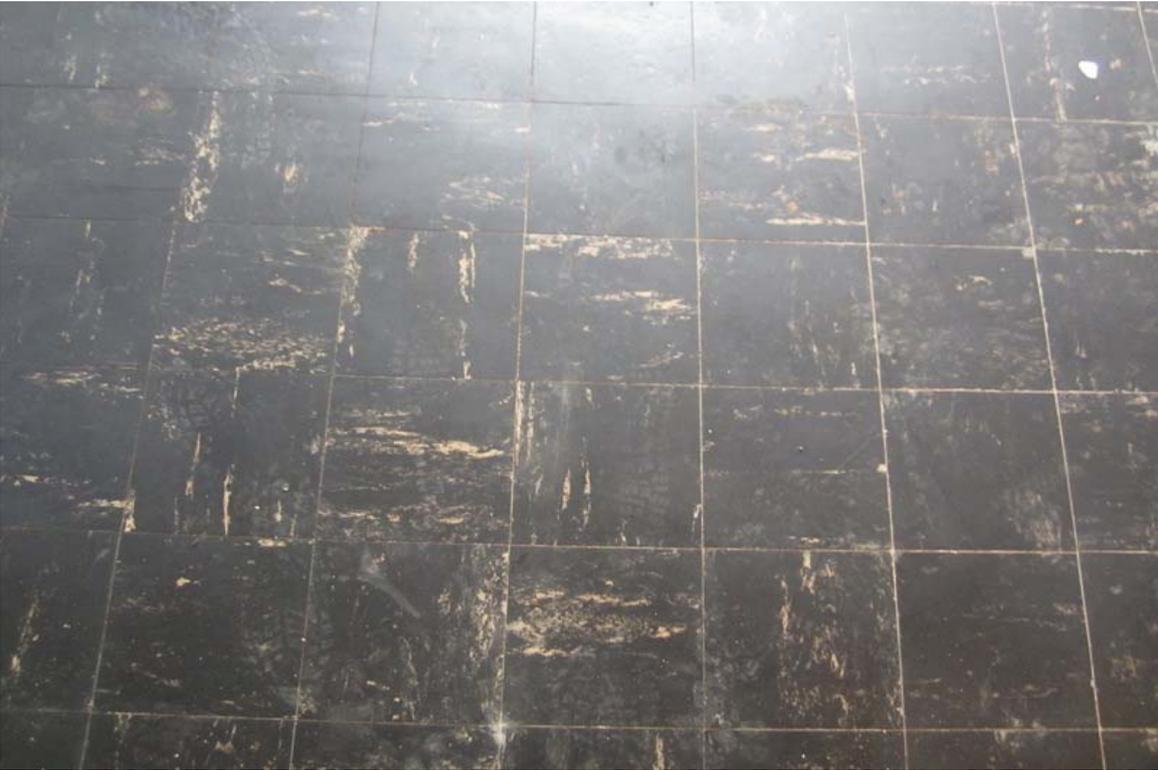
Photo Number	152	Reference number	230316MW160
Inspection / Sample	Inspection	Inspection Cross Reference / Visual I.D.	230316MW72

Notes	ACM: Asbestos Containing Material

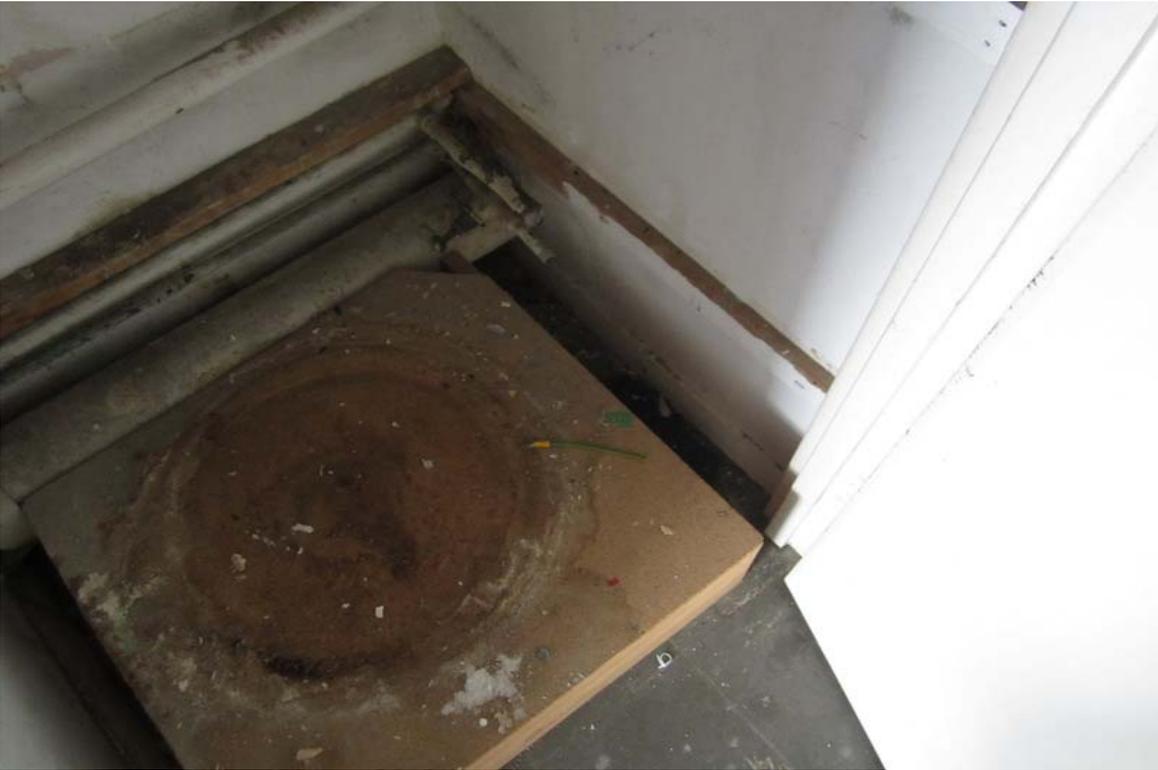
Photo Number	154	Reference number	230316MW162
Inspection / Sample	Inspection	Inspection Cross Reference / Visual I.D.	230316MW72

Notes	ACM: Asbestos Containing Material

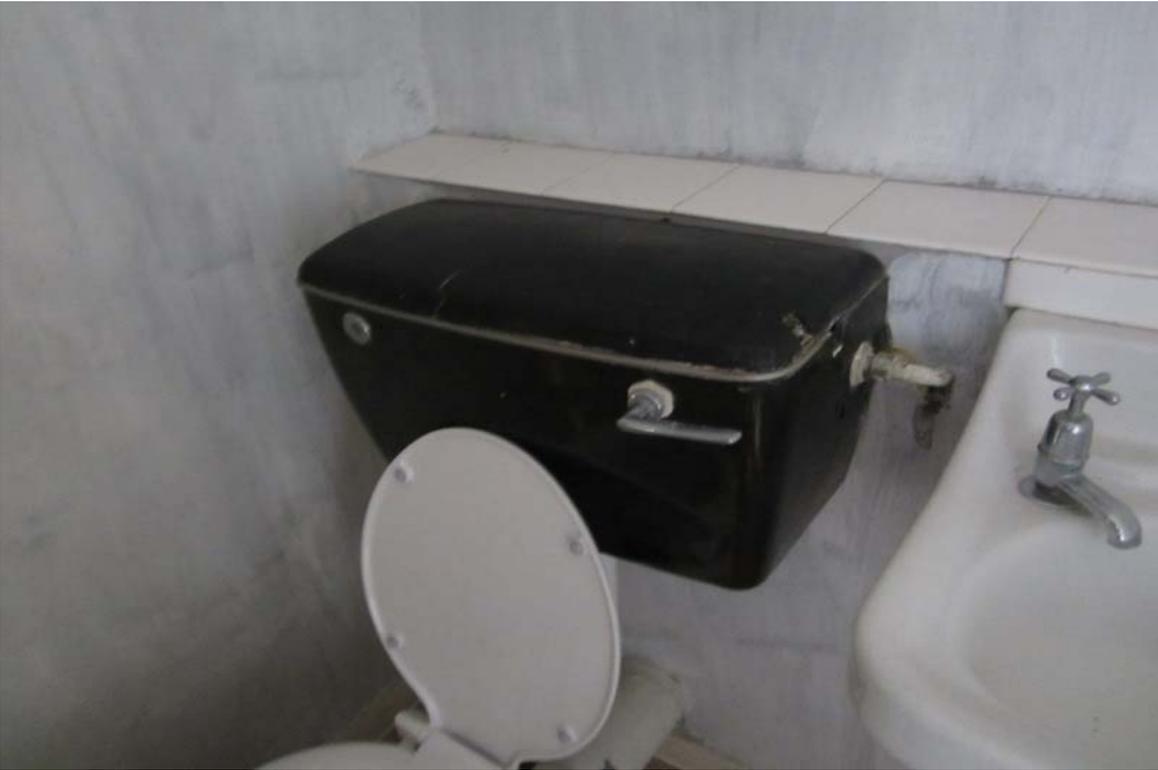
Photo Number	155	Reference number	230316MW163
Inspection / Sample	Inspection	Inspection Cross Reference / Visual I.D.	220316MW20

Notes	ACM: Asbestos Containing Material

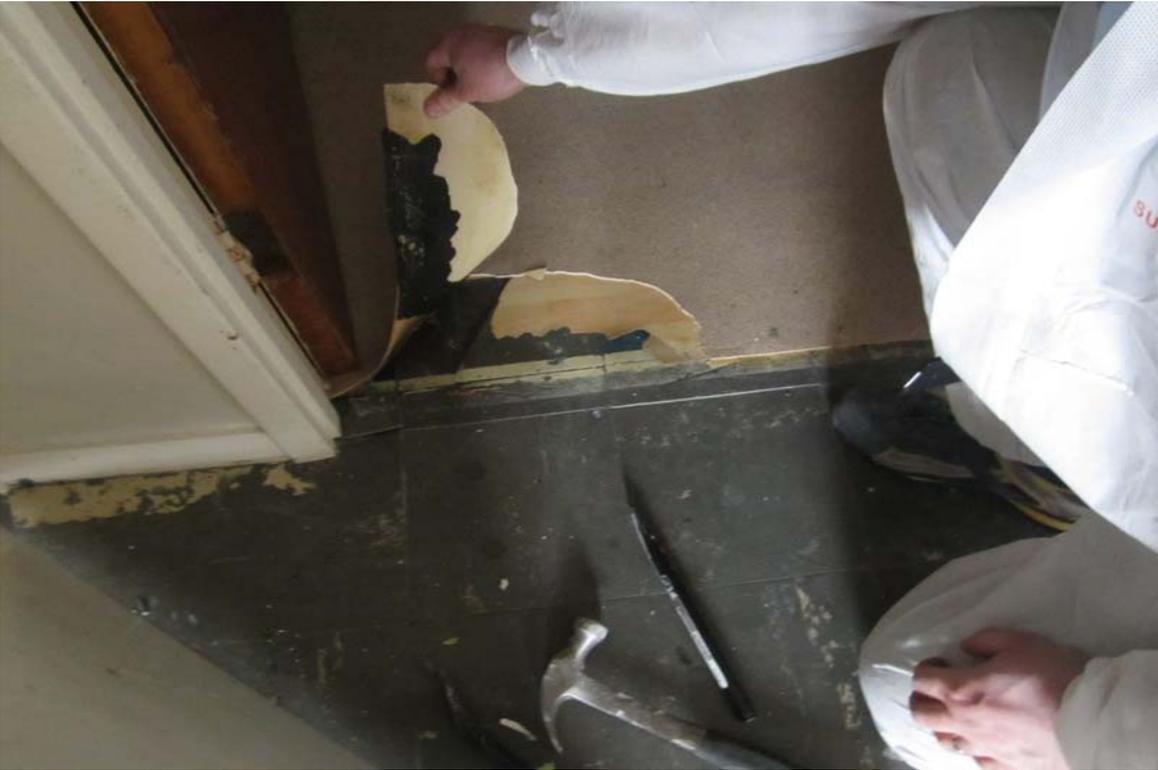
Photo Number	156	Reference number	230316MW164
Inspection / Sample	Inspection	Inspection Cross Reference / Visual I.D.	230316MW81

Notes	ACM: Asbestos Containing Material

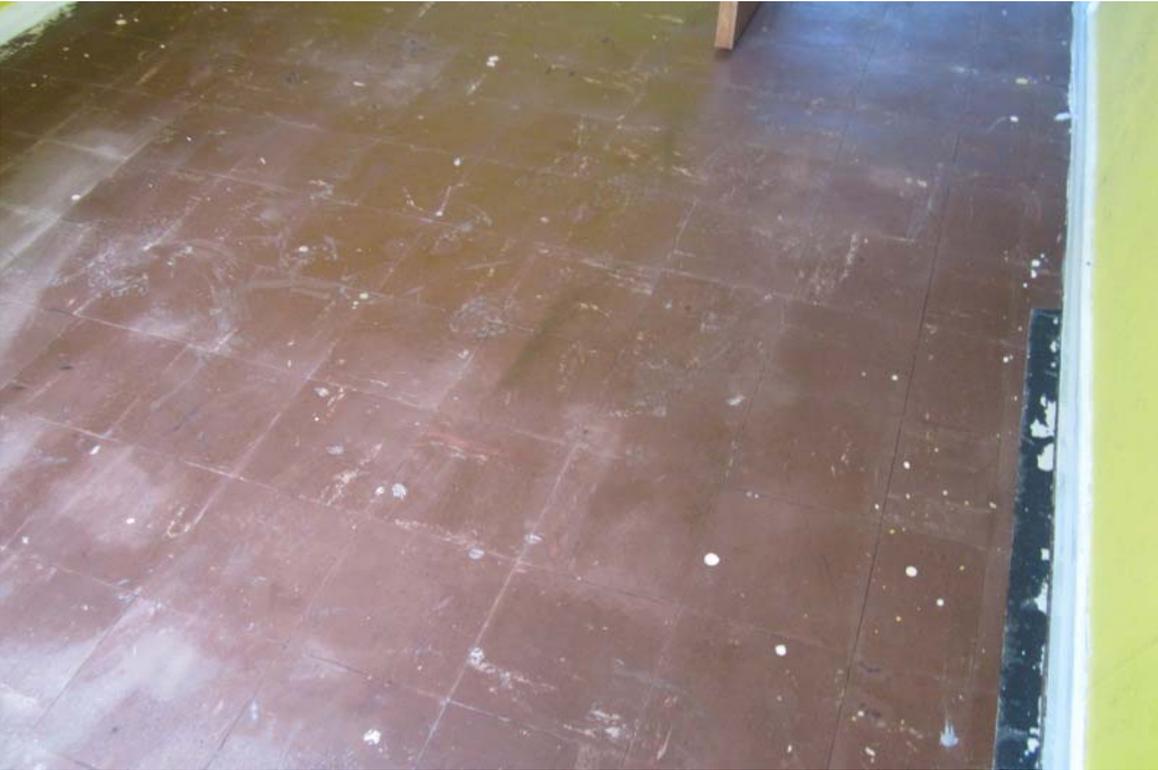
Photo Number	158	Reference number	230316MW166
Inspection / Sample	Inspection	Inspection Cross Reference / Visual I.D.	230316MW70

Notes	ACM: Asbestos Containing Material

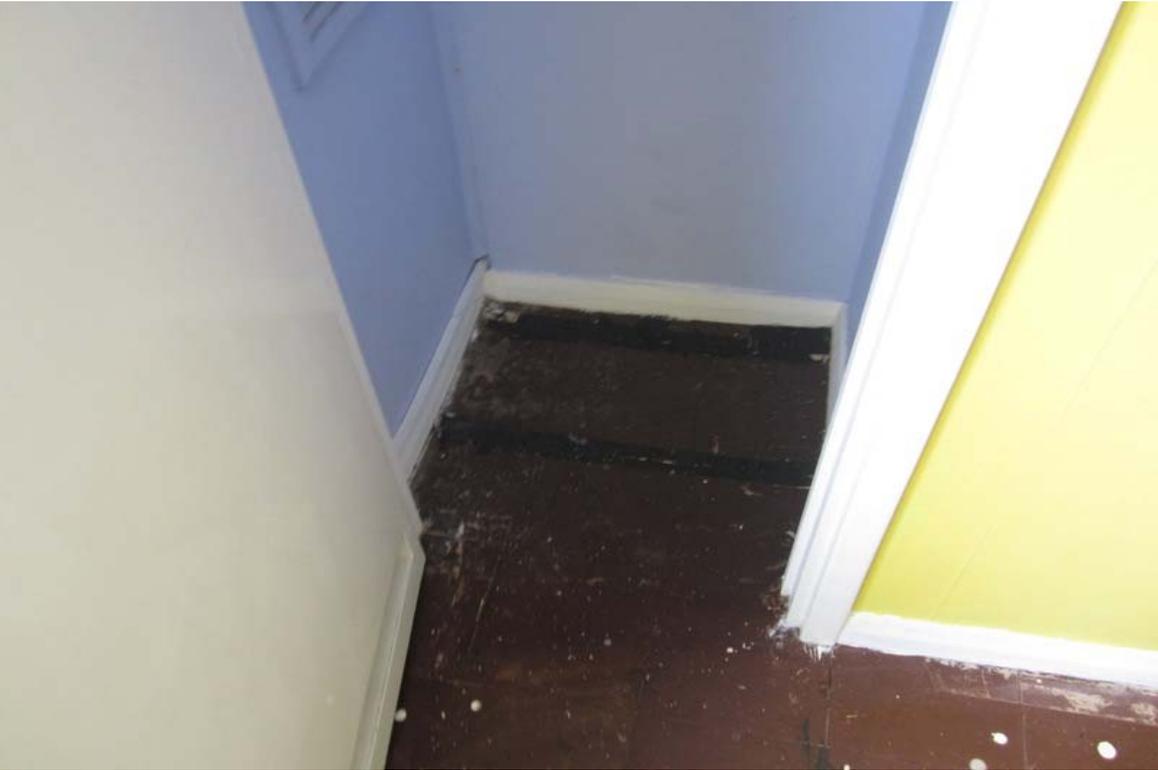
Photo Number	159	Reference number	230316MW167
Inspection / Sample	Inspection	Inspection Cross Reference / Visual I.D.	230316MW70

Notes	ACM: Asbestos Containing Material

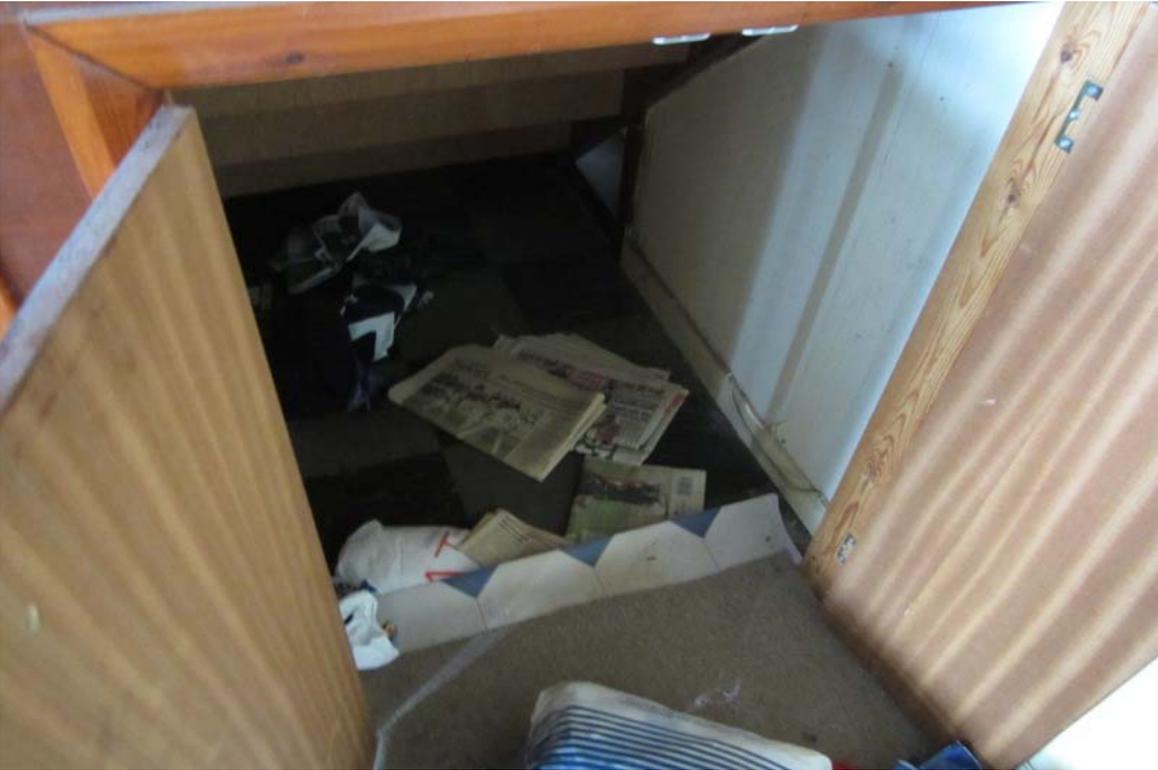
Photo Number	161	Reference number	230316MW171
Inspection / Sample	Inspection	Inspection Cross Reference / Visual I.D.	230316MW72

Notes	ACM: Asbestos Containing Material

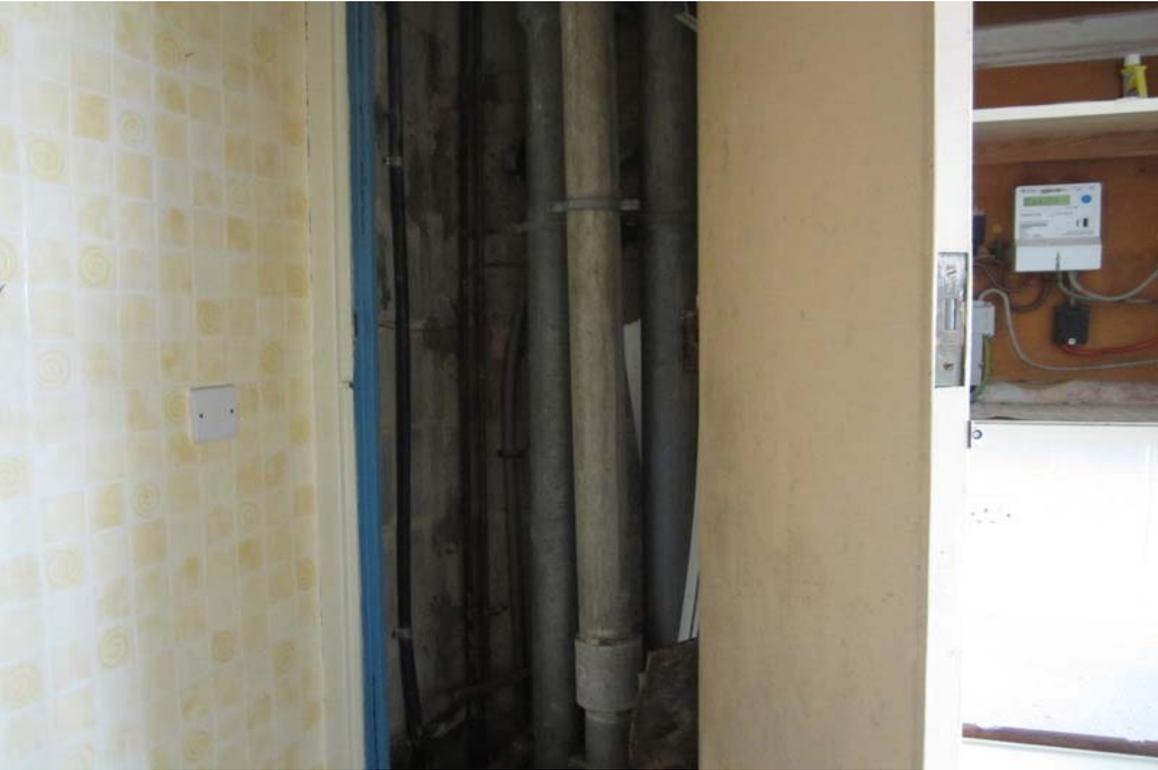
Photo Number	165	Reference number	230316MW175
Inspection / Sample	Sample	Inspection Cross Reference / Visual I.D.	Not Applicable

Notes	ACM: Asbestos Containing Material

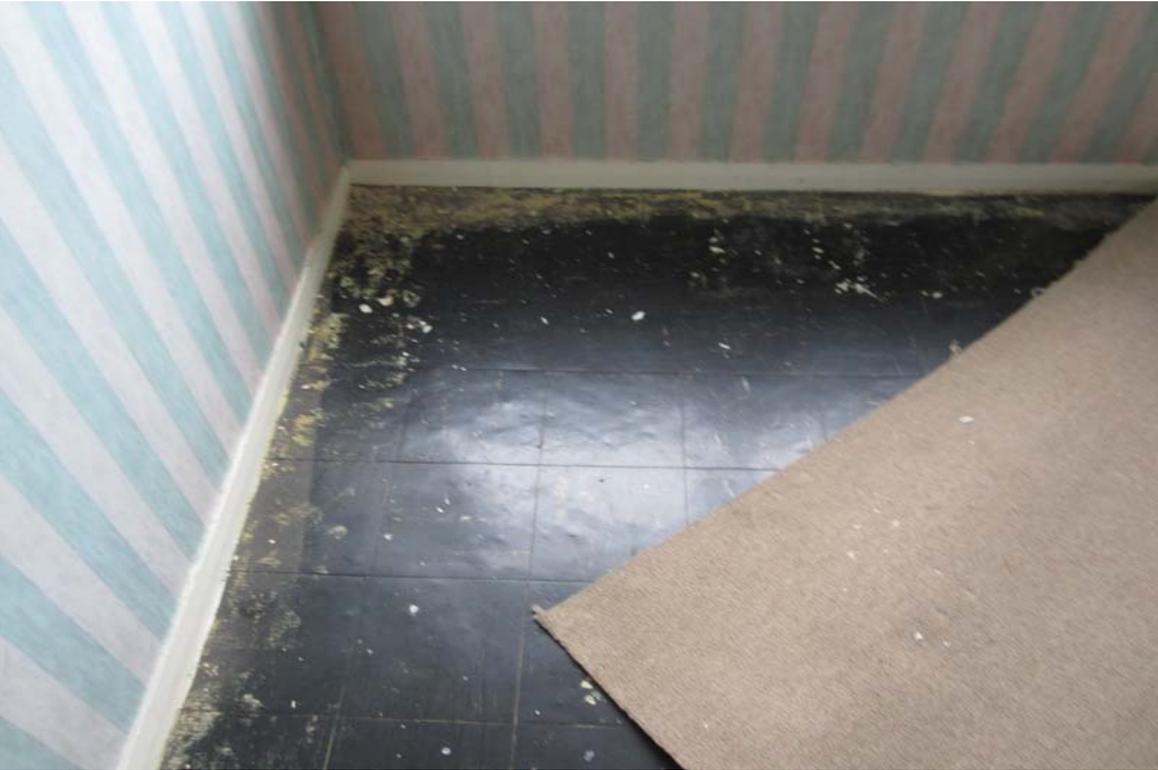
Photo Number	166	Reference number	230316MW176
Inspection / Sample	Inspection	Inspection Cross Reference / Visual I.D.	230316MW72

Notes	ACM: Asbestos Containing Material

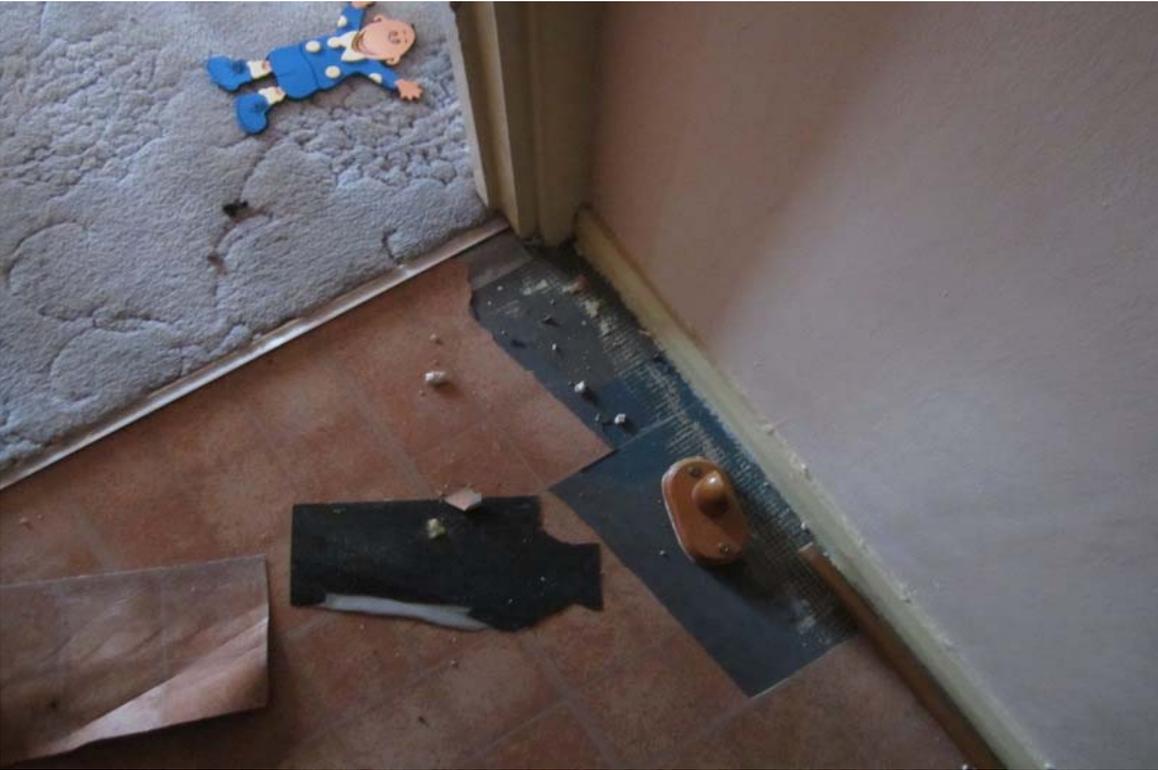
Photo Number	173	Reference number	230316MW183
Inspection / Sample	Inspection	Inspection Cross Reference / Visual I.D.	230316MW81

Notes	ACM: Asbestos Containing Material

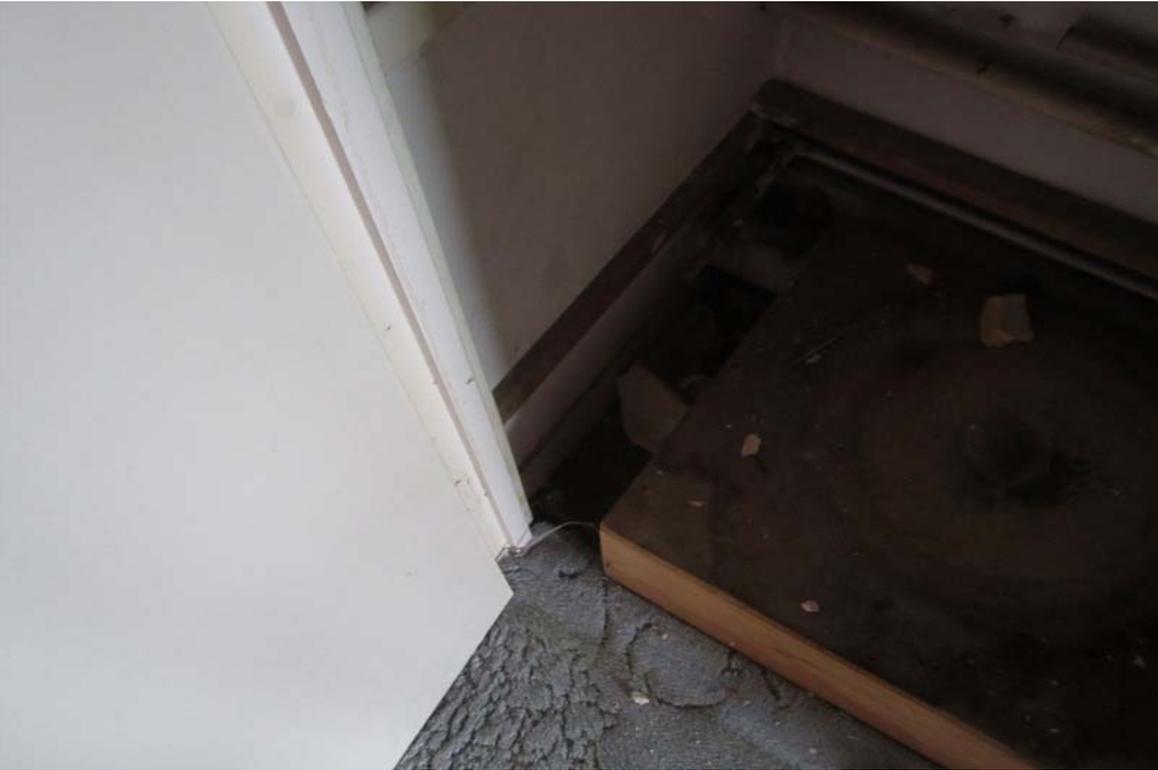
Photo Number	174	Reference number	230316MW184
Inspection / Sample	Inspection	Inspection Cross Reference / Visual I.D.	230316MW72

Notes	ACM: Asbestos Containing Material

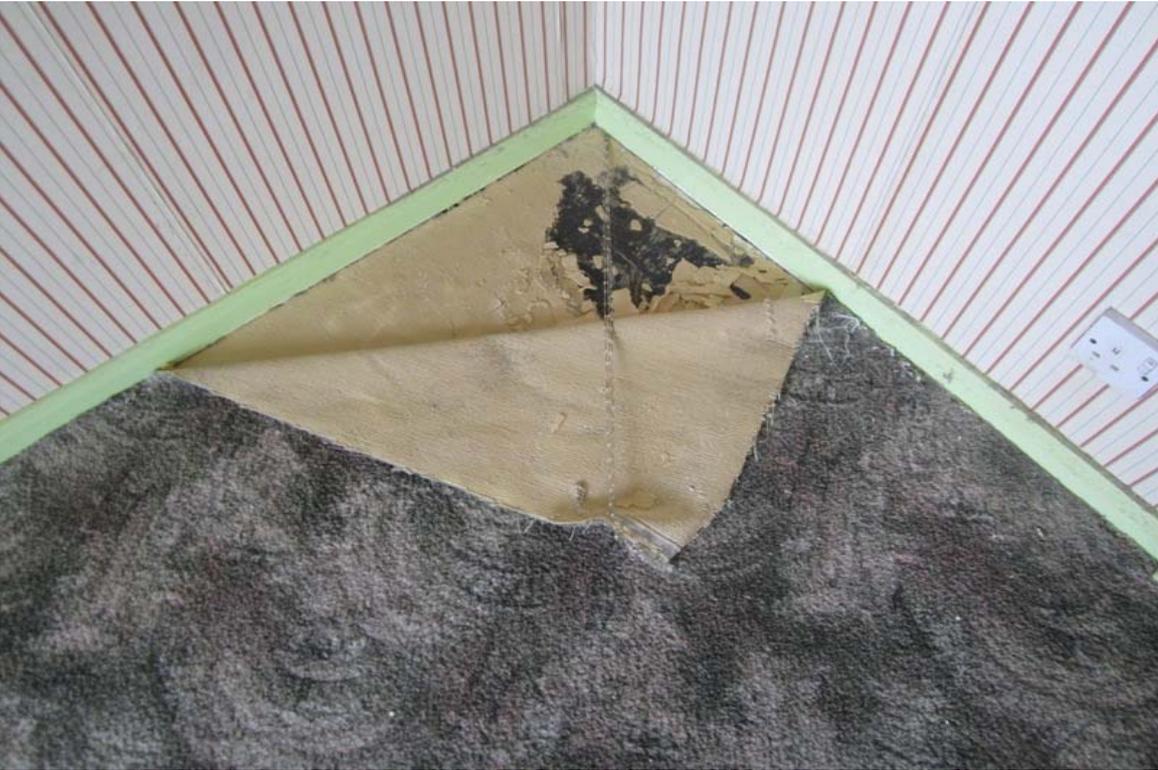
Photo Number	176	Reference number	230316MW186
Inspection / Sample	Inspection	Inspection Cross Reference / Visual I.D.	230316MW72

Notes	ACM: Asbestos Containing Material

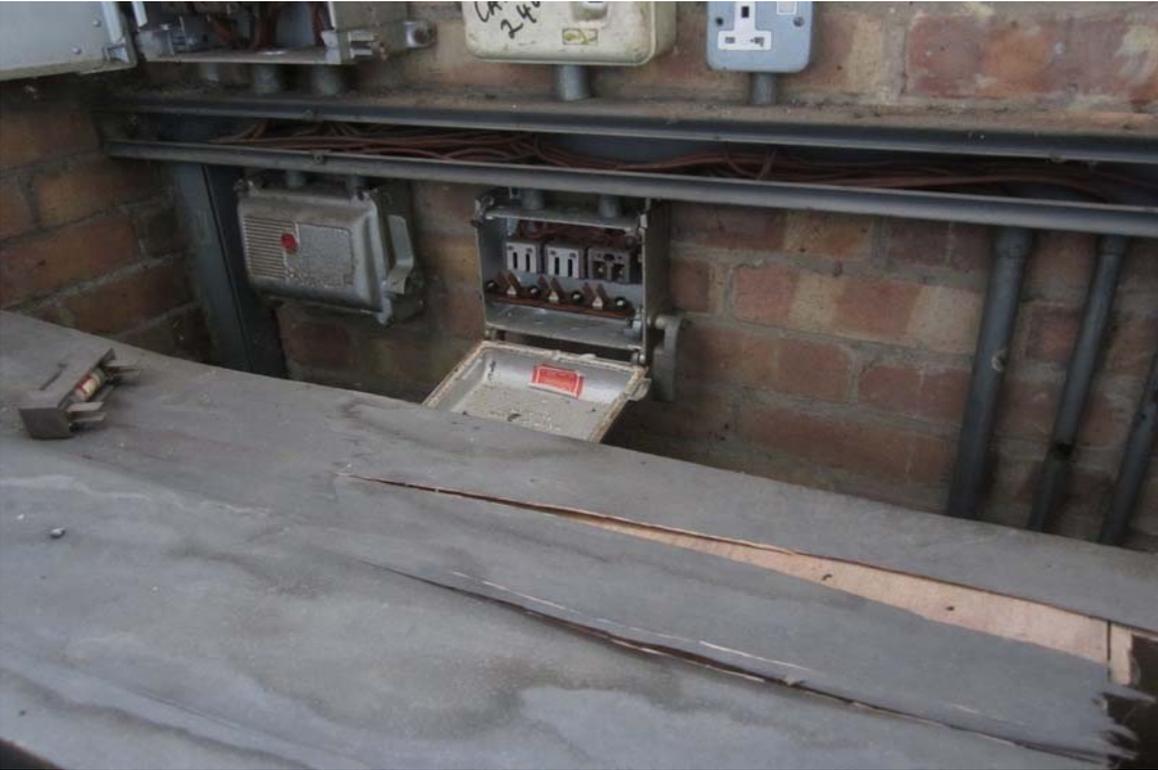
Photo Number	177	Reference number	220316MW31
Inspection / Sample	Sample	Inspection Cross Reference / Visual I.D.	Not Applicable

Notes	ACM: Asbestos Containing Material

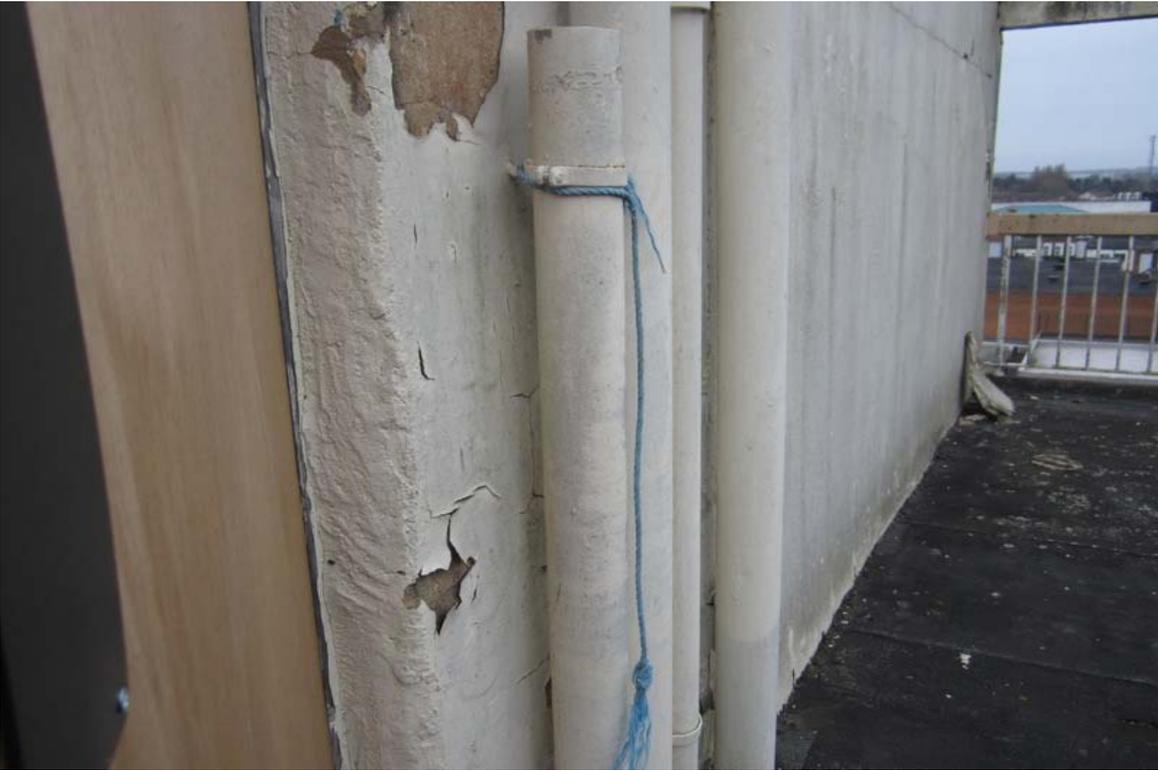
Photo Number	184	Reference number	240316MW194
Inspection / Sample	Inspection	Inspection Cross Reference / Visual I.D.	240316MW193

Notes	ACM: Asbestos Containing Material
