Building Survey
1 Cattle Market, Hexham

Summary Building Survey

**1 CATTLE MARKET
HEXHAM
NORTHUMBERLAND
NE46 1NJ**

DATE: October 2021

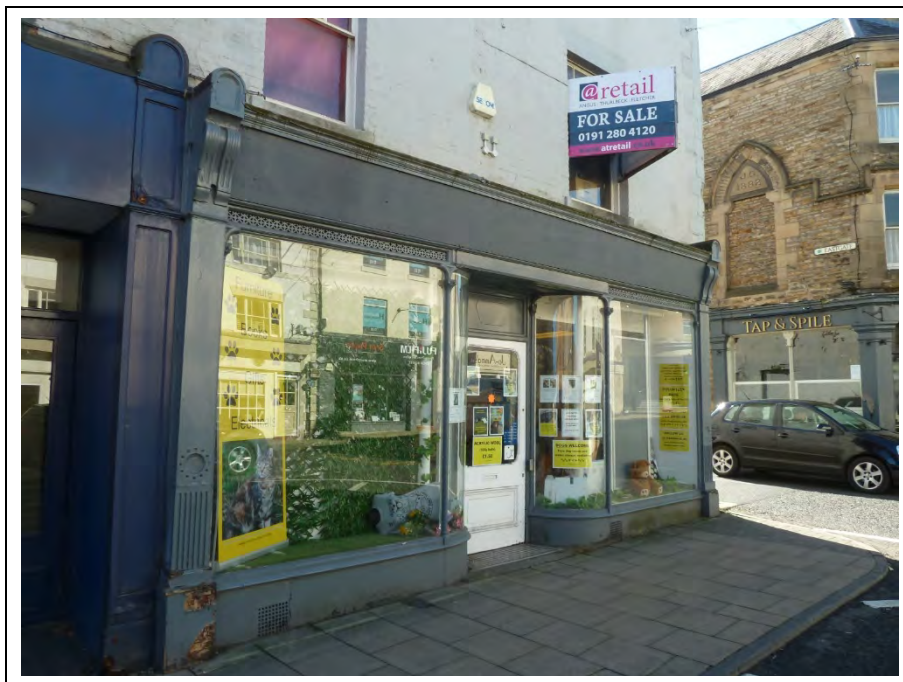
2. Damaged shop front at low level

3.3	<p>At ground floor level, the building has two shopfronts. These were previously occupied by William Hill to the left section of the property and Boots The Chemist to the right section of the property. A decorative Victorian-style shopfront is incorporated with curved glazing and a recessed principal entrance into the subject property. Timber and plywood panelling at low level is suffering from wet rot. At high level the shopfront extends out slightly from the principal elevation. Detritus and damp is noted to the elevation in this location. We recommend that this section is cleaned down and new flashings are incorporated. At low level the shopfront should be repaired, with sections of damaged plywood replaced.</p>	●

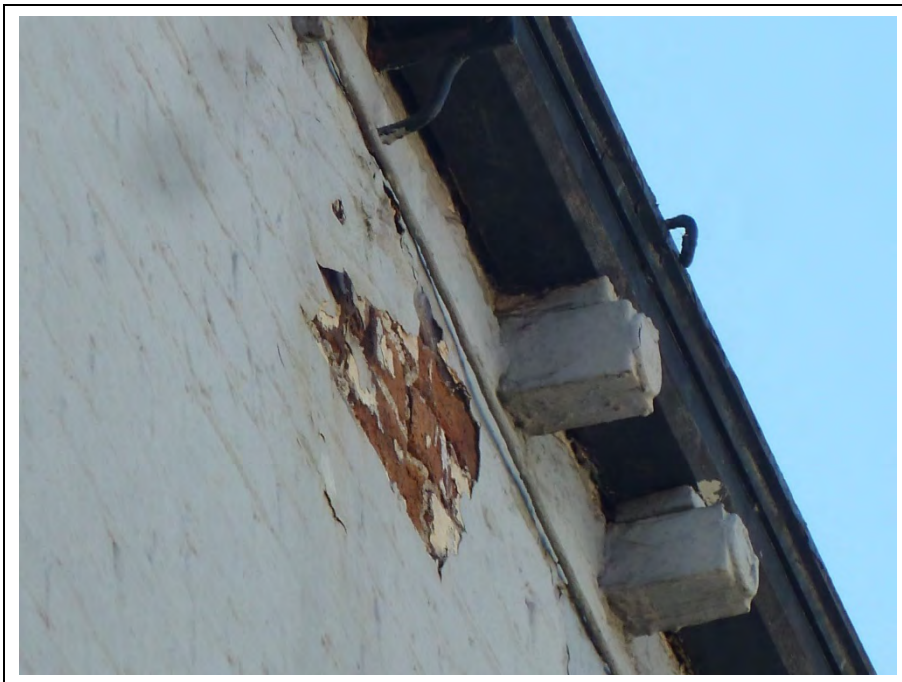
3. Spalling bricks at high level to front elevation

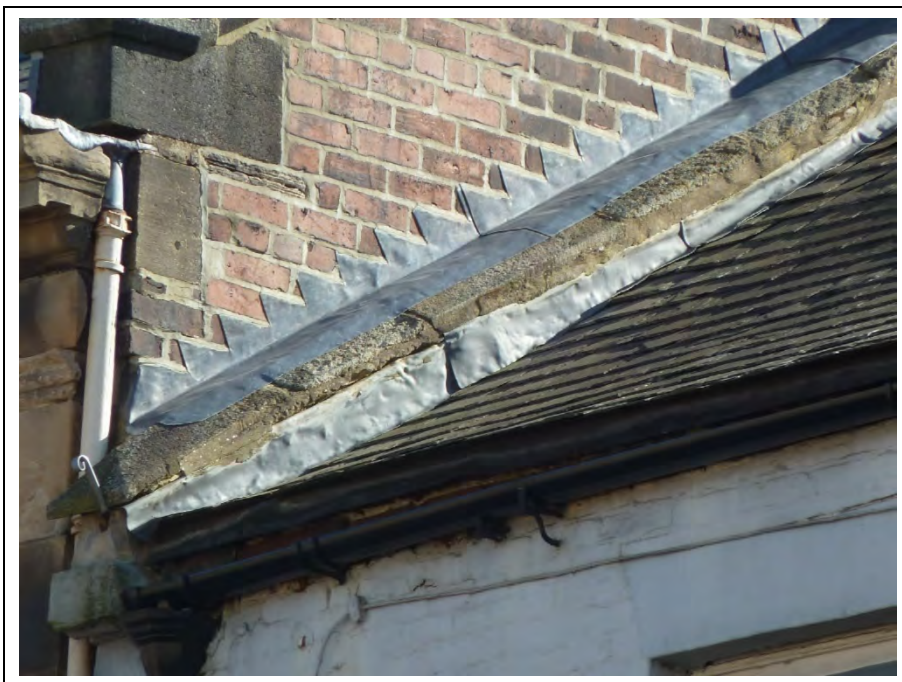
4. Good condition flashings to front pitch of front roof

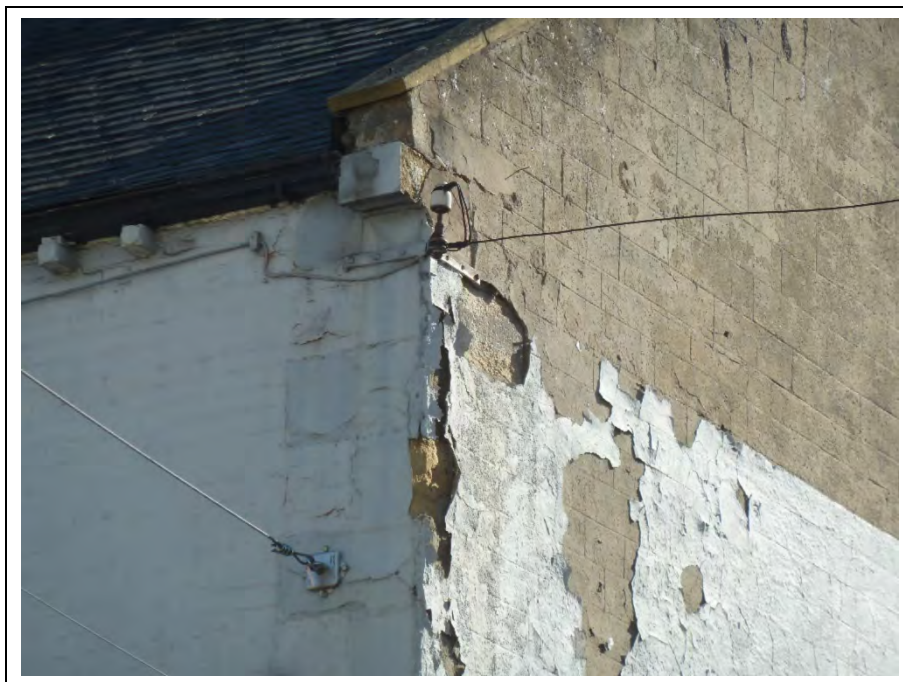
6. Peeling paint to render along right elevation

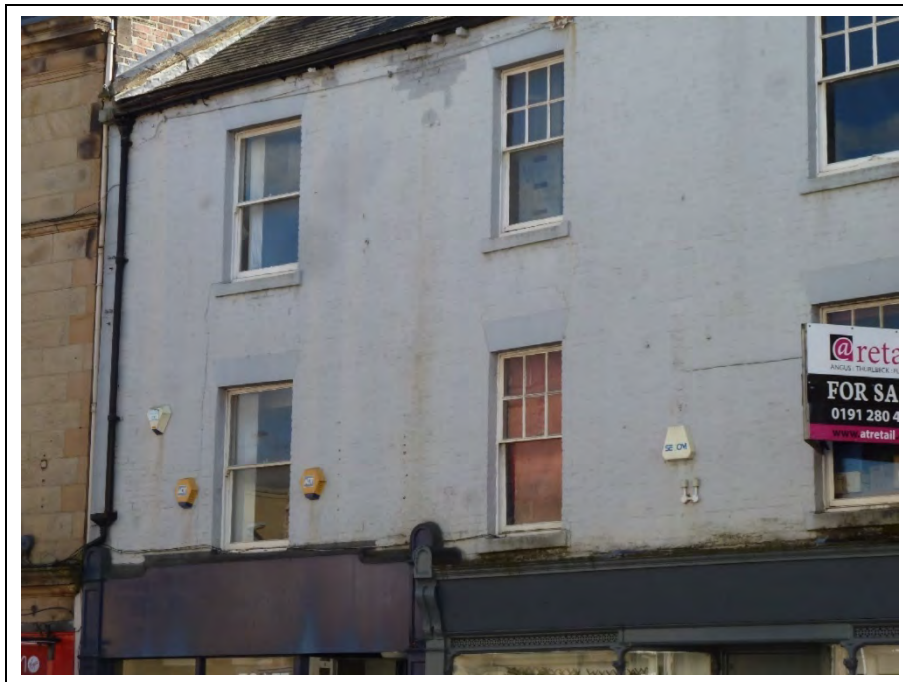
7. Poor detail between two types of gutter causing staining to elevation

2.2	Rainwater discharges into leading edge gutters. These are a combination of ogee profile gutters over the subject property and half-round cast iron gutters to the adjacent property to the left. The rainwater discharges into the cast iron hopper heads and downpipe fixed to the front elevation of the adjacent property. This subsequently discharges into a gully on the pavement and into the gutter on the road in front. There is evidence of staining to the front elevation caused by defective gutters at high level. This has caused saturation to the stonework which has been patch-repaired in part. This is particularly prevalent where the properties meet where the ogee profile gutters remain on the subject property and the half-round gutters have been used on the adjacent property. We recommend that the gutter is replaced along the front elevation to both properties creating one uniform design to prevent this weak point at the junction.	●

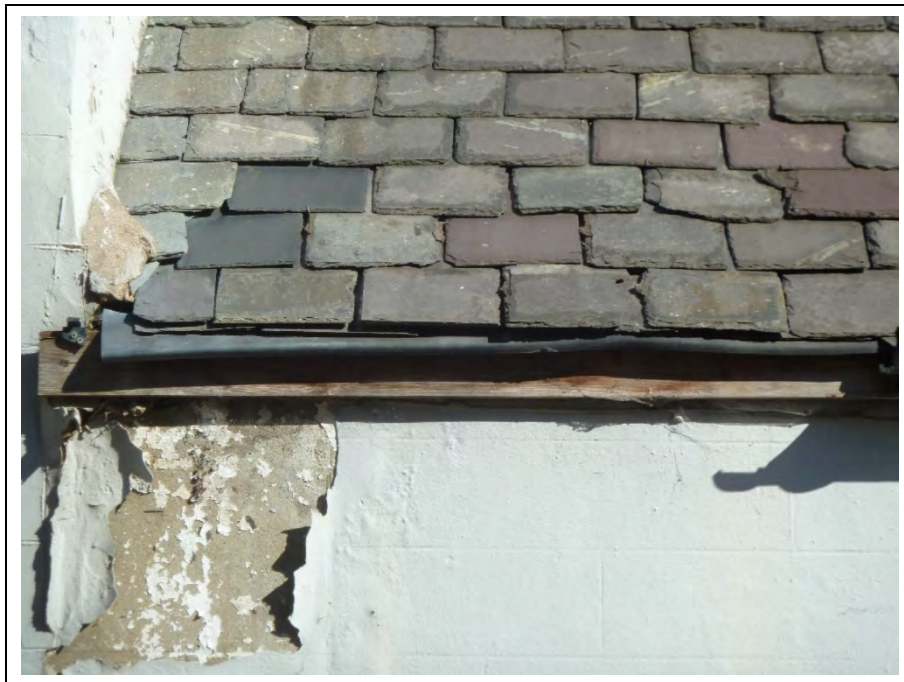
2.6	We suspect that vehicle traffic has impact-damaged the guttering along the left corner of this roof. A section of the gutter is missing. We recommend that this gutter is replaced. Whilst the gutter is temporarily removed, this opportunity should be taken to decorate the fascia boards behind. The lack of this gutter has caused an accelerated deterioration of the old render finish below.	●

9. Impact damage to guttering

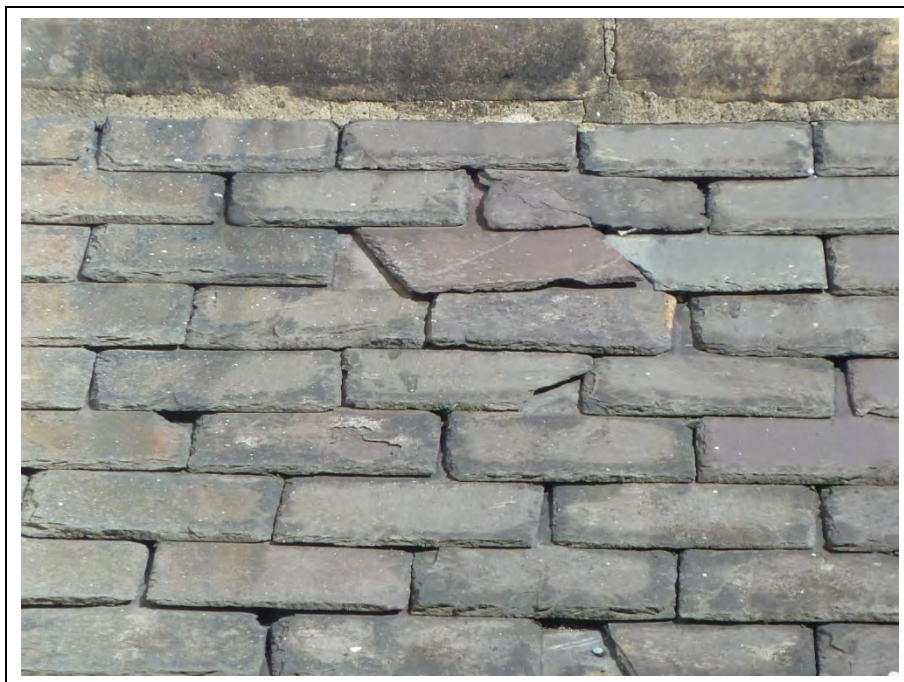
10. Slipped and damaged slates to mid section roof

support on the leading edges are replaced. It was noted that one was missing at the front right corner.	
2.5	The link building in the centre of the property is single-storey. This has a dual-pitched roof with double-lap slate covering. There are a number of cracked and missing slates across this roof. Patch repairs are noted in a number of locations. We did not have access to the roof void within this area and therefore cannot comment on the presence of a sarking felt or conditions of the timber elements within. We recommend that a roofing contractor is engaged to replace the missing and cracked slates.	●

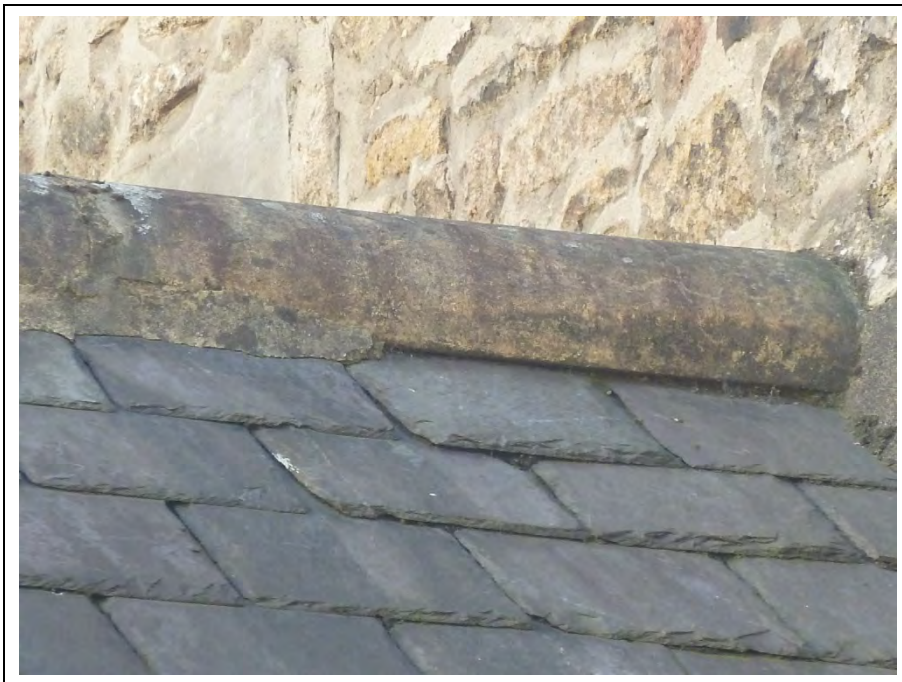
11. Missing cement bedding to ridge tiles

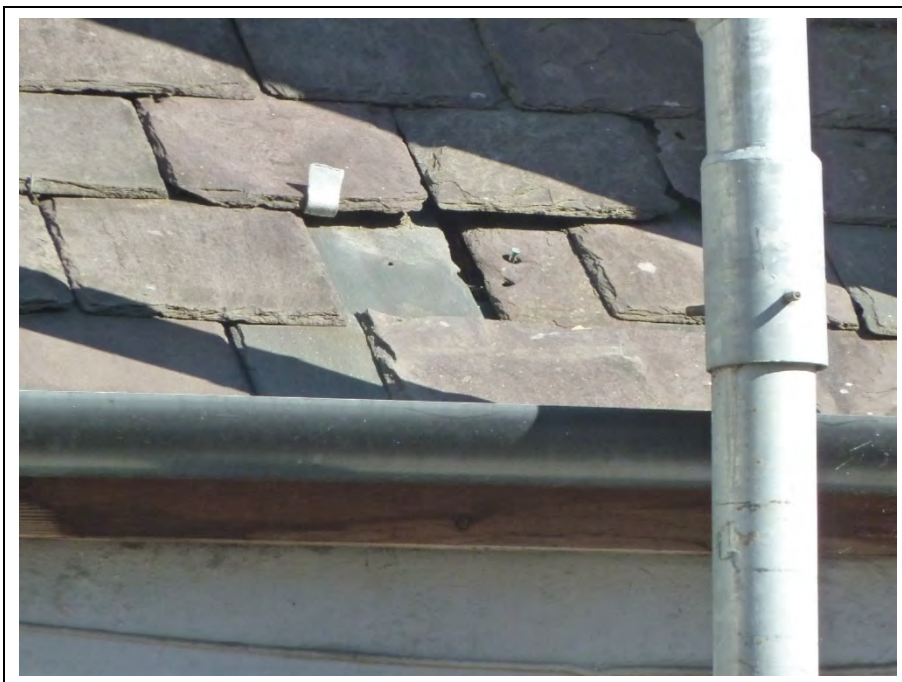
12. Missing slates and lead tingles noted to mid section roof

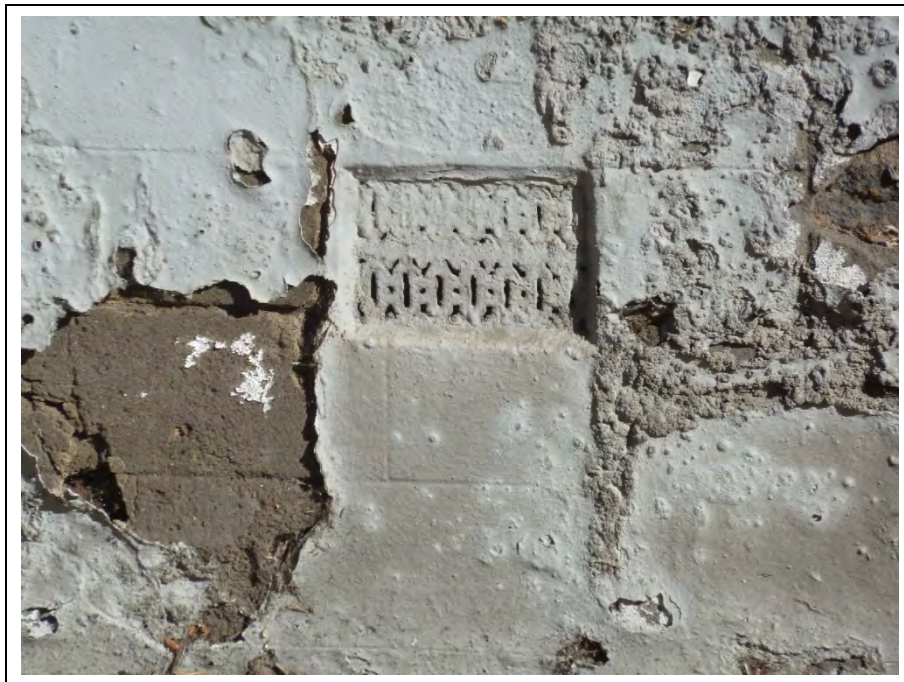
13. Historic air vents to right elevation

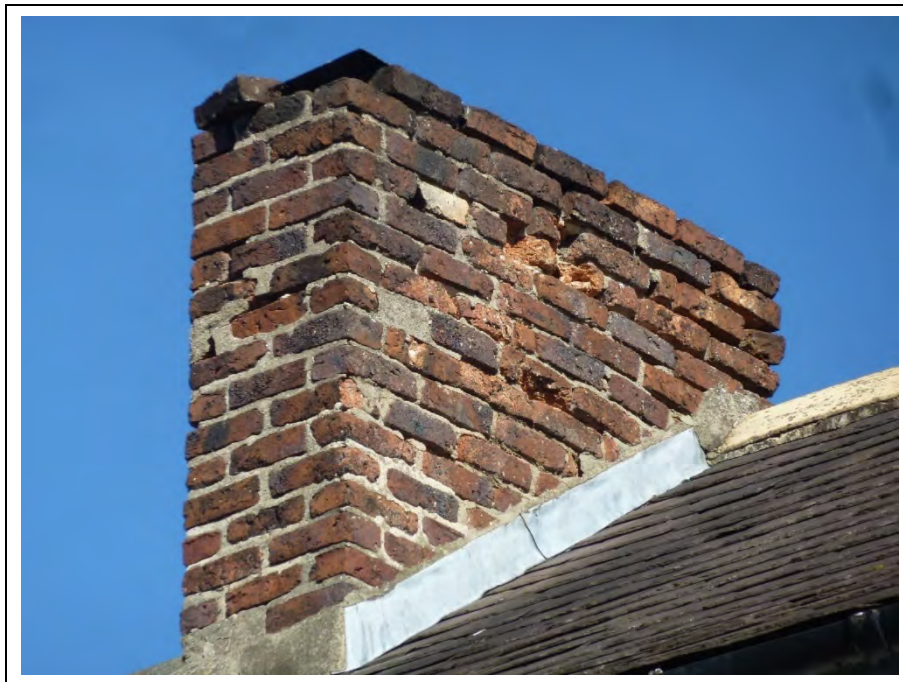
2.10	<p>A brickwork chimney stack is located on the boundary/party wall with the adjacent premises at the very rear, rising up through the roof with a combination of lead and cement flashings. The brickwork is in a very poor state of repair with recessed mortar joints and worn bricks. Chimney pots have been removed with slate used to cap the chimney. We recommend that once safe access is provided by way of a scaffold, an allowance is made for rebuilding this chimney stack and capping appropriately with a ventilation cowl.</p>	●

15. Defective chimney stack to rear section

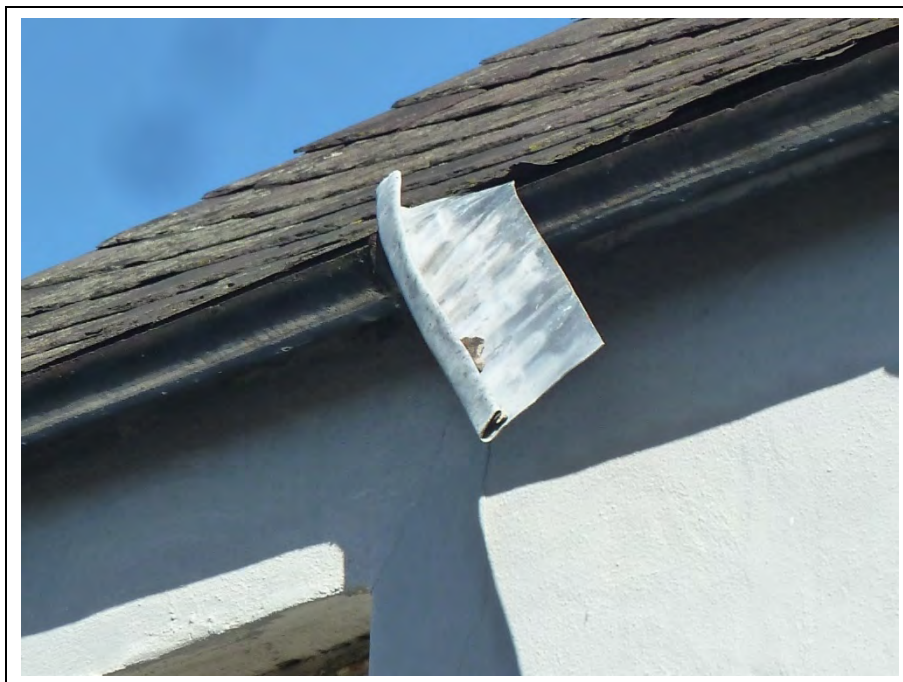
2.11	<p>To the three-storey rear section of the property there are sections of lead flashings coming away from the chimney stack dangerously hanging from the gutter detail. This requires repairs to the chimney on the party wall line. We recommend that this lead flashing is repaired in the short term to prevent a potential health and safety hazard.</p>	●
3	Walls and Cladding

16. Loose section of lead flashing fallen from chimney stack

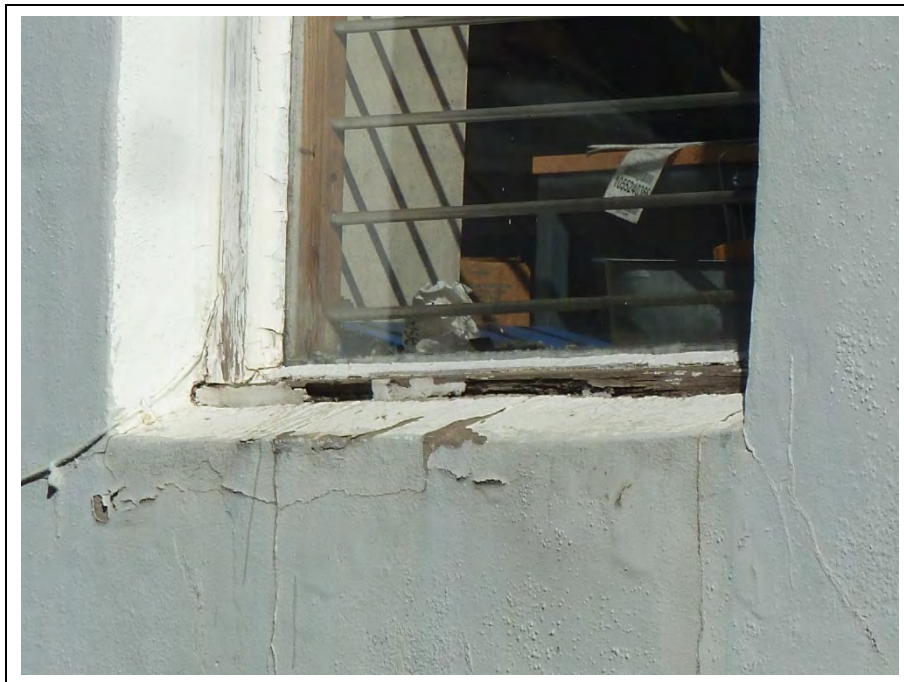
4.7	<p>The windows to the right elevation on the three storey section at the rear are single glazed timber framed units most likely dating from the 1970s or 1980s. These have worn sealant around the frames and a worn decorative finish. Early signs of wet rot are noted to the window frames. We recommend that an allowance is made for replacing these with modern double glazed units which will improve the thermal and acoustic performance of the building.</p>	●

17. Wet rot to windows to rear section

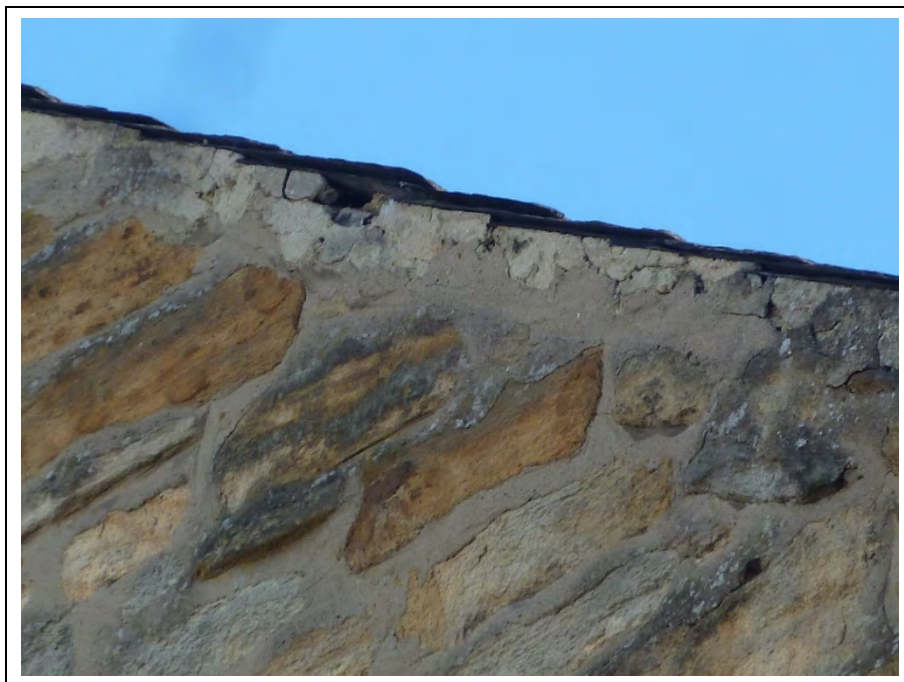
18. Worn verge detail to rear section

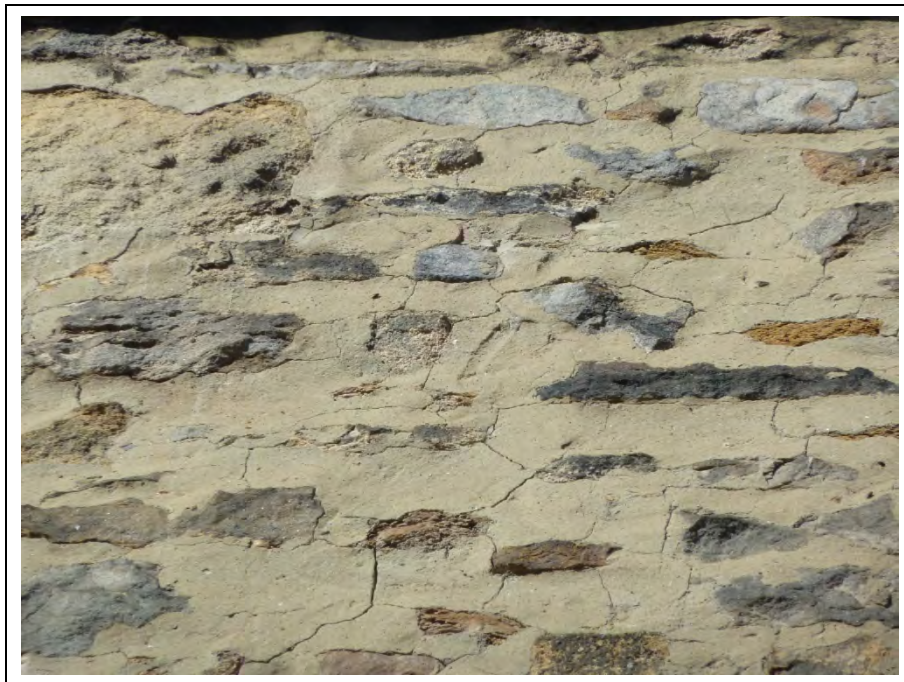
19. Poor quality pointing works to rear of front section

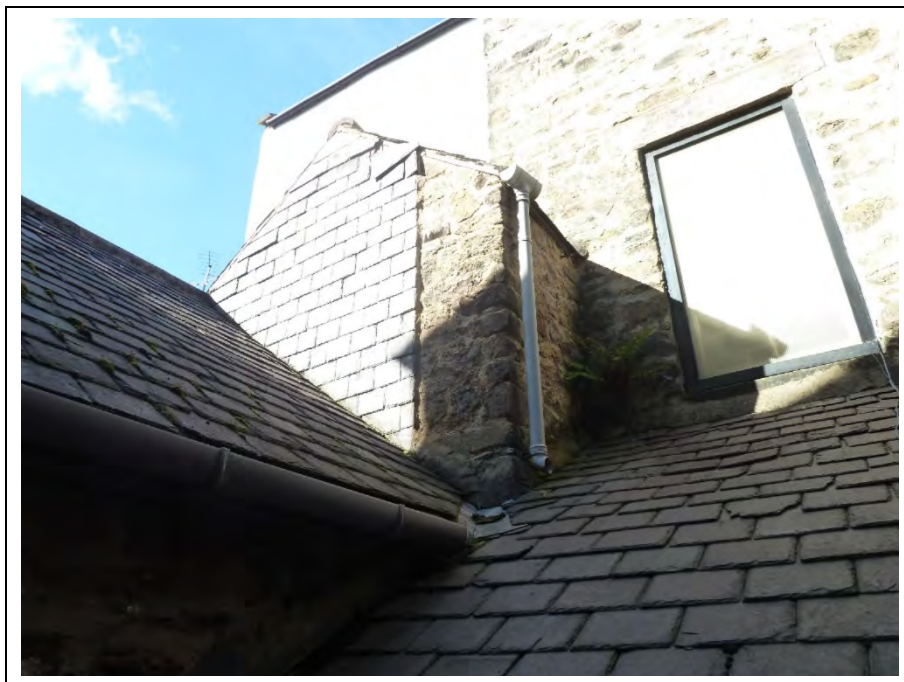
3.10	The rear elevation of the front section of the property is formed with stonework. Vegetation growth is noted from the stonework at first floor indicating retained moisture. This is most likely caused by the lack of gutter detail to a small section of roof on the rear of the front section of the property. Once this gutter is replaced this should remove the root cause of this damp issue and the stonework should be cleaned and repointed.	●
4	Windows and Doors

20. Missing section of gutter causing damp to stonework

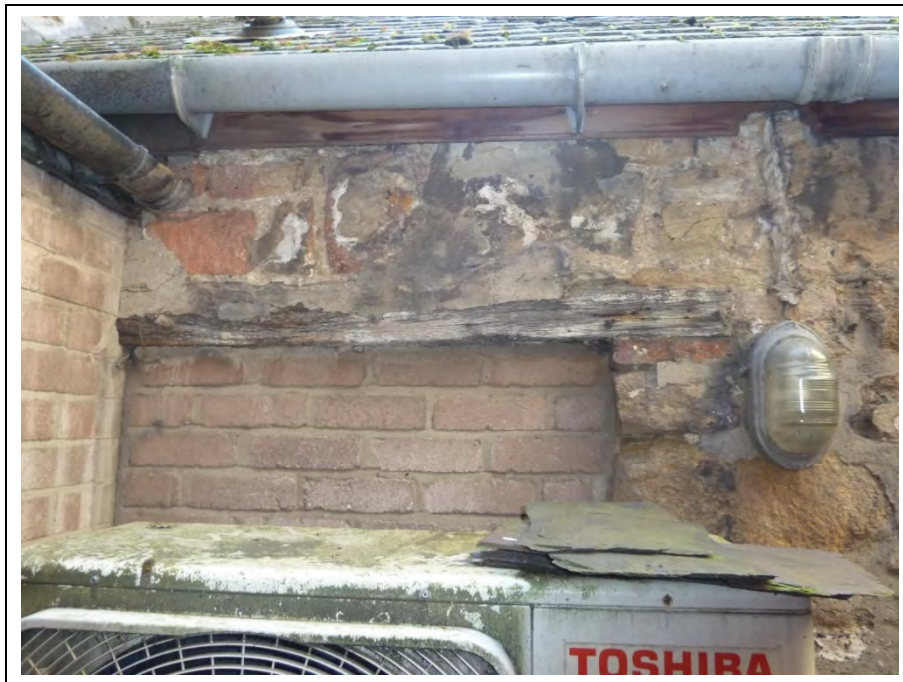
21. Rotten timber lintol over previous opening in courtyard

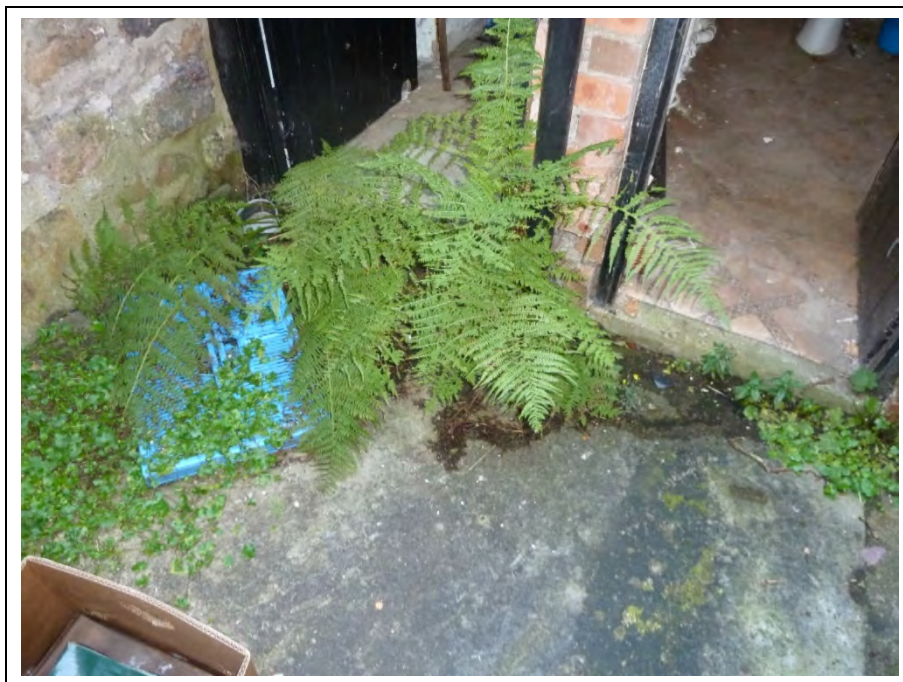
22. Blocked drain outlet in courtyard

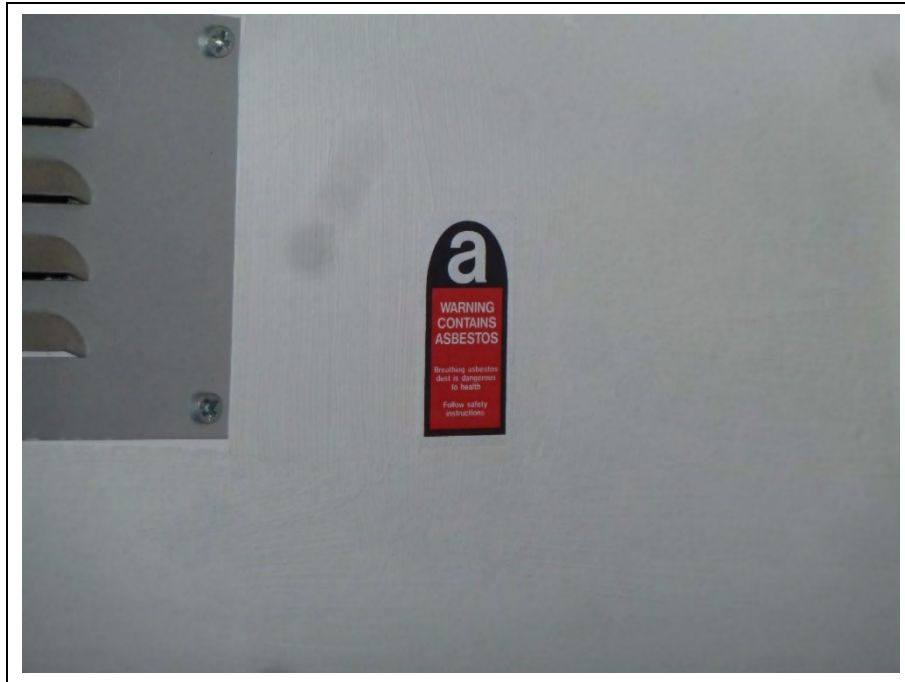
property an asbestos sticker is noted to a panel above a door leading into the rear stairwell. We recommend copies of the most recent asbestos survey report/register is obtained from the vendor.

23. Asbestos sticker to panel above internal door frame

12.1	We recommend that a copy of the most recent asbestos register is obtained and reviewed.	●
12.2	During any refurbishment or reconfiguration works careful consideration with regard to fire protection to structural elements, fire compartmentation and fire detection should be considered for this property. Any future layouts should be reviewed by an approved building control surveyor or fire officer for their comments and advice.	●
13	Environmental Considerations

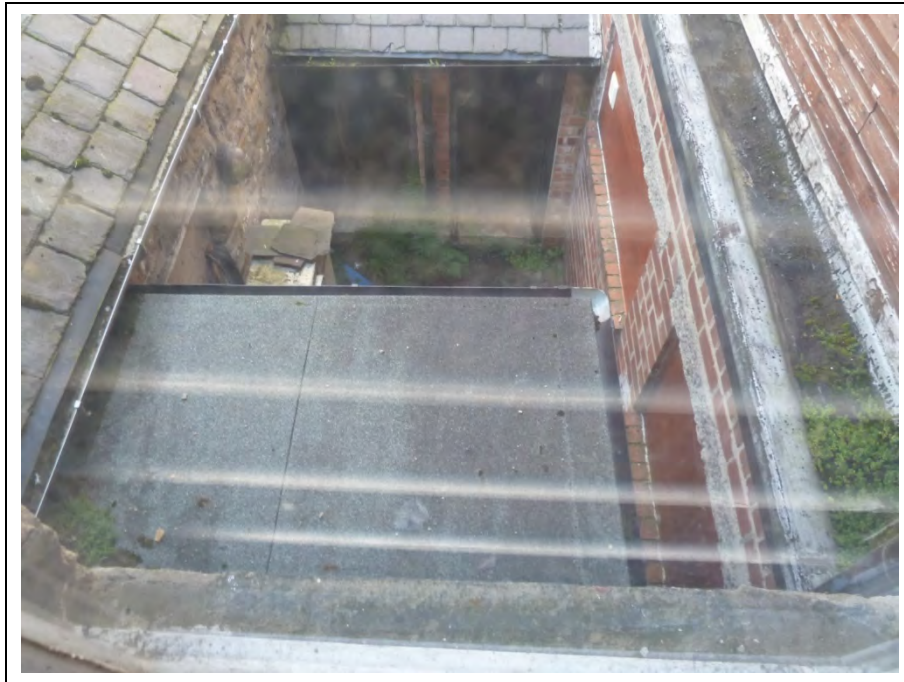
1.3	A porch area has been installed on the rear of the building, creating access into the courtyard area. The purpose of this small porch is not obvious. The porch is formed with a half-brick thick walls and a flat roof, most likely in the 1950s. This is in a poor state of repair. We understand from discussions that this would be demolished under any conversion schemes, as this area is converted into a garage area for the dwellings above.

25. Plat roof over porch in courtyard

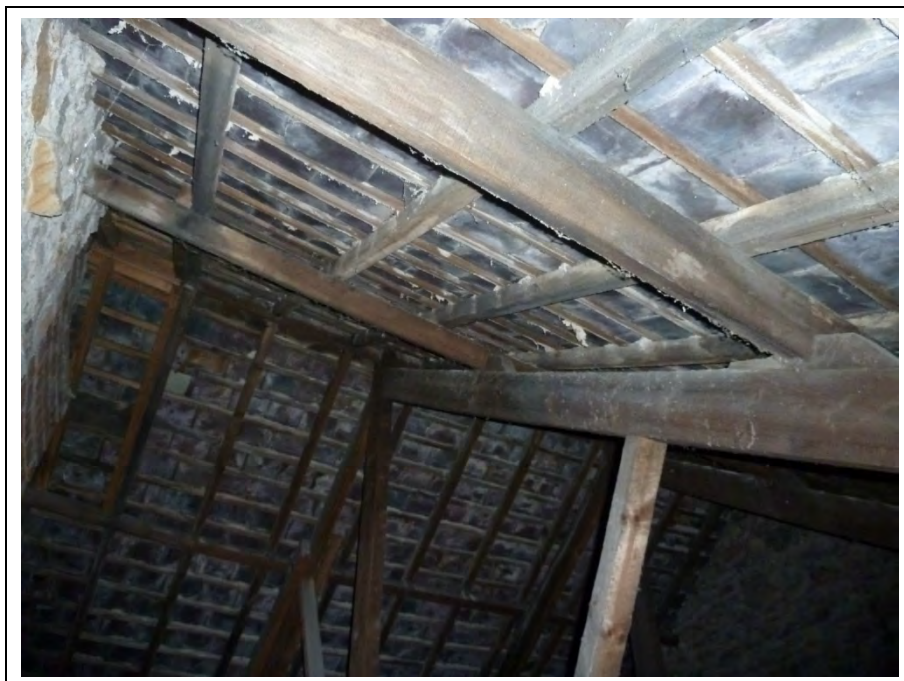
26. Roof void in rear section showing no sarking felt and kingpost design truss

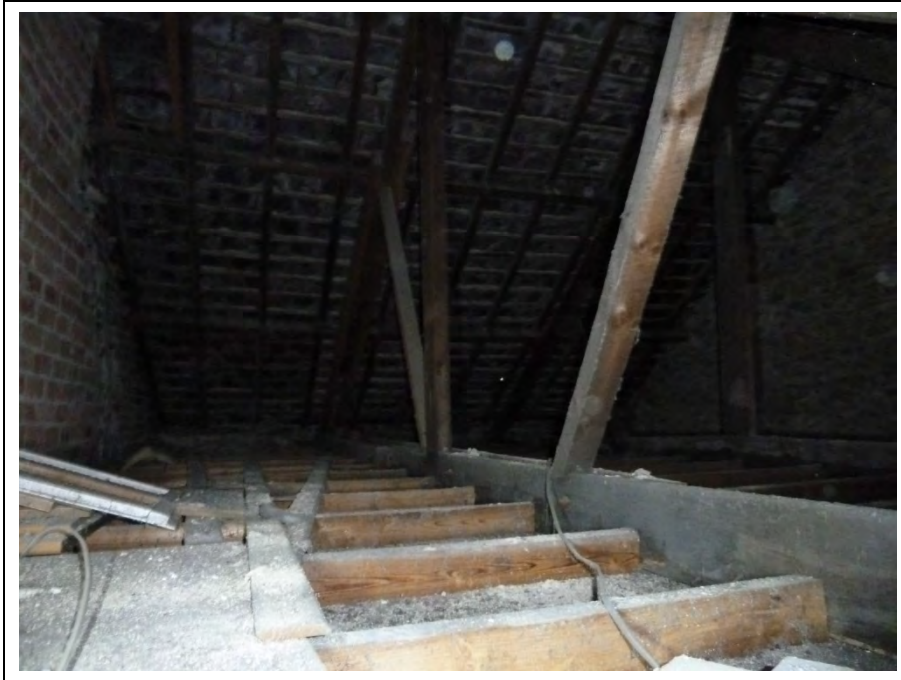
27. Roof void in rear section – note no insulation

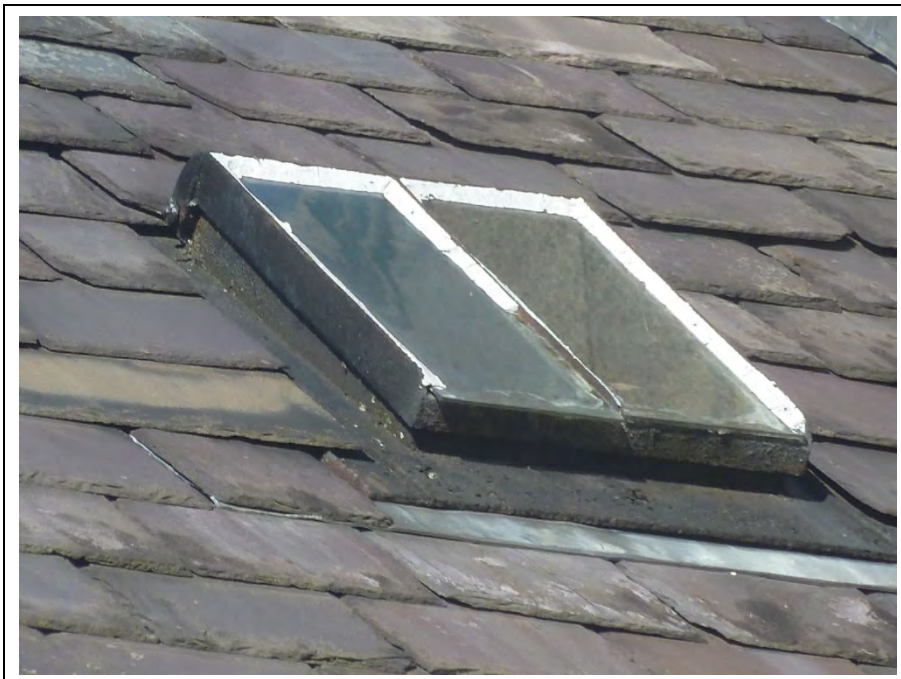
28. Metal roof light on rear pitch of adjoining property

2.8	The rear pitch of the building above William Hill incorporates rooflights. These are simple single-glazed metal-framed units. If it is the intention to purchase this section of the property and incorporate a refurbishment/conversion scheme to residential, we recommend you make an allowance to replace these rooflights with double-glazed Heritage units.	●

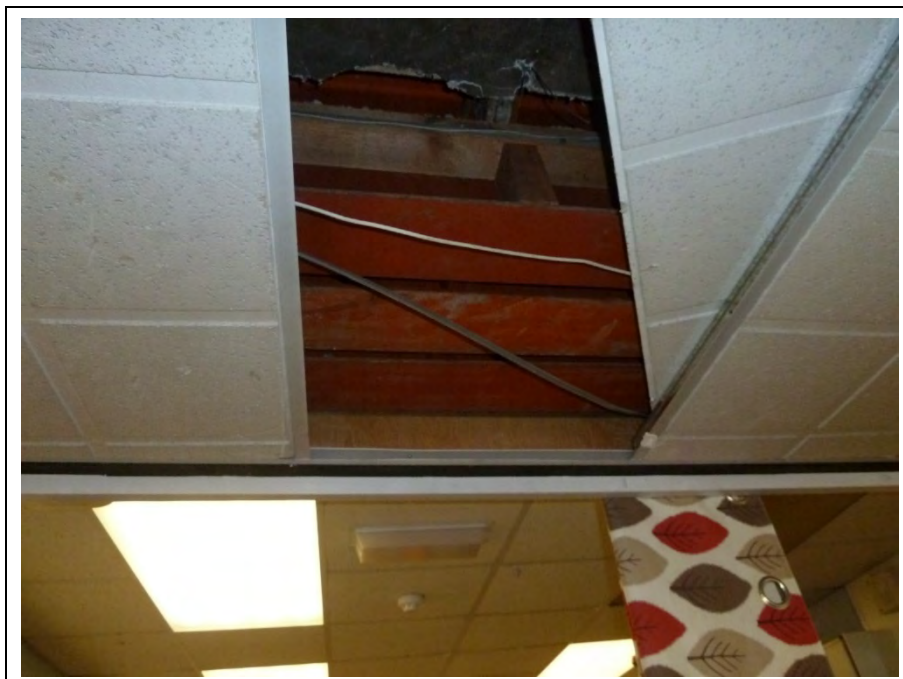
5.4	When viewing the exposed structural steelwork from within the suspended ceiling void, we noted that there is no fire protection to this steelwork. We recommend you allow for installing fire protection to the steelwork during any future refurbishment works.	●

30. Steel beams across width of retail area

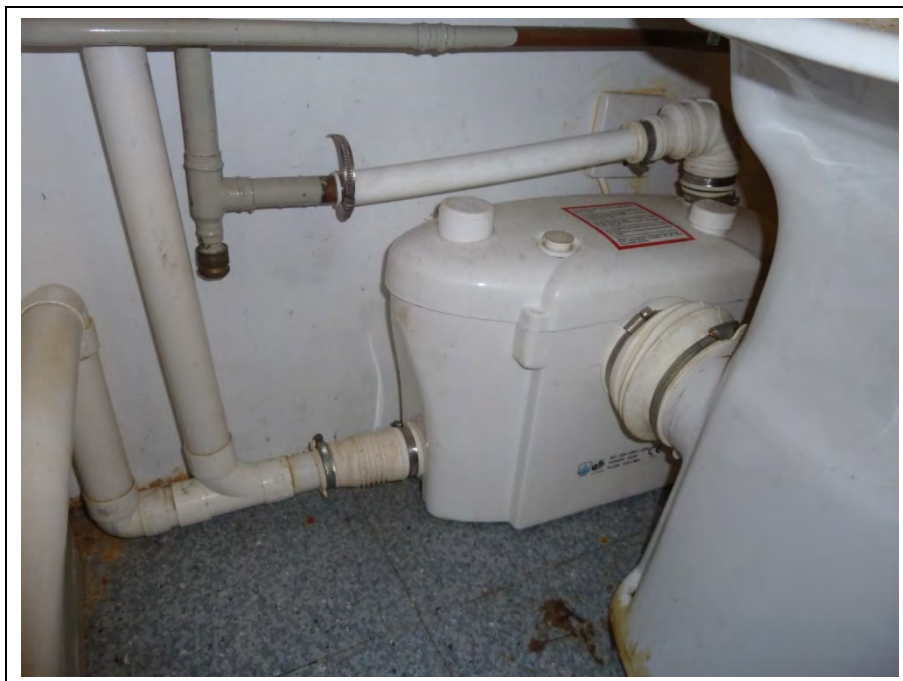
9.1	The property has a disabled WC facility at the rear of the retail space which was installed by Boots the Chemist. This is in a functional and a fair condition. However, the WC relies upon a saniflo digester system to pump the waste away from this location. We recommend an allowance is made for stripping this toilet out and all associated pipework.	●

32. Saniflow waste system in staff toilet

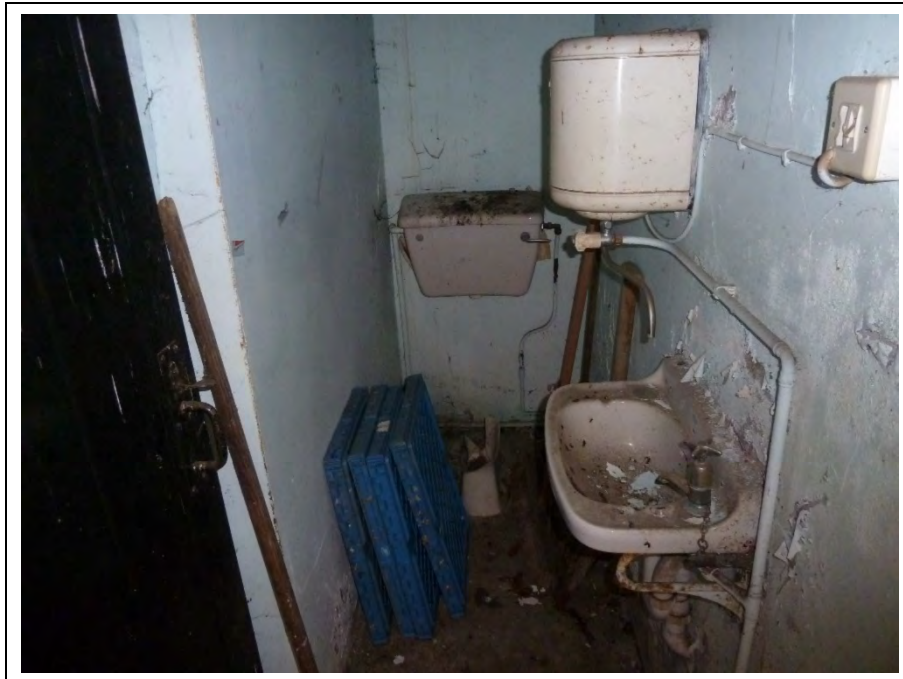
9.2	Originally the property had two separate WC toilets accessed from the external courtyard. These have not been used for many years and are in a poor state of repair. One of the WC units has been dismantled. We assume that these would be removed as part of the future plans. No WC accommodation is provided on the upper floors at present.	●

33. Historic w.c. accommodation

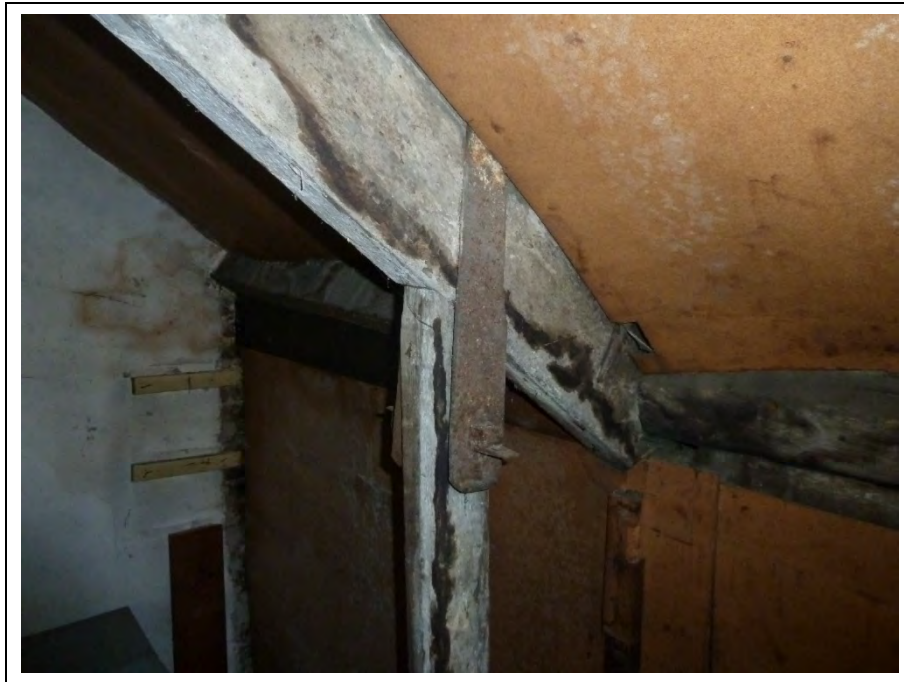
45. Historic damp staining to timber roof trusses

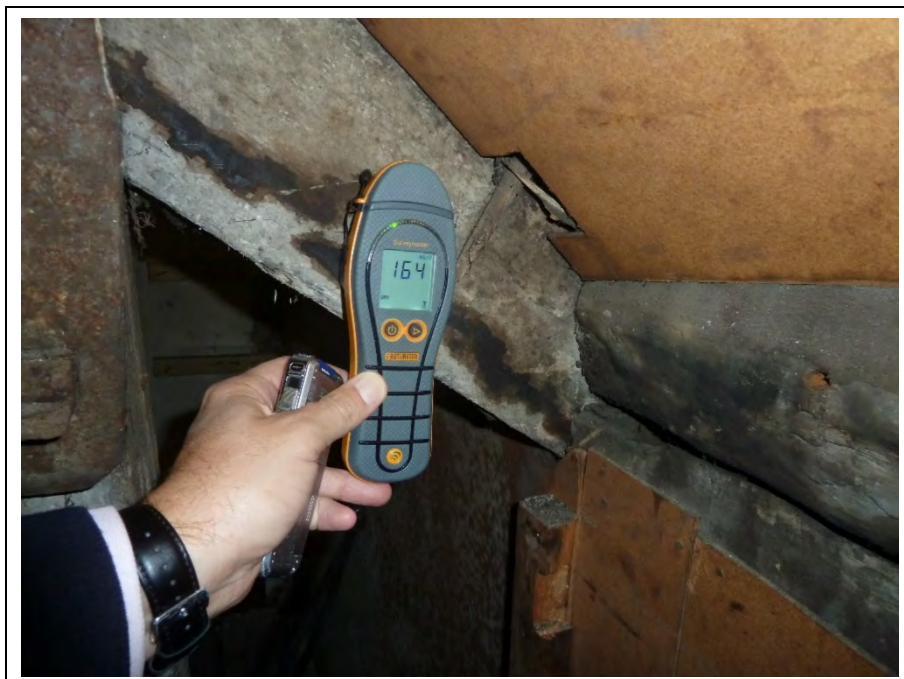
46. Low damp meter readings from timber trusses

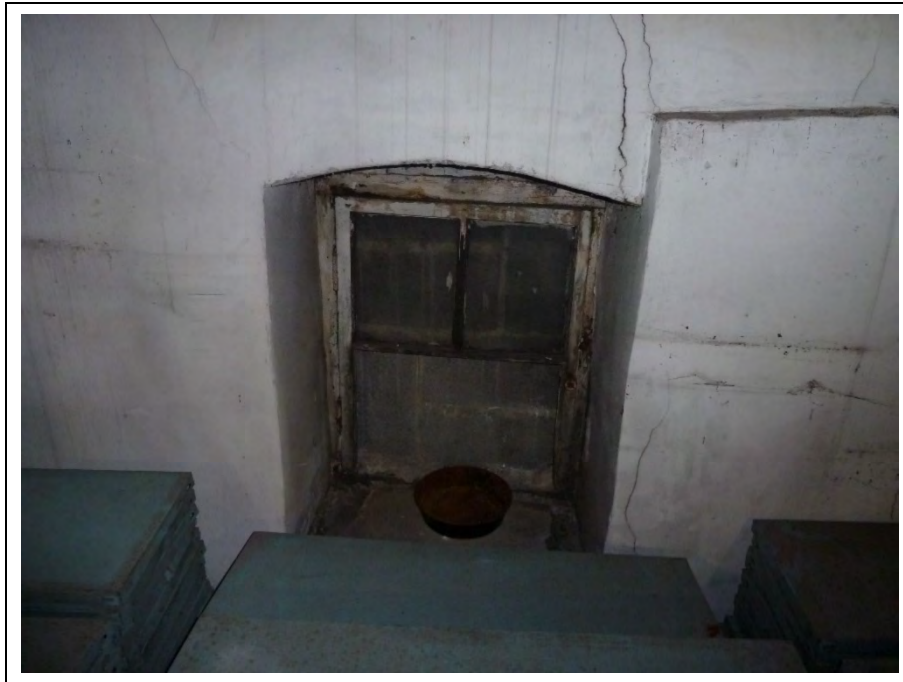
47. Blocked up window along right elevation at 3rd floor level

4.5	<p>To the right elevation a previous window at third floor level has been blocked up externally. The window frame remains in situ internally. During any works we recommend that this block work is removed and an allowance provided for a new window frame into this location. This will allow natural daylight into the third floor loft space.</p>	●
