TASK NO.	TASK/DESCRIPTION	NOTES
	H2 HULL AND STRUCTURE – EXTERNAL DECKS AND ASSOCIATED FITTINGS	
H2.01	<p>Redundant Deck Fittings.</p>

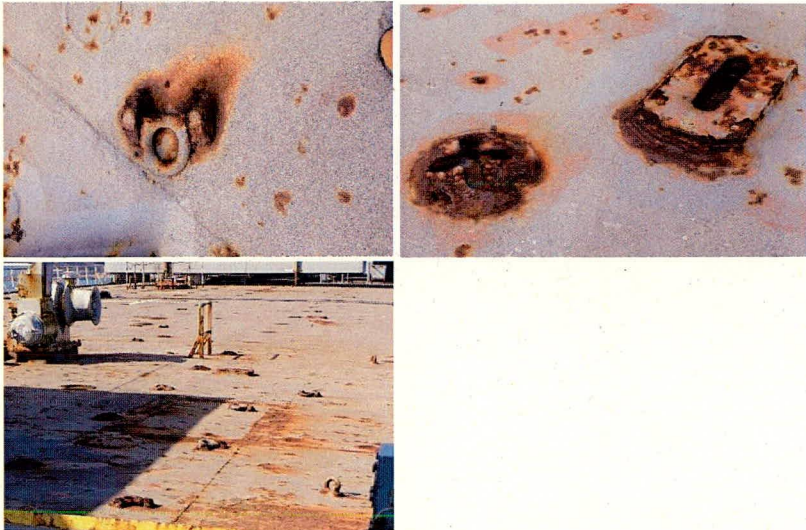
<p>Numerous vehicle deck deck fittings are excessively corroded. As no longer required, they are to be removed and any areas of corroded plate cropped out and weld inserts fitted, REPRESENT affected areas. ALLOW for 50 in number fittings. ALLOW for 30m² REPRESENTATION</p>	<p>Hotwork Required – Appropriate precautions to be taken iaw General 8.4.</p> <p>Iaw Paint scheme -General 12 and Annex B refer.</p>

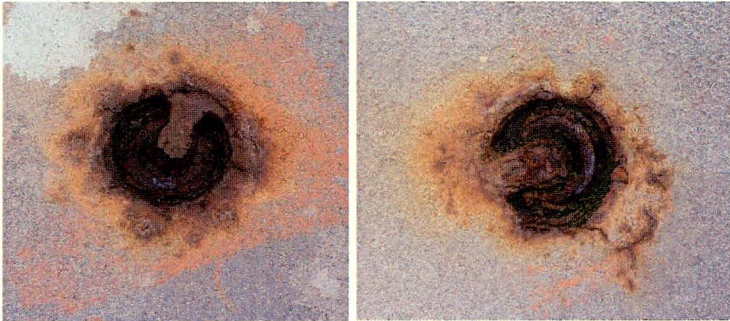
TASK NO.	TASK/DESCRIPTION	NOTES
	H2 HULL AND STRUCTURE – EXTERNAL DECKS AND ASSOCIATED FITTINGS	
H2.02	<p>Redundant vehicle deck tie-down points.</p>

<p>Clear out heavily corroded redundant vehicle deck tie down points and resin fill. REPRESENT area on completion. ALLOW for 50 tie down points and 20m² REPRESENTATION.</p>	IAW Paint scheme - General 12 and Annex B refer.

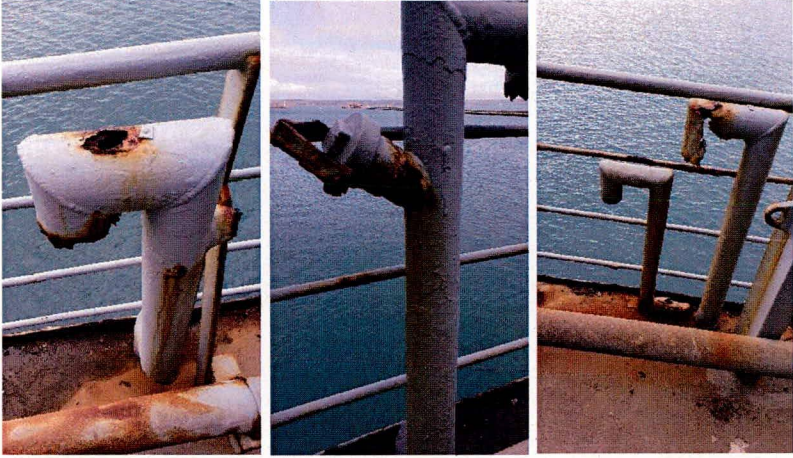
TASK NO.	TASK/DESCRIPTION	NOTES
	H2 HULL AND STRUCTURE – EXTERNAL DECKS AND ASSOCIATED FITTINGS	
H2.03	<p>Tank Vent Goose Necks</p>

<p>Numerous tank vent Goose Necks are have suffered excessive corrosion such that full thickness penetration is evident and some have come detached from deck. Manufacture and RENEW goosenecks affected. Goosenecks are welded to deck. REPRESENT goosenecks and deck area on completion.</p> <p>ALLOW for 10 goose necks. ALLOW for 15m² REPRESENTATION.</p>	<p>Hotwork Required – Appropriate precautions to be taken iaw General 8.4.</p> <p>IAW Paint scheme -General 12 and Annex B refer.</p>

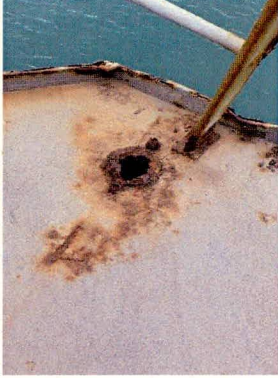
TASK NO.	TASK/DESCRIPTION	NOTES
	H2 HULL AND STRUCTURE – EXTERNAL DECKS AND ASSOCIATED FITTINGS	
H2.04	<p>Deck Drain Opening</p>

<p>Forecastle deck drain port side has grill missing allowing ingress of debris and is heavily corroded. Prove drain clear and unblock as necessary. RENEW grill studs, REPRESENT deck drain opening and surrounding deck area. Supply and fit new deck drain grill.</p> <p>ALLOW for 1m² REPRESENTATION.</p>	<p>Hotwork Required – Appropriate precautions to be taken iaw General 8.4.</p> <p>IAW Paint scheme -General 12 and Annex B refer.</p>

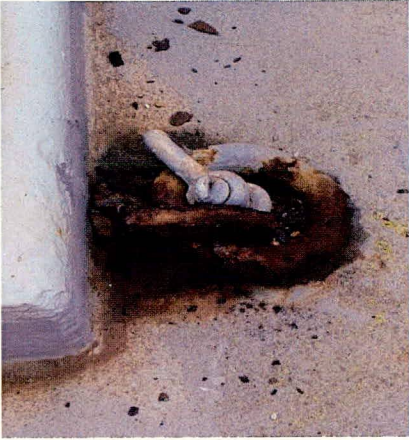
TASK NO.	TASK/DESCRIPTION	NOTES
	H2 HULL AND STRUCTURE – EXTERNAL DECKS AND ASSOCIATED FITTINGS	
H2.05	<p>Forecastle Deck Fittings</p>

<p>Numerous unused Forecastle deck fittings are excessively corroded and beyond preservation. Fittings to be removed and deck area REPRESENTED on completion. Fittings to be identified to contractor by Authority's Authorised Representative. Contractor to dispose of redundant fittings.</p> <p>ALLOW for 10 in number fittings. ALLOW for 5m² REPRESENTATION.</p>	<p>Hotwork Required – Appropriate precautions to be taken iaw General 8.4.</p> <p>IAW Paint scheme -General 12 and Annex B refer.</p>

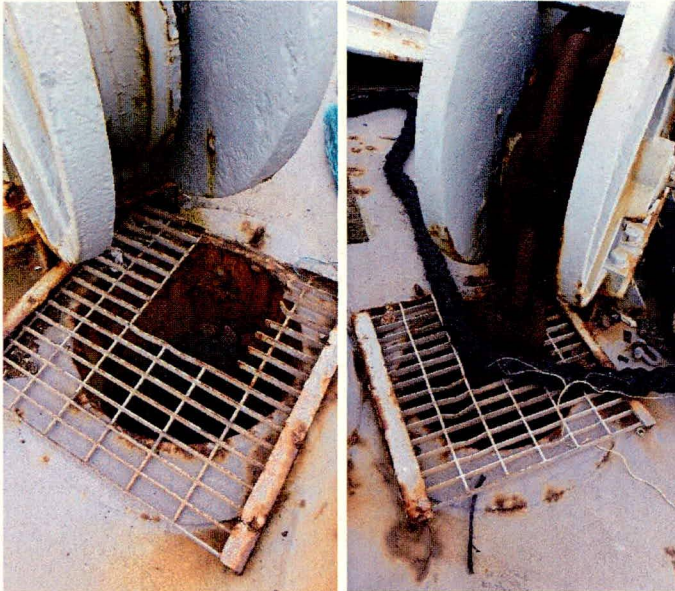
TASK NO.	TASK/DESCRIPTION	NOTES
	H2 HULL AND STRUCTURE – EXTERNAL DECKS AND ASSOCIATED FITTINGS	
H2.06	<p>Hawse Pipes</p>

<p>There is evidence of pitting within the port and stbd hawse pipes.</p> <p>Abrade back and NDE to determine remaining wall thickness. To be at least 2/3 original thickness in areas in contact with chain or anchor, else 4mm is adequate to retain watertight integrity (original fitted thickness may be estimated based on thickness measurement of uncorroded area). REPRESENTATION on completion.</p> <p>ALLOW for 15m² REPRESENTATION.</p>	<p>NDE Required</p> <p>IAW Paint scheme - General 12 and Annex B refer.</p>

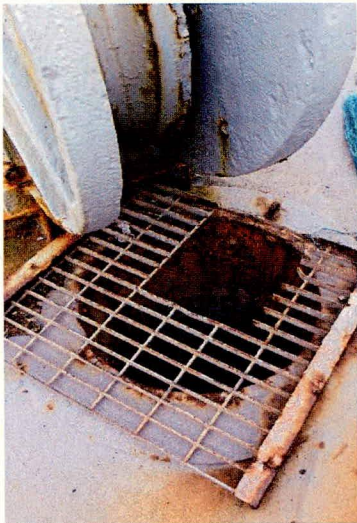
TASK NO.	TASK/DESCRIPTION	NOTES
	H2 HULL AND STRUCTURE – EXTERNAL DECKS AND ASSOCIATED FITTINGS	
H2.07	<p>Hawse Pipe Grill</p>

<p>The stbd hawse pipe grill has cut-out for cable however cable not fitted on stbd side leaving unnecessary opening on deck. Existing grill to be RENEWED with one that covers entire hawse pipe opening. REPRESENTATIVE securing brackets on completion.</p> <p>ALLOW for 2m² REPRESENTATION.</p>	<p>Hotwork Required – Appropriate precautions to be taken iaw General 8.4.</p> <p>To be done in conjunction with H2.06.</p> <p>IAW Paint scheme - General 12 and Annex B refer.</p>

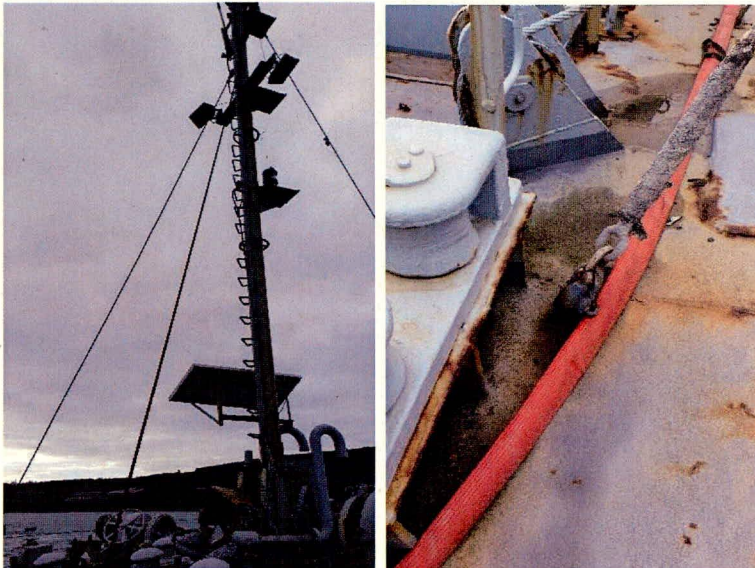
TASK NO.	TASK/DESCRIPTION	NOTES
	H2 HULL AND STRUCTURE – EXTERNAL DECKS AND ASSOCIATED FITTINGS	
H2.08	<p>Foremast Wire Stays</p>

<p>The 3 in number foremast cable stays are showing galvanising breakdown and corrosion. RENEW 3 in number cable stays and REPRESENT anchor points.</p> <p>ALLOW for 3m² REPRESENTATION.</p>	<p>IAW Paint scheme - General 12 and Annex B refer.</p>

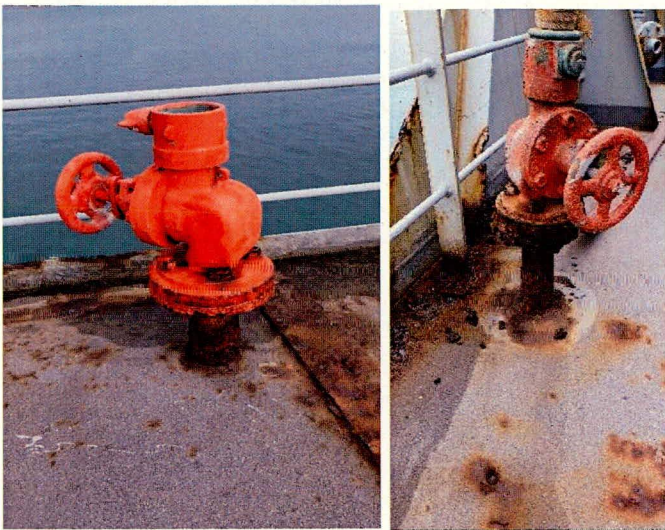
TASK NO.	TASK/DESCRIPTION	NOTES
	H2 HULL AND STRUCTURE – EXTERNAL DECKS AND ASSOCIATED FITTINGS	
H2.09	<p>Redundant Fire Hydrants</p>

<p>All fire hydrants now redundant, pipework heavily corroded with no paint coatings remaining and with wall thickness severely reduced. REMOVE hydrants (x5) and weld blanks in place to cover deck penetrations. REPRESENT on completion.</p> <p>ALLOW for 5m² REPRESENTATION.</p>	<p>Hotwork Required – Appropriate precautions to be taken iaw General 8.4.</p> <p>IAW Paint scheme -General 12 and Annex B refer.</p>

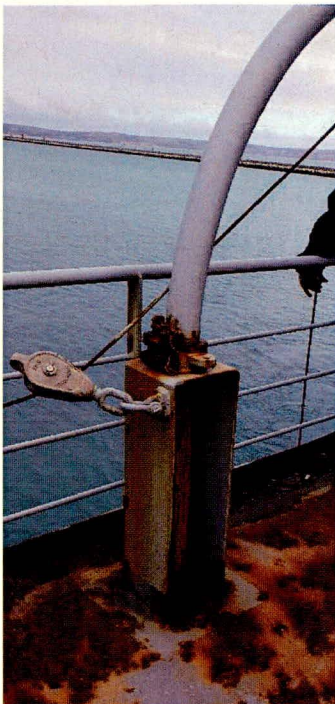
TASK NO.	TASK/DESCRIPTION	NOTES
	H2 HULL AND STRUCTURE – EXTERNAL DECKS AND ASSOCIATED FITTINGS	
H2.10	<p>Redundant Accommodation Ladder Davit</p>

<p>Active corrosion and paint coating breakdown at base of redundant accommodation ladder davit. Davit no longer used therefore davit to be REMOVED and deck area REPRESENTED. Contractor to dispose of all removed materials on completion.</p> <p>ALLOW for 1m² REPRESENTATION.</p>	<p>Hotwork Required – Appropriate precautions to be taken iaw General 8.4.</p> <p>To be completed in conjunction with H2.17</p> <p>IAW Paint scheme - General 12 and Annex B refer.</p>

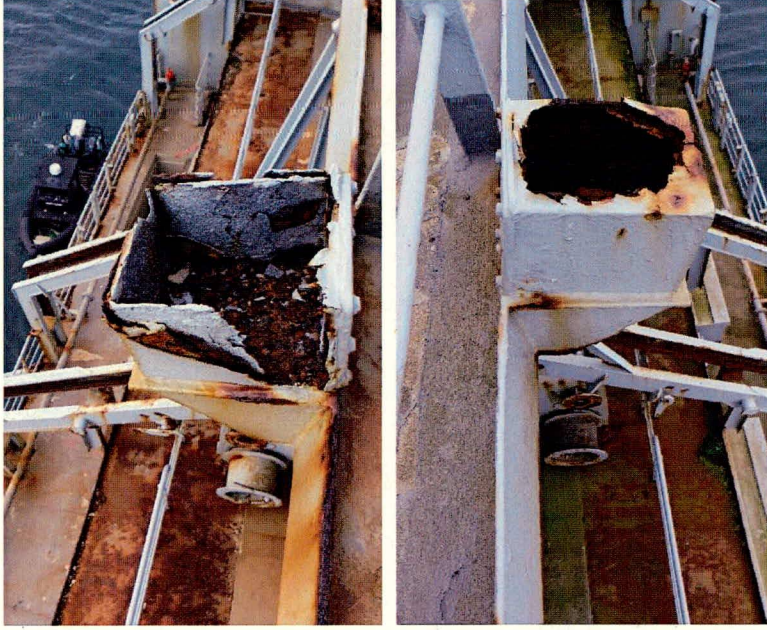
TASK NO.	TASK/DESCRIPTION	NOTES
	H2 HULL AND STRUCTURE – EXTERNAL DECKS AND ASSOCIATED FITTINGS	
H2.12	<p>Gundeck Aerial Boxes</p>

<p>Port and stbd aerial mounting boxes have corroded to the extent aials have now become detached. Aerials are redundant. Remove both mounting boxes and PRESERVE affected area. Contractor to dispose of removed items.</p> <p>ALLOW for 2m² PRESERVATION.</p>	<p>Hotwork Required – Appropriate precautions to be taken iaw General 8.4.</p> <p>IAW Paint scheme -General 12 and Annex B refer.</p>

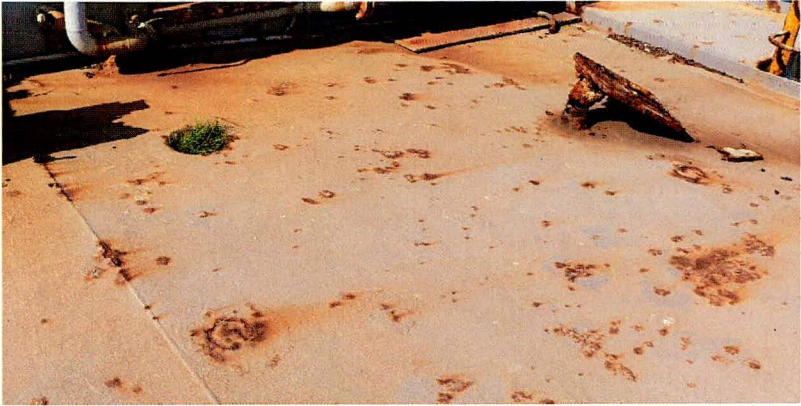
TASK NO.	TASK/DESCRIPTION	NOTES
	H2 HULL AND STRUCTURE – EXTERNAL DECKS AND ASSOCIATED FITTINGS	
H2.13	<p>Flight Deck Paint Coating</p>

<p>The flight deck has many areas of paint coating breakdown leading to active corrosion of the deck. Carry out patch repair PRESERVATION.</p> <p>ALLOW for 25m². PRESERVATION.</p>	<p>IAW Paint scheme -General 12 and Annex B refer.</p> <p>To be completed in conjunction with H2.14.</p>

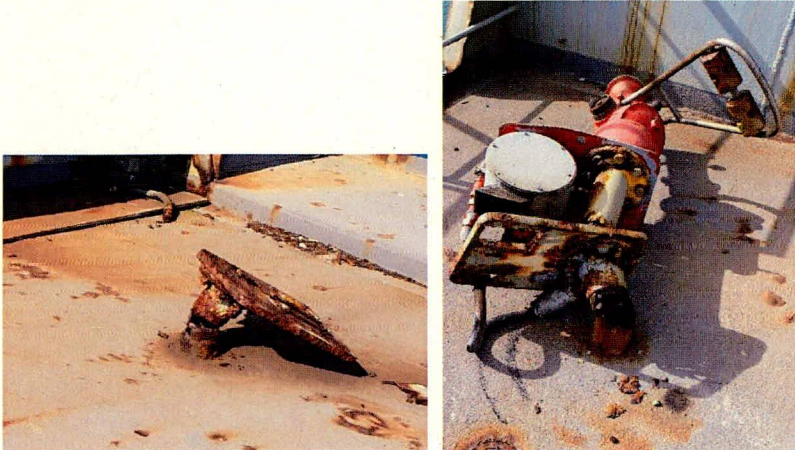
TASK NO.	TASK/DESCRIPTION	NOTES
	H2 HULL AND STRUCTURE – EXTERNAL DECKS AND ASSOCIATED FITTINGS	
H2.14	<p>Flight Deck Monitors</p>

<p>Both flight deck monitors are redundant, and excessive pipe corrosion has resulted in them becoming detached from the deck. Contractor to dispose of both monitors, cut remaining pipework to deck level and weld blanks in place. REPRESENT on completion.</p> <p>ALLOW for 2m² REPRESENTATION.</p>	<p>Hotwork Required – Appropriate precautions to be taken iaw General 8.4.</p> <p>IAW Paint scheme -General 12 and Annex B refer.</p> <p>To be completed in conjunction with H2.13.</p>

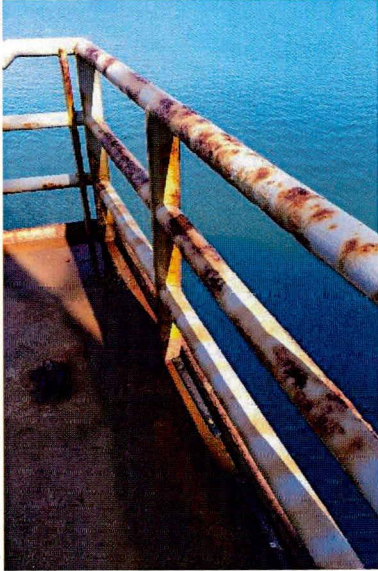
TASK NO.	TASK/DESCRIPTION	NOTES
	H2 HULL AND STRUCTURE – EXTERNAL DECKS AND ASSOCIATED FITTINGS	
H2.15	<p>Port and Stbd Bridge Wing Decks</p>

<p>Port and stbd Bridge Wing decks have large areas of paint coating breakdown and active corrosion present. REPRESENT deck coatings. Allow for 30m² total. REPRESENTATION.</p>	<p>IAW Paint scheme -General 12 and Annex B refer.</p> <p>To be completed in conjunction with H3.05.</p>

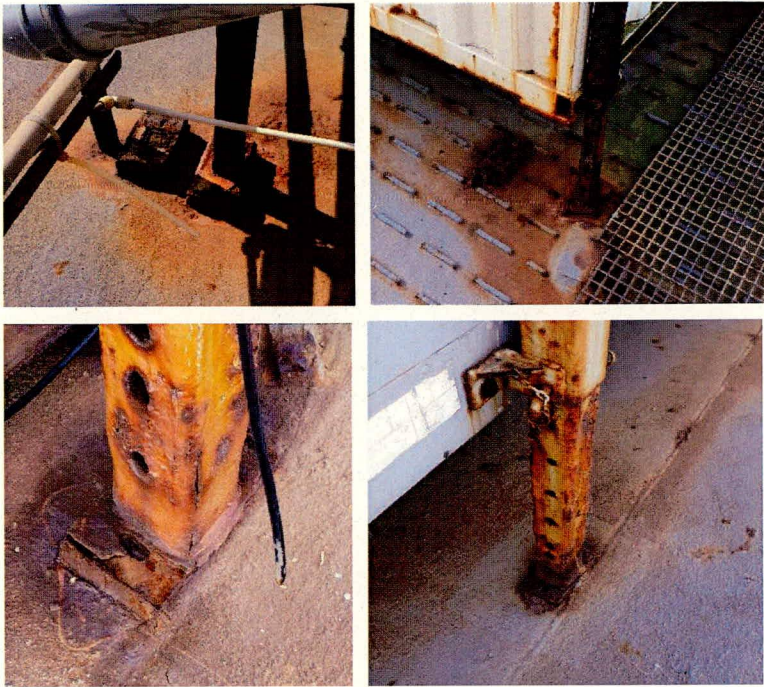
TASK NO.	TASK/DESCRIPTION	NOTES
	H2 HULL AND STRUCTURE – EXTERNAL DECKS AND ASSOCIATED FITTINGS	
H2.17	<p>Office and Toilet Block Securing Points</p>

<p>Current Office and toilet block support legs are not securely fixed to deck (welds suffering active corrosion). Following removal of existing facilities, hold-down points to be welded to deck to facilitate securing of new office and toilet block facilities. Total deck area beneath existing fit to be assessed and REPRESENTED accordingly.</p> <p>ALLOW for 8 in number securing points. ALLOW for 80m² REPRESENTATION.</p>	<p>Hotwork Required – Appropriate precautions to be taken iaw General 8.4.</p> <p>IAW Paint scheme -General 12 and Annex B refer.</p> <p>To be completed in conjunction with H2.17 and H9.02.</p>

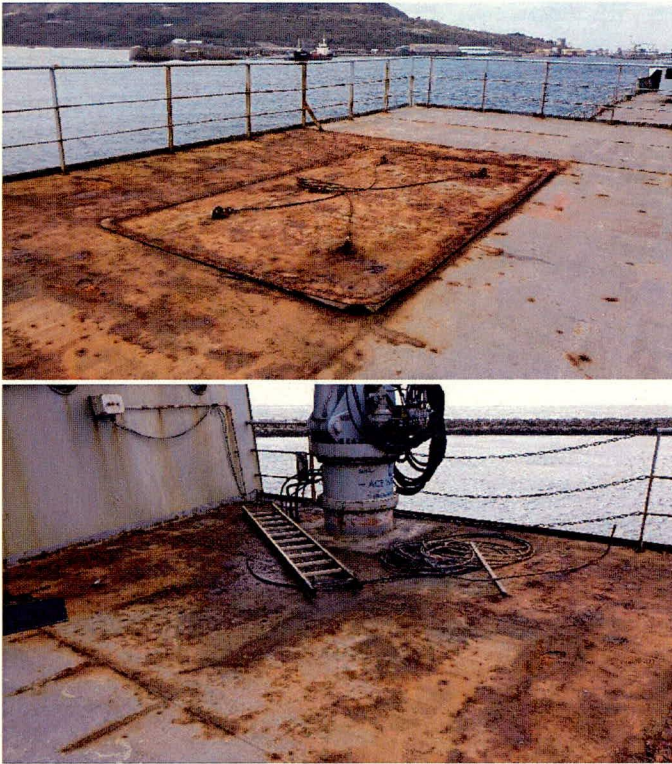
TASK NO.	TASK/DESCRIPTION	NOTES
	H2 HULL AND STRUCTURE – EXTERNAL DECKS AND ASSOCIATED FITTINGS	
H2.18	<p>Crane Deck and Soft Patch</p>

<p>The Crane Deck and associated removable soft patch have large areas of total paint coating breakdown and consequently are showing signs of active corrosion. Soft patch eyeplates to be removed and soft patch welded in place. On completion of crane removal (M1.01) deck and soft patch to be REPRESENTED.</p> <p>ALLOW for 25m² REPRESENTATION.</p>	<p>Hotwork Required – Appropriate precautions to be taken iaw General 8.4.</p> <p>IAW Paint scheme -General 12 and Annex B refer.</p> <p>To be carried out post M1.01</p>

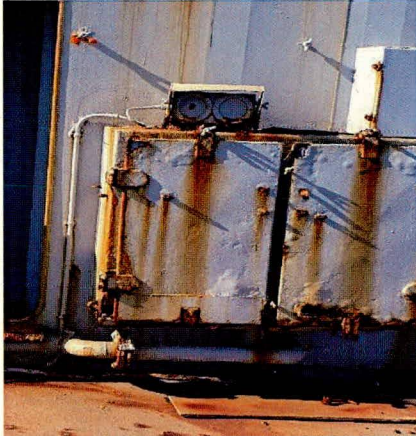
TASK NO.	TASK/DESCRIPTION	NOTES
	H2 HULL AND STRUCTURE – EXTERNAL DECKS AND ASSOCIATED FITTINGS	
H2.19	<p>Redundant Upperdeck Items</p>

<p>Numerous upperdeck fixtures and fittings are now redundant, and showing signs of paint coating breakdown and excessive corrosion. These items are to be removed and disposed of by the Contractor, and deck /bulkhead areas affected REPRESENTED on completion. Items to be removed will be identified on board by Authority's Authorised Representative.</p> <p>ALLOW for 80 man hours. ALLOW for 50m² REPRESENTATION.</p>	<p>Hotwork Required – Appropriate precautions to be taken iaw General 8.4.</p> <p>IAW Paint scheme -General 12 and Annex B refer.</p>

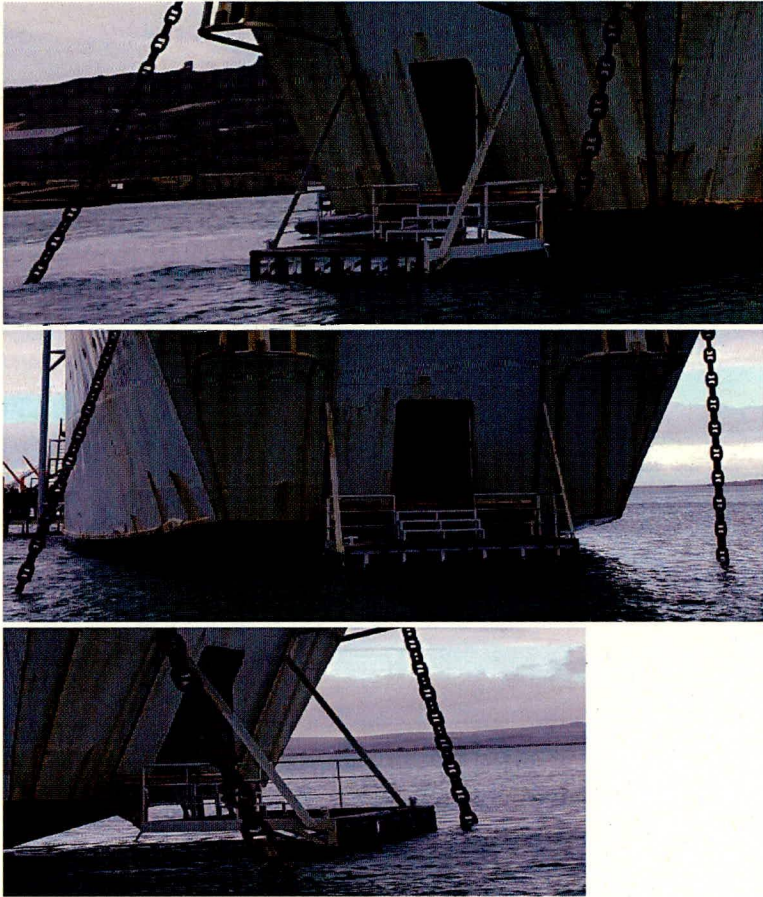
TASK NO.	TASK/DESCRIPTION	NOTES
	H2 HULL AND STRUCTURE – EXTERNAL DECKS AND ASSOCIATED FITTINGS	
H2.20	<p>Stern Landing Platform</p>

<p>The stern landing platform has proved to be too short to allow access for the boats offloading personnel and equipment and requires extending. New design to be agreed with Authority's Authorised Representative. PRESERVE platform on completion. Platform will be removed prior to berthing for period of Refit, work to be conducted in shoreside facility.</p> <p>ALLOW for 20m² PRESERVATION. ALLOW for 8m² extension</p>	<p>Hotwork Required – Appropriate precautions to be taken iaw General 8.4.</p> <p>IAW Paint scheme -General 12 and Annex B refer.</p> <p>To be completed in conjunction with H1.02.</p>
