Refurbishment Survey (with MA + PA)

Wivenhoe Town Council Offices
77 High Street
Wivenhoe
CO7 9AB

Ashbee Surveying Limited
Newbridge Farm
Fox Street
Ardleigh
Colchester
CO7 7PN

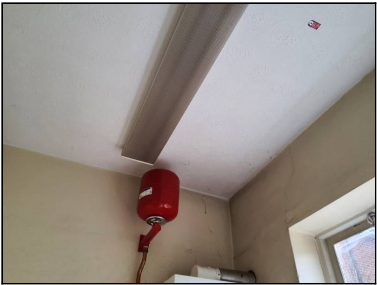
Survey Date:	Lead Surveyor	Survey Type	Floor	Analysis
	6 Jun 2022	Steve Lynn	Refurbishment Survey	Ground Floor	Chrysotile (1)
	Building	Room	Item	Quantity	
	Main	Kitchen G01	Textured coating to plasterboard Ceiling	4m ²	
	Sample No (S,SP,P,As)	Product Type	Surface Treatment	Condition	Accessibility
	SL000659 (S)	Textured Coating (1)	Surface Sealed (1)	Low Damage (1)	Usually inaccessible or unlikely to be disturbed (0)

Normal Occupancy	Score	Likelihood of disturbance	Score	Exposure Potential	Score	Maintenance Activity	Score
Main type of activity	1	Location	2	Number of occupants	1	Type of Maintenance	0
		Accessibility	0	Frequency of use	3	Frequency of maintenance	0
		Amount	1	Average Time	0		
Average Score	1	Average Score	1	Average Score	2	Average Score	0
Average of Priority	4						
Material Assessment Score	4						
Recommendation	Removal

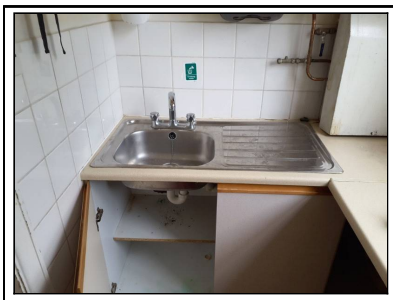
Survey Date:	Lead Surveyor	Survey Type	Floor	Analysis
	6 Jun 2022	Steve Lynn	Refurbishment Survey	Ground Floor	No Asbestos Detected
	Building	Room	Item	Quantity	
	Main	Kitchen G01	Bitumen pad Sink	1no.	Accessibility
	Sample No (S,SP,P,As)	Product Type	Surface Treatment	Condition	
	SL000660 (S)	N/A	N/A	N/A	N/A

Normal Occupancy	Score	Likelihood of disturbance	Score	Exposure Potential	Score	Maintenance Activity	Score
Main type of activity	N/A	Location	N/A	Number of occupants	N/A	Type of Maintenance	N/A
		Accessibility	N/A	Frequency of use	N/A	Frequency of maintenance	N/A
		Amount	N/A	Average Time	N/A		
Average Score	N/A	Average Score	N/A	Average Score	N/A	Average Score	N/A
Average of Priority	N/A						
Material Assessment Score	N/A						
Recommendation	No further action required

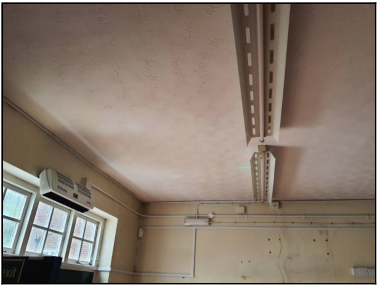
Survey Date:	Lead Surveyor	Survey Type	Floor	Analysis
	6 Jun 2022	Steve Lynn	Refurbishment Survey	Ground Floor	Chrysotile (1)
	Building	Room	Item	Quantity	
	Main	Sorting room G02	Textured coating to plasterboard Ceiling	23m ²	
	Sample No (S,SP,P,As)	Product Type	Surface Treatment	Condition	Accessibility
	SL000661 (S)	Textured Coating (1)	Surface Sealed (1)	Low Damage (1)	Usually inaccessible or unlikely to be disturbed (0)

Normal Occupancy	Score	Likelihood of disturbance	Score	Exposure Potential	Score	Maintenance Activity	Score
Main type of activity	1	Location	2	Number of occupants	2	Type of Maintenance	0
		Accessibility	0	Frequency of use	3	Frequency of maintenance	0
		Amount	2	Average Time	2		
Average Score	1	Average Score	2	Average Score	3	Average Score	0
Average of Priority	6						
Material Assessment Score	4						
Recommendation	Removal

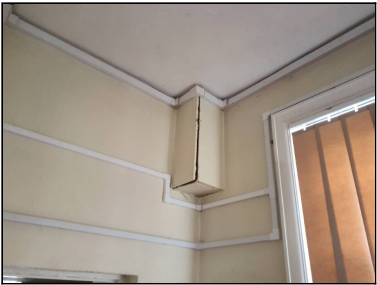
Survey Date:	Lead Surveyor	Survey Type	Floor	Analysis
	6 Jun 2022	Steve Lynn	Refurbishment Survey	Ground Floor	Chrysotile + Crocidolite (3)
	Building	Room	Item	Quantity	
	Main	Sorting room G02	Bitumen pipe Within timber boxing	11m	
	Sample No (S,SP,P,As)	Product Type	Surface Treatment	Condition	Accessibility
	SL000662 (S)	Reinforced Composite (1)	Completely Sealed (0)	Good Condition (0)	Usually inaccessible or unlikely to be disturbed (0)

Normal Occupancy	Score	Likelihood of disturbance	Score	Exposure Potential	Score	Maintenance Activity	Score
Main type of activity	1	Location	2	Number of occupants	2	Type of Maintenance	0
		Accessibility	0	Frequency of use	3	Frequency of maintenance	0
		Amount	1	Average Time	2		
Average Score	1	Average Score	1	Average Score	3	Average Score	0
Average of Priority	5						
Material Assessment Score	4						
Recommendation	Removal

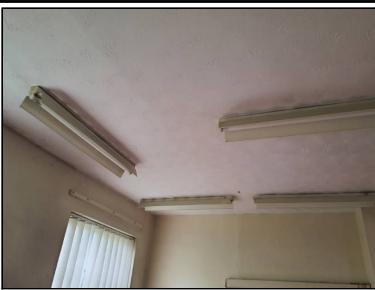
Survey Date:	Lead Surveyor	Survey Type	Floor	Analysis
	6 Jun 2022	Steve Lynn	Refurbishment Survey	Ground Floor	Chrysotile (1)
	Building	Room	Item	Quantity	
	Main	Annex area G03	Textured coating to plasterboard Ceiling	14m ²	
	Sample No (S,SP,P,As)	Product Type	Surface Treatment	Condition	Accessibility
	SL000663 (S)	Textured Coating (1)	Surface Sealed (1)	Low Damage (1)	Usually inaccessible or unlikely to be disturbed (0)

Normal Occupancy	Score	Likelihood of disturbance	Score	Exposure Potential	Score	Maintenance Activity	Score
Main type of activity	1	Location	2	Number of occupants	2	Type of Maintenance	0
		Accessibility	0	Frequency of use	3	Frequency of maintenance	0
		Amount	2	Average Time	2		
Average Score	1	Average Score	2	Average Score	3	Average Score	0
Average of Priority	6						
Material Assessment Score	4						
Recommendation	Removal

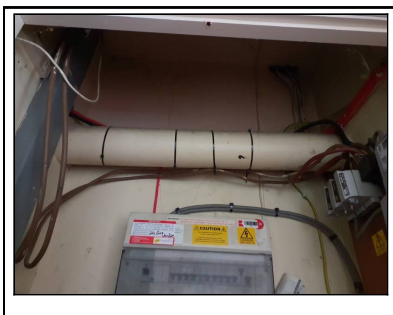
Survey Date:	Lead Surveyor	Survey Type	Floor	Analysis
	6 Jun 2022	Steve Lynn	Refurbishment Survey	Ground Floor	Chrysotile + Crocidolite (3)
	Building	Room	Item	Quantity	
	Main	Electrical cupboard G04	Bitumen pipe High level horizontal	11m	
	Sample No (S,SP,P,As)	Product Type	Surface Treatment	Condition	Accessibility
	As SL000662 (SP)	Reinforced Composite (1)	Completely Sealed (0)	Good Condition (0)	Usually inaccessible or unlikely to be disturbed (0)

Normal Occupancy	Score	Likelihood of disturbance	Score	Exposure Potential	Score	Maintenance Activity	Score
Main type of activity	1	Location	2	Number of occupants	0	Type of Maintenance	0
		Accessibility	0	Frequency of use	3	Frequency of maintenance	0
		Amount	1	Average Time	0		
Average Score	1	Average Score	1	Average Score	1	Average Score	0
Average of Priority	3						
Material Assessment Score	4						
Recommendation	Removal

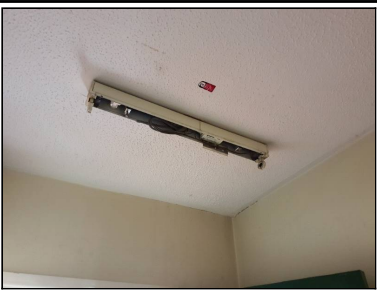
Survey Date:	Lead Surveyor	Survey Type	Floor	Analysis
	6 Jun 2022	Steve Lynn	Refurbishment Survey	Ground Floor	Chrysotile (1)
	Building	Room	Item	Quantity	
	Main	Lobby G05	Textured coating to plasterboard Ceiling	2m ²	
	Sample No (S,SP,P,As)	Product Type	Surface Treatment	Condition	Accessibility
	SL000664 (S)	Textured Coating (1)	Surface Sealed (1)	Low Damage (1)	Usually inaccessible or unlikely to be disturbed (0)

Normal Occupancy	Score	Likelihood of disturbance	Score	Exposure Potential	Score	Maintenance Activity	Score
Main type of activity	1	Location	2	Number of occupants	1	Type of Maintenance	0
		Accessibility	0	Frequency of use	3	Frequency of maintenance	0
		Amount	1	Average Time	0		
Average Score	1	Average Score	1	Average Score	2	Average Score	0
Average of Priority	4						
Material Assessment Score	4						
Recommendation	Removal

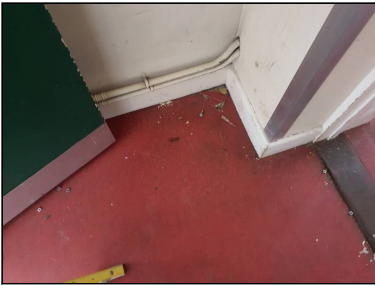
Survey Date:	Lead Surveyor	Survey Type	Floor	Analysis
	6 Jun 2022	Steve Lynn	Refurbishment Survey	Ground Floor	Chrysotile (1)
	Building	Room	Item	Quantity	
	Main	Lobby G05	Bitumen adhesive Beneath modern vinyl flooring	2m ²	
	Sample No (S,SP,P,As)	Product Type	Surface Treatment	Condition	Accessibility
	SL000665 (S)	Well Bound Material (1)	Completely Sealed (0)	Good Condition (0)	Usually inaccessible or unlikely to be disturbed (0)

Normal Occupancy	Score	Likelihood of disturbance	Score	Exposure Potential	Score	Maintenance Activity	Score
Main type of activity	1	Location	2	Number of occupants	0	Type of Maintenance	0
		Accessibility	0	Frequency of use	3	Frequency of maintenance	0
		Amount	1	Average Time	0		
Average Score	1	Average Score	1	Average Score	1	Average Score	0
Average of Priority	3						
Material Assessment Score	2						
Recommendation	Removal

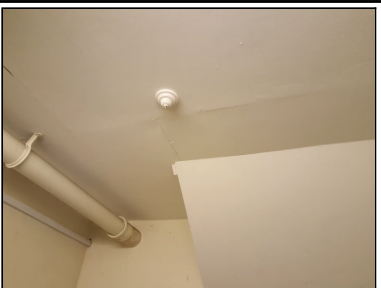
Survey Date:	Lead Surveyor	Survey Type	Floor	Analysis
	6 Jun 2022	Steve Lynn	Refurbishment Survey	Ground Floor	Chrysotile + Amosite (2)
	Building	Room	Item	Quantity	
	Main	Store room G06	Insulation board Ceiling	5m²	
	Sample No (S,SP,P,As)	Product Type	Surface Treatment	Condition	Accessibility
	SL000666 (S)	Asbestos Insulating Board (2)	Surface Sealed (1)	Low Damage (1)	Usually inaccessible or unlikely to be disturbed (0)

Normal Occupancy	Score	Likelihood of disturbance	Score	Exposure Potential	Score	Maintenance Activity	Score
Main type of activity	1	Location	2	Number of occupants	1	Type of Maintenance	1
		Accessibility	0	Frequency of use	3	Frequency of maintenance	0
		Amount	1	Average Time	1		
Average Score	1	Average Score	1	Average Score	2	Average Score	1
Average of Priority	5						
Material Assessment Score	6						
Recommendation	Removal By Licensed Contractor

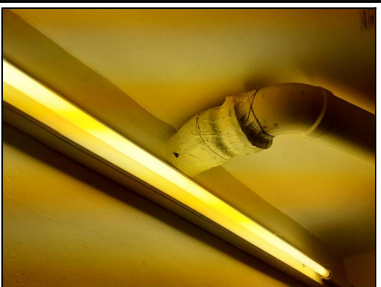
Survey Date:	Lead Surveyor	Survey Type	Floor	Analysis
	6 Jun 2022	Steve Lynn	Refurbishment Survey	Ground Floor	Chrysotile + Crocidolite (3)
	Building	Room	Item	Quantity	
	Main	Store room G06	Bitumen Pipe	<1lm	
	Sample No (S,SP,P,As)	Product Type	Surface Treatment	Condition	Accessibility
	As SL000662 (SP)	Reinforced Composite (1)	Completely Sealed (0)	Good Condition (0)	Usually inaccessible or unlikely to be disturbed (0)

Normal Occupancy	Score	Likelihood of disturbance	Score	Exposure Potential	Score	Maintenance Activity	Score
Main type of activity	1	Location	2	Number of occupants	1	Type of Maintenance	0
		Accessibility	0	Frequency of use	3	Frequency of maintenance	0
		Amount	1	Average Time	0		
Average Score	1	Average Score	1	Average Score	2	Average Score	0
Average of Priority	4						
Material Assessment Score	4						
Recommendation	Removal

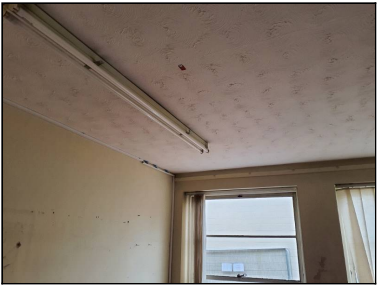
Survey Date:	Lead Surveyor	Survey Type	Floor	Analysis
	6 Jun 2022	Steve Lynn	Refurbishment Survey	Ground Floor	Chrysotile (1)
	Building	Room	Item	Quantity	
	Main	Office 1 G07	Textured coating to plasterboard Ceiling	13m ²	
	Sample No (S,SP,P,As)	Product Type	Surface Treatment	Condition	Accessibility
	SL000667 (S)	Textured Coating (1)	Surface Sealed (1)	Low Damage (1)	Usually inaccessible or unlikely to be disturbed (0)

Normal Occupancy	Score	Likelihood of disturbance	Score	Exposure Potential	Score	Maintenance Activity	Score
Main type of activity	1	Location	2	Number of occupants	2	Type of Maintenance	0
		Accessibility	0	Frequency of use	3	Frequency of maintenance	0
		Amount	2	Average Time	2		
Average Score	1	Average Score	2	Average Score	3	Average Score	0
Average of Priority	6						
Material Assessment Score	4						
Recommendation	Removal

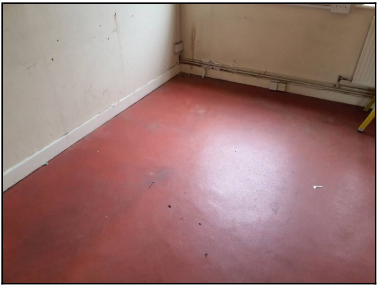
Survey Date:	Lead Surveyor	Survey Type	Floor	Analysis
	6 Jun 2022	Steve Lynn	Refurbishment Survey	Ground Floor	Chrysotile (1)
	Building	Room	Item	Quantity	
	Main	Office 1 G07	Bitumen adhesive Beneath modern vinyl flooring	13m ²	
	Sample No (S,SP,P,As)	Product Type	Surface Treatment	Condition	Accessibility
	As SL000665 (SP)	Well Bound Material (1)	Completely Sealed (0)	Good Condition (0)	Usually inaccessible or unlikely to be disturbed (0)

Normal Occupancy	Score	Likelihood of disturbance	Score	Exposure Potential	Score	Maintenance Activity	Score
Main type of activity	1	Location	2	Number of occupants	2	Type of Maintenance	0
		Accessibility	0	Frequency of use	3	Frequency of maintenance	0
		Amount	2	Average Time	2		
Average Score	1	Average Score	2	Average Score	3	Average Score	0
Average of Priority	6						
Material Assessment Score	2						
Recommendation	Removal

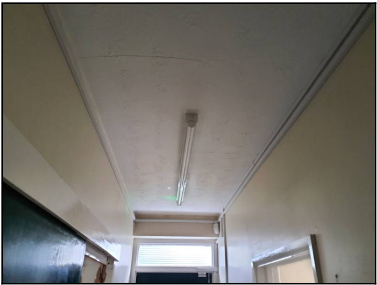
Survey Date:	Lead Surveyor	Survey Type	Floor	Analysis
	6 Jun 2022	Steve Lynn	Refurbishment Survey	Ground Floor	Chrysotile (1)
	Building	Room	Item	Quantity	
	Main	Hallway G08	Textured coating to plasterboard Ceiling	6m ²	
	Sample No (S,SP,P,As)	Product Type	Surface Treatment	Condition	Accessibility
	SL000668 (S)	Textured Coating (1)	Surface Sealed (1)	Low Damage (1)	Usually inaccessible or unlikely to be disturbed (0)

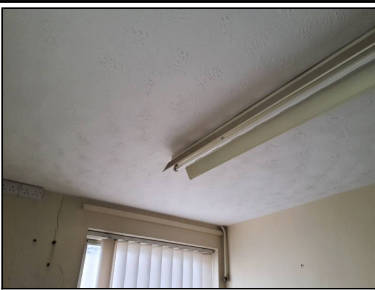
Survey Date:	Lead Surveyor	Survey Type	Floor	Analysis
	6 Jun 2022	Steve Lynn	Refurbishment Survey	Ground Floor	Chrysotile (1)
	Building	Room	Item	Quantity	
	Main	Office 2 G09	Textured coating to plasterboard Ceiling	10m ²	
	Sample No (S,SP,P,As)	Product Type	Surface Treatment	Condition	Accessibility
	SL000669 (S)	Textured Coating (1)	Surface Sealed (1)	Low Damage (1)	Usually inaccessible or unlikely to be disturbed (0)

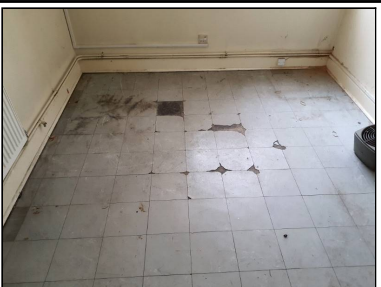
Survey Date:	Lead Surveyor	Survey Type	Floor	Analysis
	6 Jun 2022	Steve Lynn	Refurbishment Survey	Ground Floor	Chrysotile (1)
	Building	Room	Item	Quantity	
	Main	Office 2 G09	Grey tiles Concrete floor	10m ²	
	Sample No (S,SP,P,As)	Product Type	Surface Treatment	Condition	Accessibility
	SL000670 (S)	Reinforced Composite (1)	Completely Sealed (0)	High Damage (3)	Routinely disturbed (3)

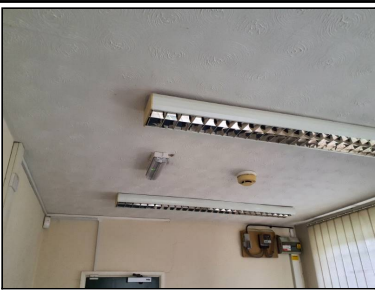
Survey Date:	Lead Surveyor	Survey Type	Floor	Analysis
	6 Jun 2022	Steve Lynn	Refurbishment Survey	Ground Floor	Chrysotile (1)
	Building	Room	Item	Quantity	
	Main	Office 3 G10	Textured coating to plasterboard Ceiling	15m ²	
	Sample No (S,SP,P,As)	Product Type	Surface Treatment	Condition	Accessibility
	SL000671 (S)	Textured Coating (1)	Surface Sealed (1)	Low Damage (1)	Usually inaccessible or unlikely to be disturbed (0)

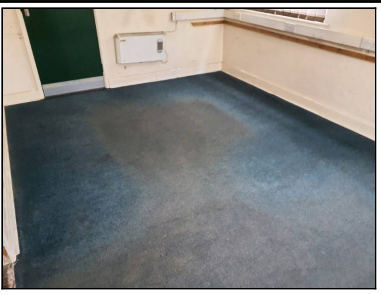
Survey Date:	Lead Surveyor	Survey Type	Floor	Analysis
	6 Jun 2022	Steve Lynn	Refurbishment Survey	Ground Floor	Chrysotile (1)
	Building	Room	Item	Quantity	
	Main	Office 3 G10	Bitumen adhesive Beneath carpet	15m ²	
	Sample No (S,SP,P,As)	Product Type	Surface Treatment	Condition	Accessibility
	As SL000665 (SP)	Well Bound Material (1)	Completely Sealed (0)	Good Condition (0)	Usually inaccessible or unlikely to be disturbed (0)

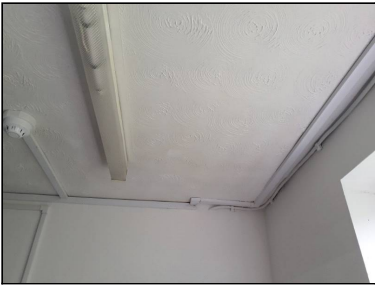
Survey Date:	Lead Surveyor	Survey Type	Floor	Analysis
	6 Jun 2022	Steve Lynn	Refurbishment Survey	Ground Floor	Chrysotile (1)
	Building	Room	Item	Quantity	
	Main	Stairwell lobby G11	Textured coating to plasterboard Ceiling	6m ²	
	Sample No (S,SP,P,As)	Product Type	Surface Treatment	Condition	Accessibility
	SL000672 (S)	Textured Coating (1)	Surface Sealed (1)	Low Damage (1)	Usually inaccessible or unlikely to be disturbed (0)

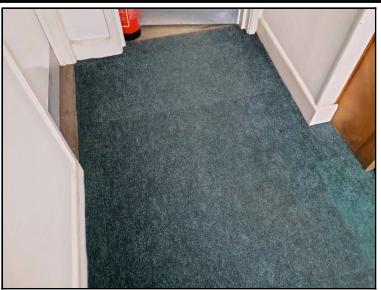
Survey Date:	Lead Surveyor	Survey Type	Floor	Analysis
	6 Jun 2022	Steve Lynn	Refurbishment Survey	Ground Floor	Chrysotile (1)
	Building	Room	Item	Quantity	
	Main	Stairwell lobby G11	Bitumen adhesive Beneath carpet	6m ²	
	Sample No (S,SP,P,As)	Product Type	Surface Treatment	Condition	Accessibility
	As SL000665 (SP)	Well Bound Material (1)	Completely Sealed (0)	Good Condition (0)	Usually inaccessible or unlikely to be disturbed (0)

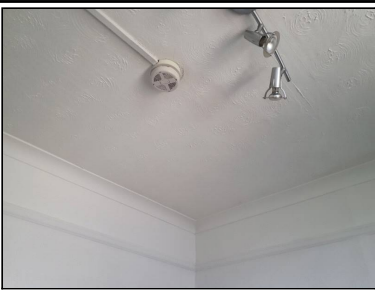
Survey Date:	Lead Surveyor	Survey Type	Floor	Analysis
	6 Jun 2022	Steve Lynn	Refurbishment Survey	Ground Floor	Chrysotile (1)
	Building	Room	Item	Quantity	
	Main	Entrance G12	Textured coating to plasterboard Ceiling	9m ²	
	Sample No (S,SP,P,As)	Product Type	Surface Treatment	Condition	Accessibility
	SL000673 (S)	Textured Coating (1)	Surface Sealed (1)	Low Damage (1)	Usually inaccessible or unlikely to be disturbed (0)

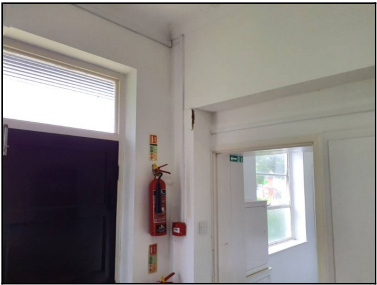
Survey Date:	Lead Surveyor	Survey Type	Floor	Analysis
	6 Jun 2022	Steve Lynn	Refurbishment Survey	Ground Floor	Chrysotile + Crocidolite (3)
	Building	Room	Item	Quantity	
	Main	Entrance G12	Bitumen pipe Within vertical timber boxing	3lm	
	Sample No (S,SP,P,As)	Product Type	Surface Treatment	Condition	Accessibility
	As SL000662 (SP)	Reinforced Composite (1)	Completely Sealed (0)	Good Condition (0)	Usually inaccessible or unlikely to be disturbed (0)

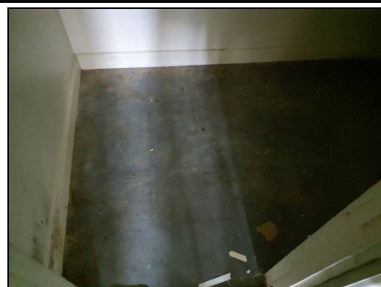
Survey Date:	Lead Surveyor	Survey Type	Floor	Analysis
	6 Jun 2022	Steve Lynn	Refurbishment Survey	Ground Floor	Chrysotile (1)
	Building	Room	Item	Quantity	
	Main	Under stairs G13	Grey tiles Concrete floor	2m ²	
	Sample No (S,SP,P,As)	Product Type	Surface Treatment	Condition	Accessibility
	SL000674 (S)	Reinforced Composite (1)	Completely Sealed (0)	Good Condition (0)	Routinely disturbed (3)

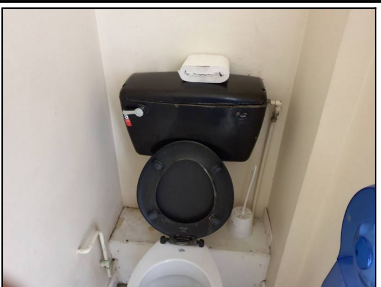
Survey Date:	Lead Surveyor	Survey Type	Floor	Analysis
	6 Jun 2022	Steve Lynn	Refurbishment Survey	1st Floor	Amosite (2)
	Building	Room	Item	Quantity	
	Main	Wc 102	Bakealight Cistern and seat	1no.	
	Sample No (S,SP,P,As)	Product Type	Surface Treatment	Condition	Accessibility
	SL000675 (S)	Reinforced Composite (1)	Completely Sealed (0)	Good Condition (0)	Easily disturbed (2)

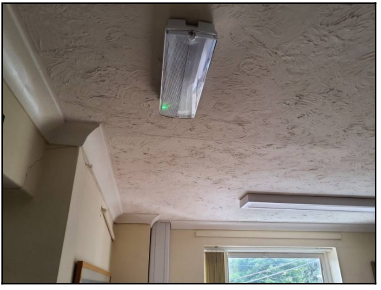
Survey Date:	Lead Surveyor	Survey Type	Floor	Analysis
	6 Jun 2022	Steve Lynn	Refurbishment Survey	1st Floor	Chrysotile (1)
	Building	Room	Item	Quantity	
	Main	Reception 105	Textured coating Ceiling	13m²	
	Sample No (S,SP,P,As)	Product Type	Surface Treatment	Condition	Accessibility
	SL000676 (S)	Textured Coating (1)	Surface Sealed (1)	Low Damage (1)	Usually inaccessible or unlikely to be disturbed (0)

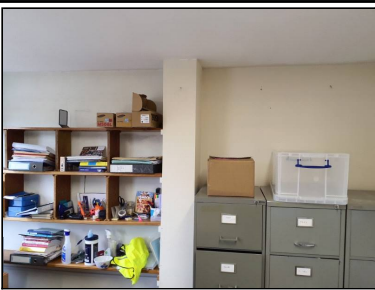
Survey Date:	Lead Surveyor	Survey Type	Floor	Analysis
	6 Jun 2022	Steve Lynn	Refurbishment Survey	1st Floor	Chrysotile + Crocidolite (3)
	Building	Room	Item	Quantity	
	Main	Office 1 107	Bitumen pipe Within vertical timber boxing	2m ²	
	Sample No (S,SP,P,As)	Product Type	Surface Treatment	Condition	Accessibility
	As SL000677 (SP)	Reinforced Composite (1)	Completely Sealed (0)	Good Condition (0)	Usually inaccessible or unlikely to be disturbed (0)

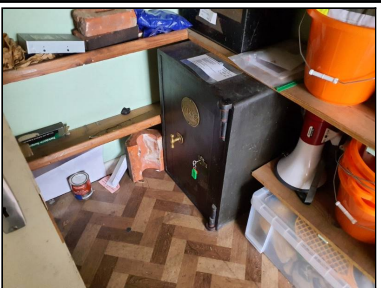
Survey Date:	Lead Surveyor	Survey Type	Floor	Analysis
	6 Jun 2022	Steve Lynn	Refurbishment Survey	1st Floor	Crocidolite (or unknown) (3)
	Building	Room	Item	Quantity	
	Main	Store 108	Safe Within safe linings	1no.	
	Sample No (S,SP,P,As)	Product Type	Surface Treatment	Condition	Accessibility
	Visual (P)	Asbestos Insulating Board (2)	Surface Sealed (1)	Good Condition (0)	Usually inaccessible or unlikely to be disturbed (0)

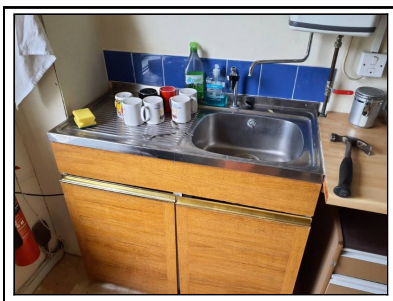
Survey Date:	Lead Surveyor	Survey Type	Floor	Analysis
	6 Jun 2022	Steve Lynn	Refurbishment Survey	1st Floor	No Asbestos Detected
	Building	Room	Item	Quantity	
	Main	Kitchen 110	Bitumen pad Sink	1no.	Accessibility
	Sample No (S,SP,P,As)	Product Type	Surface Treatment	Condition	
	SL000678 (S)	N/A	N/A	N/A	N/A

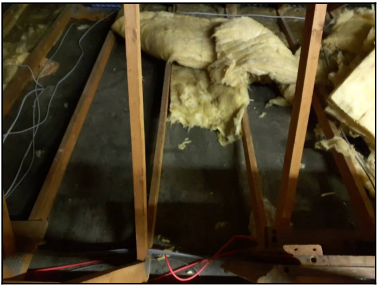
Survey Date:	Lead Surveyor	Survey Type	Floor	Analysis
	6 Jun 2022	Steve Lynn	Refurbishment Survey	Roof Void	Chrysotile (1)
	Building	Room	Item	Quantity	
	Main	Loft R01	Bitumen adhesive Beneath mmmf insulation to floor	120m ²	
	Sample No (S,SP,P,As)	Product Type	Surface Treatment	Condition	Accessibility
	SL000679 (S)	Well Bound Material (1)	Completely Sealed (0)	Medium Damage (2)	Usually inaccessible or unlikely to be disturbed (0)

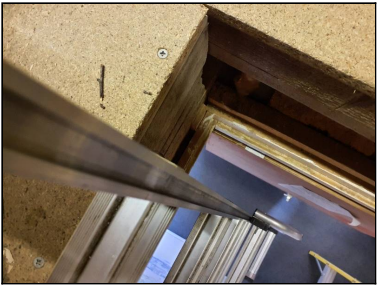
Survey Date:	Lead Surveyor	Survey Type	Floor	Analysis
	6 Jun 2022	Steve Lynn	Refurbishment Survey	Roof Void	Chrysotile (1)
	Building	Room	Item	Quantity	
	Main	Loft R01	Roof tile debris To loft hatch area	<1m ²	
	Sample No (S,SP,P,As)	Product Type	Surface Treatment	Condition	Accessibility
	SL000680 (S)	Asbestos Cement (1)	Surface Sealed (1)	High Damage (3)	Usually inaccessible or unlikely to be disturbed (0)

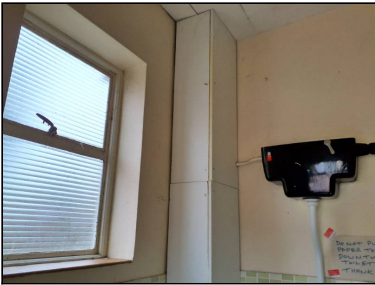
Survey Date:	Lead Surveyor	Survey Type	Floor	Analysis
	6 Jun 2022	Steve Lynn	Refurbishment Survey	External	Chrysotile + Crocidolite (3)
	Building	Room	Item	Quantity	
	Main	Wc E01	Bitumen pipe Within vertical timber boxing	3lm	
	Sample No (S,SP,P,As)	Product Type	Surface Treatment	Condition	Accessibility
	As SL000662 (SP)	Reinforced Composite (1)	Completely Sealed (0)	Good Condition (0)	Usually inaccessible or unlikely to be disturbed (0)

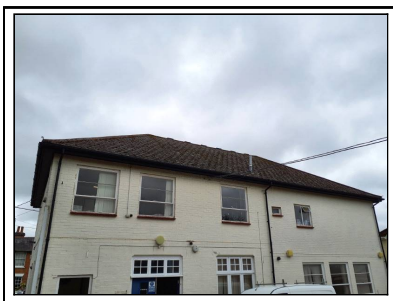
Survey Date:	Lead Surveyor	Survey Type	Floor	Analysis
	6 Jun 2022	Steve Lynn	Refurbishment Survey	External	Chrysotile (1)
	Building	Room	Item	Quantity	
	Main	External E02	Tiles Roof	145m ²	
	Sample No (S,SP,P,As)	Product Type	Surface Treatment	Condition	Accessibility
	SL000682 (S)	Asbestos Cement (1)	Surface Sealed (1)	Good Condition (0)	Usually inaccessible or unlikely to be disturbed (0)
