Highways England

National Asset Delivery
Technical Surveys and Testing

Area 7 - Concrete Portal Frame Structures Testing

Site Information

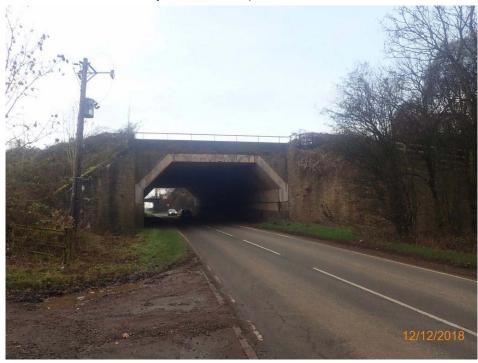
1.1: General photograph of the structure.

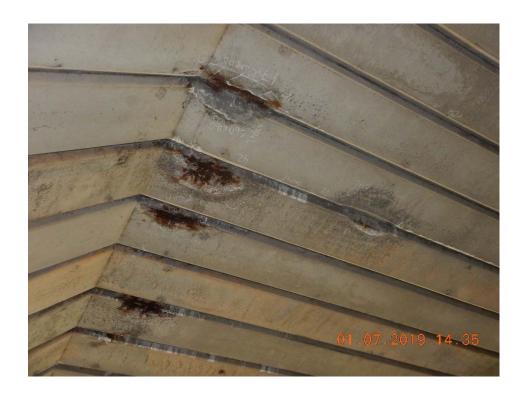
1.2: Typical areas of spalling and corrosion to the reinforcement within the portal beams.

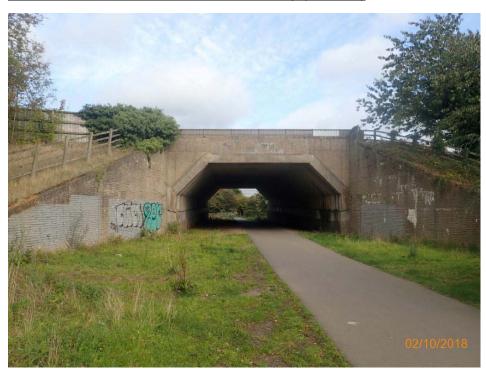
2.1: General photograph of the structure.

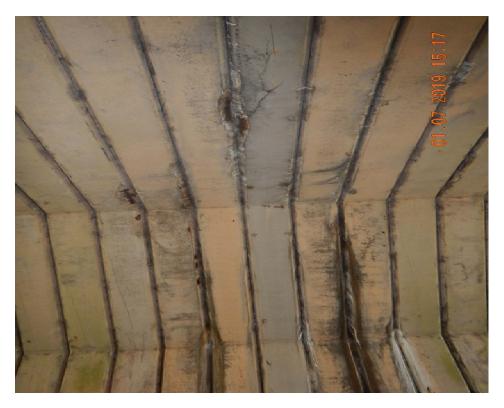
2.2: Typical areas of spalling and corrosion to the reinforcement within the portal beams.
