## **ASBESTOS SURVEY REPORT**

**SURVEY TYPE :** Refurbishment Survey

**SURVEY REPORT NO. :** HSS/RS/JD/07630

**ADDRESS :** Greenfield Sports Field  
Straight Drove  
Sawtry  
Cambridgeshire  
PE28 5XN

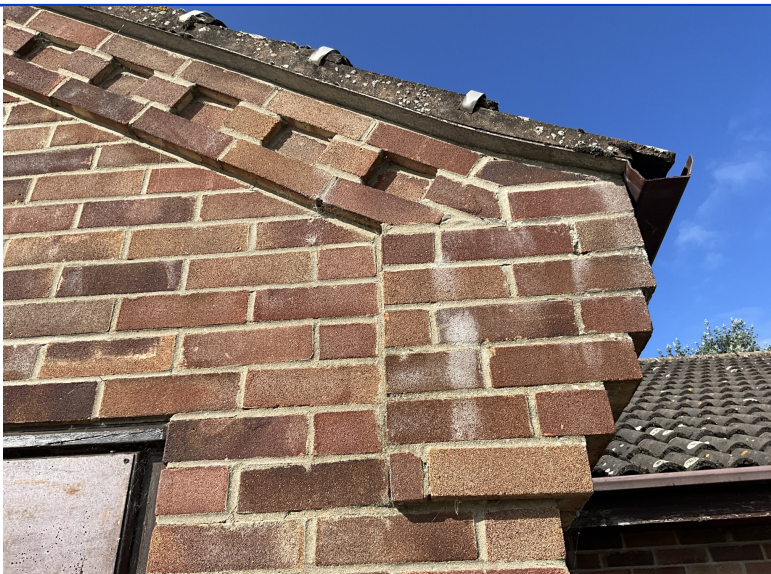
<b>Sample Number</b>	RM/62970

<b>Site</b>	<b>Greenfield Sports Field, Straight Drove, Sawtry, Cambridgeshire, PE28 5XN</b>		
<b>Building</b>		<b>Floor</b>	0
<b>Location</b>	External		
<b>Building Component</b>	Under Cloaking		
<b>Material</b>	Cement		
<b>Area References</b>	0020/12

<b>Analysis Result</b>	Chrysotile	
<b>Quantity</b>	30 Linear Meters

Material Assessment Algorithm				Results				
Product Type	Damage	Surface Treatment	Asbestos Type	Material Score	Access	Total	Action Priority	Recommendation
1	1	0	1	3	1	3	Low	Remove

A sample was collected and the material listed above was found to contain Chrysotile.

The material was found to be in a relatively good condition, however, some minor damage was identified.

Materials of this type are unlikely to give rise significant airborne fibre release, however, if the material is expected to be disturbed during the proposed works then it should be removed prior to the works commencing.

The removal or encapsulation of materials of this type do not require the use of a licensed asbestos removal contractor although they should be carried out in a controlled manner and materials disposed of as asbestos waste in accordance with the 'Control of Asbestos Regulations 2012'.

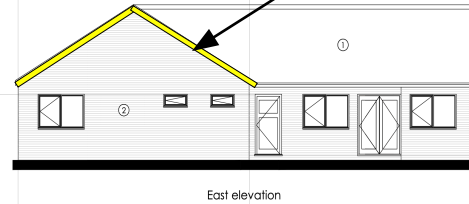
East elevation

Asbestos cement  
under cloaking  
Ref: 20/12

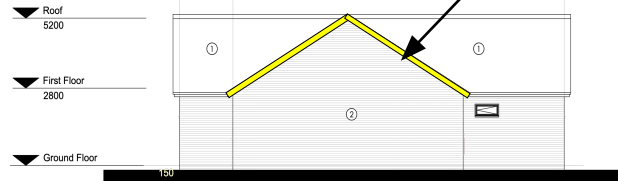
North elevation

Asbestos cement  
under cloaking  
Ref: 20/12

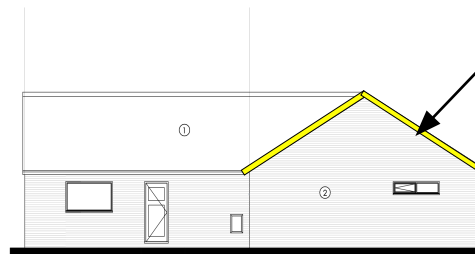
West elevation

Asbestos cement  
under cloaking  
Ref: 20/12
