3G FTP

Test Report

Pitch Location	Thorn Collegiate Academy
Pitch Address	Stockwell Avenue Quarry Bank, Brierley Hill Dudley
Post Code	DY5 2NU
Club Name (If Applicable)	N/A
FA - Site Location / Site ID	BIR007
Pitch ID	Main 3G Pitch
Date Of Construction	2019
Pitch Contact Name	Lee Slater
Contact Email	LSlater@TCA.shirelandcat.net
Client (Name)	Lee Slater
Client Address	Thorn Collegiate Academy Stockwell Avenue Quarry Bank, Brierley Hill Dudley, DY5 2NU
Client Contact (Email)	LSlater@TCA.shirelandcat.net
Test Institute	Labosport Ltd
Test Institute Reference	24-0337-A1
Date of Test	07/06/2024

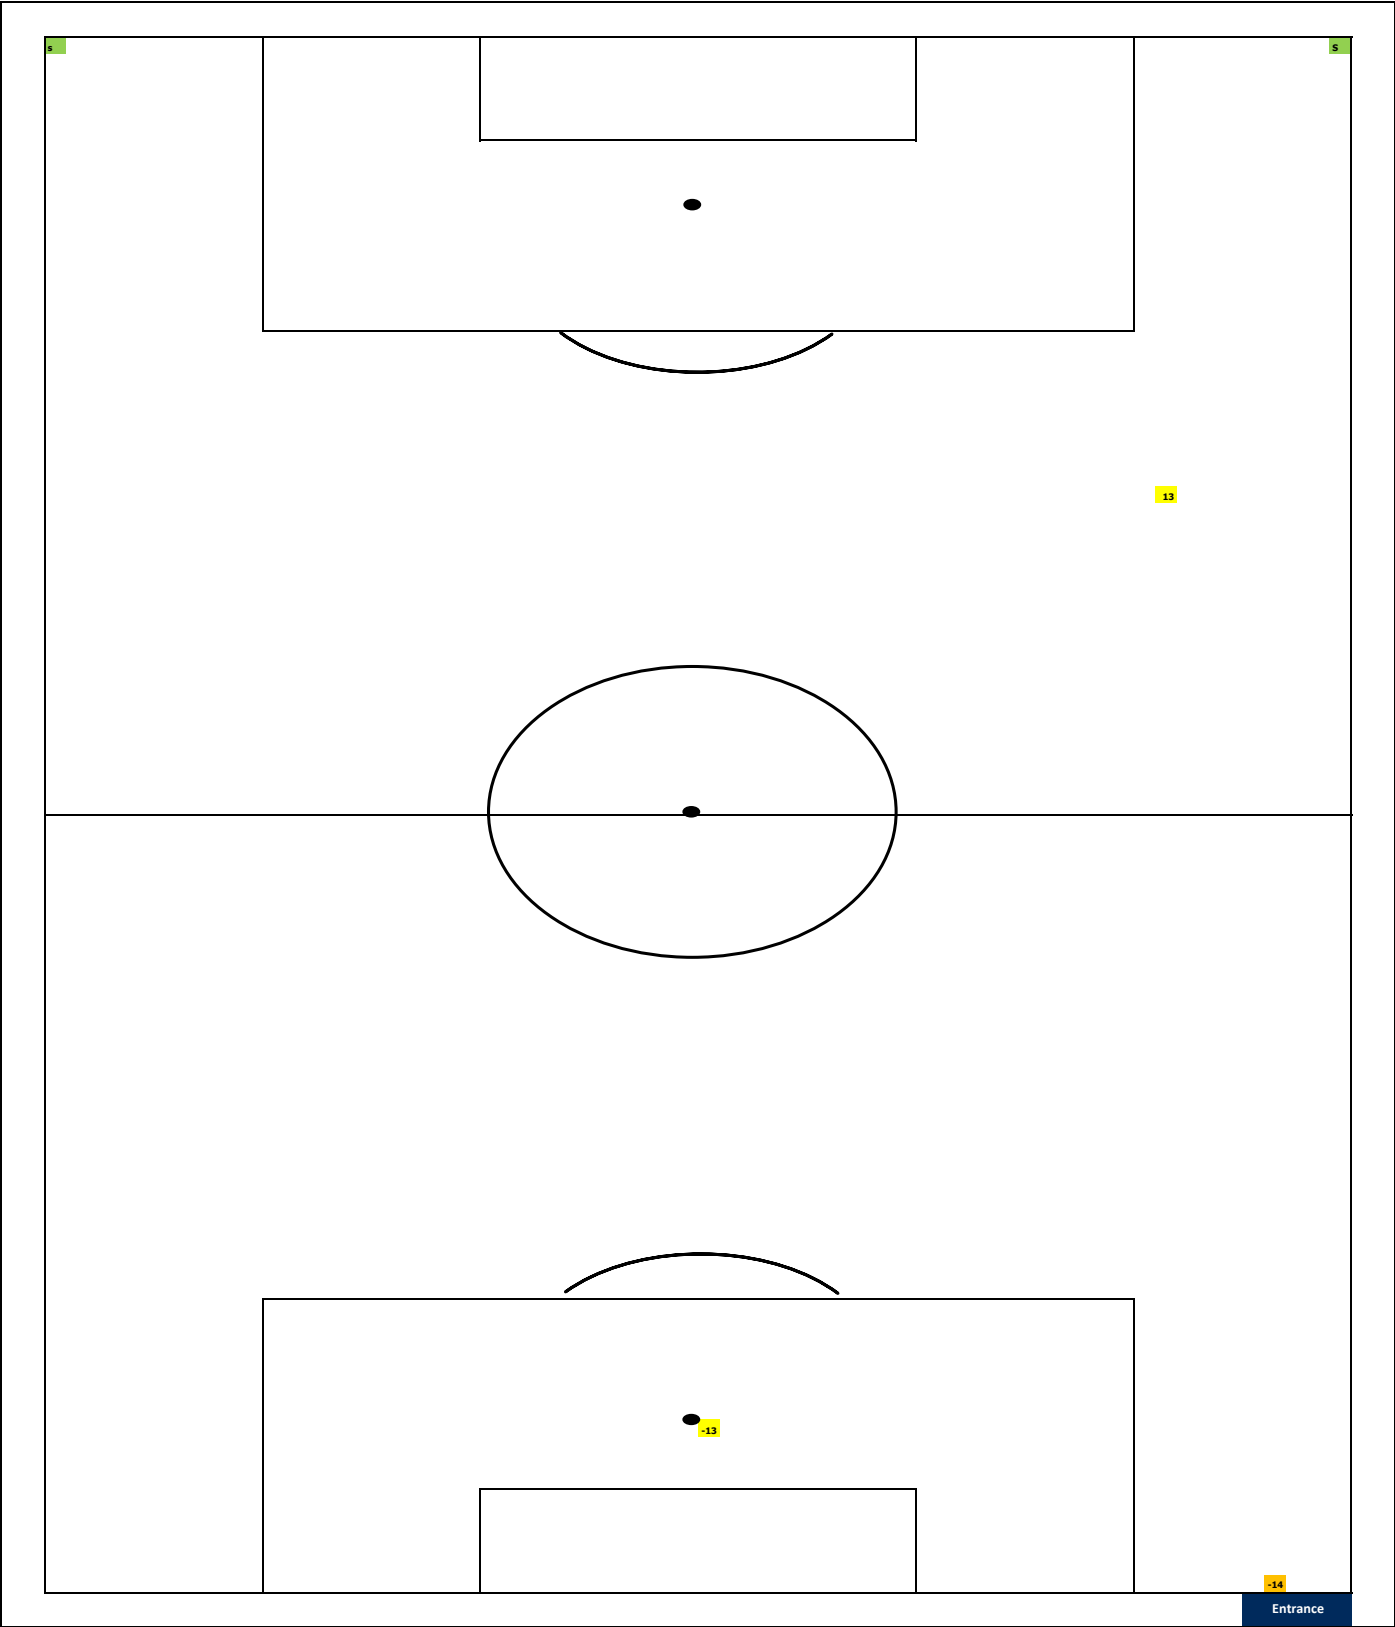
Plan Showing Surface Irregularities > ± 10mm

Positions				
		1	2	3	4	5
Ball/Surface Interaction	Vertical Ball Rebound (m)	1.00	1.03	0.97	0.99	1.01
	Consistency (%)	-0.2%	3.2%	-3.0%	-1.0%	1.2%
	Ball Roll (m)	14.9	14.3	13.9	14.0	13.8
	Consistency (%)	4.8%	0.6%	-1.8%	-1.2%	-2.4%
		Deviations $\geq \pm 10\text{mm}$				
Construction Requirements	Surface Regularity (See diagram Page 6)	3 undulations				
	Number of Visual Defects	2				
	Average Infill Depth (mm)	1	2	3	4	5
		25	23	30	25	22
	Average Free Pile Height (mm)	4	3	5	4	4
	Dimensions (m)	Parameter		Distance (m)		
		Length		100.0		
		Width		63.0		
		Run-off side		3.0		
		Run-off behind		3.0

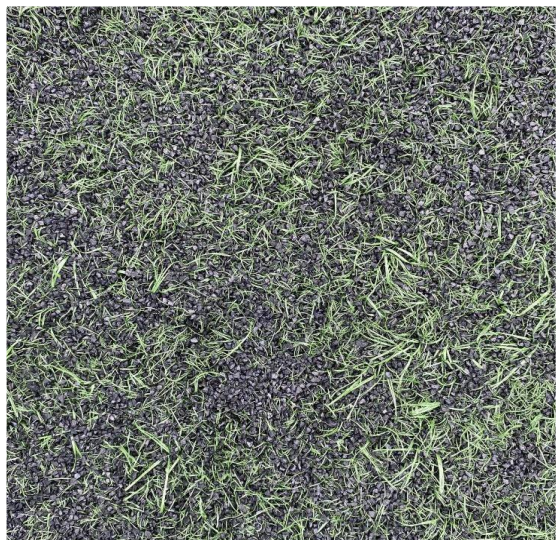
Close-up of pile

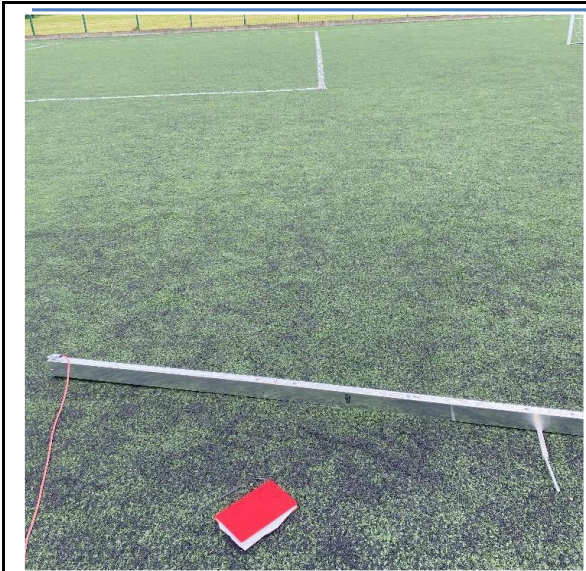
+13mm high spot

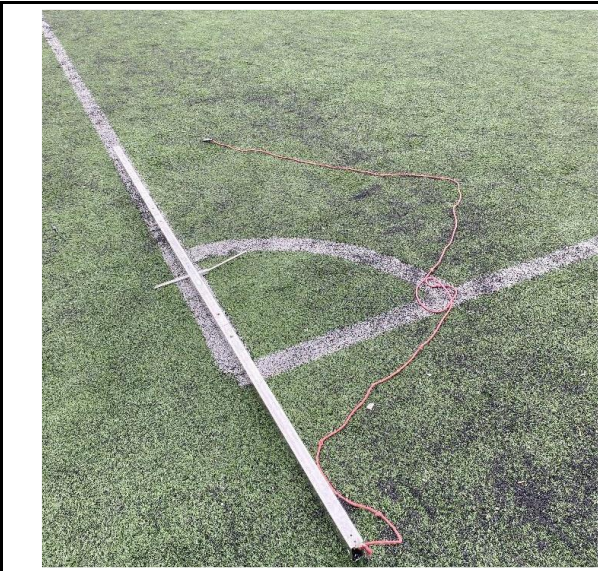
-14mm undulation near entrance

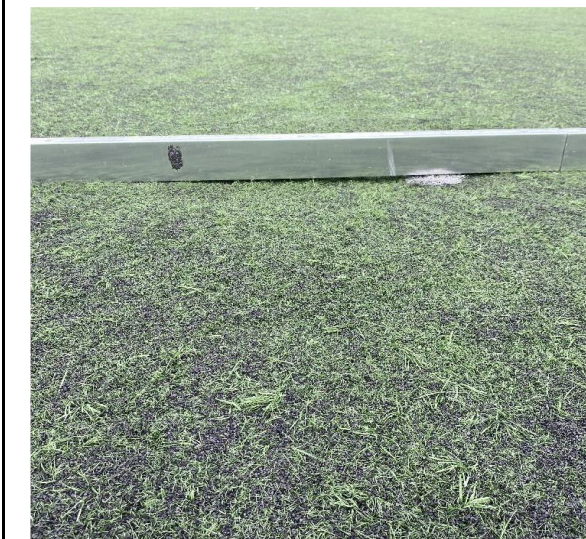
-13mm undulation on penalty spot

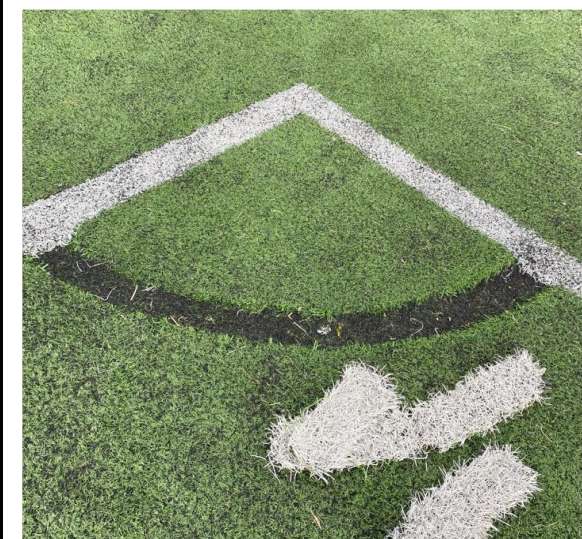
Visual Inspection	Property	Condition
	Yarn/Pile	Pile is flat across the length of the pitch.
	Seams	One corner arc seam is torn open and is no longer attached. Another corner arc seam is beginning to tear open.
	Line Markings	No issues observed.
	Infill	Inconsistent levels of infill. There is low infill around both penalty spots.
	Goals, Equipment, Fencing	Goals and netting are in reasonable condition. Some of the netting needs to be reattached to the goalposts.
	Housekeeping (Litter etc)	There is a bin provided to ensure that litter does not clutter the pitch.

Corner arc seam is damaged

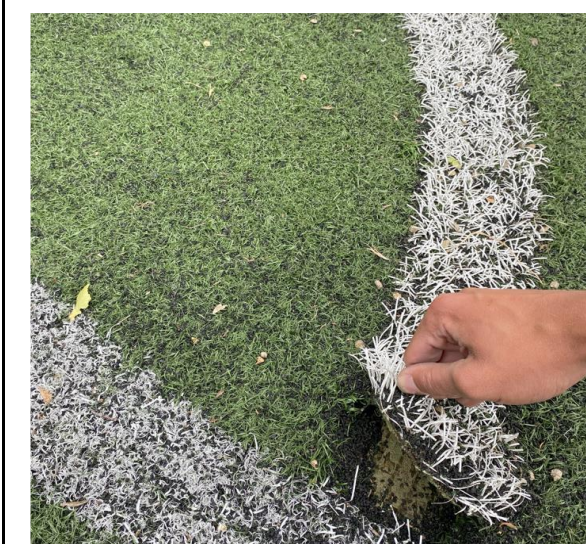
Open seam on corner arc
