Asbestos Refurbishment/Demolition Survey for Environment Agency

Grafton Lock House
Grafton
Nr. Lechlade
Oxfordshire
OX18 2RY

Amicus Environmental Limited	Project Number:	S13327
	Survey Date:	14 January 2021
	Printed On:	18 January 2021
	Page:	Page 1 of 1

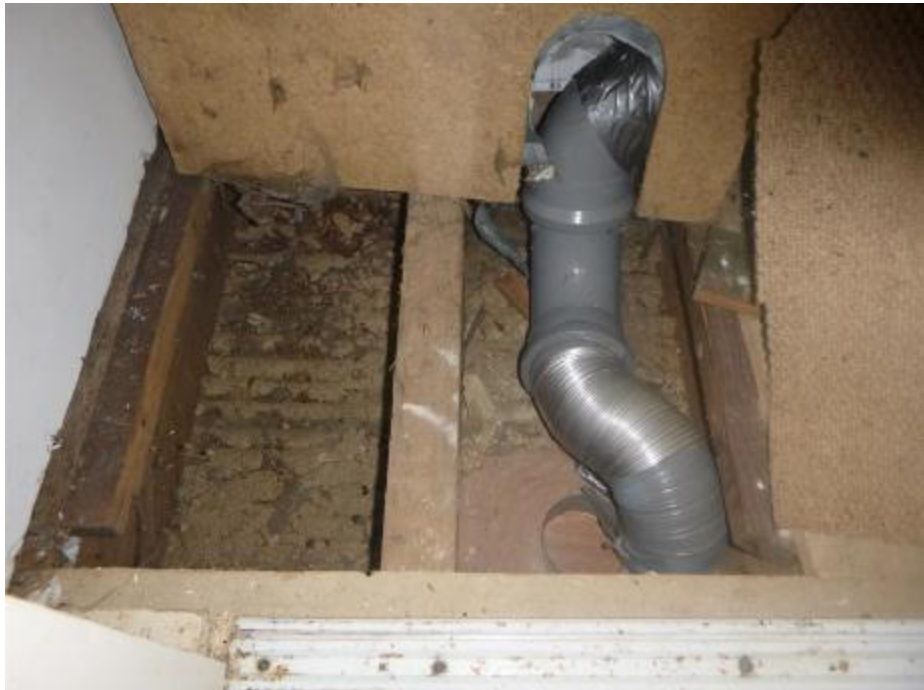
Location ID:	32450	Survey Type:	RDS
Location Ref:	01	Product Type:	Not Applicable
Product:	Floor Inspections	Damage:	Not Applicable
Area:	Grafton Lock House	Treatment:	Not Applicable
Floor:	First floor	Asbestos Type:	Not Applicable
Room:	1.01	Identification:	Identified
Surveyor Name:	R.Clark	Quantity:	Not Applicable.
Drawing Ref:	As Location Ref.		
Asbestos ?	No		
Date:	14 January 2021		
Next Inspection:	Not Applicable

No asbestos containing materials identified upon visual inspection of floor. Consists of carpet onto timber floor board with lath and plaster ceiling below. Unlagged pipe work and electrical cabling within void.

Action: No Action Required

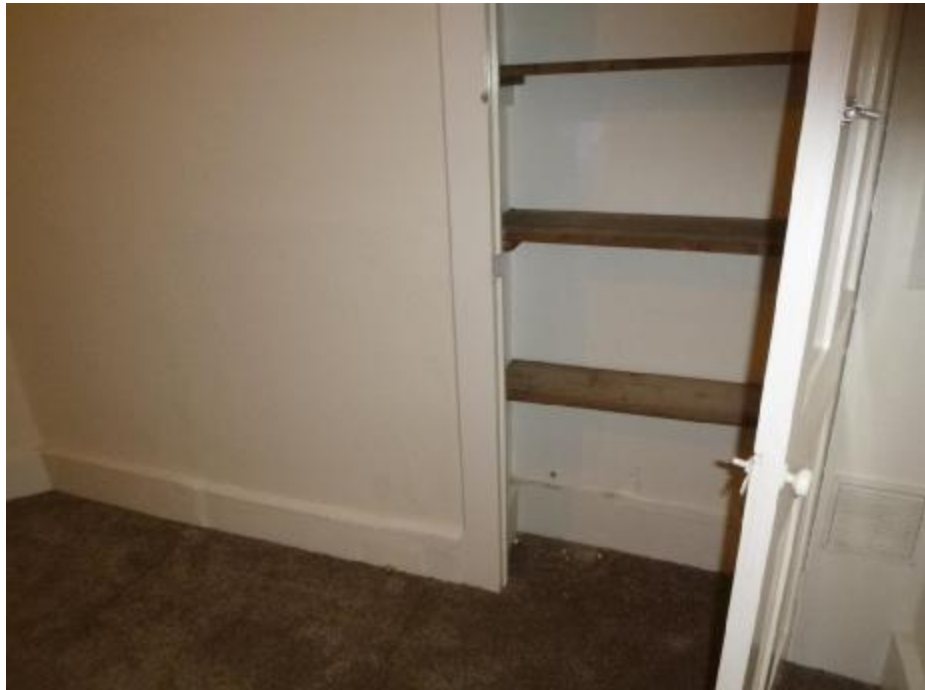
Location ID:	32451	Survey Type:	RDS
Location Ref:	02	Product Type:	Not Applicable
Product:	Wall Inspection	Damage:	Not Applicable
Area:	Grafton Lock House	Treatment:	Not Applicable
Floor:	First floor	Asbestos Type:	Not Applicable
Room:	1.02	Identification:	Identified
Surveyor Name:	R.Clark	Quantity:	Not Applicable.
Drawing Ref:	As Location Ref		
Asbestos ?	No		
Date:	14 January 2021		
Next Inspection:	Not Applicable

Material Comments: No asbestos containing materials identified upon visual inspection of walls. Consists of plaster finish to masonry and lath and plaster walls.

Action: No Action Required

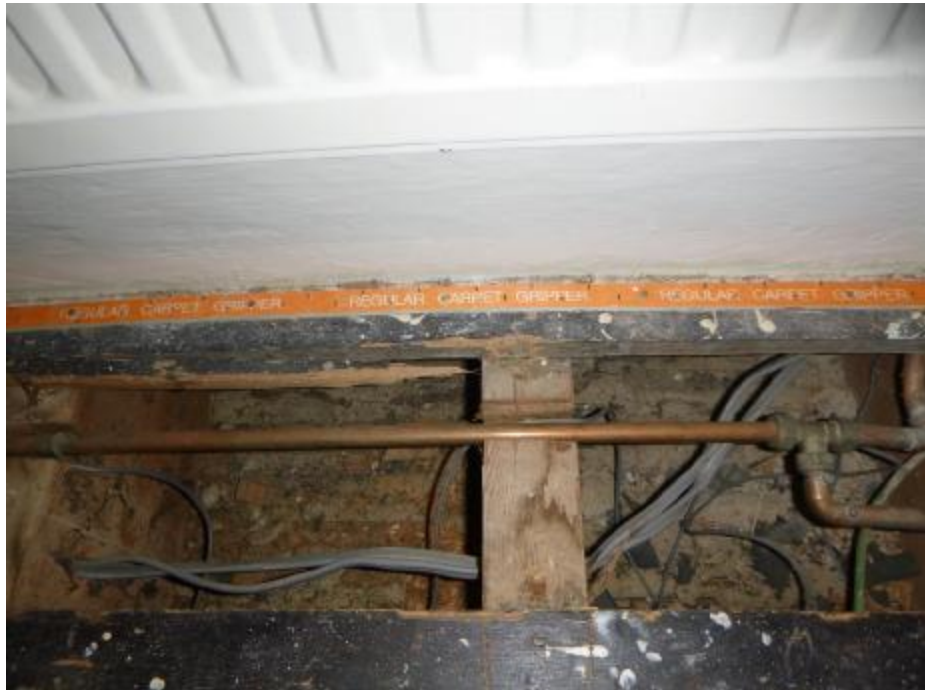
Location ID:	32453	Survey Type:	RDS
Location Ref:	03	Product Type:	Not Applicable
Product:	Floor Inspections	Damage:	Not Applicable
Area:	Grafton Lock House	Treatment:	Not Applicable
Floor:	First floor	Asbestos Type:	Not Applicable
Room:	1.03	Identification:	Identified
Surveyor Name:	R.Clark	Quantity:	Not Applicable.
Drawing Ref:	As Location Ref		
Asbestos ?	No		
Date:	14 January 2021		
Next Inspection:	Not Applicable

No asbestos containing materials identified upon visual inspection of floor. Consists of carpet onto timber floor board with lath and plaster ceiling below. Unlagged pipe work and electrical cabling within void.

Action: No Action Required

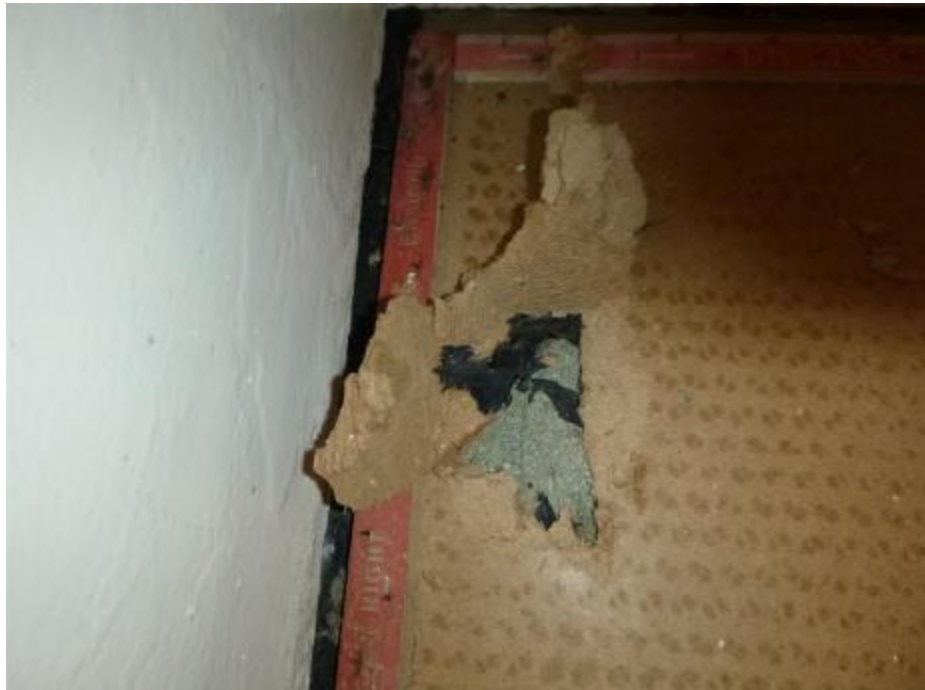
Location ID:	32454	Survey Type:	RDS
Location Ref:	04	Product Type:	Not Applicable
Product:	Floor Inspections	Damage:	Not Applicable
Area:	Grafton Lock House	Treatment:	Not Applicable
Floor:	Ground floor	Asbestos Type:	Not Applicable
Room:	G.01	Identification:	Identified
Surveyor Name:	R.Clark	Quantity:	Not Applicable.
Drawing Ref:	As Location Ref		
Asbestos ?	No		
Date:	14 January 2021		
Next Inspection:	Not Applicable

Material Comments: No asbestos containing materials identified upon visual inspection of floor. Consists of carpet to timber and concrete.

Action: No Action Required

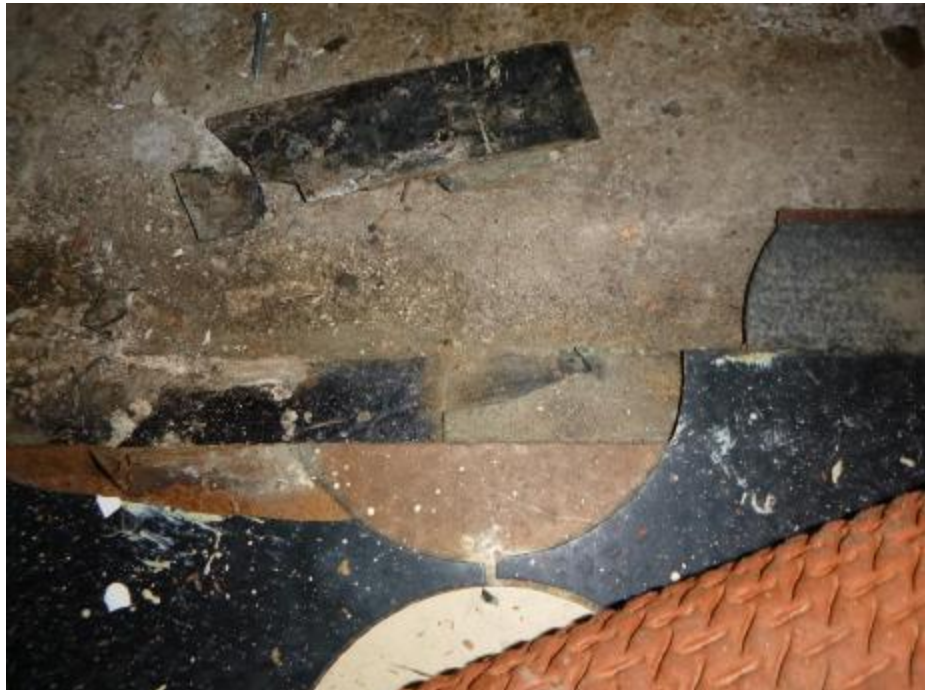
Location ID:	32458	Survey Type:	RDS
Location Ref:	05	Product Type:	Vinyl floor tiles
Product:	Vinyl floor tile & adhesive	Damage:	Low damage
Area:	Grafton Lock House	Treatment:	Vinyl tiles
Floor:	Ground floor	Asbestos Type:	Chrysotile
Room:	G.02	Identification:	Identified
Surveyor Name:	R.Clark	Quantity:	Approx. 2m ²
Drawing Ref:	As Location Ref		
Asbestos ?	Yes		
Date:	14 January 2021		
Next Inspection:	14 January 2022

Material Comments: Located beneath carpet to concrete floor.

Action: Removal

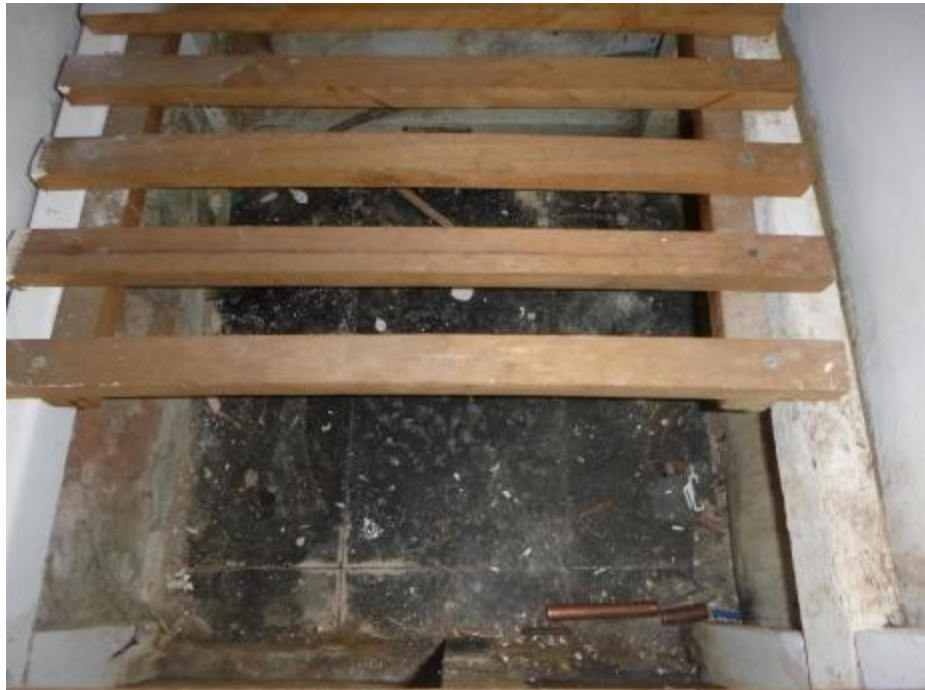
Location ID:	32461	Survey Type:	RDS
Location Ref:	06	Product Type:	Vinyl floor tiles
Product:	Vinyl floor tile & adhesive	Damage:	Low damage
Area:	Grafton Lock House	Treatment:	Vinyl tiles
Floor:	Ground floor	Asbestos Type:	Chrysotile
Room:	G.03	Identification:	Strongly Presumed as previous sample
Surveyor Name:	R.Clark	Quantity:	Approx. 0.5m ²
Drawing Ref:	As Location Ref		
Asbestos ?	Yes		
Date:	14 January 2021		
Next Inspection:	14 January 2022

Material Comments: Refer to sample 05 for analysis. Located to concrete floor of airing cupboard only.

Action: Removal

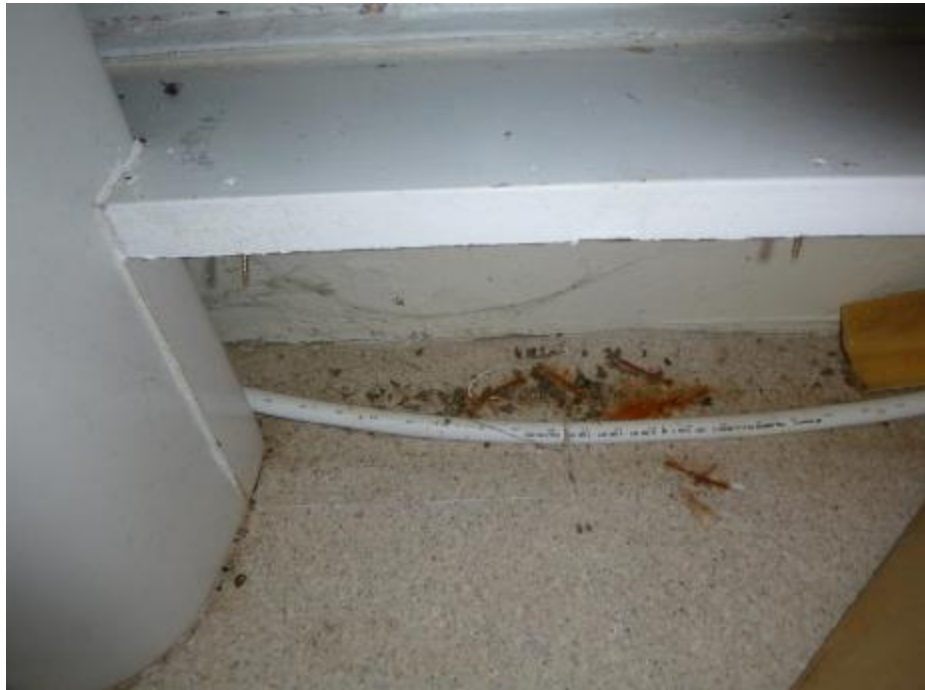
Location ID:	32463	Survey Type:	RDS
Location Ref:	07	Product Type:	Not Applicable
Product:	Boxing Inspection	Damage:	Not Applicable
Area:	Grafton Lock House	Treatment:	Not Applicable
Floor:	Ground floor	Asbestos Type:	Not Applicable
Room:	G.03	Identification:	Identified
Surveyor Name:	R.Clark	Quantity:	Not Applicable.
Drawing Ref:	As Location Ref		
Asbestos ?	No		
Date:	14 January 2021		
Next Inspection:	Not Applicable

No asbestos containing materials identified upon visual inspection of boxing. Consists of timber panels housing unlagged plastic pipe work.

Action: No Action Required

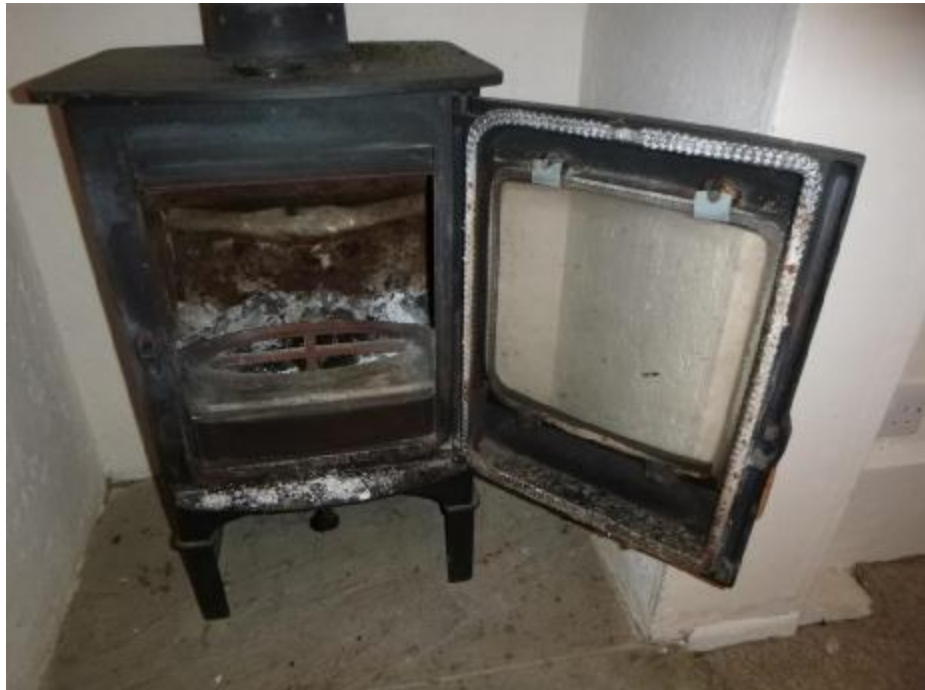
Location ID:	32468	Survey Type:	RDS
Location Ref:	08	Product Type:	NADIS
Product:	Rope seal	Damage:	NADIS
Area:	Grafton Lock House	Treatment:	NADIS
Floor:	Ground floor	Asbestos Type:	NADIS
Room:	G.04	Identification:	Identified
Surveyor Name:	R.Clark	Quantity:	1 x Door
Drawing Ref:	As Location Ref		
Asbestos ?	No		
Date:	14 January 2021		
Next Inspection:	Not Applicable

Material Comments: No Asbestos Detected In Sample (NADIS) obtained for analysis. Located to the door of wood burner.

Action: No Action Required

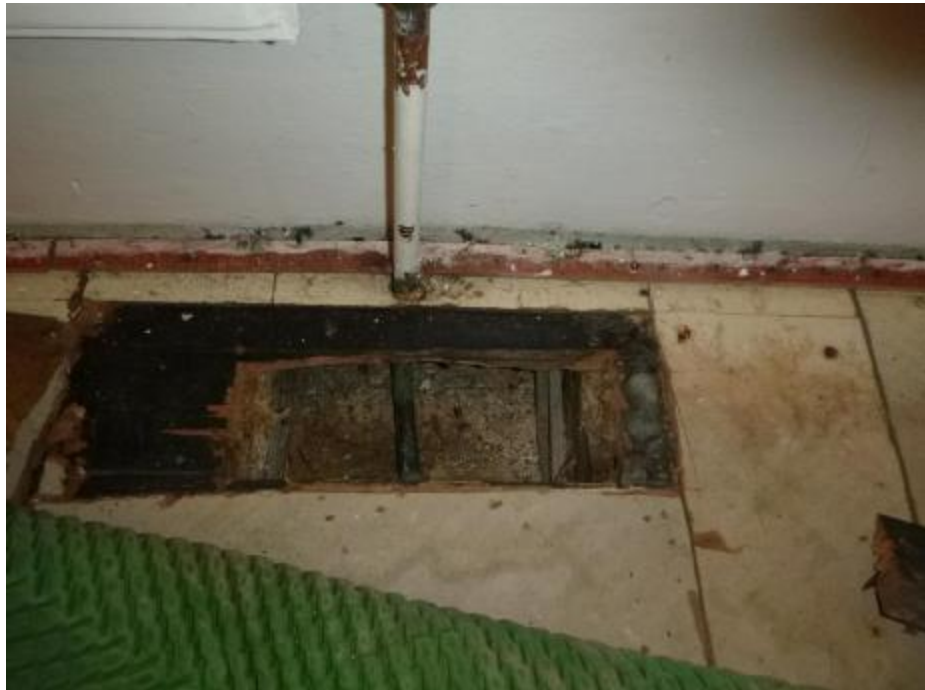
Location ID:	32469	Survey Type:	RDS
Location Ref:	09	Product Type:	Not Applicable
Product:	Floor Inspections	Damage:	Not Applicable
Area:	Grafton Lock House	Treatment:	Not Applicable
Floor:	Ground floor	Asbestos Type:	Not Applicable
Room:	G.04	Identification:	Identified
Surveyor Name:	R.Clark	Quantity:	Not Applicable.
Drawing Ref:	As Location Ref		
Asbestos ?	No		
Date:	14 January 2021		
Next Inspection:	Not Applicable

No asbestos containing materials identified upon visual inspection of floor. Consists of carpet to timber boards. Unlagged metal pipe work and electrical cabling within void.

Action: No Action Required

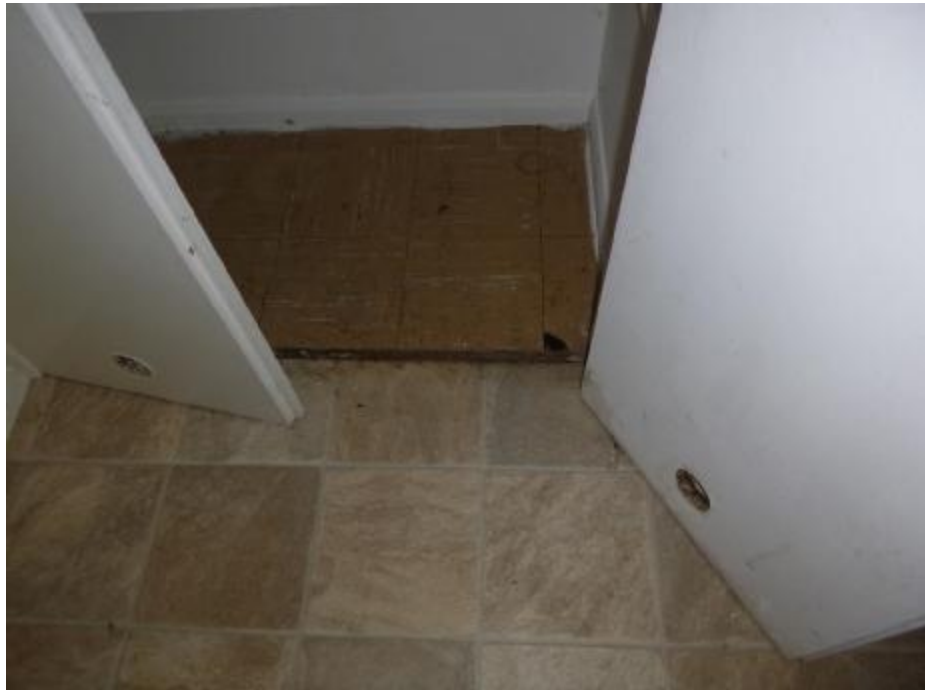
Location ID:	32470	Survey Type:	RDS
Location Ref:	10	Product Type:	Vinyl floor tiles
Product:	Vinyl Floor Tile and Adhesive	Damage:	Low damage
Area:	Grafton Lock House	Treatment:	Vinyl tiles
Floor:	Ground floor	Asbestos Type:	Chrysotile
Room:	G.05	Identification:	Identified
Surveyor Name:	R.Clark	Quantity:	Approx. 8m ²
Drawing Ref:	As Location Ref		
Asbestos ?	Yes		
Date:	14 January 2021		
Next Inspection:	14 January 2022

Material Comments: Located beneath modern vinyl flooring to concrete floor.

Action: Removal

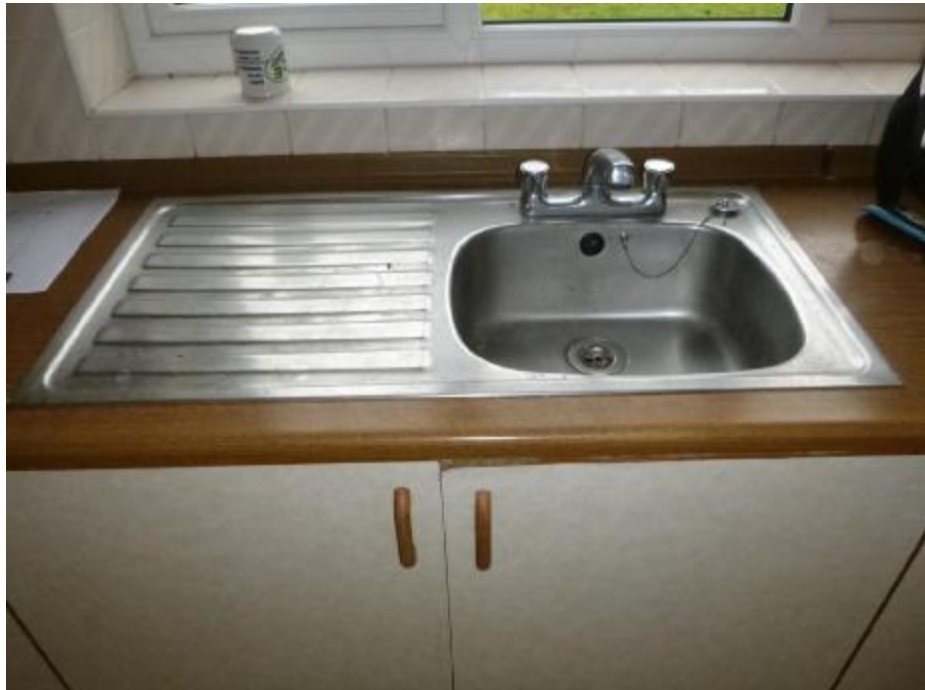
Location ID:	32471	Survey Type:	RDS
Location Ref:	11	Product Type:	NADIS
Product:	Sink Pad	Damage:	NADIS
Area:	Grafton Lock House	Treatment:	NADIS
Floor:	Ground floor	Asbestos Type:	NADIS
Room:	G.05	Identification:	Identified
Surveyor Name:	R.Clark	Quantity:	1 No.
Drawing Ref:	As Location Ref		
Asbestos ?	No		
Date:	14 January 2021		
Next Inspection:	Not Applicable

Material Comments: No Asbestos Detected In Sample (NADIS) obtained for analysis. Located to underside of metal sink and drainer.

Action: No Action Required

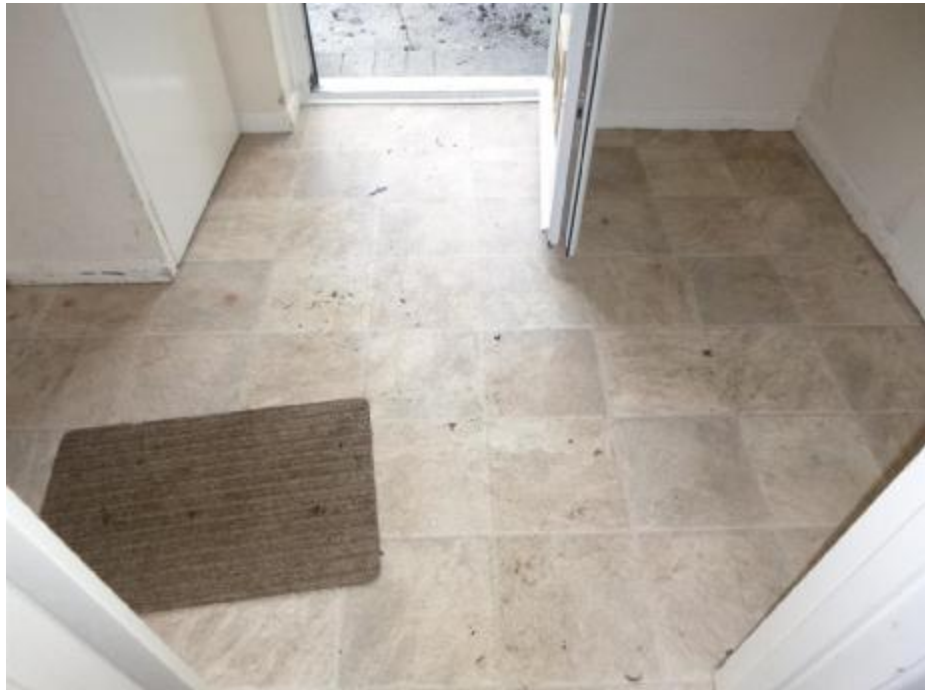
Location ID:	32472	Survey Type:	RDS
Location Ref:	12	Product Type:	Vinyl floor tiles
Product:	Vinyl floor tile & adhesive	Damage:	Low damage
Area:	Grafton Lock House	Treatment:	Vinyl tiles
Floor:	Ground floor	Asbestos Type:	Chrysotile
Room:	G.06	Identification:	Strongly Presumed as previous sample
Surveyor Name:	R.Clark	Quantity:	Approx. 6m ²
Drawing Ref:	As Location Ref		
Asbestos ?	Yes		
Date:	14 January 2021		
Next Inspection:	14 January 2022

Refer to sample 10 for analysis. Located beneath modern vinyl flooring to concrete floor.

Removal

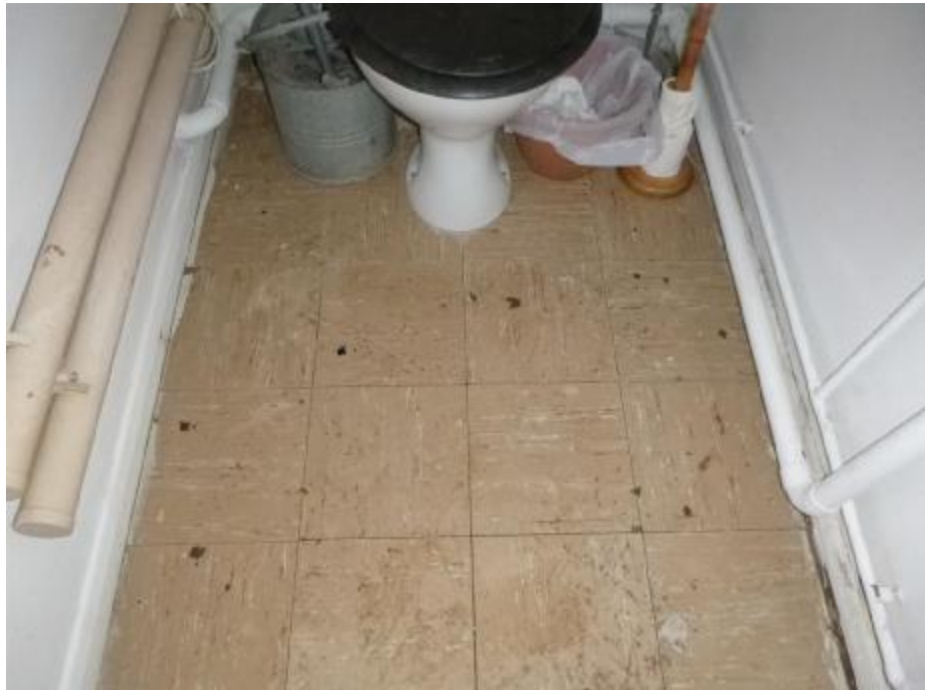
Location ID:	32473	Survey Type:	RDS
Location Ref:	13	Product Type:	Vinyl floor tiles
Product:	Vinyl floor tile & adhesive	Damage:	Low damage
Area:	Grafton Lock House	Treatment:	Vinyl tiles
Floor:	Ground floor	Asbestos Type:	Chrysotile
Room:	G.07	Identification:	Strongly Presumed as previous sample
Surveyor Name:	R.Clark	Quantity:	Approx. 2m ²
Drawing Ref:	As Location Ref		
Asbestos ?	Yes		
Date:	14 January 2021		
Next Inspection:	14 January 2022

Material Comments: Refer to sample 10 for analysis. Located to concrete floor.

Action: Removal

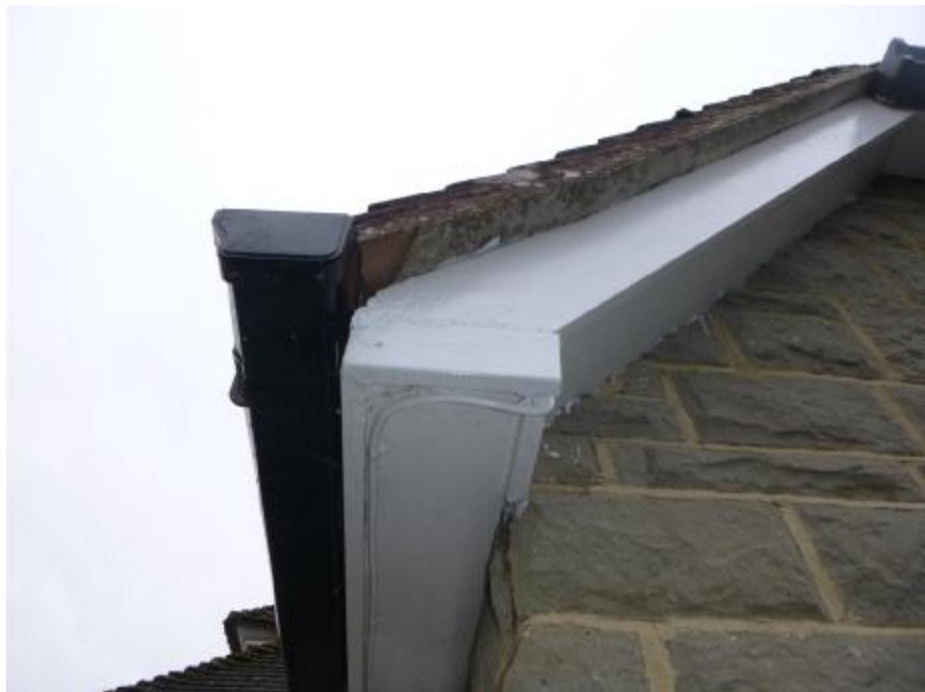
Location ID:	32474	Survey Type:	RDS
Location Ref:	14	Product Type:	NADIS
Product:	Verge Undercloak	Damage:	NADIS
Area:	Grafton Lock House	Treatment:	NADIS
Floor:	Roof level	Asbestos Type:	NADIS
Room:	External	Identification:	Identified
Surveyor Name:	R.Clark	Quantity:	Approx 18 Linear Metres.
Drawing Ref:	As Location Ref		
Asbestos ?	No		
Date:	14 January 2021		
Next Inspection:	Not Applicable

Material Comments: No Asbestos Detected In Sample (NADIS) obtained for analysis. Located to various areas of pitched roof.

Action: No Action Required

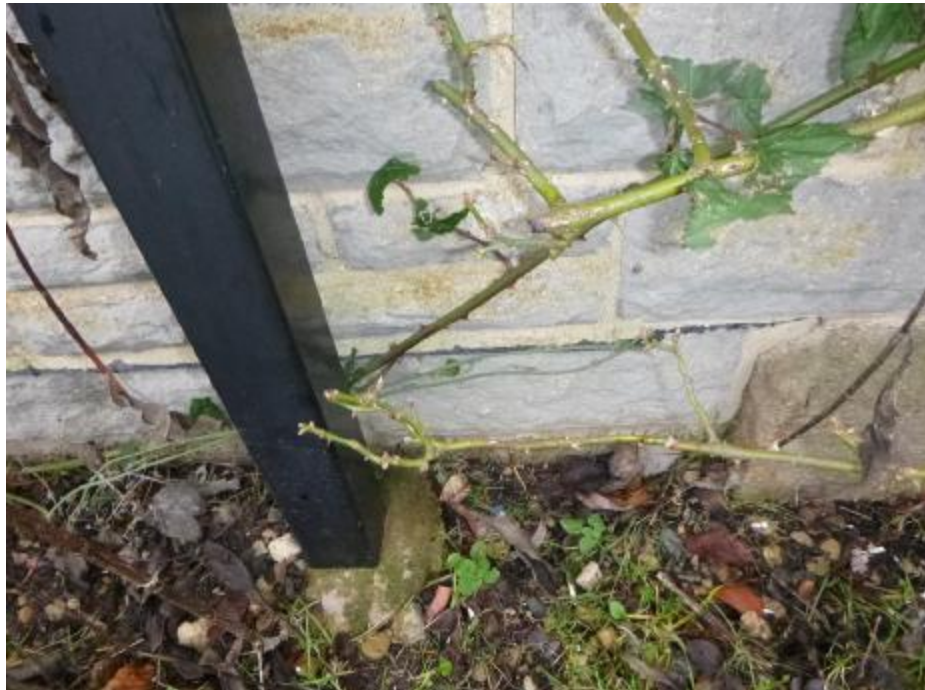
Location ID:	32475	Survey Type:	RDS
Location Ref:	15	Product Type:	NADIS
Product:	Damp Proof Course	Damage:	NADIS
Area:	Grafton Lock House	Treatment:	NADIS
Floor:	Ground floor	Asbestos Type:	NADIS
Room:	External	Identification:	Identified
Surveyor Name:	R.Clark	Quantity:	Approx. 11 Linear Metres.
Drawing Ref:	As Location Ref		
Asbestos ?	No		
Date:	14 January 2021		
Next Inspection:	Not Applicable

Material Comments: No Asbestos Detected In Sample (NADIS) obtained for analysis. Located at low level within masonry wall.

Action: No Action Required

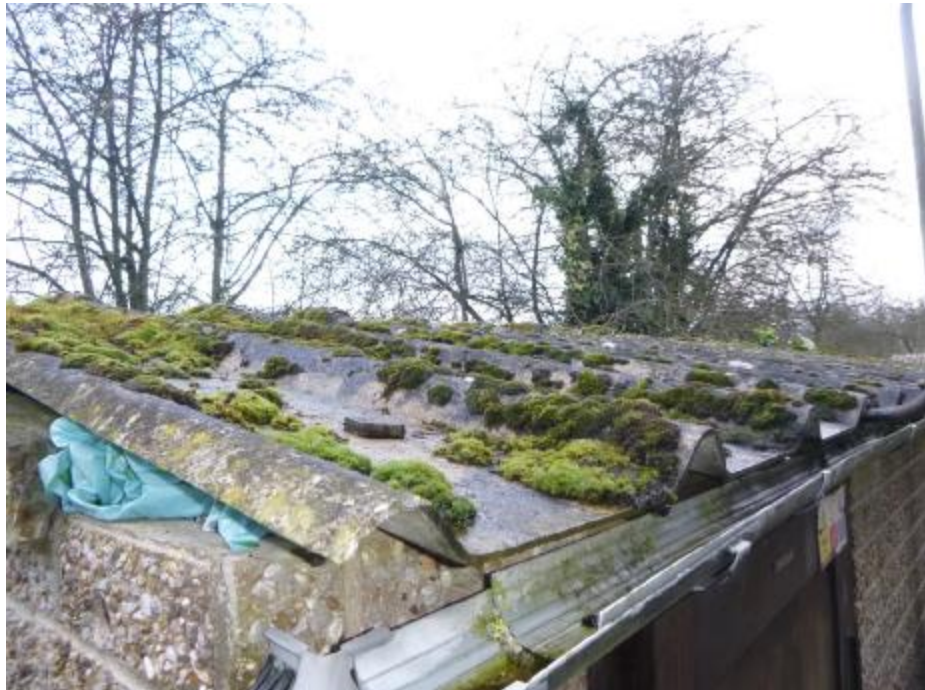
Location ID:	32476	Survey Type:	RDS
Location Ref:	16	Product Type:	Asbestos cement
Product:	Roof sheets	Damage:	Low damage
Area:	Grafton Lock House	Treatment:	Asbestos cement sheets etc
Floor:	Roof level	Asbestos Type:	Chrysotile
Room:	External	Identification:	Identified
Surveyor Name:	R.Clark	Quantity:	Approx. 15m ²
Drawing Ref:	As Location Ref.		
Asbestos ?	Yes		
Date:	14 January 2021		
Next Inspection:	14 January 2022

Material Risk Score:	4
Material Risk Band:	Very Low Risk
Priority Risk Score:	N/A

Material Comments: Located to the roof of G.08 only.

Action: Removal

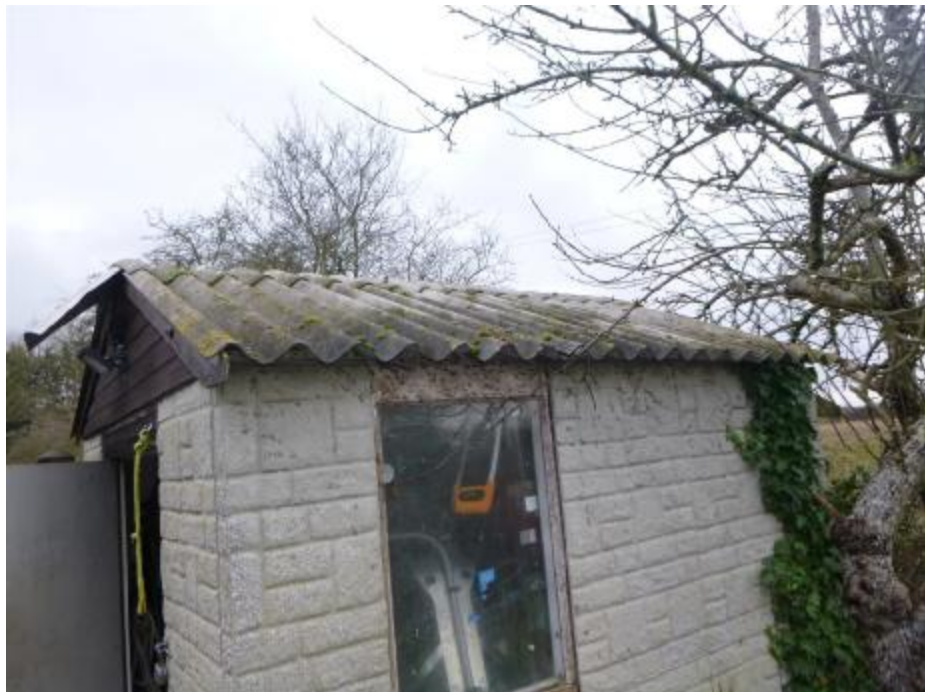
Location ID:	32477	Survey Type:	RDS
Location Ref:	17	Product Type:	NADIS
Product:	Roof sheets	Damage:	NADIS
Area:	Grafton Lock House	Treatment:	NADIS
Floor:	Roof level	Asbestos Type:	NADIS
Room:	External	Identification:	Identified
Surveyor Name:	R.Clark	Quantity:	Approx. 6m ²
Drawing Ref:	As Location Ref.		
Asbestos ?	No		
Date:	14 January 2021		
Next Inspection:	Not Applicable

Material Comments: No Asbestos Detected In Sample (NADIS) obtained for analysis. Located to the roof of G.09 only.

Action: No Action Required

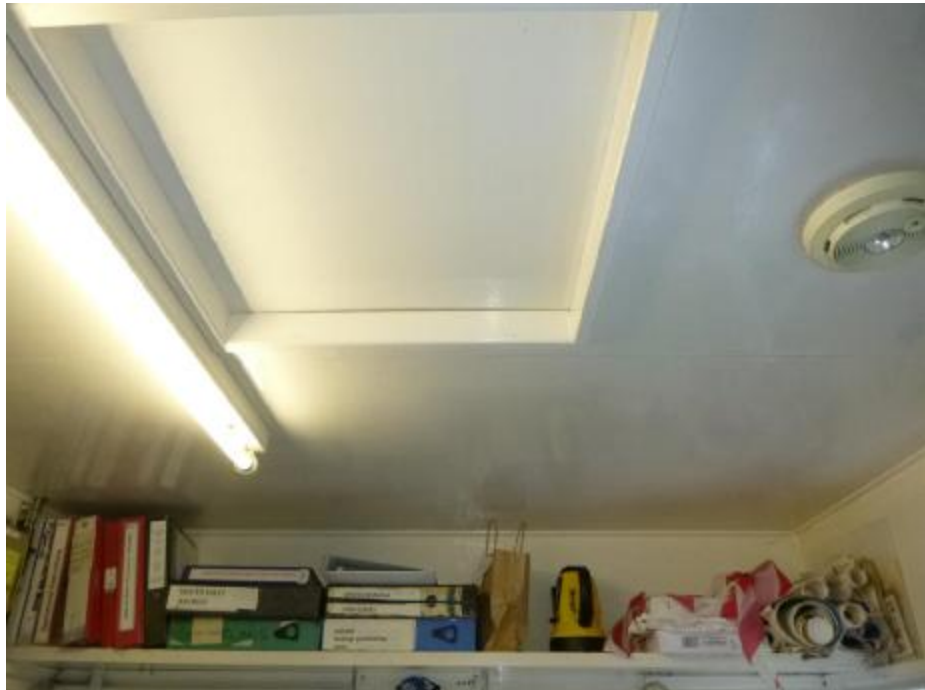
Location ID:	32478	Survey Type:	RDS
Location Ref:	18	Product Type:	NADIS
Product:	Ceiling Sheets	Damage:	NADIS
Area:	Grafton Lock House	Treatment:	NADIS
Floor:	Ground floor	Asbestos Type:	NADIS
Room:	G.10	Identification:	Identified
Surveyor Name:	R.Clark	Quantity:	Approx. 6m ²
Drawing Ref:	As Location Ref		
Asbestos ?	No		
Date:	14 January 2021		
Next Inspection:	Not Applicable

Material Comments: No Asbestos Detected In Sample (NADIS) obtained for analysis. Located to the ceiling of room.

Action: No Action Required
