Annual Inspection

Houghton Regis Town Council

Parkside Recreation Ground - Bottom

Parkside Drive, Houghton Regis, Dunstable, LU5 5RQ

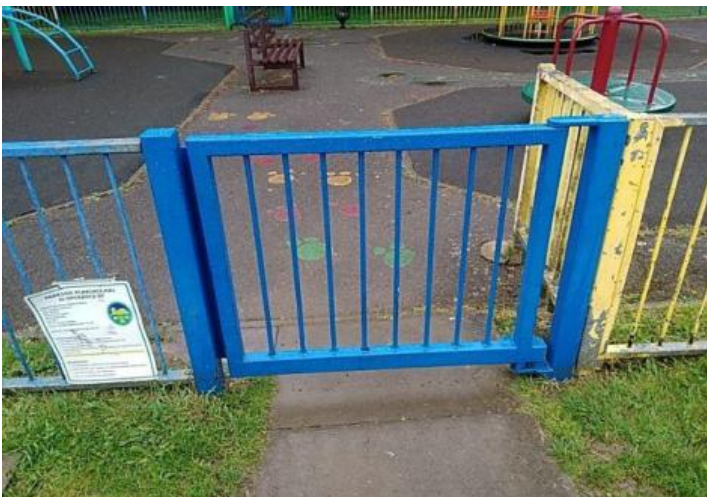
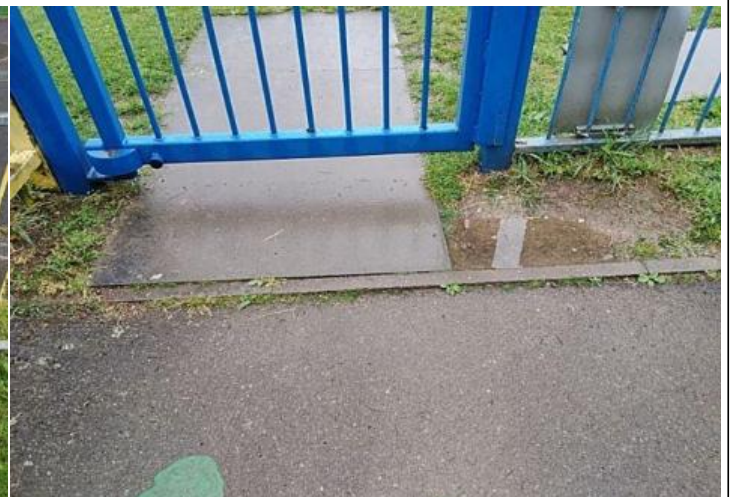
Risk Level: L - Low Risk
Surface: Paving Slabs

Finding: There are trip hazards at the edges of the surface

Action: Reinstate surrounding surface levels to remove the trip points

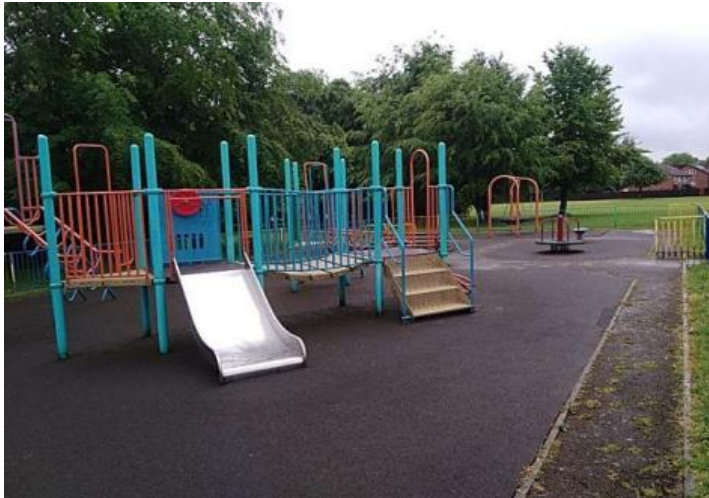
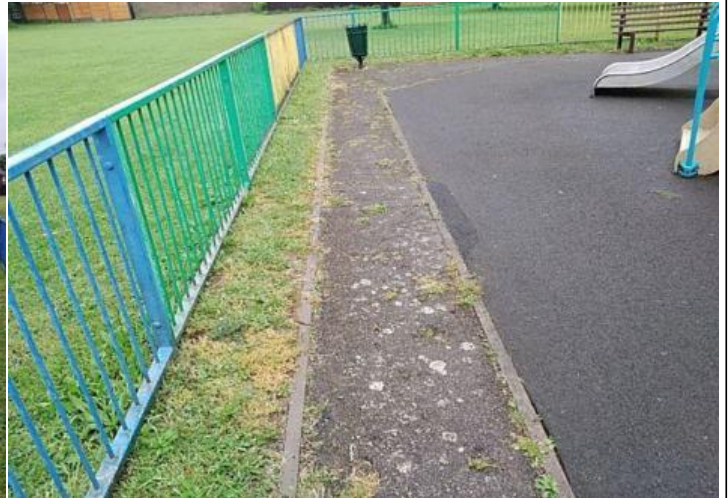
Finding: The bitumen surface is worn or damaged

Action: Repair the bitumen to provide a uniform surface

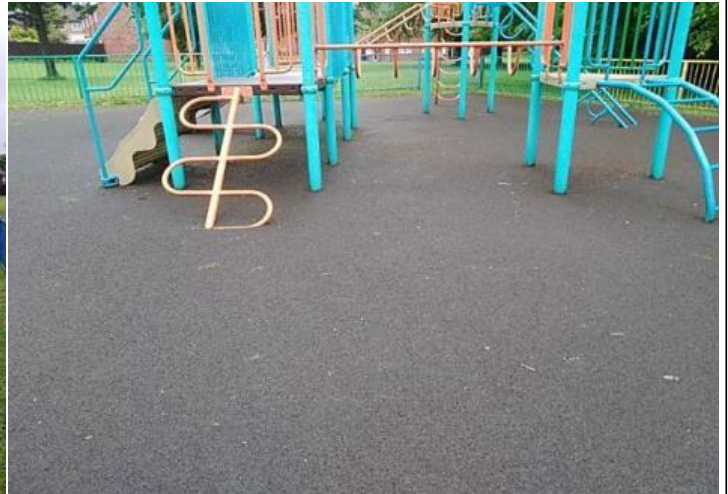
Finding: There is algae, silt or moss growth on the surface resulting in slippery conditions

Action: Clean and treat appropriately

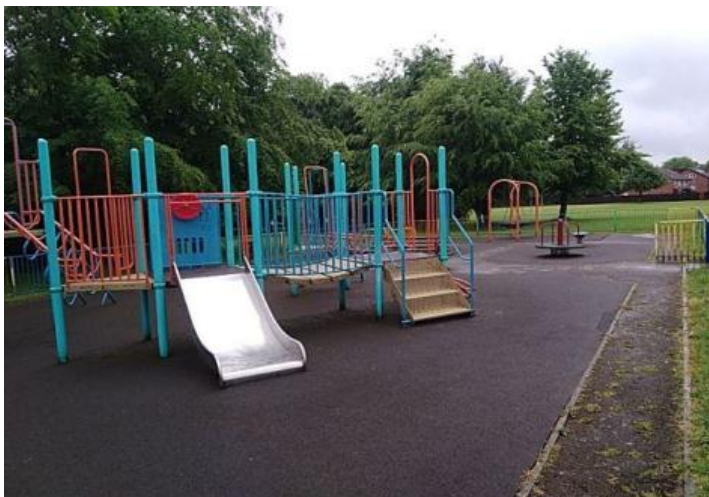
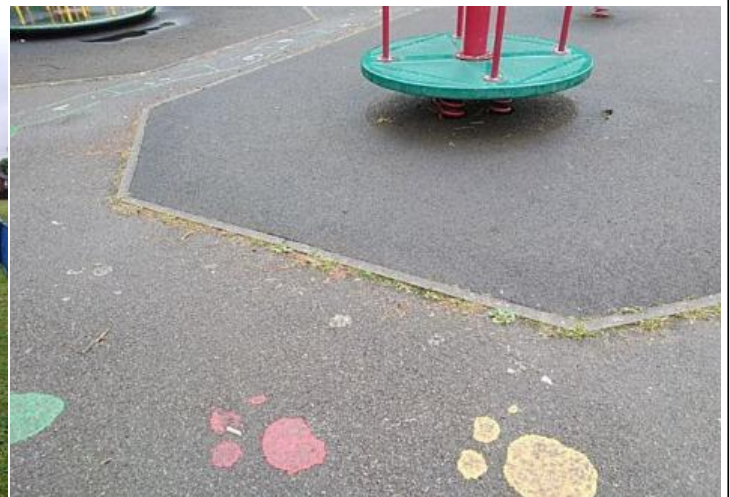
Finding: There are trip hazards at the edges of the surface
Action: Reinstate surrounding surface levels to remove the trip points

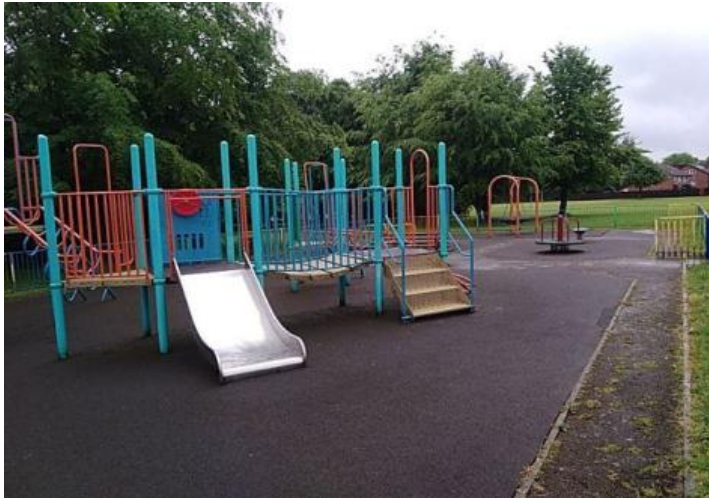
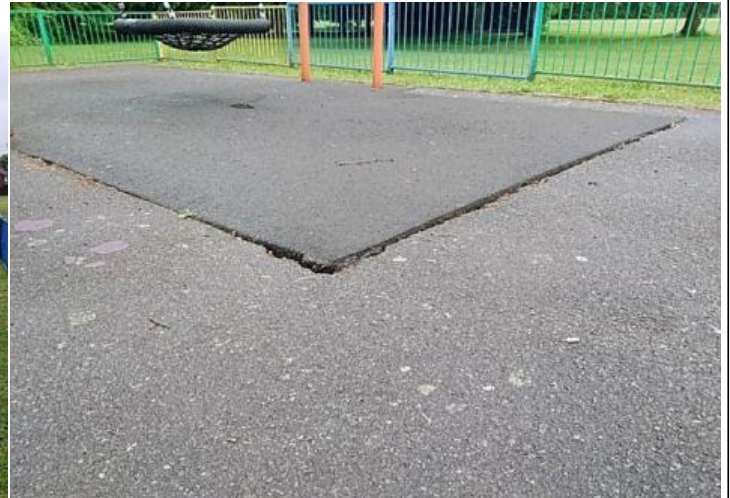
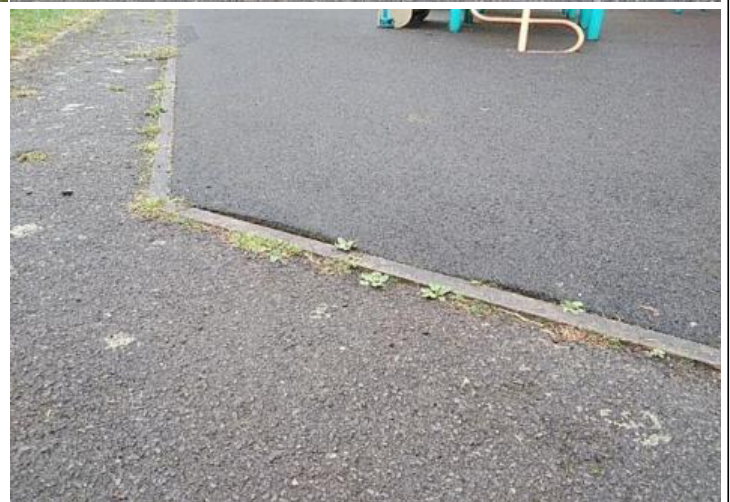
Finding: The surface is lifting at the edges and creating trip points **Action:** Repair perimeter of surfacing to remove trip points

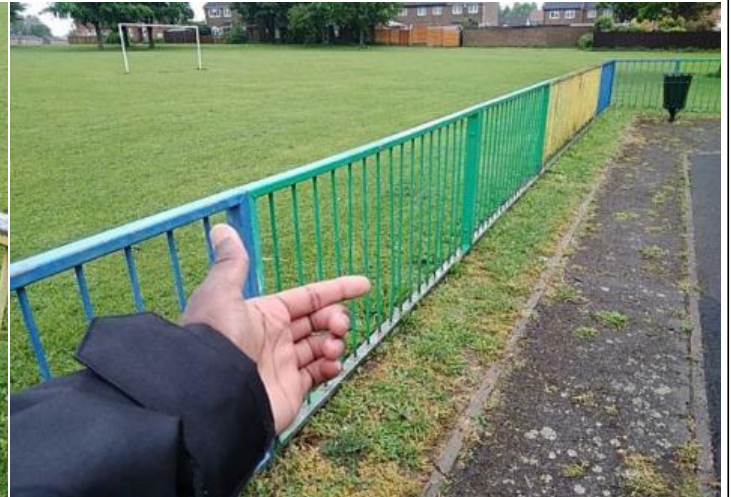
Finding: There is some damage to the fence sections

Action: Monitor for any further deterioration and repair as required

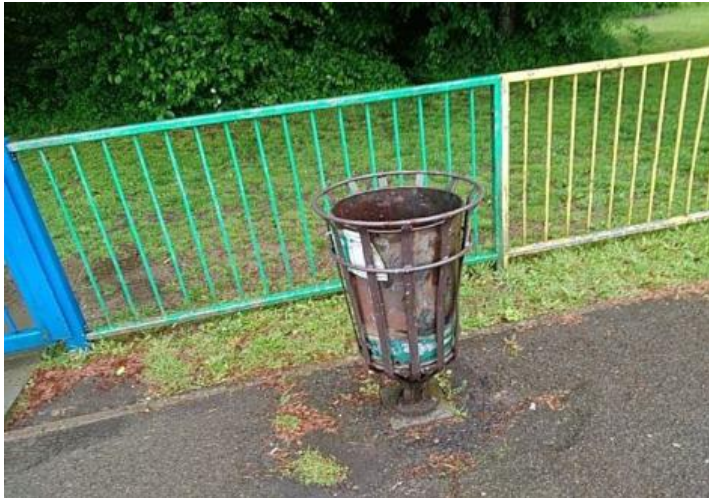
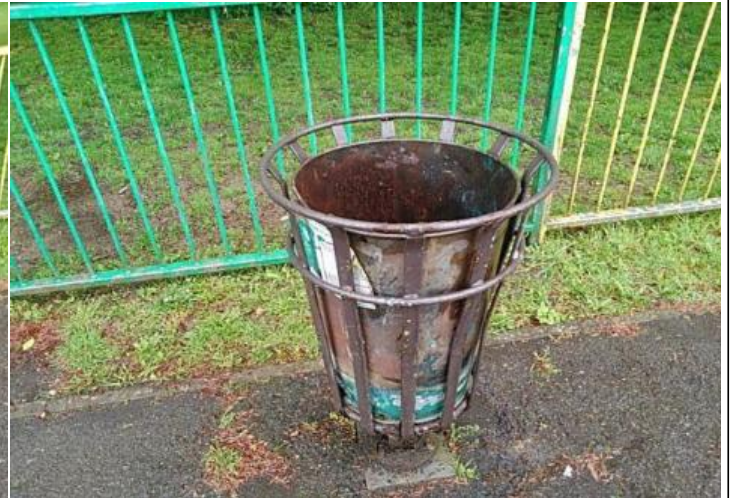
Finding: There is some evidence of fire damage to the item **Action:** Monitor for any further deterioration and repair as required

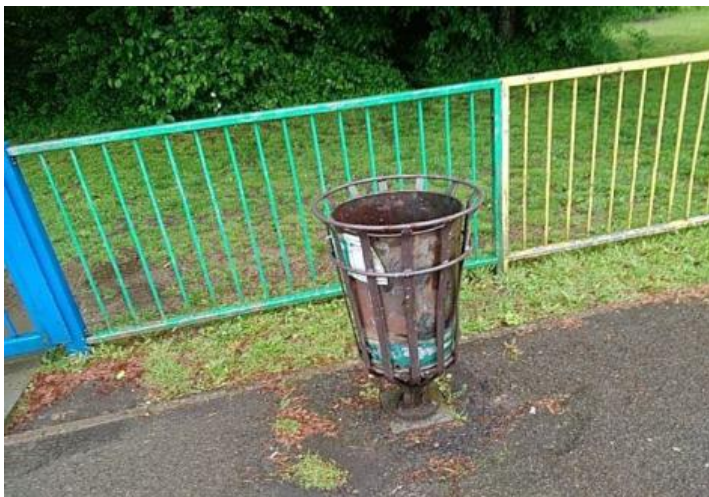
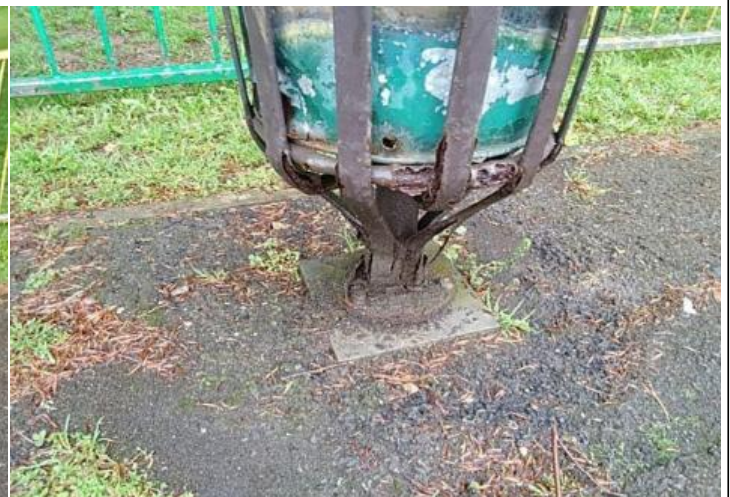
Finding: Parts of the steel on this item have corroded excessively and the metal has perforated in places **Action:** Ensure all affected areas are treated and repaired

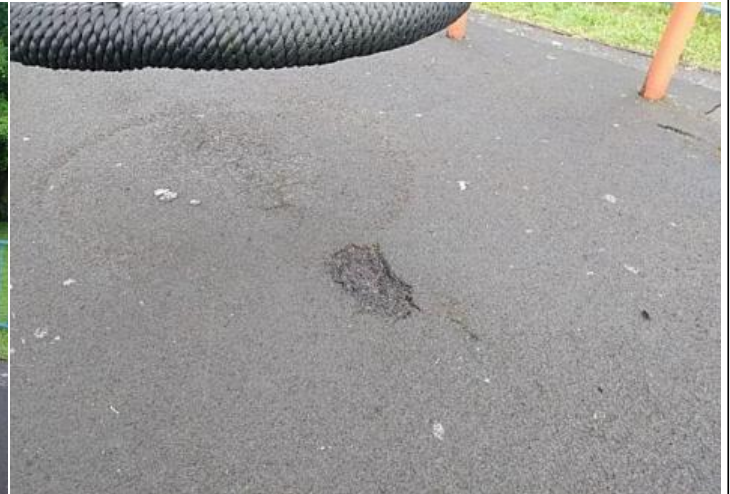
Finding: There is moderate damage to the surface

Action: Repair the damaged areas of surfacing

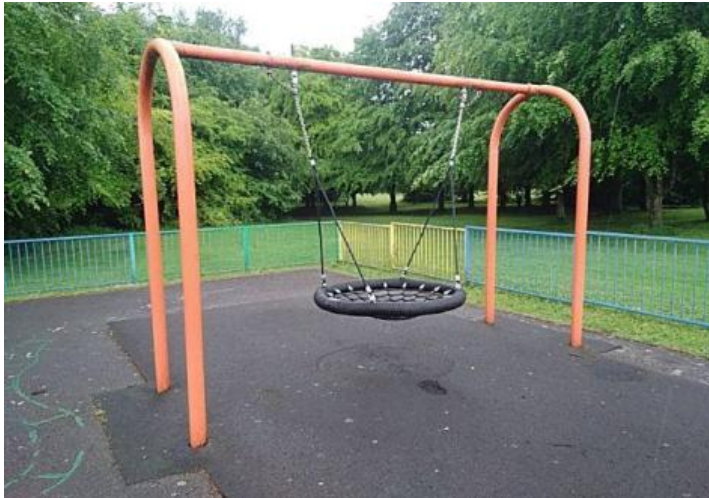
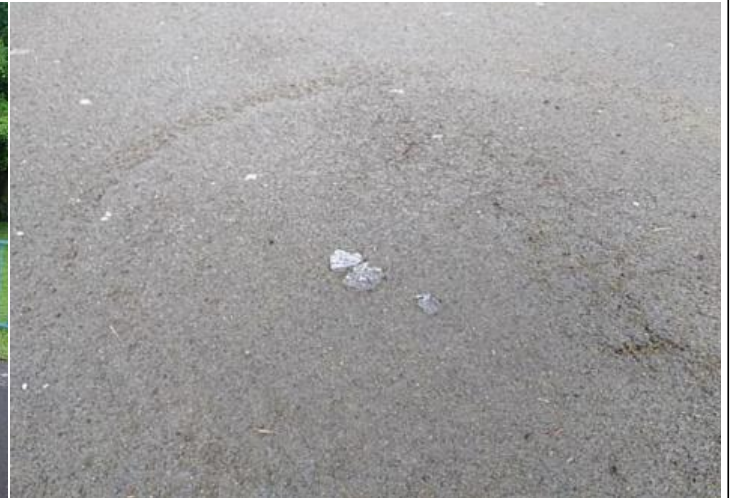
Finding: There is some evidence of fire damage to the surfacing

Action: Monitor for any further deterioration and repair as required

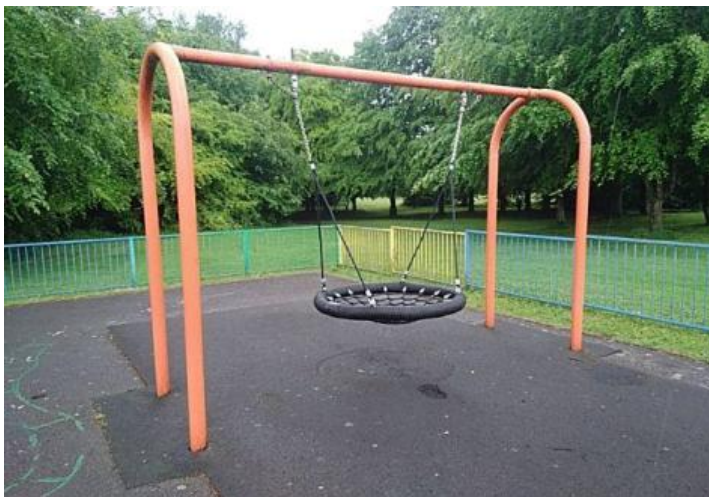
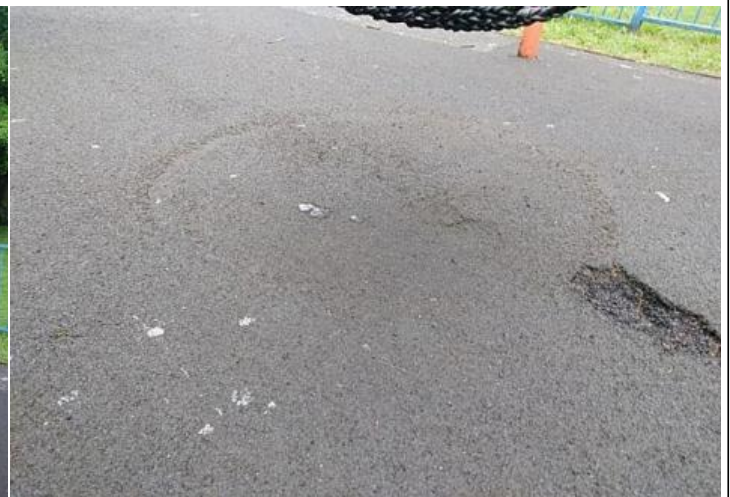
Finding: The safety surface around the area is beginning to wear

Action: Monitor for any further deterioration and repair as required

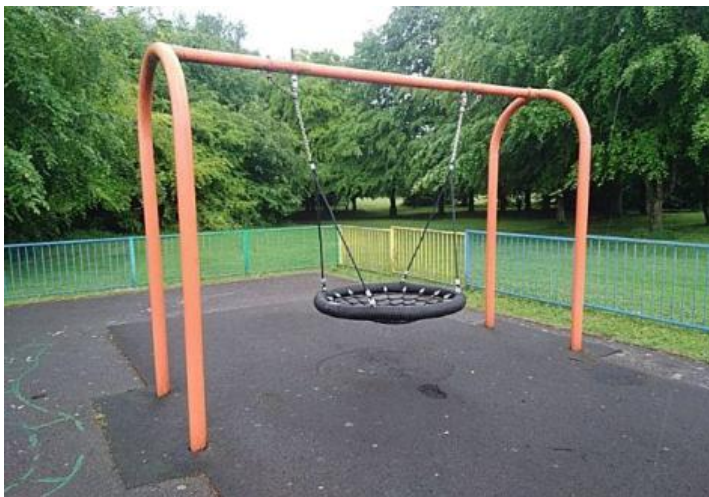
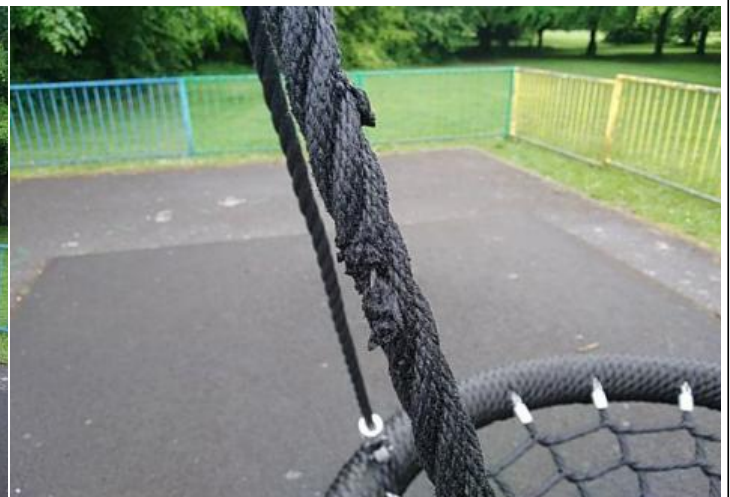
Finding: The ropes/nets are worn/damaged in places

Action: Monitor for any further deterioration and repair or replace as required

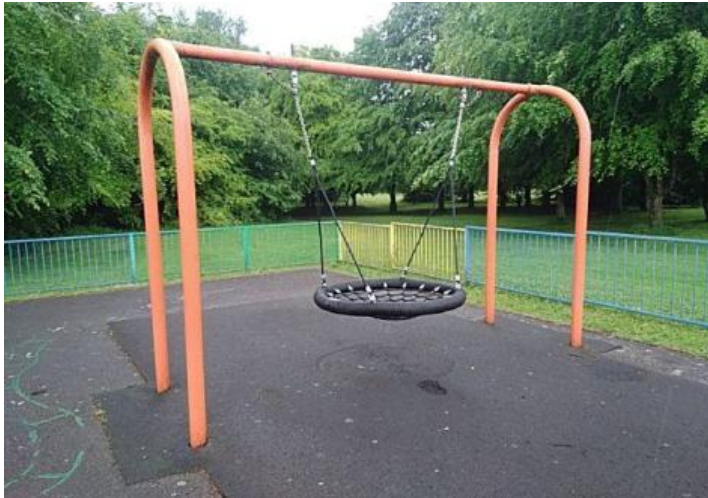
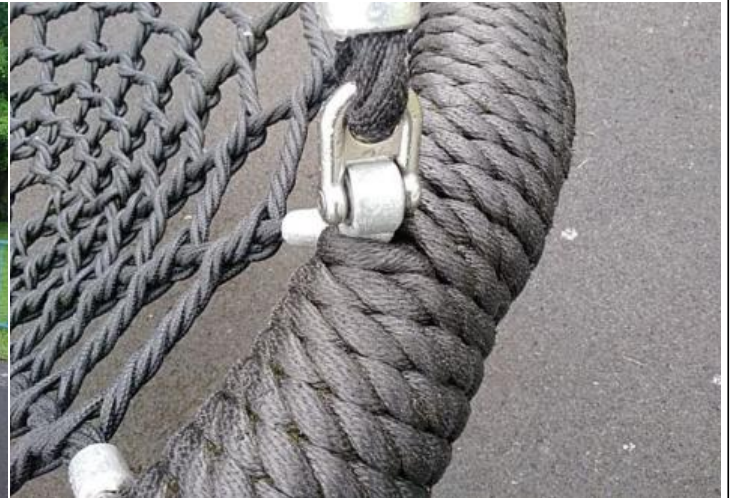
Finding: The bushes are showing signs of wear

Action: Monitor for any further deterioration and replace as required

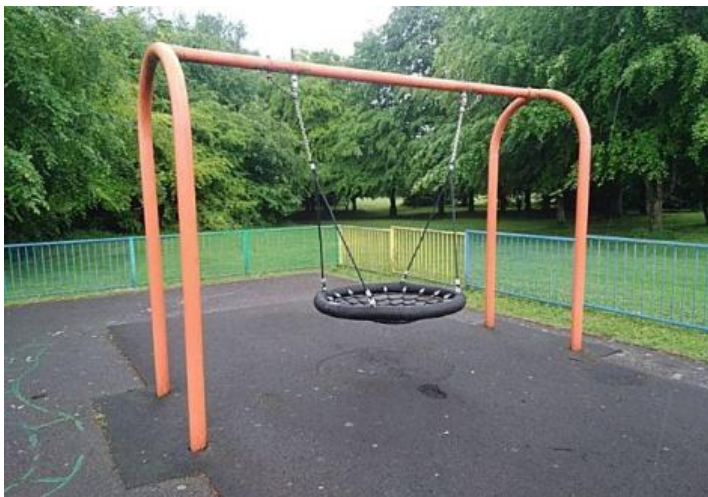
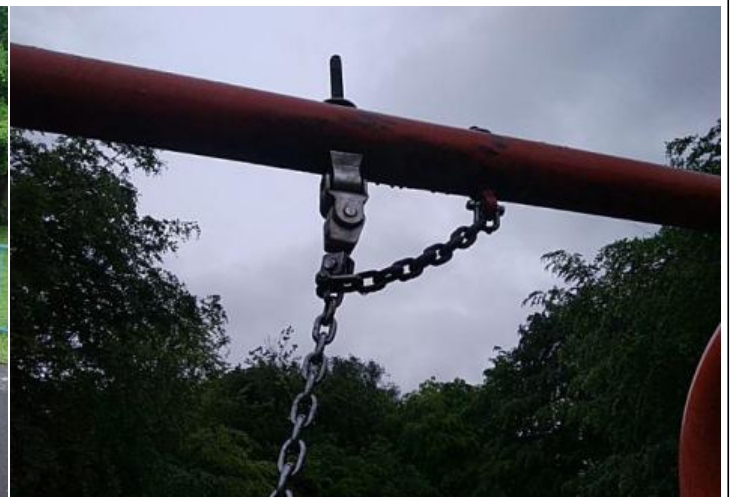
Finding: The bushes are showing signs of wear

Action: Monitor for any further deterioration and replace as required

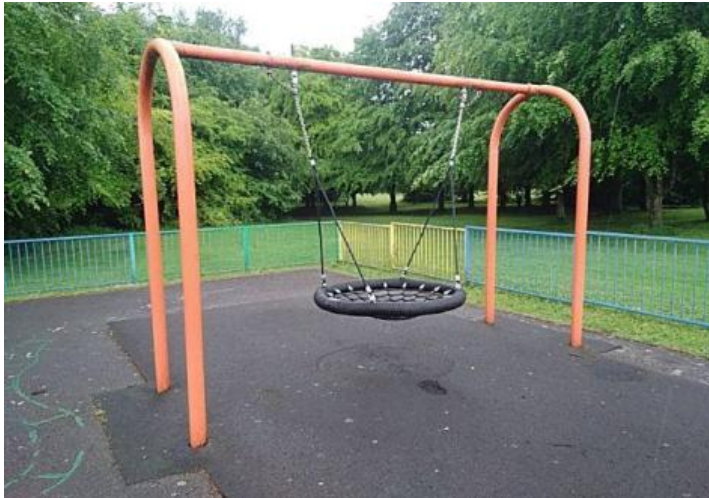
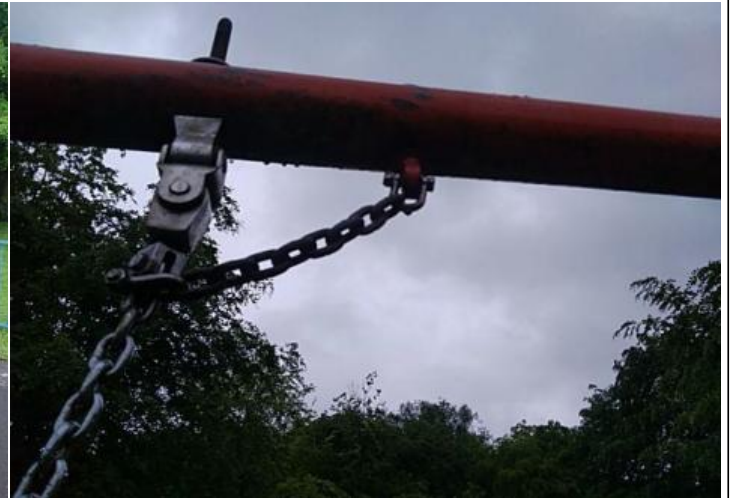
Finding: There is some wear to the shackles.

Action: Monitor for any further deterioration and replace when 40% worn

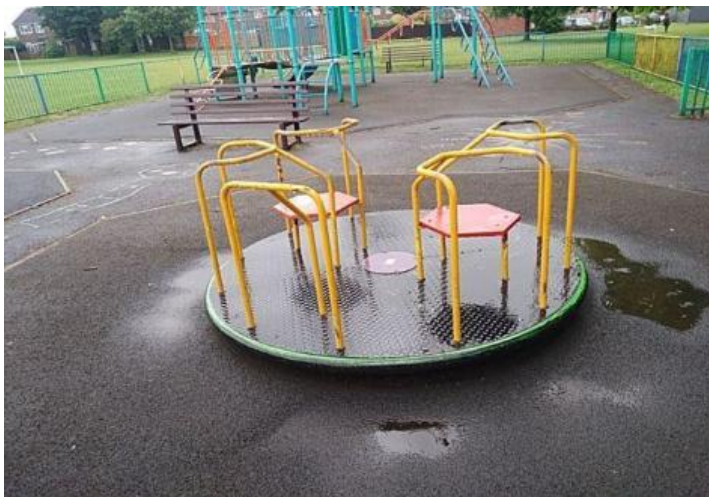
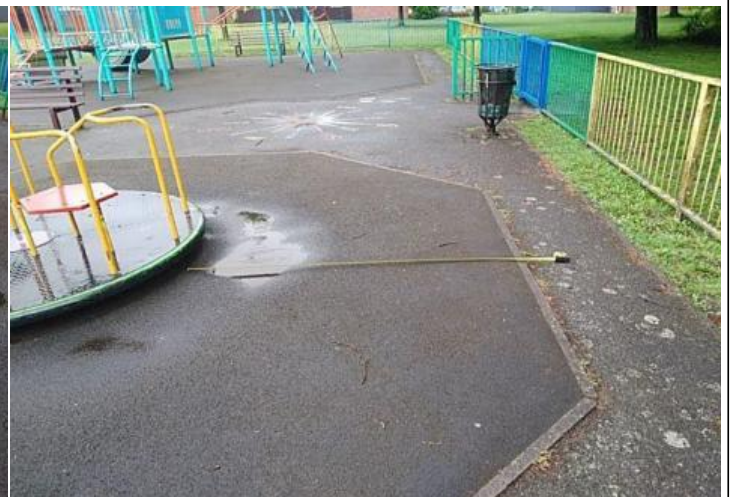
Finding: The surfacing dimensions are short and do not meet with the requirements of the current applicable standard

Action: Monitor - no remedial action recommended

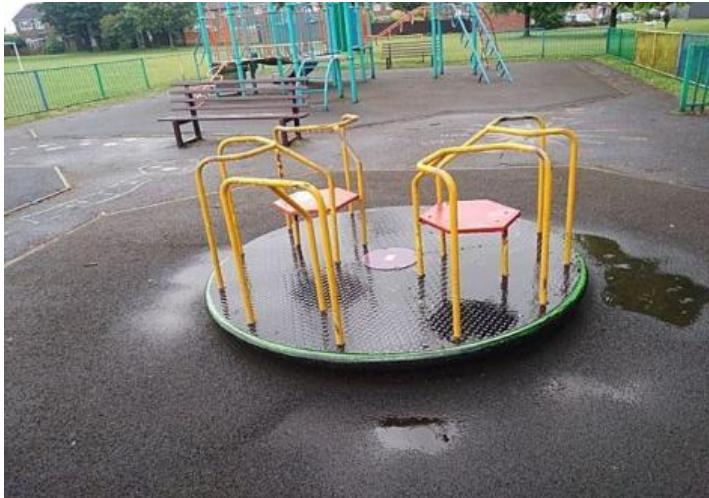
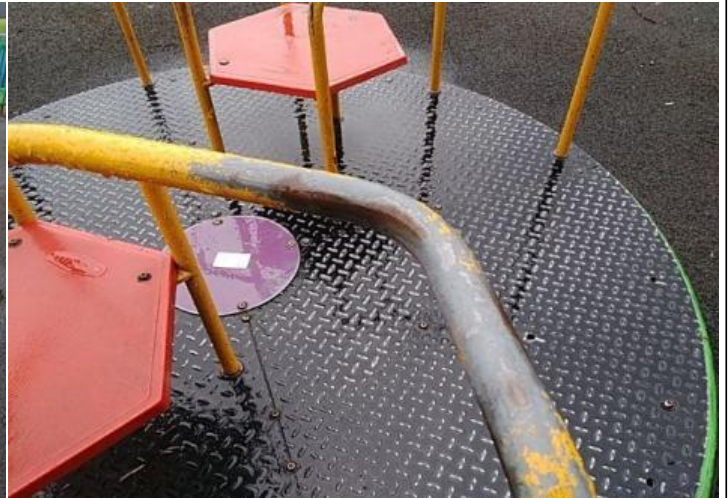
Finding: The paintwork on this item has been damaged or worn exposing the metal underneath which is rusting / corroding

Action: Treat affected areas and repaint

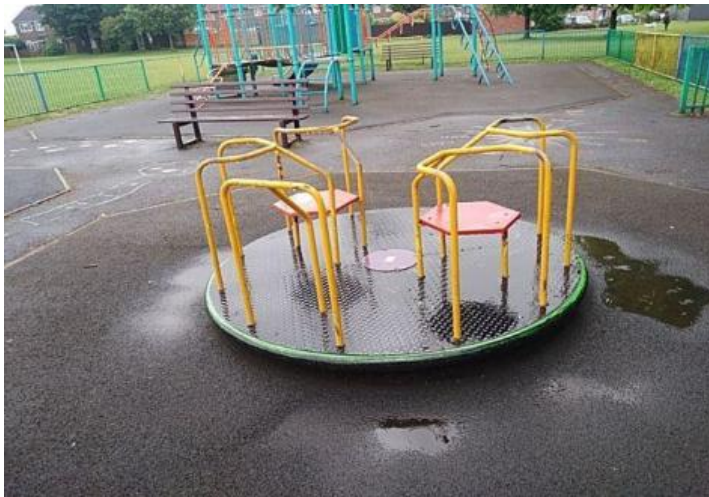
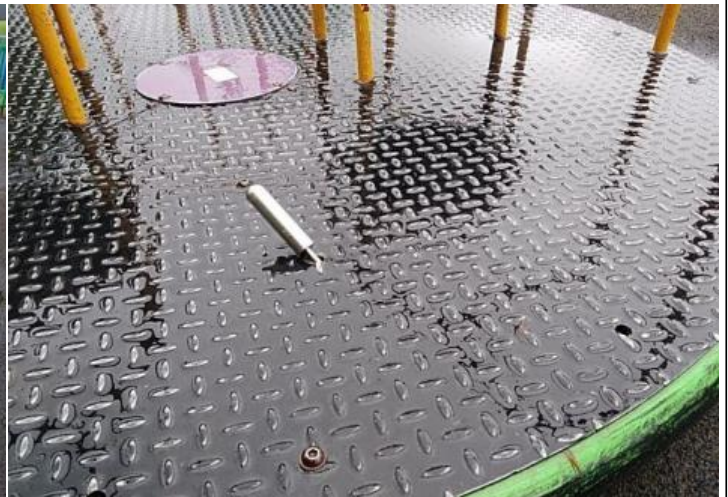
Finding: There are missing fixings creating finger entrapment/s in the roundabout and the item fails to meet the requirements of BS EN 1176 Part 1 4.2.7.6 Entrapment of fingers

Action: Replace the missing fixings to remove the entrapment

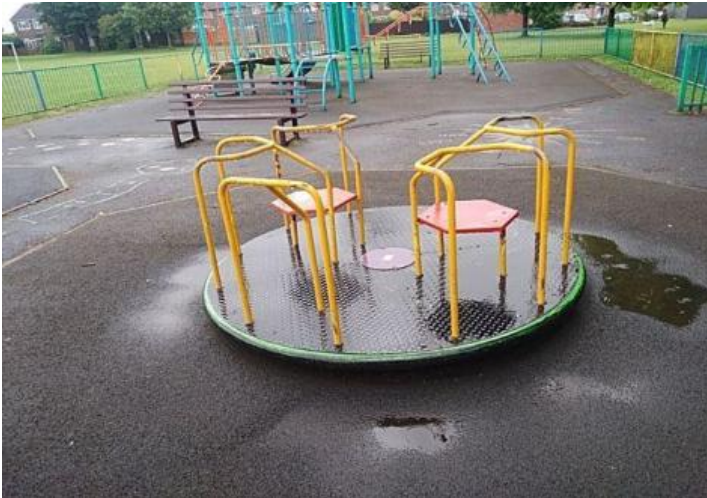
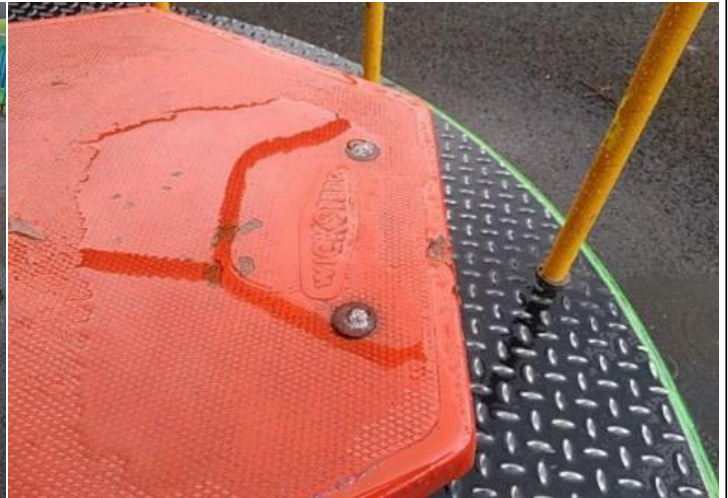
Finding: The seat has minor damage or wear

Action: Monitor for any further deterioration and replace as required

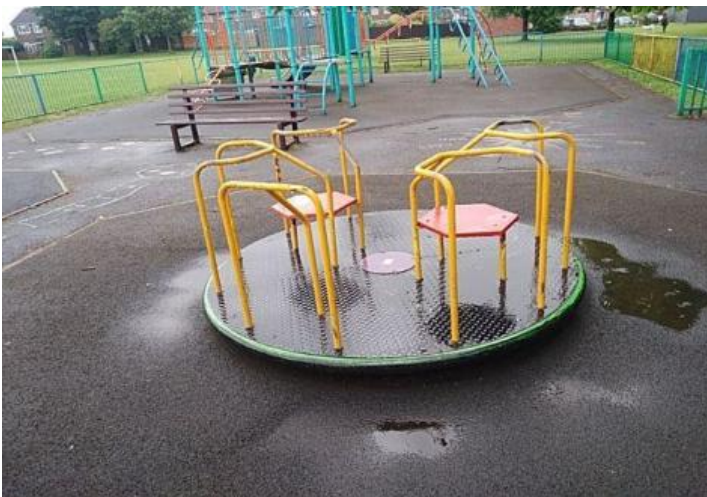
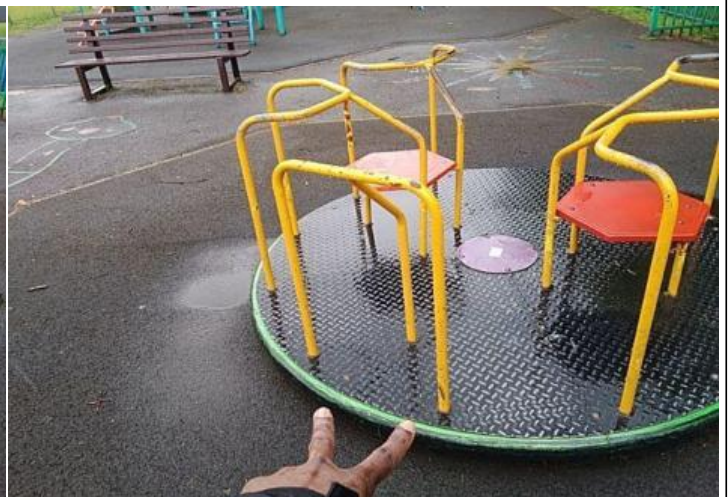
Finding: A number of fixing(s) have worked loose

Action: Secure all loose fixings

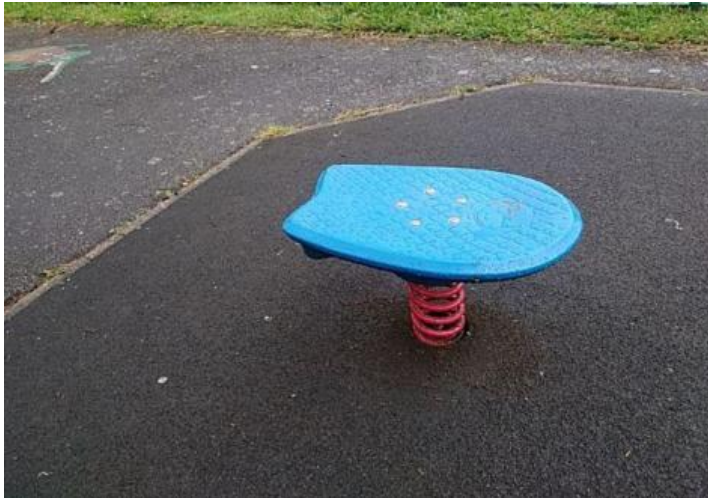
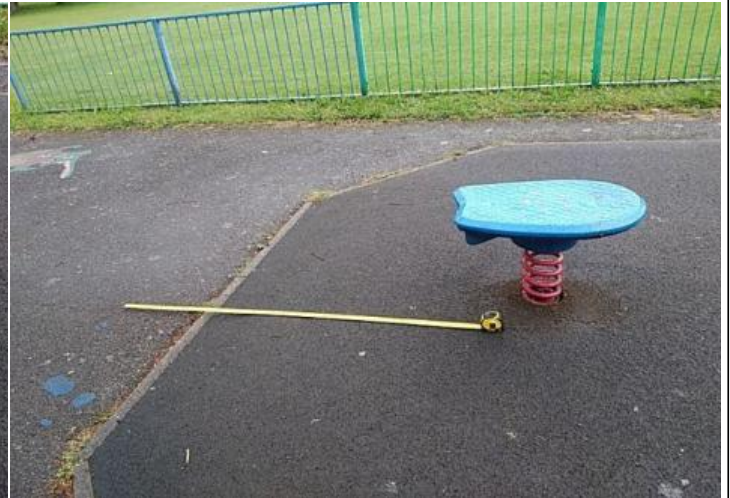
Finding: The surfacing dimensions are short and do not meet with the requirements of the current applicable standard

Action: Monitor - no remedial action recommended

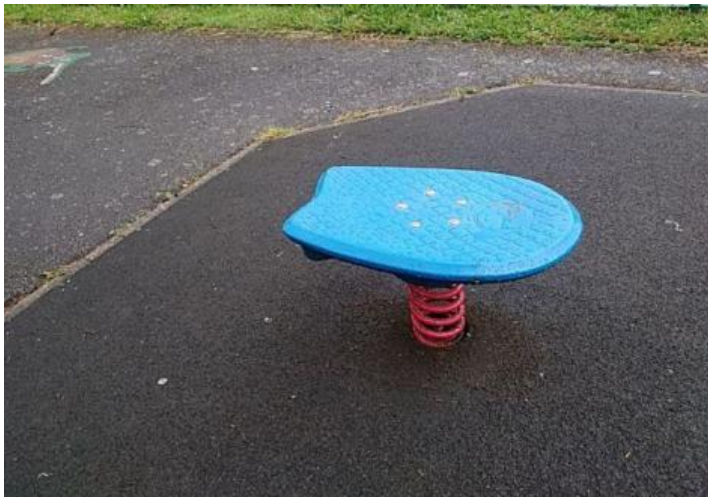
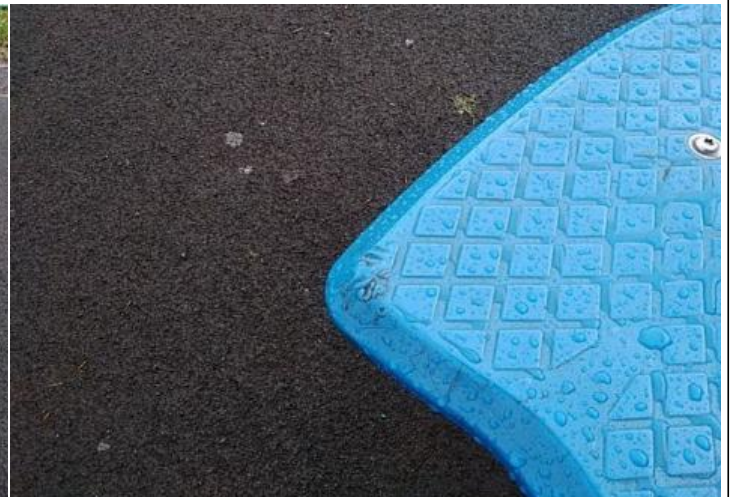
Finding: The item has been damaged

Action: Monitor for any further deterioration and replace as required

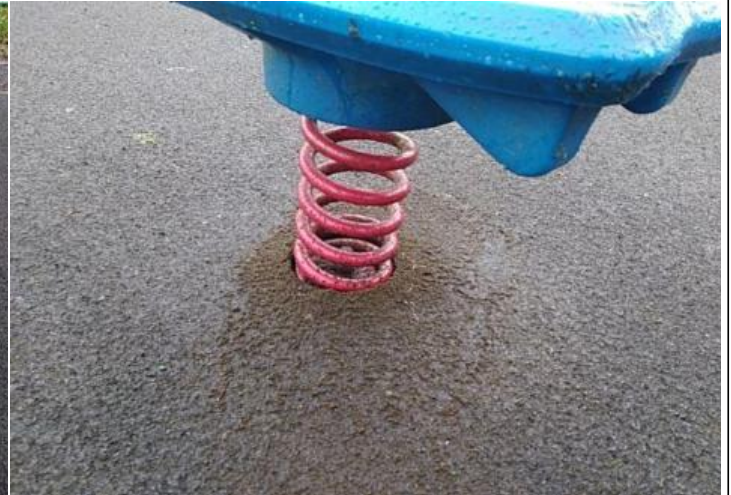
Risk Level: M - Moderate Risk
Surface: Wet Pour

Finding: The item is loose in its foundations

Action: Reinstall item to secure

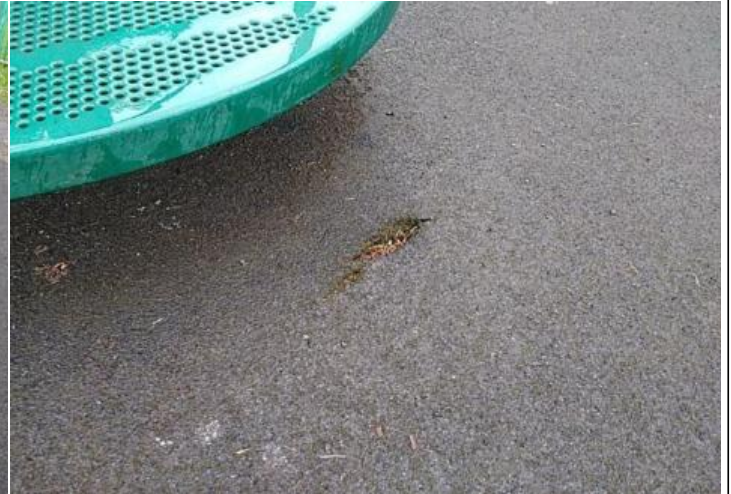
Finding: There is moderate damage to the surface

Action: Repair the damaged areas of surfacing

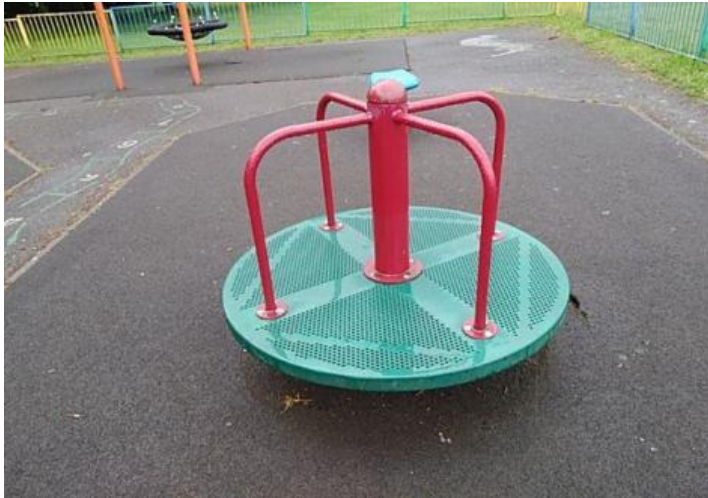
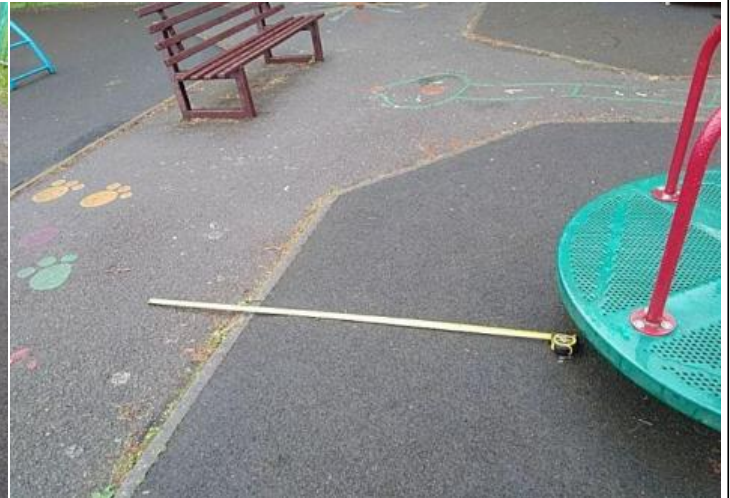
Finding: The surfacing dimensions are short and do not meet with the requirements of the current applicable standard

Action: Monitor - no remedial action recommended

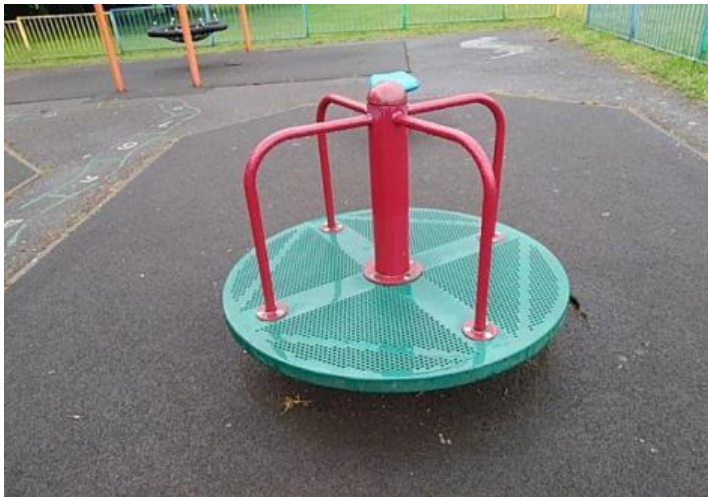
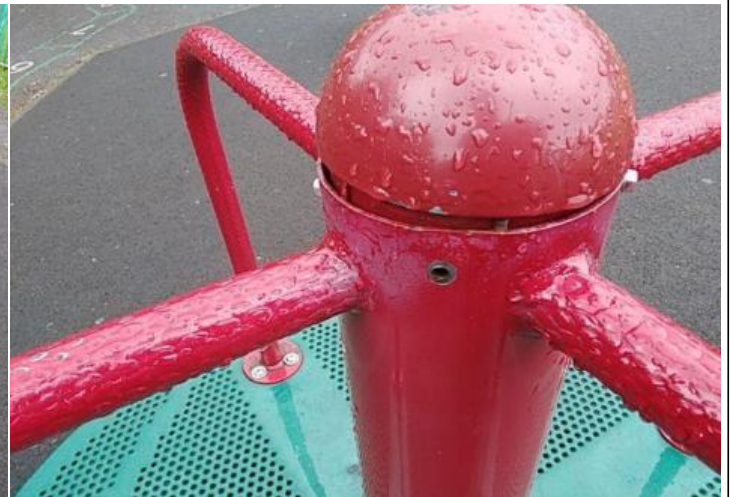
Finding: There is or are fixings missing on the item

Action: Replace all missing fixings

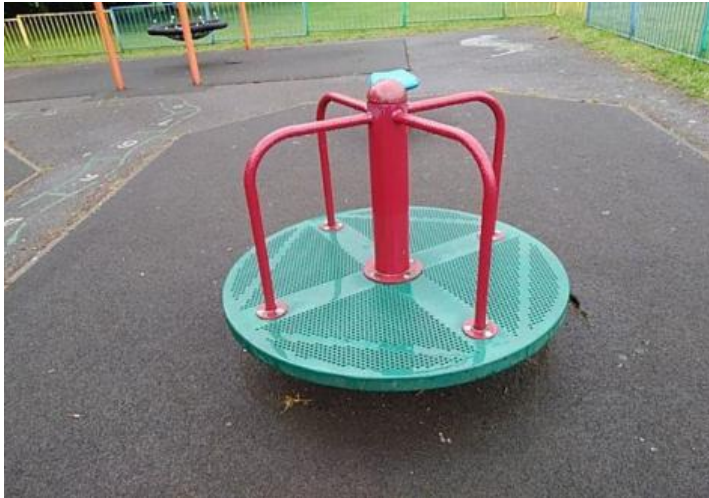
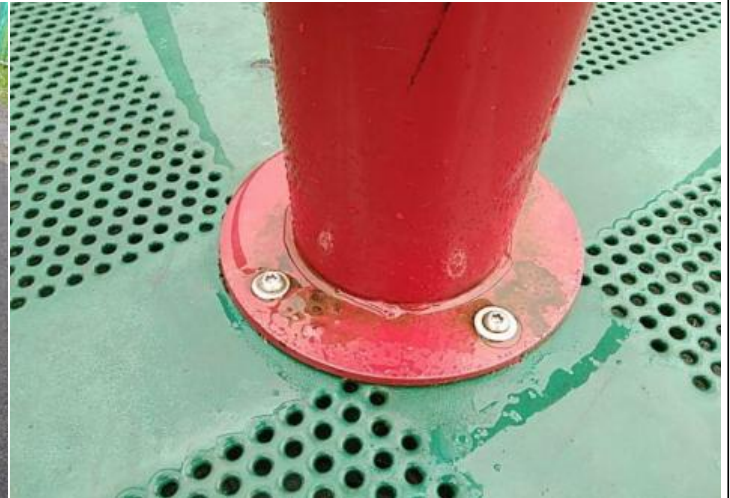
Finding: The paintwork on this item has been damaged or worn exposing the metal underneath which is rusting / corroding

Action: Treat affected areas and repaint

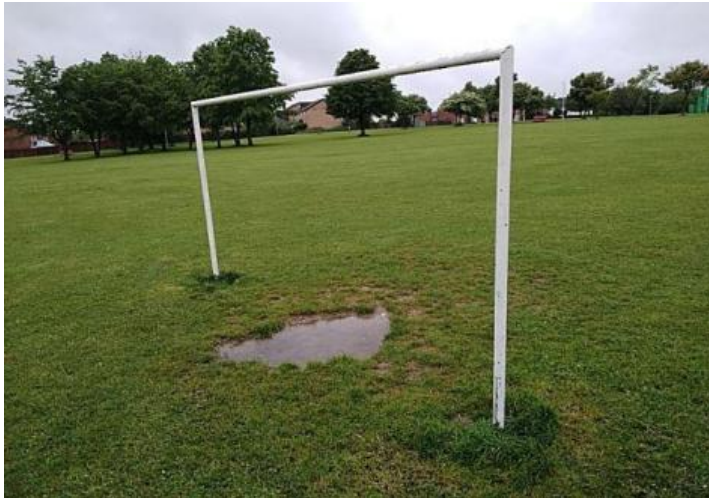
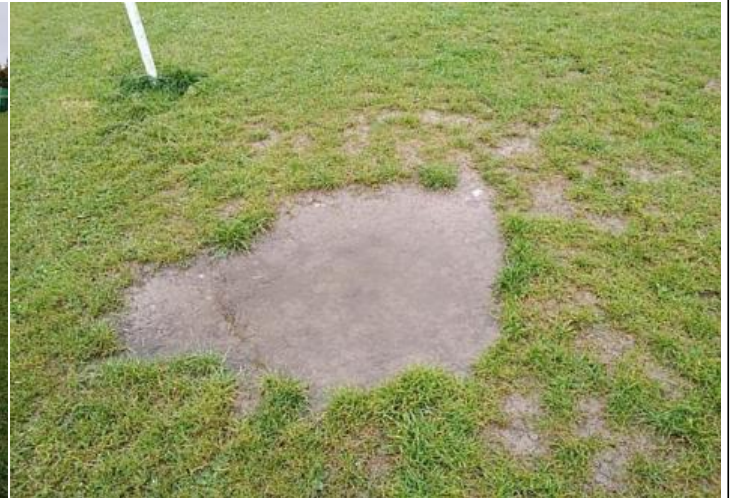
Finding: The surface has eroded in some areas and may be slippery in wet conditions
Action: Reinstate the surface

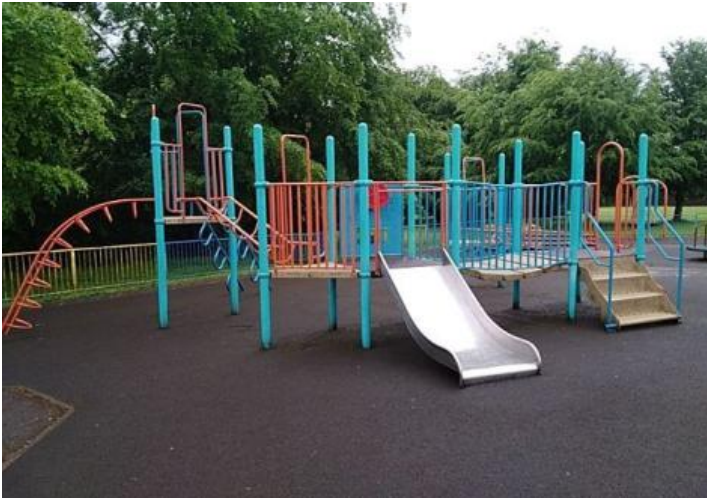
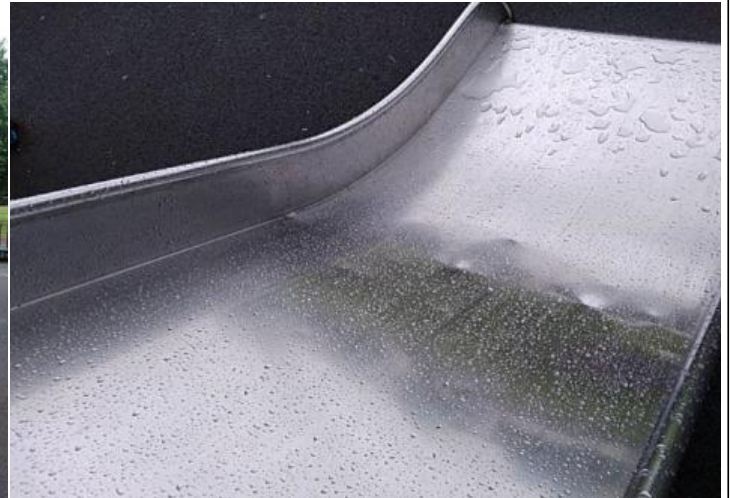
Finding: There are a number of dents in the slide surface

Action: Monitor for any further deterioration and repair as required

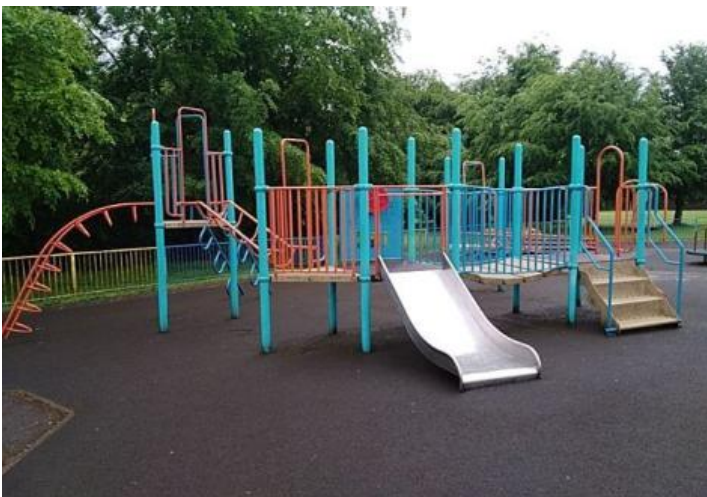
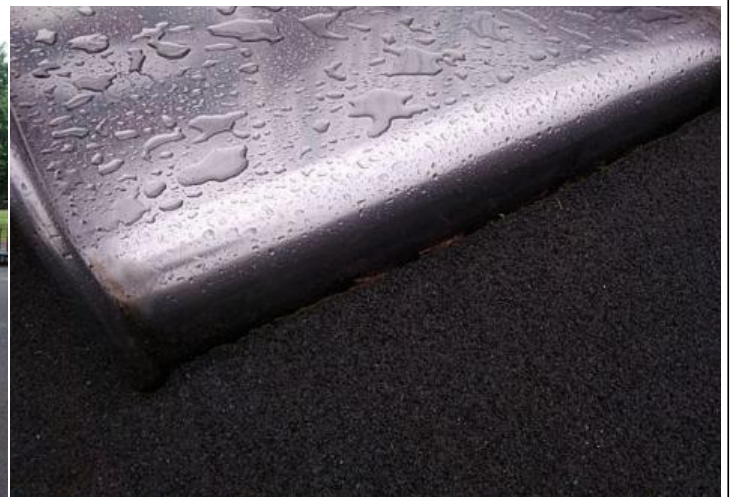
Finding: The surface is lifting at the edges and creating trip points

Action: Repair perimeter of surfacing to remove trip points

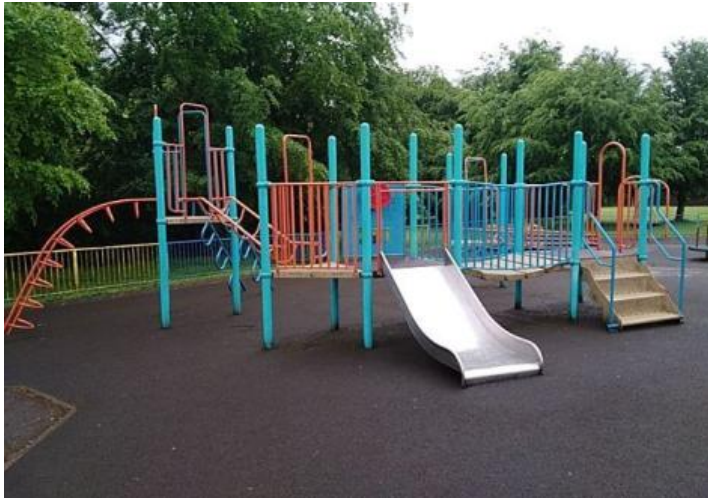
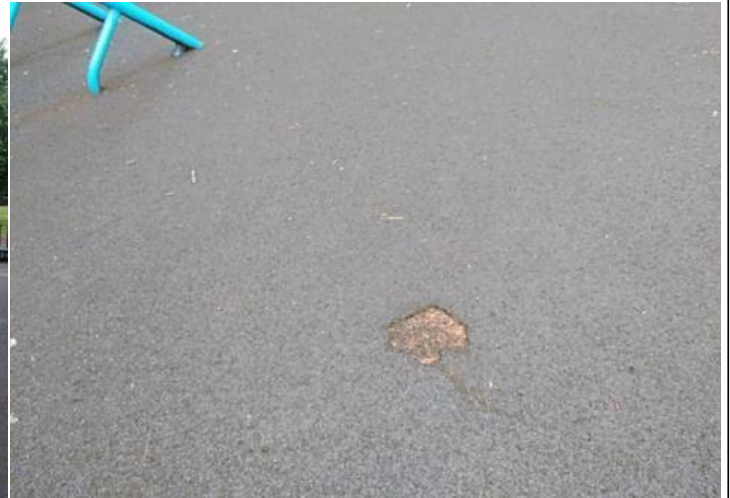
Finding: There is moderate damage to the surface

Action: Repair the damaged areas of surfacing

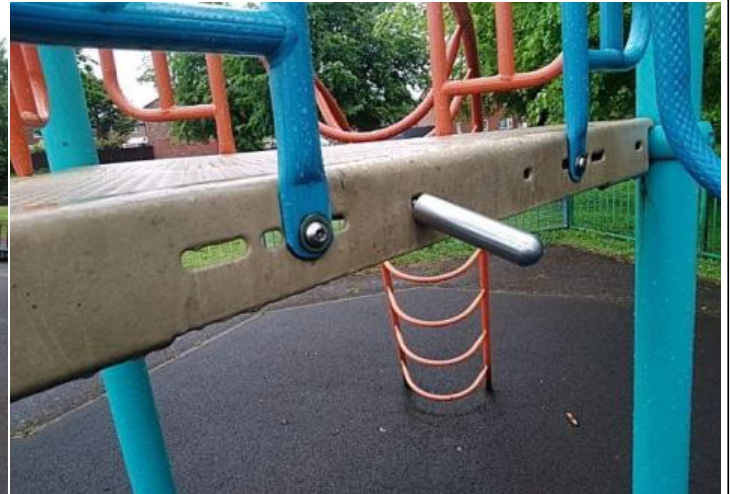
Finding: There is/are finger entrapment/s in the platform and the item fails to meet the requirements of BS EN 1176 Part 1 4.2.7.6 Entrapment of fingers

Action: Monitor - No remedial work recommended

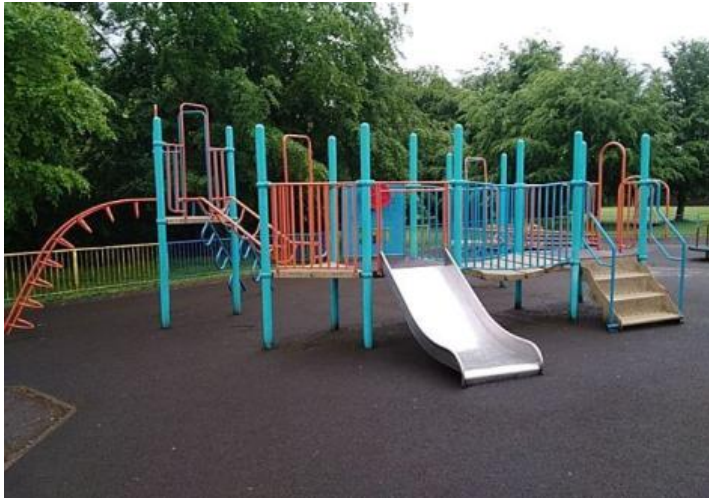
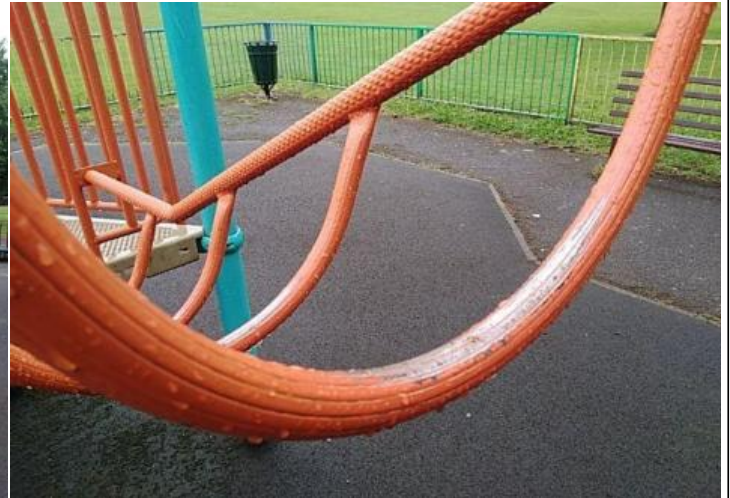
Finding: The paintwork on this item has been damaged or worn exposing the metal underneath which is rusting / corroding

Action: Treat affected areas and repaint
