Annual Inspection

Houghton Regis Town Council

Parkside Recreation Ground - Bottom

Parkside Drive, Houghton Regis, Dunstable, LU5 5RQ

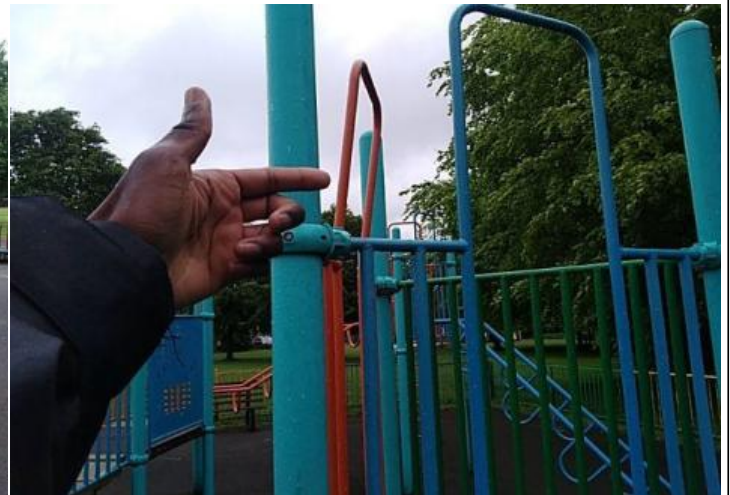
Finding: The item has been damaged

Action: Monitor for any further deterioration and replace as required

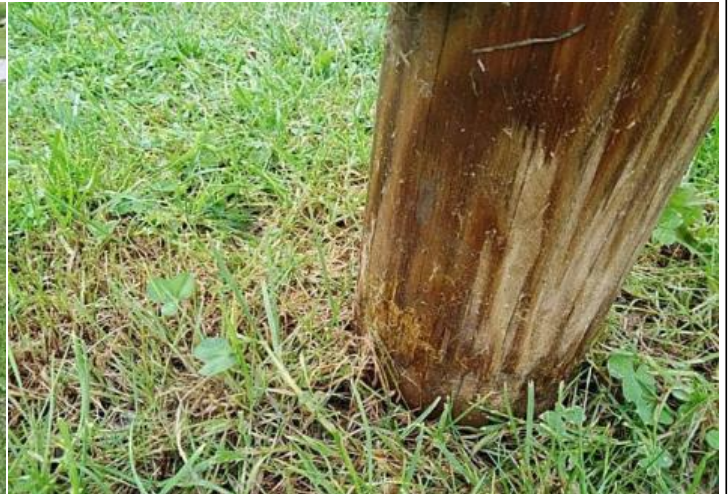
Finding: There is some strimmer / machinery damage apparent on the posts, this can penetrate the preservative applied to the timber and accelerate the rotting process

Action: Monitor for any deterioration (rot) and replace as required

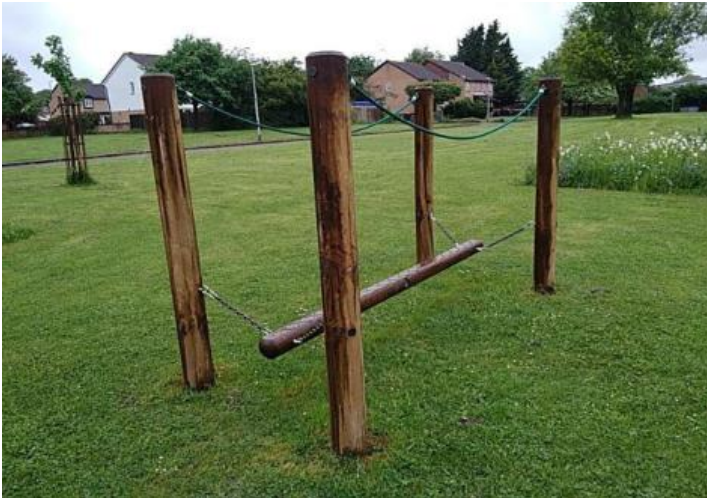
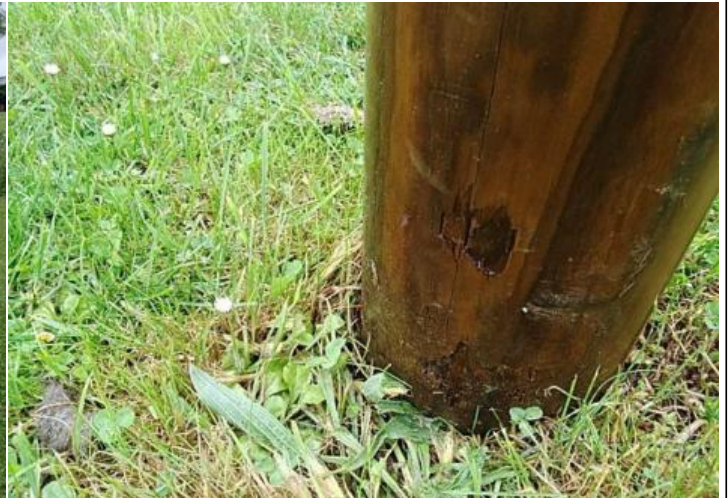
Finding: There is some strimmer / machinery damage apparent on the posts, this can penetrate the preservative applied to the timber and accelerate the rotting process

Action: Monitor for any deterioration (rot) and replace as required

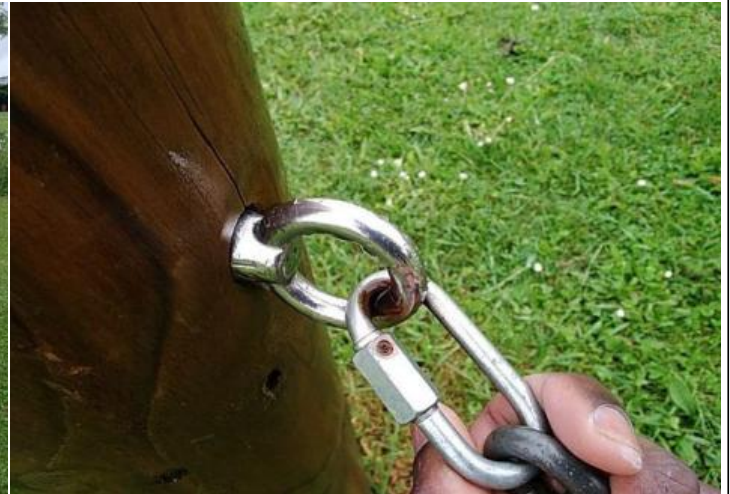
Finding: There is some wear to the shackles

Action: Monitor for any further deterioration and replace when 40% worn

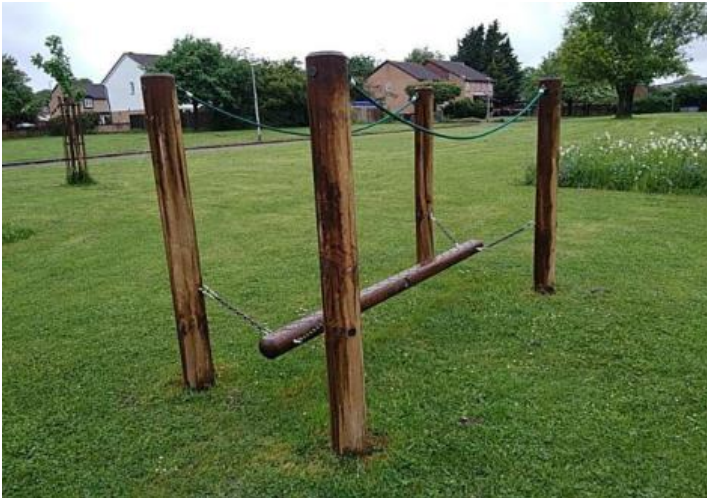
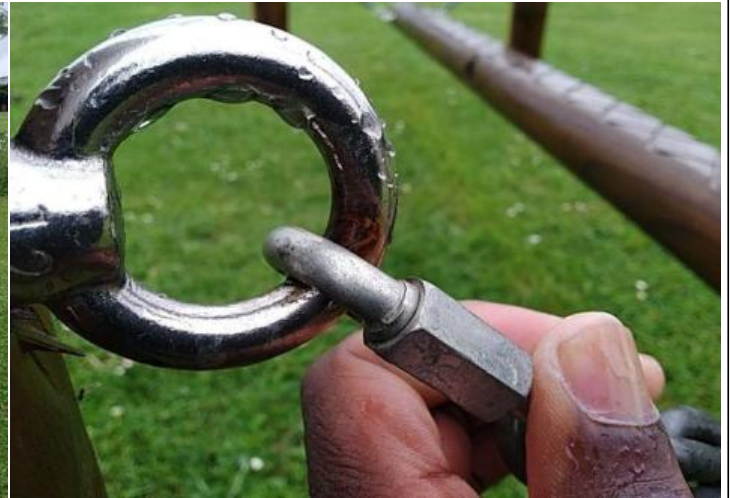
Finding: The connecting lugs are showing signs of wear

Action: Monitor for any further deterioration and repair as required
