Jewish and Congregationalist Cemeteries at Ponsharden Falmouth, Cornwall

Conservation Management Plan Volume 2: Appendices

CA Project:880188

CA Report: 17200

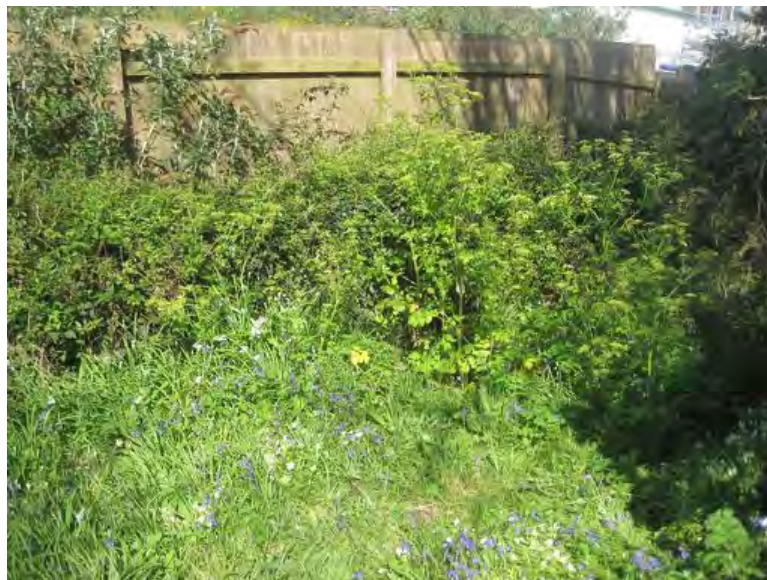
Figure 1 Northwestern end of Boundary wall. Note extensive vegetation growth completely obscuring wall.

Remove all vegetation on wall. Cut back and treat buddleia behind wall. Allow for repointing of 50% to both faces. Allow for repair of 50% of concrete coping.

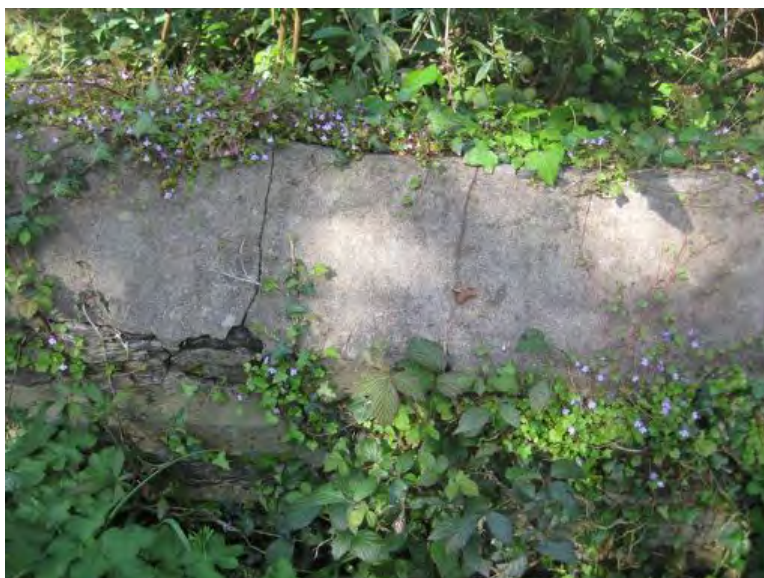
*Figure 4 Detail of concrete coping to B1.
Note cracking and damage (this is one of the best preserved sections)*

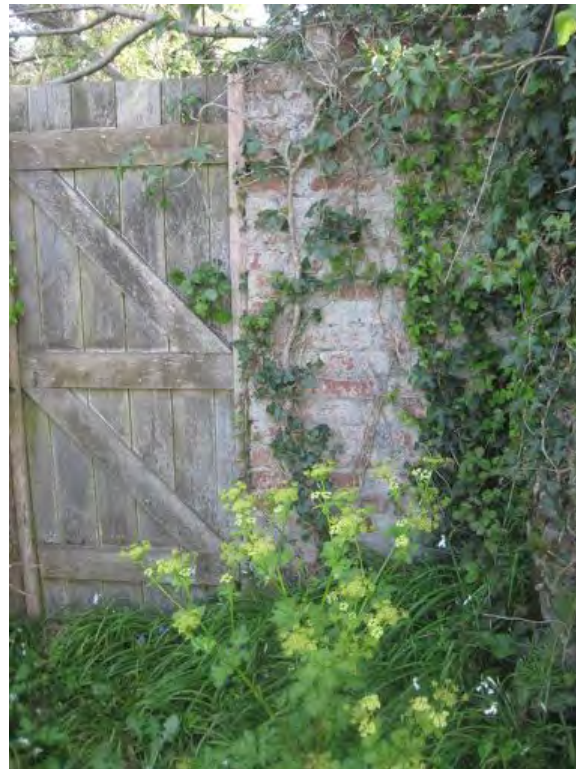
Figure 5 Brickwork wall to RHS of gateway, some missing coping bricks to wall head

Clear all ivy and vegetation growth to either side of wall. Re-bed top stones where loose. Repair brick coping. Repoint both faces of wall (allow for nominal 50%).

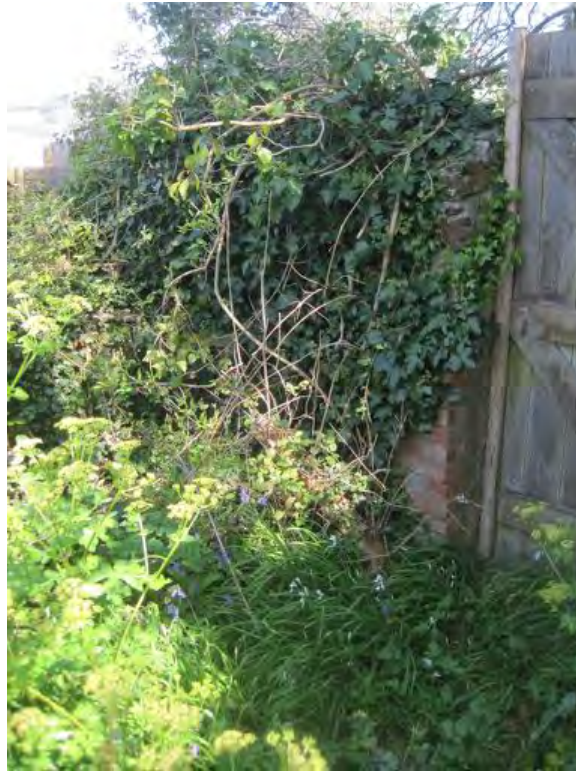
Figure 6 Overgrown brick and stone wall to LHS of gateway

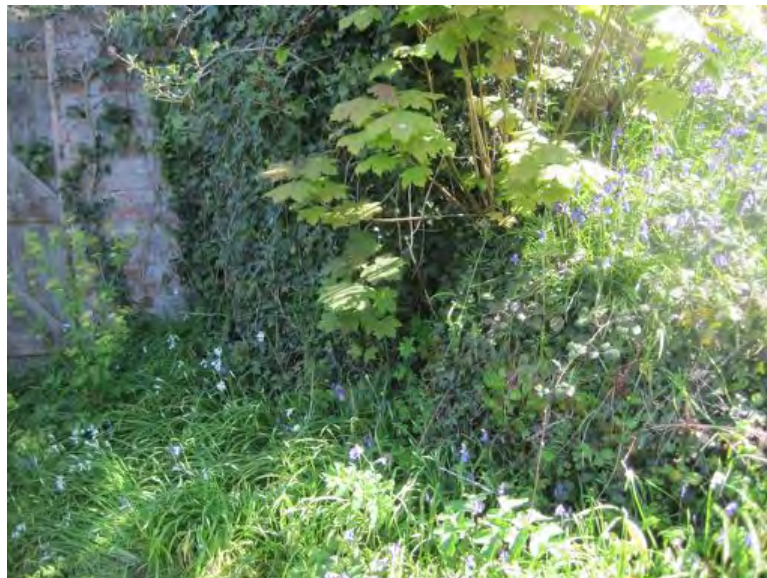
Figure 7 Rubble stone wall, possibly remains of building, very overgrown

Curved stone return wall: Remove ivy and trees to top of wall. Expose and repoint (allow for 100% repointing).

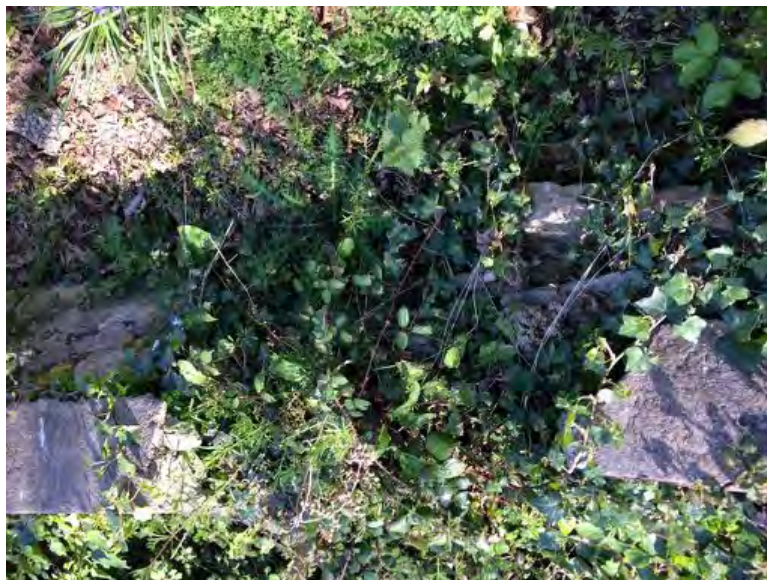
Figure 11 Collapsed section of boundary wall with broken coping

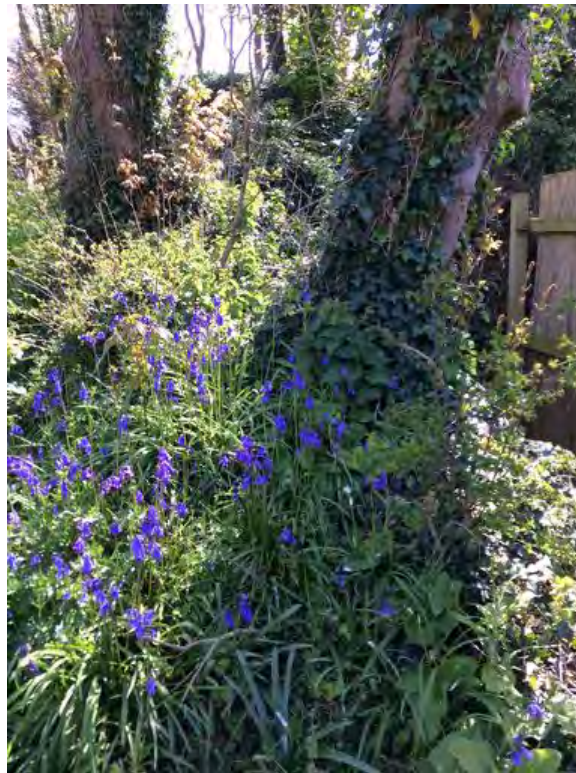
Figure 12 Earth bank overlapping stone wall

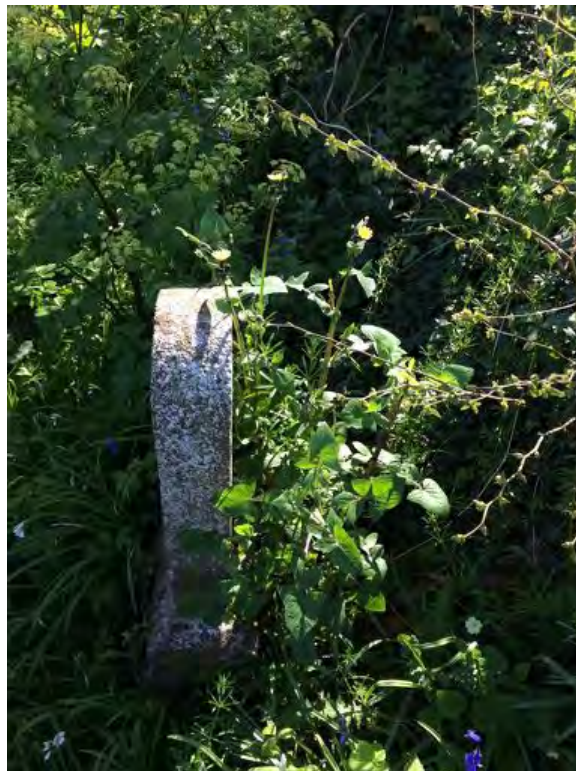
Figure 13 Bank in close proximity to gravestone (J45)

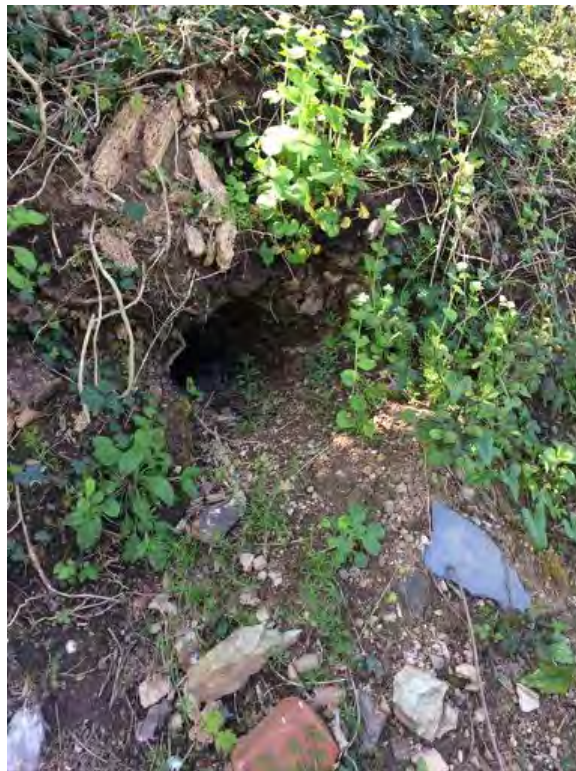
Figure 15 Detail of badger sett

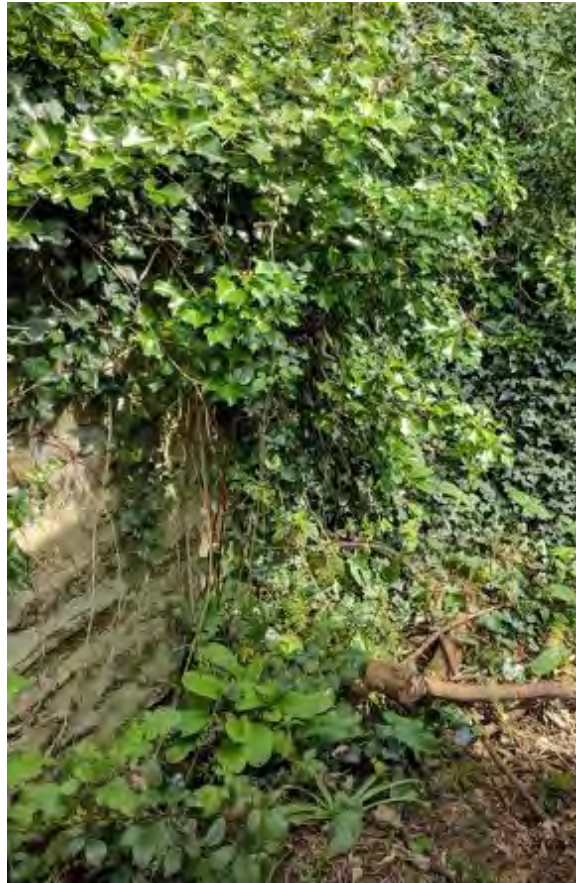
Figure 16 View of rear of wall where stonework disappears into earth bank

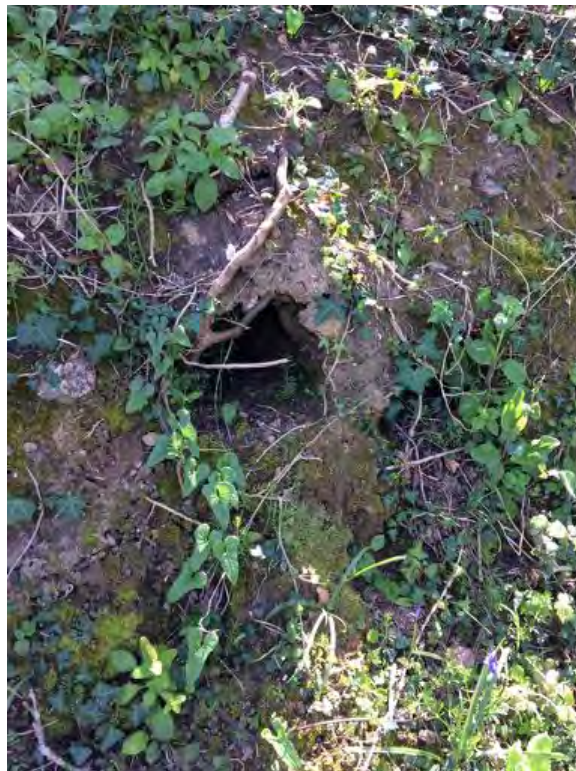
Figure 19 Detail view of animal holes in B3

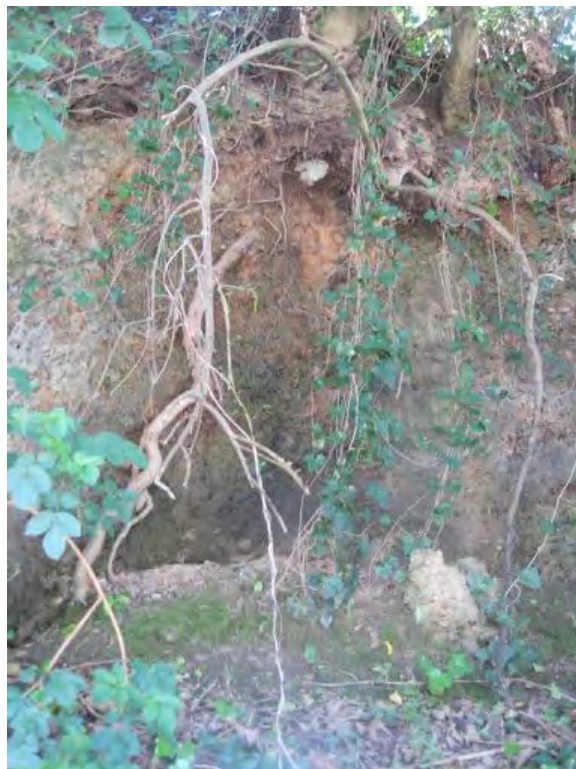
Figure 24 Detail of bank from below - note areas of substantial collapse

During these works a bund will be formed at the top of the slope to form some edge protection to users of the cemetery while maintaining a natural profile to the bank.

A timber post and rail fence to be constructed along the top edge of the bank to provide security and discourage climbing of the bank. Alternatively a stone faced bank, in a Cornish Hedge style could be formed to provide an edge without the need for fencing.

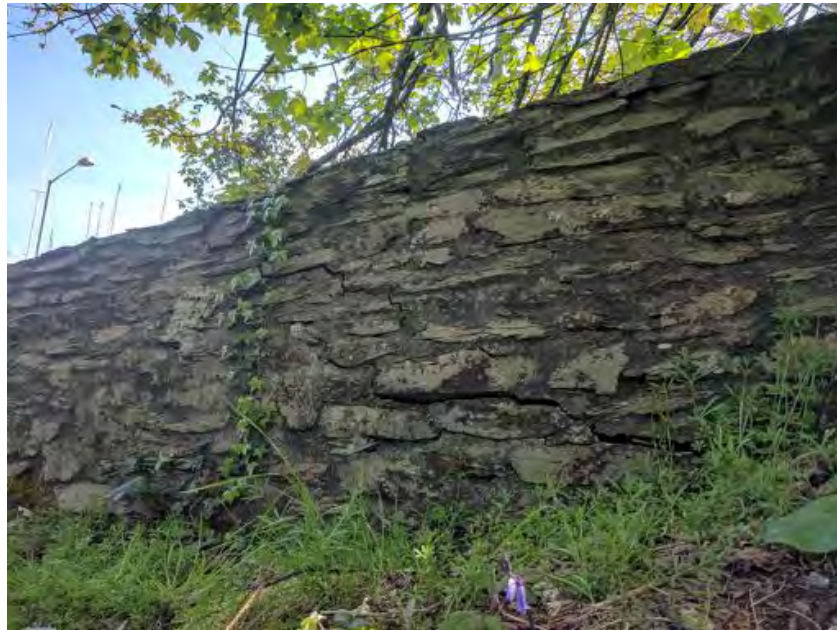
Figure 26 (approx 1m-4m) note the minor cracking to concrete coping and significant crack to centre of photograph

- Remove all vegetation growth to whole extent of wall.
- Remove CT20 and CT12 and CT13 which are all impacting on the wall.
- Rebuild collapsed sections of wall and re-bed all coping stones, where currently on wall and were collapsed in vegetation below wall.
- Repoint all rubble stone to approximate values noted above.

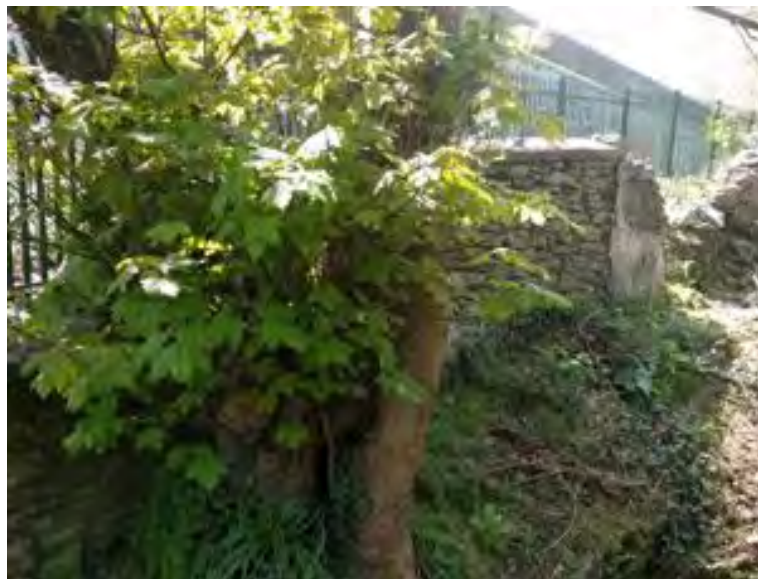
Figure 27 (approx 4m-8m) Tree CT20 in foreground. Note render remains to part of wall.

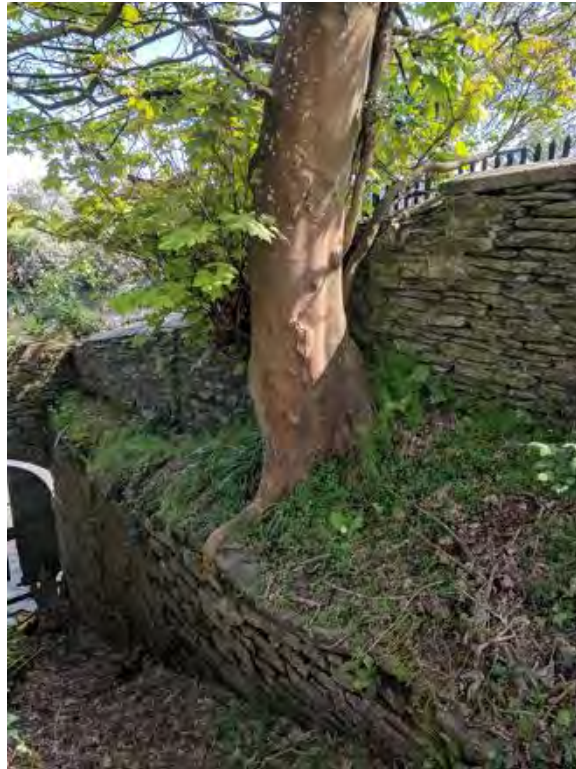
Figure 28 Detail of damage being caused by CT20

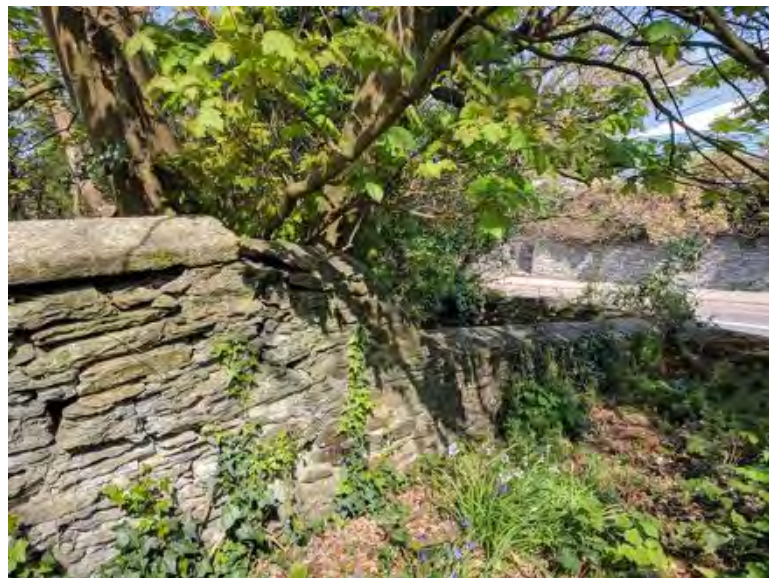
Figure 29 Detail of step change in wall at approx. 4m-5m.

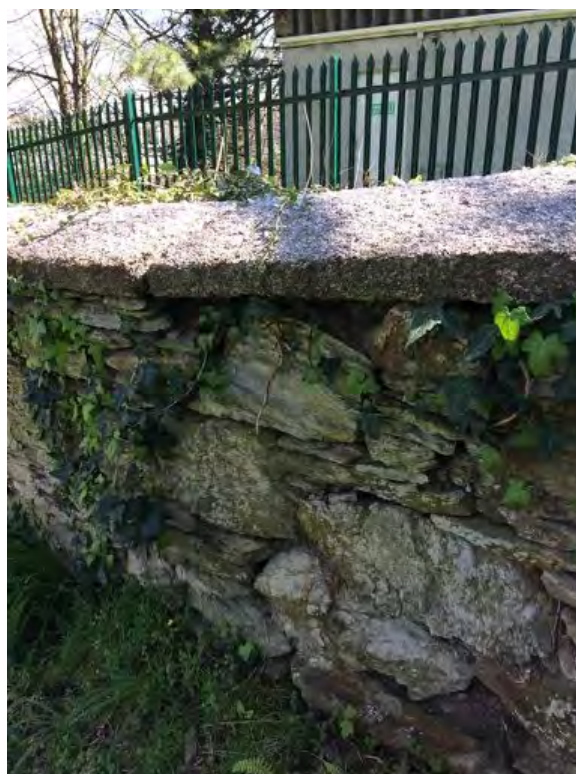
Figure 30 (4-8m) Section of B6 in good condition, coping stones need some re-bedding and stonework repointing.

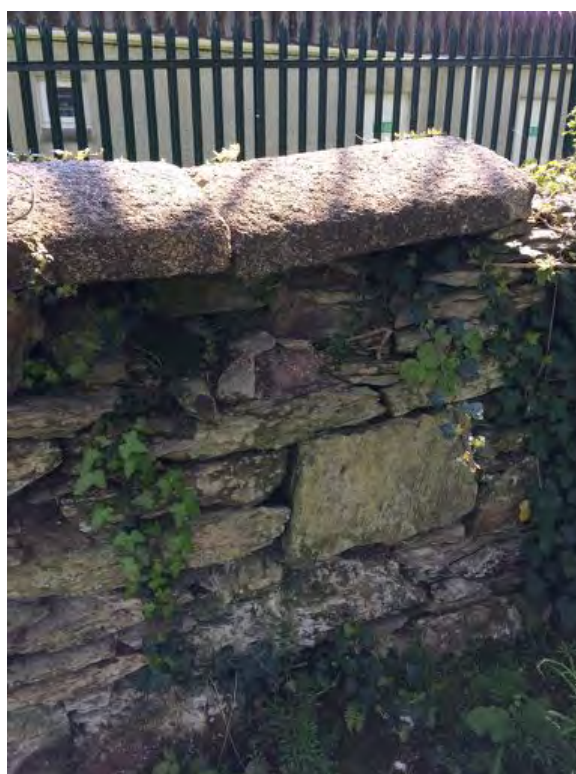
Figure 31 (8m) Detail of granite copings and deep pointing voids to stonework

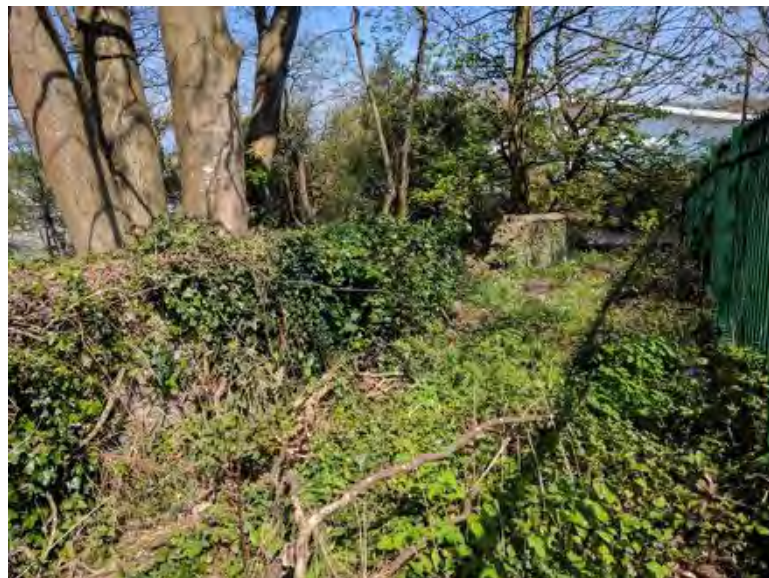
Figure 33 General view of B6 from boundary – note extensive vegetation growth.

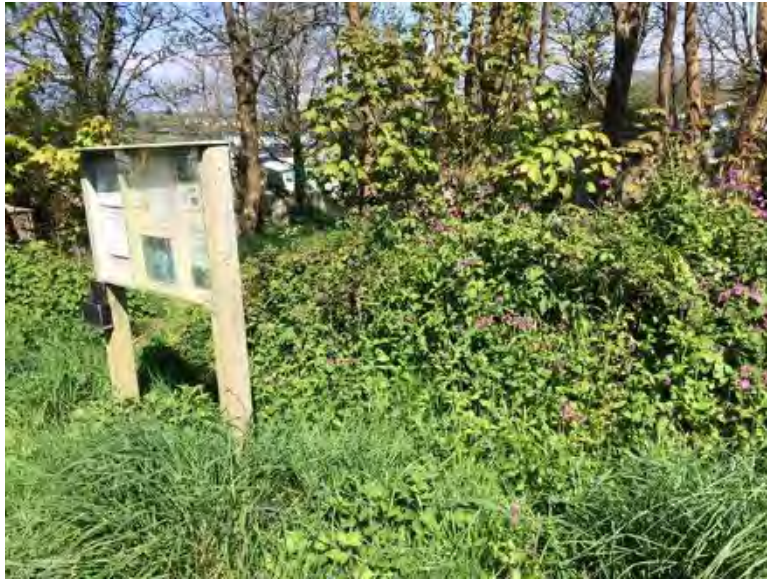
Figure 36 General view of central section, very overgrown with vegetation.

- Rebuild collapsed sections in traditional Cornish hedge construction.
- Define more clearly the original access point and undertake exploratory work to see if original extents can be determined.
- Rebuilt to approx. height of 800mm.

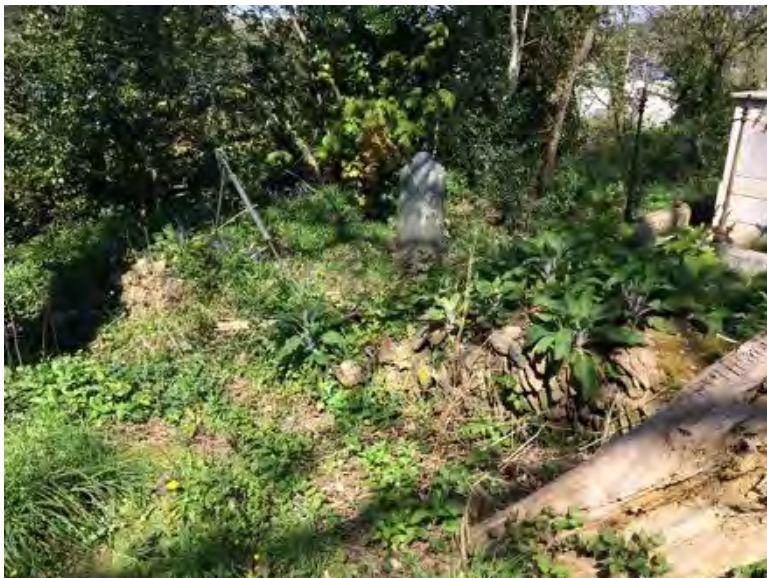
Figure 37 Partial collapsed section to western end of Cornish hedge

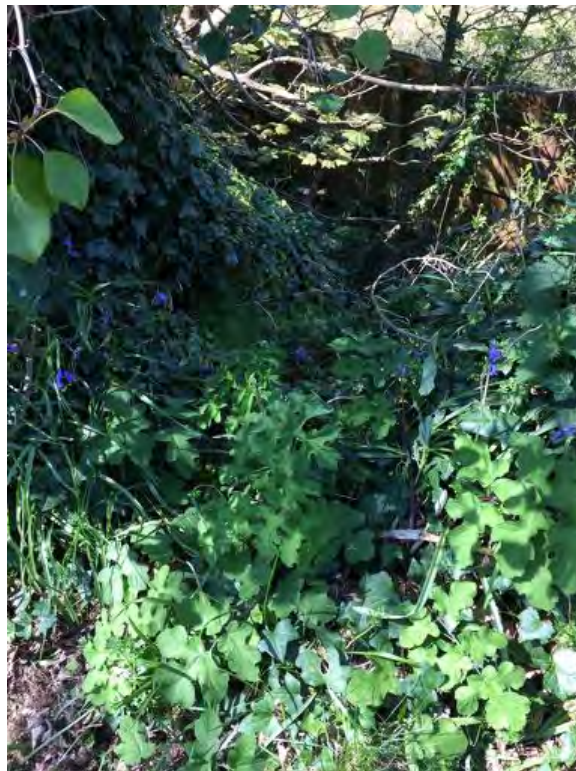
Figure 40 Detail view of breach in bank which could be a risk to the safety of the site.

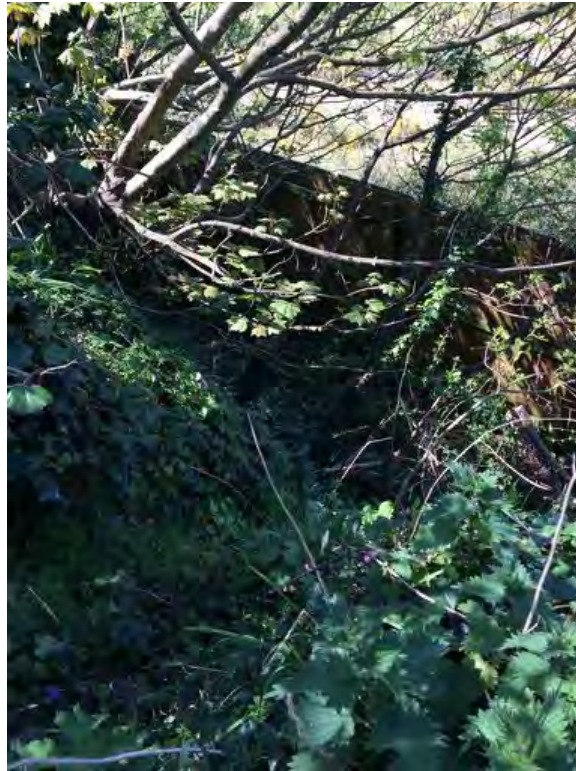
Figure 41 Further example of breach in earth bank with view down to hoarding on adjacent development site.

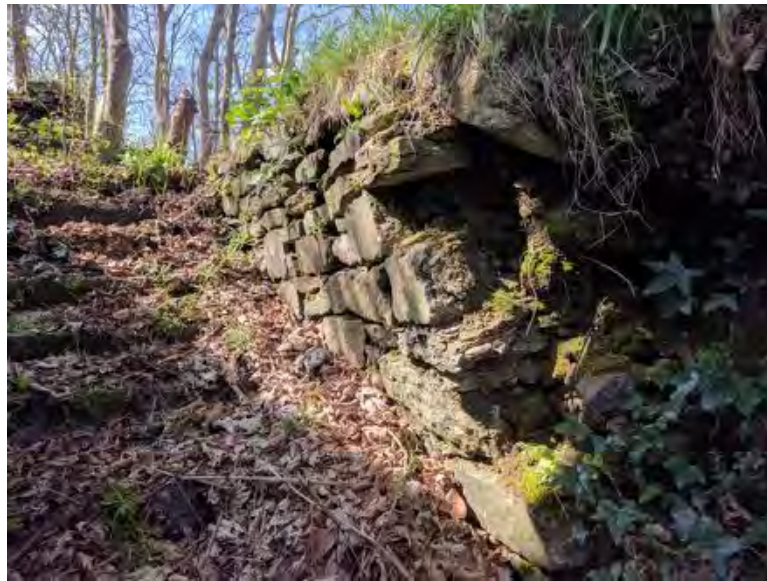
Figure 51 Collapsed inner face of western stairwell wall

West wall of steps: Remove CT20, locally rebuild stonework as necessary and allow for 100% repointing to whole of wall.

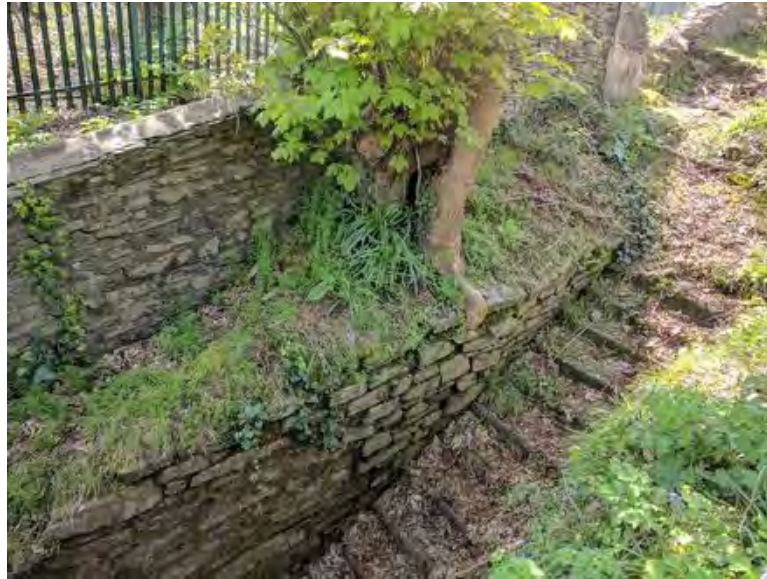
Figure 55 General view of eastern stairwell wall showing CT20 growing from wall head

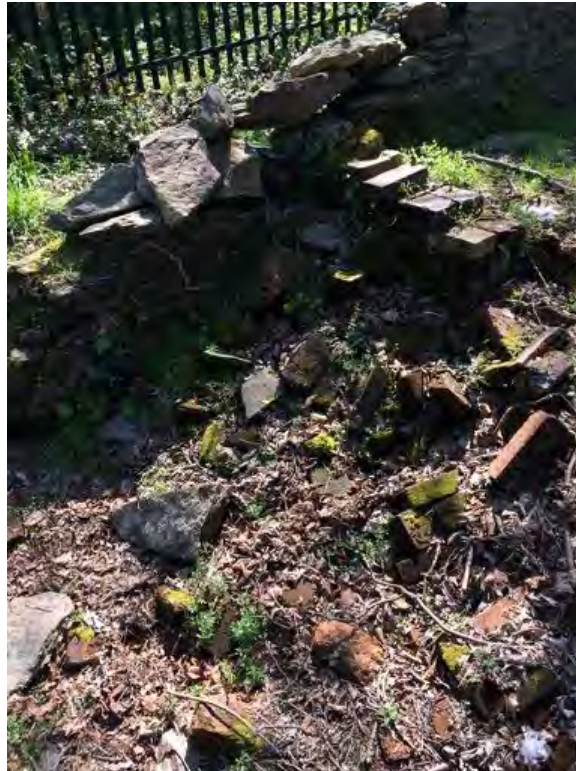
Figure 58 Detail view of collapsed brickwork within footprint of building

- Clear out brick and earth debris to inner area of structure, if possible expose to original floor level (It may be possible to use volunteer labour for some of this work).
- Salvage and store loose bricks.
- Consolidate wall tops, and re-bed loose bricks.
- No proposal to rebuild structure.
- If possible establish reveals of door opening to help make clearer original extent of building.
- Rebuild boundary wall – refer to B6 for detail.

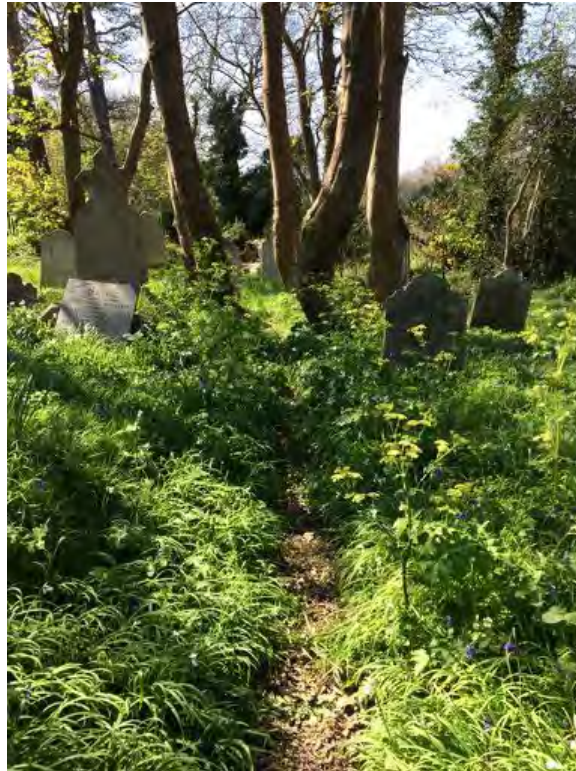
Figure 66 General view of overgrown section of path

- Excavate to establish whether any original path base exists.
- Clear vegetation and expose brick and stone edges. Re-bed brickwork
- Clear vegetation, re-bed and repoint low level (400mm max) stone wall edge.
