## ASBESTOS SURVEY REPORT

SURVEY REFERENCE No. J095286

24a Gloucester Road, Almondsbury, Bristol, BS34 4HA

Refurbishment Survey prior to planned extension works
---

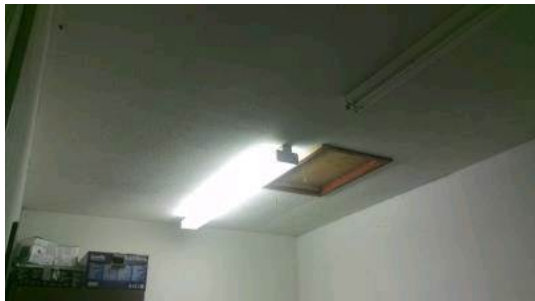
<u>Inspection Details:</u>	
Inspection Number	: 2
Inspection Date	: 27/07/2016
Inspection Type	: Sample taken
Level of Identification	: Asbestos Identified
<u>Material Location:</u>	
Building Name / No	: 24a Gloucester Road
Floor Level	: Ground Floor
Area / Room	: STORE 1
Item Description	: Ceiling Core
<u>Material Details:</u>	
Product Description	: Textured Coating
Estimated Quantity	: 9 m <sup>2</sup>
Likelihood of Disturbance	: Occasionally likely to be disturbed
Sample Number	: AQ002092
Sample Analysis	: Chrysotile

<u>Material Assessment as per HSG264:</u>		
<u>Factors</u>	<u>Assessment Description</u>	<u>Score</u>
Product/Material Type	: Textured Coating	1
Damage/Deterioration	: Low Damage	1
Surface Treatment	: Sealed Semi-Rigid Paints & Decorative Coatings	0
Asbestos Type	: Chrysotile	1
Material Assessment Score:		3
Material assessment parameters and algorithm scoring factors are detailed in the Scope of Survey Agreement.		
<u>Priority Risk Assessment as per HSG264 &amp; HSG227:</u>		
<u>Factors</u>		<u>Score</u>
Main/Secondary Activities Carried Out		N/A
Location		N/A
Accessibility		N/A
Extent/Amount		N/A
Frequency		N/A
Occupancy		N/A
Average Time area is in use		N/A
Maintenance activity		N/A
Maintenance frequency		N/A
Priority Risk Assessment Score:		N/A
The customer did not provide ACE with priority risk assessment information prior to the undertaking of this survey, therefore the risk assessment for this inspection is based on material assessment only.

Total Assessment Score:		3

Material Risk Assessment Category as per HSG264 & HSG227: Very Low
--

<u>Recommended Action:</u>	
Action	: Inspect at Intervals & Update Register
Quantity	: N/A
(Extent of material requiring treatment works)	
Priority	: Very Low
(Priority based on material assessment only)	
Next Inspection Due	: In accordance with the current Control of Asbestos Regulations

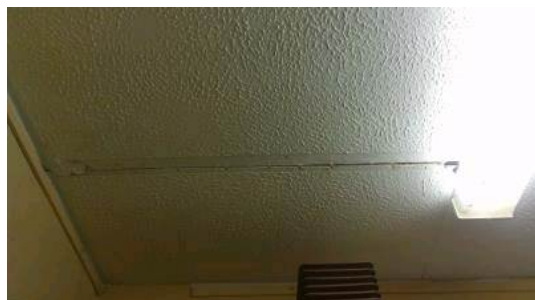
Inspection Number : 3  
 Inspection Date : 27/07/2016  
 Inspection Type : Visually similar to  
 Level of Identification : As inspection 2

Building Name / No : 24a Gloucester Road  
 Floor Level : Ground Floor  
 Area / Room : STORE 2  
 Item Description : Ceiling Core

Product Description : Textured Coating  
 Estimated Quantity : 5 m<sup>2</sup>  
 Likelihood of Disturbance : Occasionally likely to be disturbed  
 Sample Number : As Sample AQ002092  
 Sample Analysis : N/A

Factors	Assessment Description	Score
Product/Material Type	Textured Coating	1
Damage/Deterioration	Low Damage	1
Surface Treatment	Sealed Semi-Rigid Paints & Decorative Coatings	0
Asbestos Type	Chrysotile	1
Material Assessment Score:		3

Material Risk Assessment Category as per HSG264 & HSG227: Very Low

Action : Repair & Seal  
 Quantity : 5 m<sup>2</sup>

Priority : Very Low

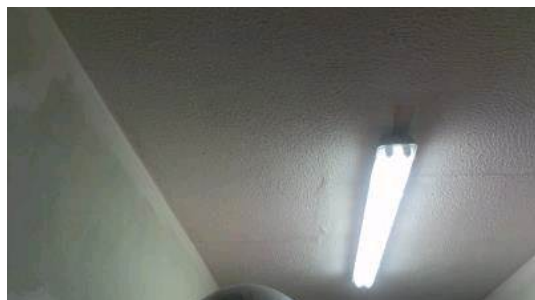
Inspection Number : 4  
 Inspection Date : 27/07/2016  
 Inspection Type : Visually similar to  
 Level of Identification : As inspection 2

Building Name / No : 24a Gloucester Road  
 Floor Level : Ground Floor  
 Area / Room : STORE 3  
 Item Description : Ceiling Core

Product Description : Textured Coating  
 Estimated Quantity : 5 m<sup>2</sup>  
 Likelihood of Disturbance : Occasionally likely to be disturbed  
 Sample Number : As Sample AQ002092  
 Sample Analysis : N/A

Factors	Assessment Description	Score
Product/Material Type	Textured Coating	1
Damage/Deterioration	Low Damage	1
Surface Treatment	Sealed Semi-Rigid Paints & Decorative Coatings	0
Asbestos Type	Chrysotile	1
Material Assessment Score:		3

Material Risk Assessment Category as per HSG264 & HSG227: Very Low

Action : Inspect at Intervals & Update Register  
 Quantity : N/A  
 (Extent of material requiring treatment works)  
 Priority : Very Low  
 (Priority based on material assessment only)  
 Next Inspection Due : In accordance with the current Control of Asbestos Regulations

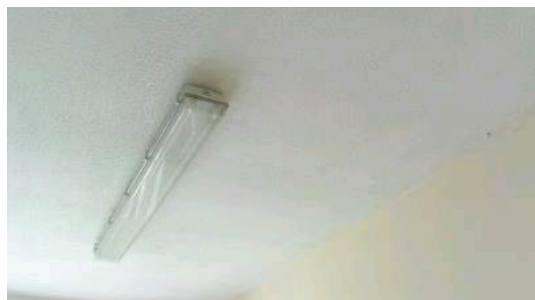
Inspection Number : 5  
 Inspection Date : 27/07/2016  
 Inspection Type : Visually similar to  
 Level of Identification : As inspection 2

Building Name / No : 24a Gloucester Road  
 Floor Level : Ground Floor  
 Area / Room : KITCHEN  
 Item Description : Ceiling Core

Product Description : Textured Coating  
 Estimated Quantity : 6 m<sup>2</sup>  
 Likelihood of Disturbance : Occasionally likely to be disturbed  
 Sample Number : As Sample AQ002092  
 Sample Analysis : N/A

Factors	Assessment Description	Score
Product/Material Type	Textured Coating	1
Damage/Deterioration	Low Damage	1
Surface Treatment	Sealed Semi-Rigid Paints & Decorative Coatings	0
Asbestos Type	Chrysotile	1
Material Assessment Score:		3

Material Risk Assessment Category as per HSG264 & HSG227: Very Low

Action : Inspect at Intervals & Update Register  
 Quantity : N/A  
 (Extent of material requiring treatment works)  
 Priority : Very Low  
 (Priority based on material assessment only)  
 Next Inspection Due : In accordance with the current Control of Asbestos Regulations

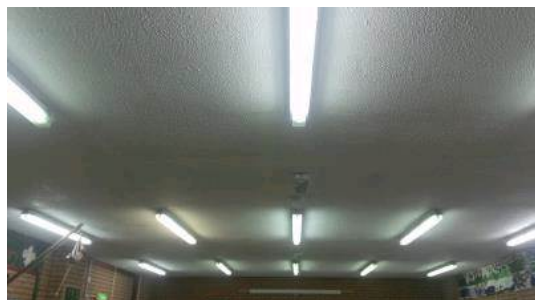
Inspection Number : 7  
 Inspection Date : 27/07/2016  
 Inspection Type : Sample taken  
 Level of Identification : Asbestos Identified

Building Name / No : 24a Gloucester Road  
 Floor Level : Ground Floor  
 Area / Room : HALL  
 Item Description : Ceiling Core

Product Description : Textured Coating  
 Estimated Quantity : 90 m<sup>2</sup>  
 Likelihood of Disturbance : Occasionally likely to be disturbed  
 Sample Number : AQ002094  
 Sample Analysis : Chrysotile

Factors	Assessment Description	Score
Product/Material Type	Textured Coating	1
Damage/Deterioration	Low Damage	1
Surface Treatment	Sealed Semi-Rigid Paints & Decorative Coatings	0
Asbestos Type	Chrysotile	1
Material Assessment Score:		3

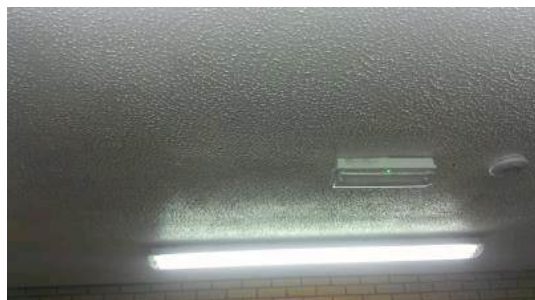
Product Description : Textured Coating  
 Estimated Quantity : 12 m<sup>2</sup>  
 Likelihood of Disturbance : Occasionally likely to be disturbed  
 Sample Number : AQ002096  
 Sample Analysis : Chrysotile

Factors	Assessment Description	Score
Product/Material Type	Textured Coating	1
Damage/Deterioration	Low Damage	1
Surface Treatment	Sealed Semi-Rigid Paints & Decorative Coatings	0
Asbestos Type	Chrysotile	1
Material Assessment Score:		3

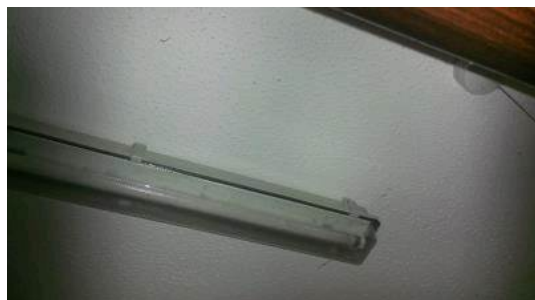
Product Description : Textured Coating  
 Estimated Quantity : 2 m<sup>2</sup>  
 Likelihood of Disturbance : Occasionally likely to be disturbed  
 Sample Number : As Sample AQ002096  
 Sample Analysis : N/A

Factors	Assessment Description	Score
Product/Material Type	Textured Coating	1
Damage/Deterioration	Low Damage	1
Surface Treatment	Sealed Semi-Rigid Paints & Decorative Coatings	0
Asbestos Type	Chrysotile	1
Material Assessment Score:		3

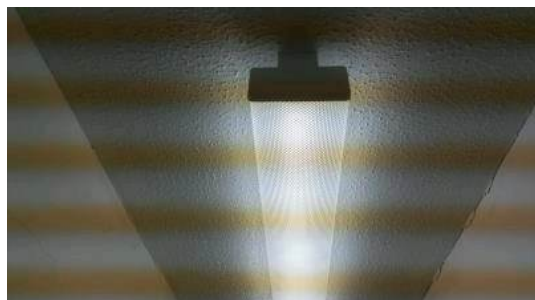
Product Description : Textured Coating  
 Estimated Quantity : 2 m<sup>2</sup>  
 Likelihood of Disturbance : Occasionally likely to be disturbed  
 Sample Number : As Sample AQ002096  
 Sample Analysis : N/A

Factors	Assessment Description	Score
Product/Material Type	Textured Coating	1
Damage/Deterioration	Low Damage	1
Surface Treatment	Sealed Semi-Rigid Paints & Decorative Coatings	0
Asbestos Type	Chrysotile	1
Material Assessment Score:		3

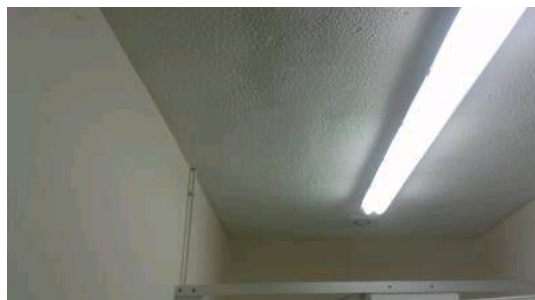
Product Description : Textured Coating  
 Estimated Quantity : 3 m<sup>2</sup>  
 Likelihood of Disturbance : Occasionally likely to be disturbed  
 Sample Number : As Sample AQ002096  
 Sample Analysis : N/A

Factors	Assessment Description	Score
Product/Material Type	Textured Coating	1
Damage/Deterioration	Low Damage	1
Surface Treatment	Sealed Semi-Rigid Paints & Decorative Coatings	0
Asbestos Type	Chrysotile	1
Material Assessment Score:		3

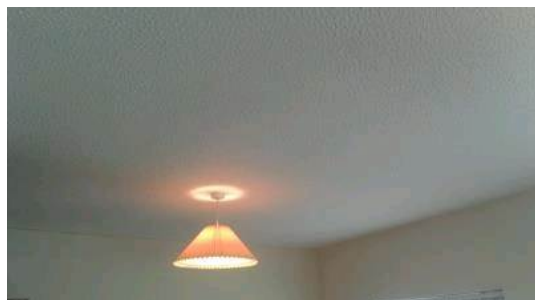
Product Description : Textured Coating  
 Estimated Quantity : 5 m<sup>2</sup>  
 Likelihood of Disturbance : Occasionally likely to be disturbed  
 Sample Number : AQ002098  
 Sample Analysis : Chrysotile

Factors	Assessment Description	Score
Product/Material Type	Textured Coating	1
Damage/Deterioration	Low Damage	1
Surface Treatment	Sealed Semi-Rigid Paints & Decorative Coatings	0
Asbestos Type	Chrysotile	1
Material Assessment Score:		3

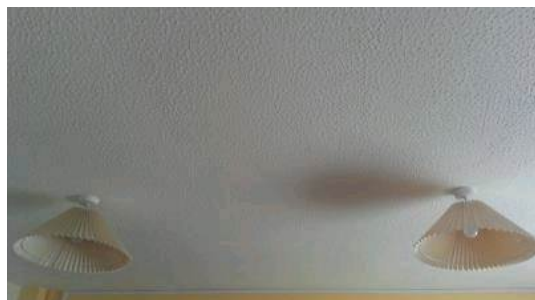
Product Description : Textured Coating  
 Estimated Quantity : 5 m<sup>2</sup>  
 Likelihood of Disturbance : Occasionally likely to be disturbed  
 Sample Number : As Sample AQ002098  
 Sample Analysis : N/A

Factors	Assessment Description	Score
Product/Material Type	Textured Coating	1
Damage/Deterioration	Low Damage	1
Surface Treatment	Sealed Semi-Rigid Paints & Decorative Coatings	0
Asbestos Type	Chrysotile	1
Material Assessment Score:		3
