ASBESTOS SURVEY REPORT

St Leonards Church
Wolborough Street
Newton Abbot
Devon

Major Refurbishment/Demolition Survey

7061

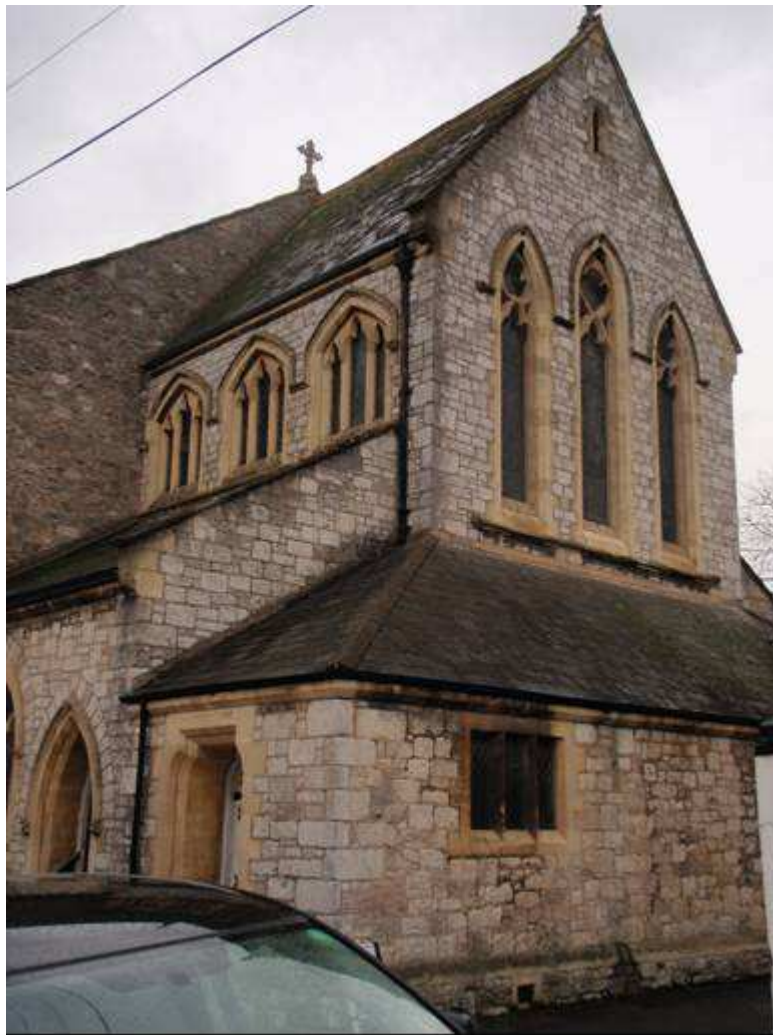
**Bulk Sample N° RA/060217/1
Photograph N° 001**

a/ Rear Extension – Pitched & Lean-to Roof Areas – Roof tiles

Sample / Date / Number	RA/060217/1
Product Type	Asbestos Cement
Analysis	Positive – contains Chrysotile Asbestos fibre.
Extent / Quantity	All rear Extension Pitched / Lean – to Roof Areas.
Condition	N/A
Surface Treatment	N/A
Algorithm / Risk	N/A
Accessibility	N/A
Management	<p>This material should only be worked on/with in accordance with The Control of Asbestos Regulations 2012.</p> <p>This material is classified as a ‘hazardous’ waste for disposal purposes. If to remain in ‘situ’, this material requires hazard warning labelling and a 12 monthly recorded inspection by a suitably trained/competent person or immediate re-assessment if damaged / disturbed.</p>

**External – Rear Extension
Pitched & Lean-to Roof Areas
Roof tiles**

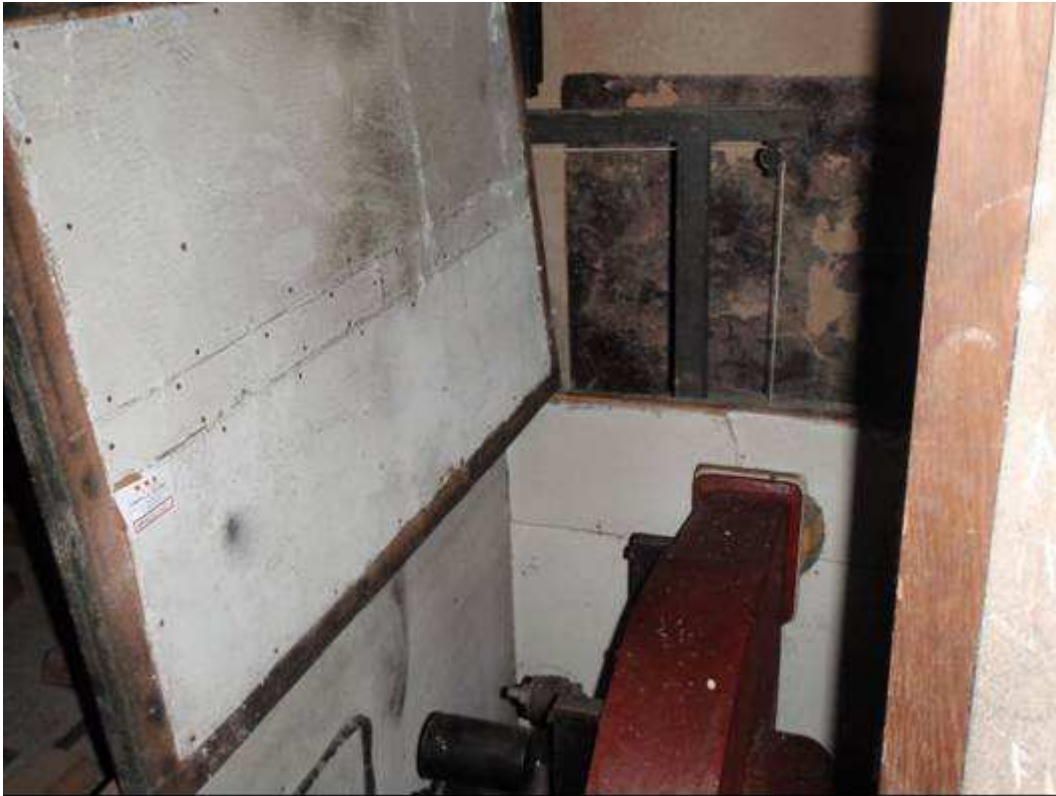
Bulk Sample N° RA/060217/2
Photograph N° 002

a/ Organ Blower Box – Internal lining panels

Sample / Date / Number	RA/060217/2
Product Type	Asbestos Insulating Board
Analysis	Positive – contains Chrysotile Asbestos fibre.
Extent / Quantity	All Internal Lining Panels.
Condition	N/A
Surface Treatment	N/A
Algorithm / Risk	N/A
Accessibility	N/A
Management	<p>This material should only be worked on/with in accordance with The Control of Asbestos Regulations 2012.</p> <p>This material is classified as a ‘hazardous’ waste for disposal purposes. If to remain in ‘situ’, this material requires hazard warning labelling and a 12 monthly recorded inspection by a suitably trained/competent person or immediate re-assessment if damaged / disturbed.</p>

Internal – Organ Blower Box
Internal box lining panels

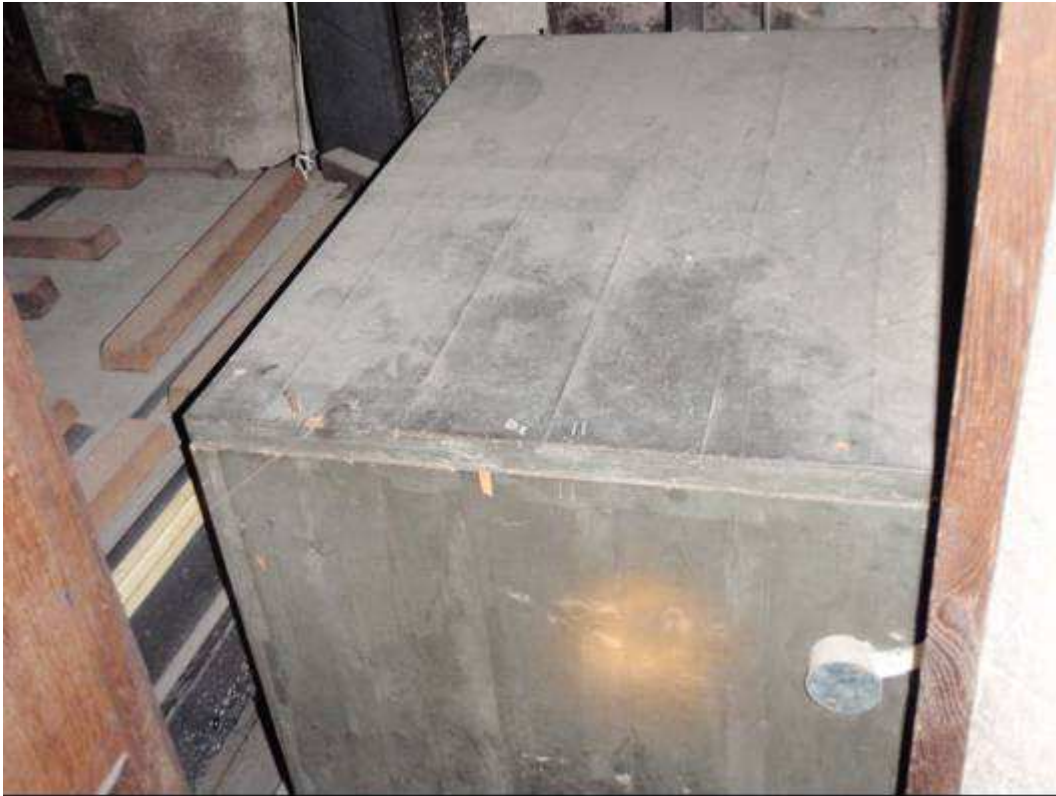
Bulk Sample N° RA/060217/2
Photograph N° 003

Internal – Organ Blower Box
Internal box lining panels

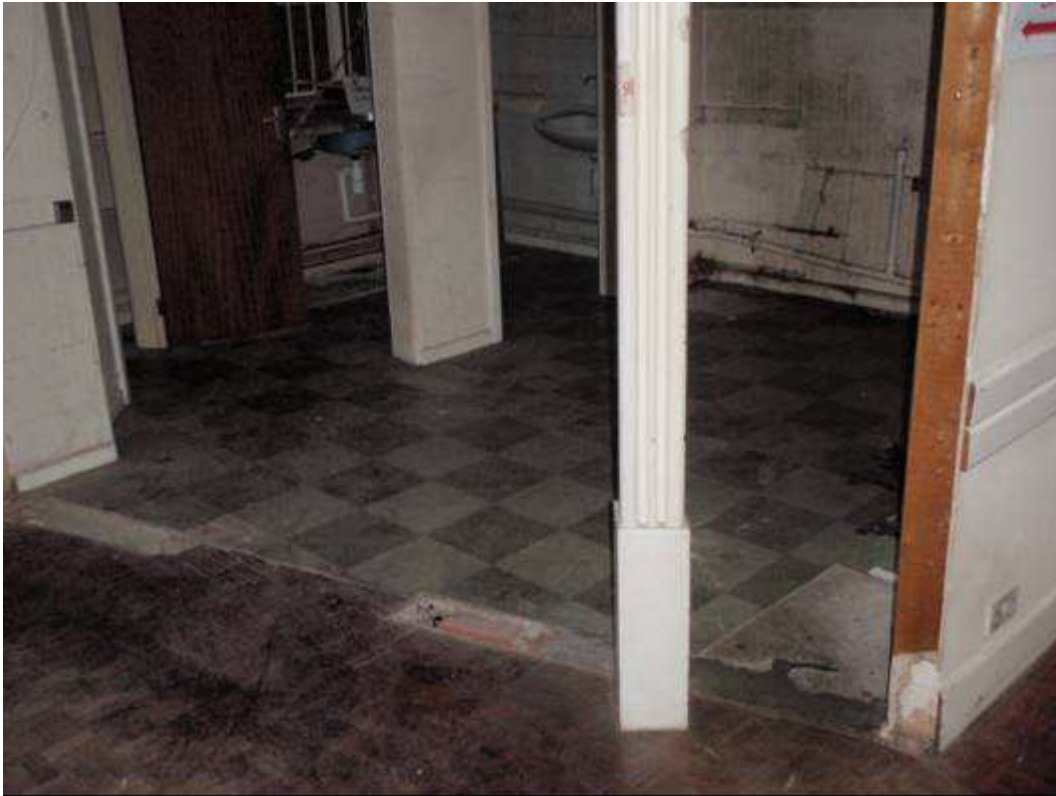
Bulk Sample N° RA/060217/3&4
Photograph N° 004

Sample / Date / Number	RA/060217/3
Product Type	Vinyl
Analysis	Negative – no asbestos fibre detected.
Extent / Quantity	N/A
Condition	N/A
Surface Treatment	N/A
Algorithm / Risk	N/A
Accessibility	N/A
Management	None required.

Sample / Date / Number	RA/060217/4
Product Type	Vinyl
Analysis	Negative – no asbestos fibre detected.
Extent / Quantity	N/A
Condition	N/A
Surface Treatment	N/A
Algorithm / Risk	N/A
Accessibility	N/A
Management	None required.

Internal – Front L/H/S – Kitchen / W/C
Floor tiles – L/Green & D/Green

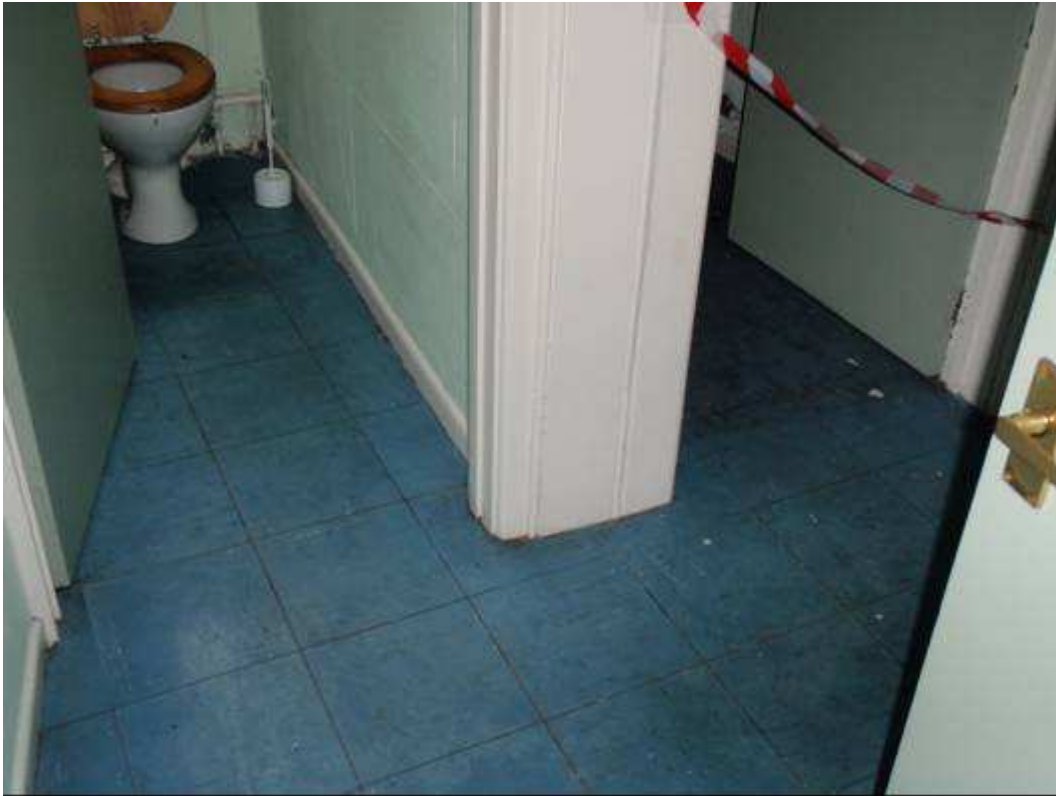
Bulk Sample N° RA/060217/5
Photograph N° 005

Sample / Date / Number	RA/060217/5
Product Type	Vinyl
Analysis	Negative – no asbestos fibre detected.
Extent / Quantity	N/A
Condition	N/A
Surface Treatment	N/A
Algorithm / Risk	N/A
Accessibility	N/A
Management	None required.

Internal – Front R/H/S – Ladies W/C
Floor tiles – Blue

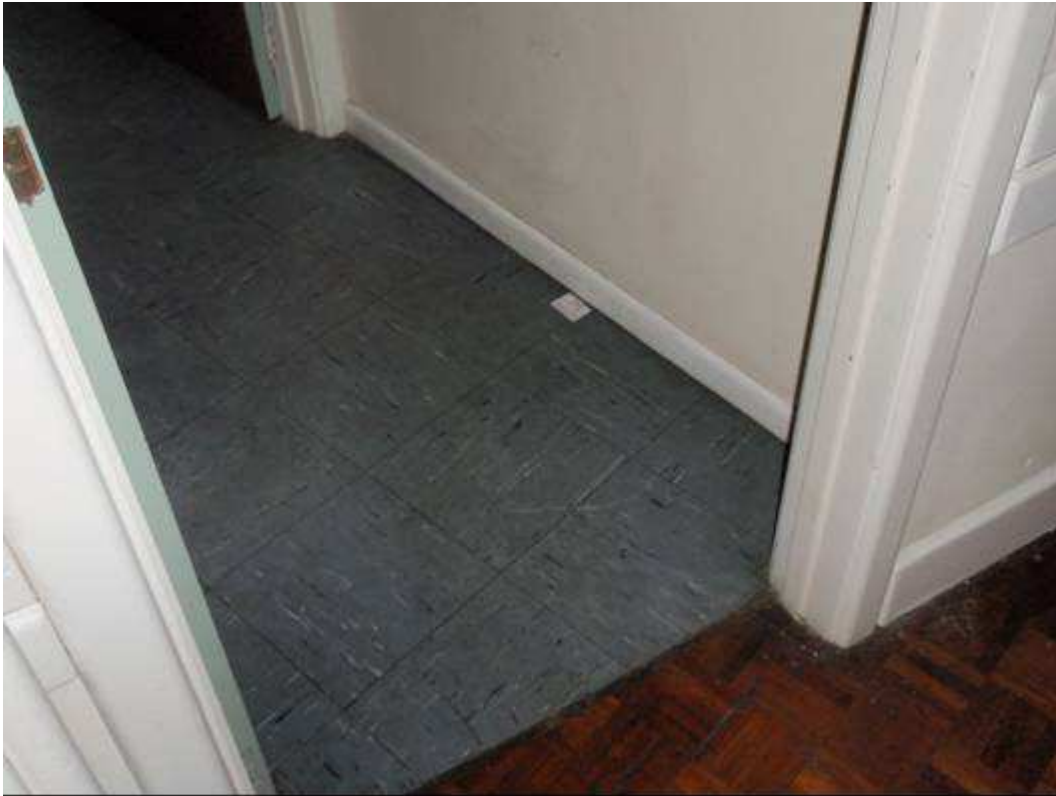
Bulk Sample N° RA/060217/6
Photograph N° 006

Sample / Date / Number	RA/060217/6
Product Type	Vinyl
Analysis	Negative – no asbestos fibre detected.
Extent / Quantity	N/A
Condition	N/A
Surface Treatment	N/A
Algorithm / Risk	N/A
Accessibility	N/A
Management	None required.

Internal – Front R/H/S – Male W/C
Floor tiles – Grey fleck

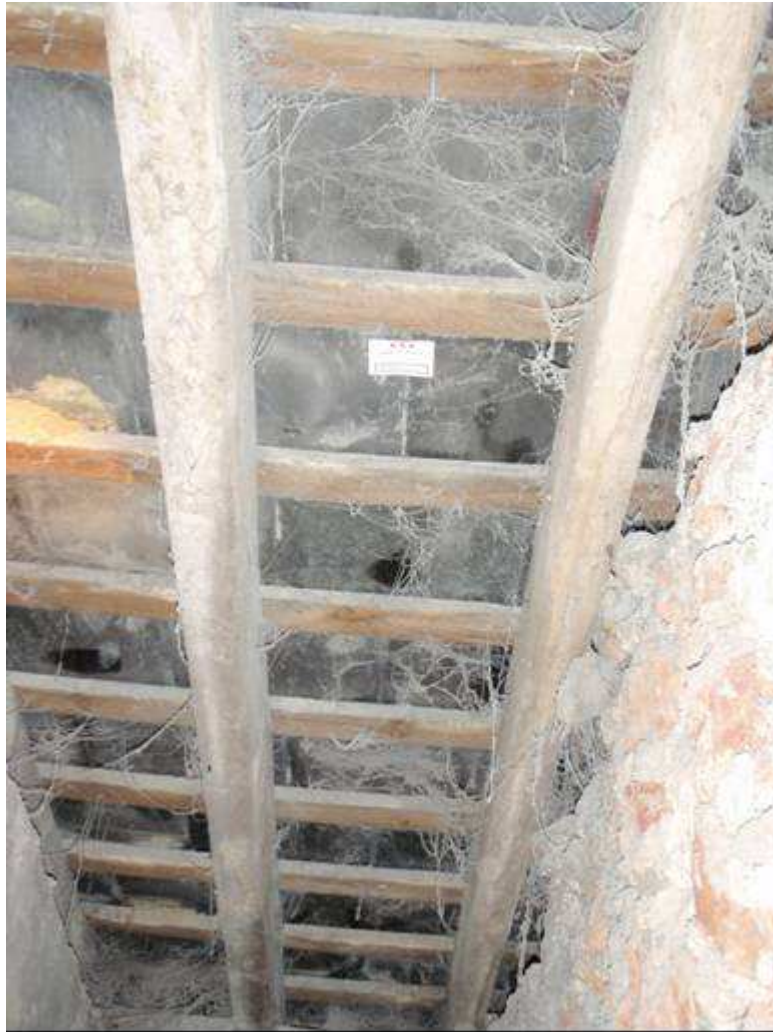
Bulk Sample N° RA/060217/7
Photograph N° 007

Sample / Date / Number	RA/060217/7
Product Type	Cement
Analysis	Negative – no asbestos fibre detected.
Extent / Quantity	N/A
Condition	N/A
Surface Treatment	N/A
Algorithm / Risk	N/A
Accessibility	N/A
Management	None required.

Internal – Main Church Pitched Roof
Roof tiles

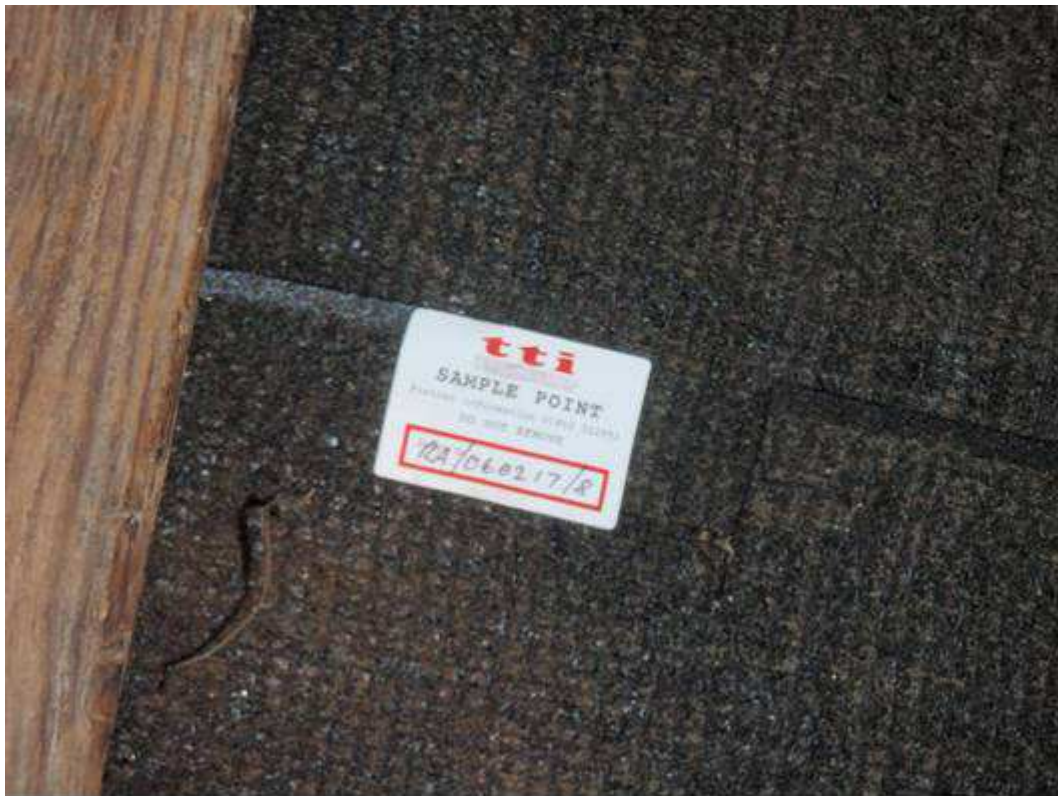
Bulk Sample N° RA/060217/8
Photograph N° 008

Sample / Date / Number	RA/060217/8
Product Type	Bituminous product
Analysis	Negative – no asbestos fibre detected.
Extent / Quantity	N/A
Condition	N/A
Surface Treatment	N/A
Algorithm / Risk	N/A
Accessibility	N/A
Management	None required.

Internal – Rear Pitched & Lean-to Roof Areas
Roof felt

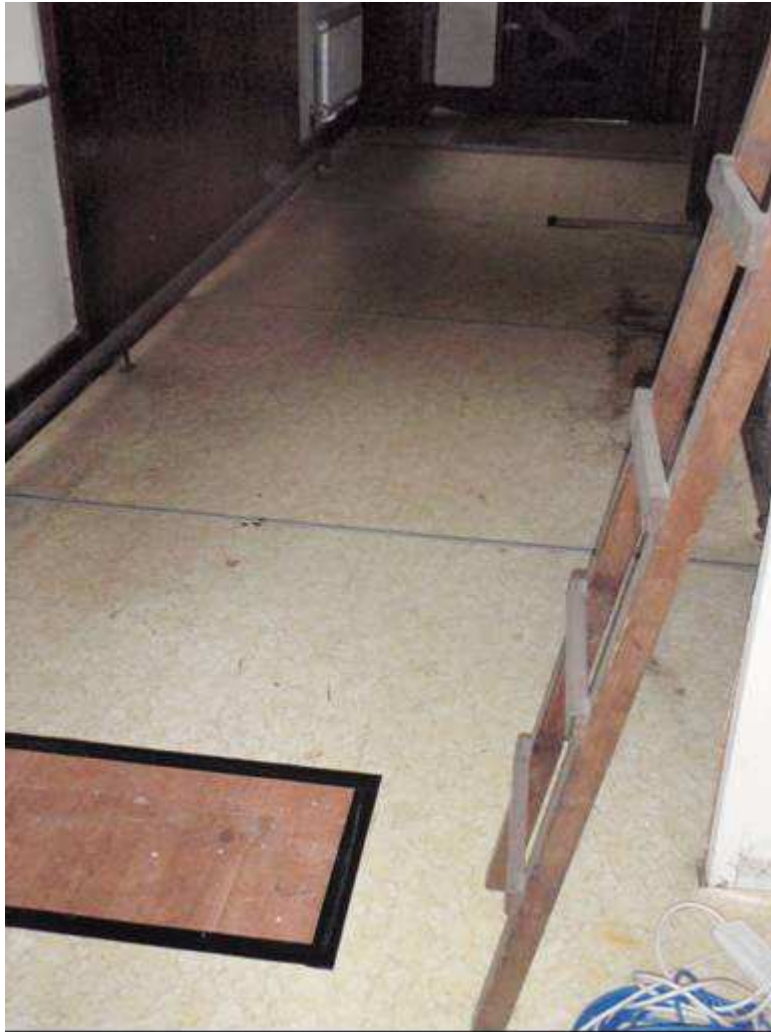
**Bulk Sample N° RA/060217/9
Photograph N° 009**

a/ GF – Rear Extension Cross Passage – Floor lino

Sample / Date / Number	RA/060217/9
Product Type	Asbestos Textiles
Analysis	Positive – contains Chrysotile Asbestos fibre.
Extent / Quantity	All Floor Lino.
Condition	N/A
Surface Treatment	N/A
Algorithm / Risk	N/A
Accessibility	N/A
Management	<p>This material should only be worked on/with in accordance with The Control of Asbestos Regulations 2012.</p> <p>This material is classified as a 'hazardous' waste for disposal purposes. If to remain in 'situ', this material requires hazard warning labelling and a 12 monthly recorded inspection by a suitably trained/competent person or immediate re-assessment if damaged / disturbed.</p>

**Internal – Rear Extension Cross Passage
Floor lino**

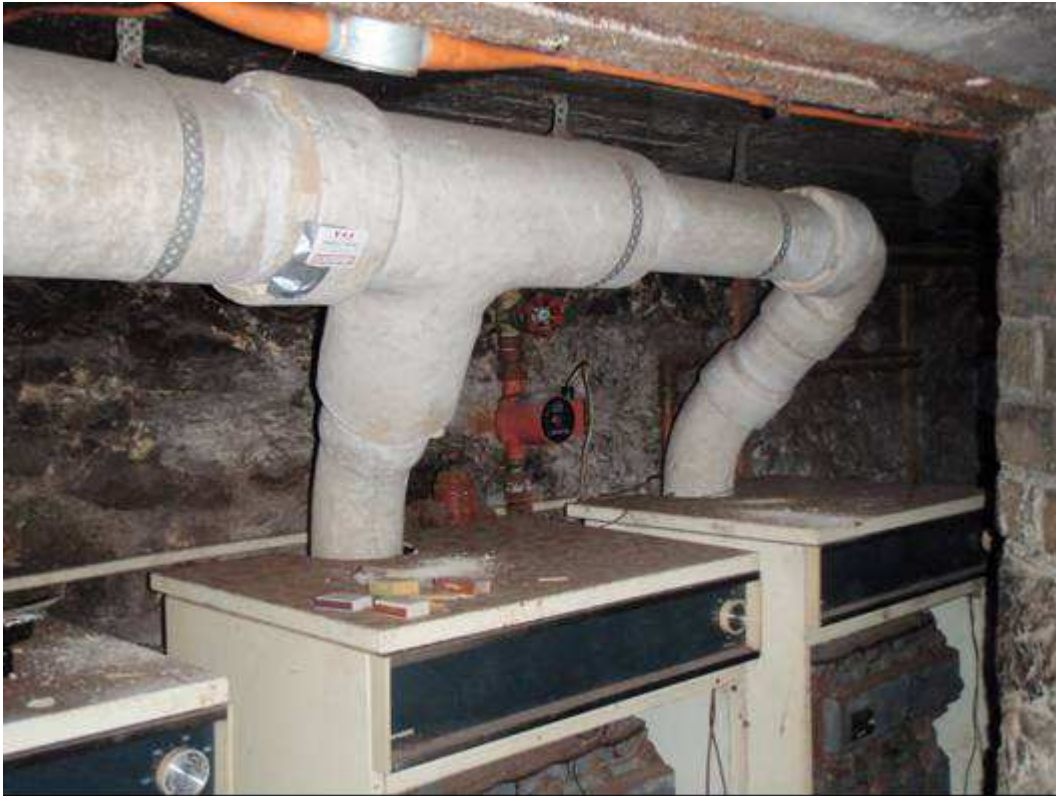
Bulk Sample N° RA/060217/10
Photograph N° 010

b/ Basement Boiler Room – Boiler flues

Sample / Date / Number	RA/060217/10
Product Type	Asbestos Cement
Analysis	Positive – contains Chrysotile Asbestos fibre.
Extent / Quantity	All Cement Flues.
Condition	N/A
Surface Treatment	N/A
Algorithm / Risk	N/A
Accessibility	N/A
Management	<p>This material should only be worked on/with in accordance with The Control of Asbestos Regulations 2012.</p> <p>This material is classified as a 'hazardous' waste for disposal purposes. If to remain in 'situ', this material requires hazard warning labelling and a 12 monthly recorded inspection by a suitably trained/competent person or immediate re-assessment if damaged / disturbed.</p>

Boiler Room
Boiler flues

Note: Refer 2.11.1a

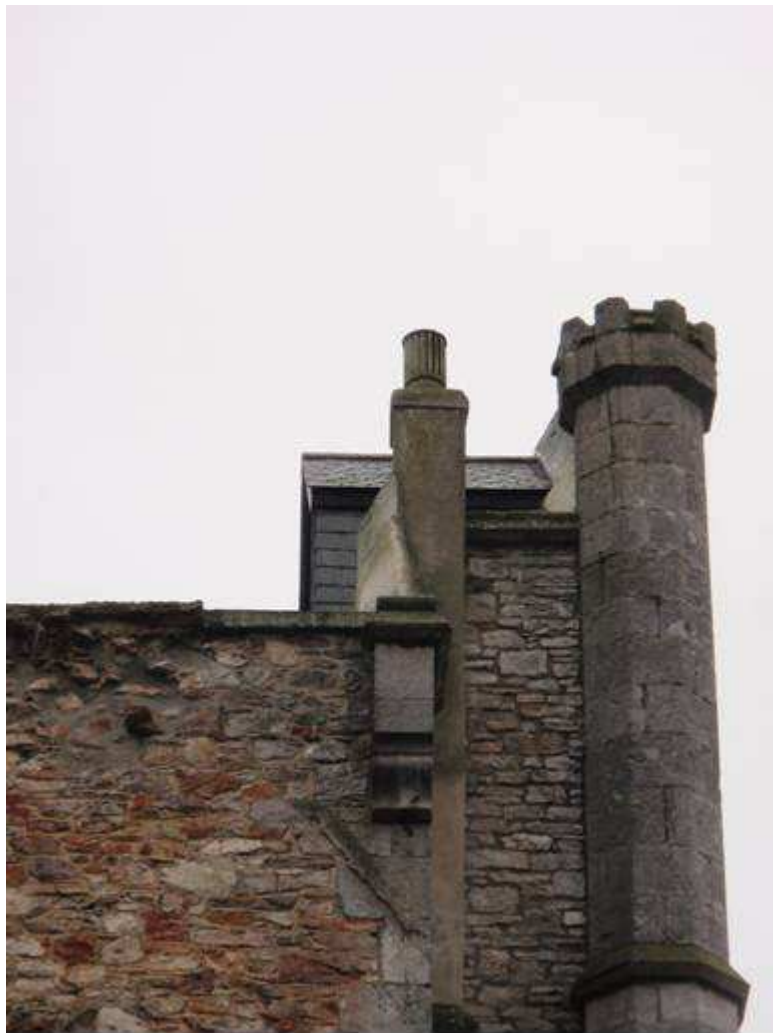
**Common to Bulk Sample N° RA/060217/10
Photograph N° 011**

Note: Visually common to external vent sited externally at roof level on top of boiler flue chimney stack.

**External Roof Area
Boiler flue chimney cowl**

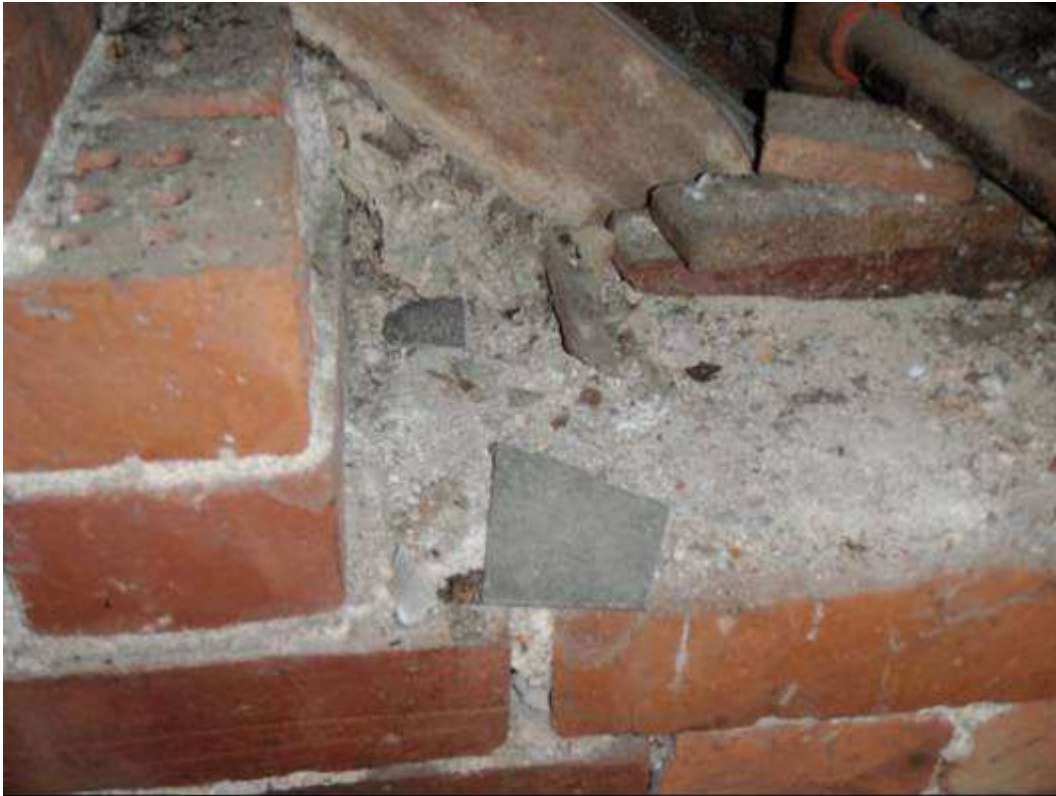
Common to Bulk Sample N° RA/060217/1
Photograph N° 012

Note: Common to debris within roof voids below accessed via the vestry passageway.

Rear Pitched & Lean-to Roof Areas
Roof tile debris within roof void

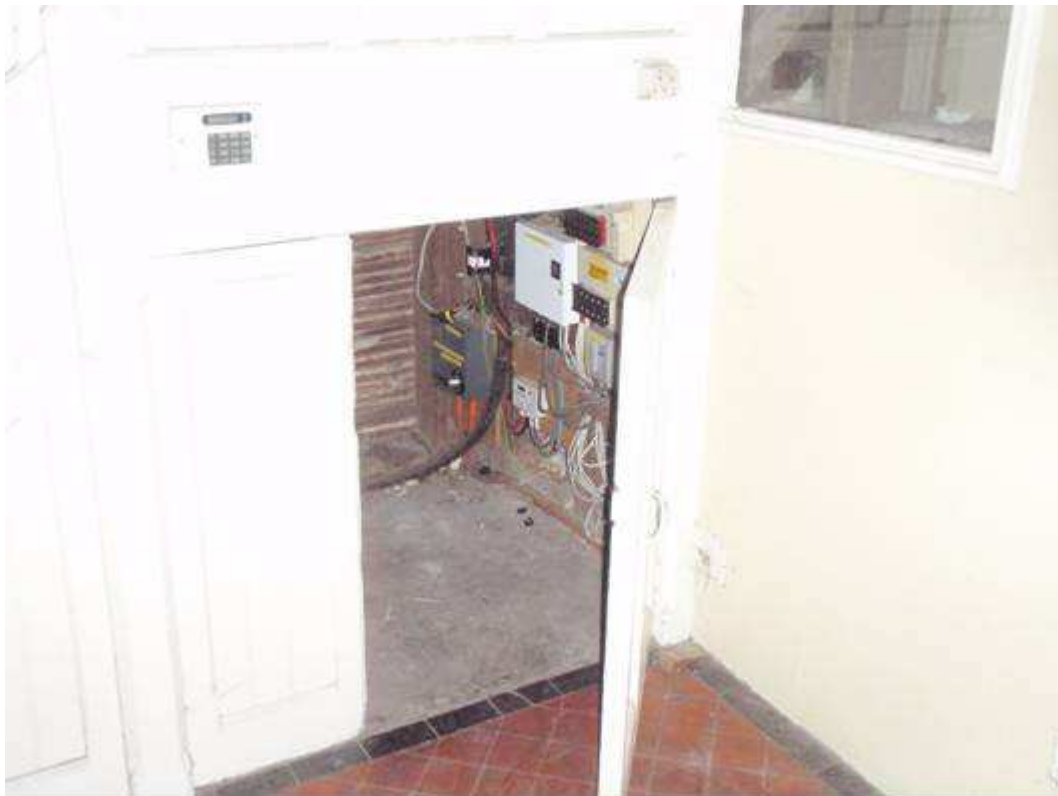
b/ Textiles – GF beneath stairs within entrance lobby – 'L' intake – Fuse flashbacks.

Sample / Date / Number	Not Bulk Sampled
Product Type	Strongly suspected Asbestos Textiles
Analysis	Strongly suspected ACM's
Extent / Quantity	Not Known.
Condition	N/A
Surface Treatment	N/A
Algorithm / Risk	N/A
Accessibility	N/A
Management	If proven positive by analysis, this material should only be worked on/with in accordance with The Control of Asbestos Regulations 2012. This material is classified as a ‘hazardous’ waste for disposal purposes. If to remain in ‘situ’, this material requires hazard warning labelling and a 12 monthly recorded inspection by a suitably trained/competent person or immediate re-assessment if damaged / disturbed.

Strongly Suspected Asbestos Textiles
Understairs 'L' Intake – Fuse flashbacks
Refer 2.11.1b
