Condition Report

Roof Condition
Various Blocks
for NOCS

Kendall Kingscott

Job No. 170071

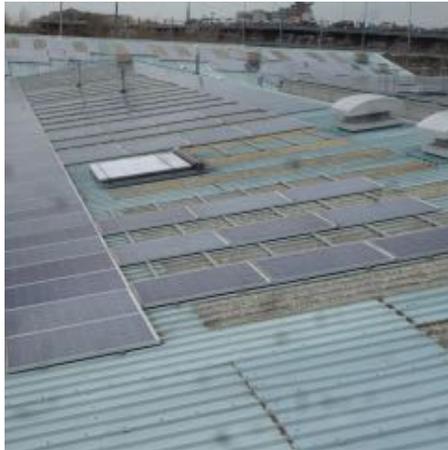
Solar panels are located to the Southern and Eastern pitches, mounted to a galvanised steel frame and fixed through the roof to the structure below. During our inspection we noted the surfaces of the solar panels are soiled and would benefit from a thorough clean to ensure they achieve their optimal performance. We also noted a solar water heating system installed within this location. This generally appeared to be in a fair condition.

No means of safe access for cleaning and maintenance of the solar panels have been provided. Most manufacturers require general cleaning of solar panels every six months to maintain optimum performance.

Photo 2: Solar panel installation.

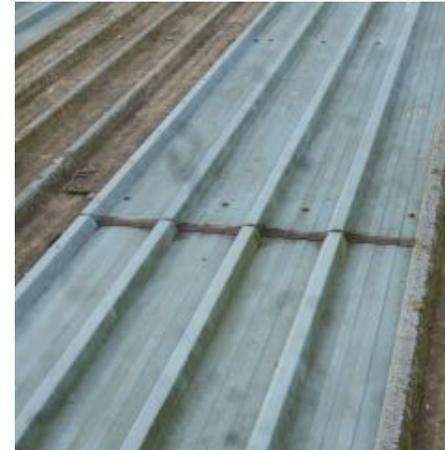
Photo 4: Cut edge corrosion to Northern roof pitch.

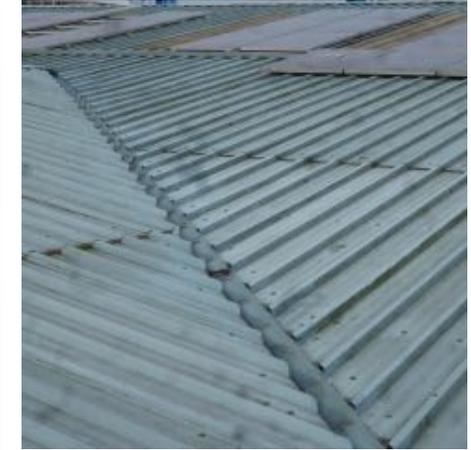
Photo 5: Cut edge corrosion to workshops and stores.

With the exception of the newer extension, we anticipate that the roof coverings are circa 20 years of age. The coatings have degraded with cut edge corrosion and additional areas of spot corrosion in various locations. Further corrosion was also noted where mechanical damage is present, likely to have been caused by general maintenance works / access. The coatings are chalking and flaking, caused by exposure to UV and further accelerated by the exposed nature of the site.

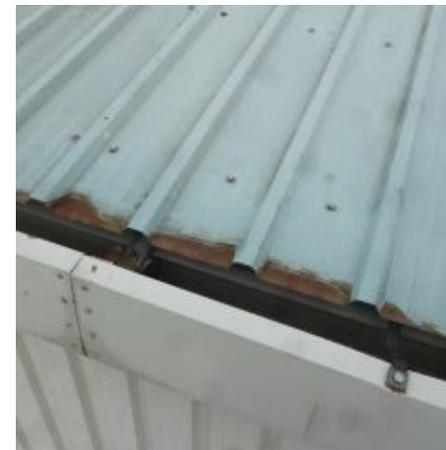
Photo 6: Cut edge corrosion at gutters to Southern roof pitch.

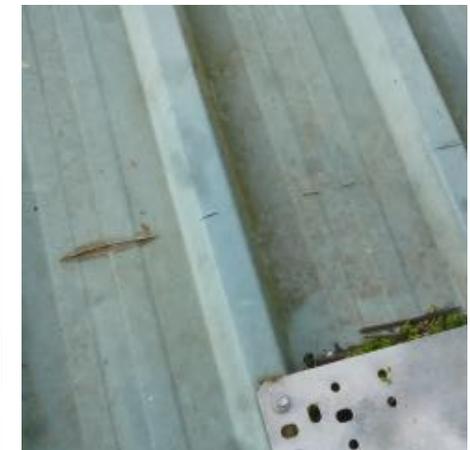
Photo 7: Mechanical damage to coatings.

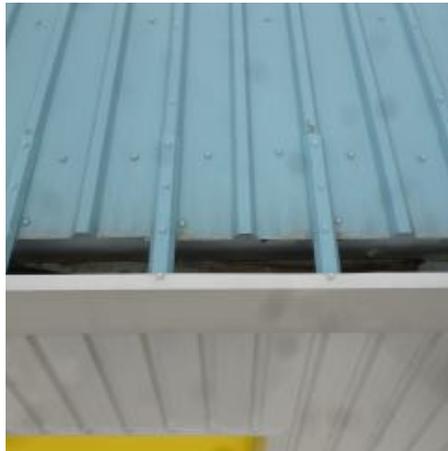
The newer roof sheets to the extension are in a fair condition with no cut edge corrosion noticeable. However, we did note soiling to the eaves which is an indication of water collecting and drying on the edges of the sheets and could eventually lead to corrosion.

Photo 8: Roof sheets to extension.

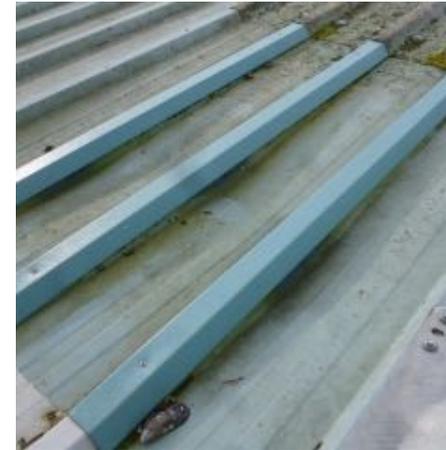
A number of areas of deflection are evident to the coverings, with this damage seeming to be concentrated below the roof lights. This type of damage can usually be attributed to maintenance access. Where this has occurred, the trapezoidal sections of the roof sheets have been capped with a new section of coated steel riveted to the original sheet. A total of twenty caps have been installed in this way to the Northern roof pitch. These repairs have been undertaken inadequately as the profiled caps have not been tucked under the sheets above, potentially due to the fragility of the GRP roof lights. This is likely to cause further issues by allowing rain water under the cap.

Photo 9: Deflection to roof sheets with caps installed.

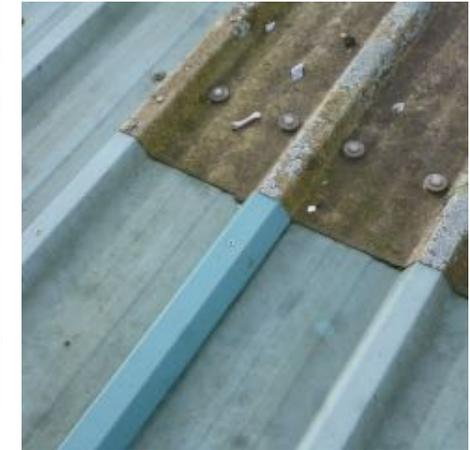
Photo 10: Caps are not tucked under the roof lights providing a route for water ingress.

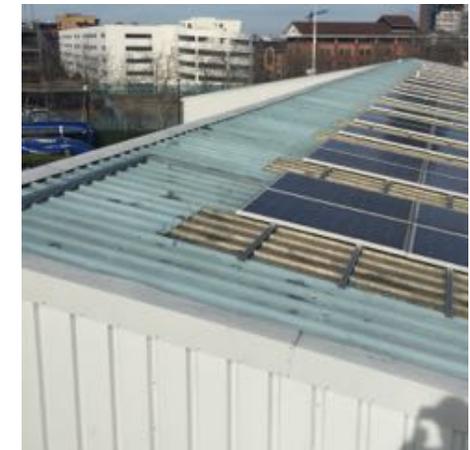
The roof has pre-finished metal trims to the gables and ridge to match the profiled roof sheets installed. These are heavily soiled and the majority of joints have been sealed using an external grade mastic. Minor impact damage and distortion was noted in various areas. The coatings to these trims appear to be the same age as the roof sheets and show signs of chalking and peeling.

Photo 11: General view of the trims to the roof.

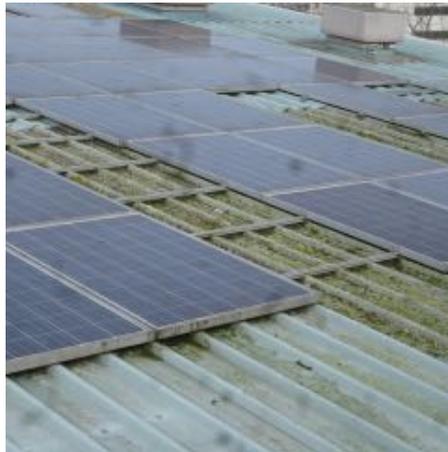
Photo 12: The solar panel framework has been installed over the roof lights in various locations.

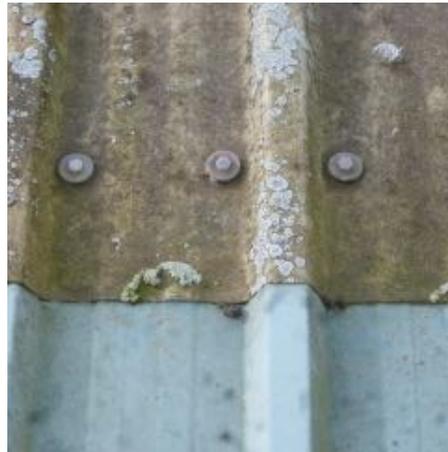
The GRP roof lights are heavily soiled and suffering from solar degradation. The matting to the GRP is exposed and we would recommend these roof lights are treated as very fragile. Some roof lights have the solar panel framework installed over them. Whilst solar panels have not been installed within these areas, these installations will cause issues in maintaining the roof lights. Viewed internally, the light transfer through the roof lights has been significantly reduced. The exception is the roof lights to the newer extension which are only lightly soiled.

Photo 13: The roof lights are soiled and GRP fibres are exposed.

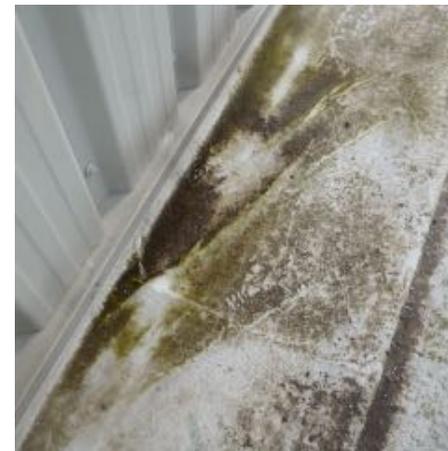
The valley gutter between the roof and the newer extension has been coated with a liquid applied system, installed to the gutter, upstands and approximately 300mm up the profiled roof sheets. Ridges are starting to form within the valley, an indication of thermal movement. Whilst this has not caused any significant defects, splits are likely to form in the short term, causing internal damage. We noted the coating already had minor splits at the end of the gutter and in a couple of locations to the profiled roof sheets. Whilst these splits / tears are relatively minor at present, they will accelerate the failure of the coating.

Photo 14: Ridges starting to form to the valley gutter.

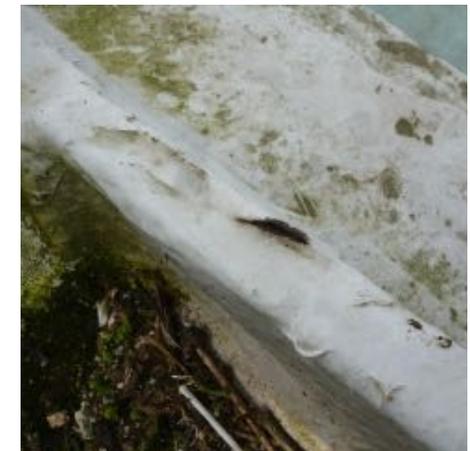
Photo 15: Tear in the membrane forming the valley gutter.

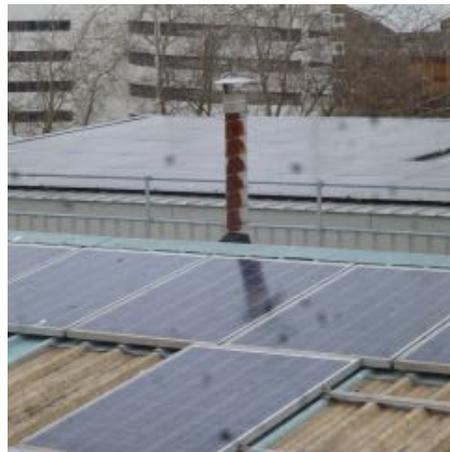
Galvanised metal flues penetrate the roofs and are sealed to the roof coverings using rubber gaskets. The flues are corroded to the South West side, with lighter surface corrosion noted to the remaining areas. The gaskets have sagged and a build up of debris surrounds them. In addition, a number of ventilation ducts penetrate the roof which are weathered but appear in a fair condition. We are unable to comment upon the servicing of these items.

Photo 16: Corrosion to flues.

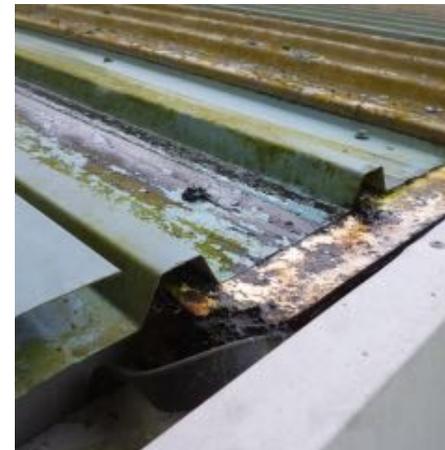
The profiled metal sheeting to the roofs have surface soiling and are showing signs of cut edge corrosion. A further section of exposed sheeting at eaves level has significant surface corrosion. The roof sheets immediately adjacent to the access door are protected from the prevailing weather, with no immediate signs of cut edge corrosion. However, the surfaces do have minor soiling and we noted surface staining caused by corrosion. We suspect this has been caused by swarf from the installation of new coverings to the roof above.

Photo 18: Heavily corroded section at gutter level.

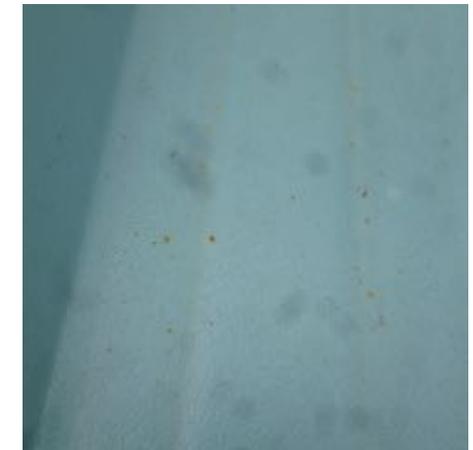
Photo 19: Staining to roof sheets caused by swarf.

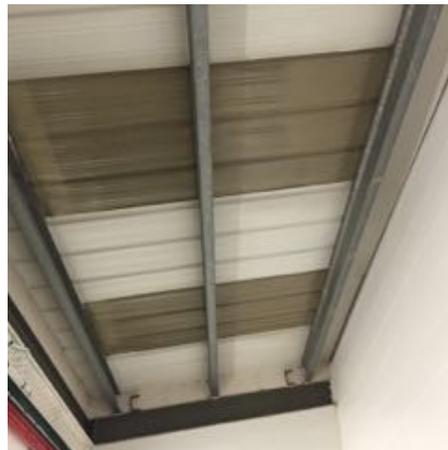
This lower roof has been extended over to form the new MARS building. When these works were undertaken, the roof coverings, including the roof lights, were left in position. Therefore a number of roof lights within the property have been built over but are still visible internally. A further section of this lower roof is also located between the MARS extension and the stores and is in a similar condition with heavy soiling to the surfaces and roof light.

Photo 20: View internally of roof lights which have been built over.

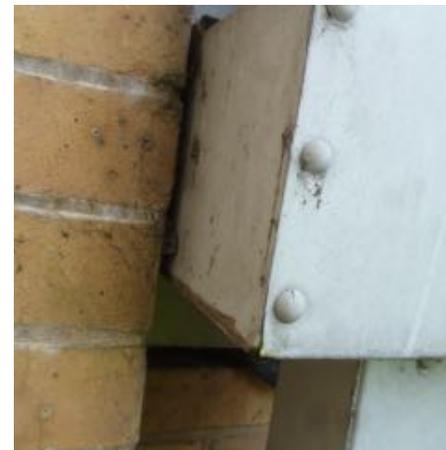
A box gutter is located to the perimeters of both the upper and lower roofs. These discharge through a downpipes located externally to the property. During our inspection, we noted a minor layer of sediment within the gutters and that the box gutter to the lower roof is leaking at the end adjacent to the main office building. The downpipes appear to be in a fair condition, although we did note some minor impact damage, minor corrosion and soiling at the junction with the below ground drainage.

Photo 22: Leaking and corroding section of gutter to lower roof.

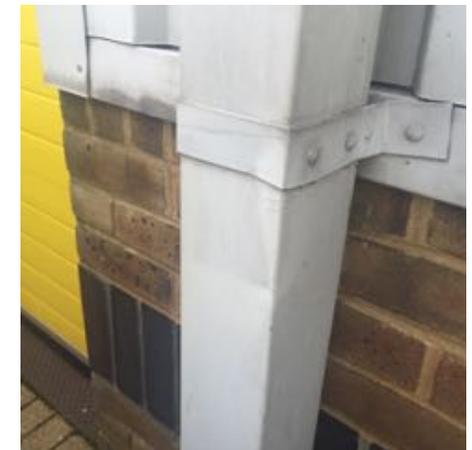
Photo 23: Impact damage to downpipe.

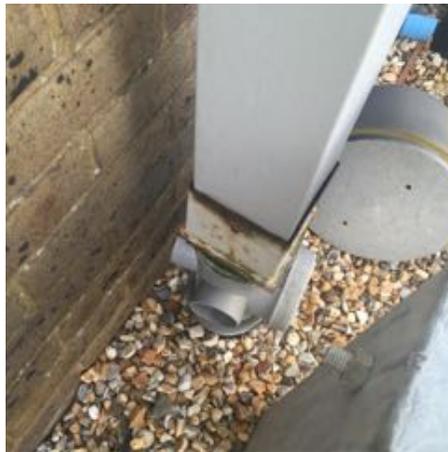
Photo 24: Corrosion to downpipes at joint with below ground drainage.

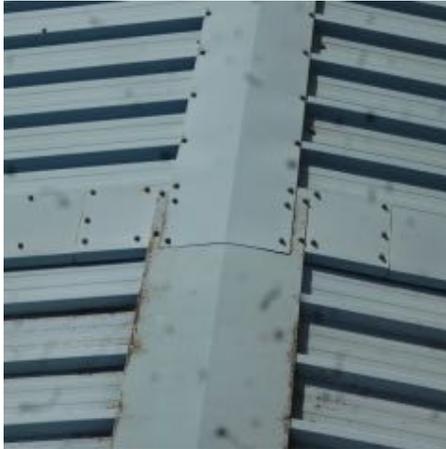
The profiled metal ridge and trims to the property are in a similar condition to the roof sheets, with cut edge corrosion and deterioration of the coatings. We also noted the joints to the ridge have been sealed using an external sealant. Whilst this may be an effective temporary repair, these sealants will break down and are not a standard detail for the installation of these trims.

Photo 26: Corrosion to the ridge.

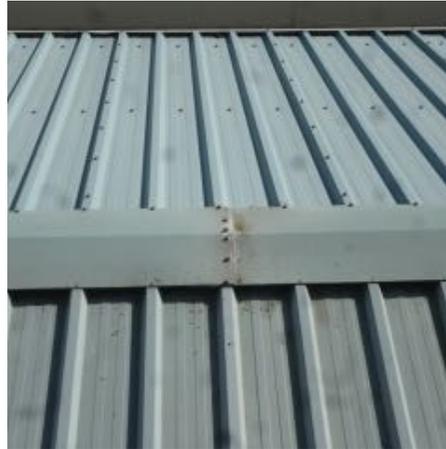
Photo 27: The ridge has been sealed using a retrospective sealant.

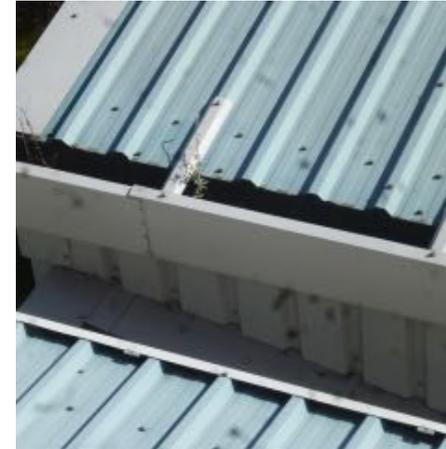
Photo 29: Vegetation growth in gutters.

Rainwater goods are in a fair condition with only a minor section of deflection noted. The gutters have some vegetation growth which requires clearing, but otherwise only minor silting was noted.

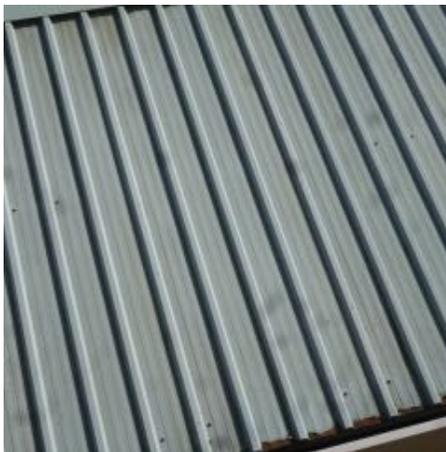
Photo 28: A large section of sheeting with no fixings to the purlin.

The fixings are corroded and a number have missing protective caps. The fixings to the purlins were also sporadic and we are of the opinion that further fixings should be installed to ensure the roof sheets are adequately secured.

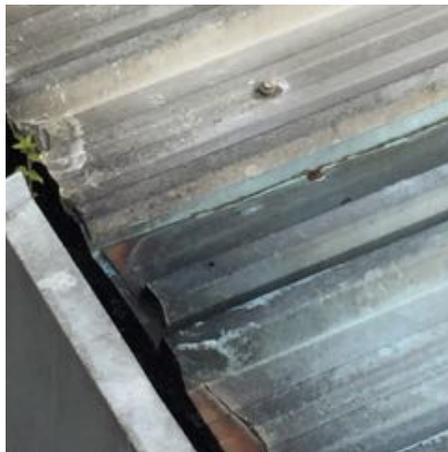
The coatings to the roof sheets have degraded with cut edge corrosion and areas of spot corrosion in various locations. The roof sheets are heavily soiled, contaminated and stained. The profiled metal ridge and trims to the property are in a similar condition to the roof sheets, with cut edge and spot corrosion alongside heavy soiling and contamination.

Photo 31: Cut edge corrosion at eaves level. Please note joint where roof coverings extended.

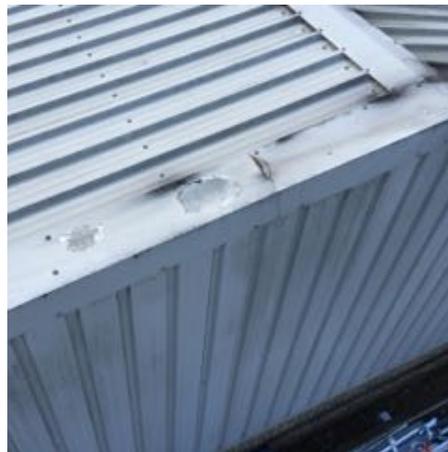
Photo 32: Deterioration to trims.

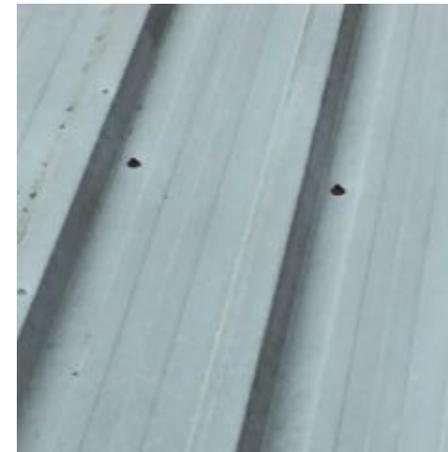
The fixings are corroded and a number have missing caps which could be the source of the minor water ingress noted within the internal accommodation. This represented itself as rust coloured streaks to the internal surfaces of the cladding which correlate with inadequately capped and corroding fixings.

Photo 33: Corroding fixings with missing caps.

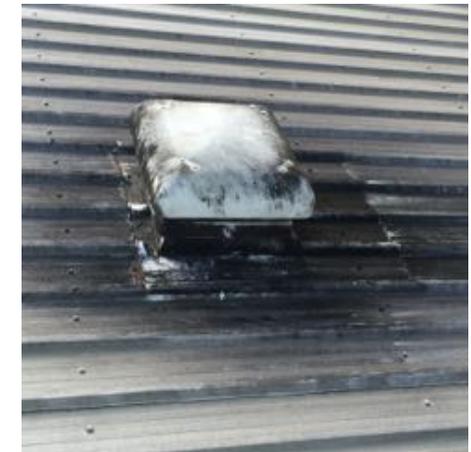
Photo 34: Typical roof vent with heavy staining and cut edge corrosion.

A total of three vents penetrate the roof coverings, all of which are heavily stained and contaminated. The roof sheets surrounding these vents are also suffering from cut edge corrosion and require remedial works.

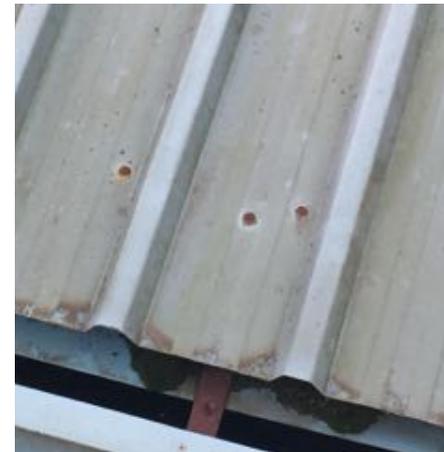
The fixings are in a fair condition although a number appeared to have some surface corrosion and missing caps. A number of sheets have been riveted in place where we would have expected these to have been screwed, indicating historic repairs to the roof coverings.

Photo 36: Corroding fixings with no protective caps.

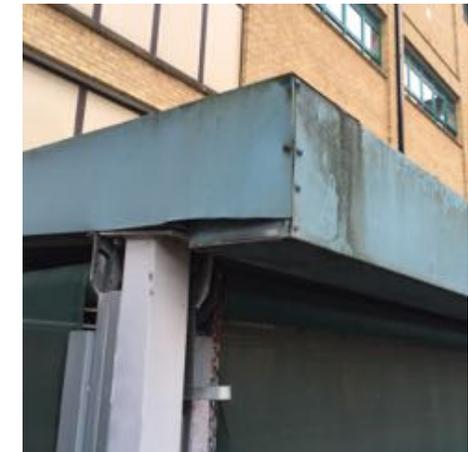
Photo 37: Minor distortion to trim and early signs of corrosion to gutter.

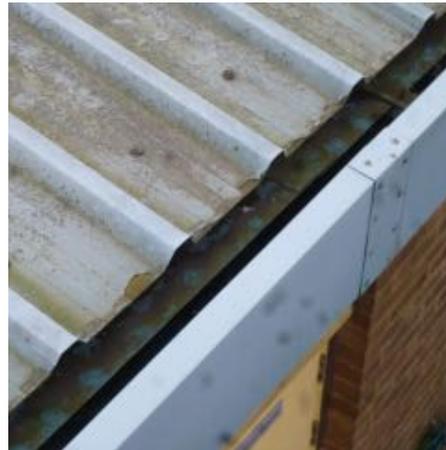
Photo 39: Cut edge corrosion at eaves level.

The coatings to the roof sheets have degraded with cut edge corrosion and areas of spot corrosion in various locations. The roof sheets are also soiled and stained. The profiled metal ridge and trims to the property have some minor distortion and some minor cut edge corrosion. The fixings are showing signs of surface corrosion and a number have missing caps.

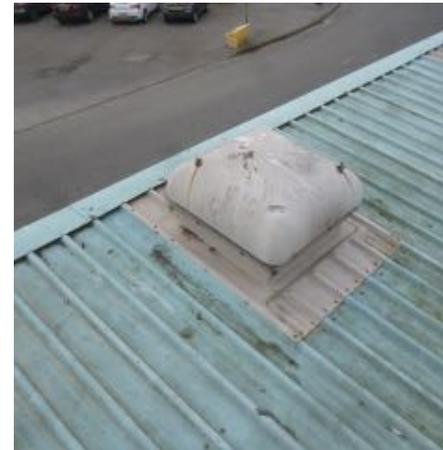
A total of five vents penetrate the roof, four of which have domes wired to the roof to provide additional support in windy conditions. We did note that a number of these ties are corroding, broken or missing. A flue also penetrates the roof and is in a fair condition.

Photo 40: Example roof vent with metal ties which are corroding, missing and damaged.

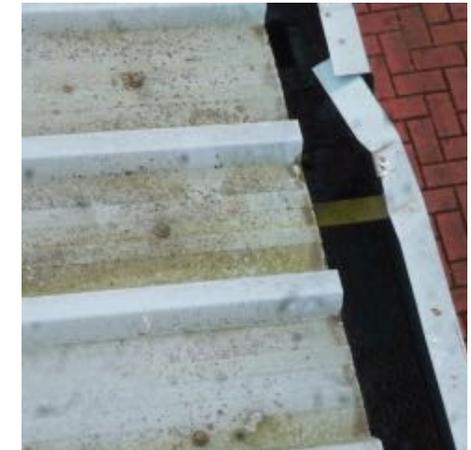
Photo 41: Damaged section of gutter.

Rainwater goods are generally in a fair condition with only minor silting and a small section of impact damage located to the top edge. This damage does not appear to be affecting the overall performance of the gutter.

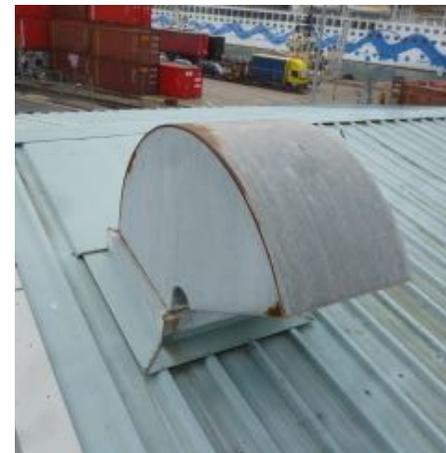
A single galvanised vent penetrates the roof and is showing signs of surface corrosion due to the exposed nature of the site.

Photo 43: Surface corrosion to roof vent.

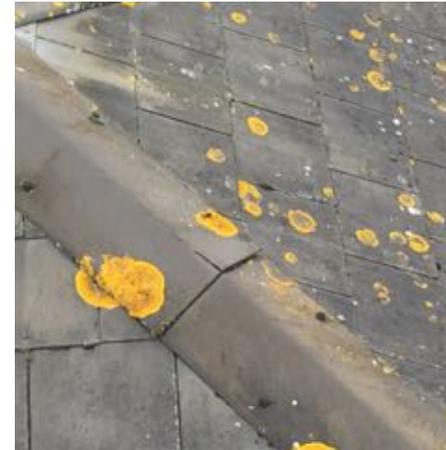
The synthetic slate roof coverings are generally soiled with considerable moss growth to the surfaces. The slates are in a fair condition with no cracks evident at the time of our inspection. We did note that one of the hip tiles near to the apex of the roof is cracked and requires replacement.

Photo 46: Cracked hip tile.

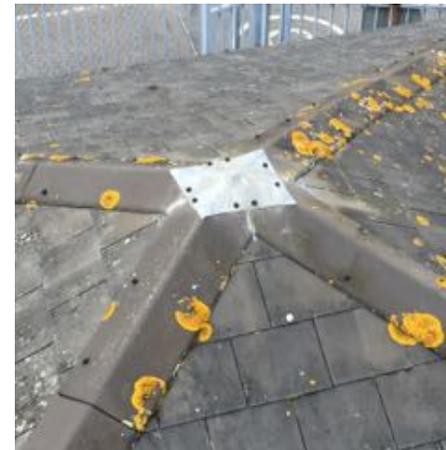
Photo 47: Lead and mastic repair to apex.

A section of lead has been retrofitted to the apex of the roof and the joints to the hip tiles below sealed with an external grade sealant. This is an inappropriate repair and we would recommend the ridge tiles are removed so further investigations can be undertaken to ascertain the condition of the dry fix system.

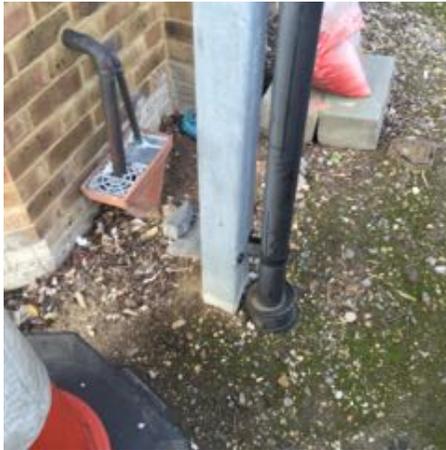
PVCu rainwater goods are fixed to the perimeter of the roof and served by two PVCu downpipes to the East side of the building. These are in a fair condition although they have faded with solar degradation.

Photo 48: Faded PVCu downpipe.

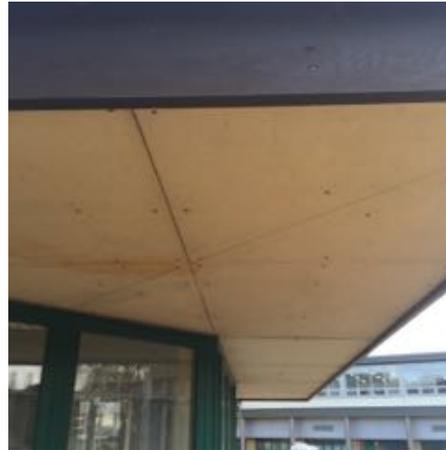
The roof has a deep soffit formed from fibre board which is in a fair condition despite some minor surface staining. The fascias to the property are stained timber which have been nailed in position. These are also in a fair condition.

Photo 49: Stained timber fascia and fibre board soffit.

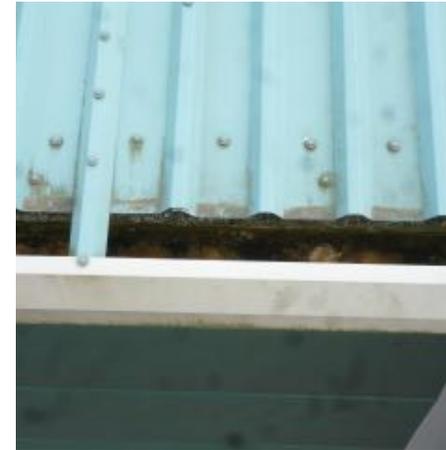
Photo 51: Staining to roof sheet at eaves level.

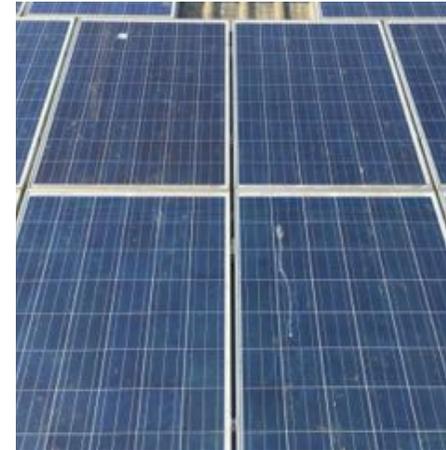
Photo 55: Soiling to surfaces of solar panels.

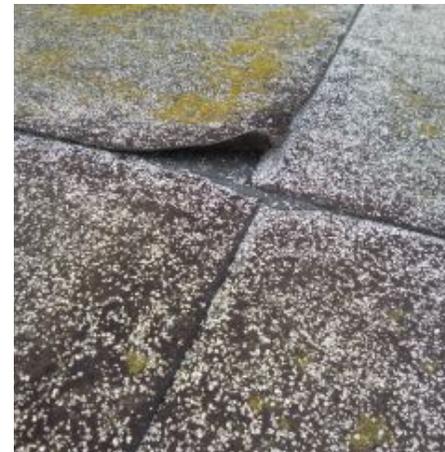
chippings, which provide UV protection, have worn away leaving the felt bare and exposed. A patch repair was also noted at the parapet up-stand to the Eastern side of the roof where we presume water ingress issues have been experienced.

Photo 58: Poorly installed felt covering.

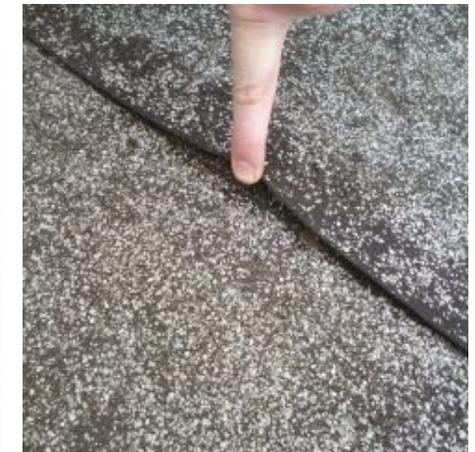
Photo 59: Poor laps to felt covering.

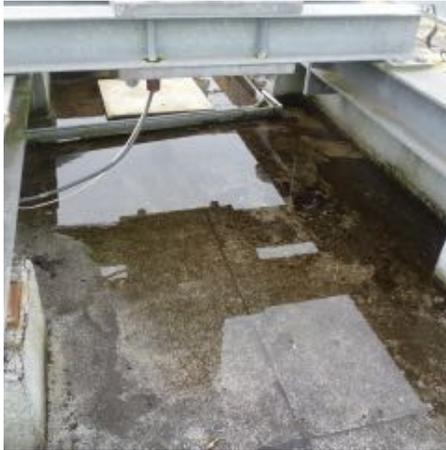
Photo 60: Ponding to felt coverings.

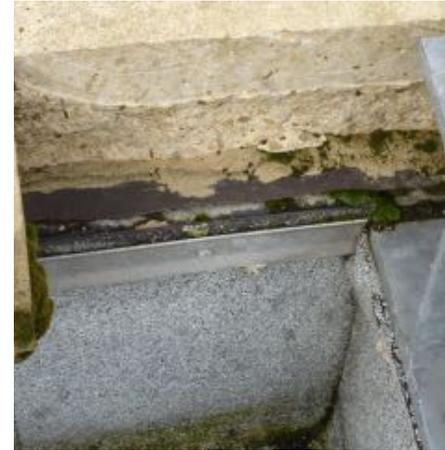
Photo 63: Damaged coping has exposed the substrate and felt up stand.

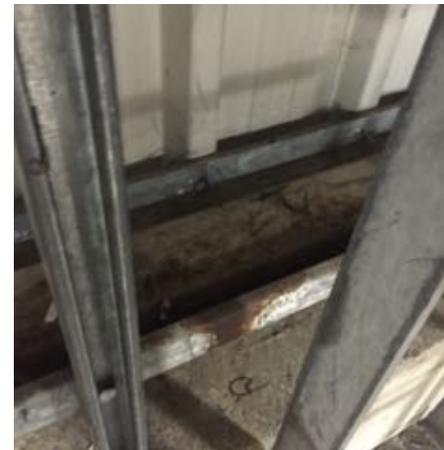
Photo 66: Corrosion to steel framework.

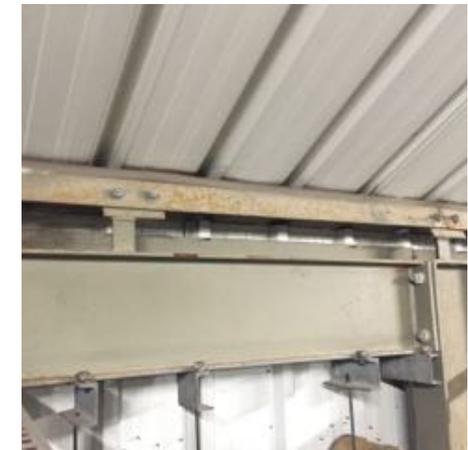
Photo 67: Corrosion to steel framework
