Our Ref: 02B727063/6218750_1

**RIVERS HOUSE, BELVEDERE ROAD, CROSSNESS, LONDON SE2 9AN
CRACKING TO INTERNAL AND EXTERNAL WALLS**

Further to your instructions dated 22 September 2017 we have undertaken an inspection of Rivers House, Crossness to review and report on cracking to the internal walls of the main office building and the separate garage building at Rivers House.

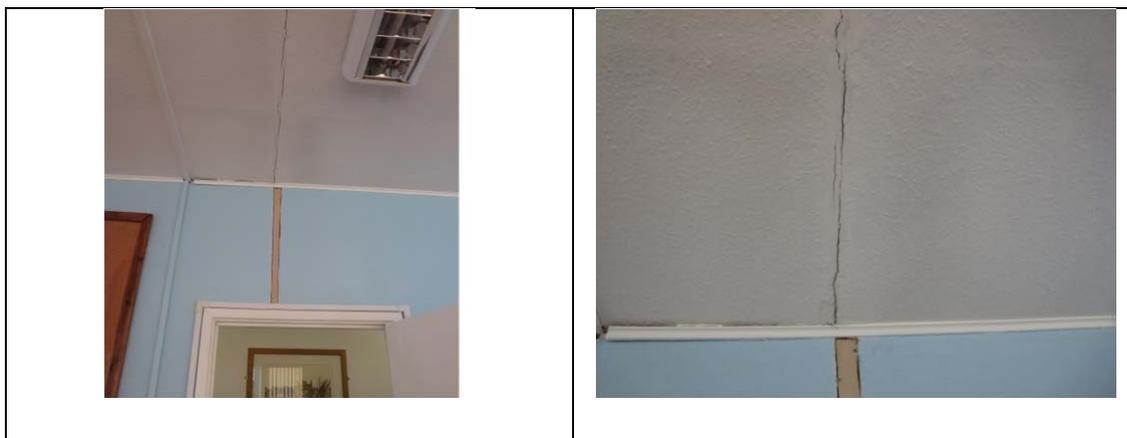
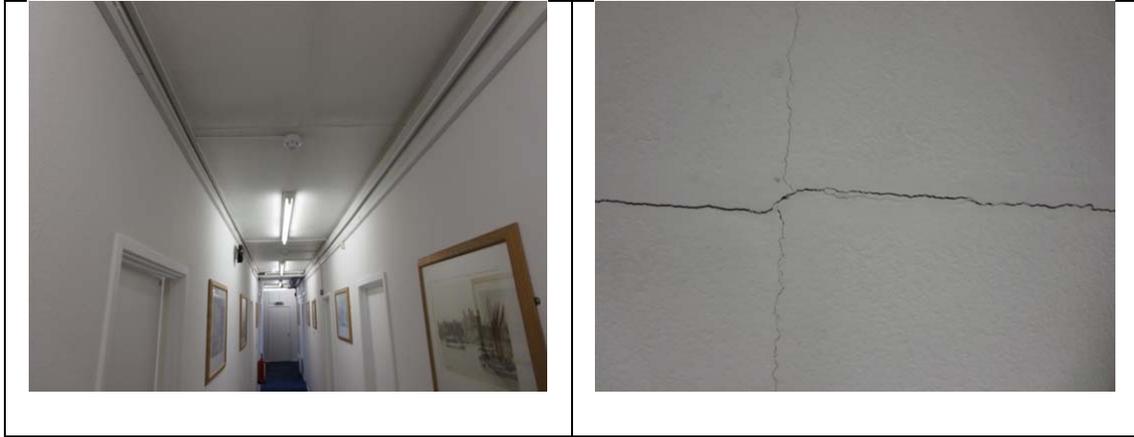
The main central corridor which runs north-south from the reception is formed with stud partitions and lined with plasterboard on either side. Regularly spaced at 1200mm centres along the corridor walls are c. 1mm vertical cracks to the internal walls which align with the c. 1mm horizontal cracks to the ceiling. The cracks align with similar cracking on the reverse side of the walls, within the adjacent rooms. The most significant crack is located around half way along the corridor and also spans across the internal and external walls within rooms C15 and C16. The rooms adjacent to the central corridor are showing the same cracking to both walls and ceilings.

The corridor walls have been redecorated within the past 12 months but the cracks have re-formed. We were advised by staff that the internal cracking to walls has been present to the same extent for the last nine years and that following each periodic redecoration the cracks shortly reappear. You have confirmed that your term maintenance contractor, Interserve, monitored the significant crack to C15 & C16 for circa 12 months from June 2014 and that no movement was identified during this period. We have located a small number of photographs taken during the 2008 refurbishment project and, although these photos do not show the entire building, the cracks they show appear not to have worsened relative to present day.

The regularity of the cracking, following the line of the plasterboard sheets, suggests that the timber frame to which they are fixed is able to move to a greater extent than the plasterboard joints are able to accommodate, with the resulting tension causing the cracking. This may be due to a lack of diagonal bracing to provide lateral stability, resulting in frequent but minor movement.

If redecorated, the joints between plasterboard sheets will re-open and the cracks re-form.

It is likely that the timber framed sections of the office building will continue to move to a minor degree due to thermal and moisture movements, sufficient to cause the internal plasterboard joints to continue to form following redecoration. We do not believe this to be of structural concern but if you wish to consider a permanent solution to prevent on-going cracking internally this would require opening up to allow a full structural review of the timber frame, the foundations and the connections to the adjacent cavity walled structures. This would allow remedial strengthening of the structure to be designed and installed. This would be costly and intrusive. Alternatively a movement joint could be introduced across the building although localised opening up would be required to determine how effective this would be.

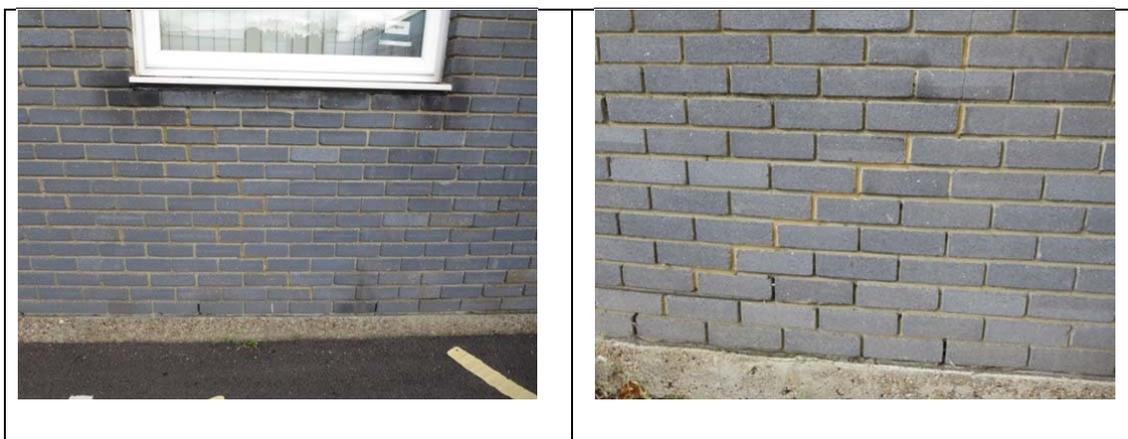
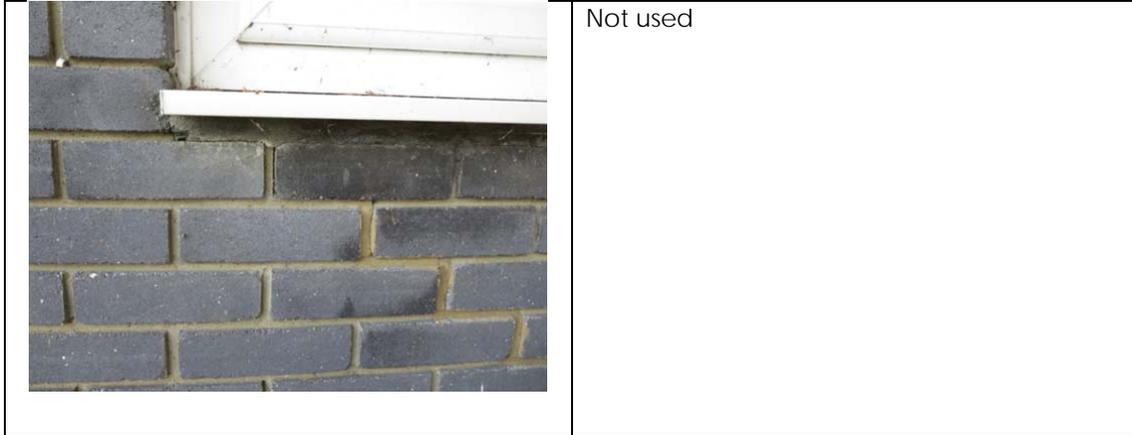
On the enclosed elevation drawing we have annotated the position of cracking within the external brickwork walls. These cracks are minor, less than 1mm wide, and it is evident that previous mortar repairs have been carried out in these areas.

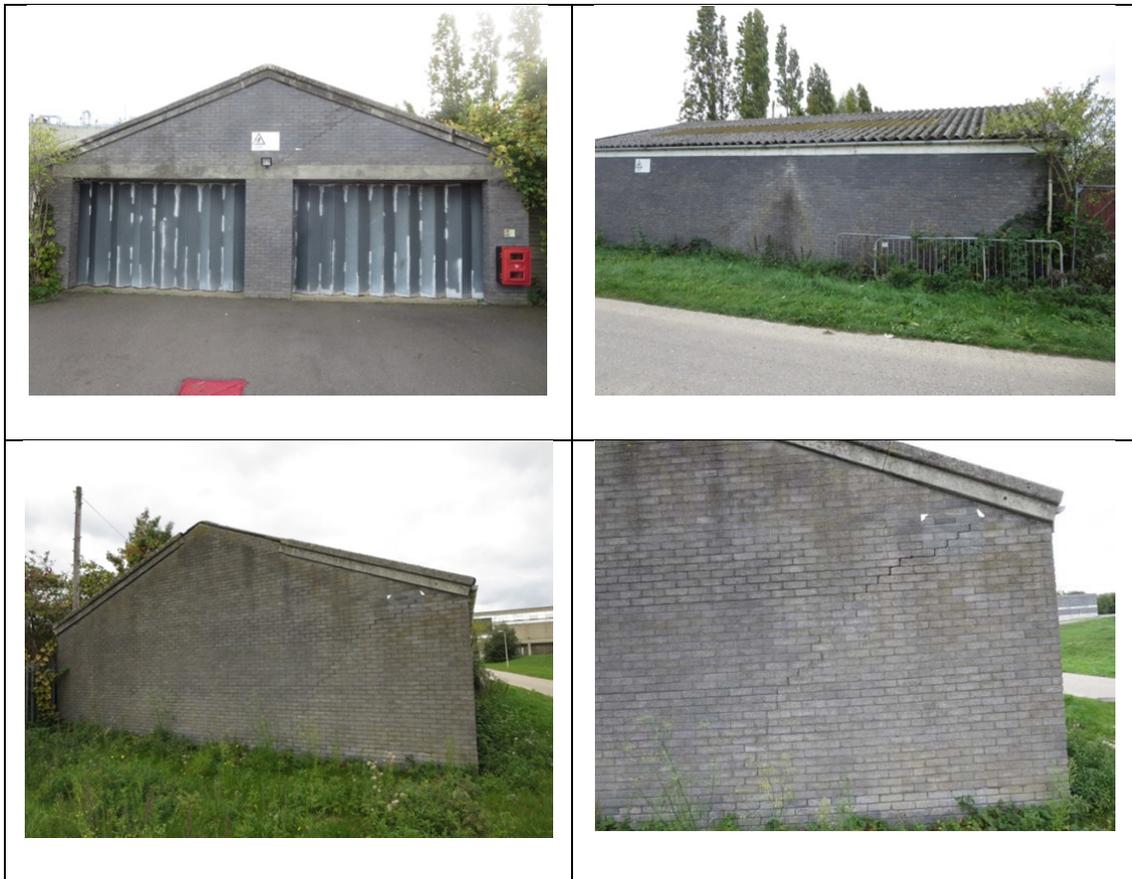
Please refer to the enclosed annotated photographs, which show the locations of internal cracks in yellow and external cracks in red.

To the front, left hand and rear elevation is diagonal cracking within the brickwork, with cracks wider at the top than the base, indicative of differential settlement or subsidence. It is likely the foundations were undersized for the soft ground conditions, however, there is no sign of progressive movement.

It would be prudent whilst the structural engineer is on site for them to inspect the garage building and report on the cracking / bowing to advise what remedial works are required. To allow thorough inspection, access will need to be arranged onto the land adjacent to the rear and side elevations of the garage.

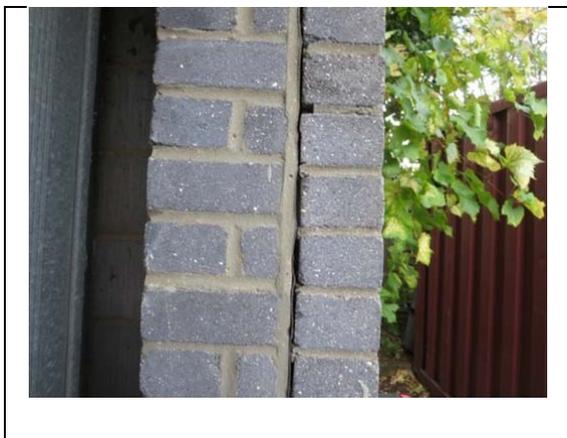
A half brick thick skin of brickwork has been on to the face of the right side of the front elevation to support the concrete lintel above the sliding doors. This outer skin is bowing outwards where it is not adequately tied back to the original brickwork.

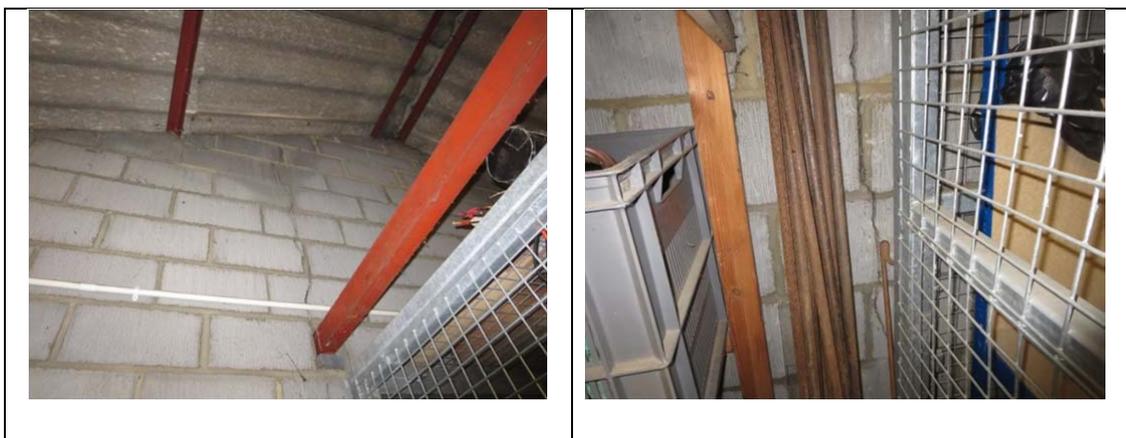
Internally the left and right flank walls have vertical cracking which appears to be caused by differential thermal movement where steelwork has been built directly into the wall with no allowance for movement and a lack of vertical movement joints.

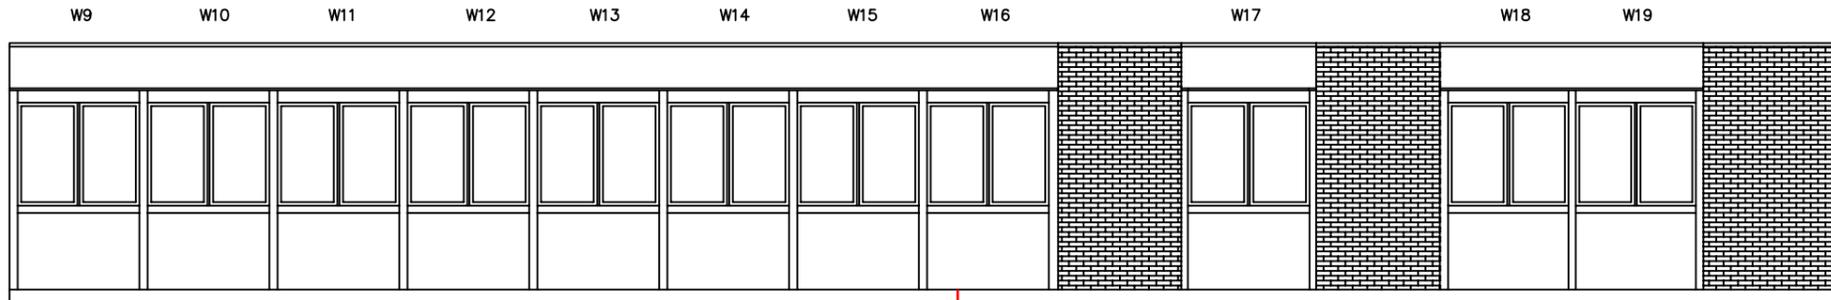
Elevation 3

10mm Crack through blockwork

We would recommend that a structural engineer is appointed to inspect the crack through the external low level block work to the rear elevation, adjacent to office C15 to advise upon its cause, significance and whether any repair works or periodic monitoring is required. Their investigation is likely to require localised lifting of carpet tiles and may require forming openings in the plasterboard wall linings to inspect the structure in the area. The structural inspection should therefore be coordinated with your maintenance contractor.
