Our Ref: 01C100699/NT11
Your Ref: Ref

15 September 2021

Roof Inspection – Rivers House, East Quay, Bridgwater

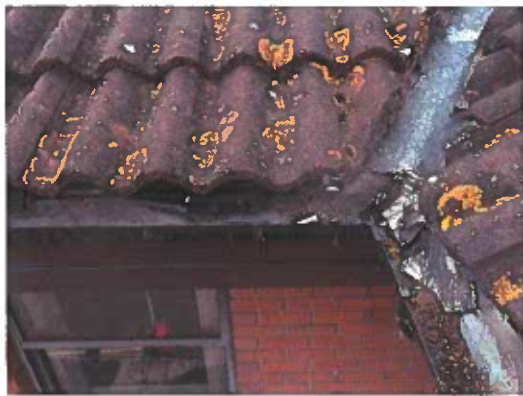
The valley gutters to the pitched roofs were all generally noted to be full of debris at high level due to bird infestation. The cement fillet to the roof tiles adjoining the valley gutters were also noted to be missing, cracked or defective in numerous locations. At times of heavy or prolonged

The drip detail, sarking felt to the underside of the roof tiles, has also degraded. Flashband repairs have been undertaken in locations.

| Photo No | Photograph Description | Photograph |
|---|--|--|
| 1. | Missing mortar pointing to edge of valley gutter and poor quality flash band repairs to pitched roof drip detail, valley over main entrance. | |

A package of works should also be considered to carefully lift the roof tiles either side of the valley gutters to ensure the existing valley linings are all correctly dressed and fixed. At the time of inspection we did not identify any significant defects with the valley lining material but consideration should be given to replace it as part of any remedial works. All tiles should then be replaced to the valley and repointing of all tiles adjoining the ridge be completed to prevent water ingress into the roof void.

The drip detail at the roof edge will also require remedial repairs and replacement in the medium to long term. This can be addressed by inserting a new drip detail below the bottom two courses of roof tiles and lapping below the existing sarking felt to ensure any water that does run down the felt, discharges into the rainwater gutter.

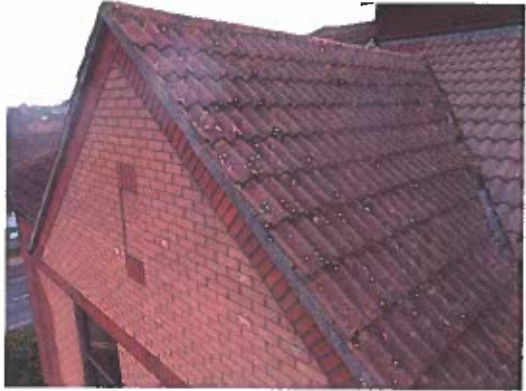
A section of concrete fillet to the verge detail over the main entrance was also noted to be cracked and loose at the time of inspection. Although this remained in position at the time of inspection this was noted as a Health and Safety risk and was highlighted with you while on site.

| Photo No | Photograph Description | Photograph |
|---|--|--|
| 2. | General view of debris to valley gutter. Cracked verge pointing evident to gable end over main entrance. | |

We consider remedial works are required in the short term in order to resolve the water ingress from the roof into Rivers House. We recommend the clearance of all debris from the valley gutters is undertaken immediately to enable rainwater to drain to the perimeter rainwater gutters and discharge accordingly and not back up causing water ingress. This could be done from a suitable access hoist in the first instance.

The section of cracked mortar to the gable over the main entrance should be removed and repointed to prevent the risk of falling material onto occupiers entering or leaving the building.

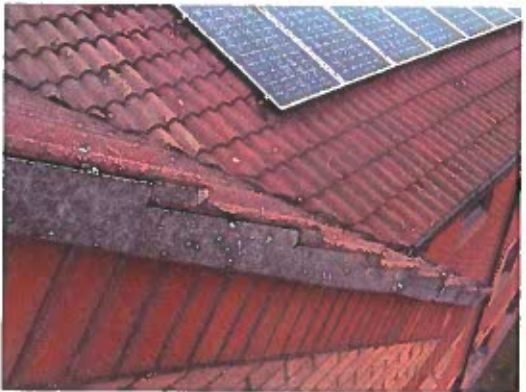
| Photo No | Photograph Description | Photograph |
|---|--|--|
| 3. | Cracked pointing to verge over main entrance that is loose and requires removal and re-pointing. | |

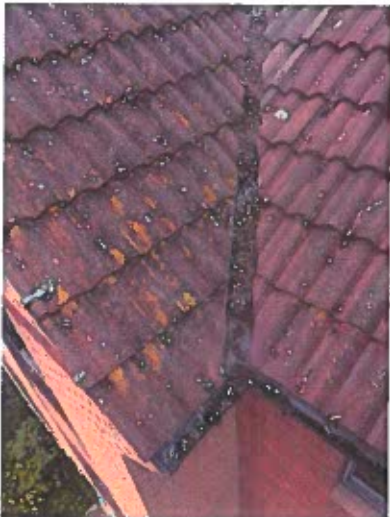
| Photo No | Photograph Description | Photograph |
|---|--|--|
| 4. | Typical example of build-up of debris to valley gutter over main entrance. | |

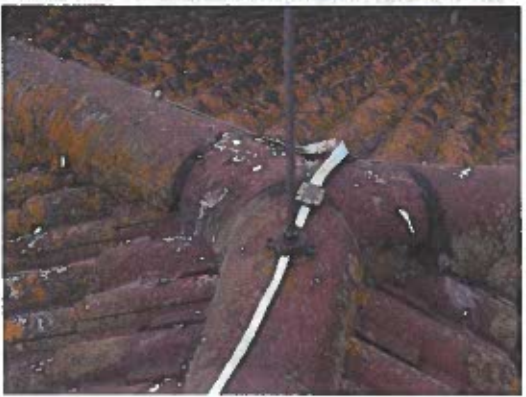
| Photo No | Photograph Description | Photograph |
|---|---|--|
| 5. | Typical example of lichen growth to roof with minor defective pointing to top of hip. | |

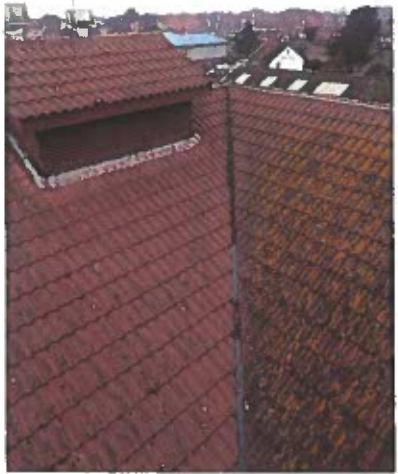
| Photo No | Photograph Description | Photograph |
|---|---|--|
| 6. | Typical example of debris to valley gutter at junction of Roof A and Roof B. | |

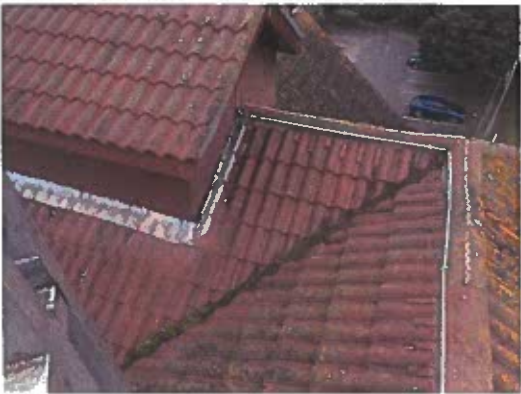
Isolated cracked or broken roof tiles were also noted to the roofs. Again, these should be replaced as part of any package of works undertaken.

| Photo No | Photograph Description | Photograph |
|---|---|--|
| 7. | Cracked tile adjacent to valley gutter on rear elevation. | |

The isolated cracked and broken roof tiles should also be considered for replacement as part of the package of works to undertake repairs to the valley gutters.

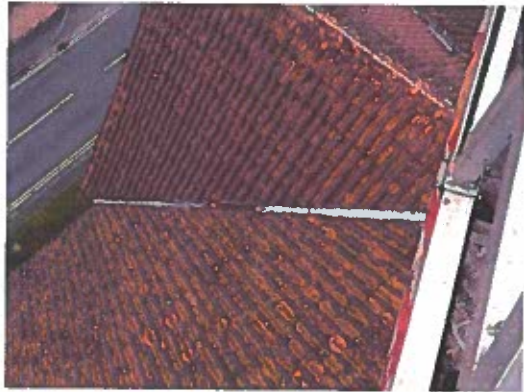
A slipped roof tile was also noted to the front elevation overlooking East Quay. This is also a potential H&S risk and should be addressed urgently.

| Photo No | Photograph Description | Photograph |
|---|---|--|
| 8. | Minor debris to valley gutter, East Quay elevation. Note slipped roof tile to bottom course of tiles, requires refixing. Valley gutter also appears to have received a coating. | |

The slipped roof tile to the front elevation should also be replaced in the short term to prevent this slipping and falling during inclement weather.

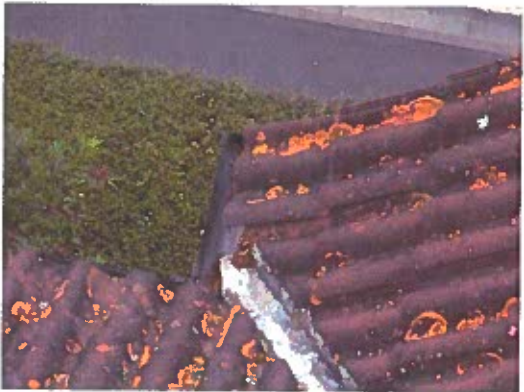
| Photo No | Photograph Description | Photograph |
|---|---|--|
| 9. | Slipped tile to East Quay elevation. | |

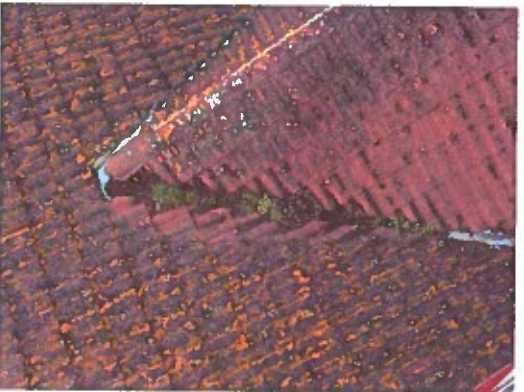
The valley gutter lining material was generally noted to be fair but becoming embrittled due to UV degradation. A coating has also been applied to the liner in some locations.

| Photo No | Photograph Description | Photograph |
|---|---|--|
| 10. | Blocked valley gutter to gable feature roof, East Quay elevation with a liquid coating evident to the valley gutter. | |

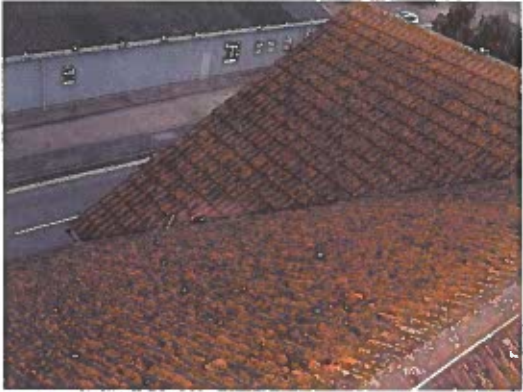
| Photo No | Photograph Description | Photograph |
|---|---|--|
| 11. | Debris build up within valley gutter to East Quay elevation. Lichen growth evident across the roof. | |

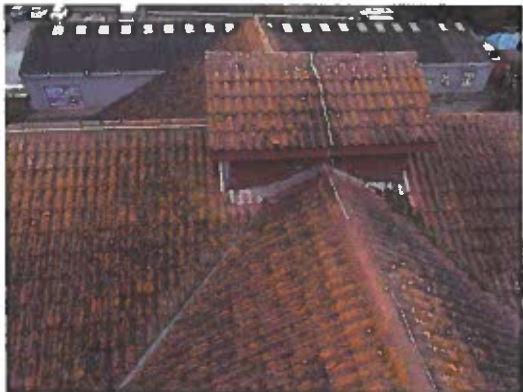
| Photo No | Photograph Description | Photograph |
|---|---|--|
| 12. | Cracked and missing pointing to valley gutter. Poor quality application of mastic sealant to areas of defective pointing. | |

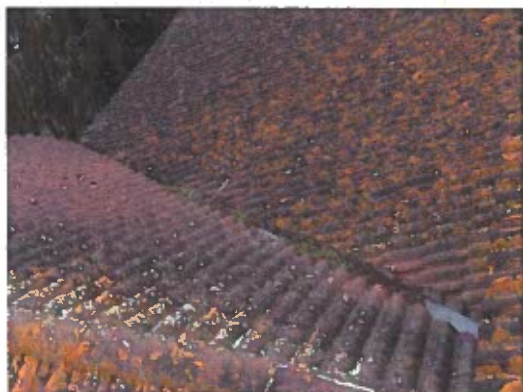
| Photo No | Photograph Description | Photograph |
|---|---|--|
| 13. | Build-up of debris to valley gutter. | |

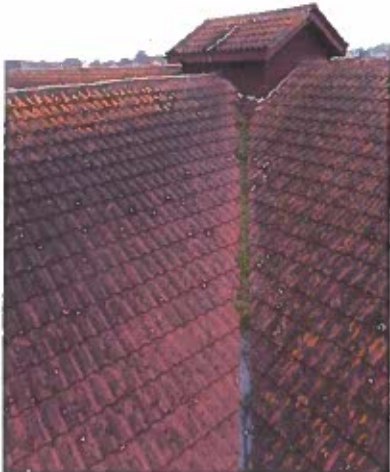
| Photo No | Photograph Description | Photograph |
|---|---|--|
| 14. | Build-up of debris to valley gutter at high level to junction of Roof B and C. | |

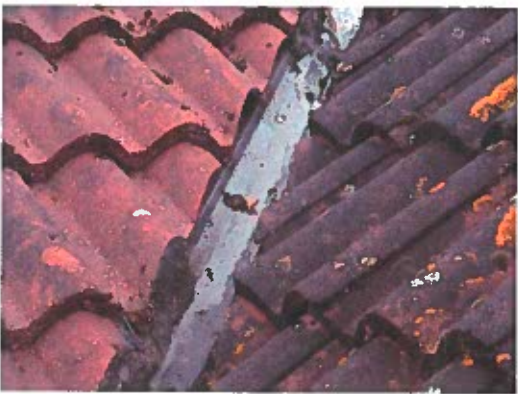
| Photo No | Photograph Description | Photograph |
|---|---|--|
| 15. | Defective pointing to junction of valley gutter and roof tiles. | |

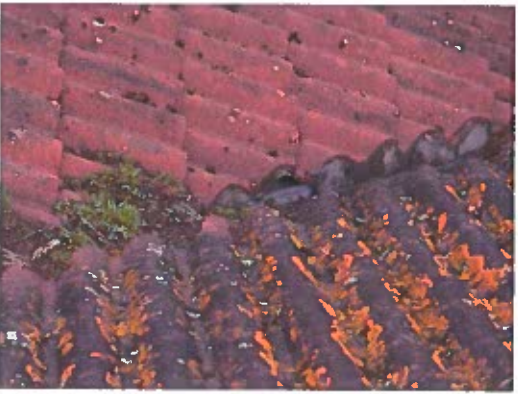
| Photo No | Photograph Description | Photograph |
|---|---|--|
| 16. | Blocked valley gutter and missing pointing to edge of tile at junction of Roof B and C. | |

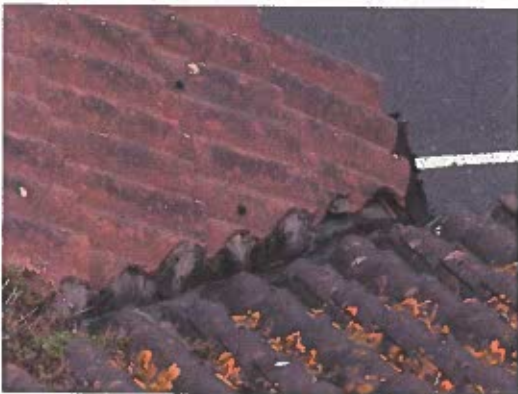
| Photo No | Photograph Description | Photograph |
|---|--|---|
| 17. | Missing pointing to edge of tiles to valley gutter, East Quay elevation. | |

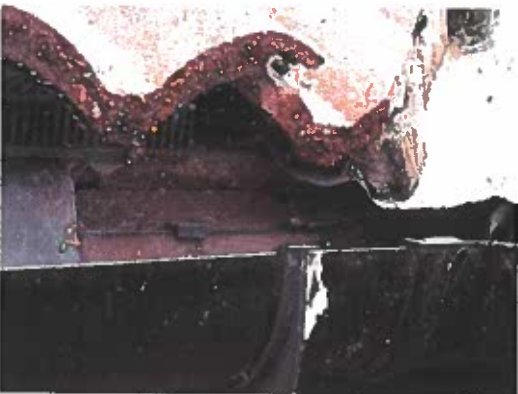
| Photo No | Photograph Description | Photograph |
|---|--|---|
| 18. | Missing drip detail to edge of Roof C. | |
