Asbestos Survey Report

Refurbishment Survey

**Shrub End Clinic
Iceni Way
Colchester
CO2 9BY**

Project Number: B-68575
Issue Date: 8TH August 2017
Issue No: 1

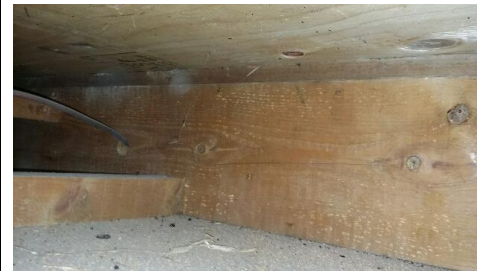
Surveyor		Ricky Gray		Room / Area		001 - Ceiling & Ceiling Void	
Survey Date		29 July 2017		Level of Identification		Inspected Area	
Next Inspection				Sample No			
Building		Shrub End Clinic		Item		Ceiling Void	
Floor		0		Amount			
A - Product Type		B - Extent of Damage		C - Surface Treatment		D - Asbestos Type	
No Suspect Materials Seen		0		0		No Asbestos Detected	
Material Ass' Score = (A+B+C+D):		0		Risk Coding		Recommendation: No Recommendation Required	
Further Information: Area visually inspected. No suspect materials seen. No suspect items found above fibreboard ceiling tiles.

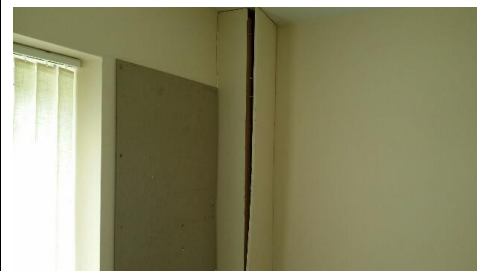
Surveyor		Ricky Gray		Room / Area		003 - Office	
Survey Date		29 July 2017		Level of Identification		Inspected Area	
Next Inspection				Sample No			
Building		Shrub End Clinic		Item		Boxing	
Floor		0		Amount			
A - Product Type		B - Extent of Damage		C - Surface Treatment		D - Asbestos Type	
No Suspect Materials Seen		0		0		No Asbestos Detected	
Material Ass' Score = (A+B+C+D):		0		Risk Coding		Recommendation: No Recommendation Required	
Further Information: Area visually inspected. No suspect materials seen.

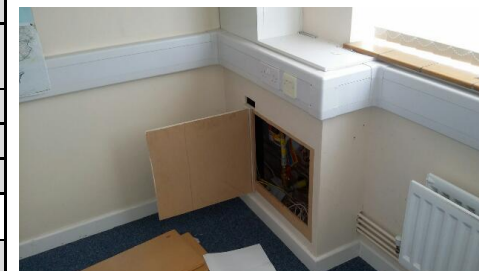
Surveyor		Ricky Gray		Room / Area		005 - Office		
Survey Date		29 July 2017		Level of Identification		Inspected Area		
Next Inspection				Sample No				
Building		Shrub End Clinic		Item		Boxing		
Floor		0		Amount				
A - Product Type		B - Extent of Damage		C - Surface Treatment		D - Asbestos Type		Accessibility
No Suspect Materials Seen	0				0	No Asbestos Detected		
Material Ass' Score = (A+B+C+D):		0		Risk Coding		Recommendation: No Recommendation Required		
Further Information: Area visually inspected. No suspect materials seen.

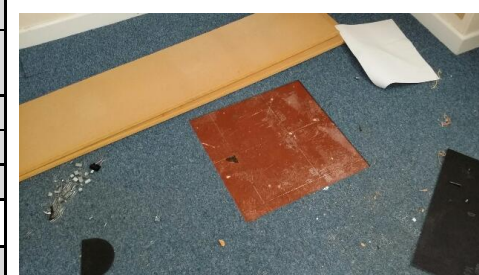
Surveyor		Ricky Gray		Room / Area		005 - Office		
Survey Date		29 July 2017		Level of Identification		Sampled		
Next Inspection		29 July 2018		Sample No		0001		
Building		Shrub End Clinic		Item		Floor Tile & Adhesive		
Floor		0		Amount		4m²		
A - Product Type		B - Extent of Damage		C - Surface Treatment		D - Asbestos Type		Accessibility
Reinforced Composites	1	Low Damage	1	Composite materials containing asbestos, plastics, resins etc.	0	Chrysotile	1	Occasional Disturbance
Material Ass' Score = (A+B+C+D):		3		Risk Coding		Recommendation: Remove by Approved Asbestos Contractor		
Further Information: Both floor tile and adhesive contain asbestos. Brown floor tiles and bitumen adhesive below carpet tiles.

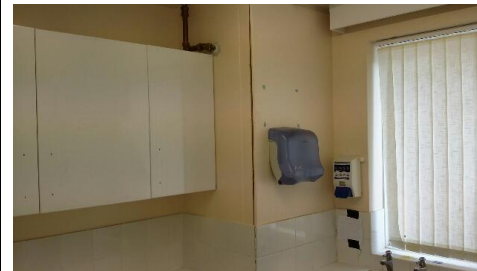
Surveyor		Ricky Gray		Room / Area		006 - Kitchen	
Survey Date		29 July 2017		Level of Identification		Inspected Area	
Next Inspection				Sample No			
Building		Shrub End Clinic		Item		Boxing	
Floor		0		Amount			
A - Product Type		B - Extent of Damage		C – Surface Treatment		D – Asbestos Type	
No Suspect Materials Seen		0		0		No Asbestos Detected	
Material Ass' Score = (A+B+C+D):		0		Risk Coding		Recommendation: No Recommendation Required	
Further Information: Area visually inspected. No suspect materials seen.

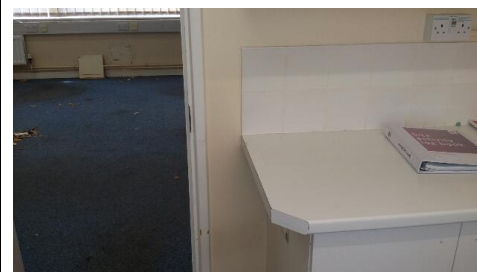
Surveyor		Ricky Gray		Room / Area		006 - Kitchen	
Survey Date		29 July 2017		Level of Identification		Inspected Area	
Next Inspection				Sample No			
Building		Shrub End Clinic		Item		Partition Wall	
Floor		0		Amount			
A - Product Type		B - Extent of Damage		C – Surface Treatment		D – Asbestos Type	
No Suspect Materials Seen		0		0		No Asbestos Detected	
Material Ass' Score = (A+B+C+D):		0		Risk Coding		Recommendation: No Recommendation Required	
Further Information: Area visually inspected. No suspect materials seen.

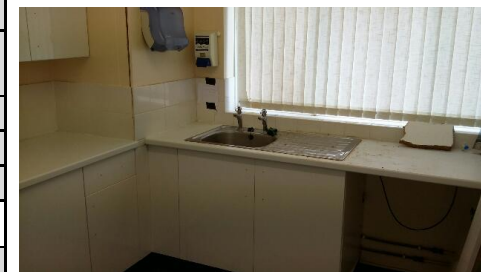
Surveyor	Ricky Gray	Room / Area	006 - Kitchen	
Survey Date	29 July 2017	Level of Identification	Sampled	
Next Inspection		Sample No	0002	
Building	Shrub End Clinic	Item	Sink Pad	
Floor	0	Amount		
A - Product Type	B - Extent of Damage	C - Surface Treatment	D - Asbestos Type	Accessibility
Bitumen Products			No Asbestos Detected	0
Material Ass' Score = (A+B+C+D):	0	Risk Coding	Recommendation: No recommendation required	
Further Information:

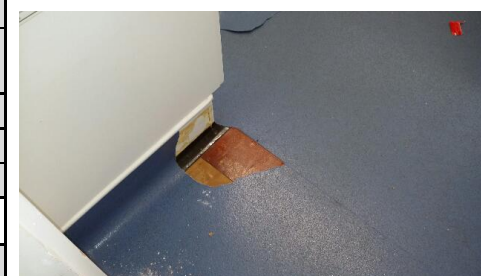
Surveyor	Ricky Gray	Room / Area	006 - Kitchen					
Survey Date	29 July 2017	Level of Identification	Strong Presumed (X)					
Next Inspection	29 July 2018	Sample No	As 0001					
Building	Shrub End Clinic	Item	Floor Tile & Adhesive					
Floor	0	Amount	8m²					
A - Product Type	B - Extent of Damage	C - Surface Treatment	D - Asbestos Type	Accessibility				
Reinforced Composites	1	Low Damage	1	Composite materials containing asbestos, plastics, resins etc.	0	Chrysotile	1	Occasional Disturbance
Material Ass' Score = (A+B+C+D):	3	Risk Coding	Very Low	Recommendation: Remove by Approved Asbestos Contractor				
Further Information:		Visually consistent with sample number 0001. Brown and Beige (Sample 4) floor tiles and bitumen adhesive below modern vinyl flooring.

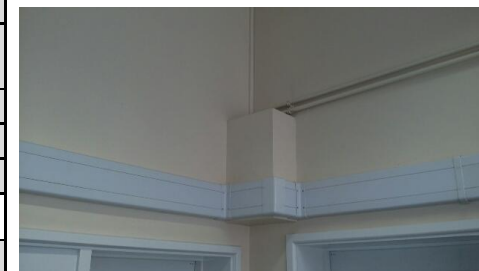
Surveyor		Ricky Gray		Room / Area		007 - Hall	
Survey Date		29 July 2017		Level of Identification		Inspected Area	
Next Inspection				Sample No			
Building		Shrub End Clinic		Item		Boxing	
Floor		0		Amount			
A - Product Type		B - Extent of Damage		C - Surface Treatment		D - Asbestos Type	
No Suspect Materials Seen		0		0		No Asbestos Detected	
Material Ass' Score = (A+B+C+D):		0		Risk Coding		Recommendation: No Recommendation Required	
Further Information: Area visually inspected. No suspect materials seen.

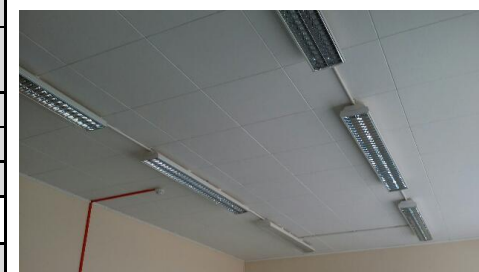
Surveyor		Ricky Gray		Room / Area		007 - Hall	
Survey Date		29 July 2017		Level of Identification		Presumed	
Next Inspection		29 July 2018		Sample No			
Building		Shrub End Clinic		Item		No Access - Ceiling Void	
Floor		0		Amount			
A - Product Type		B - Extent of Damage		C - Surface Treatment		D - Asbestos Type	
Unspecified Material						Presumed Asbestos	
Material Ass' Score = (A+B+C+D):		12		Risk Coding		Recommendation: No Access – Inspection Required Presumed Asbestos is scored 12 (worst case) until sampled/inspected	
Further Information: No access beyond high level fibreboard ceiling tiles. The ceiling tiles were inspected from ladders however unable to inspect beyond at this height. Inspection required.

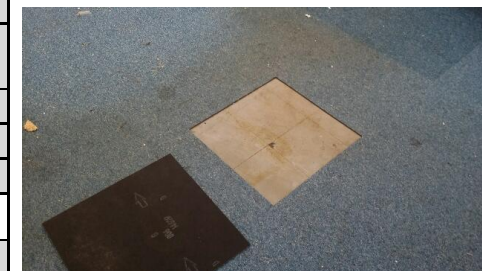
Surveyor		Ricky Gray		Room / Area		007 - Hall	
Survey Date		29 July 2017		Level of Identification		Sampled	
Next Inspection		29 July 2018		Sample No		0003	
Building		Shrub End Clinic		Item		Floor Tile & Adhesive	
Floor		0		Amount		40m ²	
A - Product Type		B - Extent of Damage		C - Surface Treatment		D - Asbestos Type	
Reinforced Composites	1	Low Damage	1	Composite materials containing asbestos, plastics, resins etc.	0	Chrysotile	1
Material Ass' Score = (A+B+C+D):		3		Risk Coding	Very Low	Recommendation: Remove by Approved Asbestos Contractor	
Further Information:		Both floor tile and adhesive contain asbestos. Grey floor tiles and bitumen adhesive below carpet tiles.

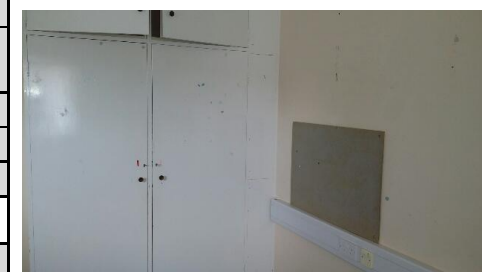
Surveyor		Ricky Gray		Room / Area		008 - Office	
Survey Date		29 July 2017		Level of Identification		Inspected Area	
Next Inspection				Sample No			
Building		Shrub End Clinic		Item		Boxing	
Floor		0		Amount			
A - Product Type		B - Extent of Damage		C - Surface Treatment		D - Asbestos Type	
No Suspect Materials Seen	0				0	No Asbestos Detected	
Material Ass' Score = (A+B+C+D):		0		Risk Coding		Recommendation: No Recommendation Required	
Further Information:		Area visually inspected. No suspect materials seen.

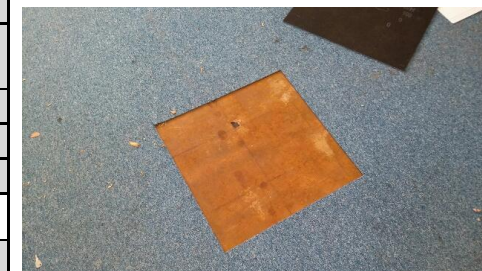
Surveyor		Ricky Gray		Room / Area		008 - Office	
Survey Date		29 July 2017		Level of Identification		Sampled	
Next Inspection		29 July 2018		Sample No		0004	
Building		Shrub End Clinic		Item		Floor Tile & Adhesive	
Floor		0		Amount		20m ²	
A - Product Type		B - Extent of Damage		C – Surface Treatment		D – Asbestos Type	
Reinforced Composites	1	Low Damage	1	Composite materials containing asbestos, plastics, resins etc.	0	Chrysotile	1
Material Ass' Score = (A+B+C+D):		3		Risk Coding	Very Low	Recommendation: Remove by Approved Asbestos Contractor	
Further Information:		Both floor tile and adhesive contain asbestos. Beige floor tiles and bitumen adhesive below carpet tiles.

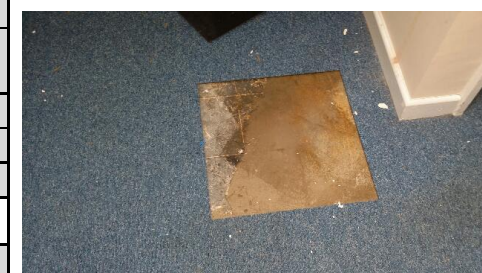
Surveyor		Ricky Gray		Room / Area		009 - Office	
Survey Date		29 July 2017		Level of Identification		Sampled	
Next Inspection		29 July 2018		Sample No		0005	
Building		Shrub End Clinic		Item		Floor Tile & Adhesive	
Floor		0		Amount		10m ²	
A - Product Type		B - Extent of Damage		C – Surface Treatment		D – Asbestos Type	
Reinforced Composites	1	Low Damage	1	Composite materials containing asbestos, plastics, resins etc.	0	Chrysotile	1
Material Ass' Score = (A+B+C+D):		3		Risk Coding	Very Low	Recommendation: Remove by Approved Asbestos Contractor	
Further Information:		Both floor tile and adhesive contain asbestos. Black floor tiles and bitumen adhesive below carpet tiles.

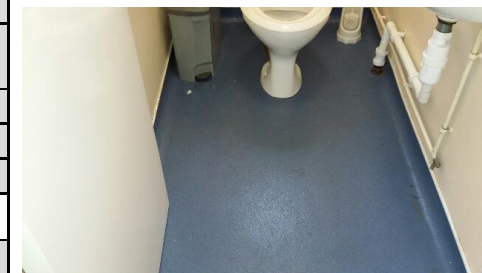
Surveyor		Ricky Gray		Room / Area		010 - Wc	
Survey Date		29 July 2017		Level of Identification		Strong Presumed (X)	
Next Inspection		29 July 2018		Sample No		As 0005	
Building		Shrub End Clinic		Item		Floor Tile & Adhesive	
Floor		0		Amount		2m ²	
A - Product Type		B - Extent of Damage		C - Surface Treatment		D - Asbestos Type	
Reinforced Composites	1	Low Damage	1	Composite materials containing asbestos, plastics, resins etc.	0	Chrysotile	1
Material Ass' Score = (A+B+C+D):		3		Risk Coding	Very Low	Recommendation: Remove by Approved Asbestos Contractor	
Further Information:		Visually consistent with sample number 0005. Black floor tiles and bitumen adhesive below modern vinyl flooring.

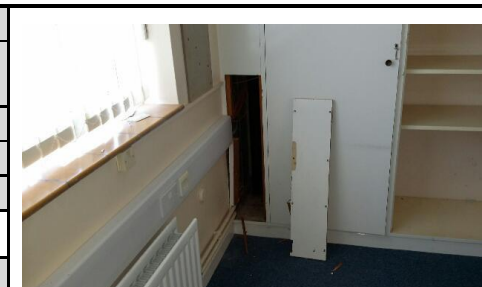
Surveyor		Ricky Gray		Room / Area		011 - Office	
Survey Date		29 July 2017		Level of Identification		Inspected Area	
Next Inspection				Sample No			
Building		Shrub End Clinic		Item		Boxing	
Floor		0		Amount			
A - Product Type		B - Extent of Damage		C - Surface Treatment		D - Asbestos Type	
No Suspect Materials Seen	0				0	No Asbestos Detected	
Material Ass' Score = (A+B+C+D):		0		Risk Coding		Recommendation: No Recommendation Required	
Further Information:		Area visually inspected. No suspect materials seen.

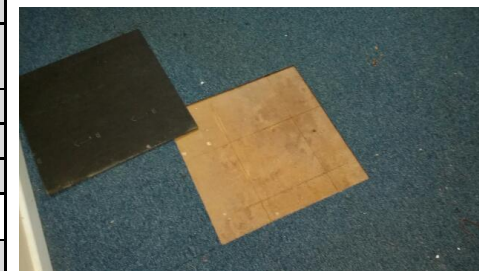
Surveyor		Ricky Gray		Room / Area		011 - Office		
Survey Date		29 July 2017		Level of Identification		Strong Presumed (X)		
Next Inspection		29 July 2018		Sample No		As 0004		
Building		Shrub End Clinic		Item		Floor Tile & Adhesive		
Floor		0		Amount		16m ²		
A - Product Type		B - Extent of Damage		C – Surface Treatment		D – Asbestos Type		Accessibility
Reinforced Composites	1	Low Damage	1	Composite materials containing asbestos, plastics, resins etc.	0	Chrysotile	1	Occasional Disturbance
Material Ass' Score = (A+B+C+D):		3		Risk Coding	Very Low	Recommendation: Remove by Approved Asbestos Contractor		
Further Information:		Visually consistent with sample number 0004. Beige floor tiles and bitumen adhesive below carpet tiles.

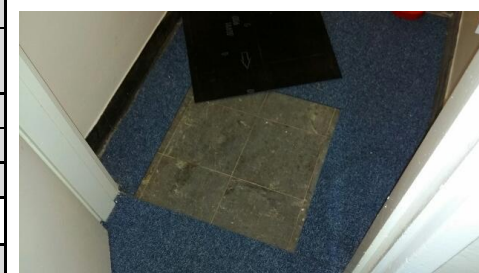
Surveyor		Ricky Gray		Room / Area		012 - Cupboard		
Survey Date		29 July 2017		Level of Identification		Strong Presumed (X)		
Next Inspection		29 July 2018		Sample No		As 0005		
Building		Shrub End Clinic		Item		Floor Tile & Adhesive		
Floor		0		Amount		1m ²		
A - Product Type		B - Extent of Damage		C – Surface Treatment		D – Asbestos Type		Accessibility
Reinforced Composites	1	Low Damage	1	Composite materials containing asbestos, plastics, resins etc.	0	Chrysotile	1	Occasional Disturbance
Material Ass' Score = (A+B+C+D):		3		Risk Coding	Very Low	Recommendation: Remove by Approved Asbestos Contractor		
Further Information:		Visually consistent with sample number 0005. Black floor tiles and bitumen adhesive below carpet tiles.

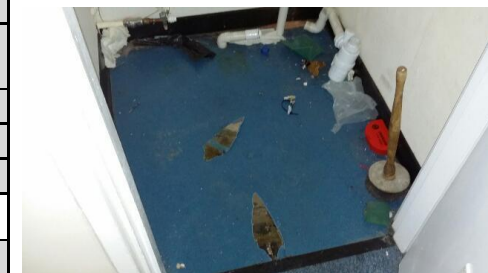
Surveyor		Ricky Gray		Room / Area		013 - Cupboard		
Survey Date		29 July 2017		Level of Identification		Sampled		
Next Inspection		29 July 2018		Sample No		0006		
Building		Shrub End Clinic		Item		Floor Adhesive		
Floor		0		Amount		1m ²		
A - Product Type		B - Extent of Damage		C - Surface Treatment		D - Asbestos Type		Accessibility
Bitumen Products	1	Low Damage	1	Composite materials containing asbestos, plastics, resins etc.	0	Chrysotile	1	Occasional Disturbance
Material Ass' Score = (A+B+C+D):		3		Risk Coding	Very Low	Recommendation: Remove by Approved Asbestos Contractor		
Further Information: Bitumen adhesive beneath modern vinyl flooring.

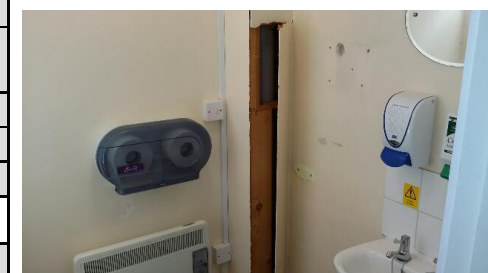
Surveyor		Ricky Gray		Room / Area		014 - Wc		
Survey Date		29 July 2017		Level of Identification		Inspected Area		
Next Inspection				Sample No				
Building		Shrub End Clinic		Item		Boxing		
Floor		0		Amount				
A - Product Type		B - Extent of Damage		C - Surface Treatment		D - Asbestos Type		Accessibility
No Suspect Materials Seen	0				0	No Asbestos Detected		
Material Ass' Score = (A+B+C+D):		0		Risk Coding		Recommendation: No Recommendation Required		
Further Information: Area visually inspected. No suspect materials seen.

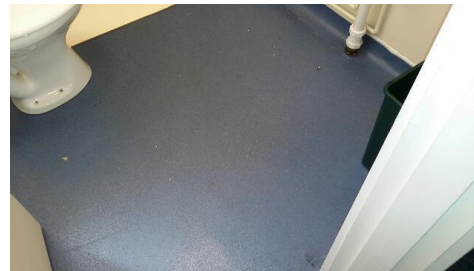
Surveyor		Ricky Gray		Room / Area		014 - Wc	
Survey Date		29 July 2017		Level of Identification		Strong Presumed (X)	
Next Inspection		29 July 2018		Sample No		As 0005	
Building		Shrub End Clinic		Item		Floor Tile & Adhesive	
Floor		0		Amount		4m ²	
A - Product Type		B - Extent of Damage		C – Surface Treatment		D – Asbestos Type	
Reinforced Composites	1	Low Damage	1	Composite materials containing asbestos, plastics, resins etc.	0	Chrysotile	1
Material Ass' Score = (A+B+C+D):		3		Risk Coding	Very Low	Recommendation: Remove by Approved Asbestos Contractor	
Further Information:		Visually consistent with sample number 0005. Black floor tiles and bitumen adhesive below modern vinyl.

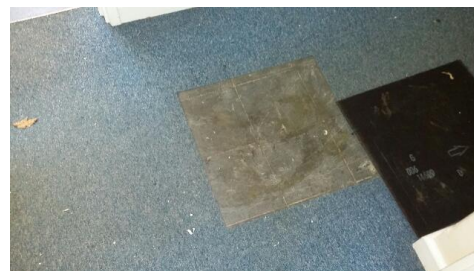
Surveyor		Ricky Gray		Room / Area		015 - Corridor	
Survey Date		29 July 2017		Level of Identification		Strong Presumed (X)	
Next Inspection		29 July 2018		Sample No		As 0005	
Building		Shrub End Clinic		Item		Floor Tile & Adhesive	
Floor		0		Amount		4m ²	
A - Product Type		B - Extent of Damage		C – Surface Treatment		D – Asbestos Type	
Reinforced Composites	1	Low Damage	1	Composite materials containing asbestos, plastics, resins etc.	0	Chrysotile	1
Material Ass' Score = (A+B+C+D):		3		Risk Coding	Very Low	Recommendation: Remove by Approved Asbestos Contractor	
Further Information:		Visually consistent with sample number 0005. Black floor tiles and bitumen adhesive below carpet tiles.

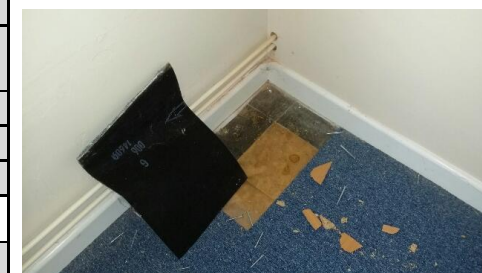
Surveyor		Ricky Gray		Room / Area		016 - Office	
Survey Date		29 July 2017		Level of Identification		Strong Presumed (X)	
Next Inspection		29 July 2018		Sample No		As 0005	
Building		Shrub End Clinic		Item		Floor Tile & Adhesive	
Floor		0		Amount		16m ²	
A - Product Type		B - Extent of Damage		C - Surface Treatment		D - Asbestos Type	
Reinforced Composites	1	Low Damage	1	Composite materials containing asbestos, plastics, resins etc.	0	Chrysotile	1
Material Ass' Score = (A+B+C+D):		3		Risk Coding	Very Low	Recommendation: Remove by Approved Asbestos Contractor	
Further Information:		Visually consistent with sample number 0005. Black and Beige (Sample 4) floor tiles and bitumen adhesive below carpet tiles.

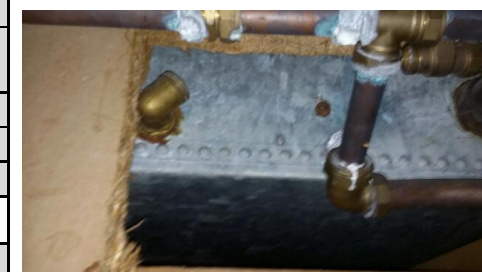
Surveyor		Ricky Gray		Room / Area		017 - Water Tank Void	
Survey Date		29 July 2017		Level of Identification		Inspected Area	
Next Inspection				Sample No			
Building		Shrub End Clinic		Item		Void	
Floor		0		Amount			
A - Product Type		B - Extent of Damage		C - Surface Treatment		D - Asbestos Type	
No Suspect Materials Seen	0				0	No Asbestos Detected	
Material Ass' Score = (A+B+C+D):		0		Risk Coding		Recommendation: No Recommendation Required	
Further Information:		Area visually inspected. No suspect materials seen.

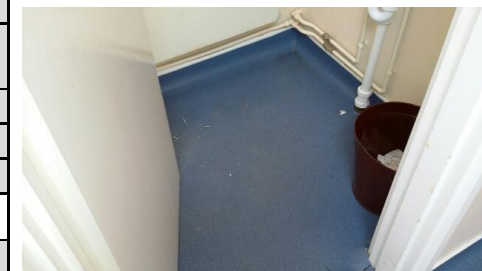
Surveyor		Ricky Gray		Room / Area		018 - Wc		
Survey Date		29 July 2017		Level of Identification		Strong Presumed (X)		
Next Inspection		29 July 2018		Sample No		As 0001		
Building		Shrub End Clinic		Item		Floor Tile & Adhesive		
Floor		0		Amount		2m ²		
A - Product Type		B - Extent of Damage		C – Surface Treatment		D – Asbestos Type		Accessibility
Reinforced Composites	1	Low Damage	1	Composite materials containing asbestos, plastics, resins etc.	0	Chrysotile	1	Occasional Disturbance
Material Ass' Score = (A+B+C+D):		3		Risk Coding	Very Low	Recommendation: Remove by Approved Asbestos Contractor		
Further Information:		Visually consistent with sample number 0001. Brown floor tiles and bitumen adhesive below modern vinyl flooring.

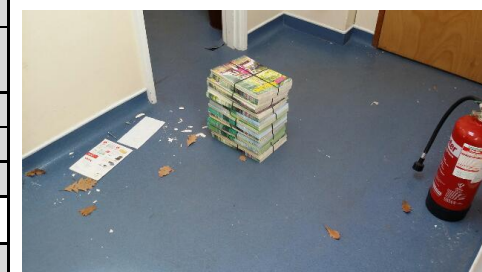
Surveyor		Ricky Gray		Room / Area		019 - Lobby		
Survey Date		29 July 2017		Level of Identification		Strong Presumed (X)		
Next Inspection		29 July 2018		Sample No		As 0005		
Building		Shrub End Clinic		Item		Floor Tile & Adhesive		
Floor		0		Amount		6m ²		
A - Product Type		B - Extent of Damage		C – Surface Treatment		D – Asbestos Type		Accessibility
Reinforced Composites	1	Low Damage	1	Composite materials containing asbestos, plastics, resins etc.	0	Chrysotile	1	Occasional Disturbance
Material Ass' Score = (A+B+C+D):		3		Risk Coding	Very Low	Recommendation: Remove by Approved Asbestos Contractor		
Further Information:		Visually consistent with sample number 0005. Black floor tiles and bitumen adhesive below modern vinyl.

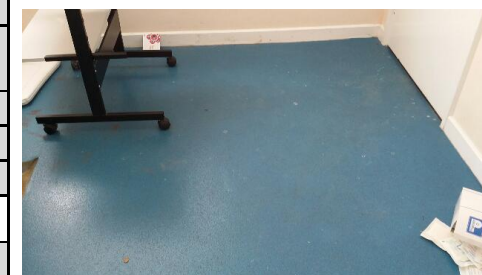
Surveyor		Ricky Gray		Room / Area		020 - Treatment Room		
Survey Date		29 July 2017		Level of Identification		Strong Presumed (X)		
Next Inspection		29 July 2018		Sample No		As 0004		
Building		Shrub End Clinic		Item		Floor Tile & Adhesive		
Floor		0		Amount		9m ²		
A - Product Type		B - Extent of Damage		C - Surface Treatment		D - Asbestos Type		Accessibility
Reinforced Composites	1	Low Damage	1	Composite materials containing asbestos, plastics, resins etc.	0	Chrysotile	1	Occasional Disturbance
Material Ass' Score = (A+B+C+D):		3		Risk Coding	Very Low	Recommendation: Remove by Approved Asbestos Contractor		
Further Information:		Visually consistent with sample number 0004. Beige floor tiles and bitumen adhesive below modern vinyl flooring.

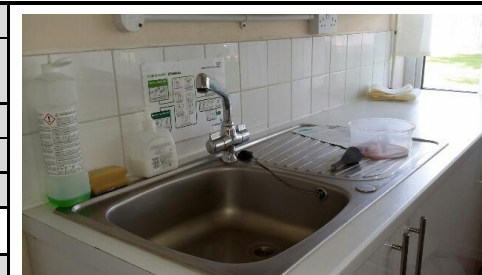
Surveyor		Ricky Gray		Room / Area		021 - Staff Room		
Survey Date		29 July 2017		Level of Identification		Strong Presumed (X)		
Next Inspection				Sample No		As 0002		
Building		Shrub End Clinic		Item		Sink Pad		
Floor		0		Amount				
A - Product Type		B - Extent of Damage		C - Surface Treatment		D - Asbestos Type		Accessibility
Bitumen Products						No Asbestos Detected	0	
Material Ass' Score = (A+B+C+D):		0		Risk Coding		Recommendation: No recommendation required		
Further Information:		Visually consistent with sample number 0002.

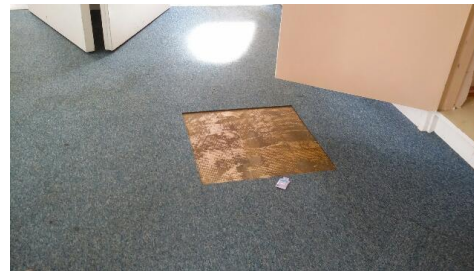
Surveyor		Ricky Gray		Room / Area		021 - Staff Room	
Survey Date		29 July 2017		Level of Identification		Strong Presumed (X)	
Next Inspection		29 July 2018		Sample No		As 0004	
Building		Shrub End Clinic		Item		Floor Tile & Adhesive	
Floor		0		Amount		25m ²	
A - Product Type		B - Extent of Damage		C – Surface Treatment		D – Asbestos Type	
Reinforced Composites	1	Low Damage	1	Composite materials containing asbestos, plastics, resins etc.	0	Chrysotile	1
Material Ass' Score = (A+B+C+D):		3		Risk Coding	Very Low	Recommendation: Remove by Approved Asbestos Contractor	
Further Information:		Visually consistent with sample number 0004. Beige floor tiles and bitumen adhesive below carpet tiles.

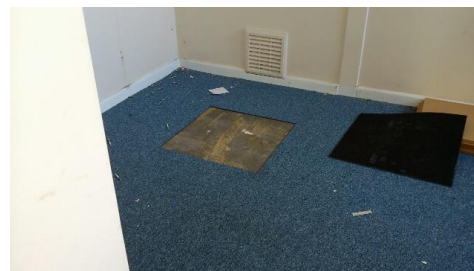
Surveyor		Ricky Gray		Room / Area		022 - Office	
Survey Date		29 July 2017		Level of Identification		Strong Presumed (X)	
Next Inspection		29 July 2018		Sample No		As 0004	
Building		Shrub End Clinic		Item		Floor Tile & Adhesive	
Floor		0		Amount		10m ²	
A - Product Type		B - Extent of Damage		C – Surface Treatment		D – Asbestos Type	
Reinforced Composites	1	Low Damage	1	Composite materials containing asbestos, plastics, resins etc.	0	Chrysotile	1
Material Ass' Score = (A+B+C+D):		3		Risk Coding	Very Low	Recommendation: Remove by Approved Asbestos Contractor	
Further Information:		Visually consistent with sample number 0004. Beige floor tiles and bitumen adhesive below carpet tiles.

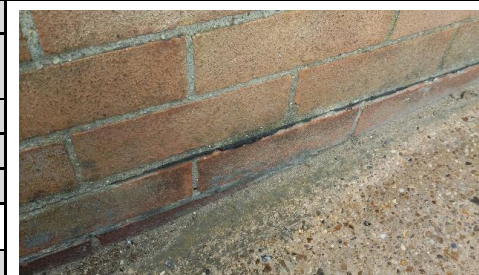
Surveyor		Ricky Gray		Room / Area		023 - External	
Survey Date		29 July 2017		Level of Identification		Sampled	
Next Inspection				Sample No		0007	
Building		Shrub End Clinic		Item		Damp Proof Course	
Floor		External		Amount			
A - Product Type		B - Extent of Damage		C – Surface Treatment		D – Asbestos Type	
Bitumen Products						Accessibility	
						No Asbestos Detected	
Material Ass' Score = (A+B+C+D):		0		Risk Coding		Recommendation: No recommendation required	
Further Information:
