Specification for the Maintenance of the Counterweights on the Chilbolton Observatory 25m antenna

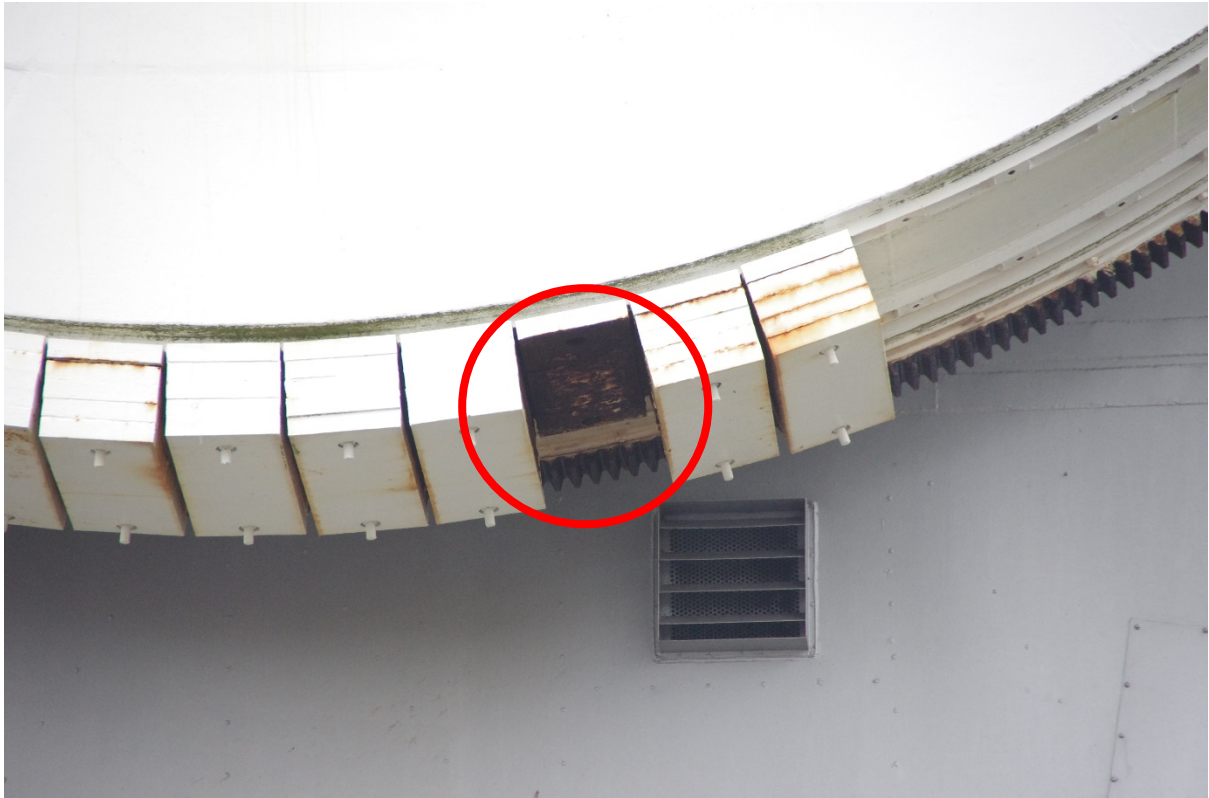
A close up of the counterweights (Figure 2) indicates the missing block. Figure 3 shows the location of the fallen counterweight. Also, note that the block on ground only comprises 4 plates, and that the 5th plate is still suspended from the fixing. This fifth plate has subsequently fallen.

Figure 2. Close up of the missing counterweight block.

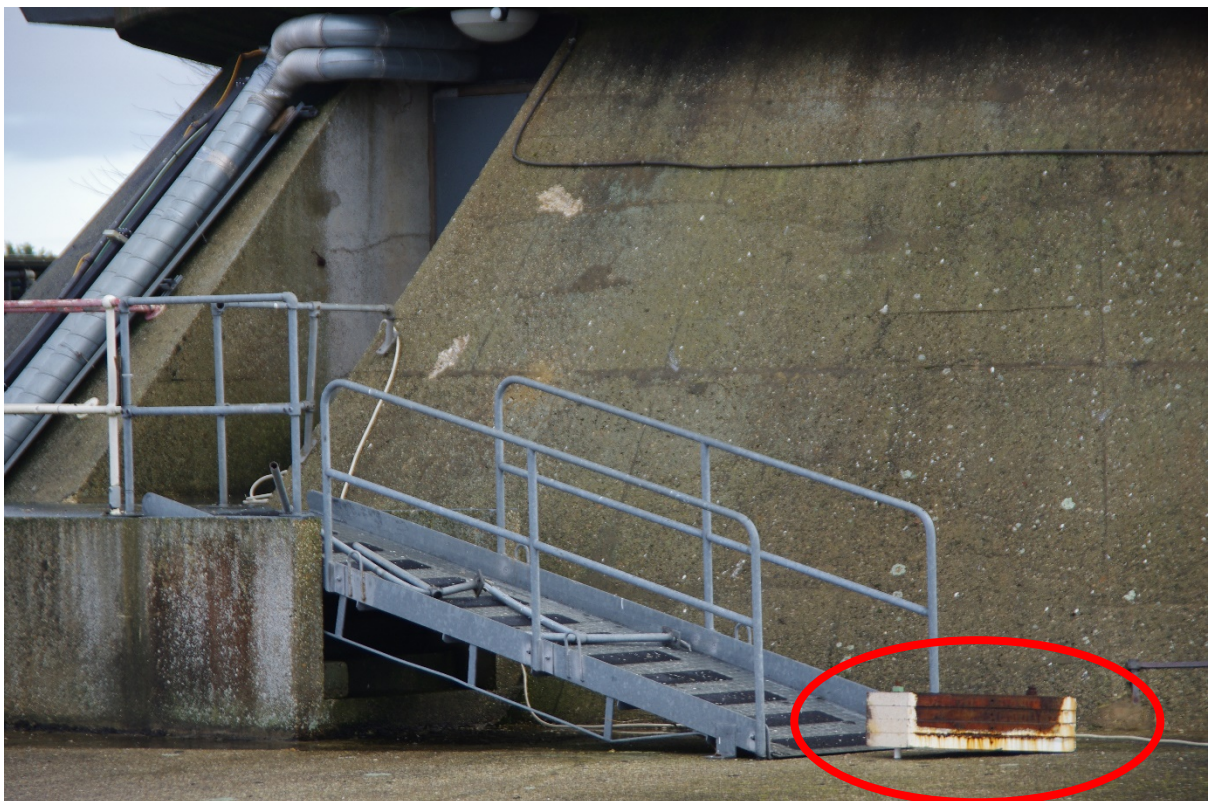
Figure 3. View of fallen counterweight block on apron below 25m antenna.

However, examination of the fallen block and plate indicate that they are badly corroded, requiring new ones to be made. It is anticipated that the new plates can be manufactured whilst the old ones are being removed, shortening the timeline for completion.

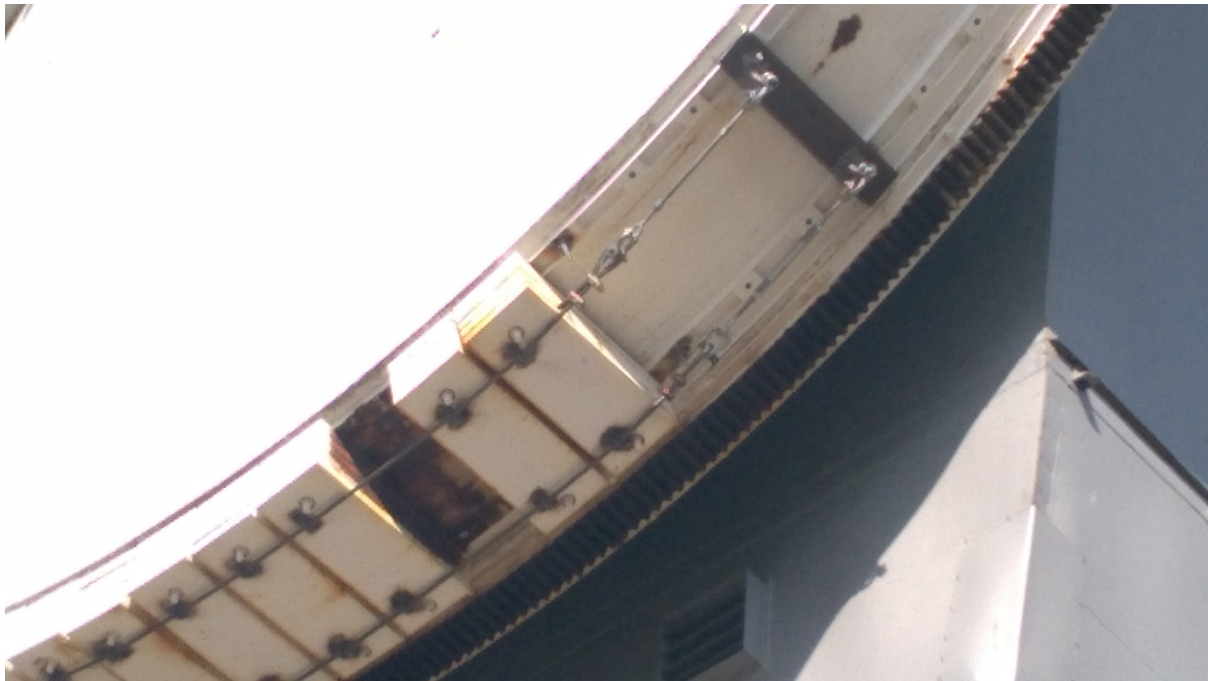
The situation has been made temporarily safe by the installation of cables slung underneath the counterweights, with each block welded onto the cable using pad eyes.

Figure 4 shows the temporary fix to prevent the blocks from falling to the ground if they break away.

Figure 4. View of the temporary fix to make the situation safe from further block falls.

All of the studs, which support the counterweight plates, will need to be removed. The wire rope and fixings that were installed to implement the temporary fixing will also need to be removed.

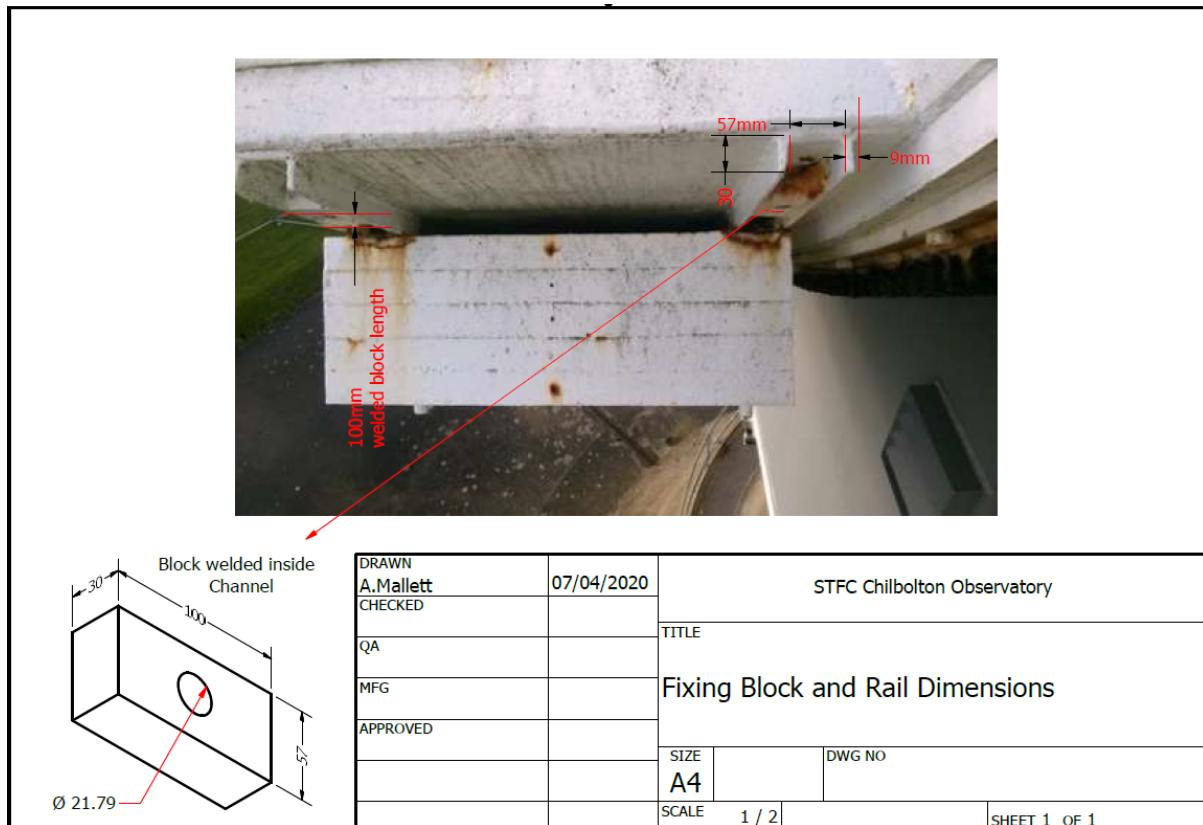
Figure 7. Dimensioned photo of counterweight fixings.

There is no clearance between the first plate and the fixing block guide channel. Cutting the stud at this point will damage the guide channel and the fixing block, which will need to be re-instated before the blocks are replaced.

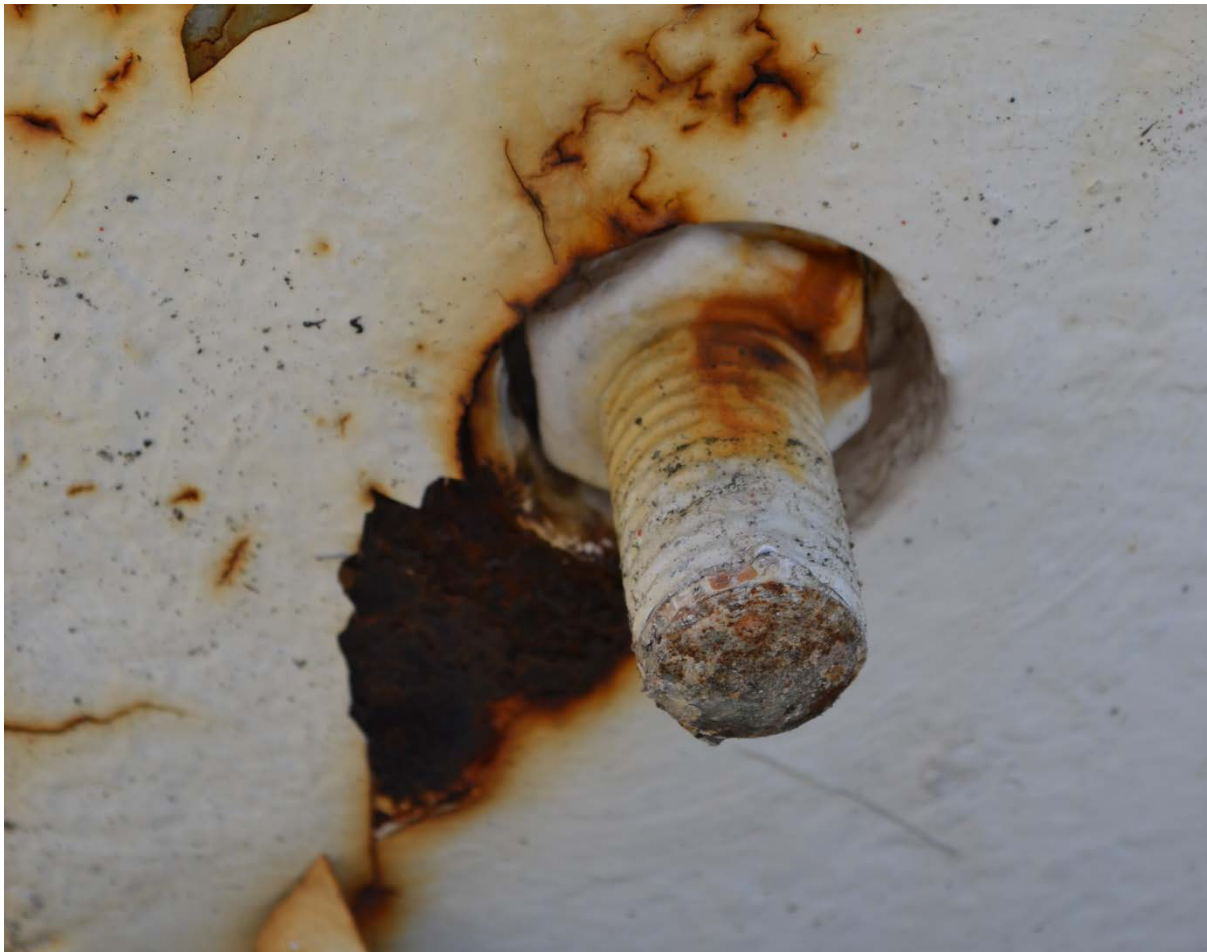
Figure 8 is a drawing of a counterweight plate. Figure 9 is a photograph of an old counterweight plate that was never fitted. The plates are individually held with a pair of nuts, which are recessed into the counter bore on the underside of the plate. Figure 10 is a close up of the nut in the counter bore of the fallen block. The limited clearance around the nut will require a pipe spanner or similar tool to be used to remove the nuts. As each plate is removed, the spanner will need to reach 50 mm further over the stud. The nuts have not been touched in decades and are unlikely to come free easily or if at all. Figure 11 shows that there is obvious evidence of corrosion having weakened the stud, so force on them while removing the plates will potentially result them breaking and the block

Figure 10. Close-up of stud and nut holding plate.

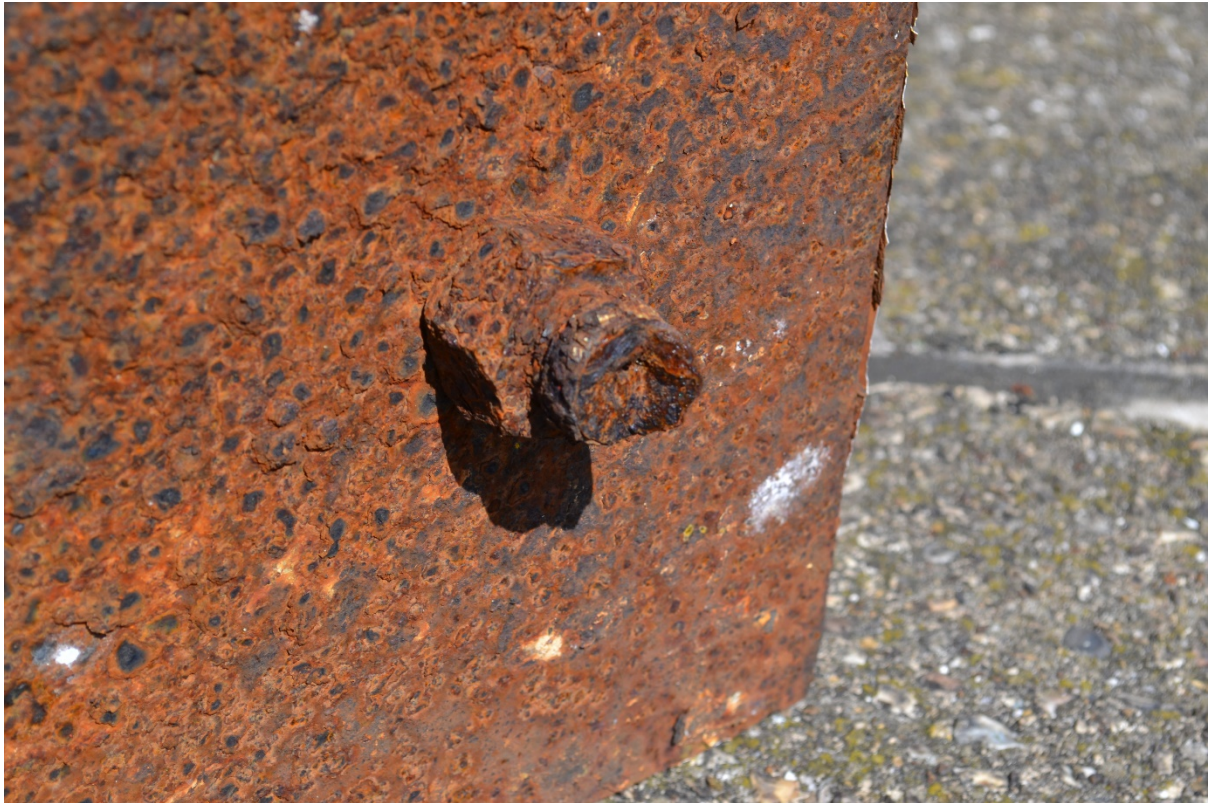
Figure 11. Close-up showing severe corrosion on nut and stud at point where the stud failed.

Once the ballast tank surfaces have been repainted, the counterweights can be refitted. New threaded studding and fasteners must be used. The studding and fasteners must be high tensile steel with a zinc plating.
