REPORT OF INSPECTION

Client:	London Borough of Lambeth
Site:	Agnes Reilly Gardens
Date of Inspection:	17 th November 2016
Type of facility:	Artificial Grass Pitch
Size (approximately):	41.9m x 34m
Stage of construction inspected:	Condition survey
Items of work undertaken during visit:	Visual inspection, Force reduction, Ball Rebound, Surface regularity (3m straight edge), Levels, Dimensions

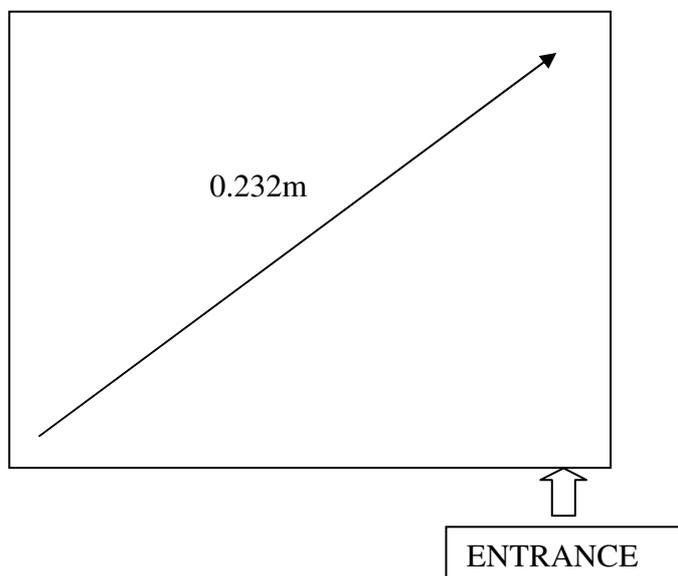
- Gradient

→ = Direction of Gradient

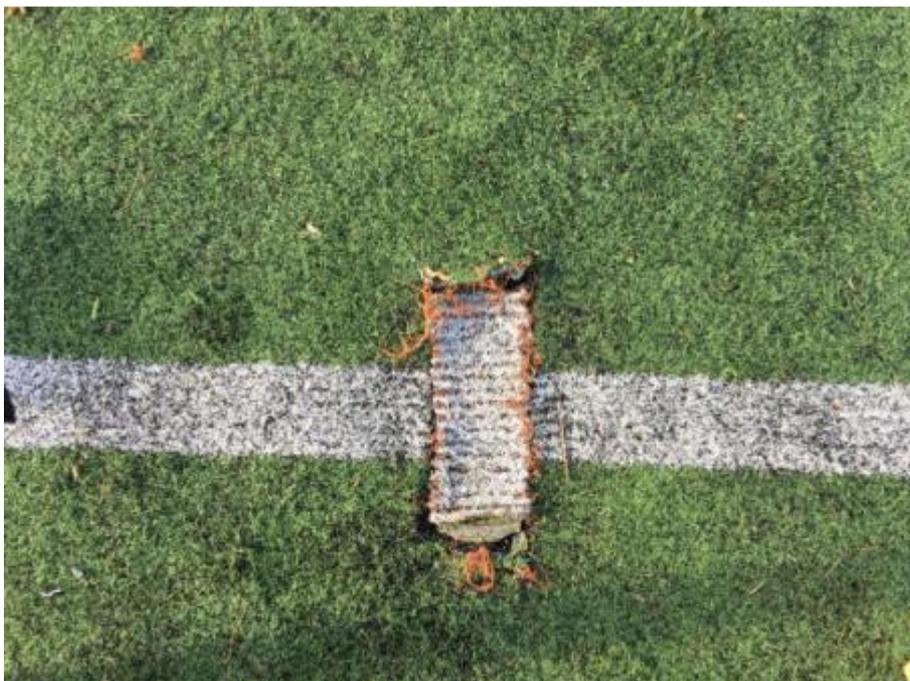
- The condition of the carpet was poor and there are adhesive failures of line markings and seams. The centre marker had completely detached from the carpet. The pile was heavily compacted.

Centre marker detached from carpet

It may be possible to rejuvenate the existing pitch by power brushing the pile and introducing more rubber. In addition, a patch of carpet can be installed in the goalmouth and the lines replaced. Replay Maintenance (01636 640506) or Technical Surfaces (08702 400700) are specialist companies that will provide a quote for the works. This may give another 1-2 years of use.

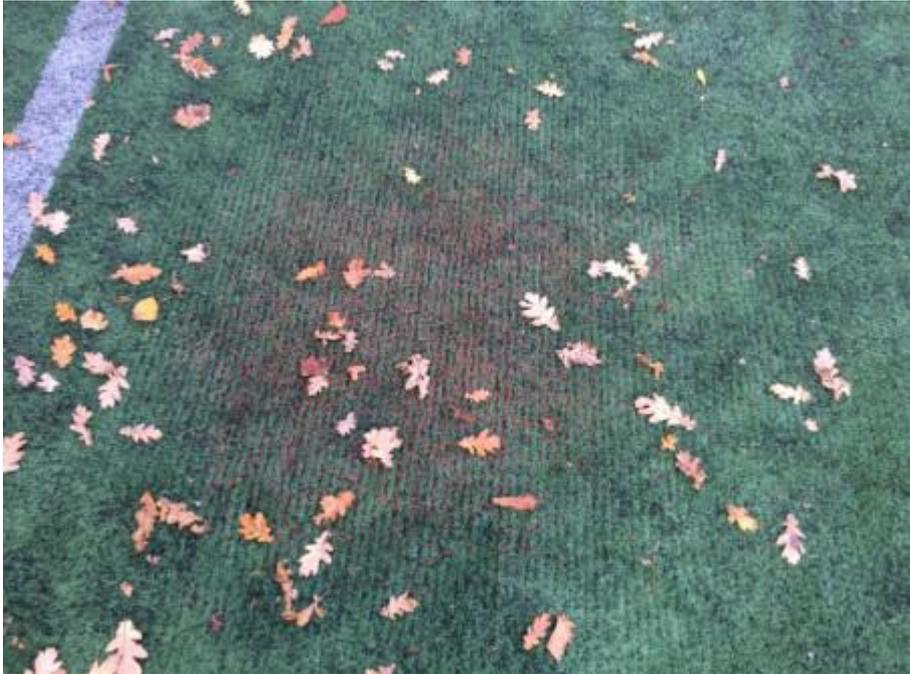
- The measured pile length of the surface was on average of 18mm. This compares against a pile height when new of 52mm.
- The carpet pile had worn down to the backing in one of the goalmouths.

- The only surface irregularity detected beneath the 3m straight edge which was above the maximum specified limit of BSEN15330 (10mm) found was where the carpet was worn down to the backing in one goalmouth.

Carpet worn through to backing in goalmouth

We recommend replacement of the carpet with a 60mm pile length monofilament 3g product. This is likely to cost in the region of £35,000 and if the shockpad requires replacement this will cost an additional £10,000. We recommend replacement is carried out by a specialist contractor being a member of SAPCA.

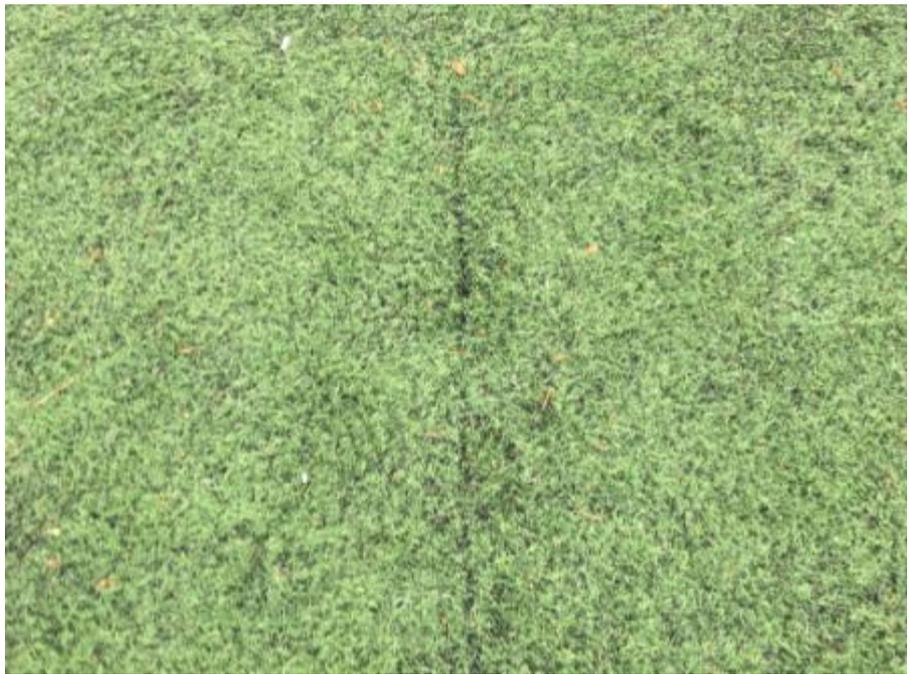
Seam failure

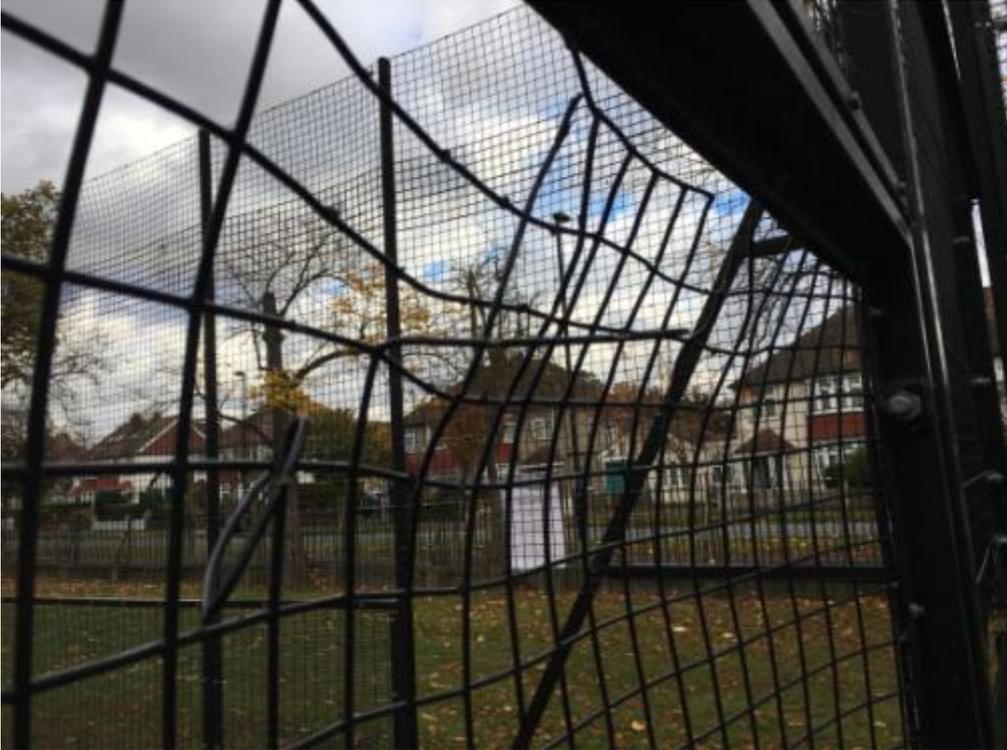
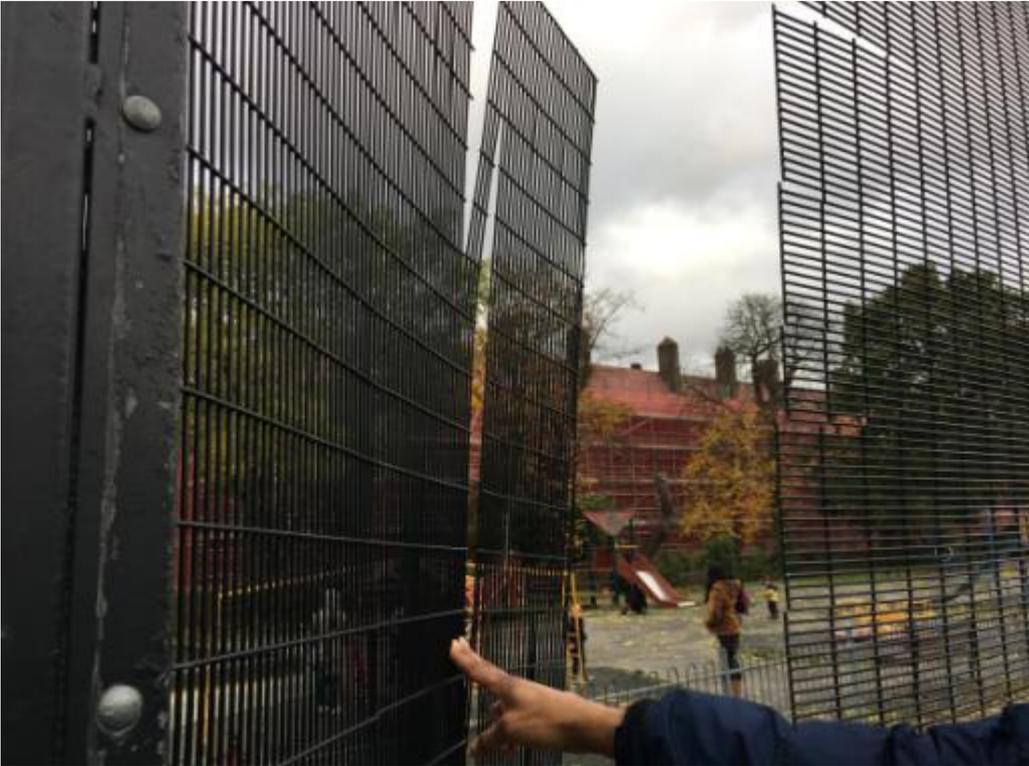
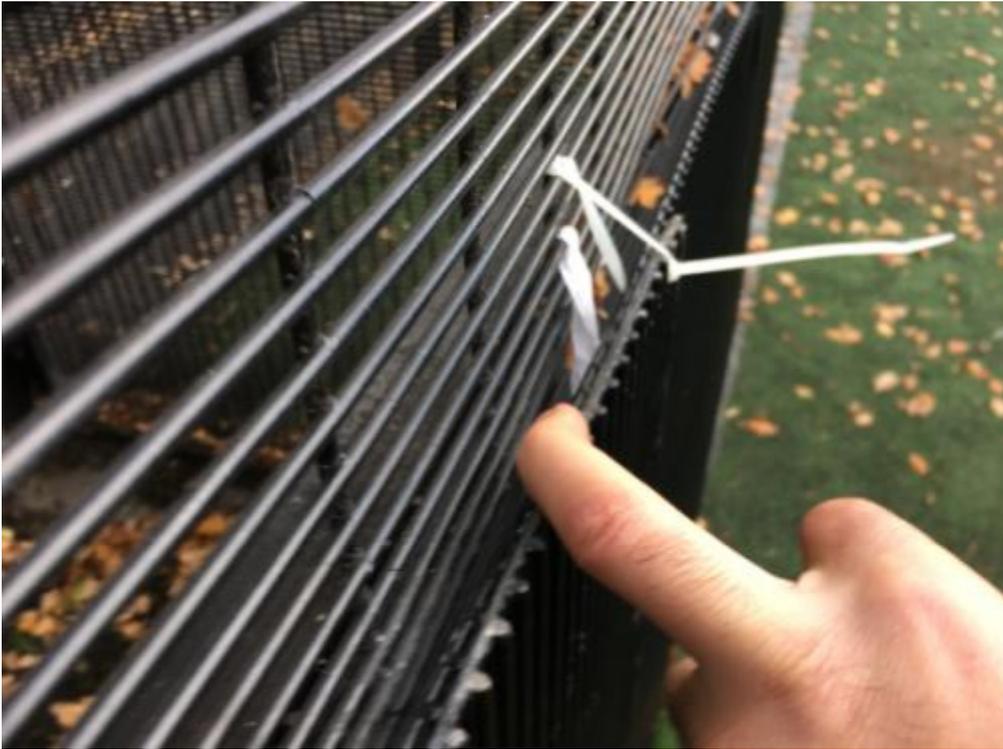
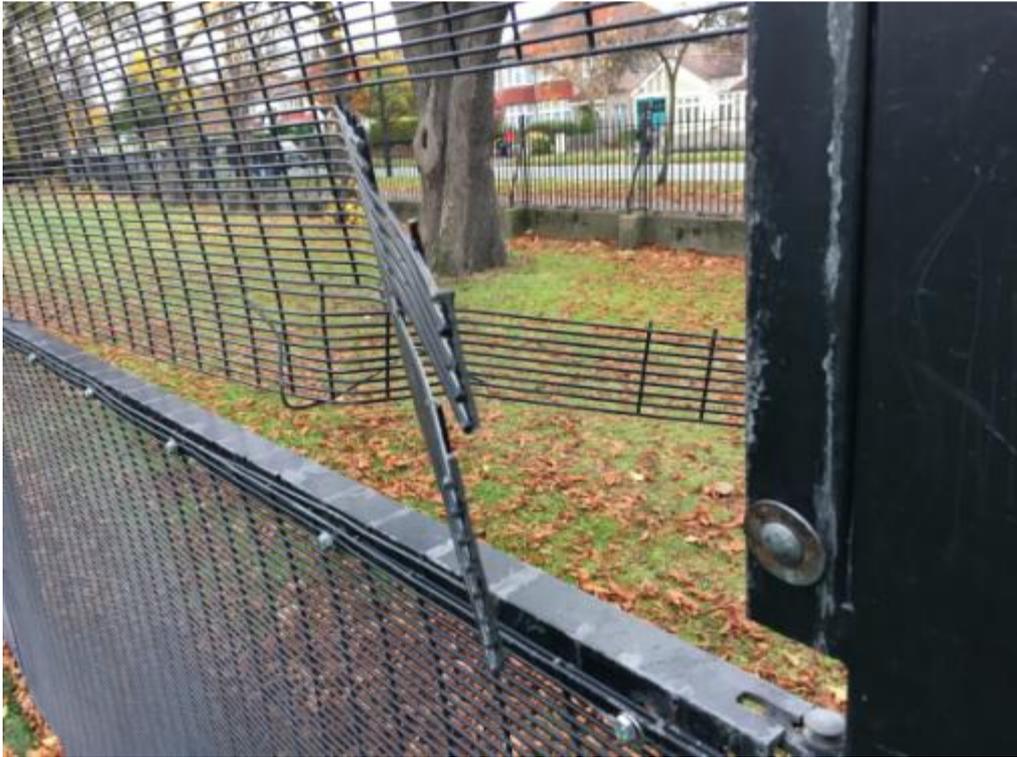
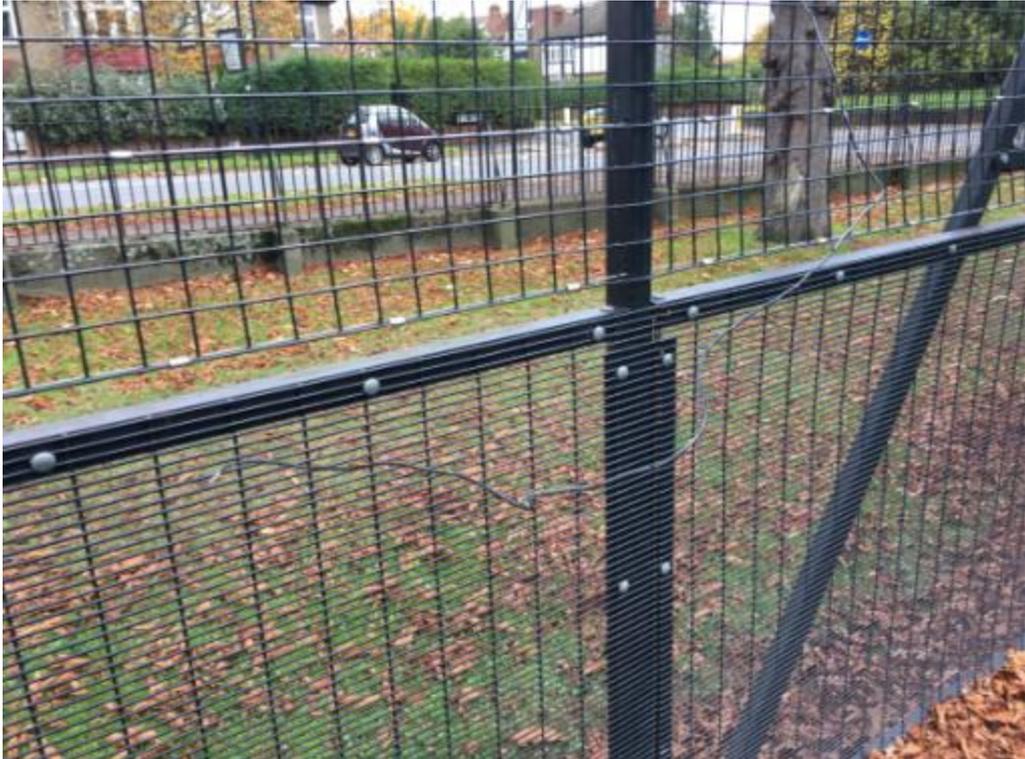
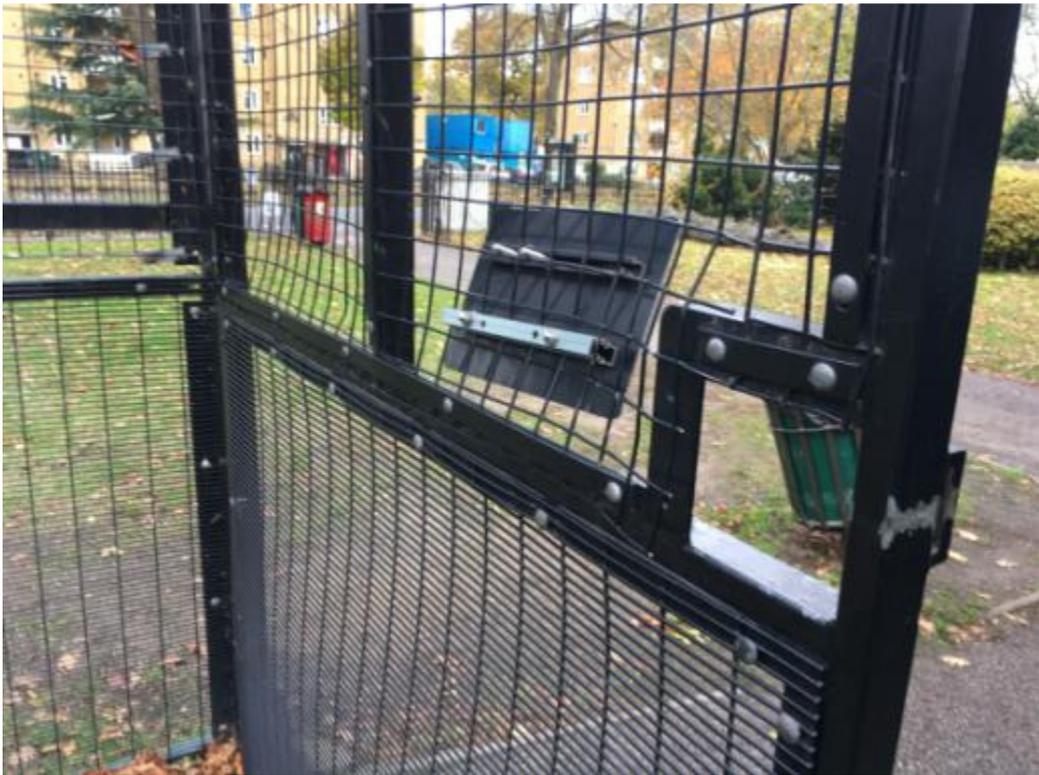
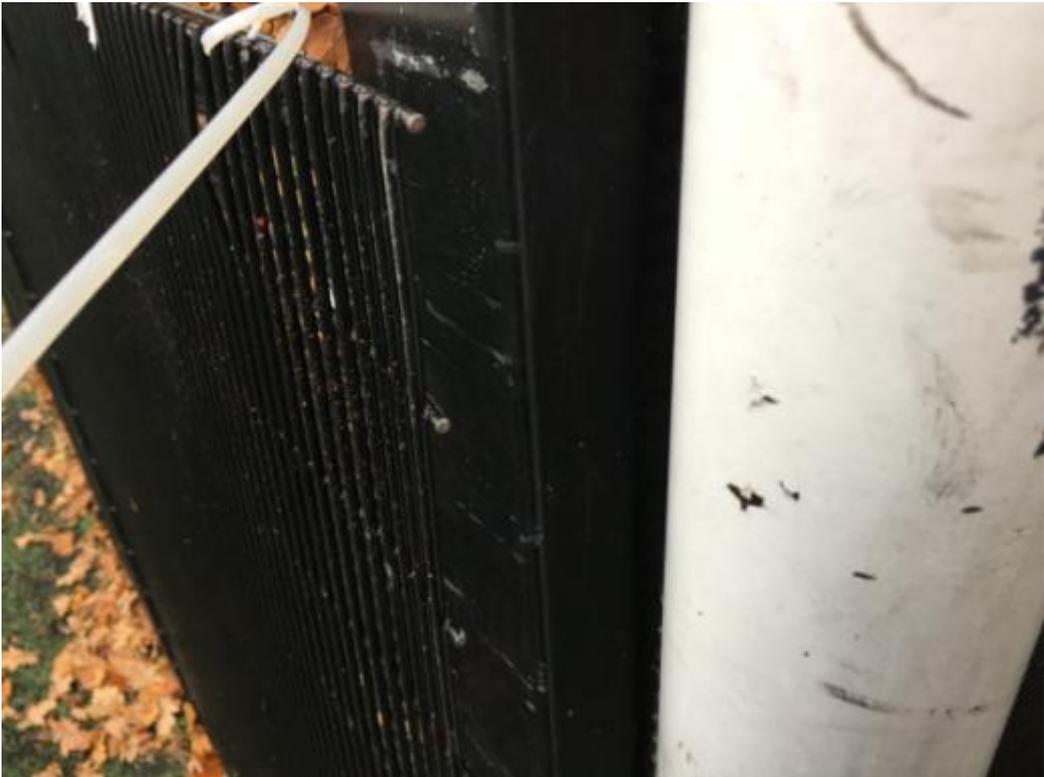
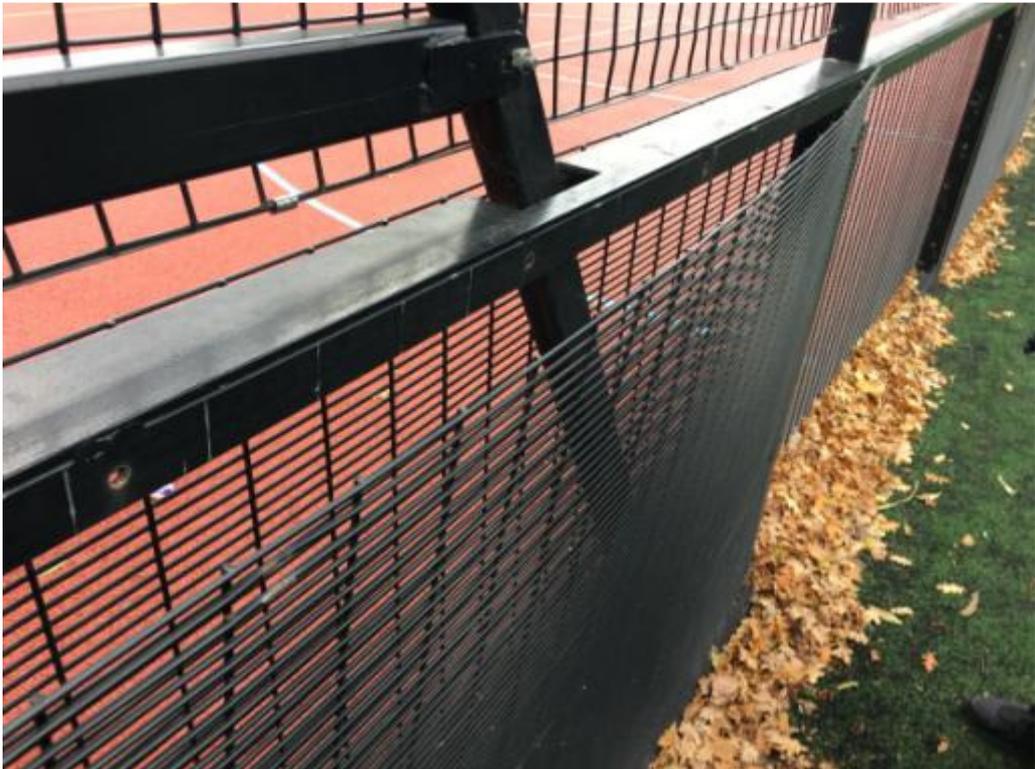
Fencing issues

- The facility comprises a sand and rubber filled artificial grass rectangle of size 41.9m x 34m.
- The pitch is surrounded by a weldmesh fence. The lower 1.2m of the fence comprises 358 mesh (prison mesh) and the upper section 50mm x 50mm aperture weldmesh. The fencing was badly damaged in many locations and hazardous to users. The fencing around the facility was severely damaged and sections have been detached and bent which present a hazard to users. There were sections of the fence missing which will allow the ball to go outside the pitch and potentially strike children playing in the play area. The fencing had many finger traps and bolts missing. The facility fencing requires immediate action. This was reported to Greg Knight of LB Lambeth by e-mail shortly after our inspection.

The fencing around the facility requires immediate action from a health and safety point of view. We recommend it is replaced with the more robust 'twin wire' fencing which will cost in the region of £30,000 to install.
