# Pre-Construction Information

Trelya Gul Skills Community Hub  
Community Health and Welfare Project

The Lescudjack Centre, Penzance

**ASBESTOS REFURBISHMENT SURVEY REPORT**  
**SITE SURVEYED**

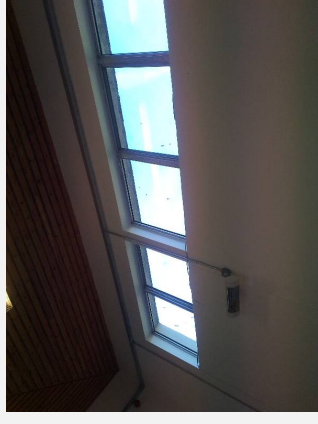
Incident Reference	Sample Number	Level	Material Location	Quantity
3	No sample taken	Ground Floor	Main Building Hall 001	Throughout
<b>ID</b>	<b>Material Description</b>	<b>Product Type</b>	<b>Asbestos Type</b>	<b>Asbestos Type</b>
NAD	Internal area around metal windows inspected	N/A	No Asbestos Detected	No Asbestos Detected
<b>Accessibility</b>	<b>Product Type</b>	<b>Extent of Damage</b>	<b>Surface Treatment</b>	<b>Priority</b>
N/A	N/A	N/A	N/A	N/A
			<b>Total</b>	<b>Recommendation</b>
			N/A	No Action
				<b>Comments</b>

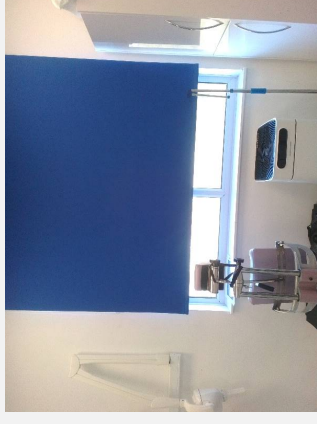
Incident Reference	Sample Number	Level	Material Location	Quantity
6	No sample taken	Ground Floor	Main Building Dental Treatment Room 002	2 no.
<b>ID</b>	<b>Material Description</b>	<b>Product Type</b>	<b>Asbestos Type</b>	<b>Asbestos Type</b>
NAD	Area around UPVC windows inspected	N/A	No Asbestos Detected	No Asbestos Detected
<b>Accessibility</b>	<b>Product Type</b>	<b>Extent of Damage</b>	<b>Surface Treatment</b>	<b>Priority</b>
N/A	N/A	N/A	N/A	N/A
			<b>Total</b>	<b>Recommendation</b>
			N/A	No Action
				<b>Comments</b>

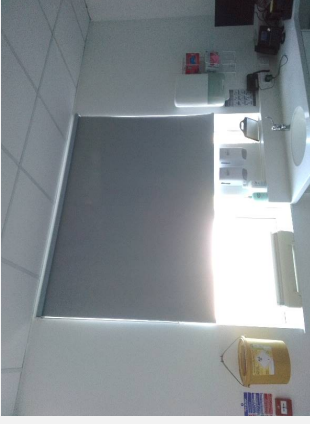
Incident Reference	Sample Number	Level	Material Location	Quantity	Comments	
7	No sample taken	Ground Floor	Main Building Dental Treatment Room 003	1 no.

ID	Material Description	Product Type	Asbestos Type	Asbestos Type		
NAD	Area around UPVC windows inspected	N/A	N/A	No Asbestos Detected		
Accessibility	Product Type	Extent of Damage	Surface Treatment	Total	Priority	Recommendation
N/A	N/A	N/A	N/A	N/A	N/A	No Action

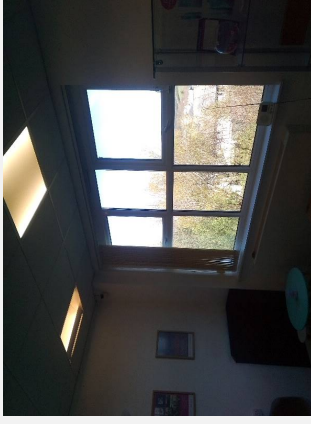
Incident Reference	Sample Number	Level	Material Location	Quantity	Comments	
8	No sample taken	Ground Floor	Main Building Dental Treatment Room 004	2 no.

ID	Material Description	Product Type	Asbestos Type	Asbestos Type		
NAD	Area around UPVC windows inspected	N/A	N/A	No Asbestos Detected		
Accessibility	Product Type	Extent of Damage	Surface Treatment	Total	Priority	Recommendation
N/A	N/A	N/A	N/A	N/A	N/A	No Action

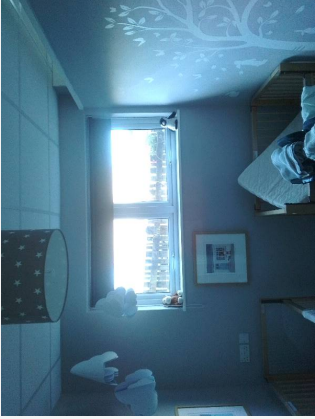
Incident Reference	Sample Number	Level	Material Location	Quantity	Image	
11	No sample taken	Z-Sub Level 1	Main Building Sleep Room B02	1 no.

ID	Material Description	Product Type	Asbestos Type	Asbestos Type		
NAD	Area around UPVC window inspected	N/A	N/A	No Asbestos Detected		
Accessibility	Product Type	Extent of Damage	Surface Treatment	Priority	Recommendation	Comments
N/A	N/A	N/A	N/A	N/A	No Action

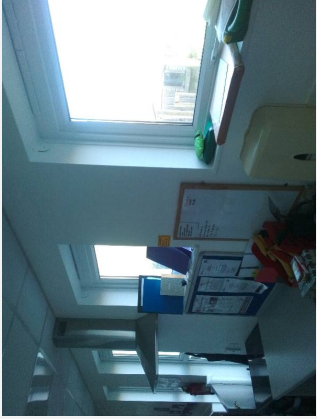
Incident Reference	Sample Number	Level	Material Location	Quantity	Image	
12	No sample taken	Z-Sub Level 1	Main Building Moonlight Room B03	8 no.

ID	Material Description	Product Type	Asbestos Type	Asbestos Type		
NAD	Area around UPVC windows and doors inspected	N/A	N/A	No Asbestos Detected		
Accessibility	Product Type	Extent of Damage	Surface Treatment	Priority	Recommendation	Comments
N/A	N/A	N/A	N/A	N/A	No Action

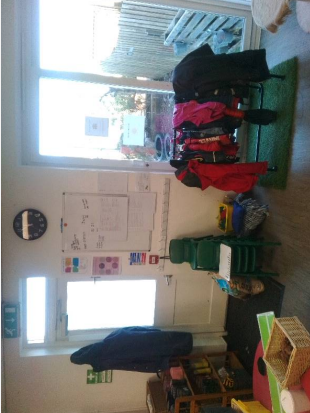
Incident Reference	Sample Number	Level	Material Location	Quantity
13	No sample taken	Z-Sub Level 1	Main Building Sunshine Room B04	2 no.
ID	Material Description	Product Type	Asbestos Type	Asbestos Type
NAD	Area around UPVC and timber doors inspected	N/A	No Asbestos Detected	No Asbestos Detected
Accessibility	Product Type	Extent of Damage	Surface Treatment	Priority
N/A	N/A	N/A	N/A	N/A
				Recommendation
				No Action
Comments

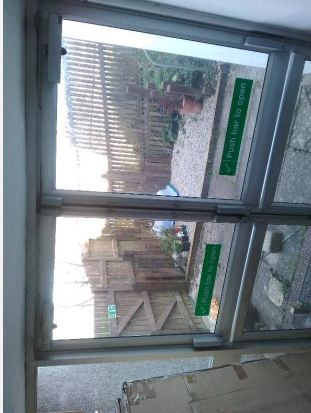
Incident Reference	Sample Number	Level	Material Location	Quantity
14	No sample taken	Z-Sub Level 1	Main Building Lobby B05	1 no.
ID	Material Description	Product Type	Asbestos Type	Asbestos Type
NAD	Area around metal door and window inspected	N/A	No Asbestos Detected	No Asbestos Detected
Accessibility	Product Type	Extent of Damage	Surface Treatment	Priority
N/A	N/A	N/A	N/A	N/A
				Recommendation
				No Action
Comments

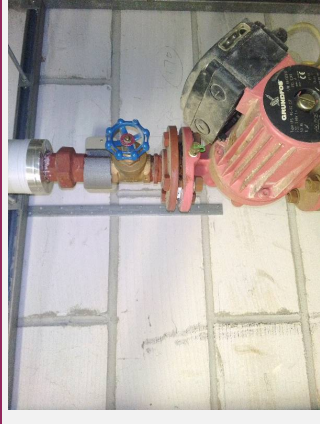
Incident Reference	Sample Number	Level	Material Location	Quantity	Comments
36	GN000523	Ground Floor	Main Building Boiler Room 006	1 no.	
<b>ID</b>	<b>Material Description</b>	<b>Product Type</b>	<b>Asbestos Type</b>	<b>Asbestos Type</b>	<b>Comments</b>
NAD	Gasket to pipework	N/A	N/A	No Asbestos Detected	
<b>Accessibility</b>	<b>Product Type</b>	<b>Extent of Damage</b>	<b>Surface Treatment</b>	<b>Total</b>	<b>Priority</b>
N/A	N/A	N/A	N/A	N/A	N/A
				<b>Recommendation</b>	
				No Action	1 sample of 7 gaskets in number, all visually similar three samples taken from different gaskets

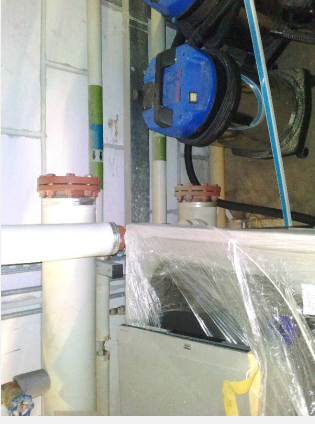
Incident Reference	Sample Number	Level	Material Location	Quantity	Image	Comments	
39	As GN000523	Ground Floor	Main Building Boiler Room 006	4 no.

ID	Material Description	Product Type	Asbestos Type	Asbestos Type			
NAD	Gaskets to pipework	N/A	N/A	No Asbestos Detected			
Accessibility	Product Type	Extent of Damage	Surface Treatment	Asbestos Type	Total	Priority	Recommendation
N/A	N/A	N/A	N/A	N/A	N/A	N/A	No Action
