Client: Leybourne Parish Council
Property: Leybourne Village Hall, Leybourne

Asbestos Survey Report

Asbestos Management Survey with part Refurbishment/Demolition

Report Number: **J012910**

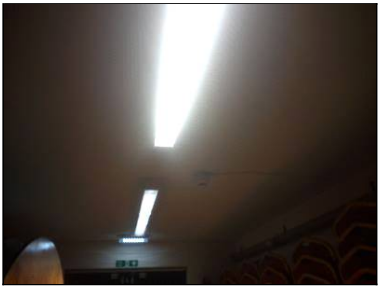
Survey Date:	Lead Surveyor	Survey Type	Floor	Analysis
	18 Feb 2019	Dayle Warsop	Management Survey with part Refurbishment/Demolition	Ground Floor	Chrysotile (1)
	Building	Room	Item	Quantity	
	Village Hall; Main building	Gnd; Store 1 G01	Textured coating to ceiling ceiling	18m ²	
	Sample No (S,SP,P,As)	Product Type	Surface Treatment	Condition	Accessibility
	AB003345 (S)	Textured Coating (1)	Surface Sealed (1)	Low Damage (1)	Easily disturbed (2)

Normal Occupancy	Score	Likelihood of disturbance	Score	Exposure Potential	Score	Maintenance Activity	Score
Main type of activity	2	Location	2	Number of occupants	1	Type of Maintenance	1
		Accessibility	2	Frequency of use	3	Frequency of maintenance	1
Average Score		Amount	2	Average Time	3	Average Score	
	2	Average Score	2	Average Score	3		1
Average of Priority	8						
Material Assessment Score	4						
Recommendation	A - Urgent Removal

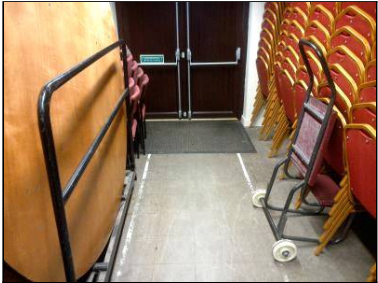
Survey Date:	Lead Surveyor	Survey Type	Floor	Analysis
	18 Feb 2019	Dayle Warsop	Management Survey with part Refurbishment/Demolition	Ground Floor	Chrysotile (1)
	Building	Room	Item	Quantity	
	Village Hall; Main building	Gnd; Store 1 G01	Vinyl Floor tiles with bitumen adhesive to concrete floor. floor	18m ²	
	Sample No (S,SP,P,As)	Product Type	Surface Treatment	Condition	Accessibility
	AB003346 (S)	Reinforced Composite (1)	Completely Sealed (0)	Low Damage (1)	Easily disturbed (2)

Normal Occupancy	Score	Likelihood of disturbance	Score	Exposure Potential	Score	Maintenance Activity	Score
Main type of activity	2	Location	2	Number of occupants	1	Type of Maintenance	1
		Accessibility	2	Frequency of use	3	Frequency of maintenance	1
Average Score		Amount	2	Average Time	3		
	2	Average Score	2	Average Score	3		Average Score
Average of Priority	8						
Material Assessment Score	3						
Recommendation	A - Urgent Removal

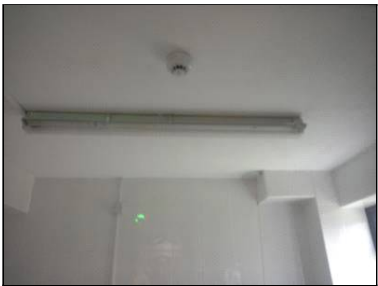
Survey Date:	Lead Surveyor	Survey Type	Floor	Analysis
	18 Feb 2019	Dayle Warsop	Management Survey with part Refurbishment/Demolition	Ground Floor	Chrysotile (1)
	Building	Room	Item	Quantity	
	Village Hall; Main building	Gnd; W/C 1 G02	Textured coating to ceiling ceiling	12m ²	
	Sample No (S,SP,P,As)	Product Type	Surface Treatment	Condition	Accessibility
	As AB003345 (SP)	Textured Coating (1)	Surface Sealed (1)	Low Damage (1)	Easily disturbed (2)

Normal Occupancy	Score	Likelihood of disturbance	Score	Exposure Potential	Score	Maintenance Activity	Score
Main type of activity	2	Location	2	Number of occupants	1	Type of Maintenance	1
		Accessibility	2	Frequency of use	3	Frequency of maintenance	1
Average Score		Amount	2	Average Time	3	Average Score	
	2	Average Score	2	Average Score	3		1
Average of Priority	8						
Material Assessment Score	4						
Recommendation	A - Urgent Removal

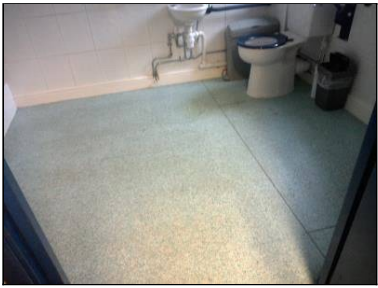
Survey Date:	Lead Surveyor	Survey Type	Floor	Analysis
	18 Feb 2019	Dayle Warsop	Management Survey with part Refurbishment/Demolition	Ground Floor	Chrysotile (1)
	Building	Room	Item	Quantity	
	Village Hall; Main building	Gnd; W/C 1 G02	Vinyl Floor tiles with bitumen adhesive to concrete floor. floor - beneath linoleum	12m ²	
	Sample No (S,SP,P,As)	Product Type	Surface Treatment	Condition	Accessibility
	As AB003346 (SP)	Reinforced Composite (1)	Completely Sealed (0)	Low Damage (1)	Easily disturbed (2)

Normal Occupancy	Score	Likelihood of disturbance	Score	Exposure Potential	Score	Maintenance Activity	Score
Main type of activity	2	Location	2	Number of occupants	1	Type of Maintenance	1
		Accessibility	2	Frequency of use	3	Frequency of maintenance	1
		Amount	2	Average Time	3		
Average Score	2	Average Score	2	Average Score	3	Average Score	1
Average of Priority	8						
Material Assessment Score	3						
Recommendation	A - Urgent Removal

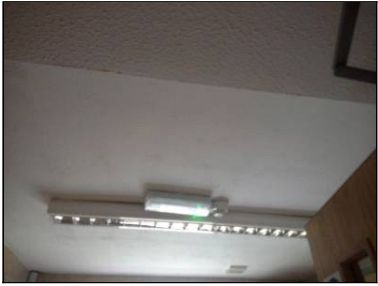
Survey Date:	Lead Surveyor	Survey Type	Floor	Analysis
	18 Feb 2019	Dayle Warsop	Management Survey with part Refurbishment/Demolition	Ground Floor	Chrysotile (1)
	Building	Room	Item	Quantity	
	Village Hall; Main building	Gnd; Kitchen G03	Textured coating to ceiling ceiling	16m ²	
	Sample No (S,SP,P,As)	Product Type	Surface Treatment	Condition	Accessibility
	As AB003345 (SP)	Textured Coating (1)	Surface Sealed (1)	Low Damage (1)	Easily disturbed (2)

Normal Occupancy	Score	Likelihood of disturbance	Score	Exposure Potential	Score	Maintenance Activity	Score
Main type of activity	2	Location	2	Number of occupants	1	Type of Maintenance	1
		Accessibility	2	Frequency of use	3	Frequency of maintenance	1
Average Score		Amount	2	Average Time	3		
	2	Average Score	2	Average Score	3		Average Score
Average of Priority	8						
Material Assessment Score	4						
Recommendation	A - Urgent Removal

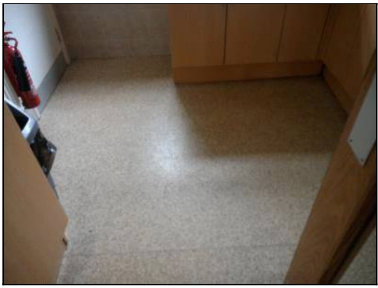
Survey Date:	Lead Surveyor	Survey Type	Floor	Analysis
	18 Feb 2019	Dayle Warsop	Management Survey with part Refurbishment/Demolition	Ground Floor	Chrysotile (1)
	Building	Room	Item	Quantity	
	Village Hall; Main building	Gnd; Kitchen G03	Vinyl Floor tiles with bitumen adhesive to concrete floor. floor - beneath linoleum	16m ²	
	Sample No (S,SP,P,As)	Product Type	Surface Treatment	Condition	Accessibility
	As AB003346 (SP)	Reinforced Composite (1)	Completely Sealed (0)	Low Damage (1)	Easily disturbed (2)

Normal Occupancy	Score	Likelihood of disturbance	Score	Exposure Potential	Score	Maintenance Activity	Score
Main type of activity	2	Location	2	Number of occupants	1	Type of Maintenance	1
		Accessibility	2	Frequency of use	3	Frequency of maintenance	1
		Amount	2	Average Time	3		
Average Score	2	Average Score	2	Average Score	3	Average Score	1
Average of Priority	8						
Material Assessment Score	3						
Recommendation	A - Urgent Removal

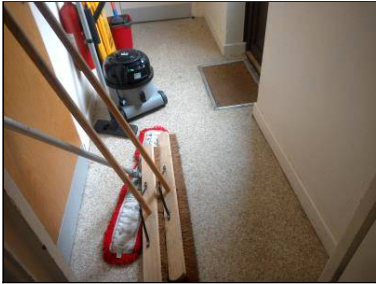
Survey Date:	Lead Surveyor	Survey Type	Floor	Analysis
	18 Feb 2019	Dayle Warsop	Management Survey with part Refurbishment/Demolition	Ground Floor	Chrysotile (1)
	Building	Room	Item	Quantity	
	Village Hall; Main building	Gnd; Corridor G04	Vinyl Floor tiles with bitumen adhesive to concrete floor. floor - beneath linoleum	4m ²	
	Sample No (S,SP,P,As)	Product Type	Surface Treatment	Condition	Accessibility
	As AB003346 (SP)	Reinforced Composite (1)	Completely Sealed (0)	Low Damage (1)	Easily disturbed (2)

Normal Occupancy	Score	Likelihood of disturbance	Score	Exposure Potential	Score	Maintenance Activity	Score
Main type of activity	2	Location	2	Number of occupants	1	Type of Maintenance	1
		Accessibility	2	Frequency of use	3	Frequency of maintenance	1
		Amount	2	Average Time	3		
Average Score	2	Average Score	2	Average Score	3	Average Score	1
Average of Priority	8						
Material Assessment Score	3						
Recommendation	A - Urgent Removal

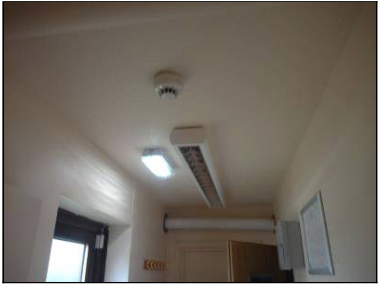
Survey Date:	Lead Surveyor	Survey Type	Floor	Analysis
	18 Feb 2019	Dayle Warsop	Management Survey with part Refurbishment/Demolition	Ground Floor	Chrysotile (1)
	Building	Room	Item	Quantity	
	Village Hall; Main building	Gnd; Corridor G04	Textured coating to ceiling ceiling	4m ²	
	Sample No (S,SP,P,As)	Product Type	Surface Treatment	Condition	Accessibility
	As AB003345 (SP)	Textured Coating (1)	Surface Sealed (1)	Low Damage (1)	Easily disturbed (2)

Normal Occupancy	Score	Likelihood of disturbance	Score	Exposure Potential	Score	Maintenance Activity	Score
Main type of activity	2	Location	2	Number of occupants	1	Type of Maintenance	1
		Accessibility	2	Frequency of use	3	Frequency of maintenance	1
Average Score		Amount	1	Average Time	3		
	2	Average Score	2	Average Score	3		Average Score
Average of Priority	8						
Material Assessment Score	4						
Recommendation	A - Urgent Removal

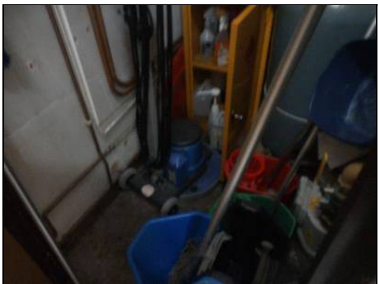
Survey Date:	Lead Surveyor	Survey Type	Floor	Analysis
	18 Feb 2019	Dayle Warsop	Management Survey with part Refurbishment/Demolition	Ground Floor	Chrysotile (1)
	Building	Room	Item	Quantity	
	Village Hall; Main building	Gnd; Boiler cupboard G05	Vinyl Floor tiles with bitumen adhesive to concrete floor. floor - beneath linoleum	3m ²	
	Sample No (S,SP,P,As)	Product Type	Surface Treatment	Condition	Accessibility
	As AB003346 (SP)	Reinforced Composite (1)	Completely Sealed (0)	Low Damage (1)	Easily disturbed (2)

Normal Occupancy	Score	Likelihood of disturbance	Score	Exposure Potential	Score	Maintenance Activity	Score
Main type of activity	2	Location	2	Number of occupants	1	Type of Maintenance	1
		Accessibility	2	Frequency of use	3	Frequency of maintenance	1
		Amount	2	Average Time	3		
Average Score	2	Average Score	2	Average Score	3	Average Score	1
Average of Priority	8						
Material Assessment Score	3						
Recommendation	A - Urgent Removal

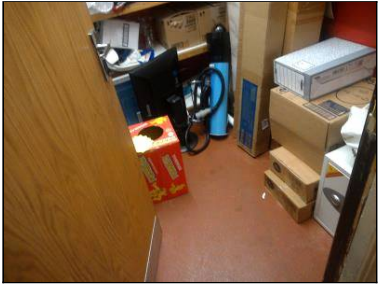
Survey Date:	Lead Surveyor	Survey Type	Floor	Analysis
	18 Feb 2019	Dayle Warsop	Management Survey with part Refurbishment/Demolition	Ground Floor	Chrysotile (1)
	Building	Room	Item	Quantity	
	Village Hall; Main building	Gnd; Store 2 G06	Vinyl Floor tiles with bitumen adhesive to concrete floor. floor - beneath linoleum	6m ²	
	Sample No (S,SP,P,As)	Product Type	Surface Treatment	Condition	Accessibility
	As AB003346 (SP)	Reinforced Composite (1)	Completely Sealed (0)	Low Damage (1)	Easily disturbed (2)

Normal Occupancy	Score	Likelihood of disturbance	Score	Exposure Potential	Score	Maintenance Activity	Score
Main type of activity	2	Location	2	Number of occupants	1	Type of Maintenance	1
		Accessibility	2	Frequency of use	3	Frequency of maintenance	1
		Amount	2	Average Time	3		
Average Score	2	Average Score	2	Average Score	3	Average Score	1
Average of Priority	8						
Material Assessment Score	3						
Recommendation	A - Urgent Removal

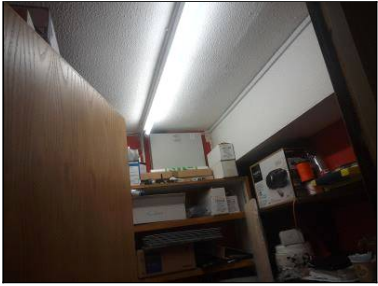
Survey Date:	Lead Surveyor	Survey Type	Floor	Analysis
	18 Feb 2019	Dayle Warsop	Management Survey with part Refurbishment/Demolition	Ground Floor	Chrysotile (1)
	Building	Room	Item	Quantity	
	Village Hall; Main building	Gnd; Store 2 G06	Textured coating to ceiling ceiling	6m ²	
	Sample No (S,SP,P,As)	Product Type	Surface Treatment	Condition	Accessibility
	As AB003345 (SP)	Textured Coating (1)	Surface Sealed (1)	Low Damage (1)	Easily disturbed (2)

Normal Occupancy	Score	Likelihood of disturbance	Score	Exposure Potential	Score	Maintenance Activity	Score
Main type of activity	2	Location	2	Number of occupants	1	Type of Maintenance	1
		Accessibility	2	Frequency of use	3	Frequency of maintenance	1
Average Score		Amount	1	Average Time	3	Average Score	
	2	Average Score	2	Average Score	3		1
Average of Priority	8						
Material Assessment Score	4						
Recommendation	A - Urgent Removal

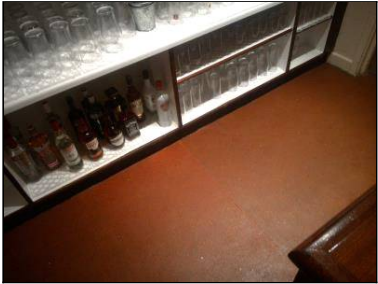
Survey Date:	Lead Surveyor	Survey Type	Floor	Analysis
	18 Feb 2019	Dayle Warsop	Management Survey with part Refurbishment/Demolition	Ground Floor	Chrysotile (1)
	Building	Room	Item	Quantity	
	Village Hall; Main building	Gnd; Bar G07	Vinyl Floor tiles with bitumen adhesive to concrete floor. floor - beneath linoleum	12m ²	
	Sample No (S,SP,P,As)	Product Type	Surface Treatment	Condition	Accessibility
	As AB003346 (SP)	Reinforced Composite (1)	Completely Sealed (0)	Low Damage (1)	Easily disturbed (2)

Normal Occupancy	Score	Likelihood of disturbance	Score	Exposure Potential	Score	Maintenance Activity	Score
Main type of activity	2	Location	2	Number of occupants	1	Type of Maintenance	1
		Accessibility	2	Frequency of use	3	Frequency of maintenance	1
		Amount	2	Average Time	3		
Average Score	2	Average Score	2	Average Score	3	Average Score	1
Average of Priority	8						
Material Assessment Score	3						
Recommendation	A - Urgent Removal

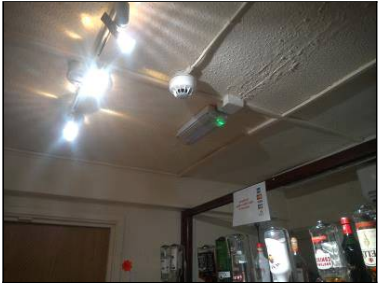
Survey Date:	Lead Surveyor	Survey Type	Floor	Analysis
	18 Feb 2019	Dayle Warsop	Management Survey with part Refurbishment/Demolition	Ground Floor	Chrysotile (1)
	Building	Room	Item	Quantity	
	Village Hall; Main building	Gnd; Bar G07	Textured coating to ceiling ceiling	12m ²	
	Sample No (S,SP,P,As)	Product Type	Surface Treatment	Condition	Accessibility
	As AB003345 (SP)	Textured Coating (1)	Surface Sealed (1)	Low Damage (1)	Easily disturbed (2)

Normal Occupancy	Score	Likelihood of disturbance	Score	Exposure Potential	Score	Maintenance Activity	Score
Main type of activity	2	Location	2	Number of occupants	1	Type of Maintenance	1
		Accessibility	2	Frequency of use	3	Frequency of maintenance	1
Average Score		Amount	1	Average Time	3		
	2	Average Score	2	Average Score	3		Average Score
Average of Priority	8						
Material Assessment Score	4						
Recommendation	A - Urgent Removal

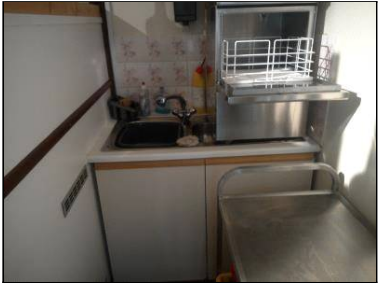
Survey Date:	Lead Surveyor	Survey Type	Floor	Analysis
	18 Feb 2019	Dayle Warsop	Management Survey with part Refurbishment/Demolition	Ground Floor	No Asbestos Detected
	Building	Room	Item	Quantity	
	Village Hall; Main building	Gnd; Bar G07	Bitumen accoustic pad to underside of sink and drainer. sink and drainer	2no.	
	Sample No (S,SP,P,As)	Product Type	Surface Treatment	Condition	Accessibility
	AB003347 (S)	N/A	N/A	N/A	N/A

Normal Occupancy	Score	Likelihood of disturbance	Score	Exposure Potential	Score	Maintenance Activity	Score
Main type of activity	N/A	Location	N/A	Number of occupants	N/A	Type of Maintenance	N/A
		Accessibility	N/A	Frequency of use	N/A	Frequency of maintenance	N/A
		Amount	N/A	Average Time	N/A		
Average Score	N/A	Average Score	N/A	Average Score	N/A	Average Score	N/A
Average of Priority	N/A						
Material Assessment Score	N/A						
Recommendation	No further action required

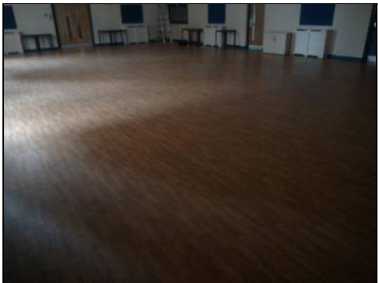
Survey Date:	Lead Surveyor	Survey Type	Floor	Analysis
	18 Feb 2019	Dayle Warsop	Management Survey with part Refurbishment/Demolition	Ground Floor	Chrysotile (1)
	Building	Room	Item	Quantity	
	Village Hall; Main building	Gnd; Main Hall G08	Vinyl Floor tiles with bitumen adhesive to concrete floor. floor - beneath linoleum	200m ²	
	Sample No (S,SP,P,As)	Product Type	Surface Treatment	Condition	Accessibility
	As AB003346 (SP)	Reinforced Composite (1)	Completely Sealed (0)	Low Damage (1)	Easily disturbed (2)

Normal Occupancy	Score	Likelihood of disturbance	Score	Exposure Potential	Score	Maintenance Activity	Score
Main type of activity	2	Location	2	Number of occupants	1	Type of Maintenance	1
		Accessibility	2	Frequency of use	3	Frequency of maintenance	1
		Amount	2	Average Time	3		
Average Score	2	Average Score	2	Average Score	3	Average Score	1
Average of Priority	8						
Material Assessment Score	3						
Recommendation	A - Urgent Removal

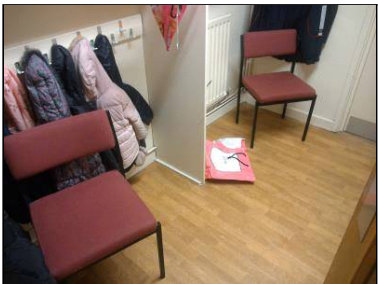
Survey Date:	Lead Surveyor	Survey Type	Floor	Analysis
	18 Feb 2019	Dayle Warsop	Management Survey with part Refurbishment/Demolition	Ground Floor	Chrysotile (1)
	Building	Room	Item	Quantity	
	Village Hall; Main building	Gnd; Cloak room G09	Vinyl Floor tiles with bitumen adhesive to concrete floor. floor - beneath linoleum	6m ²	
	Sample No (S,SP,P,As)	Product Type	Surface Treatment	Condition	Accessibility
	As AB003346 (SP)	Reinforced Composite (1)	Completely Sealed (0)	Low Damage (1)	Easily disturbed (2)

Normal Occupancy	Score	Likelihood of disturbance	Score	Exposure Potential	Score	Maintenance Activity	Score
Main type of activity	2	Location	2	Number of occupants	1	Type of Maintenance	1
		Accessibility	2	Frequency of use	3	Frequency of maintenance	1
		Amount	2	Average Time	3		
Average Score	2	Average Score	2	Average Score	3	Average Score	1
Average of Priority	8						
Material Assessment Score	3						
Recommendation	A - Urgent Removal

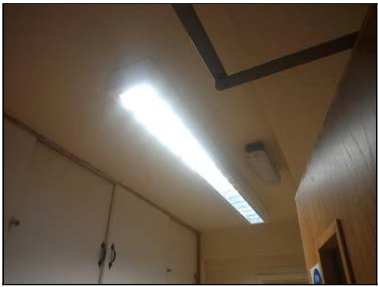
Survey Date:	Lead Surveyor	Survey Type	Floor	Analysis
	18 Feb 2019	Dayle Warsop	Management Survey with part Refurbishment/Demolition	Ground Floor	Chrysotile (1)
	Building	Room	Item	Quantity	
	Village Hall; Main building	Gnd; Cloak room G09	Textured coating to ceiling ceiling	6m ²	
	Sample No (S,SP,P,As)	Product Type	Surface Treatment	Condition	Accessibility
	As AB003345 (SP)	Textured Coating (1)	Surface Sealed (1)	Low Damage (1)	Easily disturbed (2)

Normal Occupancy	Score	Likelihood of disturbance	Score	Exposure Potential	Score	Maintenance Activity	Score
Main type of activity	2	Location	2	Number of occupants	1	Type of Maintenance	1
		Accessibility	2	Frequency of use	3	Frequency of maintenance	1
Average Score		Amount	1	Average Time	3	Average Score	
	2	Average Score	2	Average Score	3		1
Average of Priority	8						
Material Assessment Score	4						
Recommendation	A - Urgent Removal

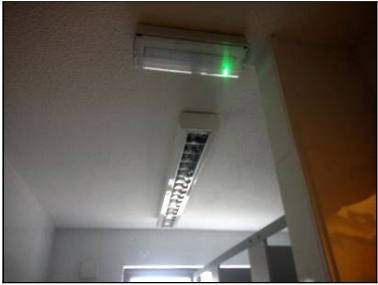
Survey Date:	Lead Surveyor	Survey Type	Floor	Analysis
	18 Feb 2019	Dayle Warsop	Management Survey with part Refurbishment/Demolition	Ground Floor	Chrysotile (1)
	Building	Room	Item	Quantity	
	Village Hall; Main building	Gnd; W/C 2 G10	Textured coating to ceiling ceiling	16m ²	
	Sample No (S,SP,P,As)	Product Type	Surface Treatment	Condition	Accessibility
	As AB003345 (SP)	Textured Coating (1)	Surface Sealed (1)	Low Damage (1)	Easily disturbed (2)

Normal Occupancy	Score	Likelihood of disturbance	Score	Exposure Potential	Score	Maintenance Activity	Score
Main type of activity	2	Location	2	Number of occupants	1	Type of Maintenance	1
		Accessibility	2	Frequency of use	3	Frequency of maintenance	1
Average Score		Amount	2	Average Time	3	Average Score	
	2	Average Score	2	Average Score	3		1
Average of Priority	8						
Material Assessment Score	4						
Recommendation	D - No Attention Required, Label

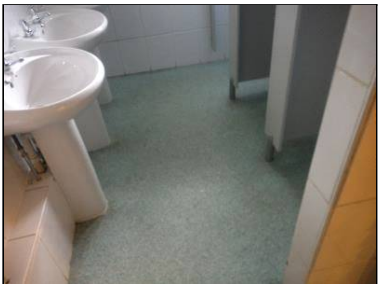
Survey Date:	Lead Surveyor	Survey Type	Floor	Analysis
	18 Feb 2019	Dayle Warsop	Management Survey with part Refurbishment/Demolition	Ground Floor	Chrysotile (1)
	Building	Room	Item	Quantity	
	Village Hall; Main building	Gnd; W/C 2 G10	Vinyl Floor tiles with bitumen adhesive to concrete floor. floor - beneath linoleum	16m ²	
	Sample No (S,SP,P,As)	Product Type	Surface Treatment	Condition	Accessibility
	As AB003346 (SP)	Reinforced Composite (1)	Completely Sealed (0)	Low Damage (1)	Easily disturbed (2)

Normal Occupancy	Score	Likelihood of disturbance	Score	Exposure Potential	Score	Maintenance Activity	Score
Main type of activity	2	Location	2	Number of occupants	1	Type of Maintenance	1
		Accessibility	2	Frequency of use	3	Frequency of maintenance	1
		Amount	2	Average Time	3		
Average Score	2	Average Score	2	Average Score	3	Average Score	1
Average of Priority	8						
Material Assessment Score	3						
Recommendation	D - No Attention Required, Label

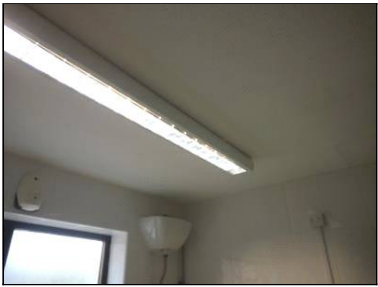
Survey Date:	Lead Surveyor	Survey Type	Floor	Analysis
	18 Feb 2019	Dayle Warsop	Management Survey with part Refurbishment/Demolition	Ground Floor	Chrysotile (1)
	Building	Room	Item	Quantity	
	Village Hall; Main building	Gnd; W/C 3 G11	Textured coating to ceiling ceiling	16m ²	
	Sample No (S,SP,P,As)	Product Type	Surface Treatment	Condition	Accessibility
	As AB003345 (SP)	Textured Coating (1)	Surface Sealed (1)	Low Damage (1)	Easily disturbed (2)

Normal Occupancy	Score	Likelihood of disturbance	Score	Exposure Potential	Score	Maintenance Activity	Score
Main type of activity	2	Location	2	Number of occupants	1	Type of Maintenance	1
		Accessibility	2	Frequency of use	3	Frequency of maintenance	1
Average Score		Amount	2	Average Time	3	Average Score	
	2	Average Score	2	Average Score	3		1
Average of Priority	8						
Material Assessment Score	4						
Recommendation	D - No Attention Required, Label

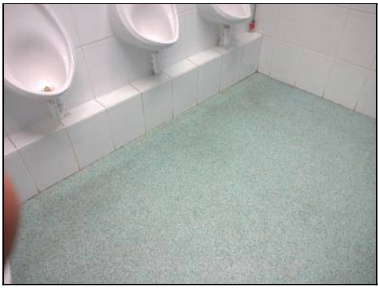
Survey Date:	Lead Surveyor	Survey Type	Floor	Analysis
	18 Feb 2019	Dayle Warsop	Management Survey with part Refurbishment/Demolition	Ground Floor	Chrysotile (1)
	Building	Room	Item	Quantity	
	Village Hall; Main building	Gnd; W/C 3 G11	Vinyl Floor tiles with bitumen adhesive to concrete floor. floor - beneath linoleum	16m ²	
	Sample No (S,SP,P,As)	Product Type	Surface Treatment	Condition	Accessibility
	As AB003346 (SP)	Reinforced Composite (1)	Completely Sealed (0)	Low Damage (1)	Easily disturbed (2)

Normal Occupancy	Score	Likelihood of disturbance	Score	Exposure Potential	Score	Maintenance Activity	Score
Main type of activity	2	Location	2	Number of occupants	1	Type of Maintenance	1
		Accessibility	2	Frequency of use	3	Frequency of maintenance	1
		Amount	2	Average Time	3		
Average Score	2	Average Score	2	Average Score	3	Average Score	1
Average of Priority	8						
Material Assessment Score	3						
Recommendation	D - No Attention Required, Label

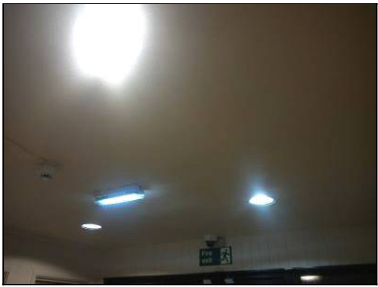
Survey Date:	Lead Surveyor	Survey Type	Floor	Analysis
	18 Feb 2019	Dayle Warsop	Management Survey with part Refurbishment/Demolition	Ground Floor	Chrysotile (1)
	Building	Room	Item	Quantity	
	Village Hall; Main building	Gnd; Lobby G12	Textured coating to ceiling ceiling	20m ²	
	Sample No (S,SP,P,As)	Product Type	Surface Treatment	Condition	Accessibility
	As AB003345 (SP)	Textured Coating (1)	Surface Sealed (1)	Low Damage (1)	Easily disturbed (2)

Normal Occupancy	Score	Likelihood of disturbance	Score	Exposure Potential	Score	Maintenance Activity	Score
Main type of activity	2	Location	2	Number of occupants	1	Type of Maintenance	1
		Accessibility	2	Frequency of use	3	Frequency of maintenance	1
Average Score		Amount	2	Average Time	3		
	2	Average Score	2	Average Score	3		Average Score
Average of Priority	8						
Material Assessment Score	4						
Recommendation	D - No Attention Required, Label

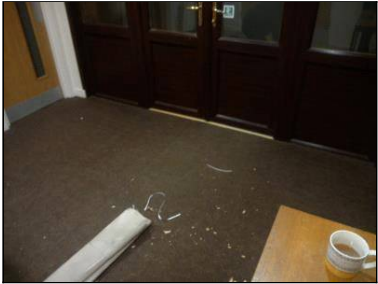
Survey Date:	Lead Surveyor	Survey Type	Floor	Analysis
	18 Feb 2019	Dayle Warsop	Management Survey with part Refurbishment/Demolition	Ground Floor	Chrysotile (1)
	Building	Room	Item	Quantity	
	Village Hall; Main building	Gnd; Lobby G12	Vinyl Floor tiles with bitumen adhesive to concrete floor. floor - beneath linoleum	20m ²	
	Sample No (S,SP,P,As)	Product Type	Surface Treatment	Condition	Accessibility
	As AB003346 (SP)	Reinforced Composite (1)	Completely Sealed (0)	Low Damage (1)	Easily disturbed (2)

Normal Occupancy	Score	Likelihood of disturbance	Score	Exposure Potential	Score	Maintenance Activity	Score
Main type of activity	2	Location	2	Number of occupants	1	Type of Maintenance	1
		Accessibility	2	Frequency of use	3	Frequency of maintenance	1
		Amount	2	Average Time	3		
Average Score	2	Average Score	2	Average Score	3	Average Score	1
Average of Priority	8						
Material Assessment Score	3						
Recommendation	D - No Attention Required, Label

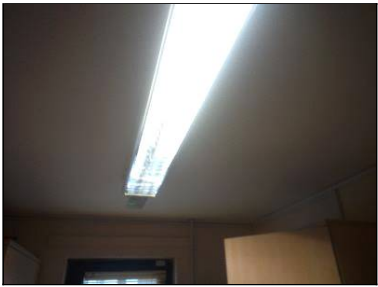
Survey Date:	Lead Surveyor	Survey Type	Floor	Analysis
	18 Feb 2019	Dayle Warsop	Management Survey with part Refurbishment/Demolition	Ground Floor	Chrysotile (1)
	Building	Room	Item	Quantity	
	Village Hall; Main building	Gnd; Entrance Lobby G13	Textured coating to ceiling ceiling	10m ²	
	Sample No (S,SP,P,As)	Product Type	Surface Treatment	Condition	Accessibility
	As AB003345 (SP)	Textured Coating (1)	Surface Sealed (1)	Low Damage (1)	Easily disturbed (2)

Normal Occupancy	Score	Likelihood of disturbance	Score	Exposure Potential	Score	Maintenance Activity	Score
Main type of activity	2	Location	2	Number of occupants	1	Type of Maintenance	1
		Accessibility	2	Frequency of use	3	Frequency of maintenance	1
Average Score		Amount	2	Average Time	3		
	2	Average Score	2	Average Score	3		Average Score
Average of Priority	8						
Material Assessment Score	4						
Recommendation	D - No Attention Required, Label

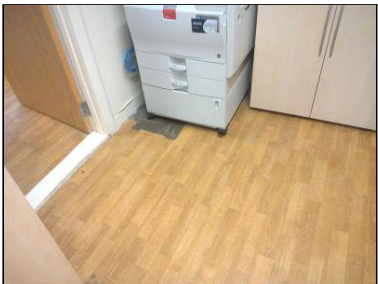
Survey Date:	Lead Surveyor	Survey Type	Floor	Analysis
	18 Feb 2019	Dayle Warsop	Management Survey with part Refurbishment/Demolition	Ground Floor	Chrysotile (1)
	Building	Room	Item	Quantity	
	Village Hall; Main building	Gnd; Entrance Lobby G13	Vinyl Floor tiles with bitumen adhesive to concrete floor. floor - beneath linoleum	10m ²	
	Sample No (S,SP,P,As)	Product Type	Surface Treatment	Condition	Accessibility
	As AB003346 (SP)	Reinforced Composite (1)	Completely Sealed (0)	Low Damage (1)	Easily disturbed (2)

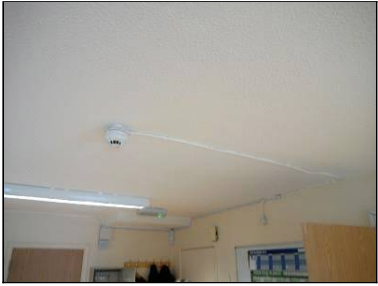
Survey Date:	Lead Surveyor	Survey Type	Floor	Analysis
	18 Feb 2019	Dayle Warsop	Management Survey with part Refurbishment/Demolition	Ground Floor	Chrysotile (1)
	Building	Room	Item	Quantity	
	Village Hall; Main building	Gnd; Office G14	Textured coating to ceiling ceiling	20m ²	
	Sample No (S,SP,P,As)	Product Type	Surface Treatment	Condition	Accessibility
	As AB003345 (SP)	Textured Coating (1)	Surface Sealed (1)	Low Damage (1)	Easily disturbed (2)

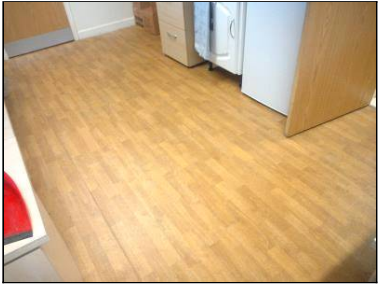
Survey Date:	Lead Surveyor	Survey Type	Floor	Analysis
	18 Feb 2019	Dayle Warsop	Management Survey with part Refurbishment/Demolition	Ground Floor	Chrysotile (1)
	Building	Room	Item	Quantity	
	Village Hall; Main building	Gnd; Office G14	Vinyl Floor tiles with bitumen adhesive to concrete floor. floor - beneath linoleum	20m ²	
	Sample No (S,SP,P,As)	Product Type	Surface Treatment	Condition	Accessibility
	As AB003346 (SP)	Reinforced Composite (1)	Completely Sealed (0)	Low Damage (1)	Easily disturbed (2)

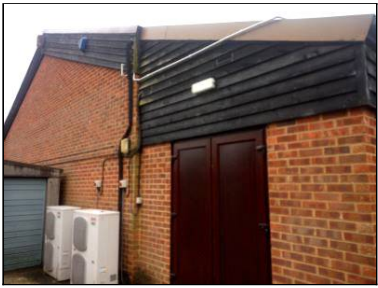
Survey Date:	Lead Surveyor	Survey Type	Floor	Analysis
	18 Feb 2019	Dayle Warsop	Management Survey with part Refurbishment/Demolition	External	No asbestos detected
	Building	Room	Item	Quantity	
	Village Hall; Main building	External; Main building E01	No Suspect asbestos containing items visually identified. Primary surfaces only	0	
	Sample No (S,SP,P,As)	Product Type	Surface Treatment	Condition	Accessibility
	Visual (P)	N/A	N/A	N/A	N/A

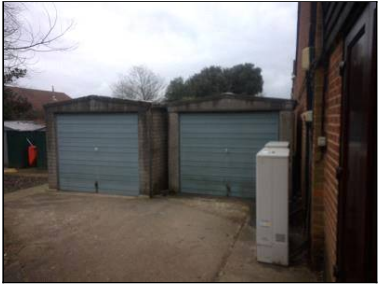
Survey Date:	Lead Surveyor	Survey Type	Floor	Analysis
	18 Feb 2019	Dayle Warsop	Management Survey with part Refurbishment/Demolition	External	Chrysotile (1)
	Building	Room	Item	Quantity	
	Village Hall; Main building	External; Garages x 2 E02	Corrugated cement ceilings/ roofs x 2 (large corrugations) garages roofs x 2	20m ²	
	Sample No (S,SP,P,As)	Product Type	Surface Treatment	Condition	Accessibility
	AB003349 (S)	Asbestos Cement (1)	Surface Sealed (1)	Low Damage (1)	Easily disturbed (2)

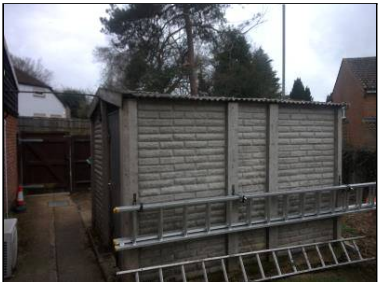
Survey Date:	Lead Surveyor	Survey Type	Floor	Analysis
	18 Feb 2019	Dayle Warsop	Management Survey with part Refurbishment/Demolition	External	Chrysotile (1)
	Building	Room	Item	Quantity	
	Village Hall; Main building	External; Shed E03	Corrugated cement ceilings/ roofs (small corrugations) shed roofs	12m ²	
	Sample No (S,SP,P,As)	Product Type	Surface Treatment	Condition	Accessibility
	As AB003349 (SP)	Asbestos Cement (1)	Surface Sealed (1)	Low Damage (1)	Easily disturbed (2)
