## Asbestos surveys – summary of reports

## Management Survey

Site: The Hub, Civic Approach, Uckfield, TN22 2AL  
Client: Uckfield Town Council  
Report No: J005397  
Survey Date: 30th September 2015  
Report Date: 2nd October 2015  
Surveyors: Paul Veness  
Report Produced By: Report Authorised By:

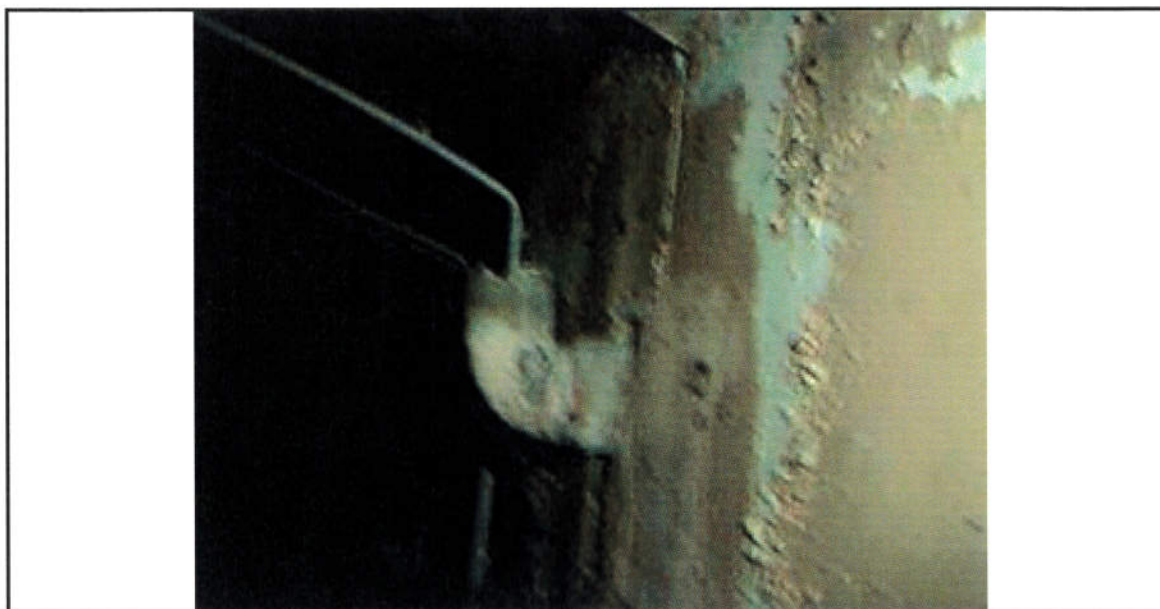
| Item No | Sample ID | Building | Floor | Room No | Room Description | Location | Extent in m2 | Substrate | Product type | Condition | Surface treatment | Asbestos type | Accessibility | Total risk assessment score | Risk category |
|---|---|---|---|---|---|---|---|---|---|---|---|---|---|---|---|
| 1 | Presumed | the hub, uckfield | Roof Void | 1 | roof void above rear lobby | to south wall - disused cement flue pipe | <1m | Bonded, Brick | (1) Asbestos Cement | (1) Low Damage | 1 | (1) Chrysotile | (0) Usually inaccessible or unlikely to be disturbed | 4 | D |

| Recommended Action: | Low risk ACM (Bound in matrix). Where appropriate label with warning signs. Undertake routine inspections for damage and deterioration. Work on this material does not require a license. Work on this material may be notifiable to the appropriate enforcing authority. Disposal of asbestos waste by a licensed contractor only. All work must conform to the 'Control of Asbestos Regulations 2012'. |

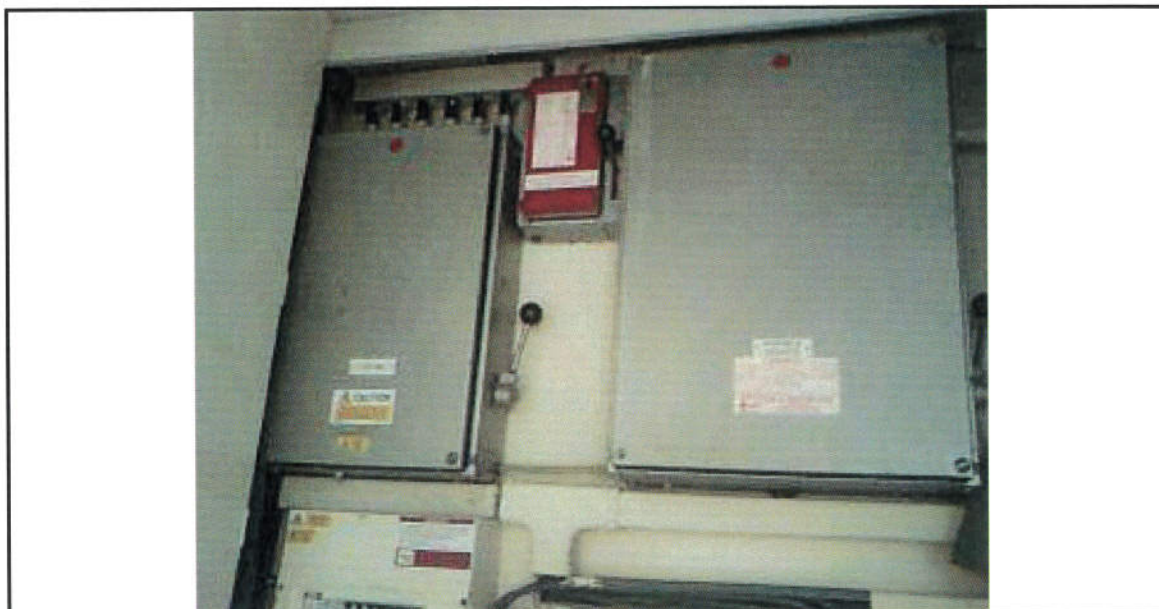
| Item No: | 16 |

| Item No | Sample ID | Building | Floor | Room No | Room Description | Location | Extent in m2 | Substrate | Product type | Condition | Surface treatment | Asbestos type | Accessibility | Total risk assessment score | Risk category |
|---|---|---|---|---|---|---|---|---|---|---|---|---|---|---|---|
| 16 | Presumed | the hub, uckfield | Ground Floor | 15 | main office | within electrical switchgear - possible rope products | <11m | Bonded, Metal | (2) Asbestos Textiles/Paper | (0) Good Condition | 2 | (1) Chrysotile | (0) Usually inaccessible or unlikely to be disturbed | 5 | C |

| Recommended Action: | Inaccessible further investigation is required. To determine the material, access, sampling and analysis would be required. Until this is carried out it must be presumed to be an ACM (Asbestos Containing Material). |

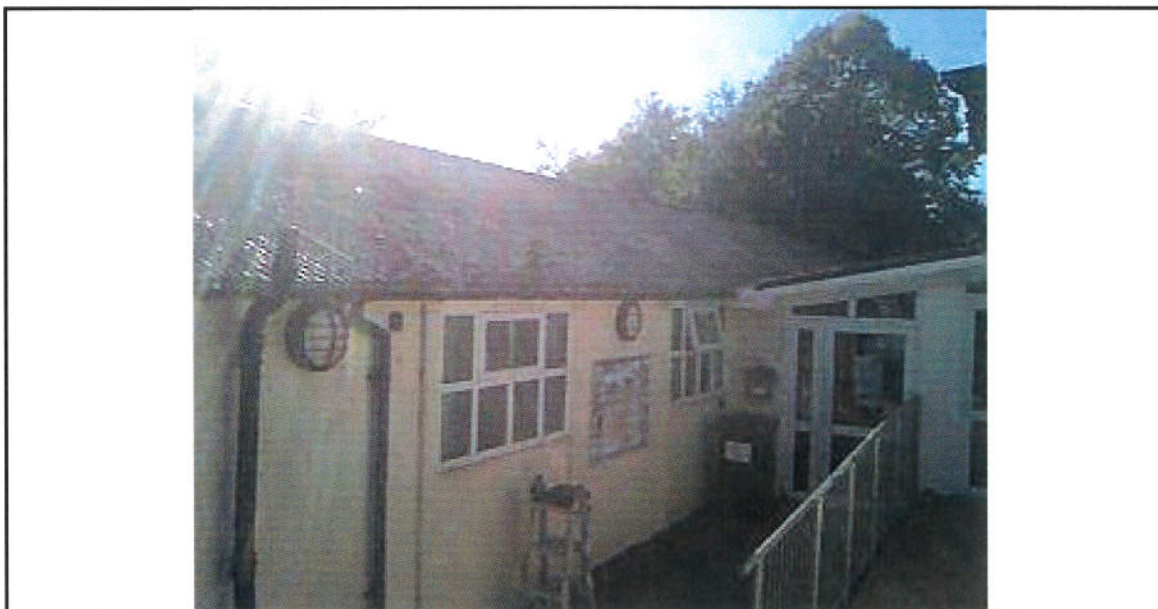
| Item No | Sample ID | Building | Floor | Room No | Room Description | Location | Extent in m2 | Substrate | Product type | Condition | Surface treatment | Asbestos type | Accessibility | Total risk assessment score | Risk category |
|---|---|---|---|---|---|---|---|---|---|---|---|---|---|---|---|
| 23 | BE003836 | the hub, uckfield | External | 1 | external elements | roof - cement profile sheets | 280m <sup>2</sup> | Bolted, Concrete | (1) Asbestos Cement | (0) Good Condition | 1 | (1) Chrysotile | (0) Usually inaccessible or unlikely to be disturbed | 3 | D |

| Recommended Action: | Low risk ACM (Bound in matrix). Where appropriate label with warning signs. Undertake routine inspections for damage and deterioration. Work on this material does not require a license. Work on this material may be notifiable to the appropriate enforcing authority. Disposal of asbestos waste by a licensed contractor only. All work must conform to the 'Control of Asbestos Regulations 2012'. |

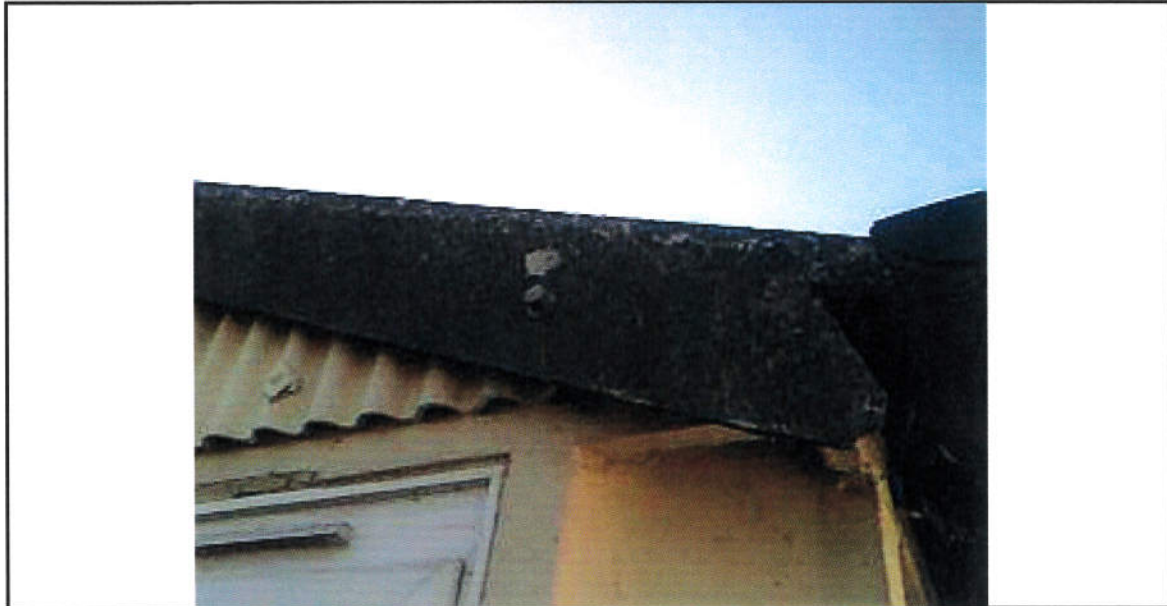
**1.3** Sample BE003837 - Material: External cement verge plates. Location: external elements / to gable ends. – Recommendation: Where appropriate label with warning signs and re-inspect in 12 months.

| Item No | Sample ID | Building | Floor | Room No | Room Description | Location | Extent in m2 | Substrate | Product type | Condition | Surface treatment | Asbestos type | Accessibility | Total risk assessment score | Risk category |
|---|---|---|---|---|---|---|---|---|---|---|---|---|---|---|---|
| 24 | BE003837 | the hub, uckfield | External | 1 | external elements | to gable ends - cement verge plates | 16lm | Bolted, Metal | (1) Asbestos Cement | (1) Low Damage | 1 | (1) Chrysotile | (0) Usually inaccessible or unlikely to be disturbed | 4 | D |

| Recommended Action: | Low risk ACM (Bound in matrix). Where appropriate label with warning signs. Undertake routine inspections for damage and deterioration. Work on this material does not require a license. Work on this material may be notifiable to the appropriate enforcing authority. Disposal of asbestos waste by a licensed contractor only. All work must conform to the 'Control of Asbestos Regulations 2012'. |

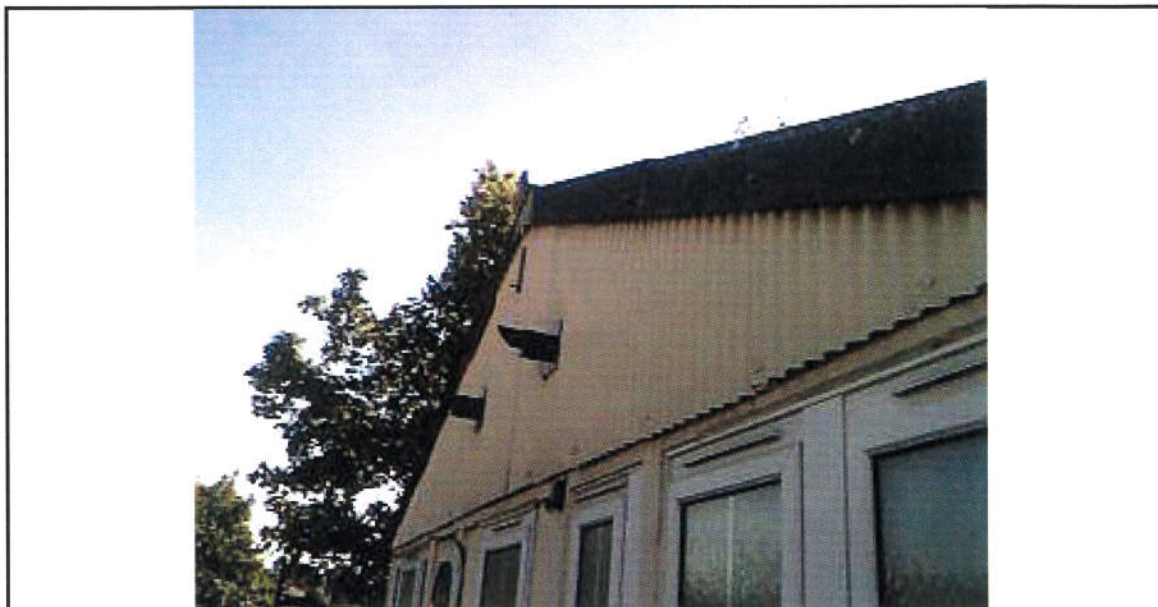
**1.4** Sample BE003838 – Material: External cement profile sheets. Location: external elements / side cladding to gable ends. – Recommendation: Where appropriate label with warning signs and re-inspect in 12 months.

| Item No | Sample ID | Building | Floor | Room No | Room Description | Location | Extent in m2 | Substrate | Product type | Condition | Surface treatment | Asbestos type | Accessibility | Total risk assessment score | Risk category |
|---|---|---|---|---|---|---|---|---|---|---|---|---|---|---|---|
| 25 | BE003838 | the hub, uckfield | External | 1 | external elements | side cladding to gable ends - cement profile sheets | 22m <sup>2</sup> | Bolted, Concrete | (1) Asbestos Cement | (0) Good Condition | 1 | (1) Chrysotile | (0) Usually inaccessible or unlikely to be disturbed | 3 | D |

| Recommended Action: | Low risk ACM (Bound in matrix). Where appropriate label with warning signs. Undertake routine inspections for damage and deterioration. Work on this material does not require a license. Work on this material may be notifiable to the appropriate enforcing authority. Disposal of asbestos waste by a licensed contractor only. All work must conform to the 'Control of Asbestos Regulations 2012'. |

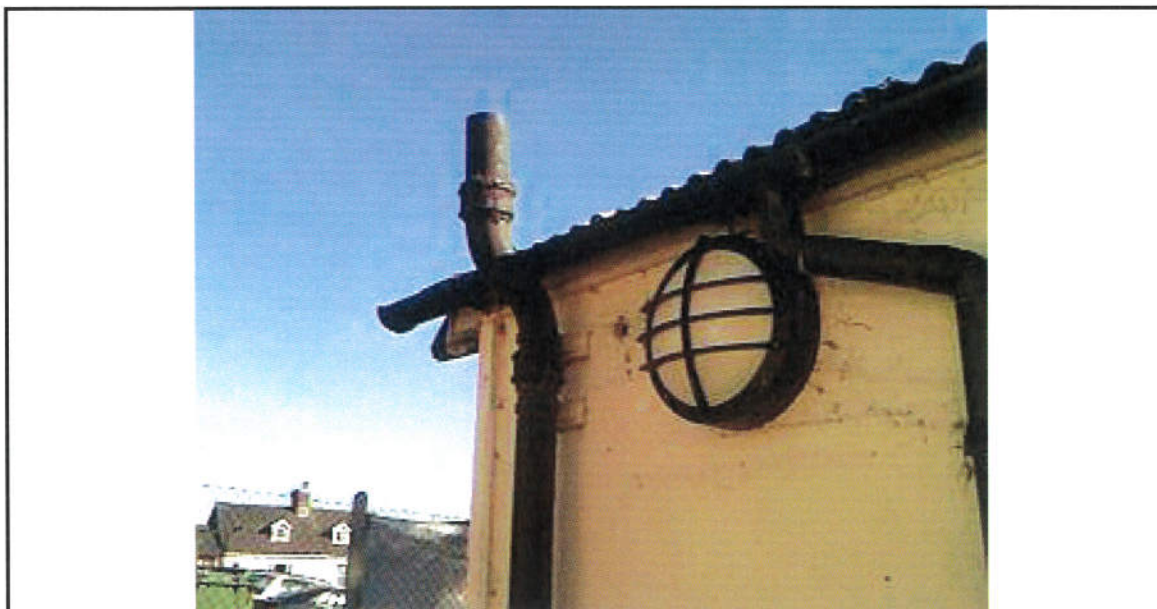
| Item No | Sample ID | Building | Floor | Room No | Room Description | Location | Extent in m2 | Substrate | Product type | Condition | Surface treatment | Asbestos type | Accessibility | Total risk assessment score | Risk category |
|---|---|---|---|---|---|---|---|---|---|---|---|---|---|---|---|
| 26 | BE003839 | the hub, uckfield | External | 1 | external elements | north elevation - cement soil pipe | 3lm | Bolted, Concrete | (1) Asbestos Cement | (0) Good Condition | 1 | (1) Chrysotile | (2) Easily disturbed | 3 | D |

| Recommended Action: | Low risk ACM (Bound in matrix). Where appropriate label with warning signs. Undertake routine inspections for damage and deterioration. Work on this material does not require a license. Work on this material may be notifiable to the appropriate enforcing authority. Disposal of asbestos waste by a licensed contractor only. All work must conform to the 'Control of Asbestos Regulations 2012'. |

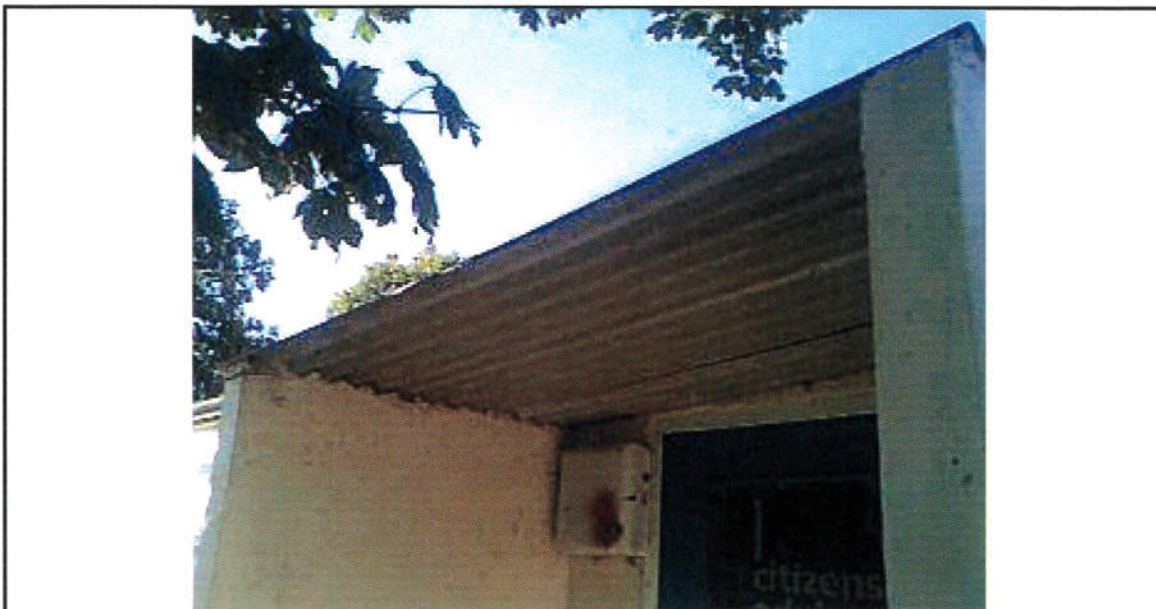
**1.5** Sample BE003840 - Material: External cement profile sheet. Location: external elements / south canopy. Recommendation: Where appropriate label with warning signs and re-inspect in 12 months.

| Item No | Sample ID | Building | Floor | Room No | Room Description | Location | Extent in m2 | Substrate | Product type | Condition | Surface treatment | Asbestos type | Accessibility | Total risk assessment score | Risk category |
|---|---|---|---|---|---|---|---|---|---|---|---|---|---|---|---|
| 27 | BE003840 | the hub, uckfield | External | 1 | external elements | south canopy - cement profile sheet | 2m² | Bonded, Brick | (1) Asbestos Cement | (0) Good Condition | 1 | (1) Chrysotile | (1) Occasionally likely to be disturbed | 3 | D |

| Recommended Action: | Low risk ACM (Bound in matrix). Where appropriate label with warning signs. Undertake routine inspections for damage and deterioration. Work on this material does not require a license. Work on this material may be notifiable to the appropriate enforcing authority. Disposal of asbestos waste by a licensed contractor only. All work must conform to the 'Control of Asbestos Regulations 2012'. |
