Building P
Priddys Hard
Gosport

E02702 - P2401

Condition & Repair Survey
As Existing
Floor & RCP Plan

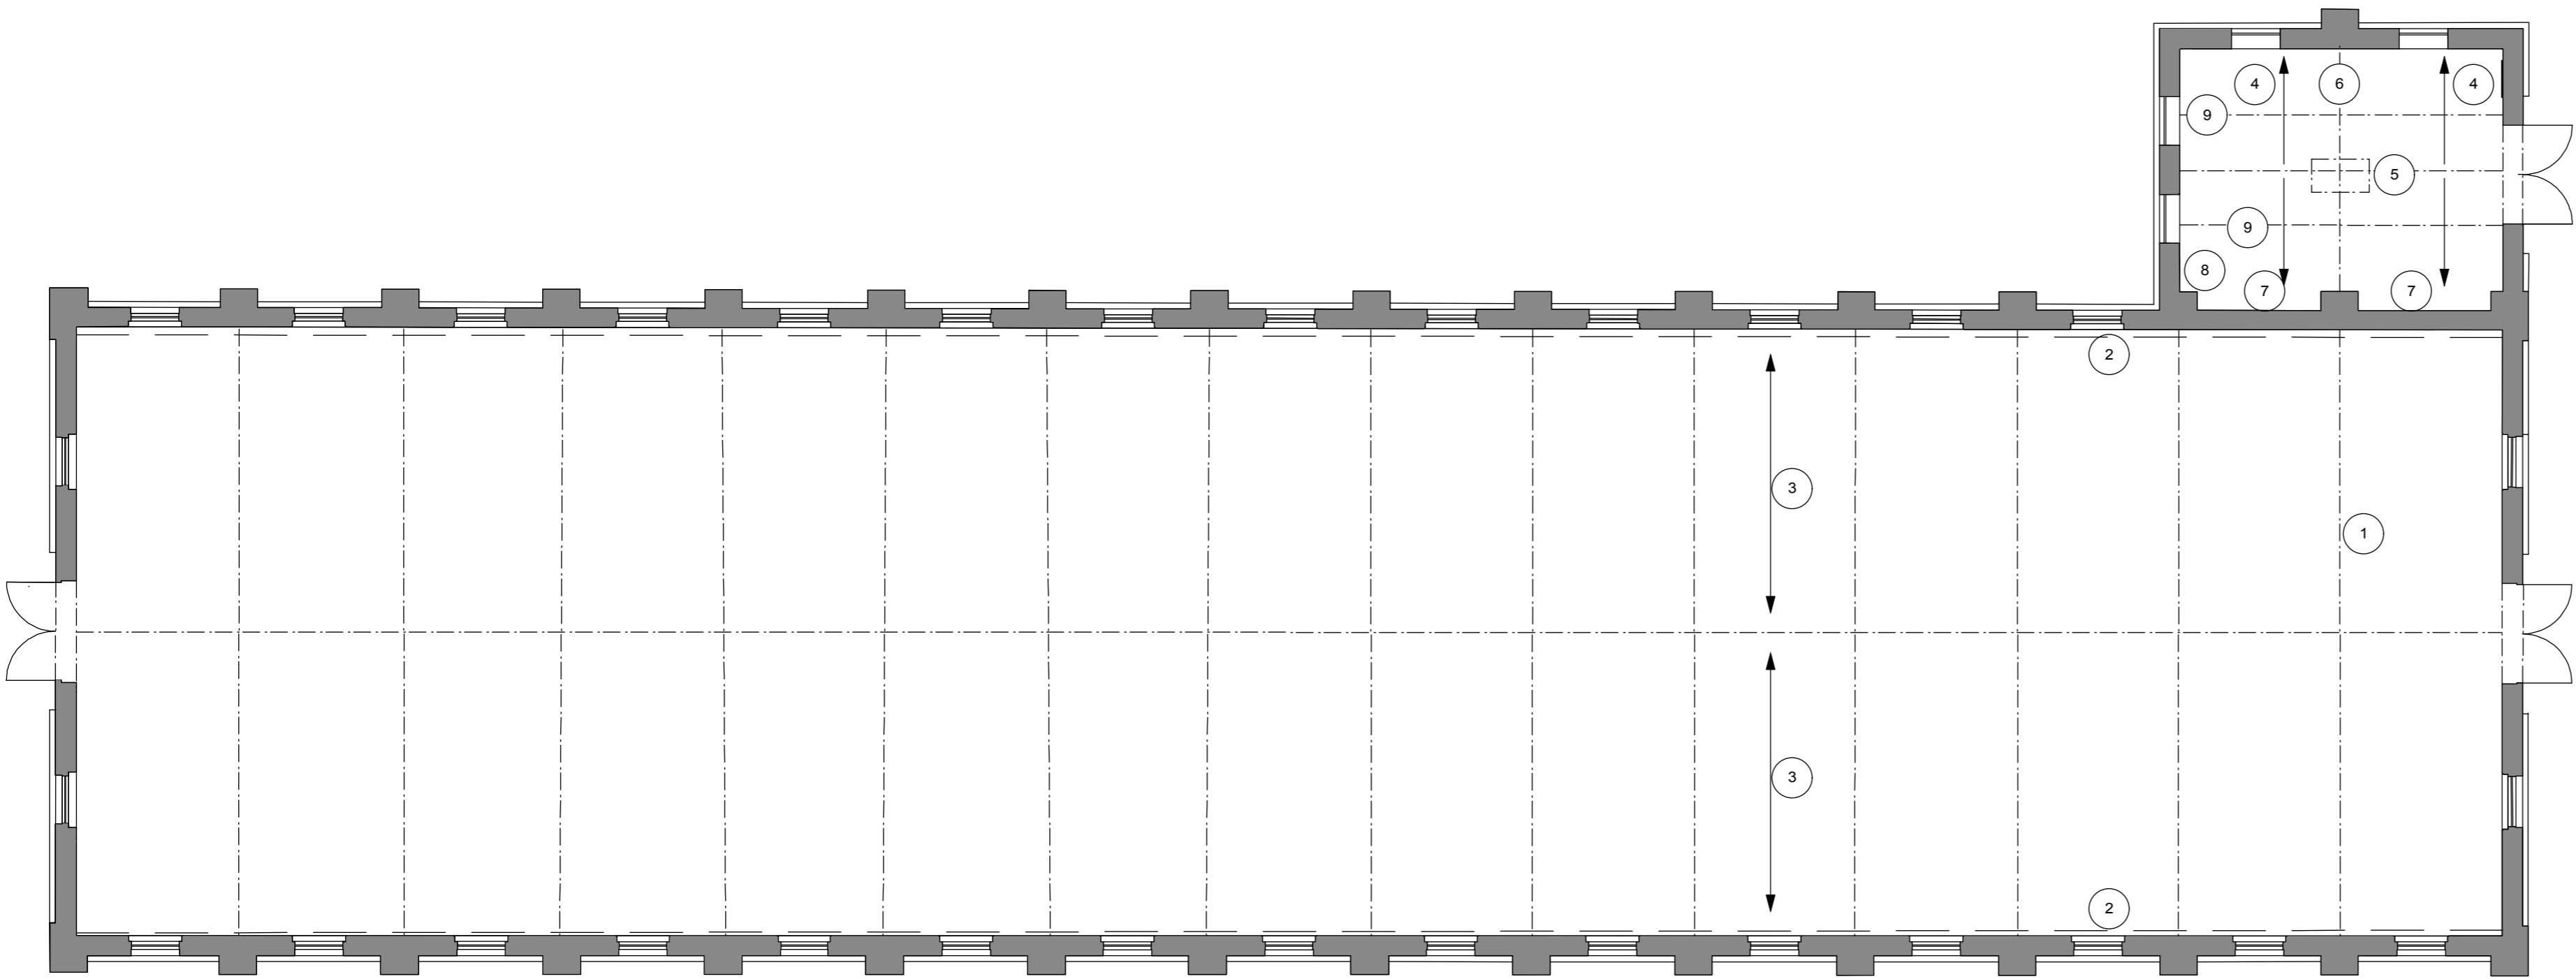
Reflected Ceiling plan

Condition Survey: High Level and Ceiling

- 1. Steel Fan Trusses
- 2. Steel Gantry system
- 3. Timber sarking boards
- 4. Asbestos Ceiling boards
- 5. Timber Roof Vent - exposed sarking boards
- 6. Timber Kingpost Truss
- 7. Wallplate and valley rotten indicates evidence of roof failure above.
- 8. HL Damp resulting from item 7.
- 9. Timber Purlins

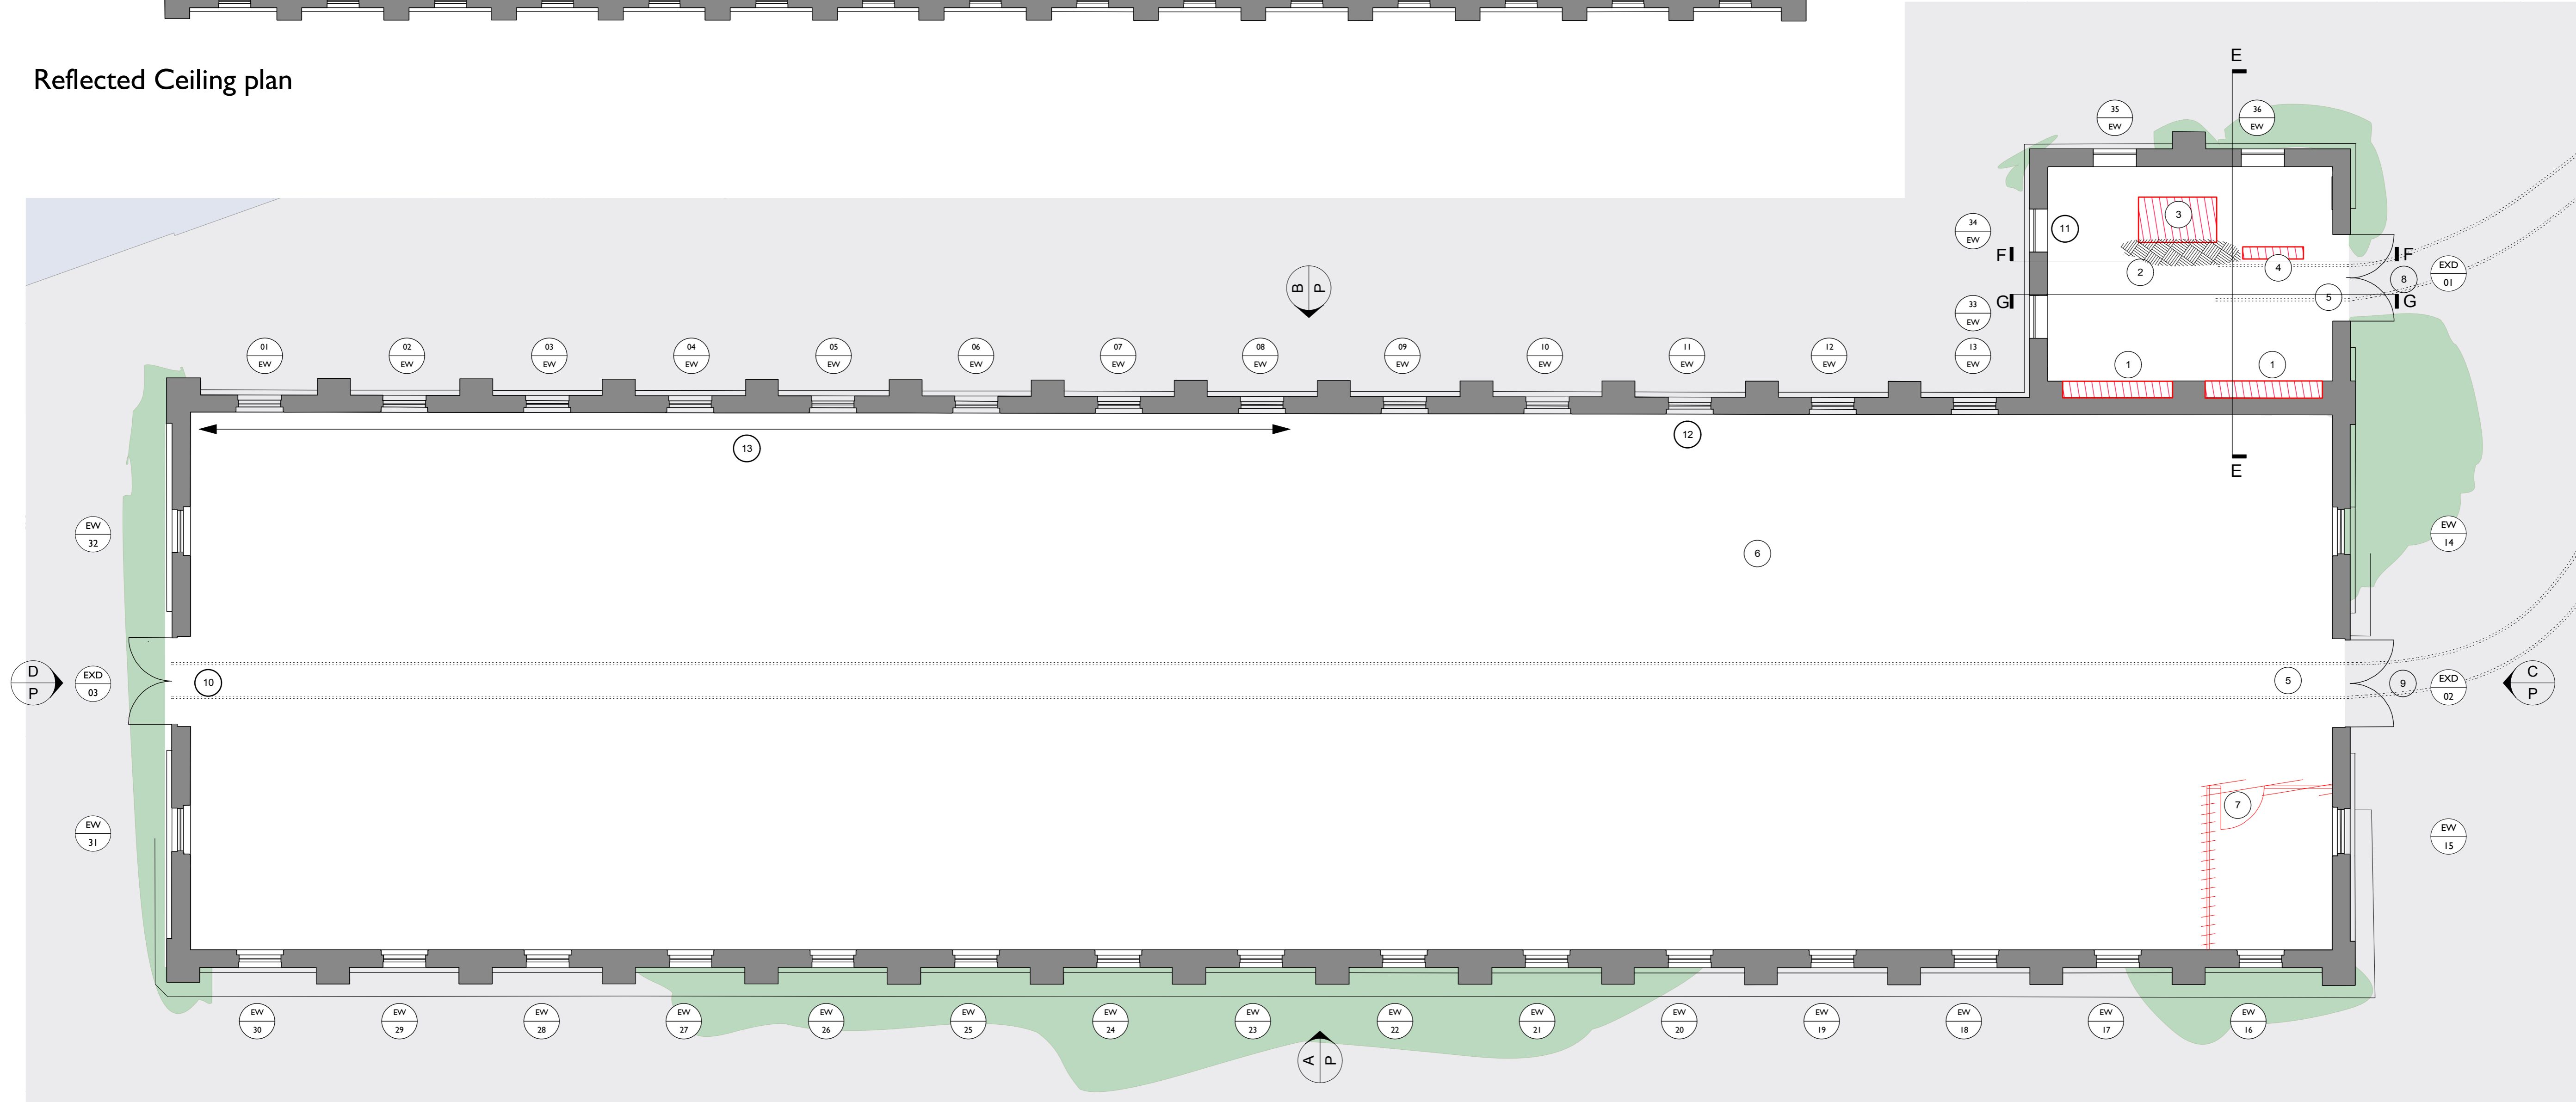
Existing Floor plan

Condition Survey: General Floor Plan

- 1. Floor Boards and joist ends rotten.
- 2. Pile of hazardous waste.
- 3. Area of concrete floor.
- 4. Floor missing
- 5. Rail tracks.
- 6. Concrete Floor
- 7. Internal partition and door
- 8. EXD-01
- 9. EXD-02
- 10. EXD-03
- 11. EW-34 Frame and casement
- 12. Casement damaged - missing mullion at low level
- 13. Internally boarded over
