Pre-Refurbishment & Demolition Asbestos Survey for Witney Town Council

2x outbuildings at West Witney Sports Grounds Burford Road Witney OX29 0NB

Amiantus Environmental Consultants Ltd.

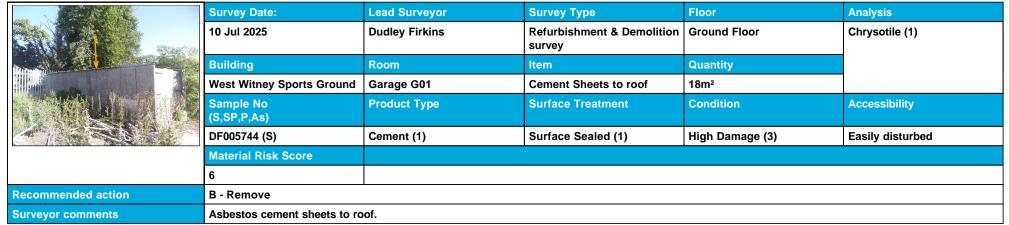
| | Survey Date: | Lead Surveyor | Survey Type | Floor | Analysis | | |
|---|---|---|---|---|---|--|--|
| | As DF005744 (SP) | Cement (1) | Surface Sealed (1) | High Damage (3) | Easily disturbed | | |

| | Survey Date: | Lead Surveyor | Survey Type | Floor | Analysis | | |
|---|---|---|---|---|---|--|--|
| Recommended action | B - Remove | | | | | | |
