The Garland Company UK, Ltd.

Roof Asset Management Programme

Shire House, Lower Flat Roofs Condition Survey

Report Date: 31/01/2019

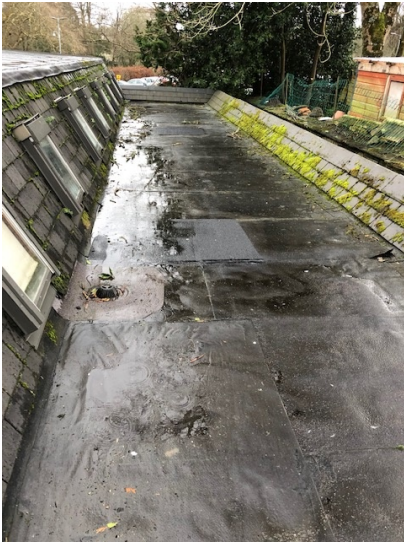
Photo 1

Overviews of the roof for reference

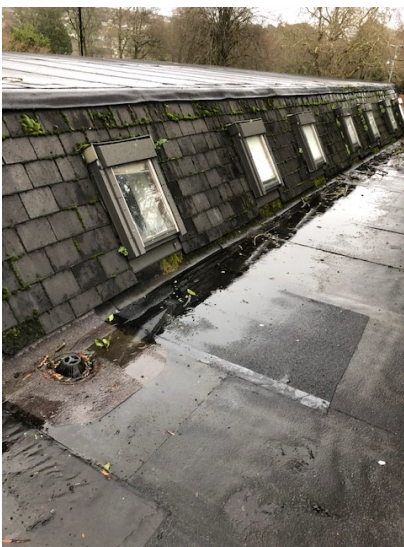
Photo 2

Velux lights are suitably high to leave in place

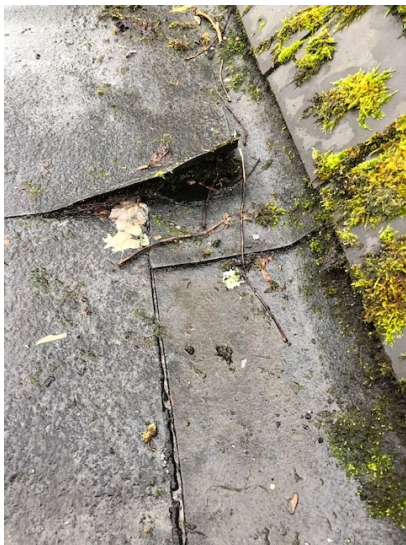
Photo 5

The felt was initially covered with a mineral surface which would have acted as a protector from UV light. However, over the years this has been worn away leaving the bitumen surface exposed. UV light dries the bitumen membranes out and takes away a number of the properties from the felt. It becomes brittle and fragile and more susceptible to splits, cracks and lap issues as thermal and building movement put it under excessive stress.

The system has lasted well at 35 years old and has simply come to the end of its serviceable life. Sections of ponding water have accelerated the degradation in some areas and any new system would be designed to minimise the amount of water on the roof system.

The felt membranes are splitting and coming off their laps across all sections

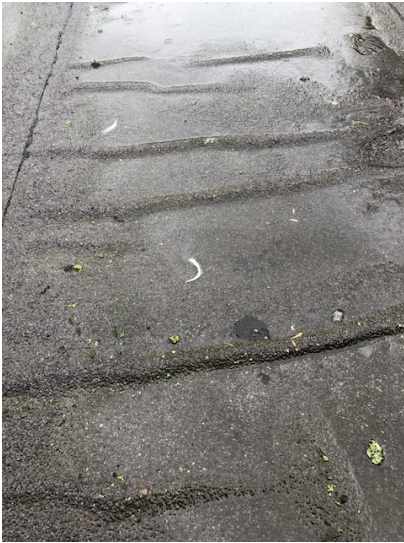
Photo 16

Patch repairs have been attempted but these are already failing with blisters appearing across the surface even under the latest patch repairs.

Repairs are poor and are failing

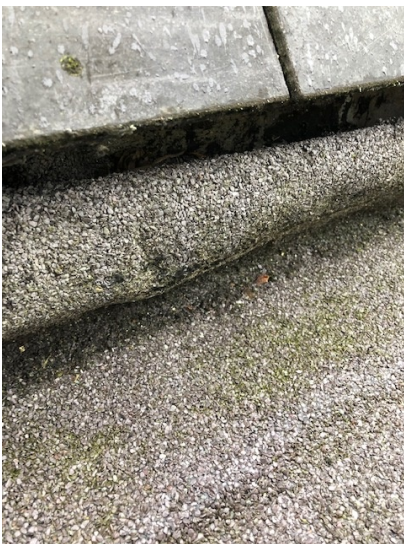
Photo 18

Edge details are poor. One area has completely slumped away from its upstand and is no longer providing an effective detail. The lead work into the main building is poor and needs replacing. However, due to the building status there will be no requirement to raise these flashings. Existing chases can be used and re cut if necessary as a gutter is formed along this section.

Upstand completely slumped away and failed

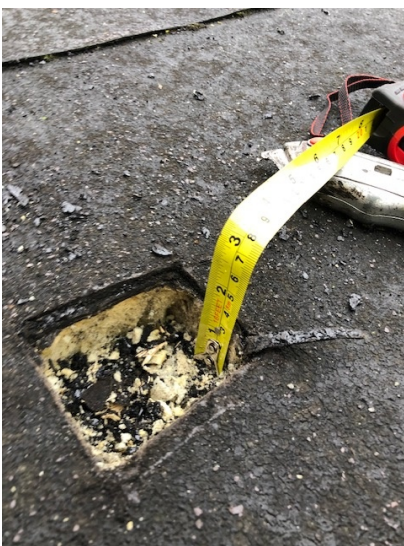
Photo 21

Core samples showed the roof to have areas that are saturated and some that are dry. The build up gives the roof a current u value of 0.65w/m2k. Current building regulations require a u value of 0.18w/m2k. The new scheme will achieve this and offer energy savings of approximately 16%.

Core sample showing insulation and roof build up
