## Annual Inspection

West Swindon Parish Council

Clayhill

Clayhill Copse, Swindon, Wiltshire, SN5 5AL

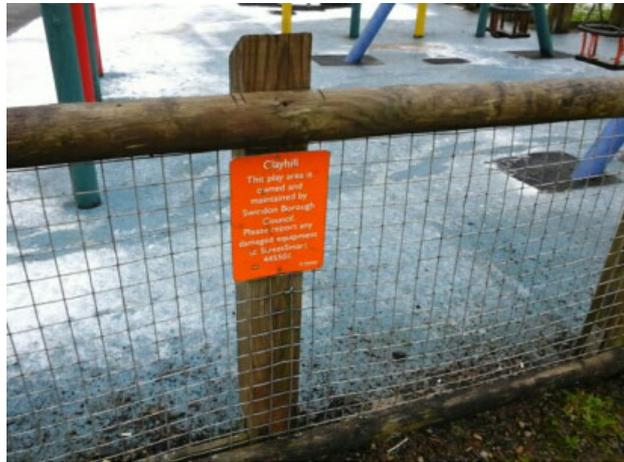
**Item:** Ancillary Items - Sign  
**Manufacturer:** Owner/Operator  
**Surface Type:** N/A  
**Equipment Compliance:** N/A  
**Surface Area Compliance:** N/A  
**Ref/Part Number:**  
**Total Findings:** 1

This item is satisfactory - no work required

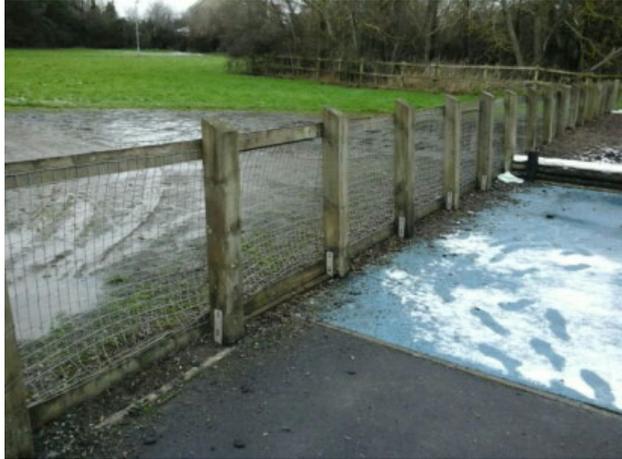
**Item:** Ancillary Items - Fence - Timber & Mesh Infill  
**Manufacturer:** Owner/Operator  
**Surface Type:** N/A  
**Equipment Compliance:** N/A  
**Surface Area Compliance:** N/A  
**Ref/Part Number:**  
**Total Findings:** 3

There are a number of loose posts around the fence - Monitor for any further deterioration and reset as required

There is some damage to the fence sections - Monitor for any further deterioration and repair as required

There is some evidence of rot in the timber - Monitor for any further deterioration and replace as required

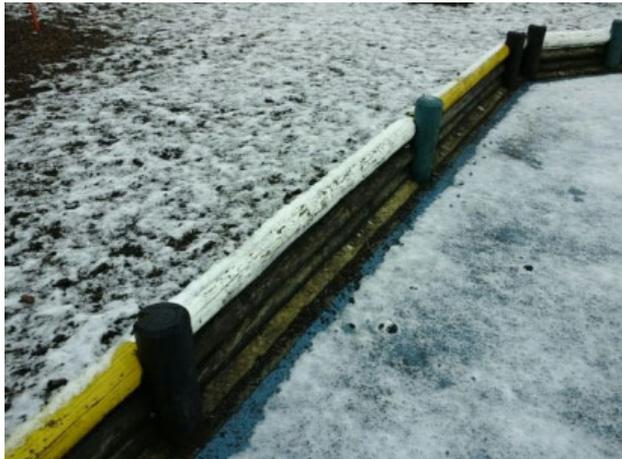
**Item:** Ancillary Items - Palisade Logs  
**Manufacturer:** Owner/Operator  
**Surface Type:** N/A  
**Equipment Compliance:** N/A  
**Surface Area Compliance:** N/A  
**Ref/Part Number:**  
**Total Findings:** 1

There is some evidence of rot in the timber - Monitor for any further deterioration and replace as required

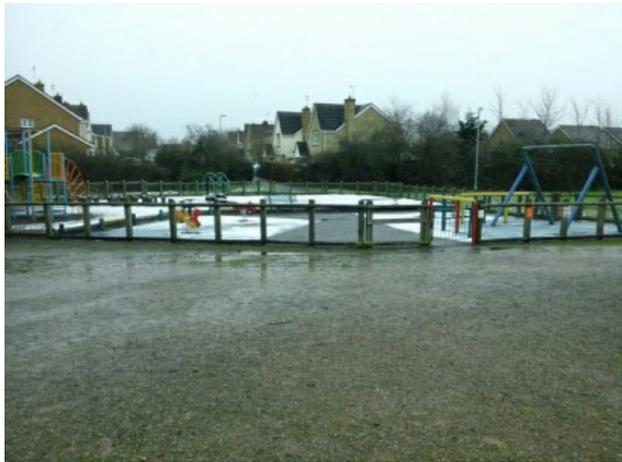
**Item:** Ancillary Items - Site General  
**Manufacturer:** Owner/Operator  
**Surface Type:** N/A  
**Equipment Compliance:** N/A  
**Surface Area Compliance:** N/A  
**Ref/Part Number:**  
**Total Findings:** 3

There are gaps opening between the wet pour surfacing and the edging surround or between the joints in the surfacing - Monitor for any further deterioration and repair as required

The wet pour surfacing is lifting at the edges and creating trip points - Repair perimeter of surfacing to remove trip points

The level of loose fill surfacing has fallen significantly below the minimum 200mm recommended by BS EN 1176 Part 1 throughout the bark surface area exposing footings and base mounts - Top up loose fill surfacing to recommended levels and ensure that any exposed mounts/footings have sufficient coverage of bark mulch.

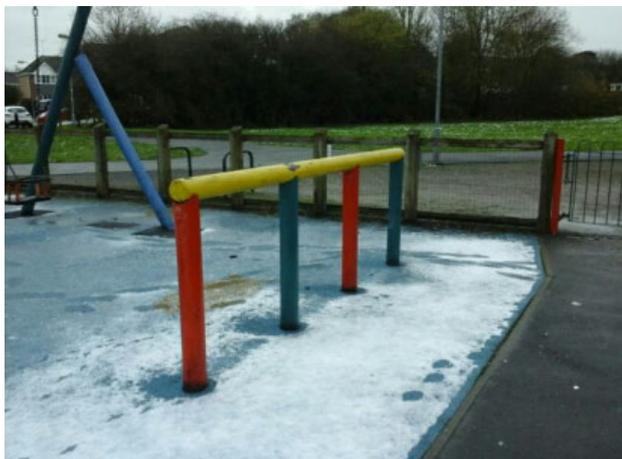
**Item:** Swings - Swing Barrier  
**Manufacturer:** Owner/Operator  
**Surface Type:** N/A  
**Equipment Compliance:** N/A  
**Surface Area Compliance:** N/A  
**Ref/Part Number:**  
**Total Findings:** 1

There is/are bolt cap covers missing or damaged on the item - Replace missing or damaged bolt cap covers

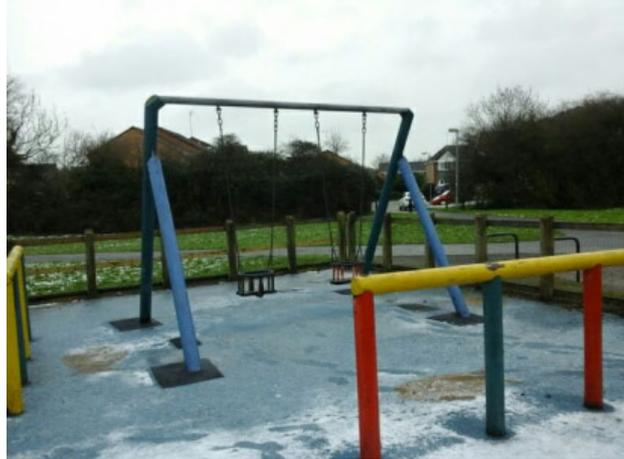
**Item:** Swings - 1 Bay 2 Seat (Cradle)  
**Manufacturer:** Playdale Playgrounds Ltd  
**Surface Type:** Wet Pour  
**Equipment Compliance:** No  
**Surface Area Compliance:** Yes  
**Ref/Part Number:**  
**Total Findings:** 6

The chain openings are in excess of 8.6mm as recommended by BS EN 1176 - Monitor use and replace with compliant chains during next maintenance cycle

BS EN 1176:2008 requires an additional 0.5m of unobstructed space at each end of the swing surfacing area. This is a relatively low risk finding and no remedial action is recommended at this point. - Monitor use

There are caps missing from the underside of the seats - Replace missing caps under the seats

The seat has minor damage or wear - Monitor for any further deterioration and replace as required

There is some notable evidence of chain wear - Monitor for any further deterioration and replace when 40% worn

There is some evidence of rot in the timber posts - Monitor for any further deterioration and replace as required

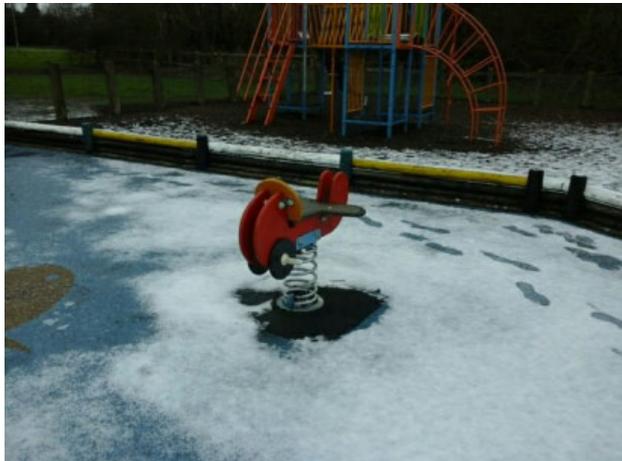
**Item:** Rocking Equipment - Spring  
 Aeroplane  
**Manufacturer:** Kompan Ltd  
**Surface Type:** Wet Pour  
**Equipment Compliance:** No  
**Surface Area Compliance:** Yes  
**Ref/Part Number:**  
**Total Findings:** 2

The end of handgrips and/or footrests have a cross section of less than 15cm<sup>2</sup> and fail to meet the requirements of BS EN 1176:2008 Part 6 - This is a relatively low risk failure and no remedial action is recommended

The paintwork on the spring has been damaged or worn exposing the metal underneath which is rusting - Treat any rusting components and repaint

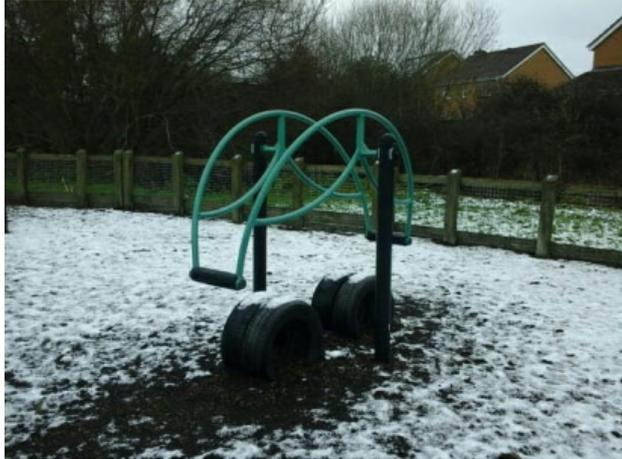
**Item:** Rocking Equipment - See Saw  
**Manufacturer:** Hags SMP  
**Surface Type:** Woodchip  
**Equipment Compliance:** Yes  
**Surface Area Compliance:** Yes  
**Ref/Part Number:**  
**Total Findings:** 1

The posts are slightly loose in the ground - Monitor for any further deterioration and repair as required

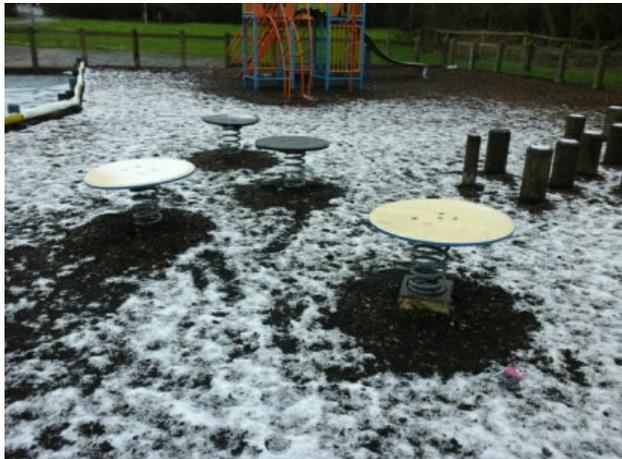
**Item:** Rocking Equipment - Spring Board  
**Manufacturer:** Not Identified  
**Surface Type:** Woodchip  
**Equipment Compliance:** No  
**Surface Area Compliance:** Yes  
**Ref/Part Number:**  
**Total Findings:** 4

The surface has eroded and the foundations are exposed - Reinstate surrounding surfaces to cover the foundations

There is/are missing fixing/s on the item - Replace all missing fixings

The spring mounting plates are slightly loose in the ground - Monitor for any further deterioration and repair as required

The stepping stones form a hard object within the falling space of the equipment in contravention of the requirements of BS EN 1176 Part 1 - Monitor use

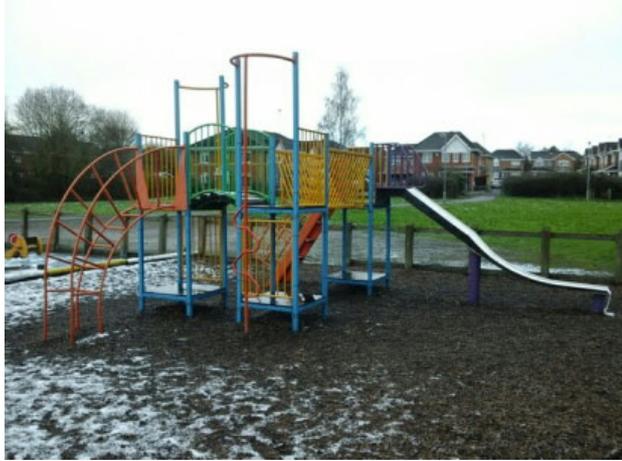
**Item:** Activity Equipment - Multi Play (Junior)  
**Manufacturer:** Not Identified  
**Surface Type:** Woodchip  
**Equipment Compliance:** No  
**Surface Area Compliance:** Yes  
**Ref/Part Number:**  
**Total Findings:** 9

The climbing element is slightly loose in the ground - Monitor for any further deterioration and repair as required

There are projecting bolt thread(s) present - Remove excess thread length and deburr or provide cap

Parts of the timber are rough or splintered - Remove all rough or sharp edges

The plywood has delaminated in some places - Remove all rough or splintered edges.

There is some evidence of rot in the timber - Monitor for any further deterioration and replace as required

There are a number of dents in the slide surface - Monitor for any further deterioration and repair as required

There are post caps missing from the item - Replace missing post caps

There is some graffiti present - Remove the graffiti

There is/are finger entrapment/s beneath the slide and the item fails to meet the requirements of BS EN 1176:2008 Part 1 4.2.7.6 Entrapment of fingers - Monitor use

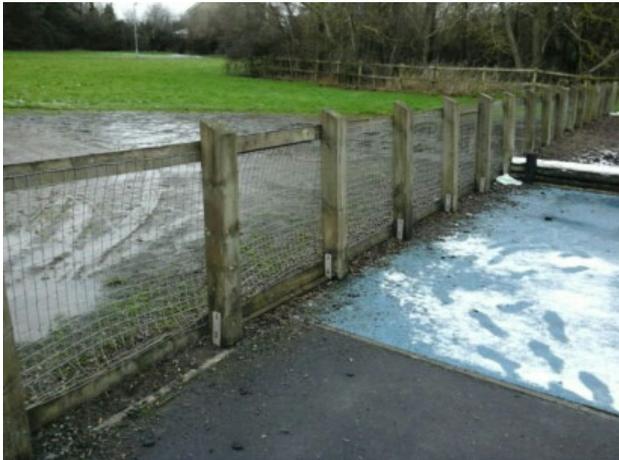
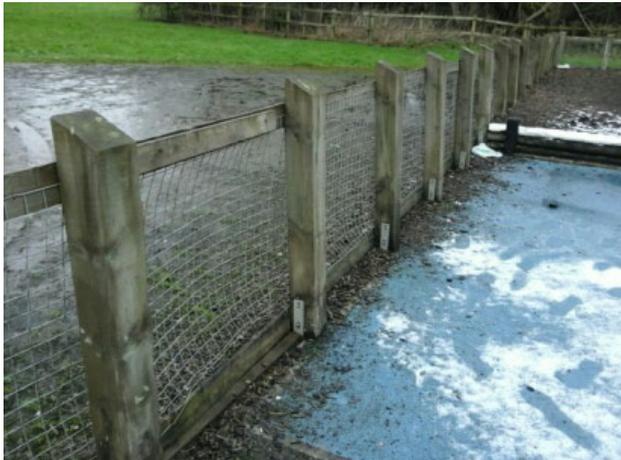
<b>6 - Low Risk (Finding 1)</b>			
<b>Item:</b>	Ancillary Items - Fence - Timber & Mesh Infill	<b>Risk Level:</b>	L - Low Risk
<b>Manufacturer:</b>	Owner/Operator	<b>Surface:</b>	N/A

<b>Finding:</b>	There are a number of loose posts around the fence	<b>Action:</b>	Monitor for any further deterioration and reset as required

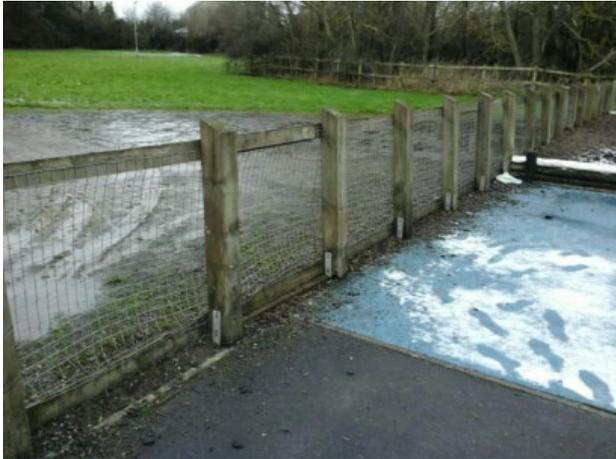
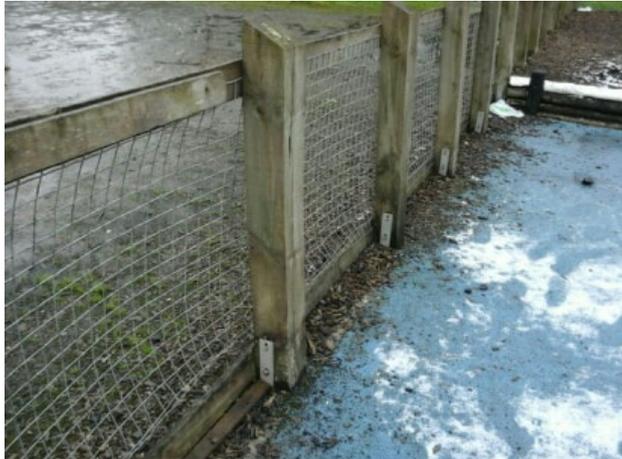
**6 - Low Risk (Finding 2)**

**Finding:** There is some damage to the fence sections  
**Action:** Monitor for any further deterioration and repair as required

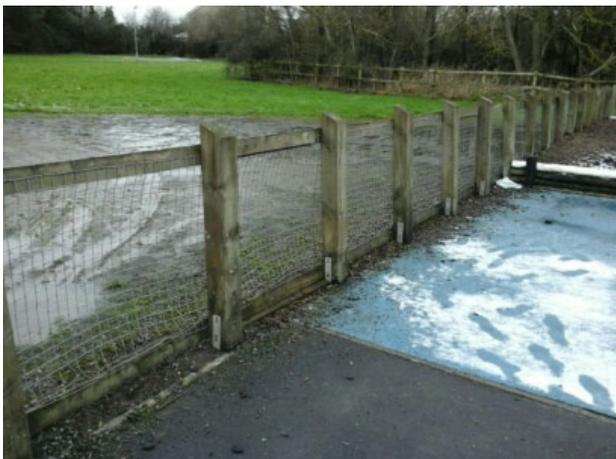
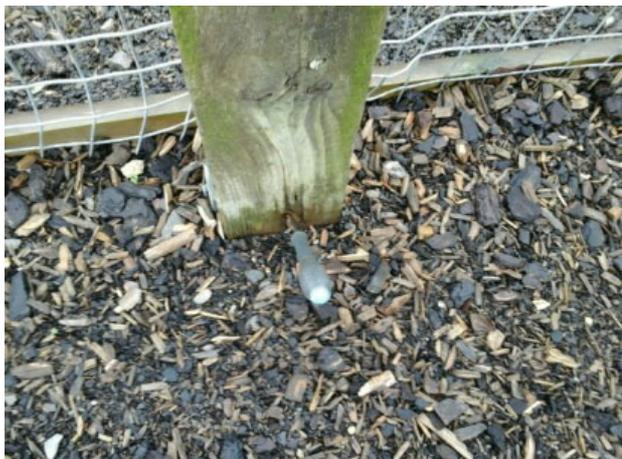
**8 - Low Risk (Finding 3)**

**Finding:** There is some evidence of rot in the timber  
**Action:** Monitor for any further deterioration and replace as required

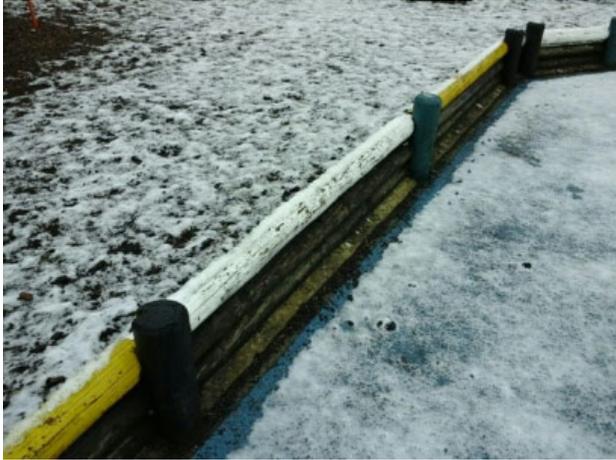
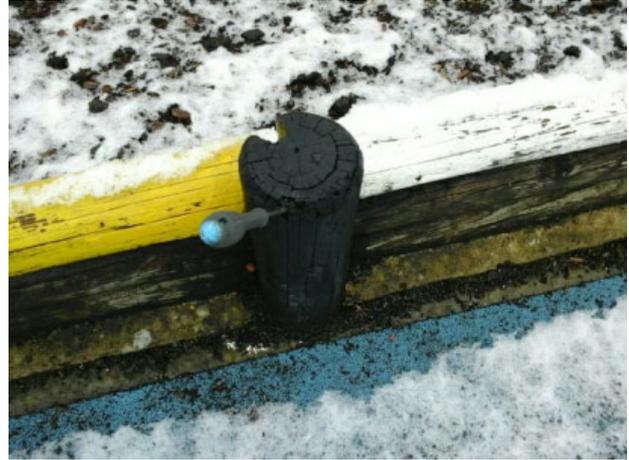
6 - Low Risk (Finding 1)

**Finding:** There is some evidence of rot in the timber

**Action:** Monitor for any further deterioration and replace as required

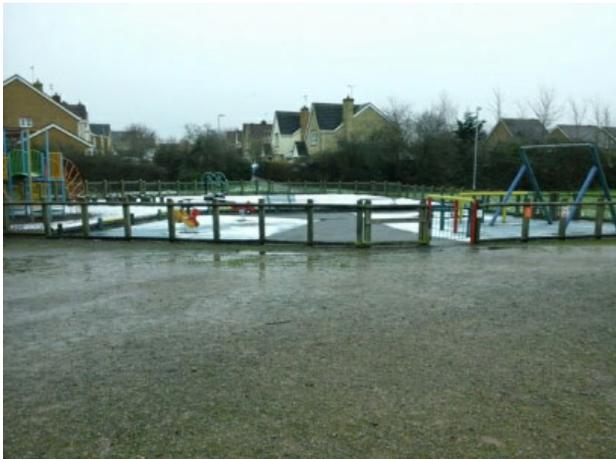
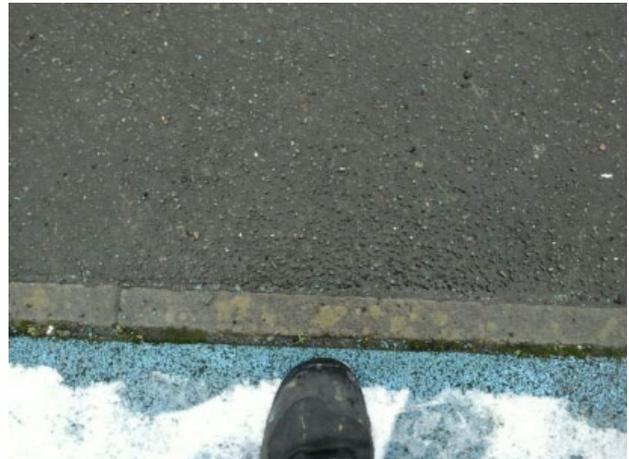
6 - Low Risk (Finding 1)

**Finding:** There are gaps opening between the wet pour surfacing and the edging surround or between the joints in the surfacing

**Action:** Monitor for any further deterioration and repair as required

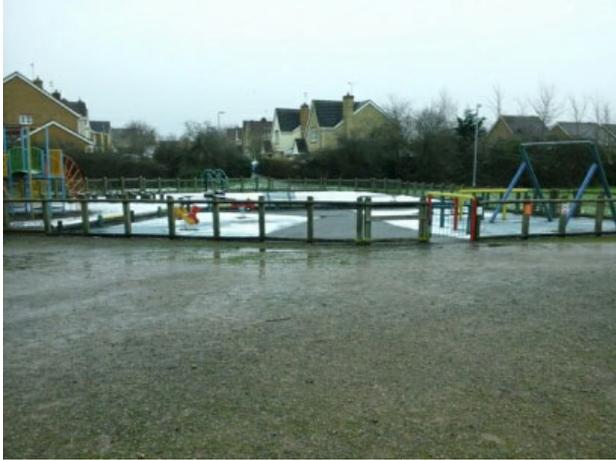
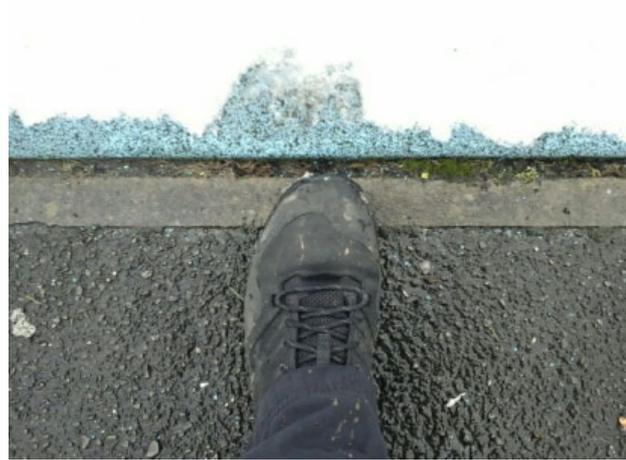
8 - Low Risk (Finding 2)

**Finding:** The wet pour surfacing is lifting at the edges and creating trip points

**Action:** Repair perimeter of surfacing to remove trip points

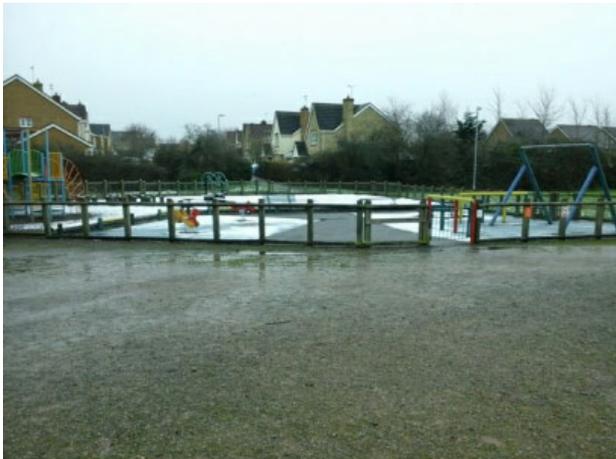
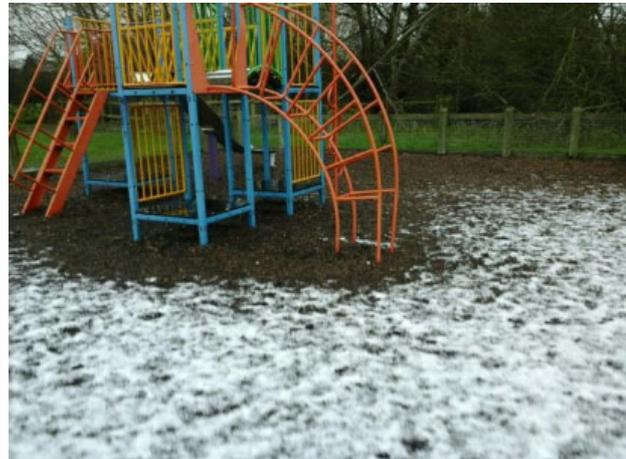
8 - Low Risk (Finding 3)

**Finding:** The level of loose fill surfacing has fallen significantly below the minimum 200mm recommended by BS EN 1176 Part 1 throughout the bark surface area exposing footings and base mounts

**Action:** Top up loose fill surfacing to recommended levels and ensure that any exposed mounts/footings have sufficient coverage of bark mulch.

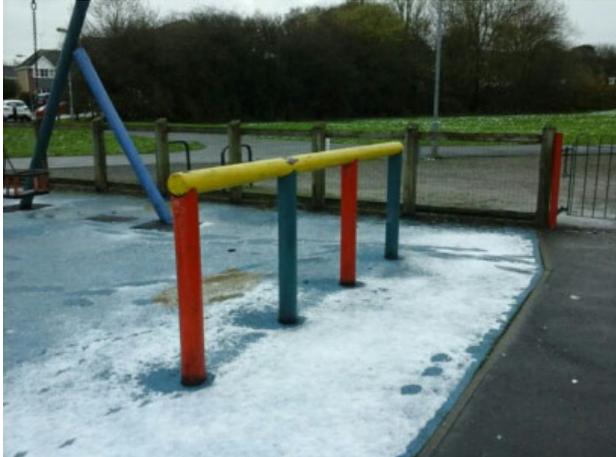
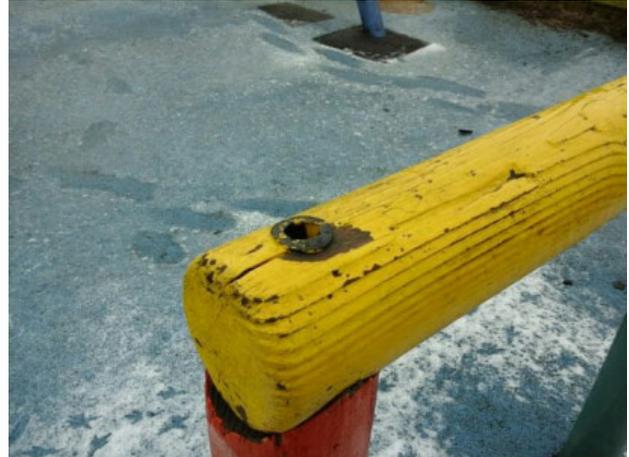
6 - Low Risk (Finding 1)

**Finding:** There is/are bolt cap covers missing or damaged on the item

**Action:** Replace missing or damaged bolt cap covers

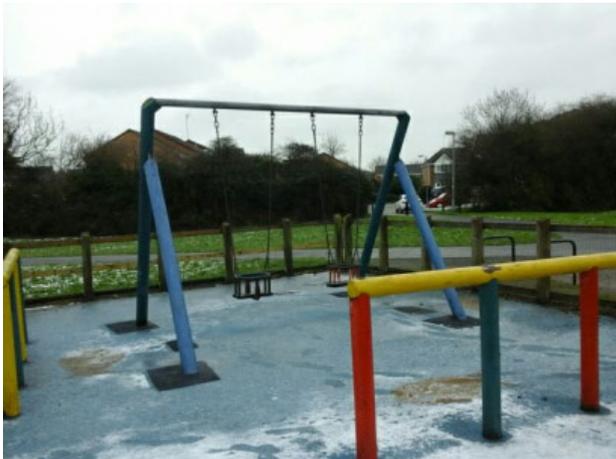
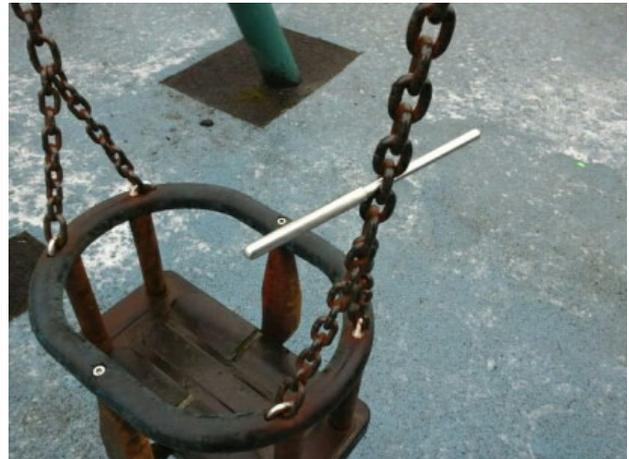
4 - Very Low Risk (Finding 1)

**Finding:** The chain openings are in excess of 8.6mm as recommended by BS EN 1176

**Action:** Monitor use and replace with compliant chains during next maintenance cycle

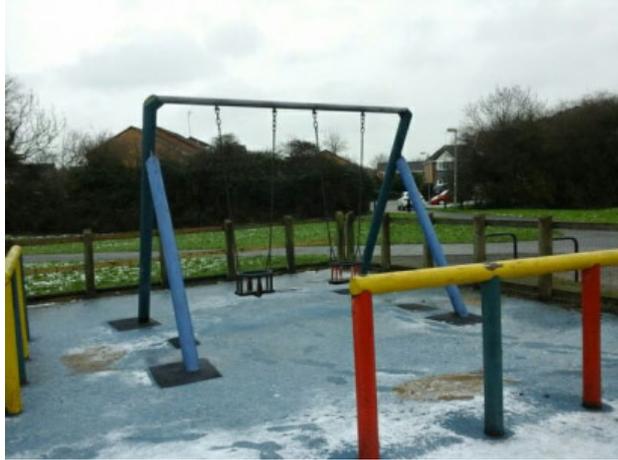
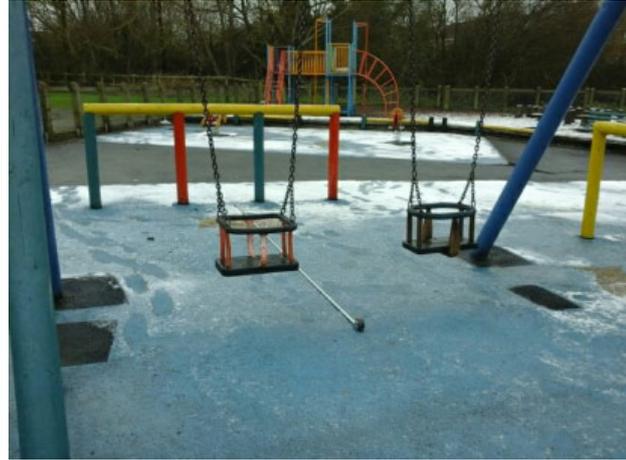
8 - Low Risk (Finding 2)

**Finding:** BS EN 1176:2008 requires an additional 0.5m of unobstructed space at each end of the swing surfacing area. This is a relatively low risk finding and no remedial action is recommended at this point.  
**Action:** Monitor use

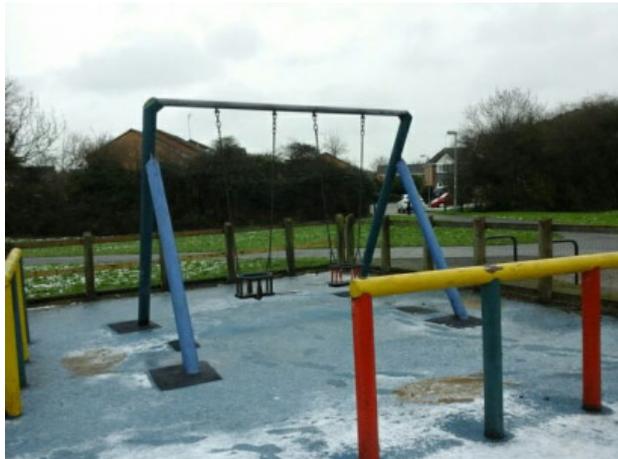
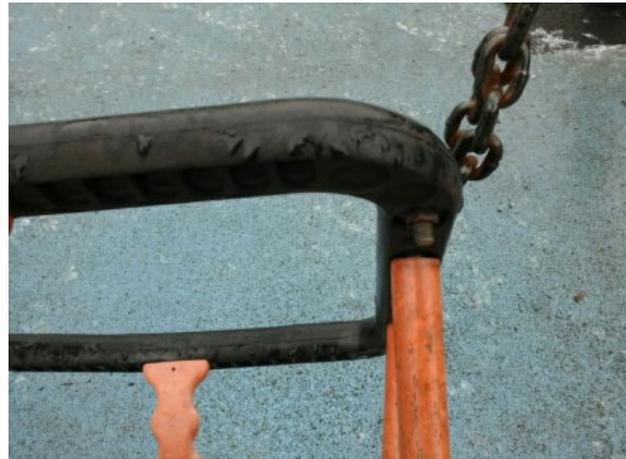
6 - Low Risk (Finding 3)

**Finding:** There are caps missing from the underside of the seats  
**Action:** Replace missing caps under the seats

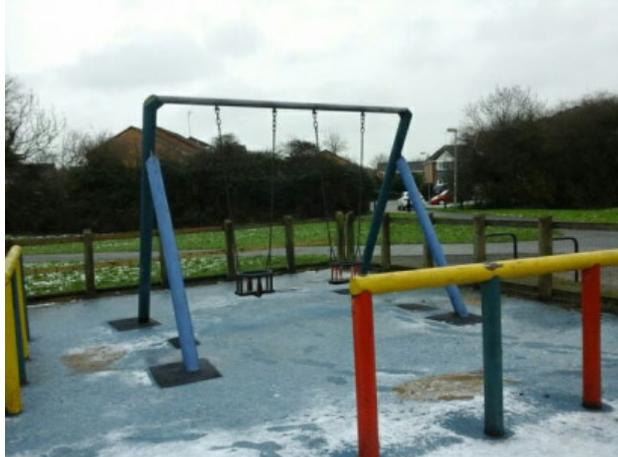
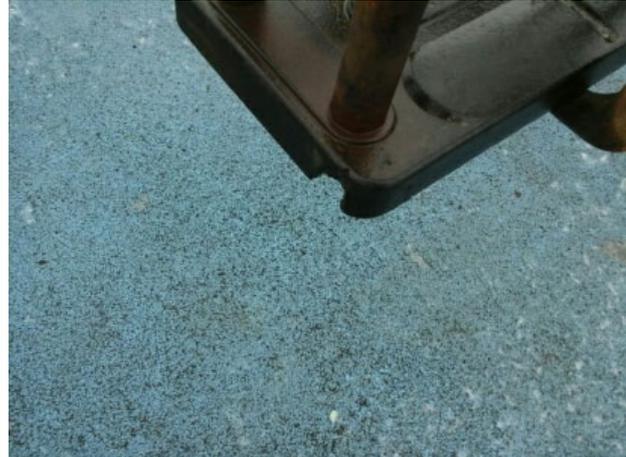
6 - Low Risk (Finding 4)

**Finding:** The seat has minor damage or wear

**Action:** Monitor for any further deterioration and replace as required

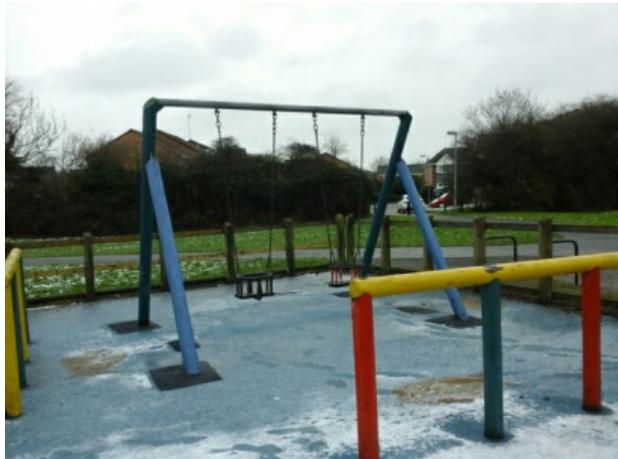
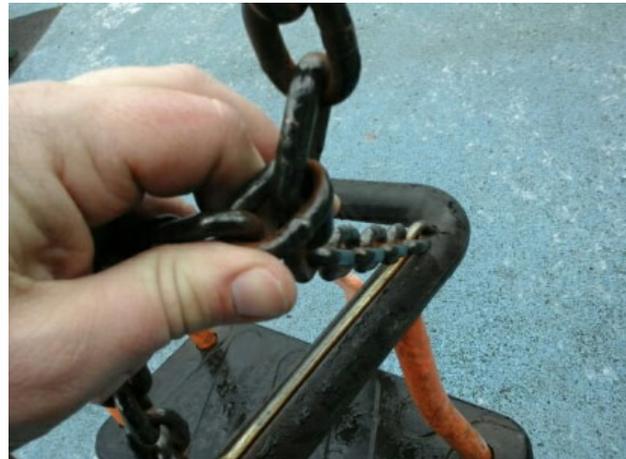
6 - Low Risk (Finding 5)

**Finding:** There is some notable evidence of chain wear

**Action:** Monitor for any further deterioration and replace when 40% worn

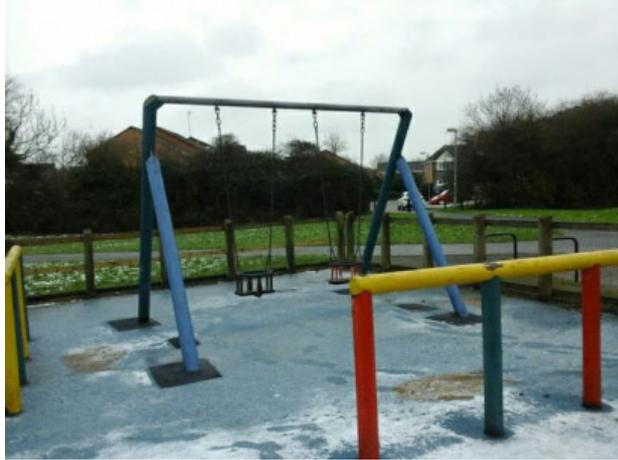
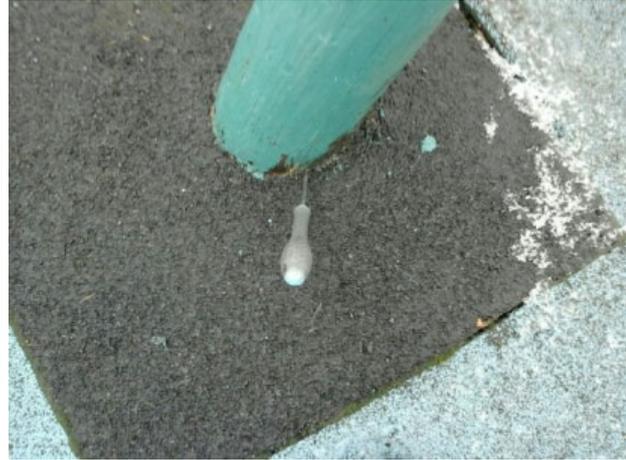
6 - Low Risk (Finding 6)

**Finding:** There is some evidence of rot in the timber posts

**Action:** Monitor for any further deterioration and replace as required

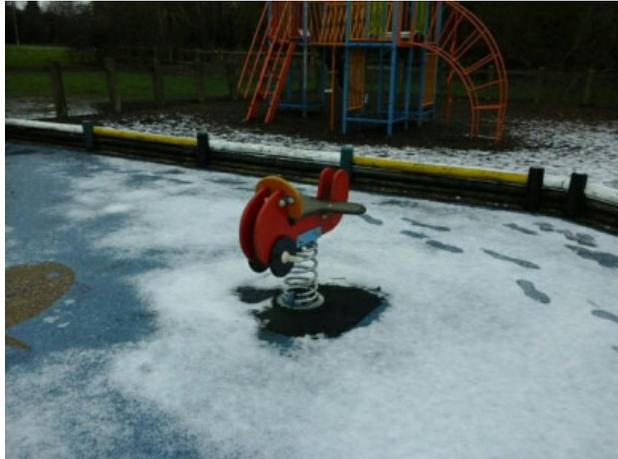
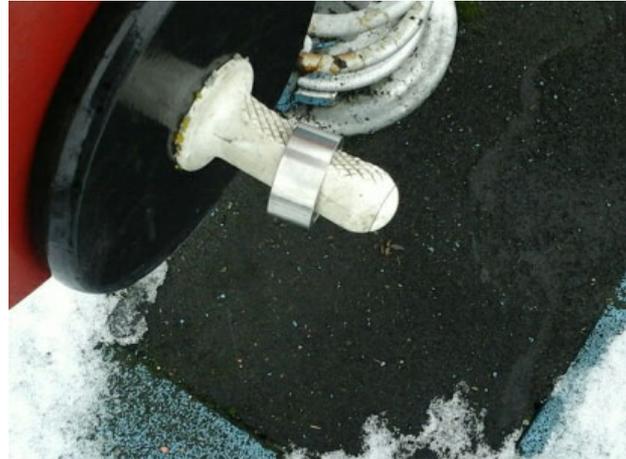
4 - Very Low Risk (Finding 1)

**Finding:** The end of handgrips and/or footrests have a cross section of less than 15cm<sup>2</sup> and fail to meet the requirements of BS EN 1176:2008 Part 6

**Action:** This is a relatively low risk failure and no remedial action is recommended

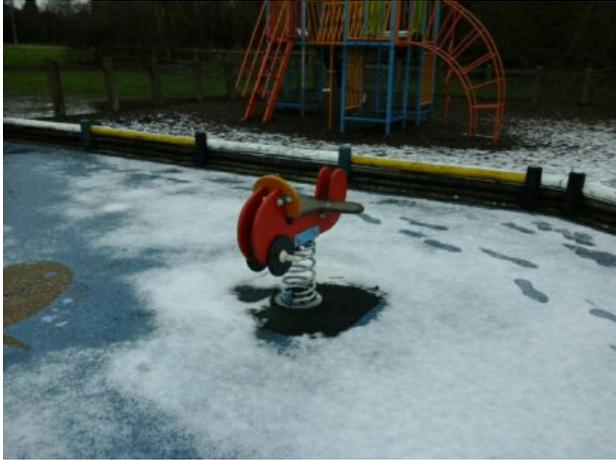
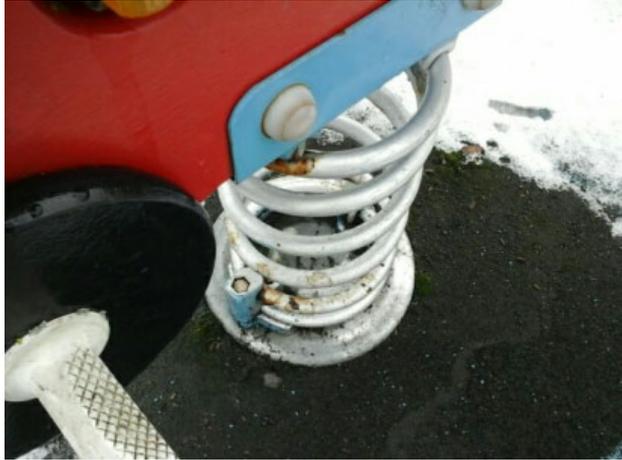
6 - Low Risk (Finding 2)

**Finding:** The paintwork on the spring has been damaged or worn exposing the metal underneath which is rusting

**Action:** Treat any rusting components and repaint

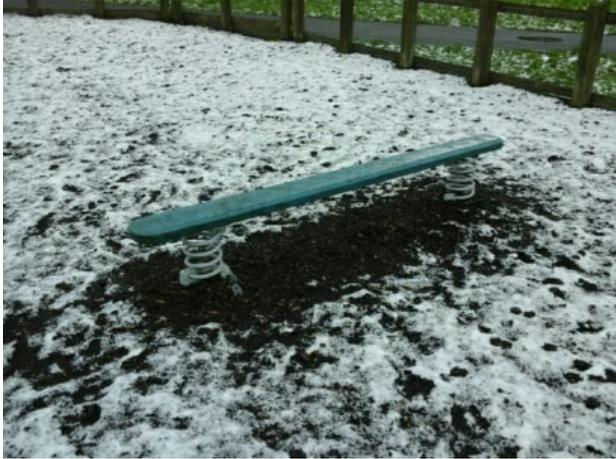
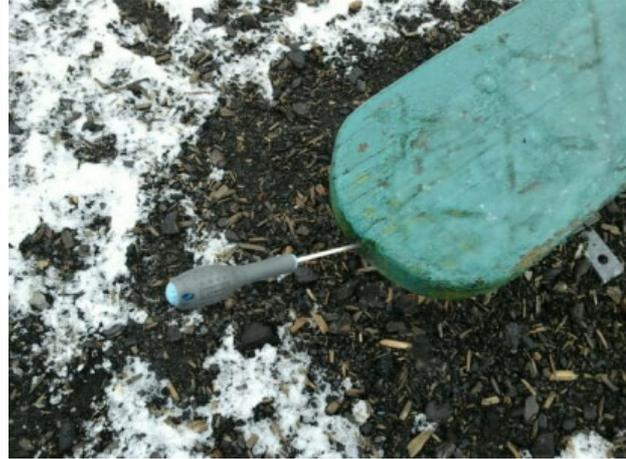
6 - Low Risk (Finding 2)

**Finding:** There is some evidence of rot in the timber

**Action:** Monitor for any further deterioration and replace as required

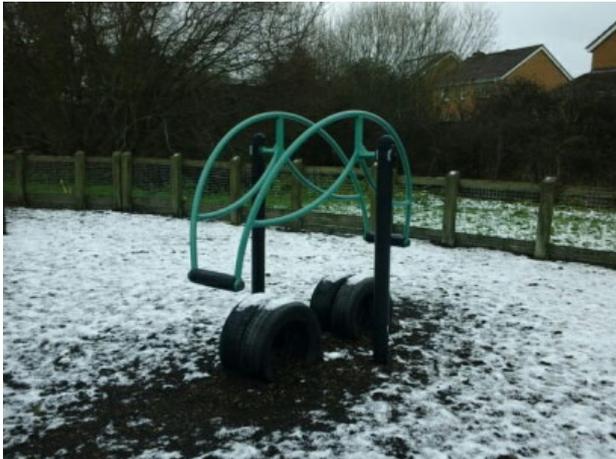
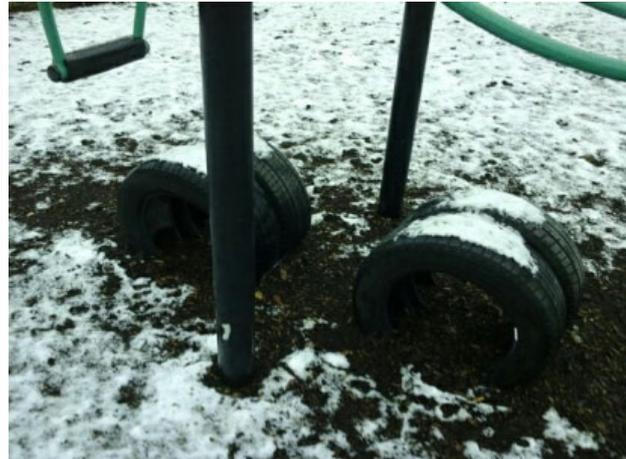
6 - Low Risk (Finding 1)

**Finding:** The posts are slightly loose in the ground

**Action:** Monitor for any further deterioration and repair as required

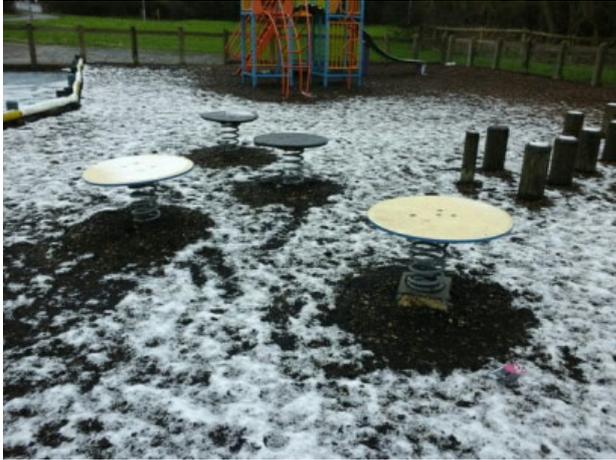
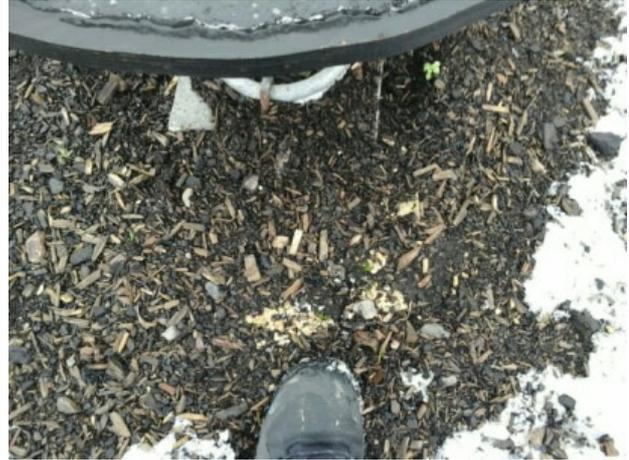
8 - Low Risk (Finding 1)

**Finding:** The surface has eroded and the foundations are exposed

**Action:** Reinstate surrounding surfaces to cover the foundations

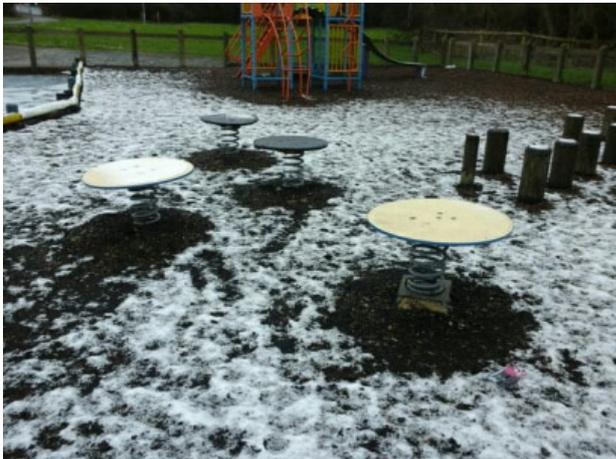
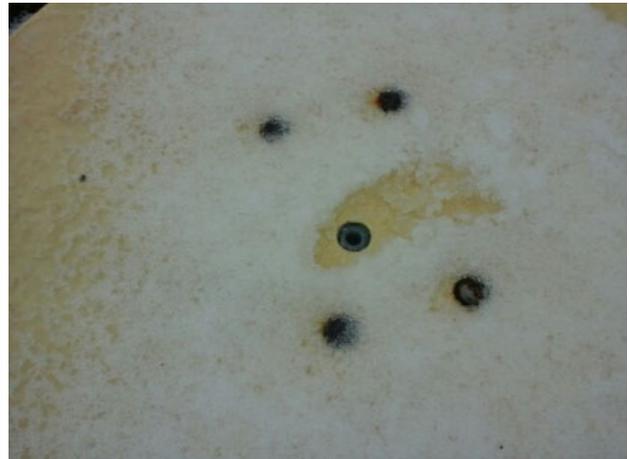
6 - Low Risk (Finding 2)

**Finding:** There is/are missing fixing/s on the item

**Action:** Replace all missing fixings

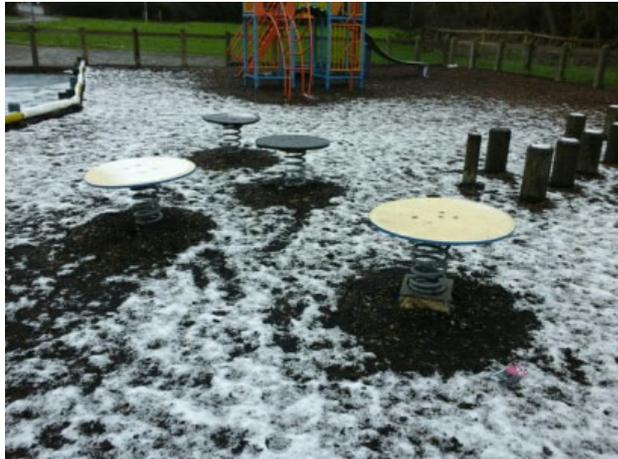
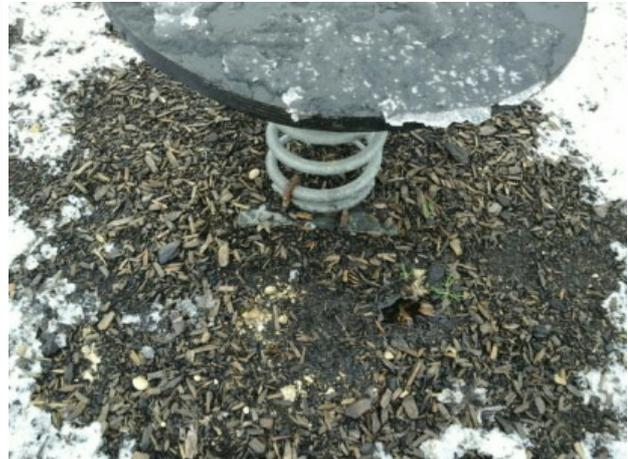
6 - Low Risk (Finding 3)

**Finding:** The spring mounting plates are slightly loose in the ground

**Action:** Monitor for any further deterioration and repair as required

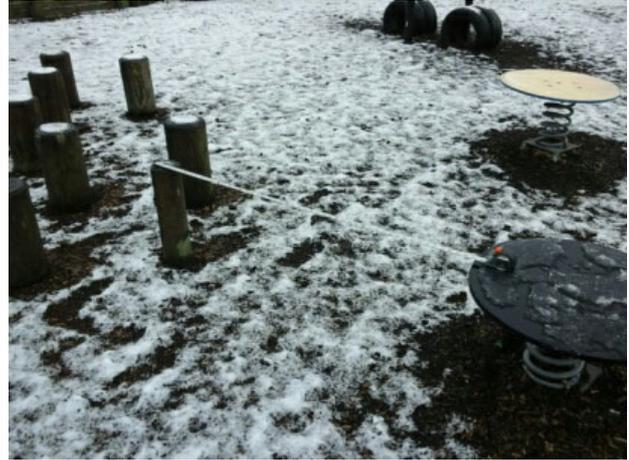
8 - Low Risk (Finding 1)

**Finding:** The spring boards form a hard object within the falling space of the equipment in contravention of the requirements of BS EN 1176 Part 1

**Action:** Monitor use

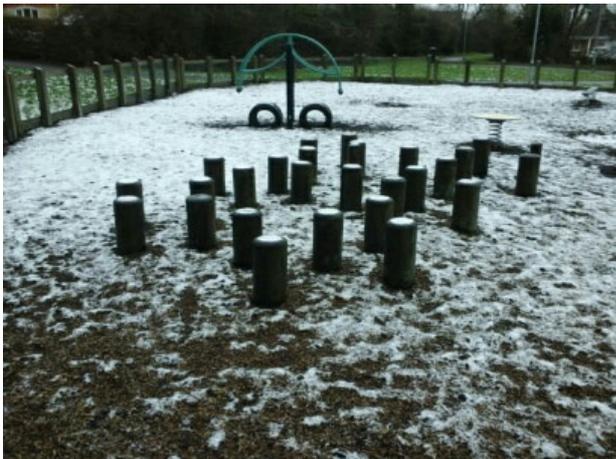
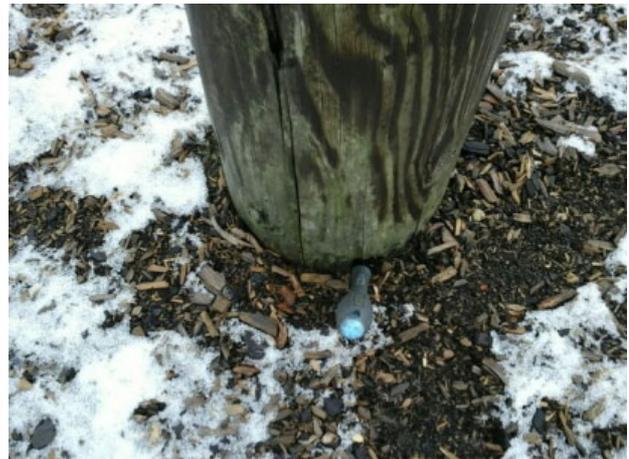
8 - Low Risk (Finding 2)

**Finding:** There are areas or parts of the timber on the structure that have rotted

**Action:** Replace all affected timbers

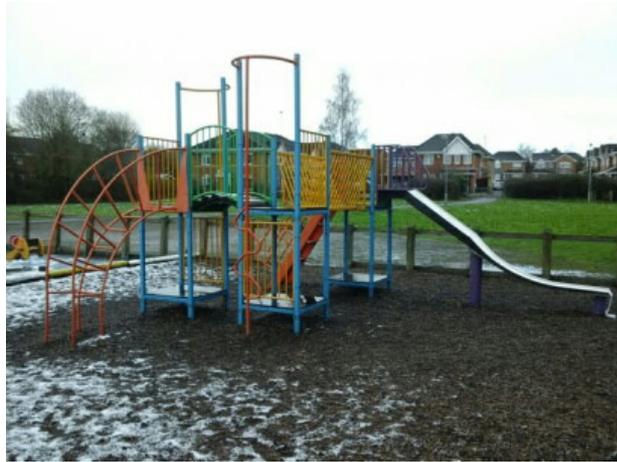
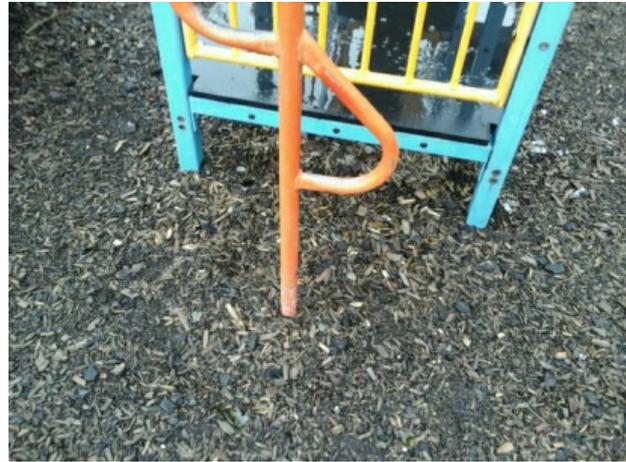
6 - Low Risk (Finding 1)

**Finding:** The climbing element is slightly loose in the ground

**Action:** Monitor for any further deterioration and repair as required

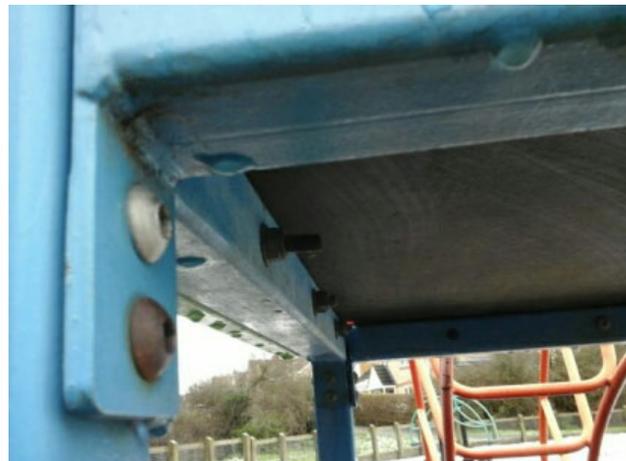
6 - Low Risk (Finding 2)

**Finding:** There are projecting bolt thread(s) present

**Action:** Remove excess thread length and deburr or provide cap

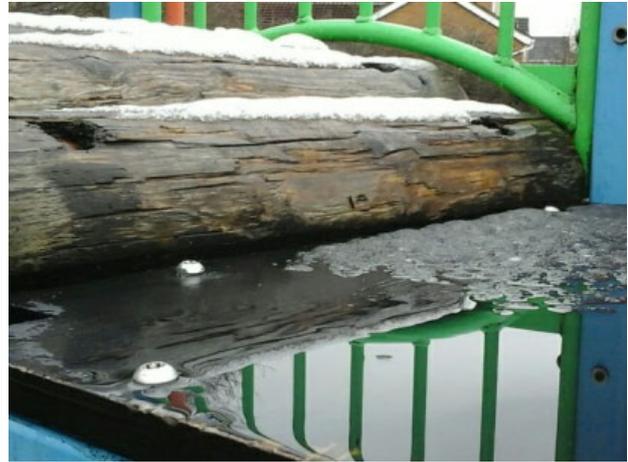
6 - Low Risk (Finding 3)

**Finding:** Parts of the timber are rough or splintered

**Action:** Remove all rough or sharp edges

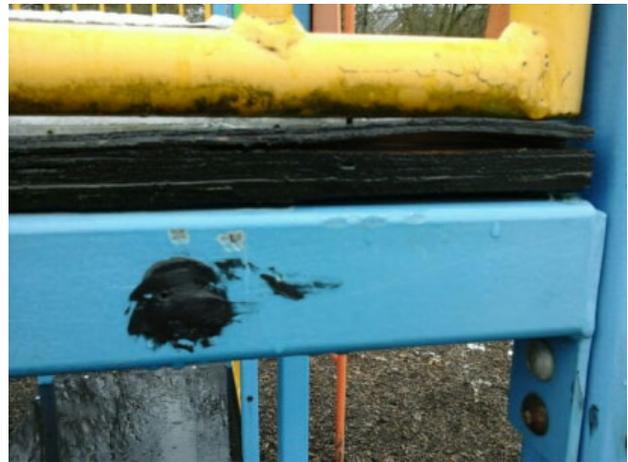
**Finding:** The plywood has delaminated in some places

**Action:** Remove all rough or splintered edges.

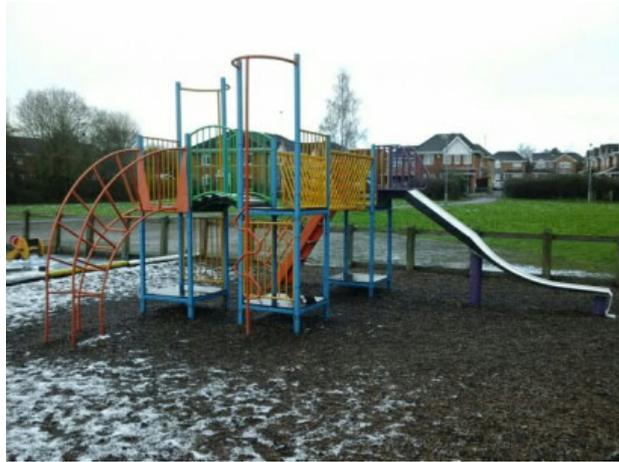
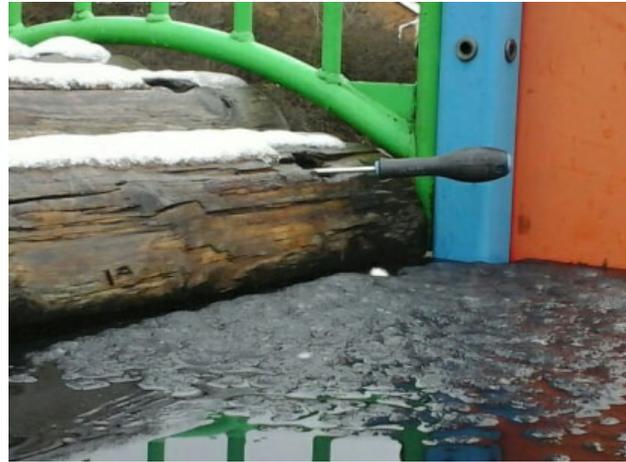
**Finding:** There is some evidence of rot in the timber

**Action:** Monitor for any further deterioration and replace as required

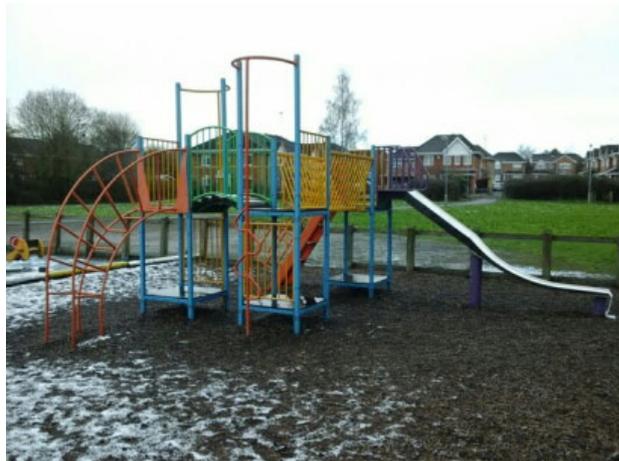
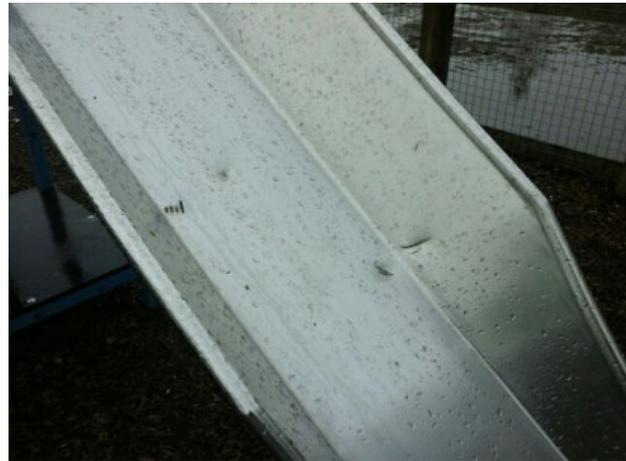
**Finding:** There are a number of dents in the slide surface

**Action:** Monitor for any further deterioration and repair as required

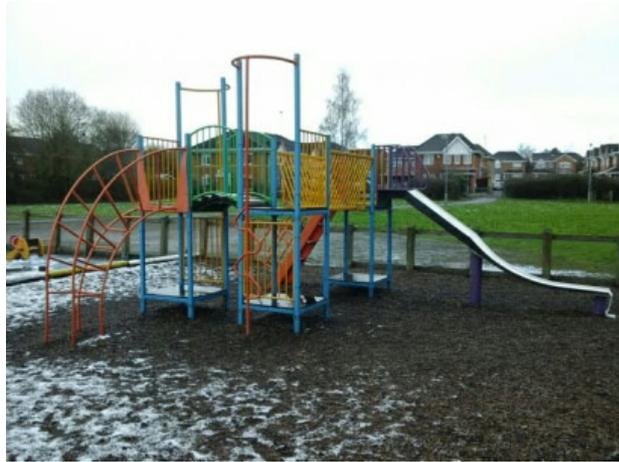
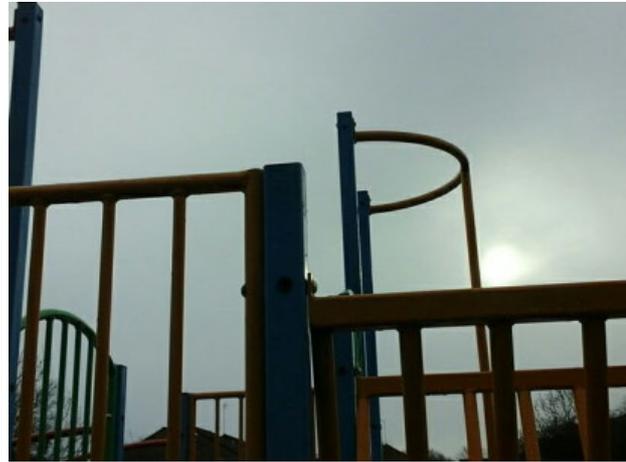
**Finding:** There are post caps missing from the item **Action:** Replace missing post caps

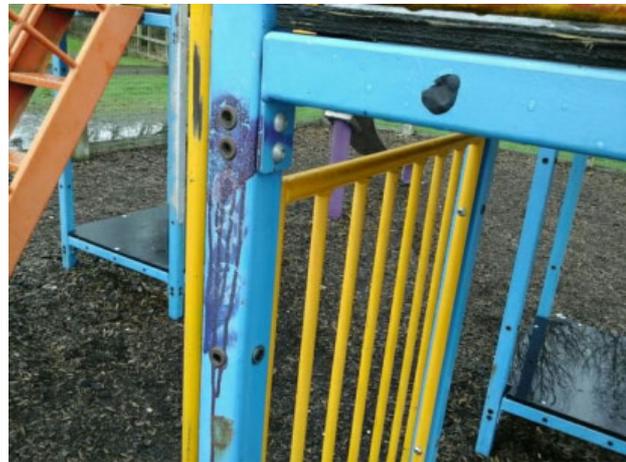
**Finding:** There is some graffiti present **Action:** Remove the graffiti

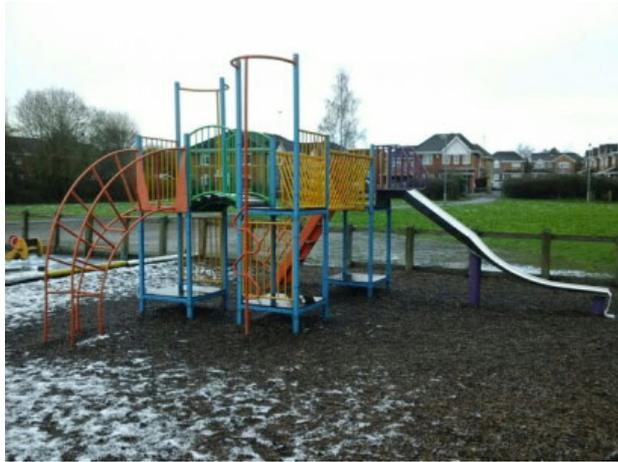
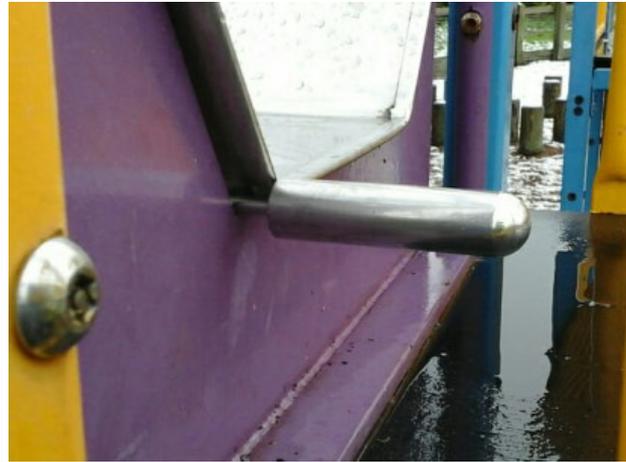
**Finding:** There is/are finger entrapment/s beneath the slide and the item fails to meet the requirements of BS EN 1176:2008 Part 1 4.2.7.6 Entrapment of fingers **Action:** Monitor use
