2722/WH/0706

ASBESTOS SURVEY REPORT

Second Severn Crossing
M4
South Wales

FOR:
Laing O'Rourke
SURVEYED ON:
18th – 20th July 2006

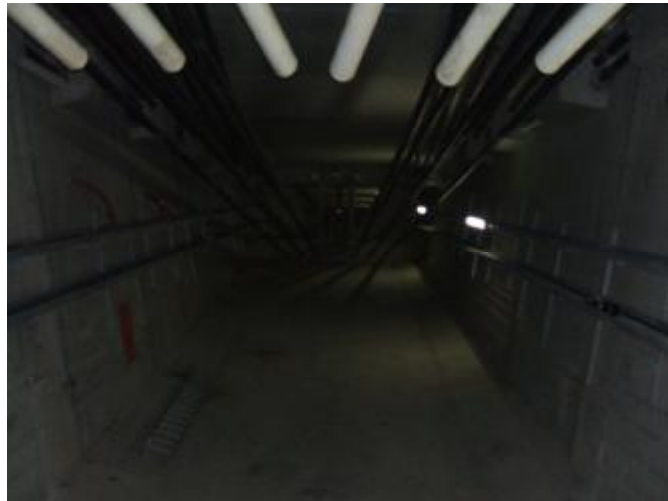
SURVEY REF NO. 2722/WH/0706		SITE: Second Severn Crossing, M4, South Wales		Date: 18 th – 20 th July 2006		SRF	PAGE	1	OF	25
SAMPLE NO:		No Sample Taken

LOCATION:		South Viaduct								
POSITION:		Piers 40 – 48								
DESCRIPTION:		Not Applicable								
PRODUCT TYPE:		Not Applicable								
EXTENT (APPROX):		Not Applicable								
LEVEL OF IDENTIFICATION: Presumed, Strongly Presumed, No Asbestos Detected, Asbestos Detected		Presumed Not To Contain Asbestos								
ACCESSIBILITY / VULNERABILITY: Very Low, Low, Medium, High		Not Applicable								
SURFACE TREATMENT:		Not Applicable

3		High damage or delaminating: of materials, sprays and thermal insulation. Visible asbestos debris.	3		Unsealed lagging and sprays.			
A			B			C			D		
TOTAL SCORE NOT APPLICABLE (A+B+C+D = (1-4 Very Low) (5-6 Low) (7-9 Medium) (>10 High)			MATERIAL ASSESSMENT PRIORITY NOT APPLICABLE			COMMENTS: No visible suspect or presumed ACMs observed within the pier 40-48.

RECOMMENDATIONS	ENCAPSULATE	REPAIR	LABEL	PROTECT / ENCLOSE	RESTRICT ACCESS	MONITOR CONDITION	REMOVE	NO ACTION
DATE ACTION TAKEN	DATE OF NEXT INSPECTION		DATE OF NEXT INSPECTION		DATE OF NEXT INSPECTION		DATE OF NEXT INSPECTION

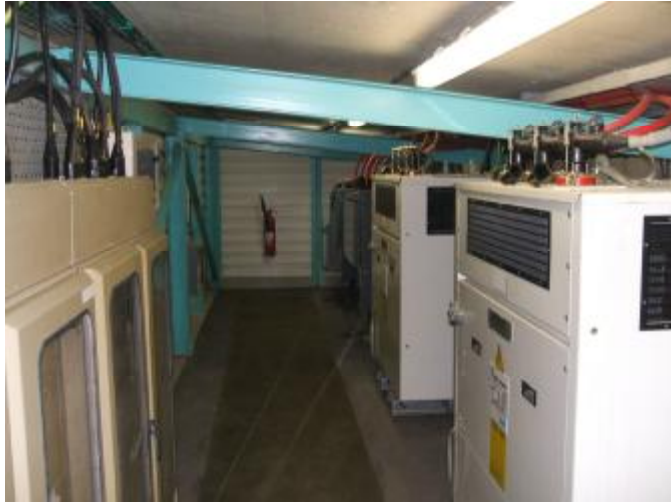
SURVEY REF NO. 2722/WH/0706	SITE: Second Severn Crossing, M4, South Wales	Date: 18th – 20th July 2006	SRF	PAGE	2	OF	25
SAMPLE NO:	No Sample Taken Due To Live Status

LOCATION:	South Viaduct Avon						
POSITION:	Sub-station P – 6						
DESCRIPTION:	Electrical Switchgear						
PRODUCT TYPE:	Unknown						
EXTENT (APPROX):	Unknown						
LEVEL OF IDENTIFICATION: Presumed, Strongly Presumed, No Asbestos Detected, Asbestos Detected	Presumed To Contain Asbestos						
ACCESSIBILITY / VULNERABILITY: Very Low, Low, Medium, High	Low						
SURFACE TREATMENT:	Sealed Units

3		High damage or delaminating: of materials, sprays and thermal insulation. Visible asbestos debris.	3		Unsealed lagging and sprays.			
A			B			C			D		
TOTAL SCORE NOT APPLICABLE (A+B+C+D = (1-4 Very Low) (5-6 Low) (7-9 Medium) (>10 High)			MATERIAL ASSESSMENT PRIORITY NOT APPLICABLE			COMMENTS: No access to electrical switch gear due to its live status, therefore presumed to contain asbestos. Exercise caution until full content can be established.

RECOMMENDATIONS	ENCAPSULATE	REPAIR	LABEL	PROTECT / ENCLOSE	RESTRICT ACCESS	MONITOR CONDITION	REMOVE	EXERCISE CAUTION
DATE ACTION TAKEN	DATE OF NEXT INSPECTION		DATE OF NEXT INSPECTION		DATE OF NEXT INSPECTION		DATE OF NEXT INSPECTION

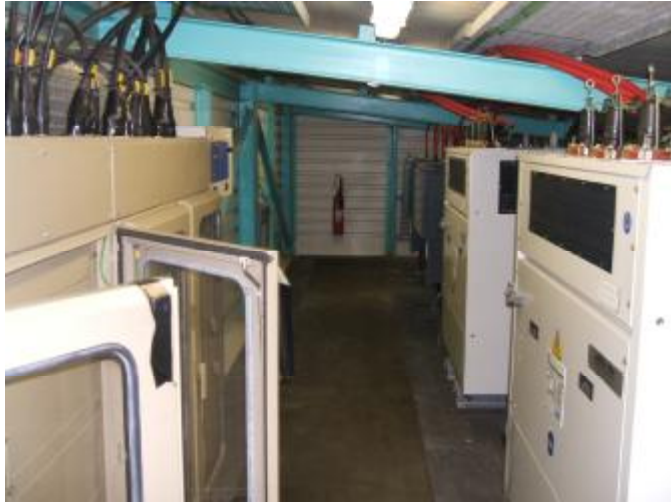
SURVEY REF NO. 2722/WH/0706	SITE: Second Severn Crossing, M4, South Wales	Date: 18th – 20th July 2006	SRF	PAGE	3	OF	25
SAMPLE NO:	No Sample Taken Due To Live Status

LOCATION:	South Viaduct Avon						
POSITION:	Sub-station P – 5						
DESCRIPTION:	Electrical Switchgear						
PRODUCT TYPE:	Unknown						
EXTENT (APPROX):	Unknown						
LEVEL OF IDENTIFICATION: Presumed, Strongly Presumed, No Asbestos Detected, Asbestos Detected	Presumed To Contain Asbestos						
ACCESSIBILITY / VULNERABILITY: Very Low, Low, Medium, High	Low						
SURFACE TREATMENT:	Sealed

3		High damage or delaminating: of materials, sprays and thermal insulation. Visible asbestos debris.	3		Unsealed lagging and sprays.			
A			B			C			D		
TOTAL SCORE NOT APPLICABLE (A+B+C+D = (1-4 Very Low) (5-6 Low) (7-9 Medium) (>10 High)			MATERIAL ASSESSMENT PRIORITY NOT APPLICABLE			COMMENTS: No access to electrical switch gear due to its live status, therefore presumed to contain asbestos. Exercise caution until full content can be established.

RECOMMENDATIONS	ENCAPSULATE	REPAIR	LABEL	PROTECT / ENCLOSE	RESTRICT ACCESS	MONITOR CONDITION	REMOVE	EXERCISE CAUTION
DATE ACTION TAKEN	DATE OF NEXT INSPECTION		DATE OF NEXT INSPECTION		DATE OF NEXT INSPECTION		DATE OF NEXT INSPECTION

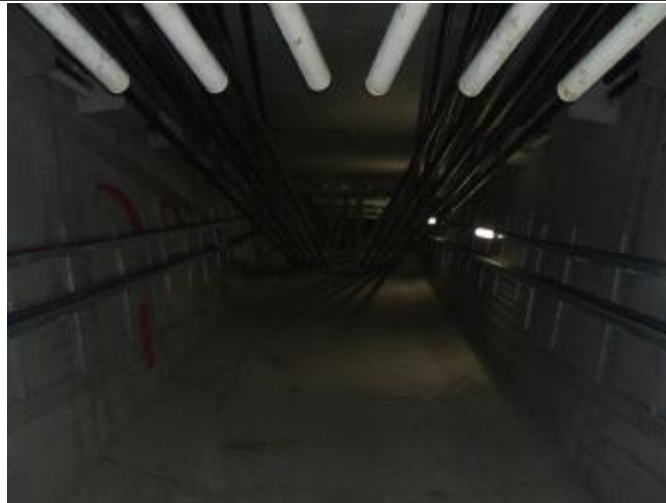
SURVEY REF NO. 2722/WH/0706		SITE: Second Severn Crossing, M4, South Wales		Date: 18 th – 20 th July 2006		SRF	PAGE	4	OF	25
SAMPLE NO:		No Sample Taken

LOCATION:		South Viaduct Avon								
POSITION:		Piers 33 – 59								
DESCRIPTION:		Not Applicable								
PRODUCT TYPE:		Not Applicable								
EXTENT (APPROX):		Not Applicable								
LEVEL OF IDENTIFICATION: Presumed, Strongly Presumed, No Asbestos Detected, Asbestos Detected		Presumed Not To Contain Asbestos								
ACCESSIBILITY / VULNERABILITY: Very Low, Low, Medium, High		Not Applicable								
SURFACE TREATMENT:		Not Applicable

3		High damage or delaminating: of materials, sprays and thermal insulation. Visible asbestos debris.	3		Unsealed lagging and sprays.			
A			B			C			D		
TOTAL SCORE NOT APPLICABLE (A+B+C+D = (1-4 Very Low) (5-6 Low) (7-9 Medium) (>10 High)			MATERIAL ASSESSMENT PRIORITY NOT APPLICABLE			COMMENTS: No visible suspect or presumed ACMs observed within the pier 33-59.

RECOMMENDATIONS	ENCAPSULATE	REPAIR	LABEL	PROTECT / ENCLOSE	RESTRICT ACCESS	MONITOR CONDITION	REMOVE	NO ACTION
DATE ACTION TAKEN	DATE OF NEXT INSPECTION		DATE OF NEXT INSPECTION		DATE OF NEXT INSPECTION		DATE OF NEXT INSPECTION

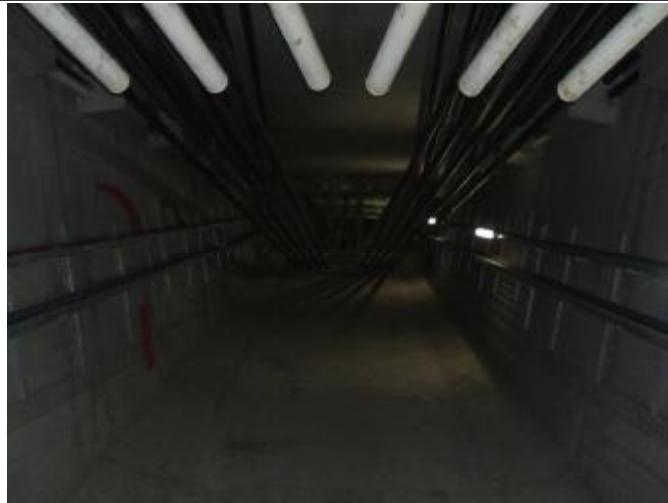
SURVEY REF NO. 2722/WH/0706		SITE: Second Severn Crossing, M4, South Wales		Date: 18 th – 20 th July 2006		SRF	PAGE	5	OF	25
SAMPLE NO:		No Sample Taken

LOCATION:		South Viaduct Avon								
POSITION:		Piers 26 – 32								
DESCRIPTION:		Not Applicable								
PRODUCT TYPE:		Not Applicable								
EXTENT (APPROX):		Not Applicable								
LEVEL OF IDENTIFICATION: Presumed, Strongly Presumed, No Asbestos Detected, Asbestos Detected		Presumed Not To Contain Asbestos								
ACCESSIBILITY / VULNERABILITY: Very Low, Low, Medium, High		Not Applicable								
SURFACE TREATMENT:		Not Applicable

3		High damage or delaminating: of materials, sprays and thermal insulation. Visible asbestos debris.	3		Unsealed lagging and sprays.			
A			B			C			D		
TOTAL SCORE NOT APPLICABLE (A+B+C+D = (1-4 Very Low) (5-6 Low) (7-9 Medium) (>10 High)			MATERIAL ASSESSMENT PRIORITY NOT APPLICABLE			COMMENTS: No visible suspect or presumed ACMs observed within the pier 26-32.

RECOMMENDATIONS	ENCAPSULATE	REPAIR	LABEL	PROTECT / ENCLOSE	RESTRICT ACCESS	MONITOR CONDITION	REMOVE	NO ACTION
DATE ACTION TAKEN	DATE OF NEXT INSPECTION		DATE OF NEXT INSPECTION		DATE OF NEXT INSPECTION		DATE OF NEXT INSPECTION

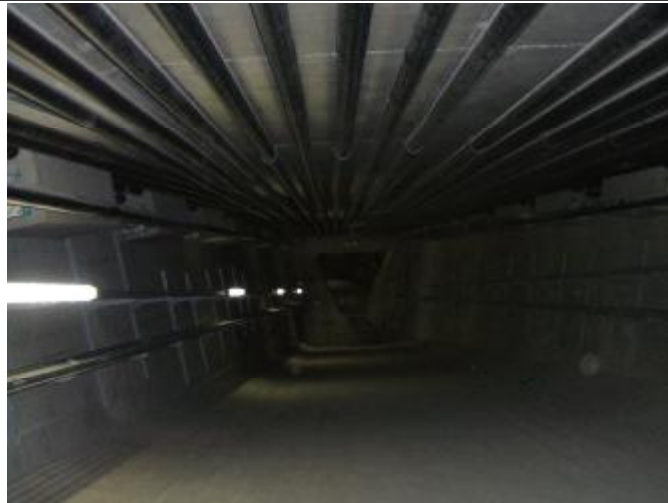
SURVEY REF NO. 2722/WH/0706		SITE: Second Severn Crossing, M4, South Wales		Date: 18 th – 20 th July 2006		SRF	PAGE	8	OF	25
SAMPLE NO:		No Sample Taken

LOCATION:		North Viaduct Avon								
POSITION:		Pier 26 – 33								
DESCRIPTION:		Not Applicable								
PRODUCT TYPE:		Not Applicable								
EXTENT (APPROX):		Not Applicable								
LEVEL OF IDENTIFICATION: Presumed, Strongly Presumed, No Asbestos Detected, Asbestos Detected		Presumed Not To Contain Asbestos								
ACCESSIBILITY / VULNERABILITY: Very Low, Low, Medium, High		Not Applicable								
SURFACE TREATMENT:		Not Applicable

3		High damage or delaminating: of materials, sprays and thermal insulation. Visible asbestos debris.	3		Unsealed lagging and sprays.			
A			B			C			D		
TOTAL SCORE NOT APPLICABLE (A+B+C+D = (1-4 Very Low) (5-6 Low) (7-9 Medium) (>10 High)			MATERIAL ASSESSMENT PRIORITY NOT APPLICABLE			COMMENTS: No visible suspect or presumed ACMs observed within the pier 26-33.

RECOMMENDATIONS	ENCAPSULATE	REPAIR	LABEL	PROTECT / ENCLOSE	RESTRICT ACCESS	MONITOR CONDITION	REMOVE	NO ACTION
DATE ACTION TAKEN	DATE OF NEXT INSPECTION		DATE OF NEXT INSPECTION		DATE OF NEXT INSPECTION		DATE OF NEXT INSPECTION

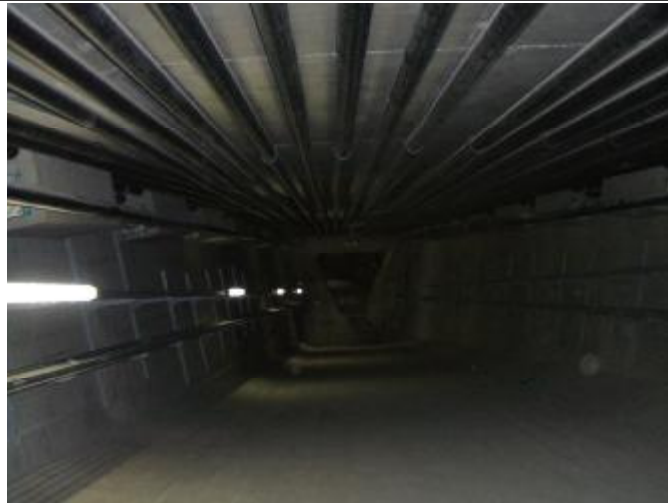
SURVEY REF NO. 2722/WH/0706		SITE: Second Severn Crossing, M4, South Wales		Date: 18 th – 20 th July 2006		SRF	PAGE	9	OF	25
SAMPLE NO:		No Sample Taken

LOCATION:		North Viaduct Avon								
POSITION:		Piers 34 – 41								
DESCRIPTION:		Not Applicable								
PRODUCT TYPE:		Not Applicable								
EXTENT (APPROX):		Not Applicable								
LEVEL OF IDENTIFICATION: Presumed, Strongly Presumed, No Asbestos Detected, Asbestos Detected		Presumed Not To Contain Asbestos								
ACCESSIBILITY / VULNERABILITY: Very Low, Low, Medium, High		Not Applicable								
SURFACE TREATMENT:		Not Applicable

RECOMMENDATIONS	ENCAPSULATE	REPAIR	LABEL	PROTECT / ENCLOSE	RESTRICT ACCESS	MONITOR CONDITION	REMOVE	NO ACTION
DATE ACTION TAKEN	DATE OF NEXT INSPECTION		DATE OF NEXT INSPECTION		DATE OF NEXT INSPECTION		DATE OF NEXT INSPECTION

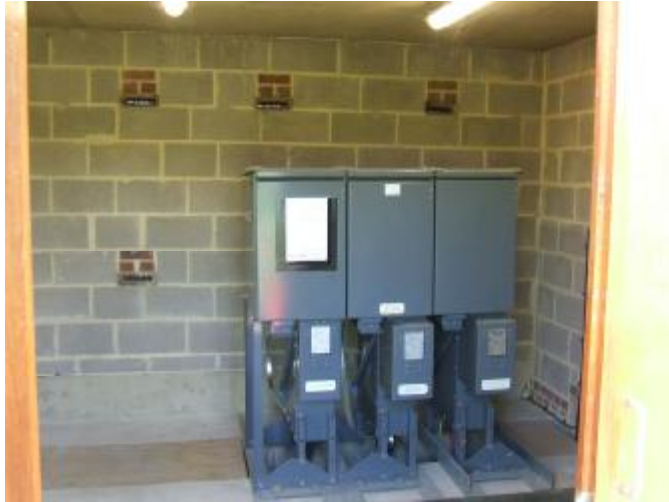
SURVEY REF NO. 2722/WH/0706	SITE: Second Severn Crossing, M4, South Wales	Date: 18 th – 20 th July 2006	SRF	PAGE	10	OF	25
SAMPLE NO:	No Sample Taken Due To Live Status

LOCATION:	Ground Floor						
POSITION:	Avon Electrical Building						
DESCRIPTION:	Electrical Switchgear						
PRODUCT TYPE:	Unknown						
EXTENT (APPROX):	Unknown						
LEVEL OF IDENTIFICATION: Presumed, Strongly Presumed, No Asbestos Detected, Asbestos Detected	Presumed To Contain Asbestos						
ACCESSIBILITY / VULNERABILITY: Very Low, Low, Medium, High	Low						
SURFACE TREATMENT:	Sealed Units

RECOMMENDATIONS	ENCAPSULATE	REPAIR	LABEL	PROTECT / ENCLOSE	RESTRICT ACCESS	MONITOR CONDITION	REMOVE	NO ACTION
DATE ACTION TAKEN	DATE OF NEXT INSPECTION		DATE OF NEXT INSPECTION		DATE OF NEXT INSPECTION		DATE OF NEXT INSPECTION

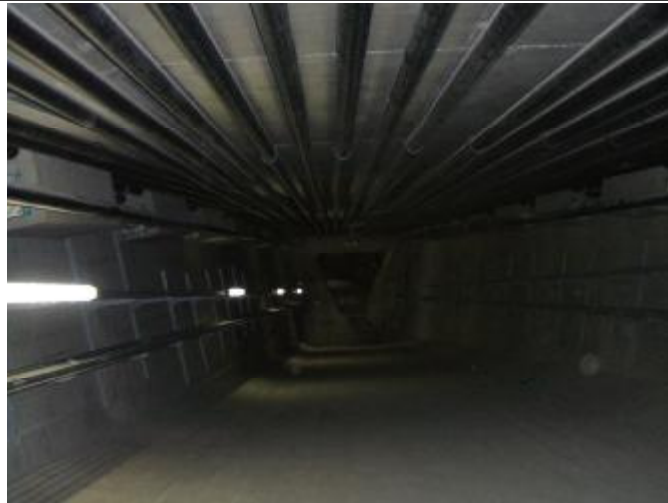
SURVEY REF NO. 2722/WH/0706		SITE: Second Severn Crossing, M4, South Wales		Date: 18 th – 20 th July 2006		SRF	PAGE	11	OF	25
SAMPLE NO:		No Sample Taken

LOCATION:		North Viaduct Gwent								
POSITION:		Piers 42 – 48								
DESCRIPTION:		Not Applicable								
PRODUCT TYPE:		Not Applicable								
EXTENT (APPROX):		Not Applicable								
LEVEL OF IDENTIFICATION: Presumed, Strongly Presumed, No Asbestos Detected, Asbestos Detected		Presumed Not To Contain Asbestos								
ACCESSIBILITY / VULNERABILITY: Very Low, Low, Medium, High		Not Applicable								
SURFACE TREATMENT:		Not Applicable

RECOMMENDATIONS	ENCAPSULATE	REPAIR	LABEL	PROTECT / ENCLOSE	RESTRICT ACCESS	MONITOR CONDITION	REMOVE	NO ACTION
DATE ACTION TAKEN	DATE OF NEXT INSPECTION		DATE OF NEXT INSPECTION		DATE OF NEXT INSPECTION		DATE OF NEXT INSPECTION

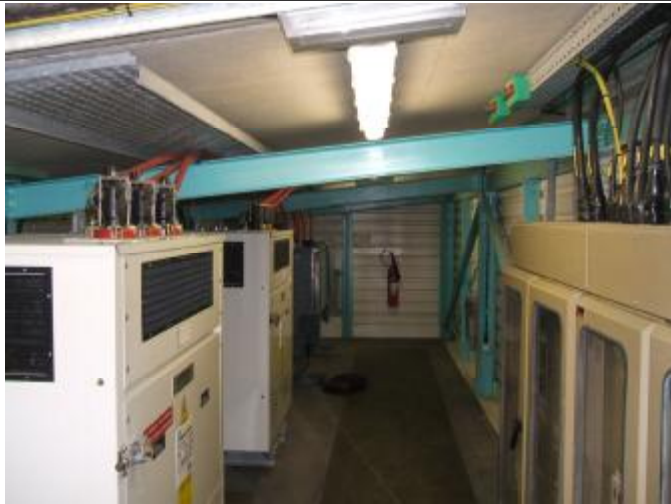
SURVEY REF NO. 2722/WH/0706	SITE: Second Severn Crossing, M4, South Wales	Date: 18th – 20th July 2006	SRF	PAGE	12	OF	25
SAMPLE NO:	No Sample Taken Due To Live Status

LOCATION:	North Viaduct Gwent						
POSITION:	Sub-station P – 1						
DESCRIPTION:	Electrical Switchgear						
PRODUCT TYPE:	Unknown						
EXTENT (APPROX):	Unknown						
LEVEL OF IDENTIFICATION: Presumed, Strongly Presumed, No Asbestos Detected, Asbestos Detected	Presumed To Contain Asbestos						
ACCESSIBILITY / VULNERABILITY: Very Low, Low, Medium, High	Low						
SURFACE TREATMENT:	Sealed Units

RECOMMENDATIONS	ENCAPSULATE	REPAIR	LABEL	PROTECT / ENCLOSE	RESTRICT ACCESS	MONITOR CONDITION	REMOVE	NO ACTION
DATE ACTION TAKEN	DATE OF NEXT INSPECTION		DATE OF NEXT INSPECTION		DATE OF NEXT INSPECTION		DATE OF NEXT INSPECTION

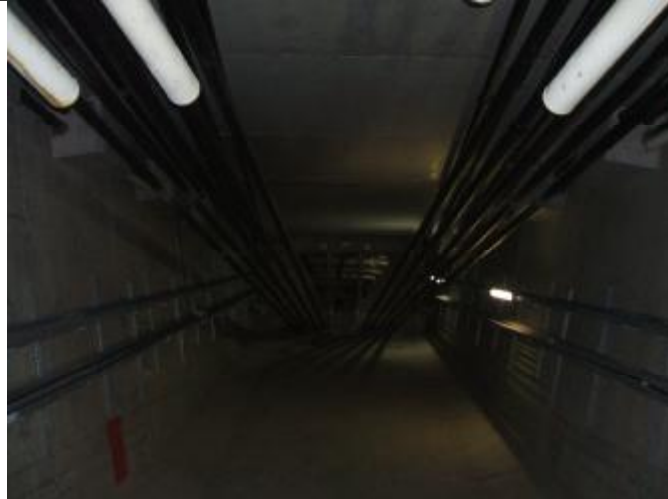
SURVEY REF NO. 2722/WH/0706		SITE: Second Severn Crossing, M4, South Wales		Date: 18 th – 20 th July 2006		SRF	PAGE	14	OF	25
SAMPLE NO:		No Sample Taken

LOCATION:		North Viaduct Gwent								
POSITION:		Piers 9 – 16								
DESCRIPTION:		Not Applicable								
PRODUCT TYPE:		Not Applicable								
EXTENT (APPROX):		Not Applicable								
LEVEL OF IDENTIFICATION: Presumed, Strongly Presumed, No Asbestos Detected, Asbestos Detected		Presumed Not To Contain Asbestos								
ACCESSIBILITY / VULNERABILITY: Very Low, Low, Medium, High		Not Applicable								
SURFACE TREATMENT:		Not Applicable

RECOMMENDATIONS	ENCAPSULATE	REPAIR	LABEL	PROTECT / ENCLOSE	RESTRICT ACCESS	MONITOR CONDITION	REMOVE	NO ACTION
DATE ACTION TAKEN	DATE OF NEXT INSPECTION		DATE OF NEXT INSPECTION		DATE OF NEXT INSPECTION		DATE OF NEXT INSPECTION

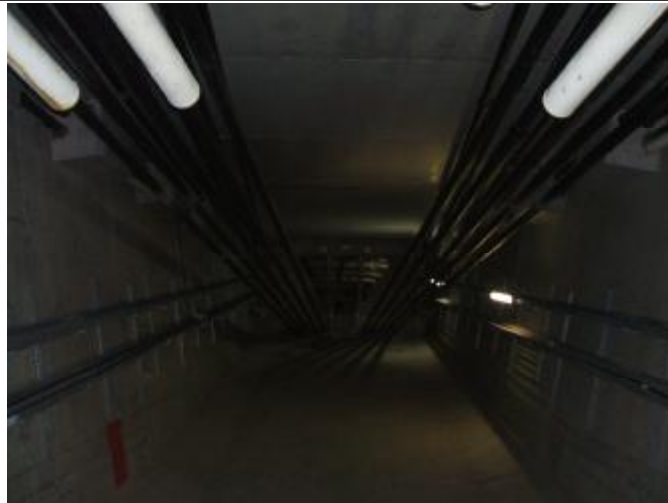
SURVEY REF NO. 2722/WH/0706		SITE: Second Severn Crossing, M4, South Wales		Date: 18 th – 20 th July 2006		SRF	PAGE	15	OF	25
SAMPLE NO:		No Sample Taken

LOCATION:		North Viaduct Gwent								
POSITION:		Piers 17 – 23								
DESCRIPTION:		Not Applicable								
PRODUCT TYPE:		Not Applicable								
EXTENT (APPROX):		Not Applicable								
LEVEL OF IDENTIFICATION: Presumed, Strongly Presumed, No Asbestos Detected, Asbestos Detected		Presumed Not To Contain Asbestos								
ACCESSIBILITY / VULNERABILITY: Very Low, Low, Medium, High		Not Applicable								
SURFACE TREATMENT:		Not Applicable

RECOMMENDATIONS	ENCAPSULATE	REPAIR	LABEL	PROTECT / ENCLOSE	RESTRICT ACCESS	MONITOR CONDITION	REMOVE	NO ACTION
DATE ACTION TAKEN	DATE OF NEXT INSPECTION		DATE OF NEXT INSPECTION		DATE OF NEXT INSPECTION		DATE OF NEXT INSPECTION

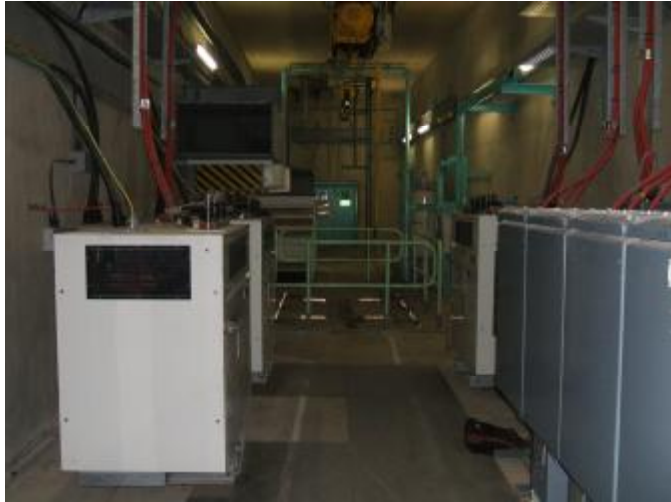
SURVEY REF NO. 2722/WH/0706	SITE: Second Severn Crossing, M4, South Wales	Date: 18 th – 20 th July 2006	SRF	PAGE	17	OF	25
SAMPLE NO:	No Sample Taken Due To Live Status

LOCATION:	North Viaduct Gwent						
POSITION:	Sub-station P – 3 Pylon M – 1						
DESCRIPTION:	Electrical Switchgear						
PRODUCT TYPE:	Unknown						
EXTENT (APPROX):	Unknown						
LEVEL OF IDENTIFICATION: Presumed, Strongly Presumed, No Asbestos Detected, Asbestos Detected	Presumed To Contain Asbestos						
ACCESSIBILITY / VULNERABILITY: Very Low, Low, Medium, High	Low						
SURFACE TREATMENT:	Sealed Units

RECOMMENDATIONS	ENCAPSULATE	REPAIR	LABEL	PROTECT / ENCLOSE	RESTRICT ACCESS	MONITOR CONDITION	REMOVE	NO ACTION
DATE ACTION TAKEN	DATE OF NEXT INSPECTION		DATE OF NEXT INSPECTION		DATE OF NEXT INSPECTION		DATE OF NEXT INSPECTION

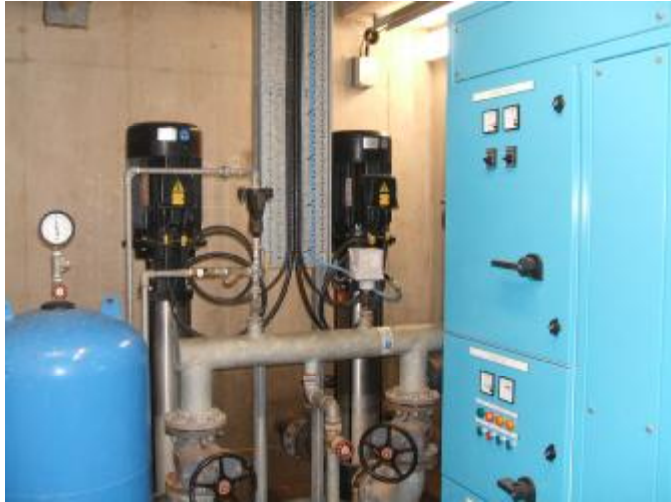
SURVEY REF NO. 2722/WH/0706	SITE: Second Severn Crossing, M4, South Wales	Date: 18 th – 20 th July 2006	SRF	PAGE	18	OF	25
SAMPLE NO:	No Sample Taken Due To Live Status

LOCATION:	Ground Floor						
POSITION:	Avon Fire Main Pumping Station						
DESCRIPTION:	Electrical Switchgear						
PRODUCT TYPE:	Unknown						
EXTENT (APPROX):	Unknown						
LEVEL OF IDENTIFICATION: Presumed, Strongly Presumed, No Asbestos Detected, Asbestos Detected	Presumed To Contain Asbestos						
ACCESSIBILITY / VULNERABILITY: Very Low, Low, Medium, High	Low						
SURFACE TREATMENT:	Sealed Units

RECOMMENDATIONS	ENCAPSULATE	REPAIR	LABEL	PROTECT / ENCLOSE	RESTRICT ACCESS	MONITOR CONDITION	REMOVE	NO ACTION
DATE ACTION TAKEN	DATE OF NEXT INSPECTION		DATE OF NEXT INSPECTION		DATE OF NEXT INSPECTION		DATE OF NEXT INSPECTION

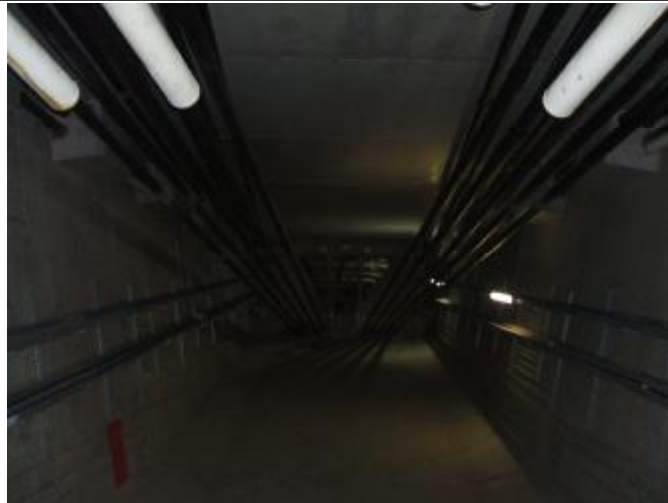
SURVEY REF NO. 2722/WH/0706		SITE: Second Severn Crossing, M4, South Wales		Date: 18 th – 20 th July 2006		SRF	PAGE	19	OF	25
SAMPLE NO:		No Sample Taken

LOCATION:		South Viaduct Gwent								
POSITION:		Piers 16 – 23								
DESCRIPTION:		Not Applicable								
PRODUCT TYPE:		Not Applicable								
EXTENT (APPROX):		Not Applicable								
LEVEL OF IDENTIFICATION: Presumed, Strongly Presumed, No Asbestos Detected, Asbestos Detected		Presumed Not To Contain Asbestos								
ACCESSIBILITY / VULNERABILITY: Very Low, Low, Medium, High		Not Applicable								
SURFACE TREATMENT:		Not Applicable

RECOMMENDATIONS	ENCAPSULATE	REPAIR	LABEL	PROTECT / ENCLOSE	RESTRICT ACCESS	MONITOR CONDITION	REMOVE	NO ACTION
DATE ACTION TAKEN	DATE OF NEXT INSPECTION		DATE OF NEXT INSPECTION		DATE OF NEXT INSPECTION		DATE OF NEXT INSPECTION

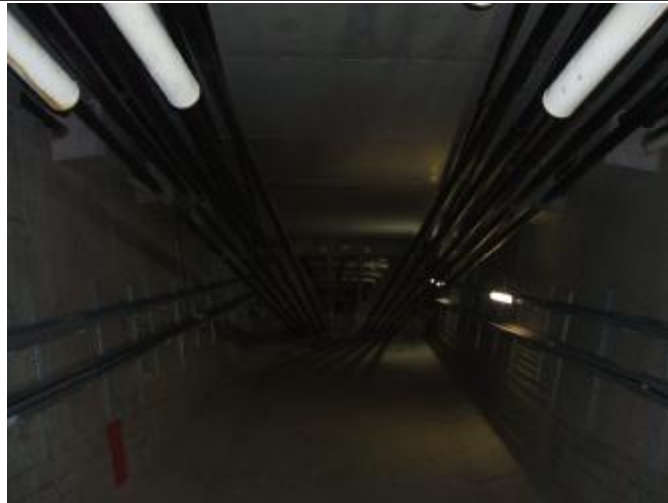
SURVEY REF NO. 2722/WH/0706		SITE: Second Severn Crossing, M4, South Wales		Date: 18 th – 20 th July 2006		SRF	PAGE	20	OF	25
SAMPLE NO:		No Sample Taken

LOCATION:		South Viaduct Gwent								
POSITION:		Piers 8 – 15								
DESCRIPTION:		Not Applicable								
PRODUCT TYPE:		Not Applicable								
EXTENT (APPROX):		Not Applicable								
LEVEL OF IDENTIFICATION: Presumed, Strongly Presumed, No Asbestos Detected, Asbestos Detected		Presumed Not To Contain Asbestos								
ACCESSIBILITY / VULNERABILITY: Very Low, Low, Medium, High		Not Applicable								
SURFACE TREATMENT:		Not Applicable

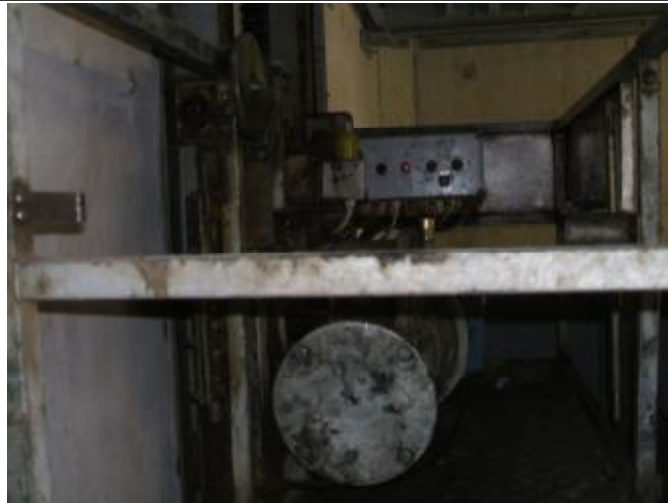
SURVEY REF NO. 2722/WH/0706		SITE: Second Severn Crossing, M4, South Wales		Date: 18 th – 20 th July 2006		SRF	PAGE	25	OF	25
SAMPLE NO:		No Sample Taken No Access

LOCATION:		Rapid Access Train (RAT)								
POSITION:		Brakes								
DESCRIPTION:		Brake Lining								
PRODUCT TYPE:		Unknown								
EXTENT (APPROX):		Unknown								
LEVEL OF IDENTIFICATION: Presumed, Strongly Presumed, No Asbestos Detected, Asbestos Detected		Presumed To Contain Asbestos								
ACCESSIBILITY / VULNERABILITY: Very Low, Low, Medium, High		Unknown								
SURFACE TREATMENT:		Unknown
