Refurbishment Survey

Camborne Library
The Cross
Camborne
TR14 8HA

TMS Environmental

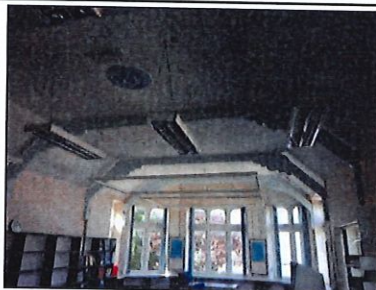
Survey Date:	Lead Surveyor	Survey Type	Floor	Analysis
13 Jun 2017	Spencer Kerrison	Refurbishment Survey	1st Floor	N/A
Building	Room	Item	Quantity	
Camborne Library, The Cross, Camborne, TR14 8HA	Reference Library	No asbestos detected	N/A	
Sample No (S,SP,P,As)	Product Type	Surface Treatment	Condition	Accessibility
Visual (P)	N/A	N/A	N/A	N/A
Material Risk Score				
N/A				
Recommended action	No further action required			
Surveyor comments	No access below carpet/coverings. Rooms are occupied at time of survey.

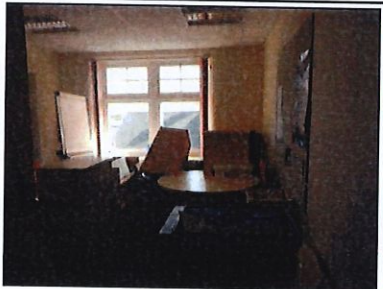
Survey Date:	Lead Surveyor	Survey Type	Floor	Analysis
13 Jun 2017	Spencer Kerrison	Refurbishment Survey	1st Floor	N/A
Building	Room	Item	Quantity	
Camborne Library, The Cross, Camborne, TR14 8HA	Staff Room	No asbestos detected	N/A	
Sample No (S,SP,P,As)	Product Type	Surface Treatment	Condition	Accessibility
Visual (P)	N/A	N/A	N/A	N/A
Material Risk Score				
N/A				
Recommended action	No further action required			
Surveyor comments	No access below carpet/coverings. Rooms are occupied at time of survey.

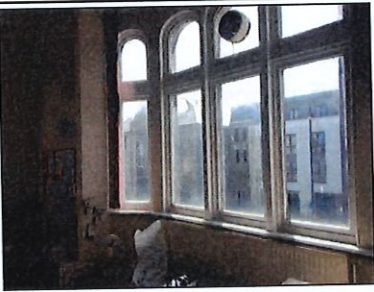
Survey Date:	Lead Surveyor	Survey Type	Floor	Analysis
	13 Jun 2017	Spencer Kerrison	Refurbishment Survey	1st Floor	N/A
	Building	Room	Item	Quantity	
	Camborne Library, The Cross, Camborne, TR14 8HA	Office	No asbestos detected	N/A	
	Sample No (S,SP,P,As)	Product Type	Surface Treatment	Condition	Accessibility
	Visual (P)	N/A	N/A	N/A	N/A
	Material Risk Score				
Recommended action		No further action required			
Surveyor comments		No access below carpet/coverings. Rooms are occupied at time of survey.

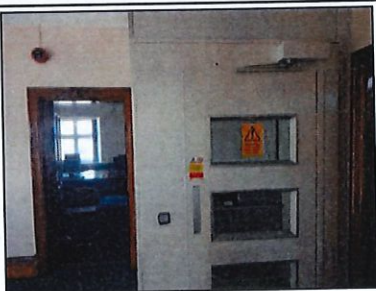
Survey Date:	Lead Surveyor	Survey Type	Floor	Analysis
	13 Jun 2017	Spencer Kerrison	Refurbishment Survey	1st Floor	N/A
	Building	Room	Item	Quantity	
	Camborne Library, The Cross, Camborne, TR14 8HA	Lift	No asbestos detected	N/A	
	Sample No (S,SP,P,As)	Product Type	Surface Treatment	Condition	Accessibility
	Visual (P)	N/A	N/A	N/A	N/A
	Material Risk Score				
Recommended action		No further action required			
Surveyor comments		No access behind wall cladding panels

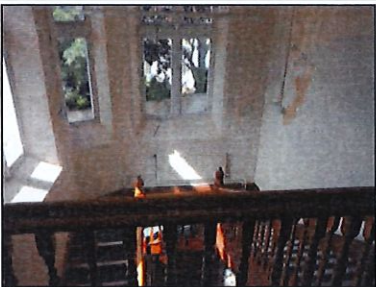
Survey Date:	Lead Surveyor	Survey Type	Floor	Analysis
	13 Jun 2017	Spencer Kerrison	Refurbishment Survey	1st Floor	N/A
	Building	Room	Item	Quantity	
	Camborne Library, The Cross, Camborne, TR14 8HA	Circulation/stairs	No asbestos detected	N/A	Accessibility
	Sample No (S,SP,P,As)	Product Type	Surface Treatment	Condition	
	Visual (P)	N/A	N/A	N/A	N/A
	Material Risk Score				
Recommended action		No further action required			
Surveyor comments		No access below carpet/coverings. Rooms are occupied at time of survey.

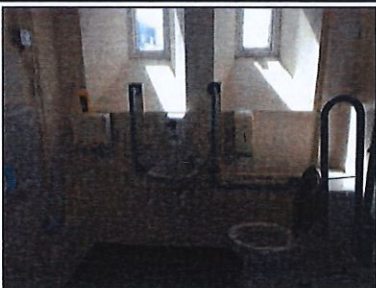
Survey Date:	Lead Surveyor	Survey Type	Floor	Analysis
	13 Jun 2017	Spencer Kerrison	Refurbishment Survey	1st Floor	N/A
	Building	Room	Item	Quantity	
	Camborne Library, The Cross, Camborne, TR14 8HA	WC	No asbestos detected	N/A	Accessibility
	Sample No (S,SP,P,As)	Product Type	Surface Treatment	Condition	
	Visual (P)	N/A	N/A	N/A	N/A
	Material Risk Score				
Recommended action		No further action required			
Surveyor comments		No access below carpet/coverings. Rooms are occupied at time of survey.

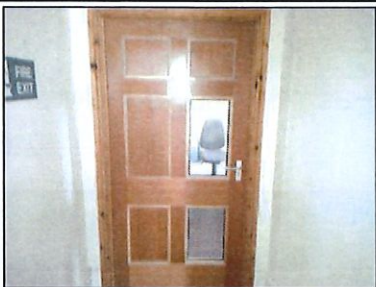
Survey Date:	Lead Surveyor	Survey Type	Floor	Analysis
	13 Jun 2017	Spencer Kerrison	Refurbishment Survey	1st Floor	N/A
	Building	Room	Item	Quantity	
	Camborne Library, The Cross, Camborne, TR14 8HA	Museum	No asbestos detected	N/A	
	Sample No (S,SP,P,As)	Product Type	Surface Treatment	Condition	Accessibility
	Visual (P)	N/A	N/A	N/A	N/A
	Material Risk Score				
Recommended action		Inspection Required			
Surveyor comments		No access - no key available at time of survey

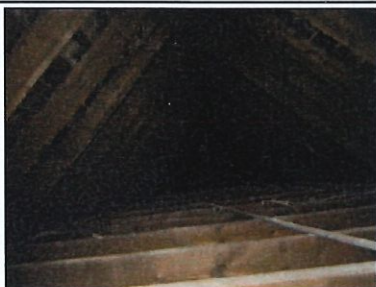
Survey Date:	Lead Surveyor	Survey Type	Floor	Analysis
	13 Jun 2017	Spencer Kerrison	Refurbishment Survey	Roof Void	N/A
	Building	Room	Item	Quantity	
	Camborne Library, The Cross, Camborne, TR14 8HA	Loft space above circulation / Stairs	No asbestos detected	N/A	
	Sample No (S,SP,P,As)	Product Type	Surface Treatment	Condition	Accessibility
	Visual (P)	N/A	N/A	N/A	N/A
	Material Risk Score				
Recommended action		No further action required			
Surveyor comments		N/A
