**Address of property:
The Village Centre
New Hill
Farnsfield
Notts
NG22 8JN**

**Prepared on behalf of:
The Parish Council**

**Date of inspection:
25th April 2017**

BUILDING SURVEY REPORT

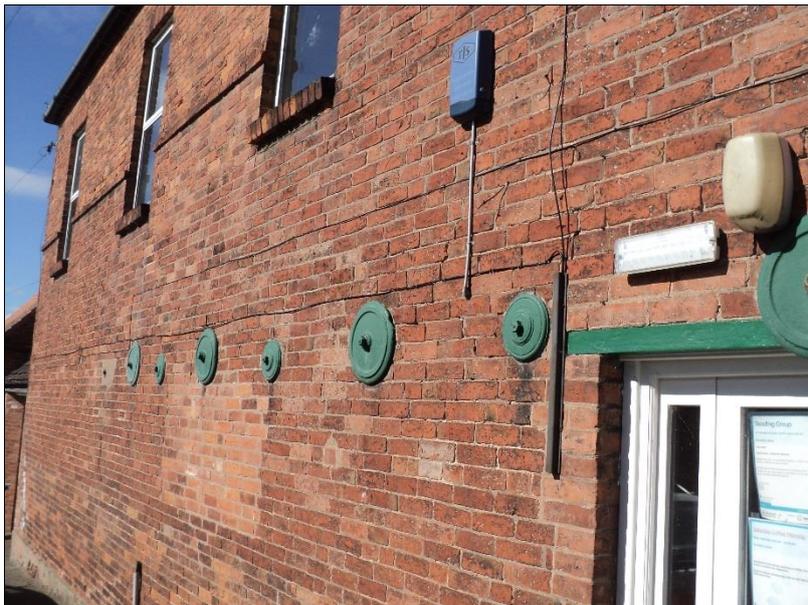
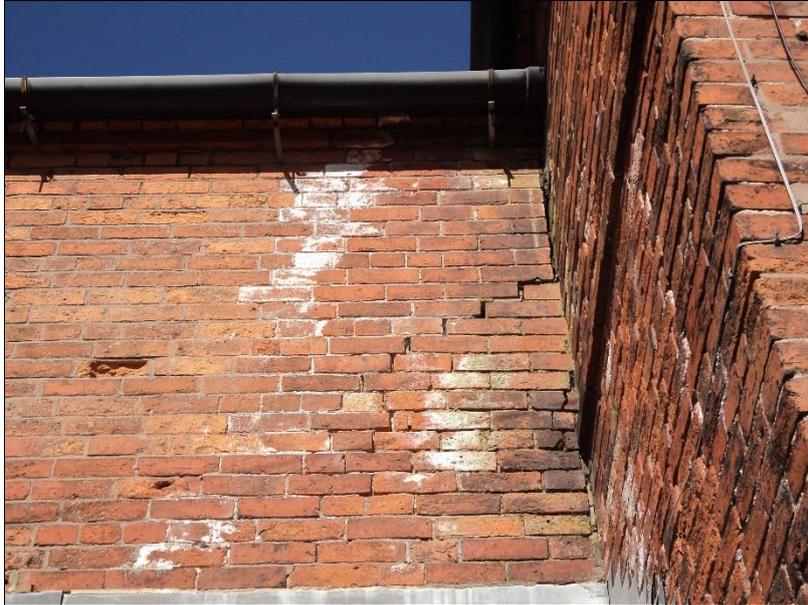
There is some minor cracking and distortion of the brickwork over the front entrance doors. This possibly occurred during internal alteration works in the foyer area and is a result of

settlement of the brickwork. We recommend that the cracks are “stitched” (repaired) with proprietary stainless steel rods resin bonded into the mortar courses across the crack and the area subsequently re pointed. We refer you to our later comments in the External Walls Section.

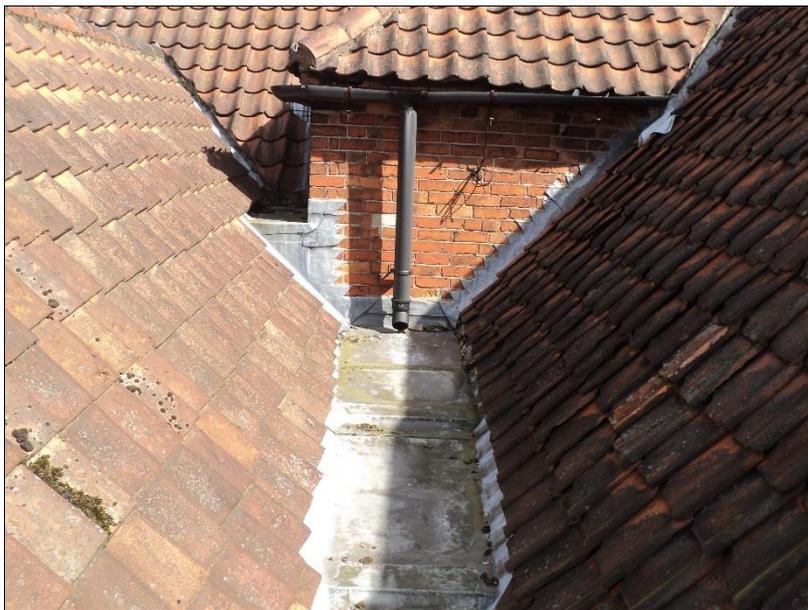
Rear valley gutter

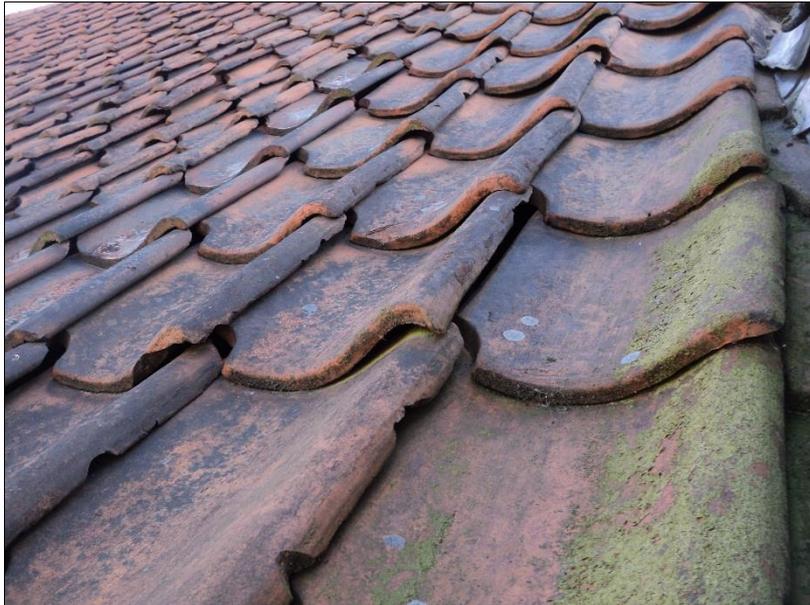
Handmade clay pantiles.

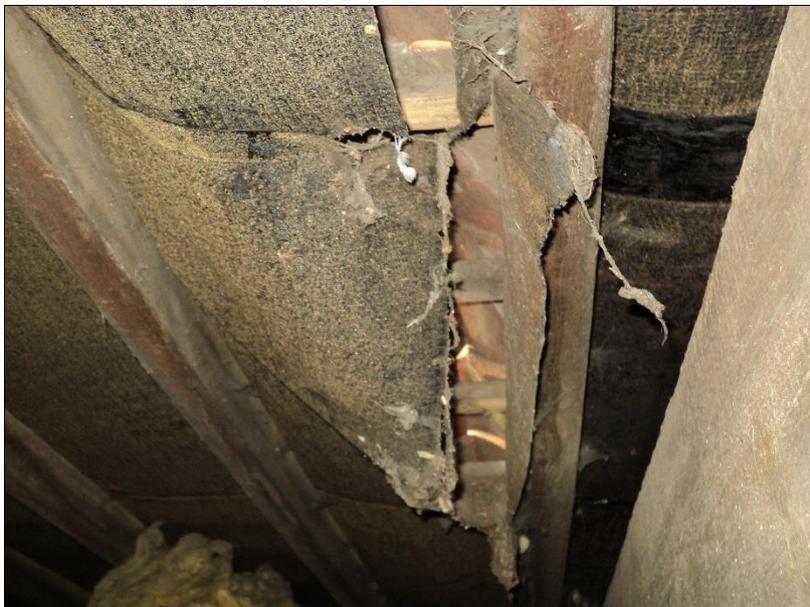
The roofs have been stripped previously (possibly circa 1970) and re laid over bitumen lining felt beneath the roof coverings to provide a secondary defence against wind driven rain or snow and leakages. This had been largely successful but bitumen felt underlining is vulnerable to ultraviolet light which causes the felt to become brittle and fail. Used under handmade pan tiles, sun light damages the felt via the open joints between the tiles and also at the roof edges where it is exposed above the guttering. We noted areas of loose and damaged felt to the left side roof space requiring attention. It should be noted that in order to undertake a correct repair to the felt, the tiles and battens need to be stripped off first.

Lining felt damage in the roof space

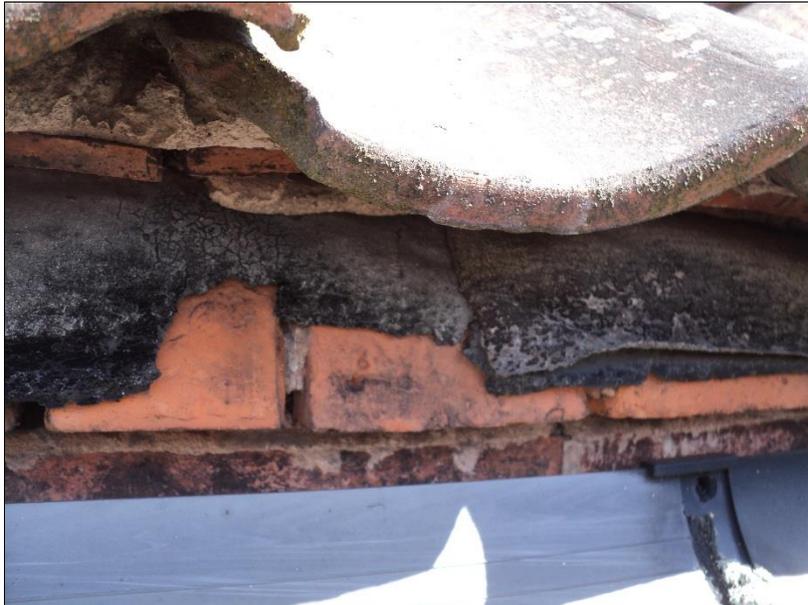
Lining felt damaged at the roof edge.

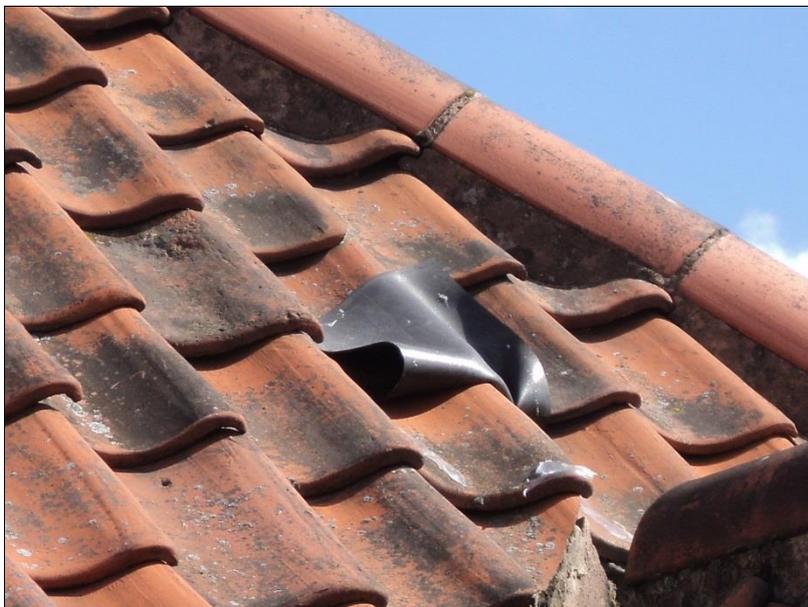
Attempted felt repair with plastic sheet.

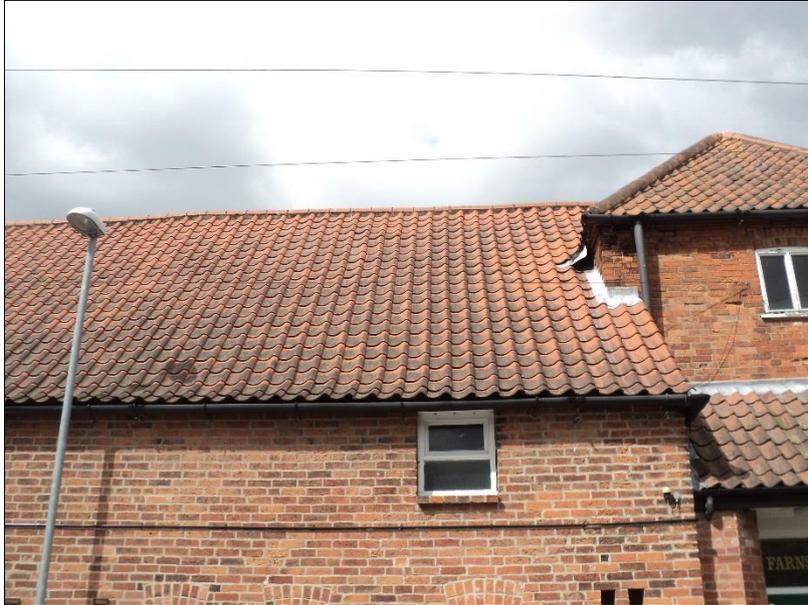
Modern clay pan tiles to front

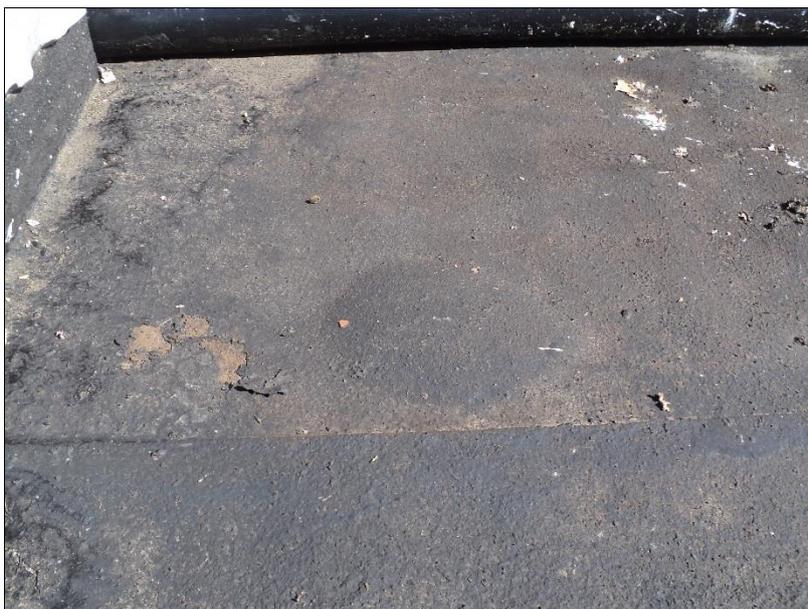
There are flat felt roofs to the rear. These appear to be in reasonable order with no current obvious defects. There is some localised bubbling to the single storey flat roof indicating that the roof covering is ageing. Replacement of these is not essential currently, but for a more long term solution, Butyl Rubber membranes or Fibreglass are a far better option than felt. Felt has a lifespan of 15-20 years depending on its quality compared with 30 plus years for Butyl and Fibreglass.

Flat roof to single storey roof.

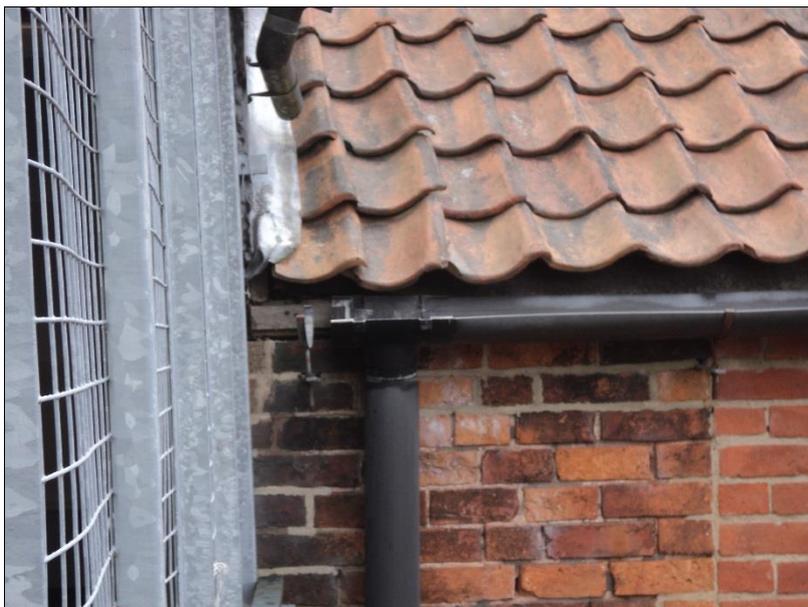
Left side

The gutters and downpipes to this property are constructed from plastic and appear to be generally free from defect or serious leakage. The guttering to the roof either side of the rear fire escape has no stopped ends and this is allowing water to run down the rear of the building. The left side gutter (picture below) is too short to catch the rainwater from the roof. This has the extra burden of dealing with water from the downpipe above.

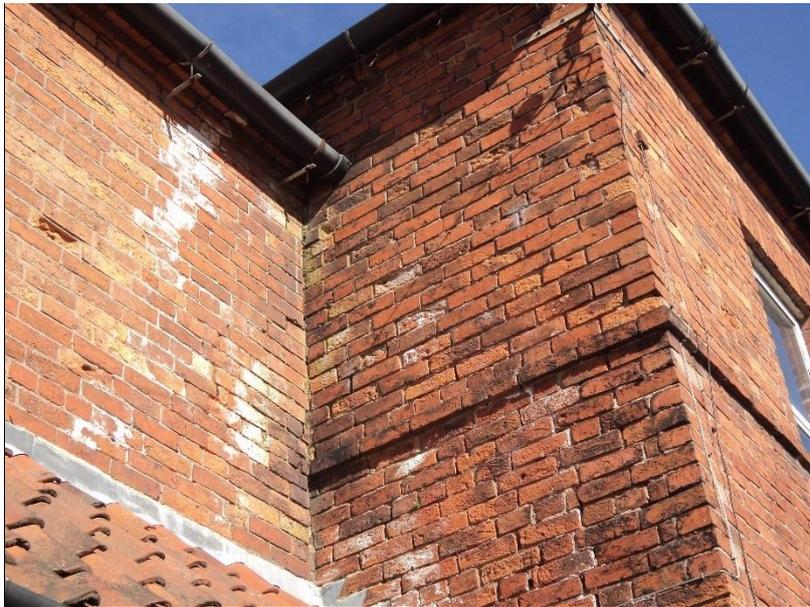
There appears to have been a problem on the front of the property over the main entrance with algae and salt staining noted to the brickwork. This may be related to overspilling blocked gutters. If this has not been previously addressed, a closer inspection should be undertaken of this area and appropriate clearing or repairs undertaken. This is the cause of the dampness noted within the foyer and file storage room below.

Salt staining/leak to front.

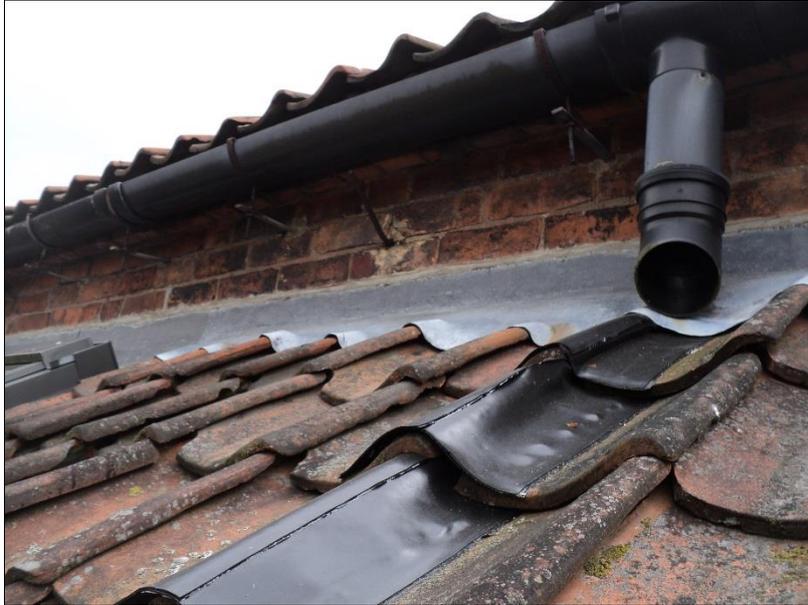
The downpipe from the rear gutter onto the flat roof over the first floor kitchen needs to be extended so that it does not discharge onto the tiled roof. An attempt has been made to cover the tiles with plastic but this will not be an effective long term solution.

Tiles covered in plastic.

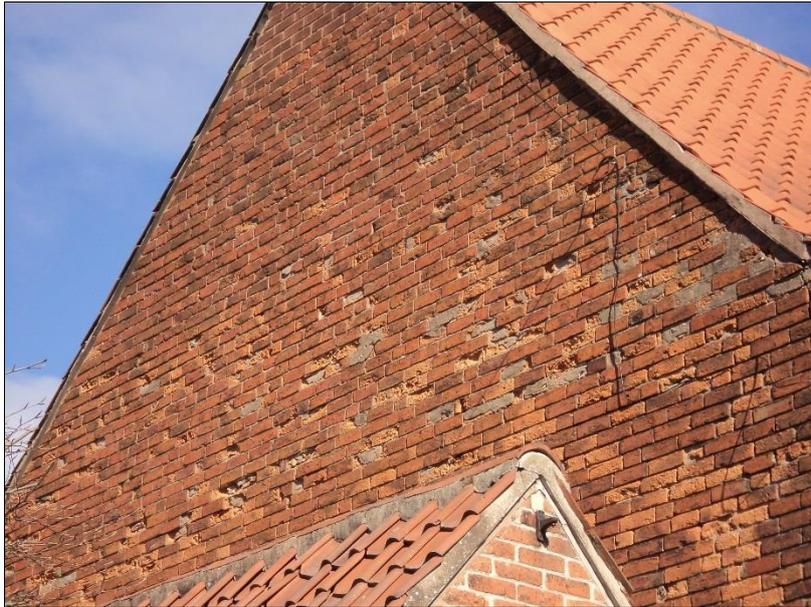
Left side

There are large areas of spalled (frost damaged) brickwork and missing pointing with the worst affected parts being: the left gable end, the rear left side, the front right side at low level and over the entrance. Extensive repairs are now required to cut out and replace the affected bricks and re point in lime mortar to match the existing. The gap at the junction of the two walls over the main doors should be infilled and re pointed.

Lime mortar will allow moisture to easily evaporate from the brickwork. Modern cement mortars retain moisture in the walls leading to frost damage. Ideally reclaimed bricks would be used to match the existing but these are often difficult to obtain. Due to the specialist nature of this type of repair we are unable to provide an estimate of costs. You should now obtain repair quotes from three brickwork contractors.

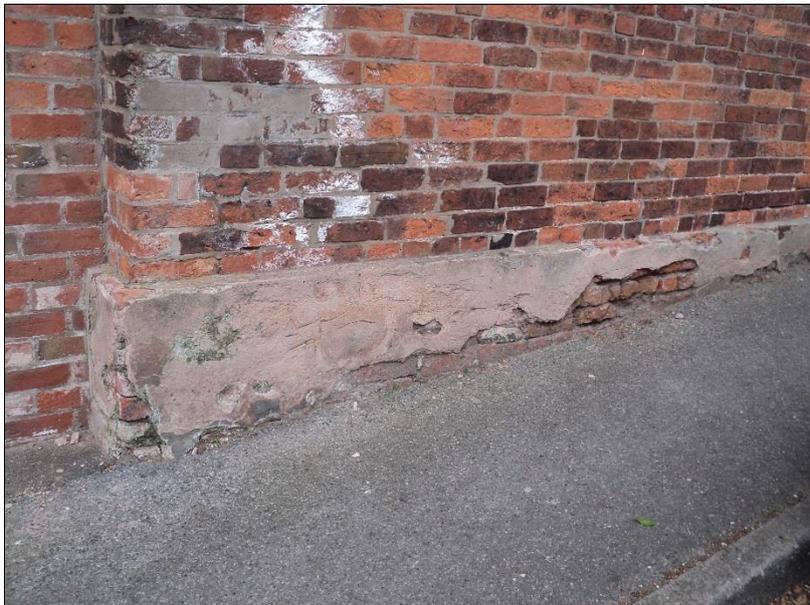
Front plinth at low level.

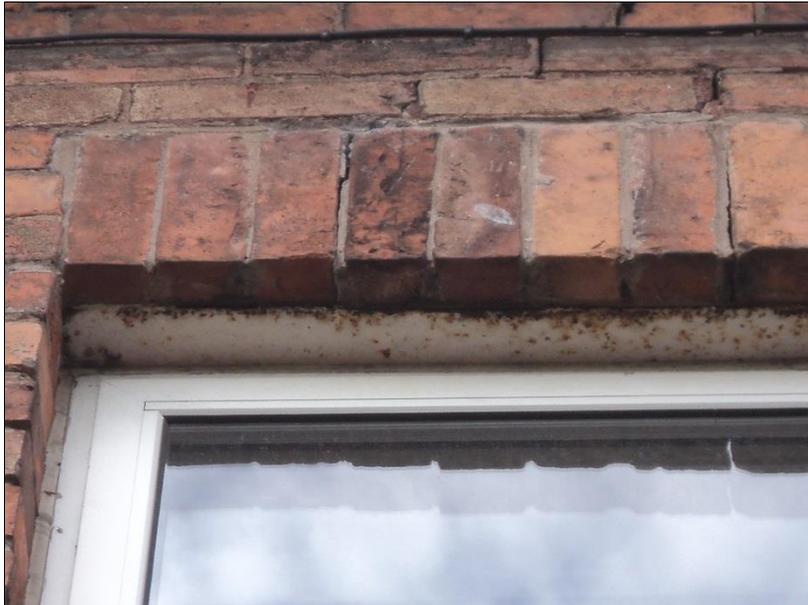
Right side hall window

Elsewhere the walls appeared to be generally satisfactory with no evidence of significant structural movement or other significant defect noted. There is some minor settlement of the brickwork over the top right side and library ground floor window. There appears to be suitable supporting lintels over the openings but minor re pointing is needed.

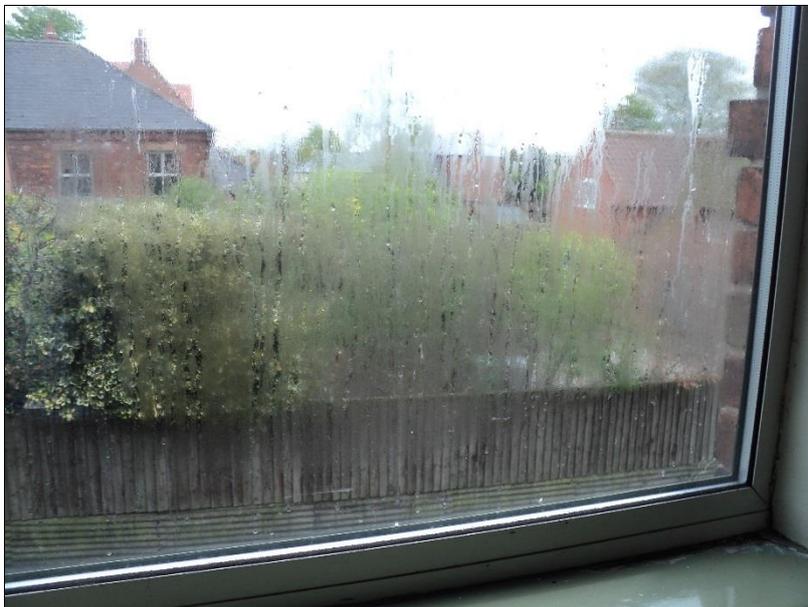
The aluminium windows are considered to be in a generally serviceable condition with no evidence of significant defects noted. There are some misted panes which need to be replaced. Double glazing can be prone to this problem, which is caused by failure of the hermetic seals at the edges of the panes of glass. The seals will deteriorate, eventually causing unsightly condensation between the panes. When this happens, there is no remedy other than to replace the affected double glazed panes. This often occurs on the windows that receive most sunlight. You should budget around £100 per pane.

Misted pane

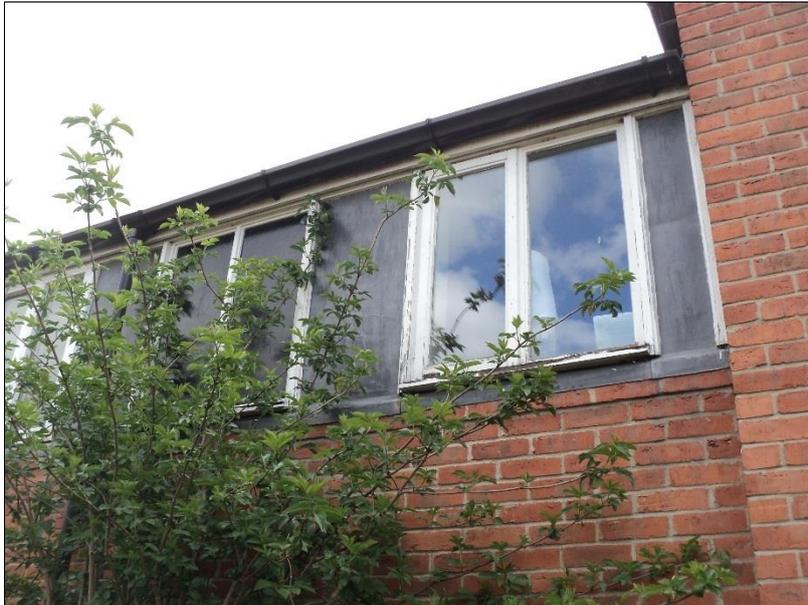
Rear extension windows

There are five rotten timber windows to the rear first floor. These will need to be replaced probably in plastic double glazed units. There is some minor developing wet rot to the front ground floor windows but this can be infilled and repaired. The windows to the ground floor on the rear are damaged and will need to be replaced.

You may wish to consider the replacement of all timber windows with plastic double glazed units if your budget allows. This will alleviate the need for redecoration and provide better thermal and sound insulation.

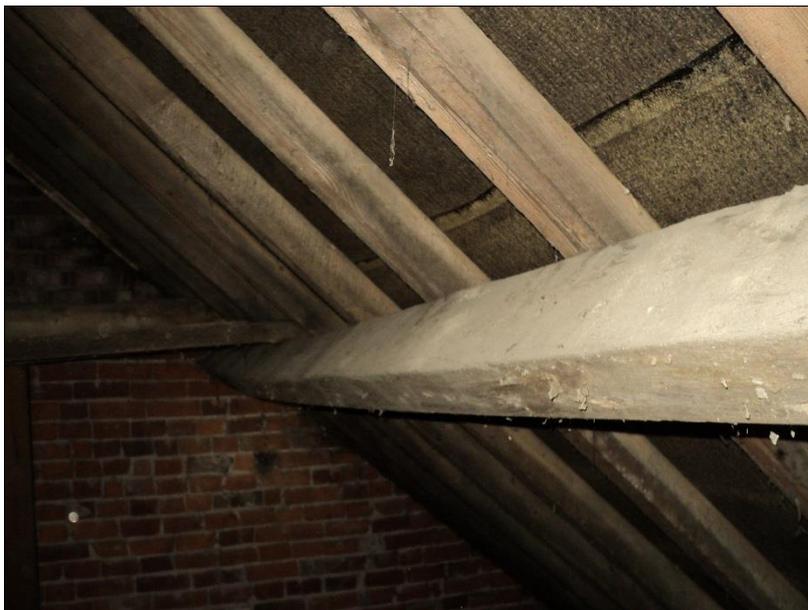
The structures mainly appear to be coping with the loading. There is a weak and slightly deformed purlin to the far left side of the roof space over the Uniformed Organisations Hall. This should be supported by an additional purlin, coach bolted alongside the existing and bearing into the gable end and onto the main truss. Elsewhere there was no evidence of any significant bowing or distortion to indicate any weakness with the roof timbers.

Weak purlin

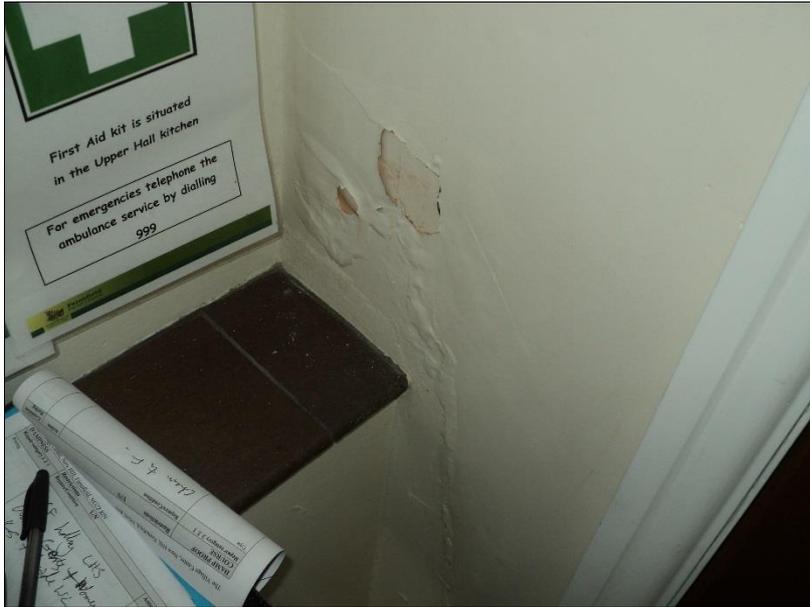
Foyer wall

- **Foyer and left side stage area:** Penetrating dampness from the roof/guttering above the entrance doors has damaged the plaster the left side of the stage and within the foyer and caused the black mould within the file storage cupboard. These areas were damp when tested but seem to be drying out. We assume that the cause of the water penetration has been addressed. The walls will struggle to dry out due to the painted finishes preventing evaporation. Ideally the plaster should be removed and the walls allowed to dry out before replastering.

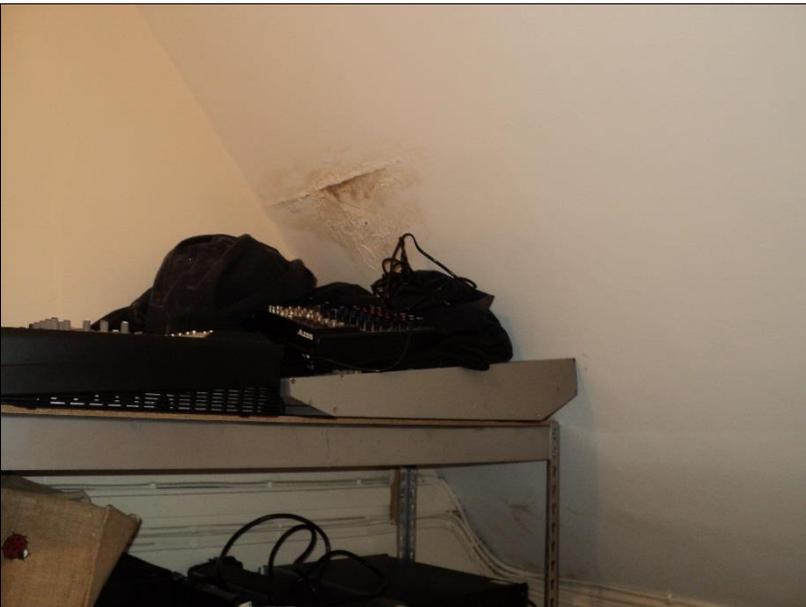
- **Kitchen and Music Store:** Old/dry stains were noted to the ceiling of the music store room to the first floor and to the purlin to the ceiling outside the first floor kitchen. It is understood that the recent roofing works addressed these leaks.

Music store ceiling

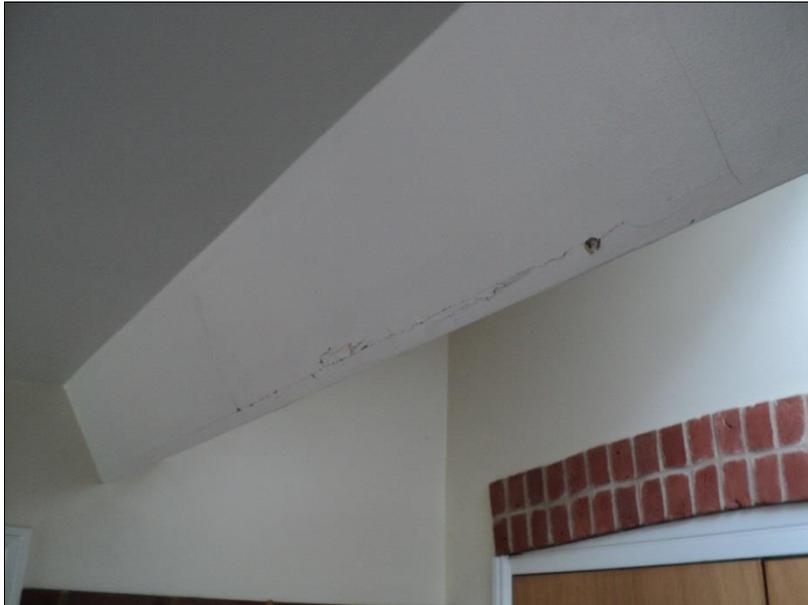
Old stain to purlin by first floor kitchen.

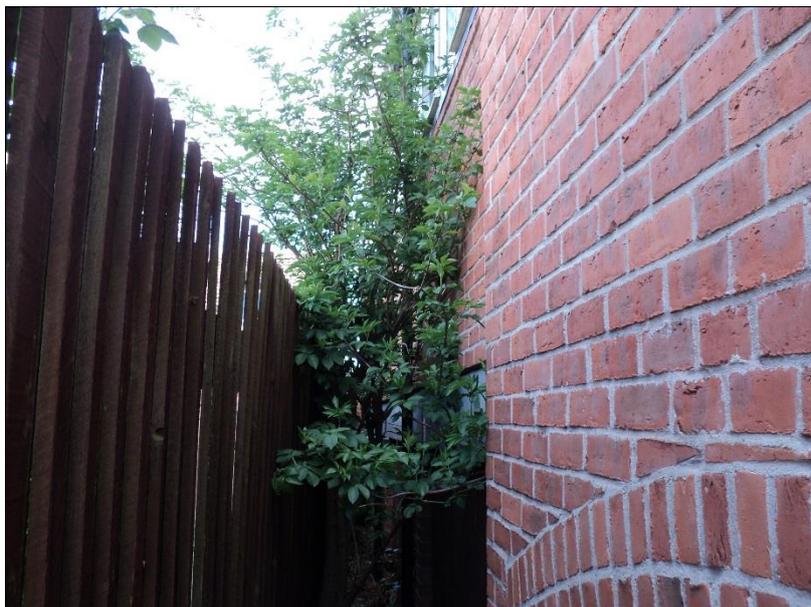
The tree to the rear should be removed as it is too close to the building.
