Congregationalist Cemetery, Ponsharden

Proforma Condition and Repairs Schedule

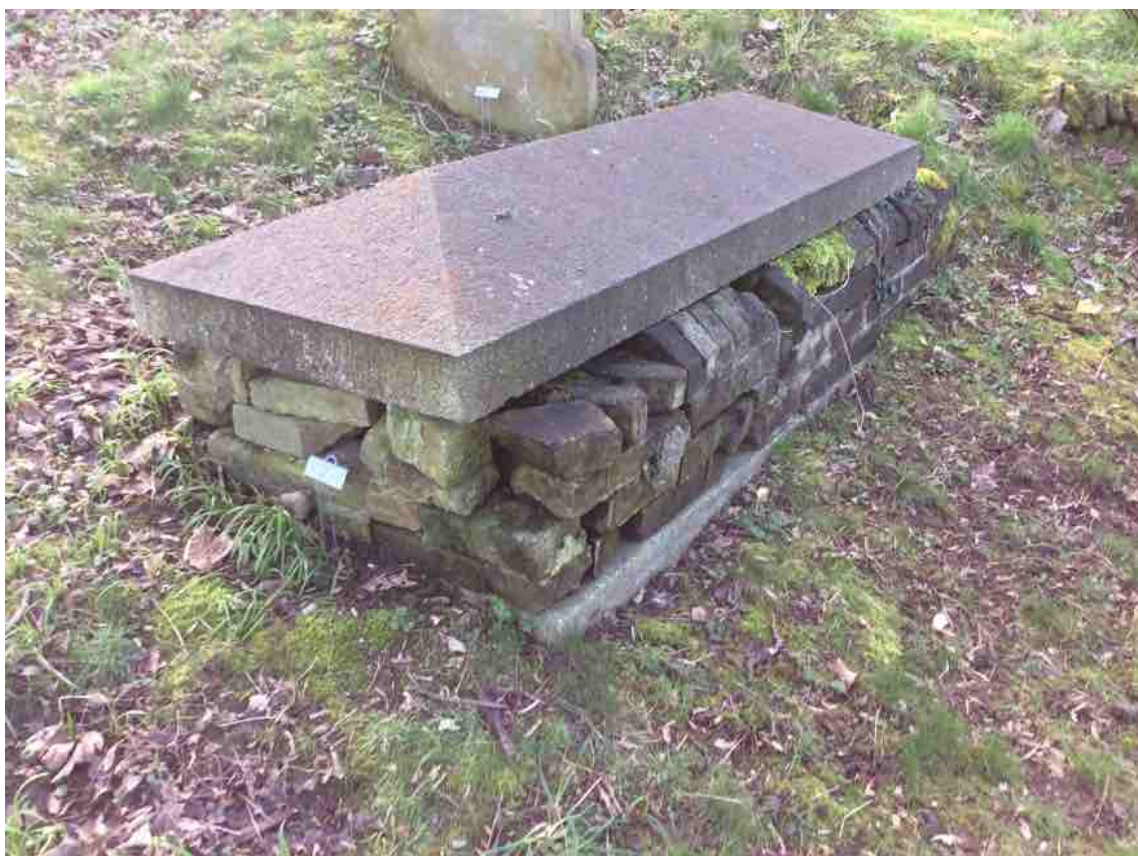
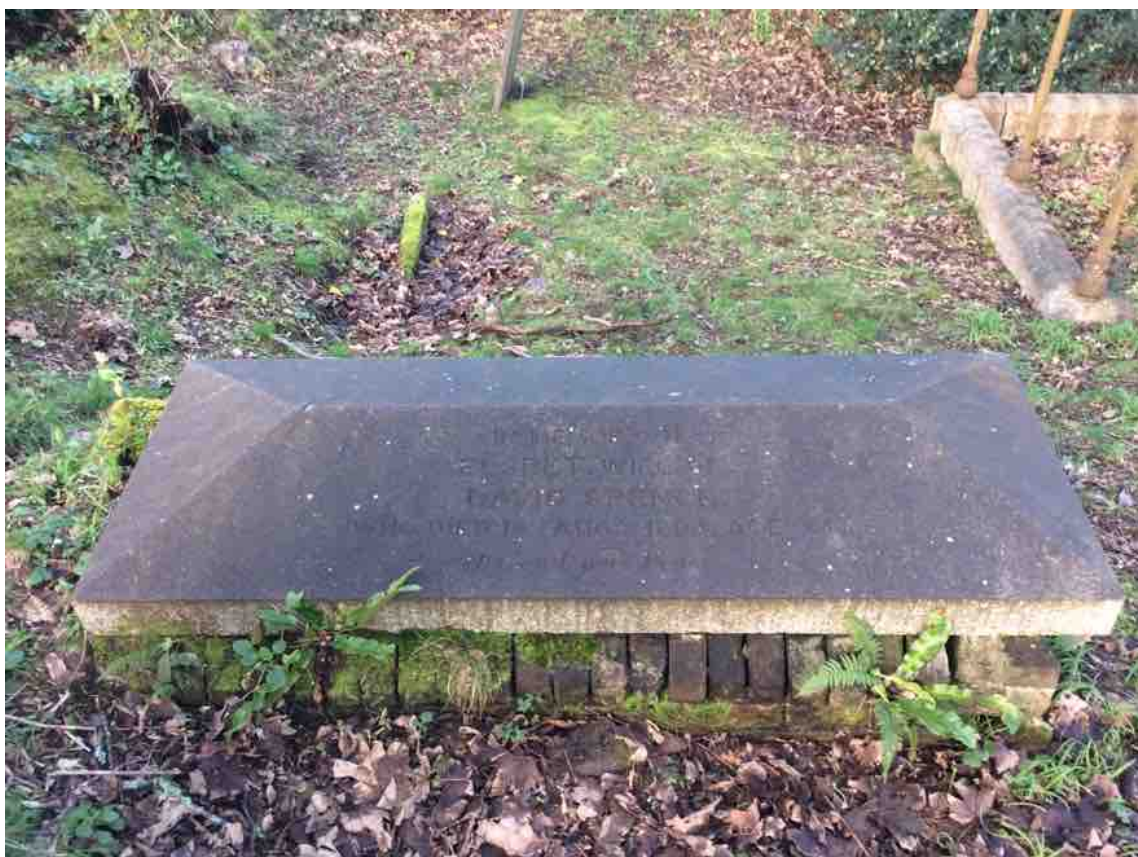
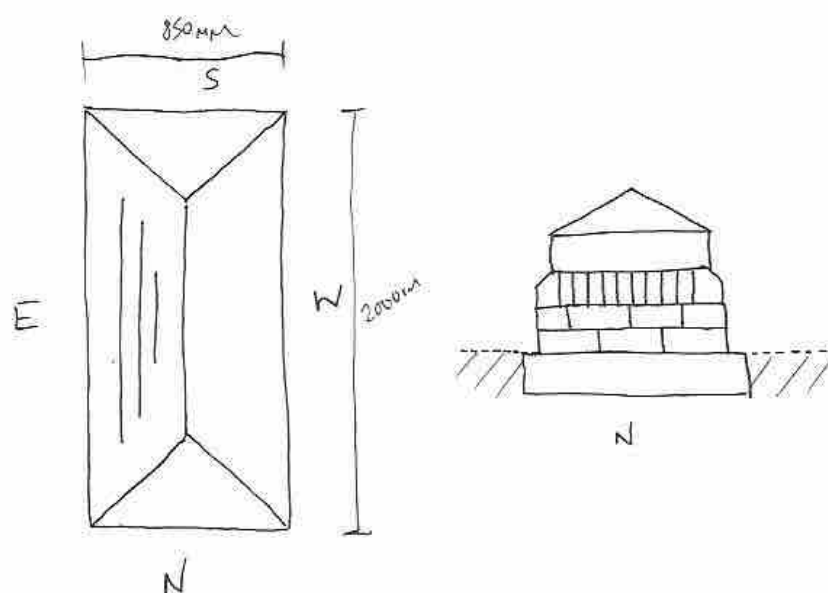
Monument 2

Damage to brickwork beneath granite slab, although slab itself sound. Lid is misaligned

Brickwork loose and disrupted, lid misaligned

Damage to brickwork beneath granite slab lid, lid misaligned

Remove granite lid. Salvage all loose bricks and clean off mortar. Rebuild 3 courses in stretcher bond plus top course of canted bricks in mortar on existing base and retained brickwork, providing secondhand matching replacement bricks where necessary. Re-bed granite lid in place on completed brickwork. Clean off organic growth and dirt.

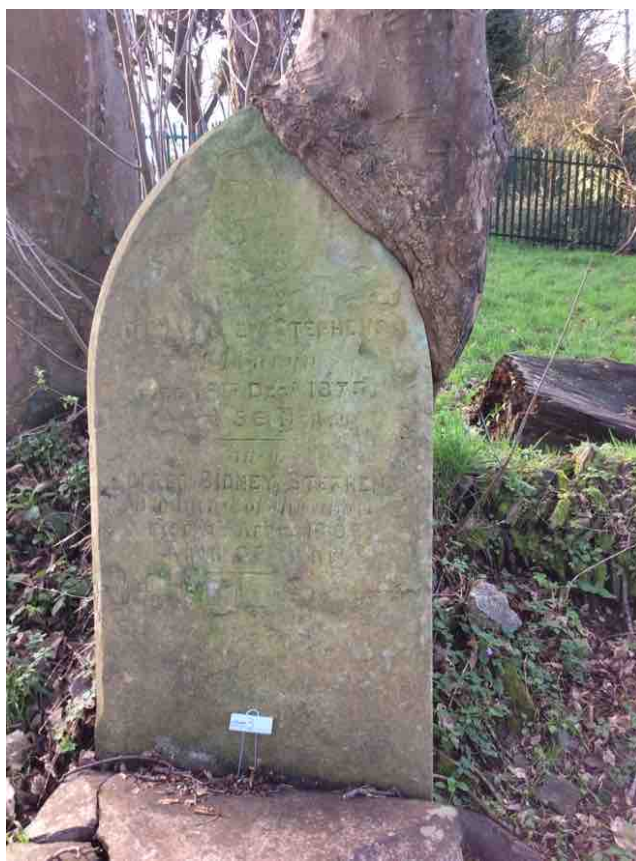
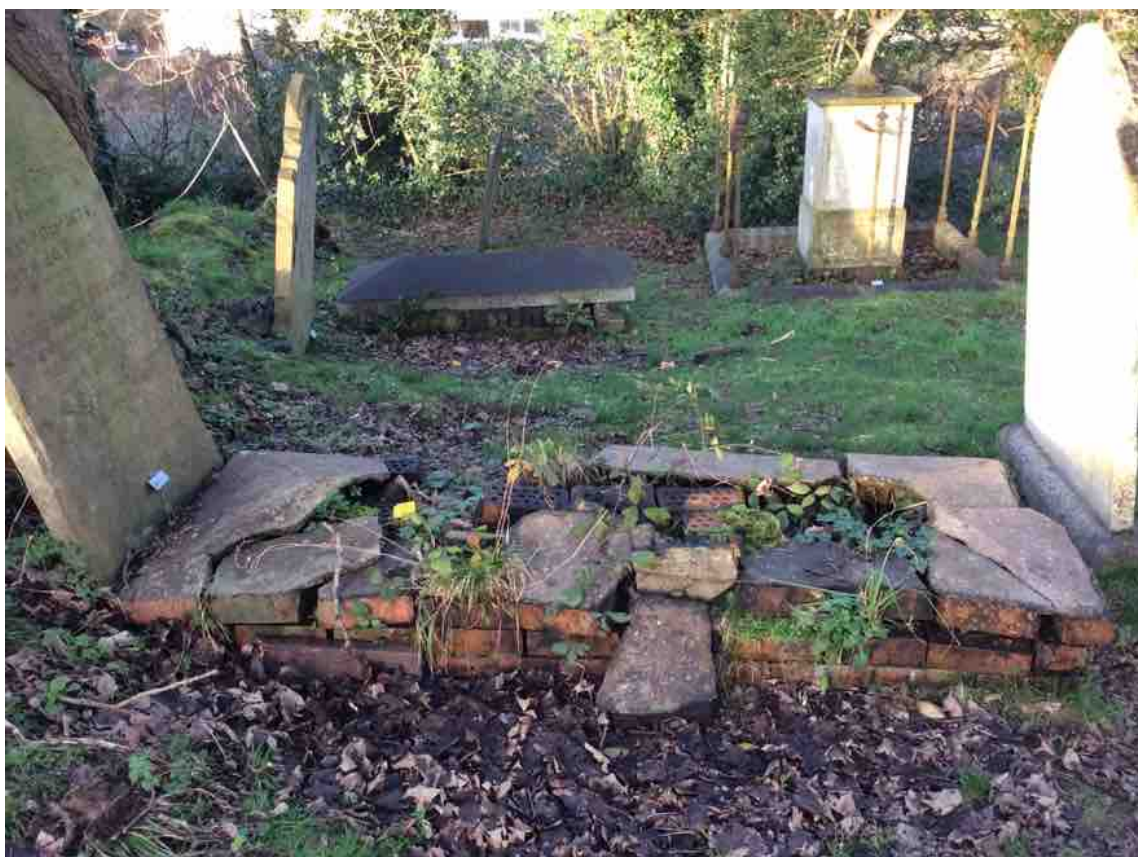
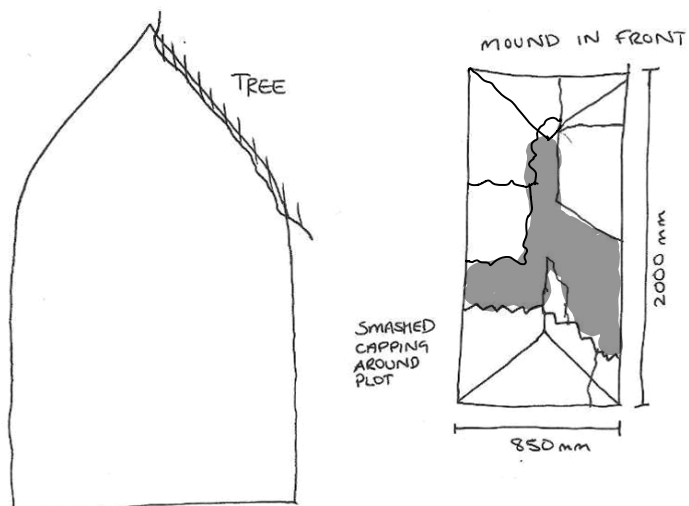
Monument 3

Overall structural condition:	Disrupted/separated	Tree growing into gravestone. Grave coping extensively smashed and damaged
Ground condition :	Good/level	
Impact of vegetation:	Disruption by roots	
Condition of foundation:	Not visible

Headstone supported by tree at present which adds to character, but may cause damage in future

Headstone embedded in tree (CT10), leave in situ, and monitor regularly. Clean off organic growth and dirt. Salvage and discard broken elements of capping, and salvage loose bricks for re-use. Rebuild 4 courses of brickwork in stretcher bond. Form core of new hipped capping with salvaged bricks and rubble stone bedded in mortar and finish with minimum 25mm thick 3 coat lime render to match original profile.

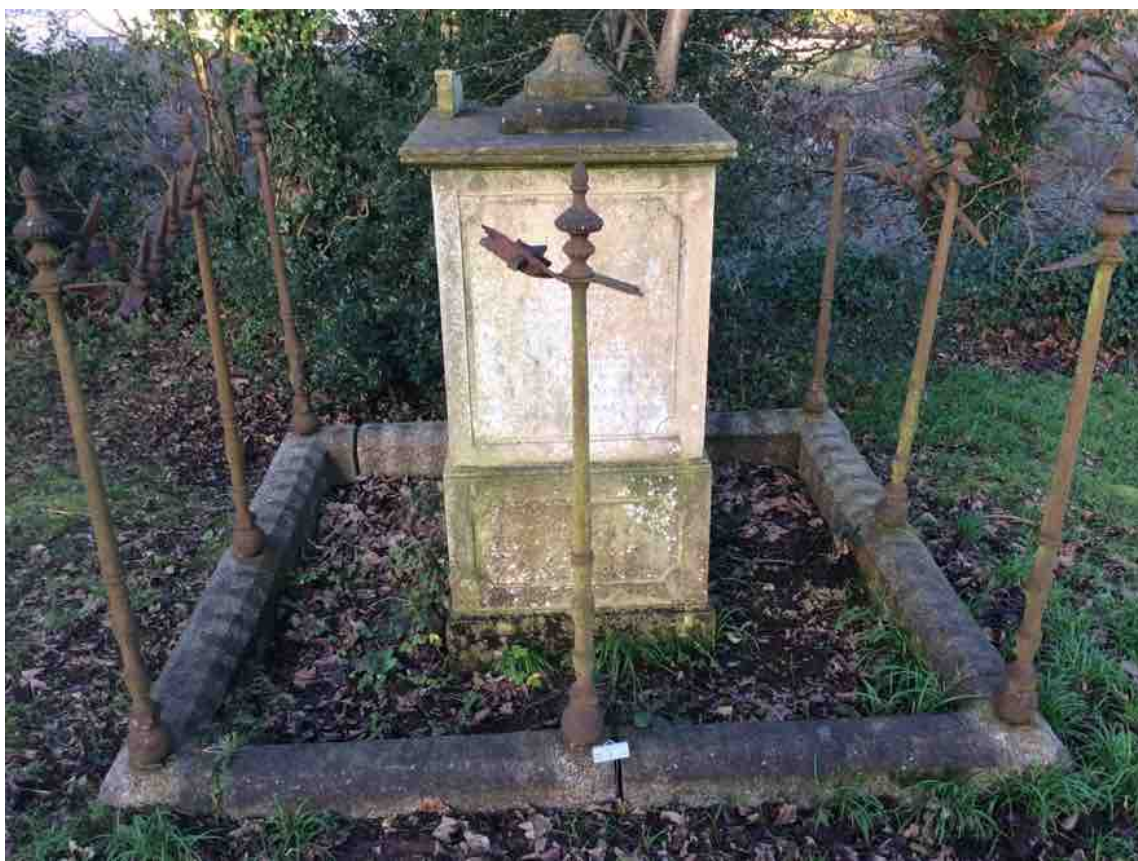
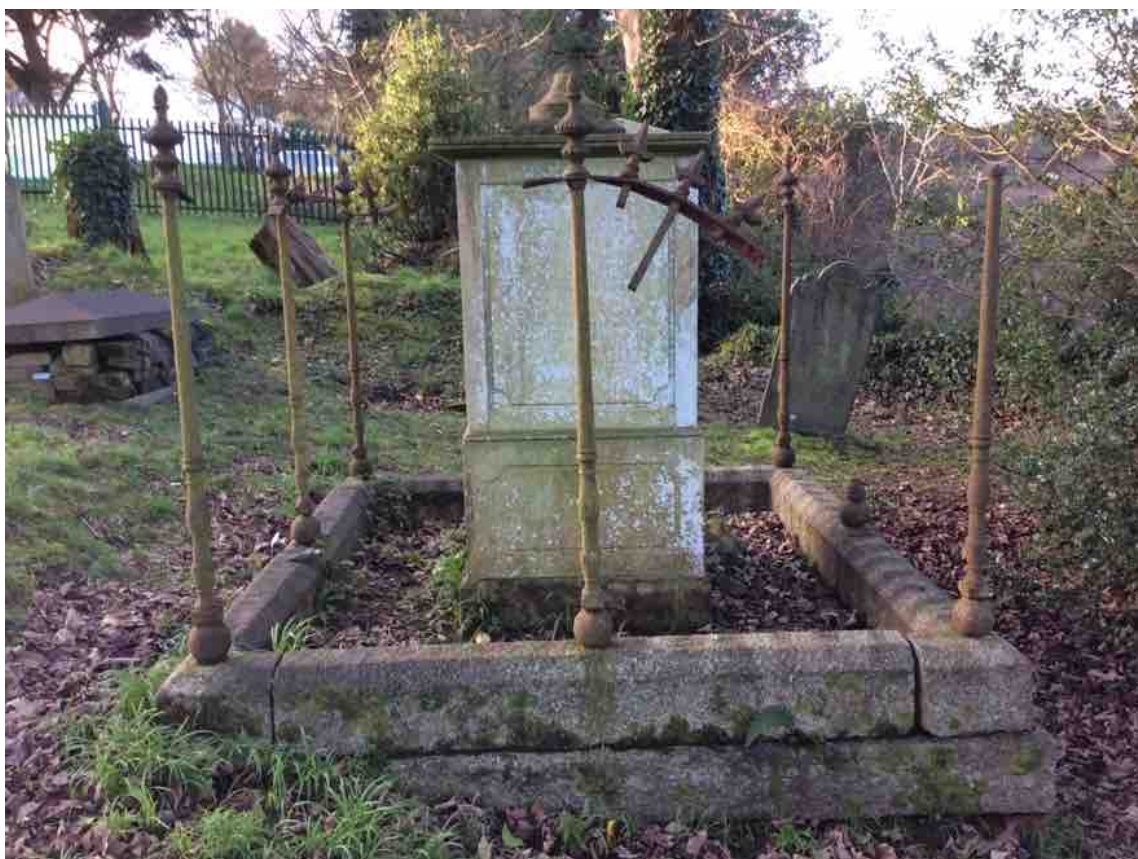
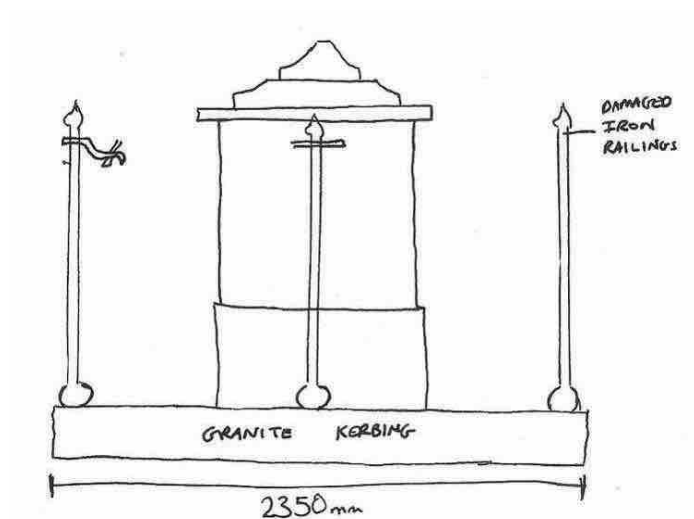
Monument

Overall structural condition:	Other	All sections slightly misaligned, cement infill cracked and missing in places. Base stones misaligned, most of railings missing
Ground condition :	Good/level	
Impact of vegetation:	Tree nearby	Very green stained
Condition of foundation:	Not visible	Kerb and monument generally sound

Part of urn lying on ground, misaligned masonry, particularly lid and kerbs, concrete slab cracked with holes

Parts of railings missing, remaining parts broken off. Leaded into plinth sockets, no spalling

Some further damage to railings since 2012 survey. Kelland comments that it was once topped by an urn - bits of which are around the site - this could be a future project to reinstate, but is not proposed at this stage

Clean stonework, realign kerb stones and repoint, reset displaced plinth sections and repoint joints. Round off sharp edges of broken balusters and horizontal bars. Clean off rust and redecorate. Repair cracked concrete slab and infill holes using matching pebbles. Refer to drawing.

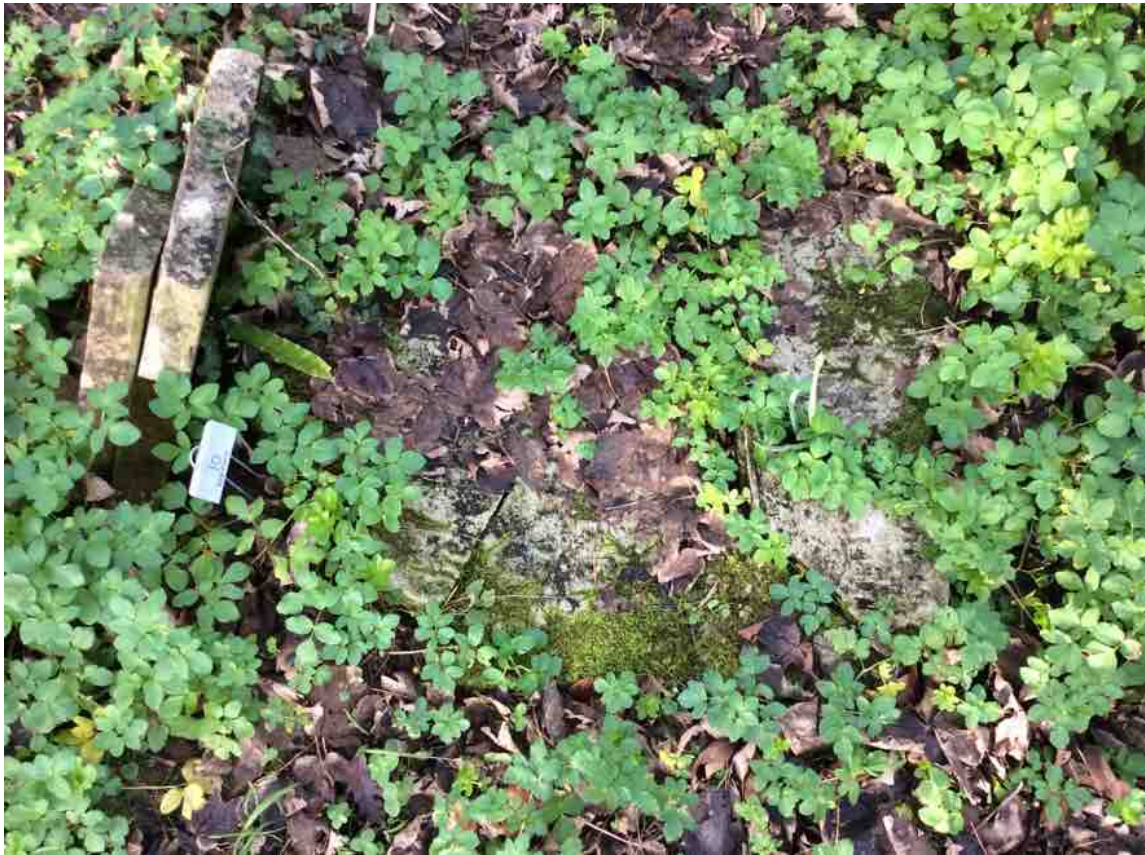
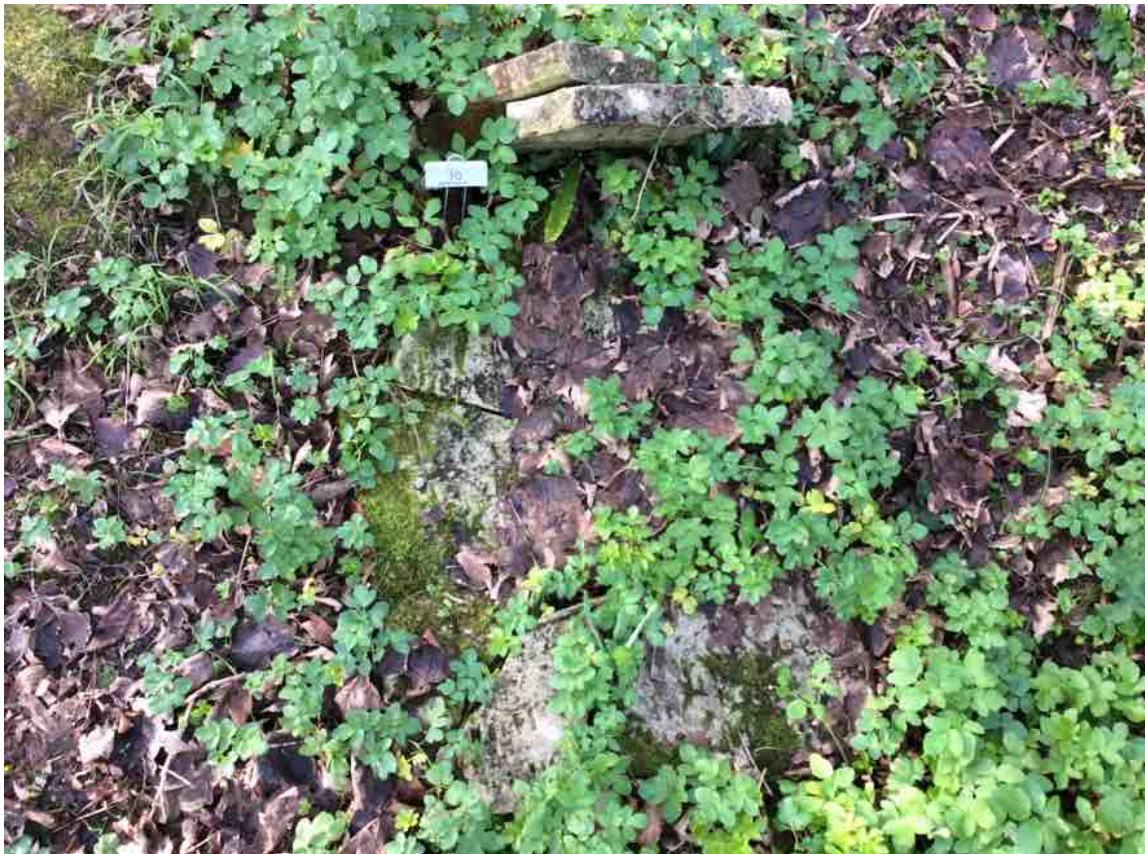
Monument 10

Overall structural condition:	Disrupted/separated	Most of marker missing and not found on site, although Kelland report photographed the pieces in situ
Ground condition :	Good/level	
Impact of vegetation:	Other	Surviving pieces slightly overgrown by low plants
Condition of foundation:	Not visible

Very damaged, most of marker missing. No works possible unless pieces found

Excavate broken pieces from the ground (approximately 7 including stub in ground), and piece together on new limecrete bed.

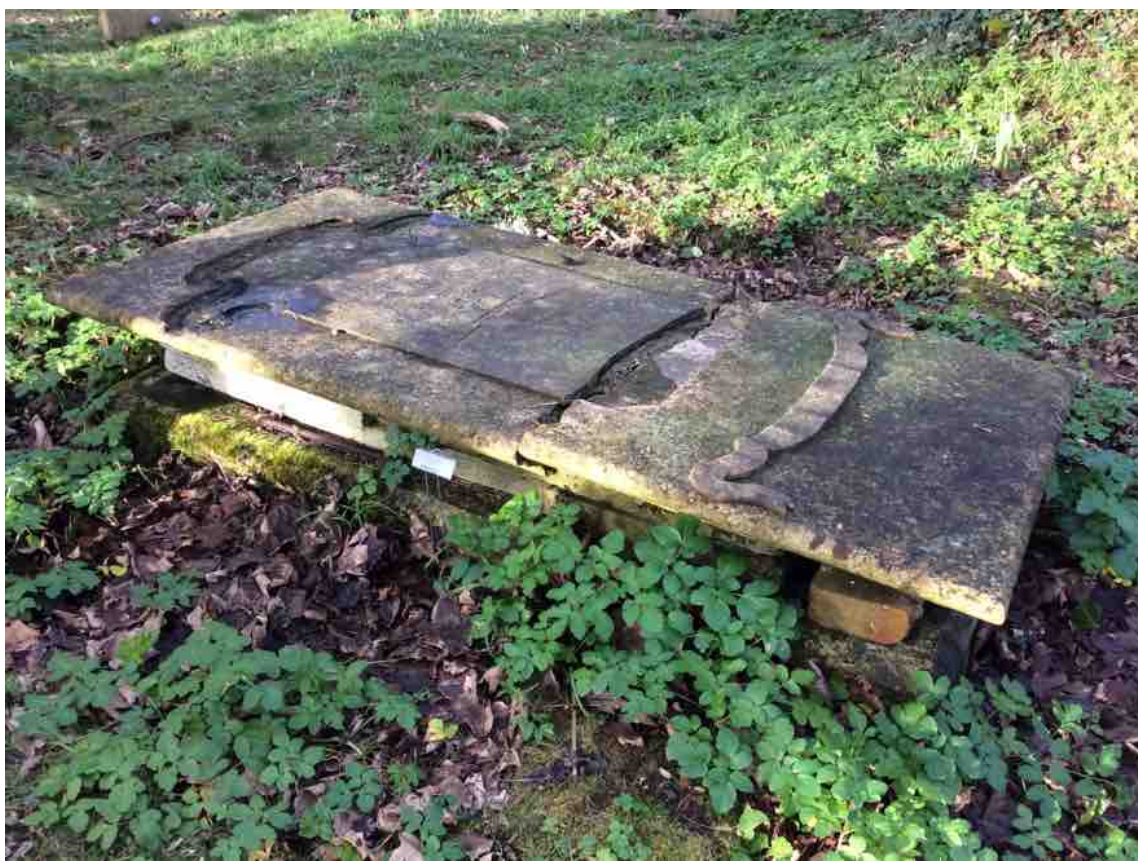
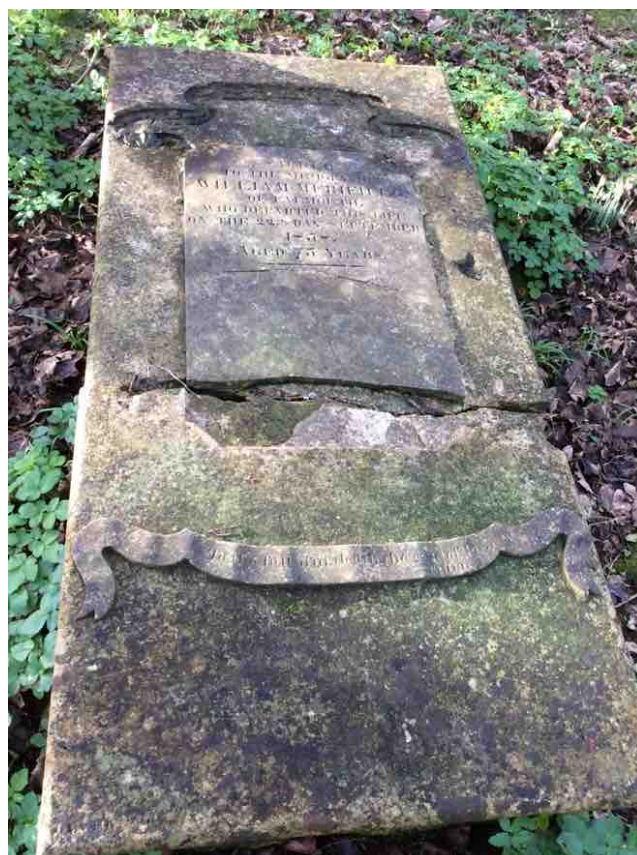
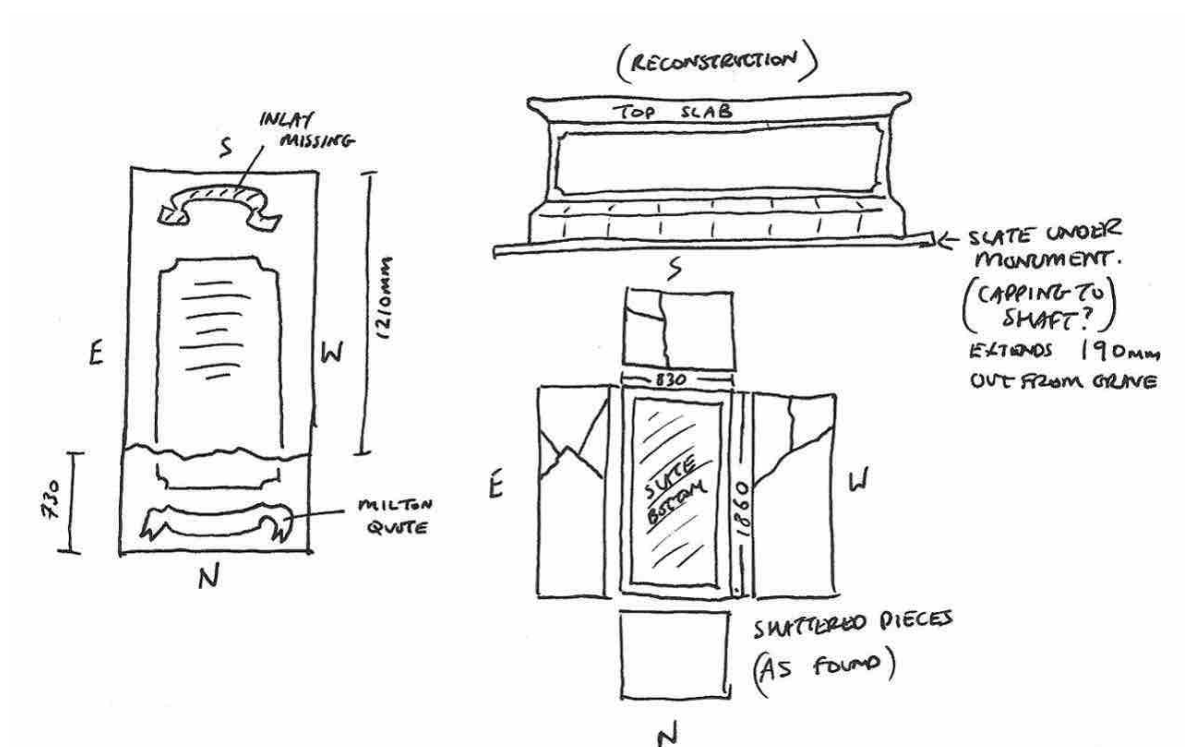
Monument 11

Top of table tomb broken, resting on tops of base stones, on slate slab, probably covering a vault. Base stones on north side broken and misaligned

Lid broken, side panels (some broken) laid inside, north side base stones broken and misaligned

High risk of further damage

Remove lid, remove iron cramps and disassemble side panels. Off slate slab base, construct core of honeycomb brickwork just higher than side panels. Reassemble 3 broken side panels (2 in 3 pieces, 1 in 4 pieces) with stainless steel dowels or cramps. Cramp side panels to block work core with stainless steel cramps, and point joints and broken pieces with mortar. Reassemble broken lid with stainless steel dowels or cramps. Bed lid onto core, point lid/side panel joints and joints between broken sections of lid with mortar. Clean.

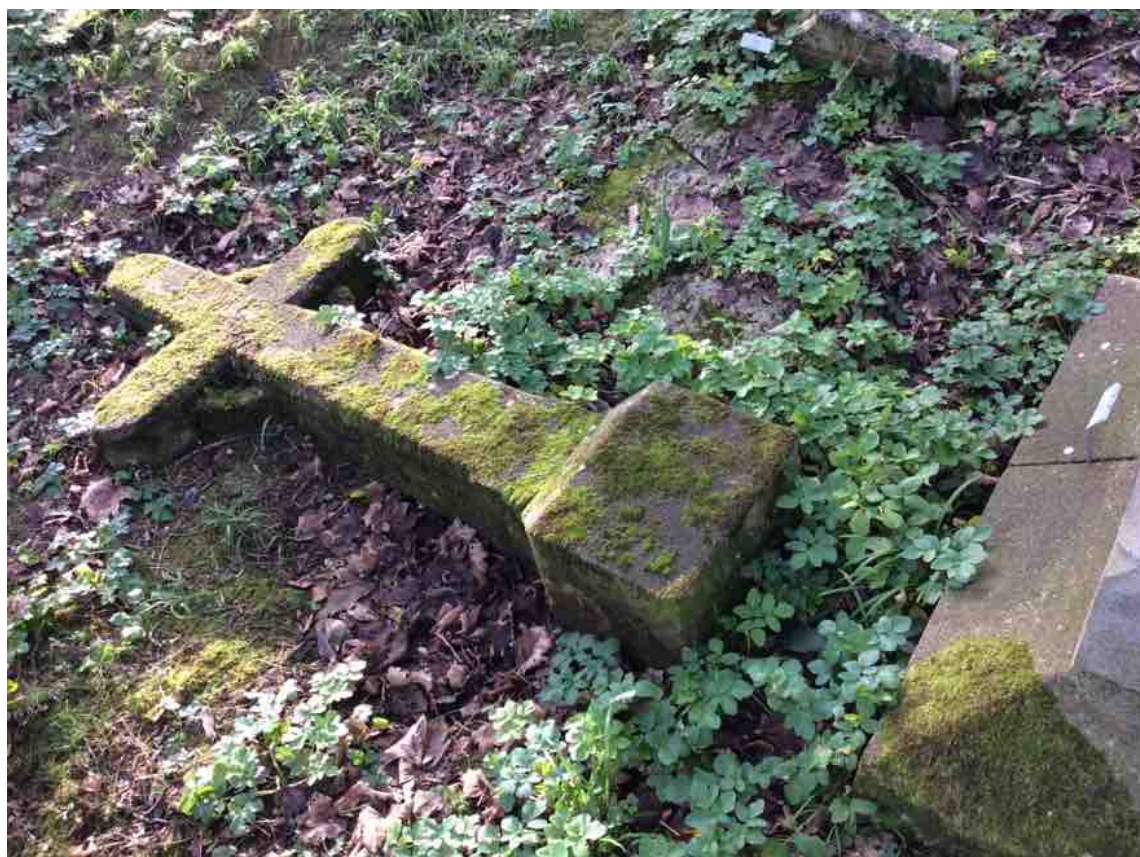
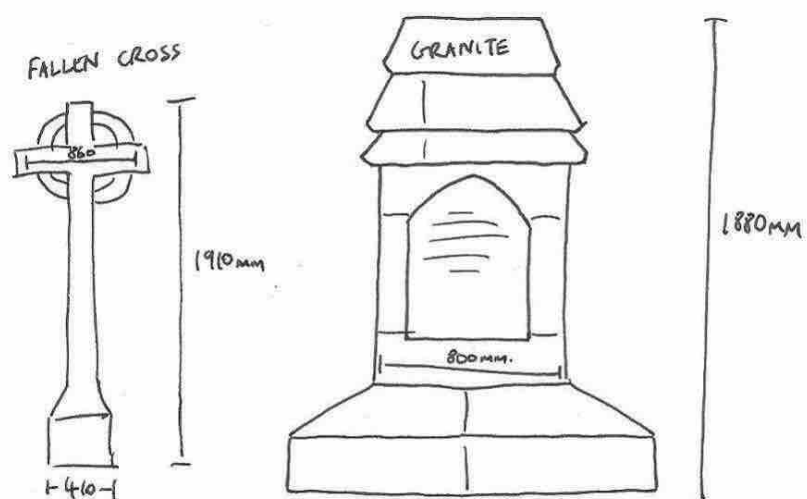
Monument 13

Some damage to lettering on the east side

Re-erect cross on top of pedestal with stainless steel dowel fixings. Repoint open joints of pedestal and fill hole in marble with mortar. Clean monument and cross. Refer to drawing.

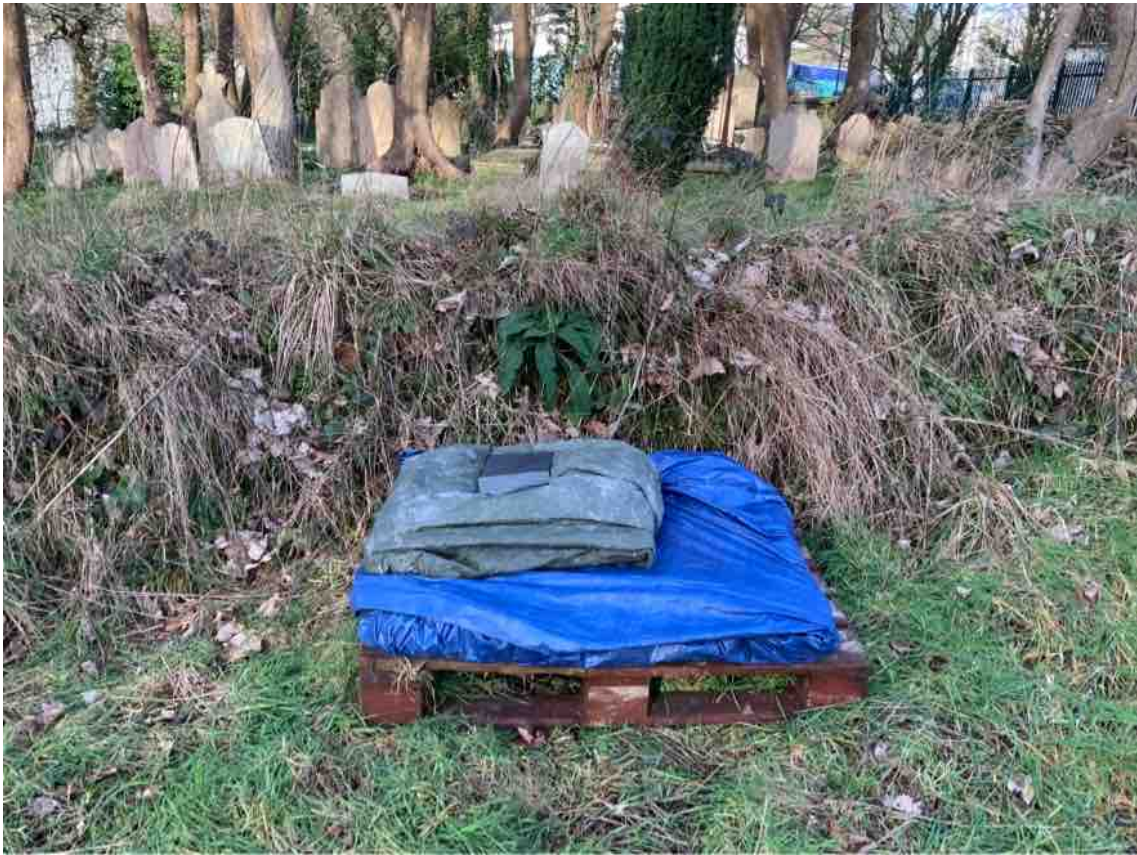
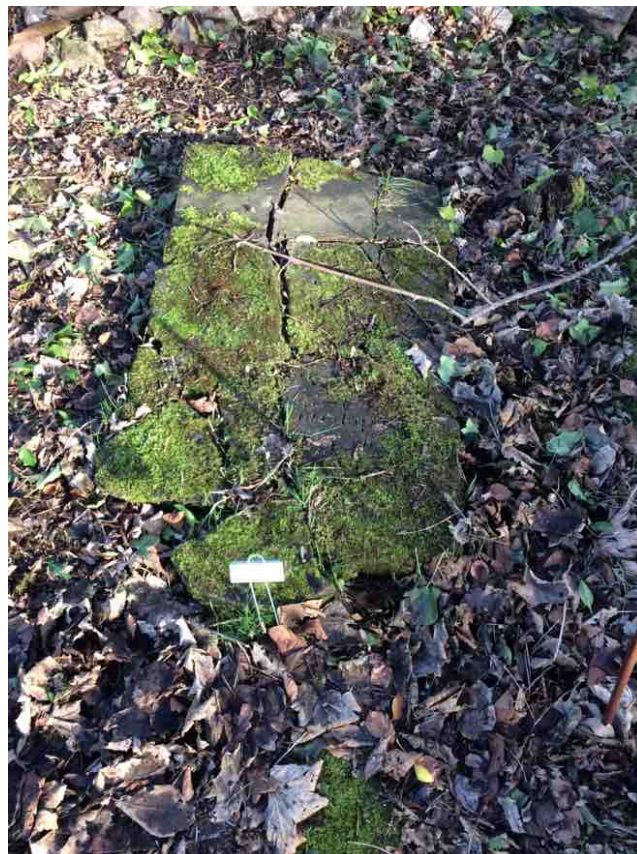
Monument 26

Types of deterioration:	Broken	All pieces removed to pallet stored within green boundary fence adjacent to south hedge of cemetery.
Surface condition :	Organic growth	and surface dirt
Condition of inscription :	Other	Unknown

General condition :	Very bad	Heritage significance:	E
General comments:	Several broken pieces. High risk of further damage/loss

Proposed repairs:	Piece together on new limecrete bed in original location (13 parts). Clean off organic growth and dirt following re-assembly.
Schedule of Work clauses:	2.05, 2.09c

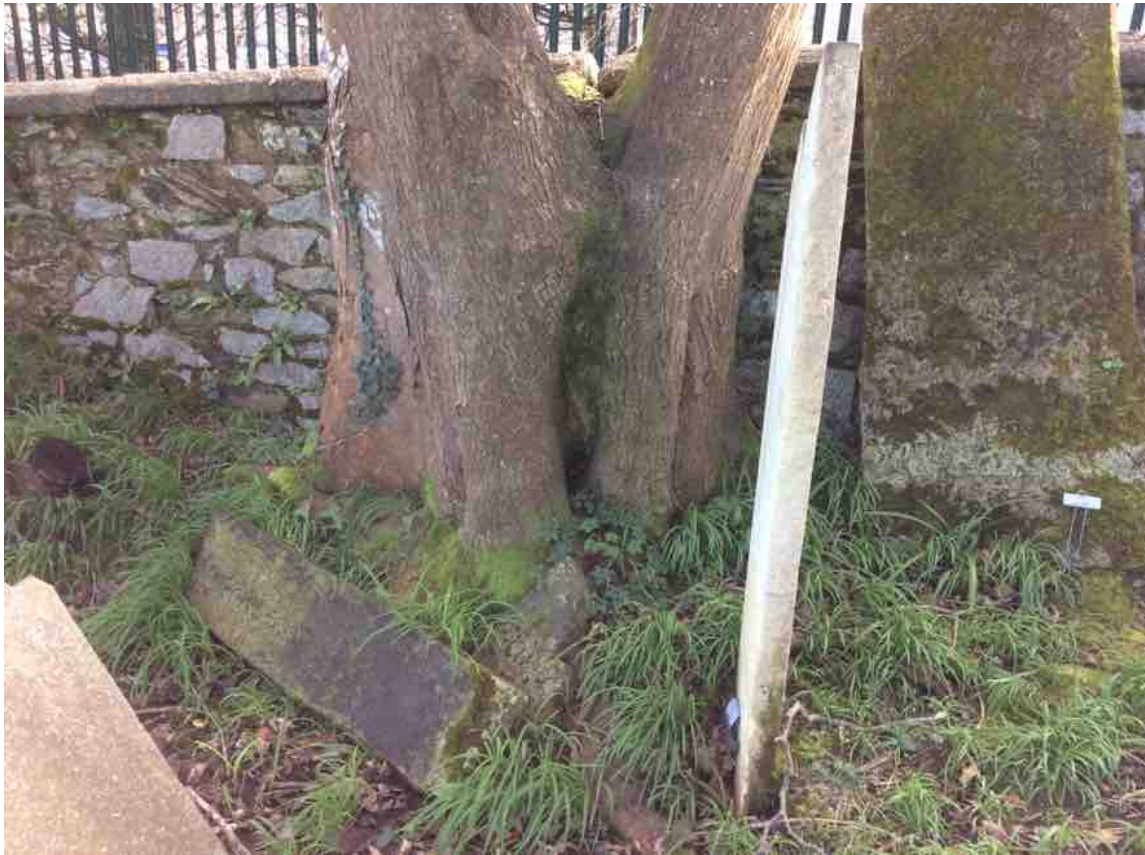
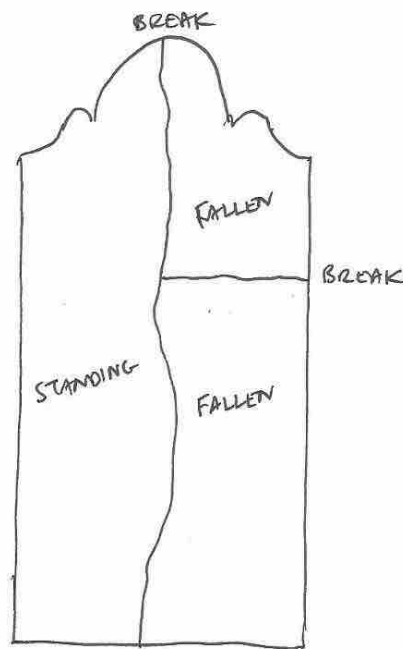
Monument 31

Vertical split caused by tree root

High risk of further damage/loss. Kelland report states current upright section is over a tree root and cannot be reassembled upright due to this

Trees CT2 and CT3 to be monolithed under separate enabling contract. Remove upright section and remove section of tree root to allow for re-erection. Pin 3 pieces together with stainless steel dowels and pin to 25mm thick slate backing. Make good joints with mortar. Clean off organic growth and dirt, and re-erect at the location of the existing base.

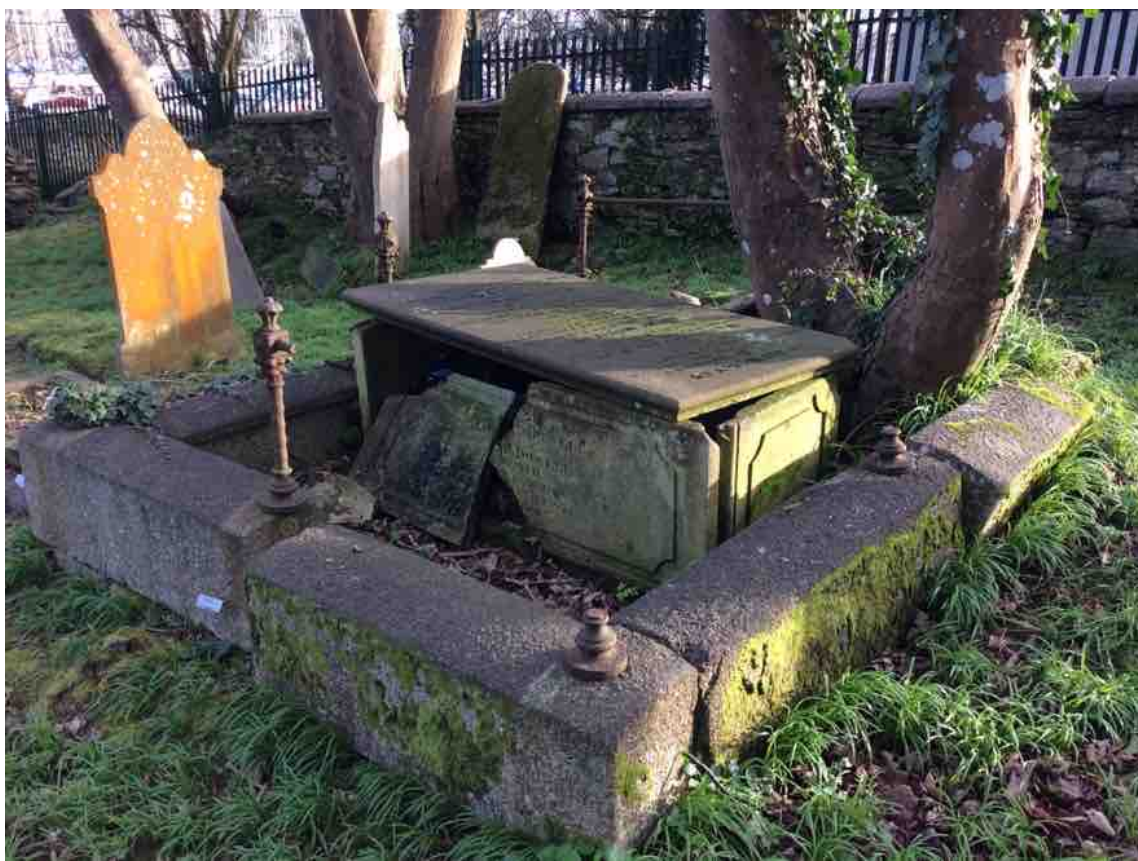
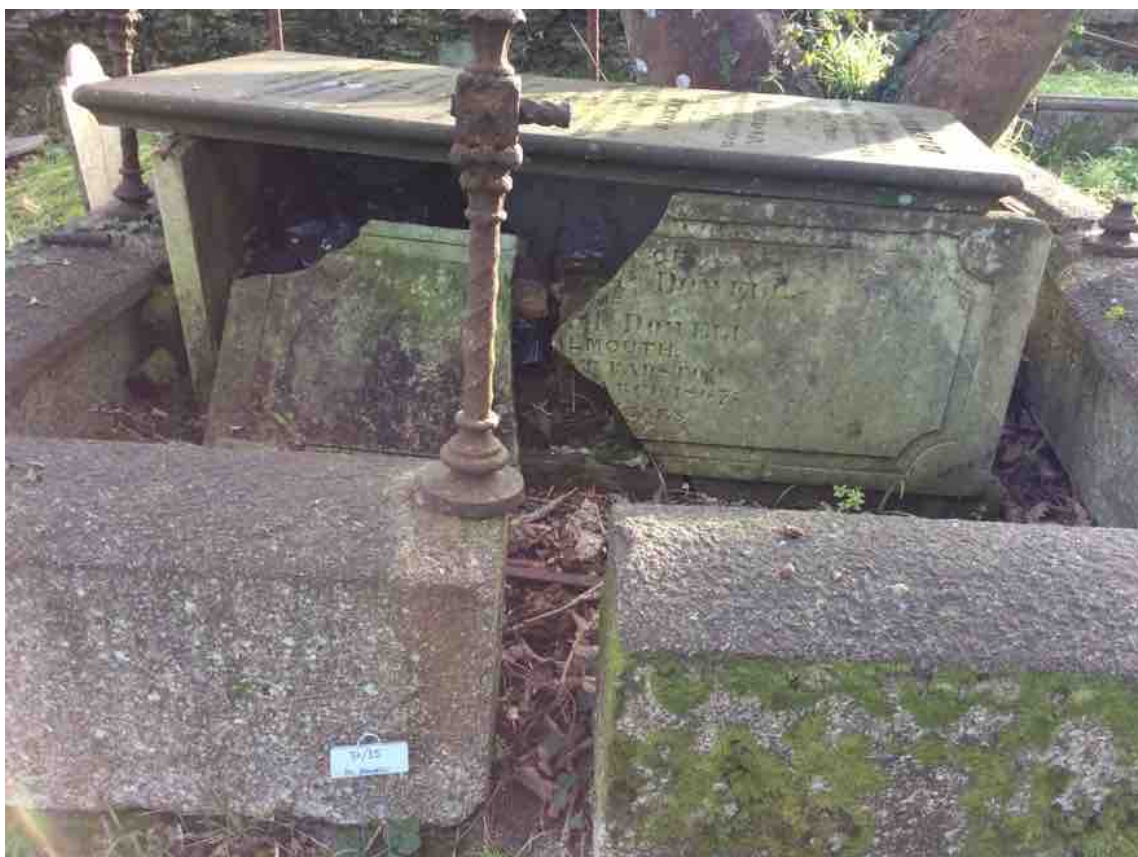
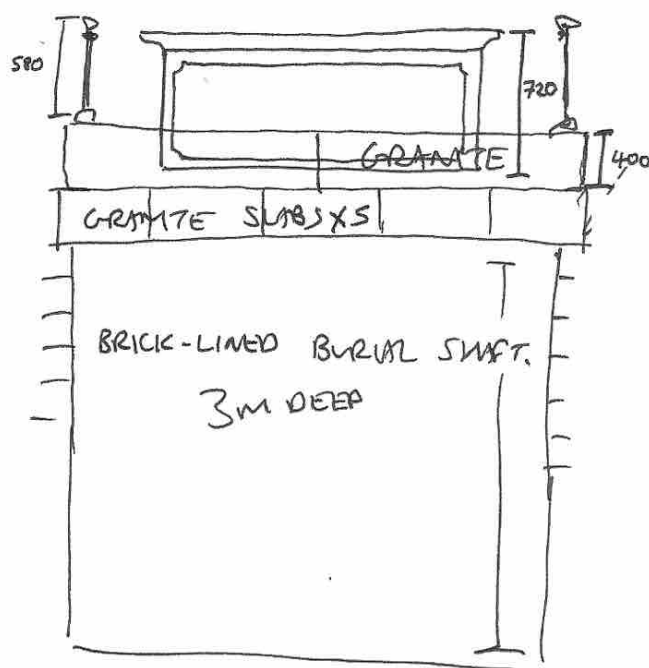
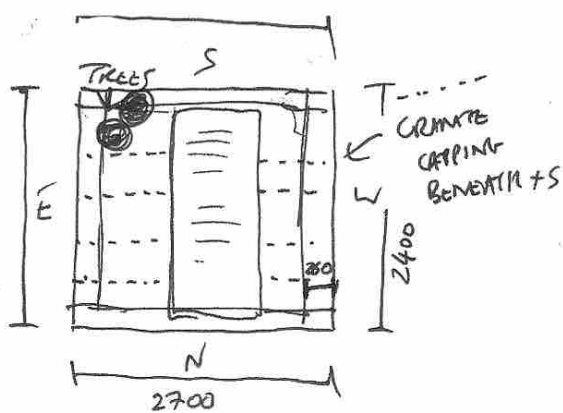
Monument 34 / 35

Overall structural condition:	Disrupted/separated	West side panel split, some elements stored inside, granite kerbs badly disrupted by tree growth
Ground condition :	Good/level	Slight slope
Impact of vegetation:	Disruption by roots	Granite surrounds disrupted by tree damage
Condition of foundation:	Not visible

Side panel fixings corroding, most of main balusters missing or broken, all railings missing

Tomb vandalised and extensively damaged, further damage since 2012 survey (broken side to chest tomb) ongoing damage by tree. High risk of further damage

Tree CT18 to be felled under separate enabling contract. Remove roots disrupting monument. Salvage parts of probable second monument stored within tomb and enclosed by tree roots, and set aside for possible re-use. Clean stonework. Remove lid and build up core off base slabs with honeycomb brickwork slightly higher than side panels. Pin or cramp broken side panel (in 5 fragments) together with stainless steel dowels or cramps, and cramp side panels to core with stainless steel fixings. Point joints. Rebed lid. De-rust and decorate surviving ironwork. Re-bed kerbs. Remove organic material within

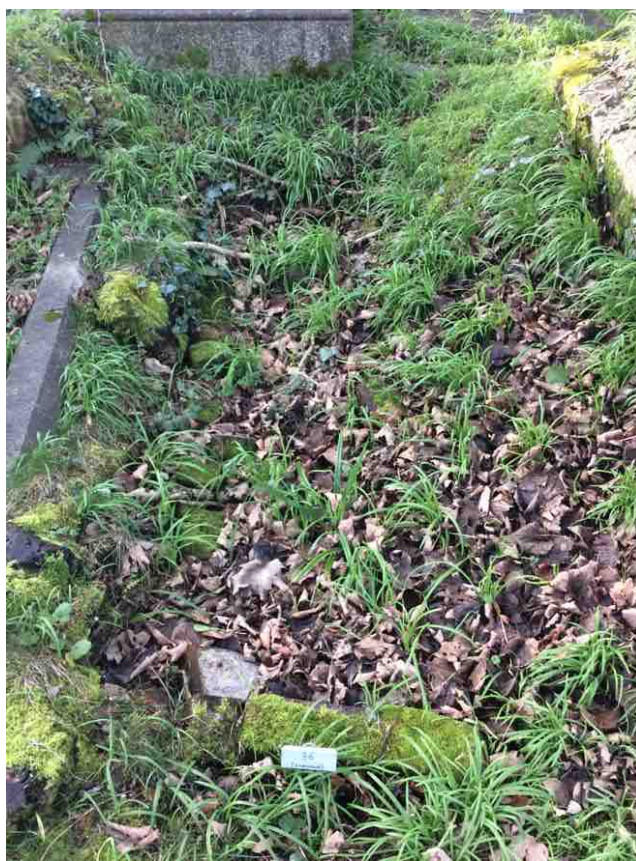
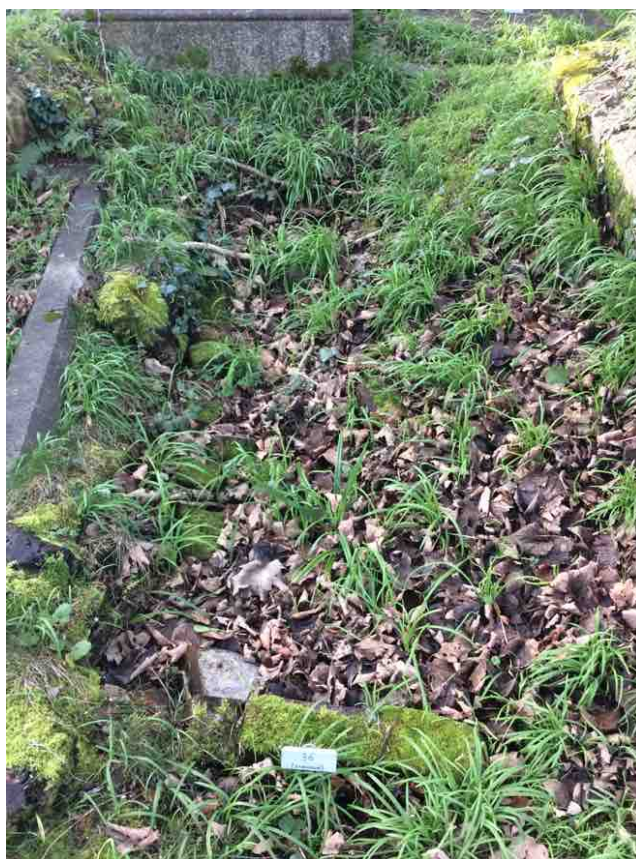
Monument 36

Robbed grave, no headstone, top courses of brick edging are loose and disrupted

Clearance and minor consolidation needed as minimum. Remove loose bricks from lining and rebuild approx 5 courses in lime mortar, clean off organic growth. Remove organic material from within grave recess, lay sheet of weed control fabric, layer of lightly compacted hardcore and 50mm thick layer of 19mm granite chippings. Possibly the site of displaced monument C90. If confirmed then re-erect C90 here.

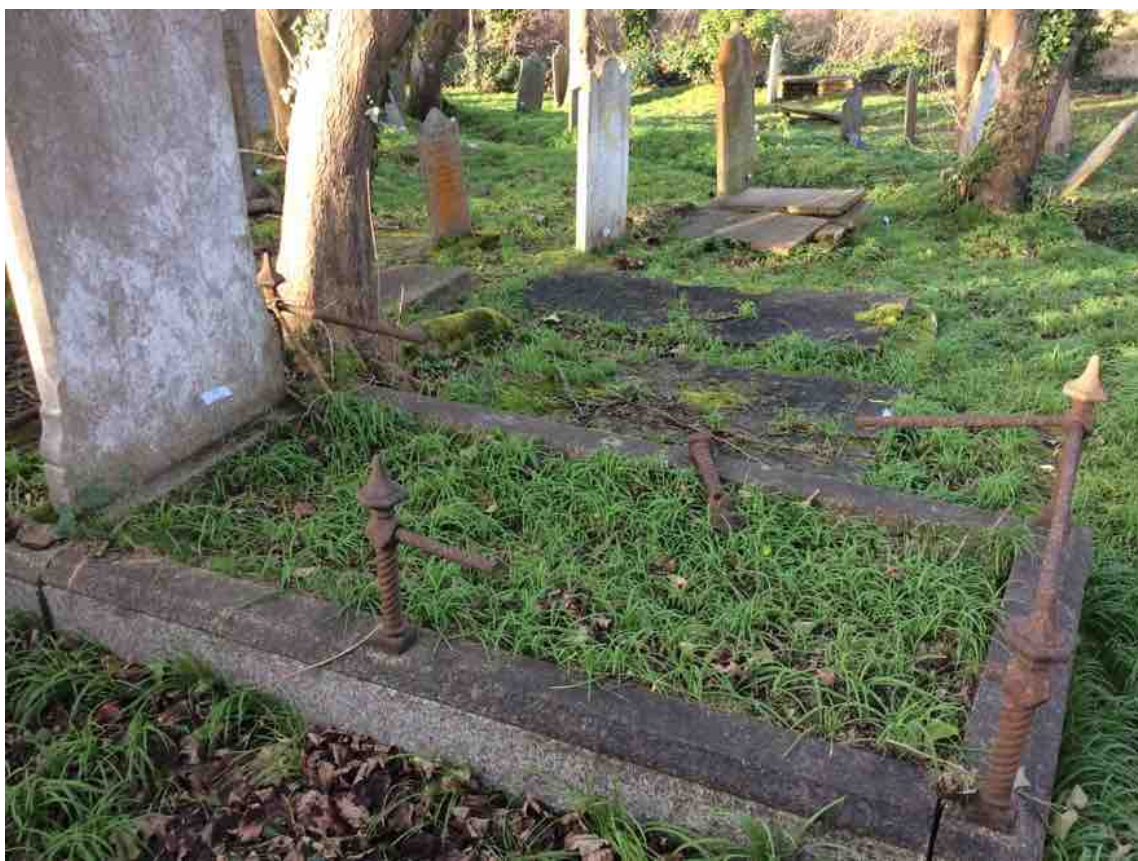
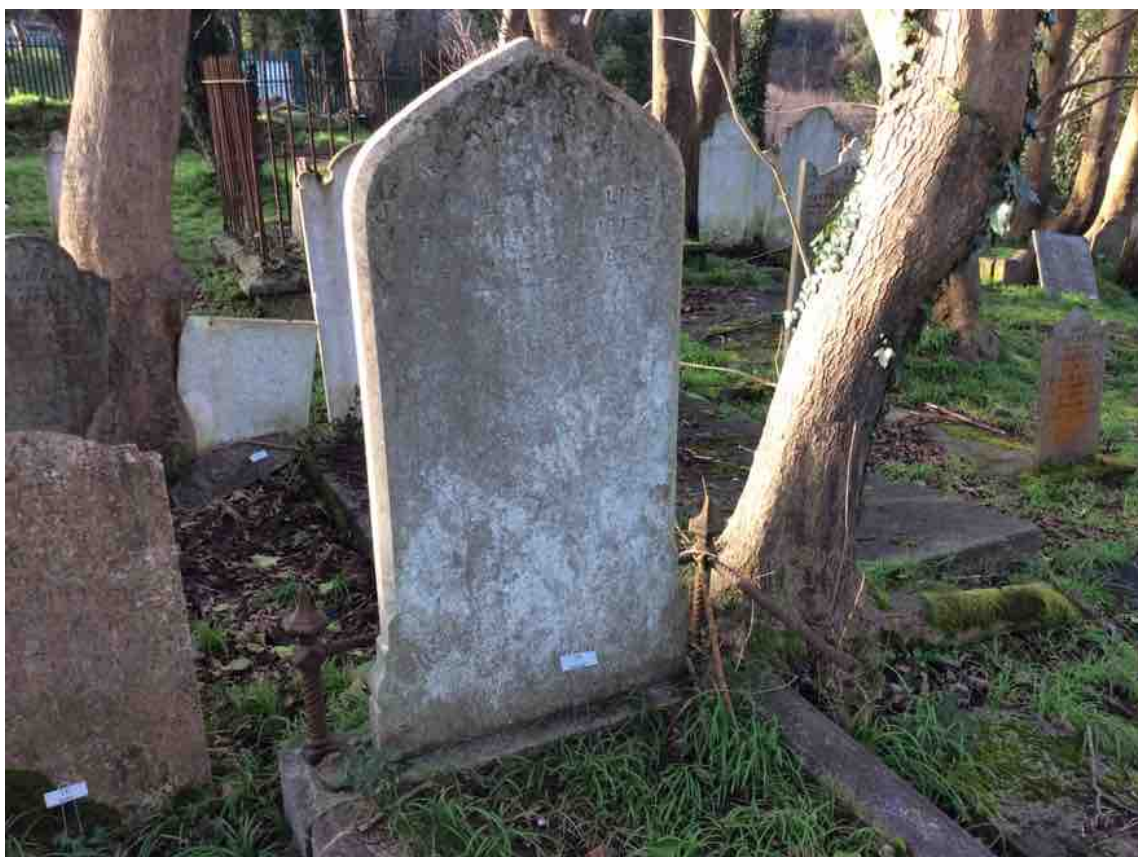
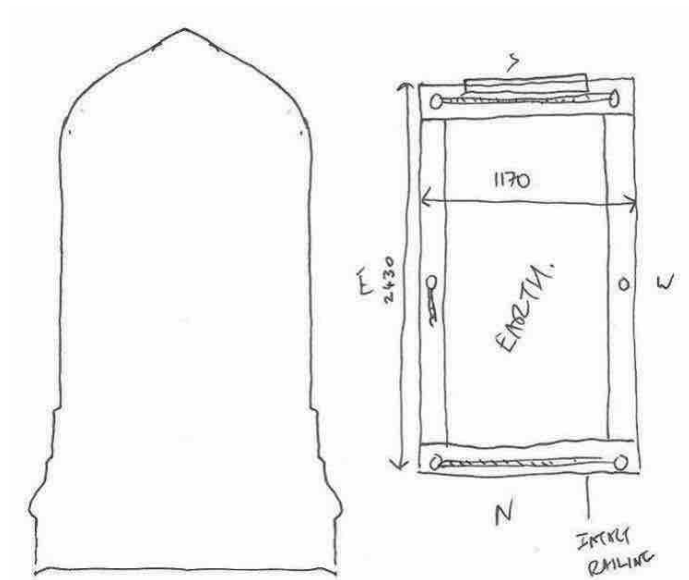
Monument 39

Parts of low balustrade are missing

Clean off organic growth and dirt. Salvage existing baluster lying on kerb. De-rust existing ironwork in situ. Remove broken rails and replace with new to match. Reinstall existing detached baluster, and decorate all ironwork. Repoint vertical joints between granite kerbs. Investigate within kerbs for evidence of rendered grave capping and chippings. Refer to drawing.
