Congregationalist Cemetery, Ponsharden

Proforma Condition and Repairs Schedule

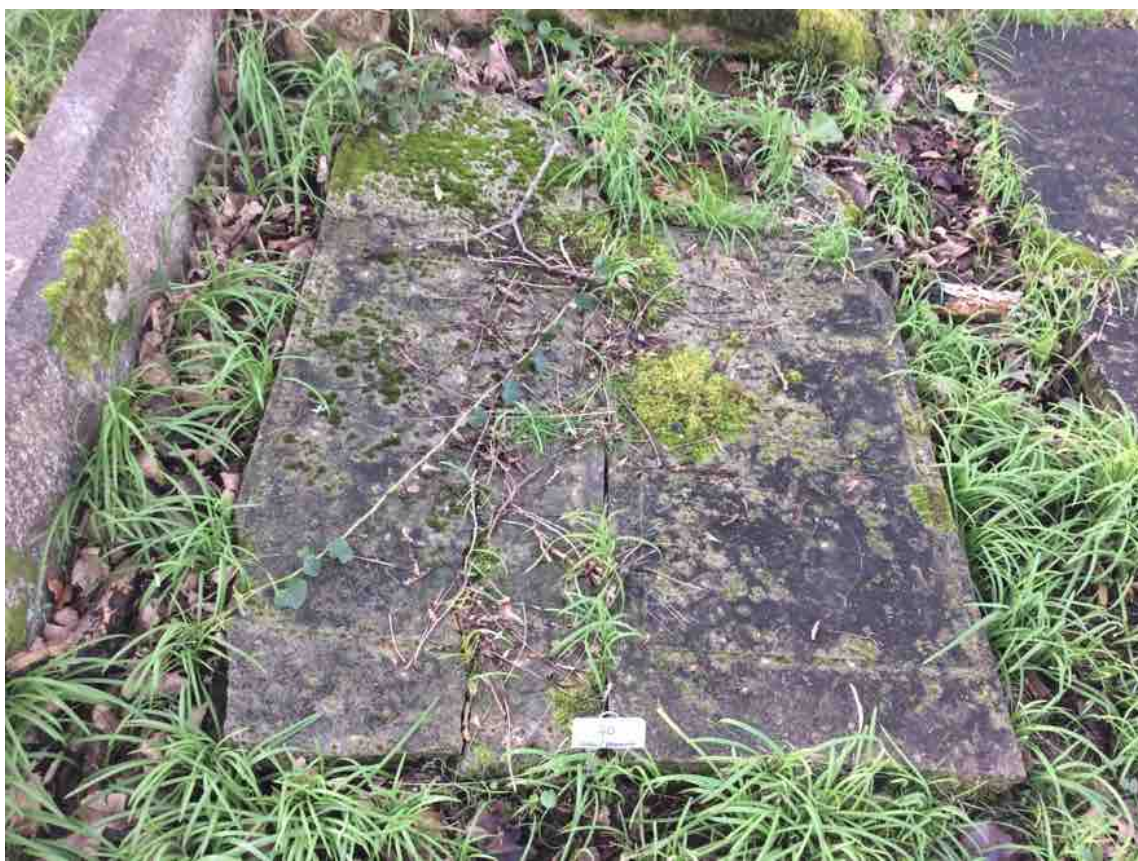
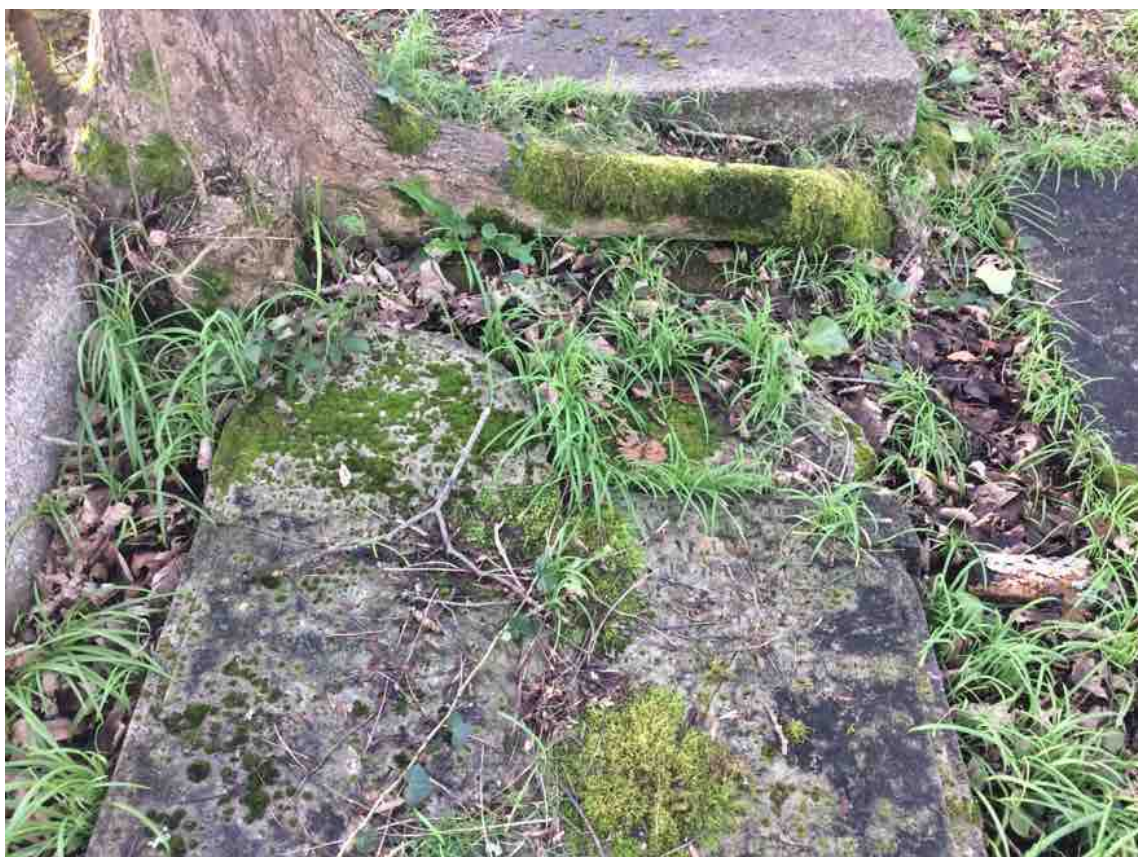
Monument 40

Both headstones cracked and broken in several places

Two headstones same size in dimensions. Both lying down, cracked and broken in several places. High risk of further damage. Granite kerb around graves.

Clean off organic growth and dirt. Pin broken sections together with stainless steel dowels, and pin to 25mm thick slate backing. One headstone is in 3 pieces, the other is in 5 pieces. Make good joints with mortar. Investigate within kerbs for evidence of rendered grave capping and chippings. Allow to re-erect in original locations, pinned to bases with stainless steel dowels. If this proves impractical, pin or cramp sections together and lay back down on limecrete bed at a slope, but slightly relocated to avoid tree root.

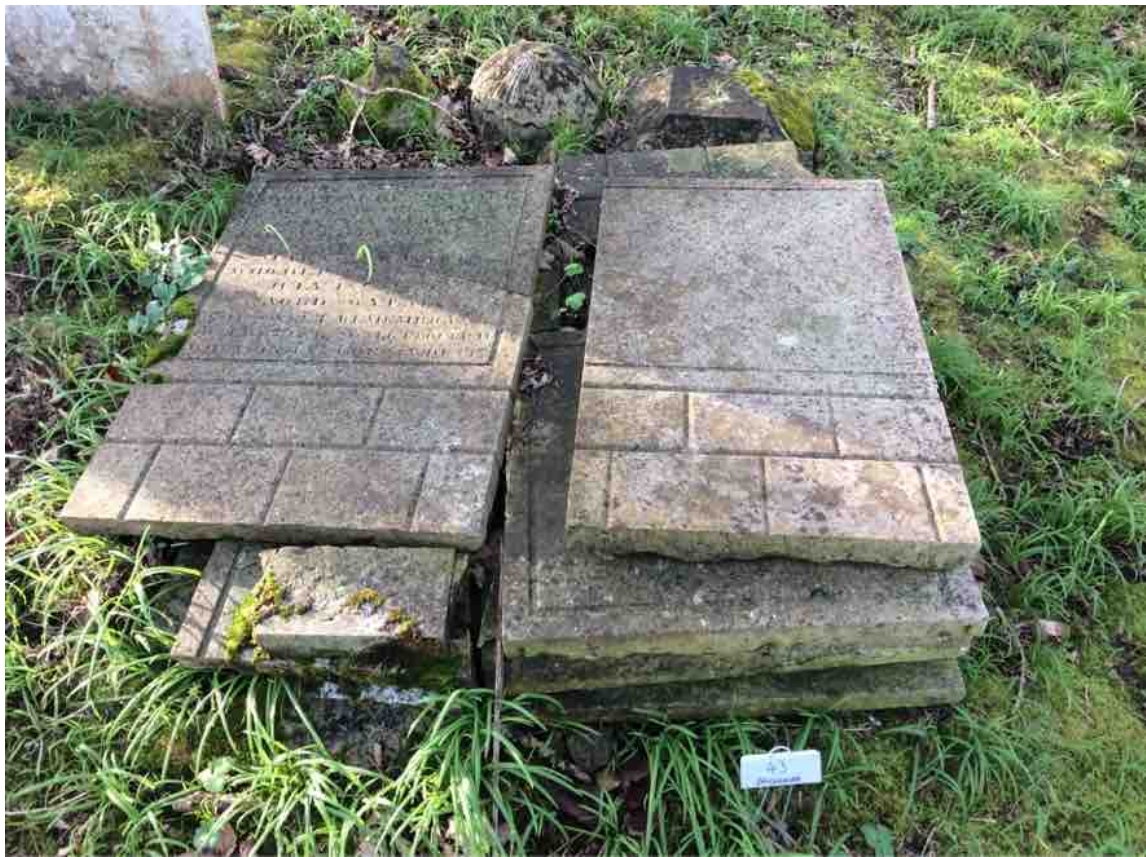
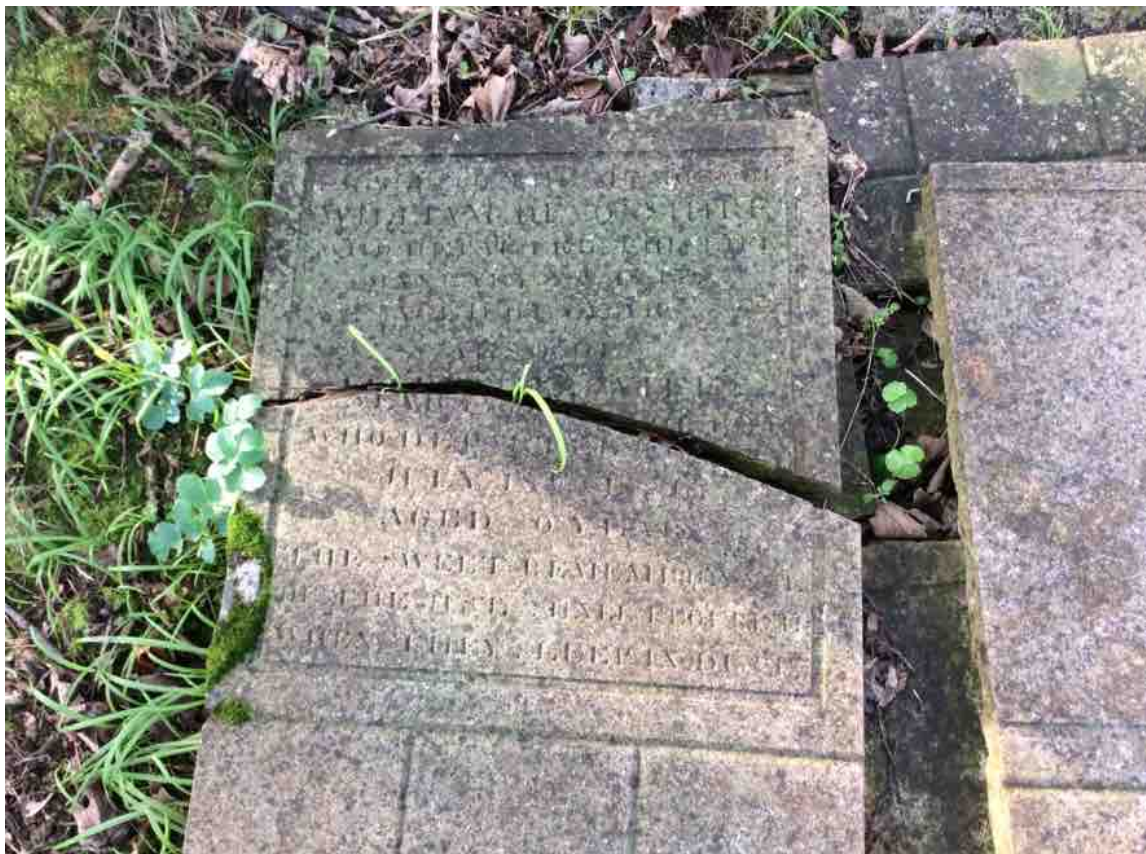
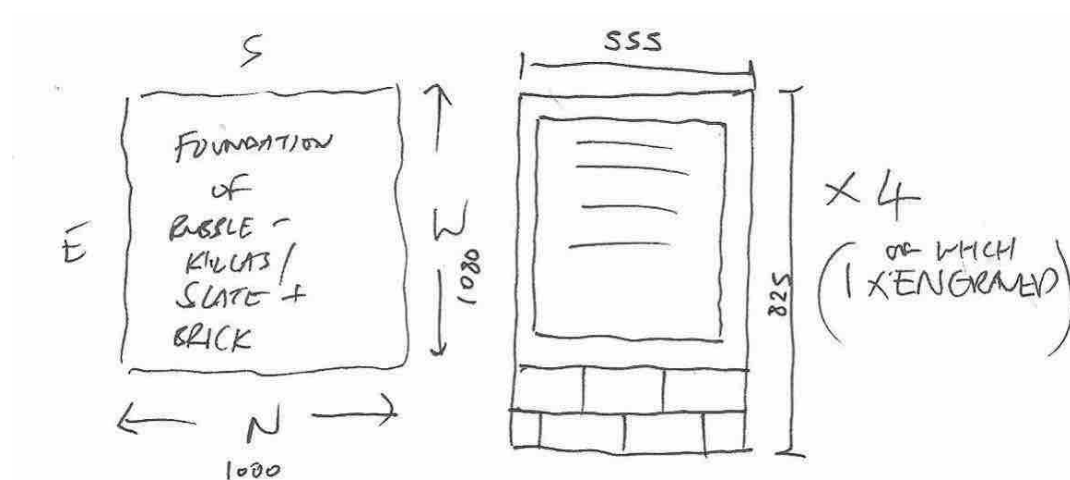
Monument 43 DEVONSHIRE

Overall structural condition:	Collapsed	Separated into constituent pieces, stacked in a pile
Ground condition :	Good/level	Slight slope
Impact of vegetation:	None	
Condition of foundation:	Good	Killas rubble foundation base, approx 1080 x 1000

Monument separated into components, some panels broken.

Vandalised tomb with some side panels broken, but most of the pieces seem to be present. Square on plan with plain plinth, one side panel with inscription, all with chiselled rusticated base, moulded square top with cap and urn.

Clean stonework. Make good existing killas base and build up honeycomb brickwork core slightly higher than side panels with 50mm gap to back of panels. Re-assemble plinth and cramp together using salvaged bronze cramps if possible, new stainless steel if not. Pin or cramp 2 broken side panels together (each in 2 pieces) and broken corner off 1 panel with stainless steel dowels or cramps, and cramp 4 side panels to core with stainless steel fixings. Rebed lid, plinth to cap (in several broken pieces), cap and urn (with stainless steel dowels if necessary). Point joints. Refer to drawing.

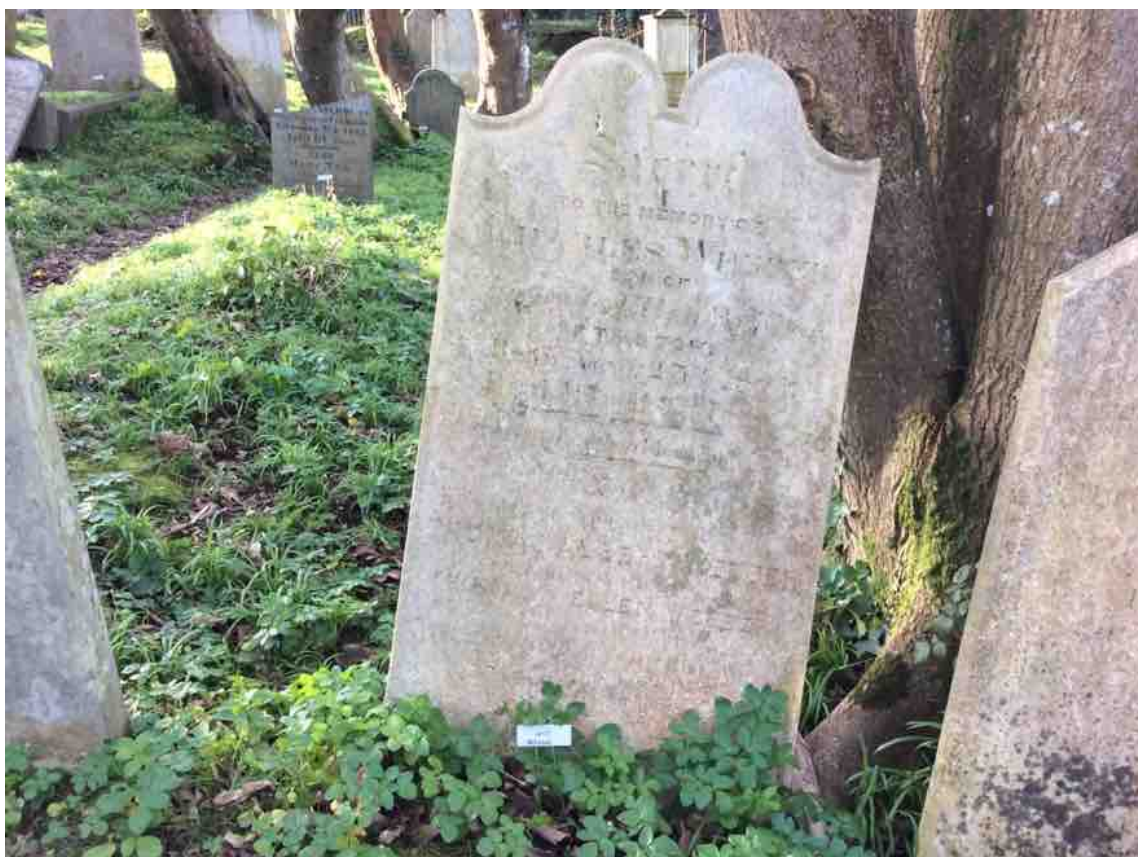
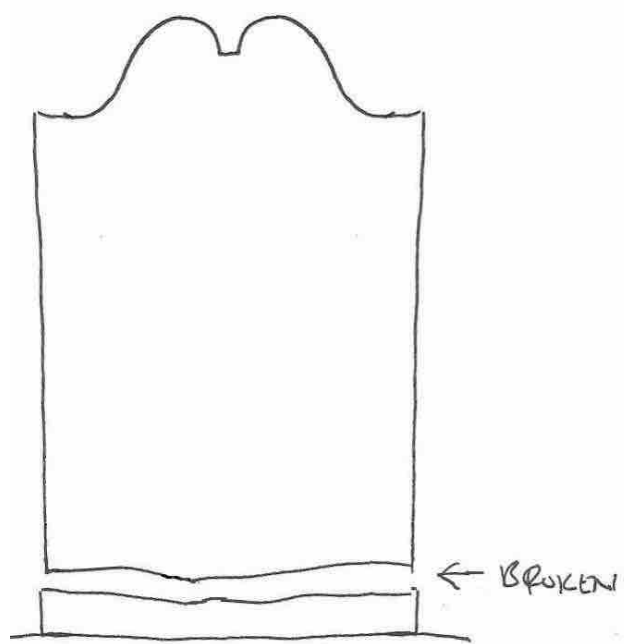
Monument 48

Currently propped against tree. High risk of further damage

Clean off organic growth and dirt. Locate and excavate base and pin broken sections together with stainless steel dowels, and pin to 25mm thick slate backing. Make good joints with mortar. Re-erect at the location of the existing base.

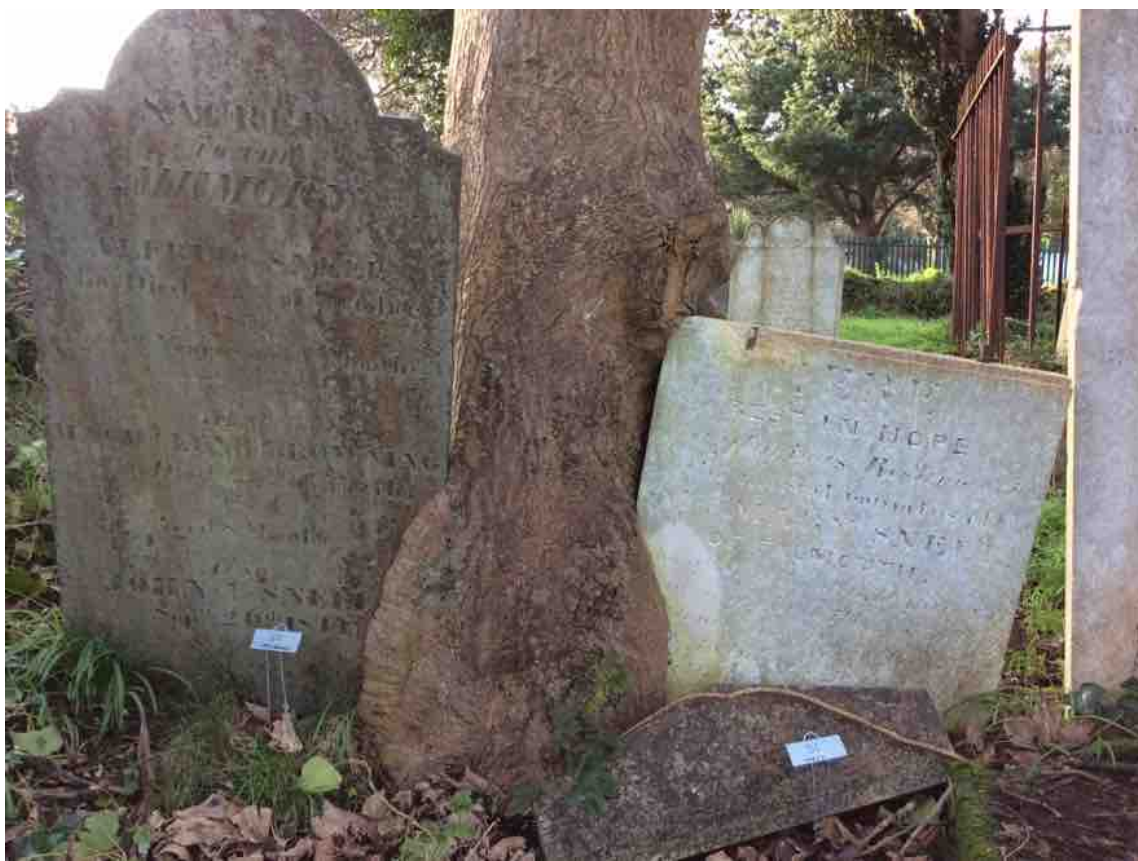
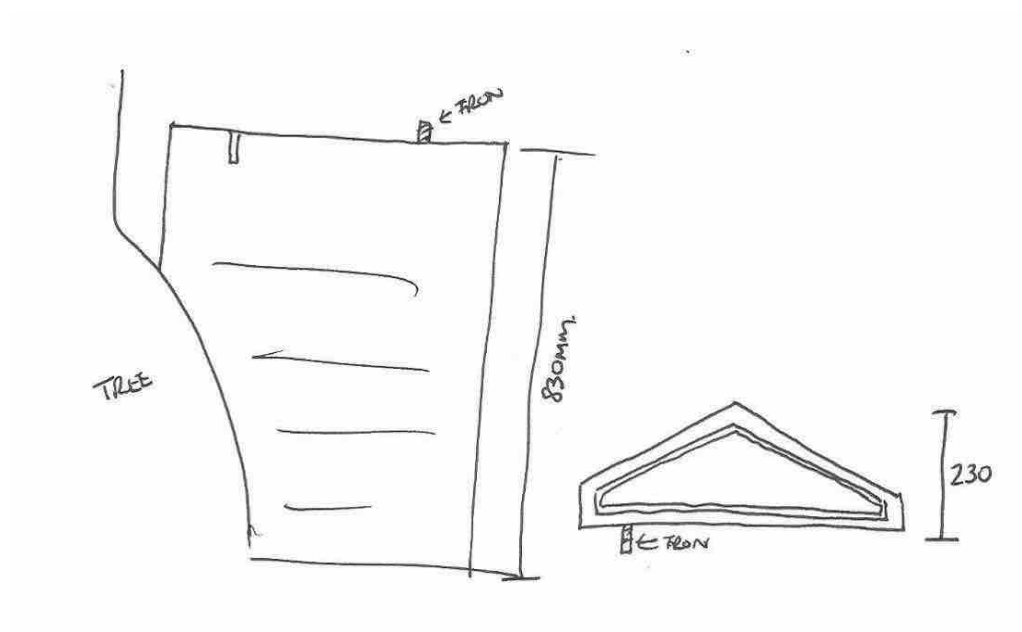
Monument 51

Tree grown into gravestone. Remains of previous repair with iron cramps. Top section laying on the ground next to the upright section

Tree CT16 to be monolithed under separate enabling contract. Clean off organic growth and dirt. Cut back bulge in tree to allow top section of headstone to be reinstated. Remove existing dowels and pin top section back onto bottom with stainless steel dowels. Make good joints with mortar. If top section cannot be refitted, remove corroding dowels, make good holes and lay top section on the ground at a slope on limecrete bed.
