Annual Inspection

West Swindon Parish Council

Camden Close

Annual Inspection - 27 December 2017 at 09:06 Inspector: Leon Pope RPII Annual Inspector

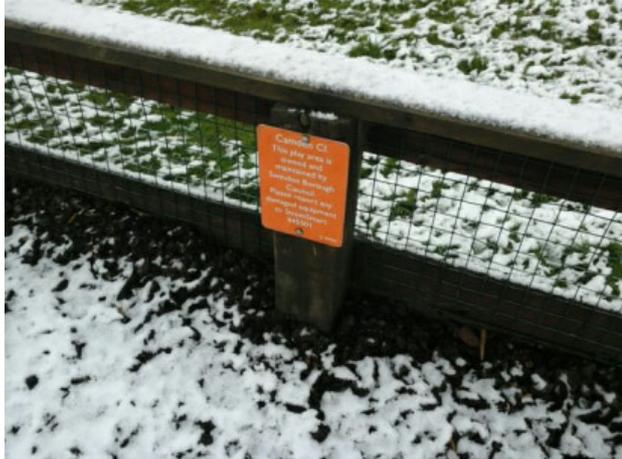
Item: Ancillary Items - Sign
Manufacturer: Owner/Operator
Surface Type: N/A
Equipment Compliance: N/A
Surface Area Compliance: N/A
Ref/Part Number:
Total Findings: 1

This item is satisfactory - no work required

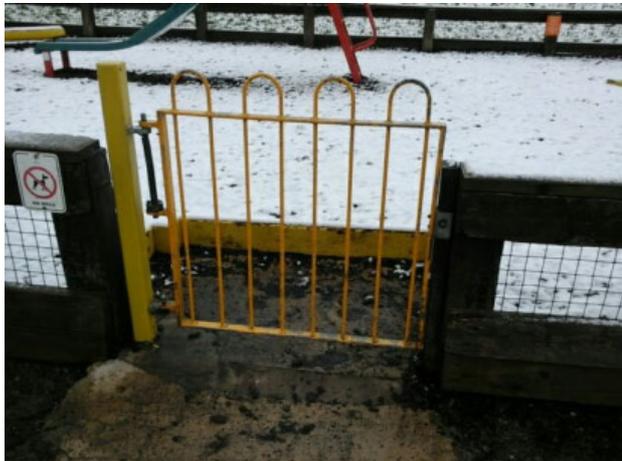
Item: Ancillary Items - Gate - Self Closing
Manufacturer: Owner/Operator
Surface Type: N/A
Equipment Compliance: N/A
Surface Area Compliance: N/A
Ref/Part Number:
Total Findings: 2

The gate is closing too quickly (less than 4 seconds) - Take corrective action to ensure that the gate closes in 4-8 seconds

The opening between the gate and the post is less than 12mm and could trap users fingers - Adjust gate to ensure a 12mm opening all around

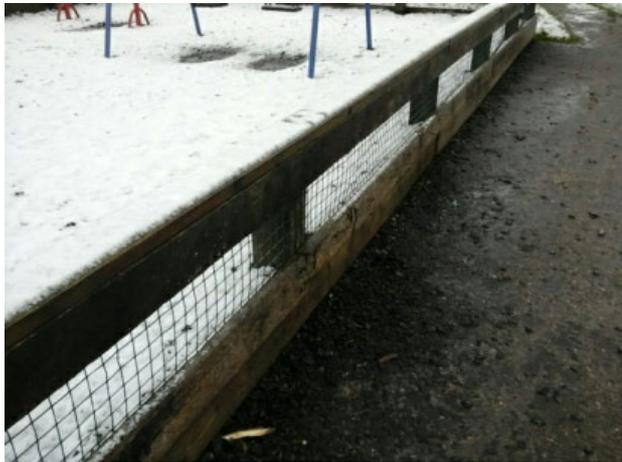
Item: Ancillary Items - Fence - Timber & Mesh Infill
Manufacturer: Owner/Operator
Surface Type: N/A
Equipment Compliance: N/A
Surface Area Compliance: N/A
Ref/Part Number:
Total Findings: 1

There are areas or parts of the timber on the structure that have rotted - Replace all affected timbers

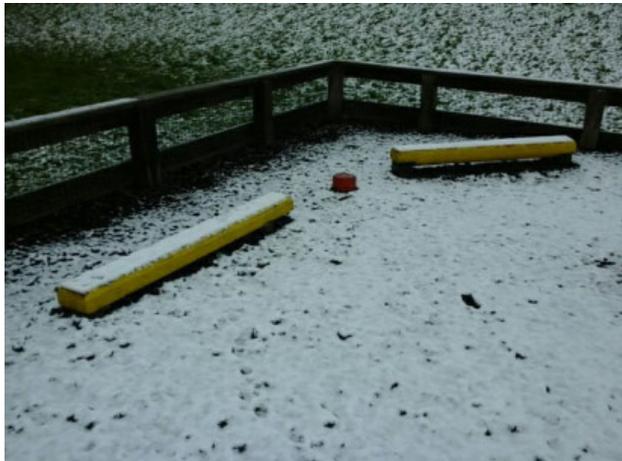
Item: Activity Equipment - Balance Beam
Manufacturer: Not Identified
Surface Type: Bark Mulch
Equipment Compliance: No
Surface Area Compliance: Yes
Ref/Part Number:
Total Findings: 2

The fence forms a hard object within the falling space of the equipment in contravention of the requirements of BS EN 1176 Part 1 - Monitor use

There is some evidence of rot in the timber - Monitor for any further deterioration and replace as required

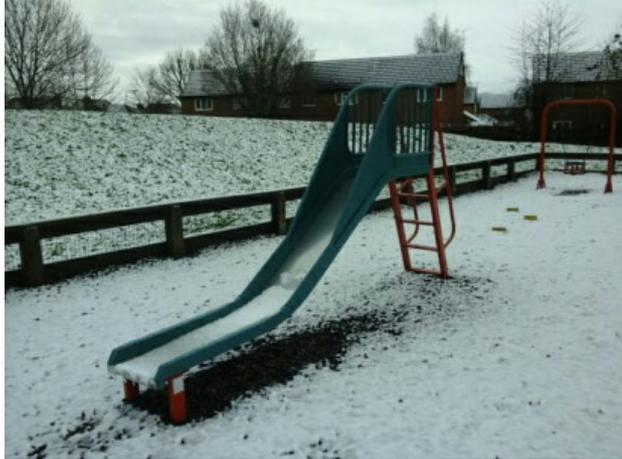
Item: Other - Free Standing Slide
Manufacturer: Record RSS
Surface Type: Bark Mulch
Equipment Compliance: Yes
Surface Area Compliance: Yes
Ref/Part Number:
Total Findings: 1

There are a number of dents in the slide surface - Monitor for any further deterioration and repair as required

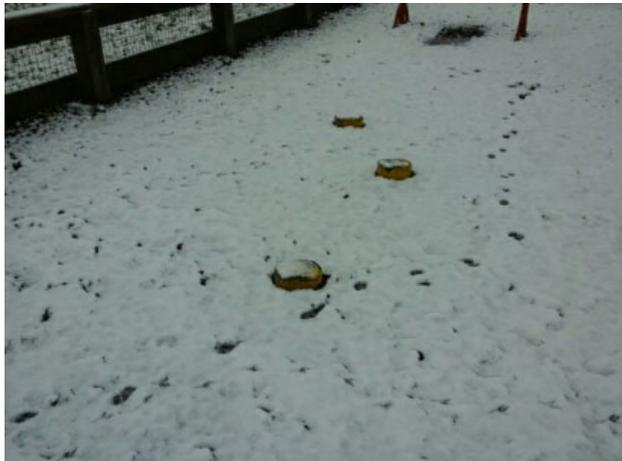
Item: Activity Equipment - Stepping Stones
Manufacturer: Not Identified
Surface Type: Bark Mulch
Equipment Compliance: Yes
Surface Area Compliance: Yes
Ref/Part Number:
Total Findings: 1

There is some evidence of rot in the timber - Monitor for any further deterioration and replace as required

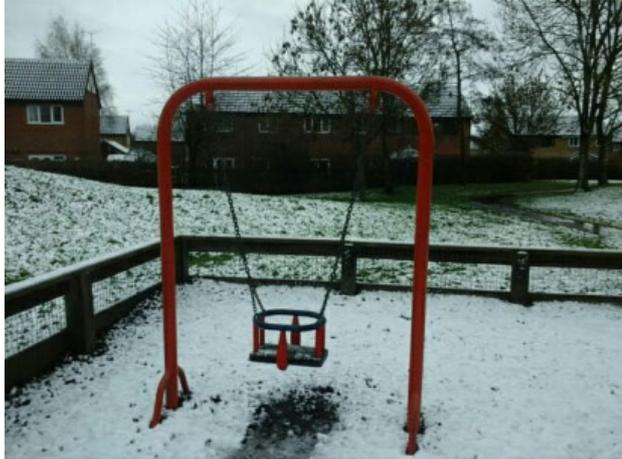
Item: Swings - 1 Bay 1 Seat (Cradle) - Type 1
Manufacturer: Not Identified
Surface Type: Bark Mulch
Equipment Compliance: No
Surface Area Compliance: No
Ref/Part Number:
Total Findings: 4

The chain openings are in excess of the 8.6mm as recommended by BS EN 1176 - Monitor use

The seats are too close to the frame as defined in BS EN 1176 Part 2; this is a low risk failure and no remedial action is required - Monitor use

The surfacing dimensions do not meet with the requirements of the current applicable standard - We consider this to be a low risk finding and no remedial action is recommended - monitor use

There is some notable evidence of chain wear - Monitor for any further deterioration and replace when 40% worn

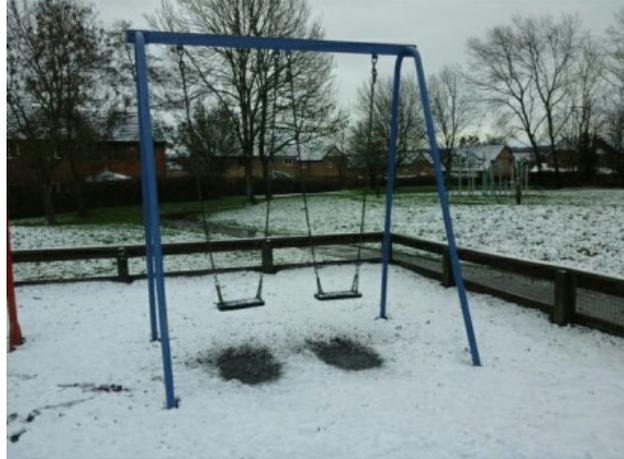
Item: Swings - 1 Bay 2 Seat (Flat)
Manufacturer: S M P (Playgrounds Ltd)
Surface Type: Bark Mulch
Equipment Compliance: No
Surface Area Compliance: No
Ref/Part Number:
Total Findings: 5

The bushes are showing signs of wear - Monitor for any further deterioration and replace as required

There is some notable evidence of chain wear - Monitor for any further deterioration and replace when 40% worn

The chain openings are in excess of the 8.6mm as recommended by BS EN 1176 - Monitor use and replace with compliant chains during next maintenance cycle.

The seats are too close to the frame as defined in BS EN 1176 Part 2; this is a low risk failure and no remedial action is required - Monitor use

The surfacing dimensions do not meet with the requirements of the current applicable standard - We consider this to be a low risk finding and no remedial action is recommended - monitor use

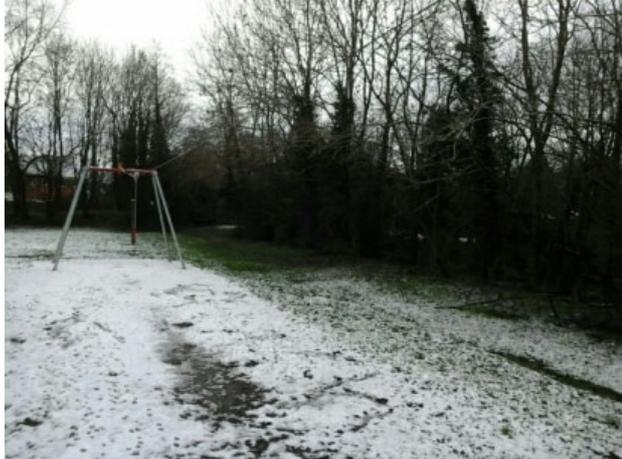
Item: Other - Cable Runway
Manufacturer: Kaiser & Kuhne
Surface Type: Bark Mulch
Equipment Compliance: No
Surface Area Compliance: Yes
Ref/Part Number:
Total Findings: 4

We recommend that the main cable is removed from the cableway at least once every 2 years to inspect for damage or internal rusting, this will help to ensure the continued safe use of the equipment - Remove and inspect cable every 24 months

There is some graffiti present - Remove the graffiti

There is some chain wear - Monitor for any further deterioration and replace when 40% worn

The seat is less than 2.0 metres from the post when extended at 45 degrees at the end of the area of travel - Adjust the cable stop position to ensure the minimum distance is maintained

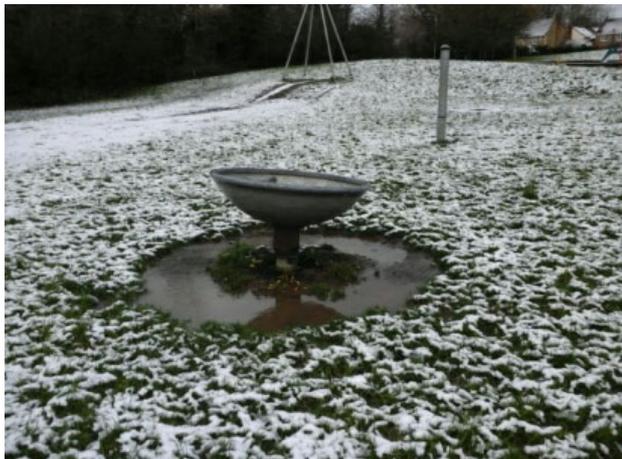
Item: Rotor Play - Spinner Bowl
Manufacturer: Sutcliffe Play Limited
Surface Type: Grass Matrix Tiles
Equipment Compliance: Yes
Surface Area Compliance: Yes
Ref/Part Number:
Total Findings: 2

Fixing Pins have been installed in the impact areas of the grass mats - Remove pins from impact areas

There is some graffiti present - Remove the graffiti

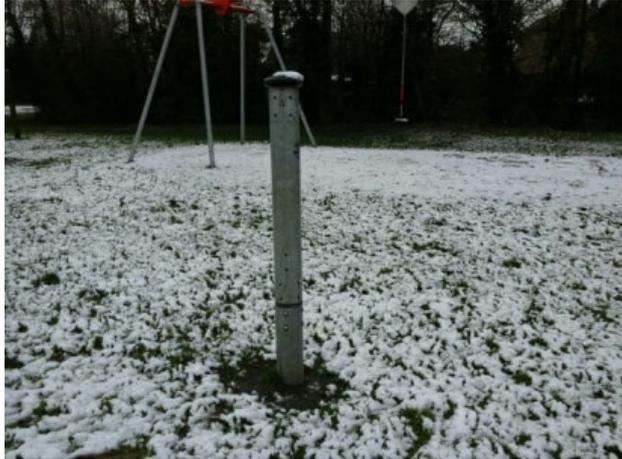
Item: Rotor Play - Low Rotator
Manufacturer: Sutcliffe Play Limited
Surface Type: Grass Matrix Tiles
Equipment Compliance: N/A
Surface Area Compliance: N/A
Ref/Part Number:
Total Findings: 1

The item has missing component(s) - Consider replacing missing components

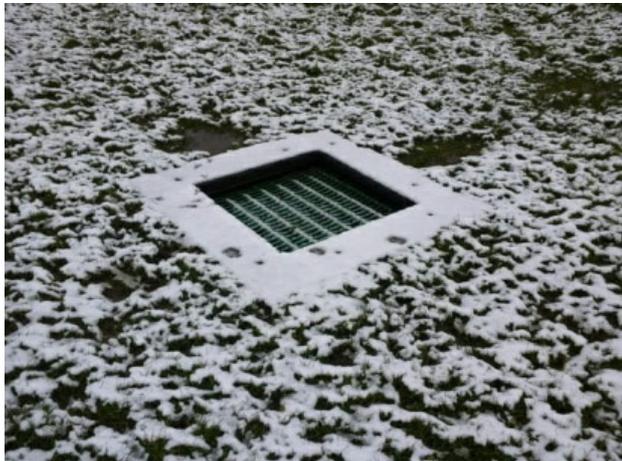
Item: Other - Trampoline
Manufacturer: Not Identified
Surface Type: Grass
Equipment Compliance: Yes
Surface Area Compliance: Yes
Ref/Part Number:
Total Findings: 1

There is water evident under the trampoline bed - Ensure that water is removed and that adequate drainage has been provided

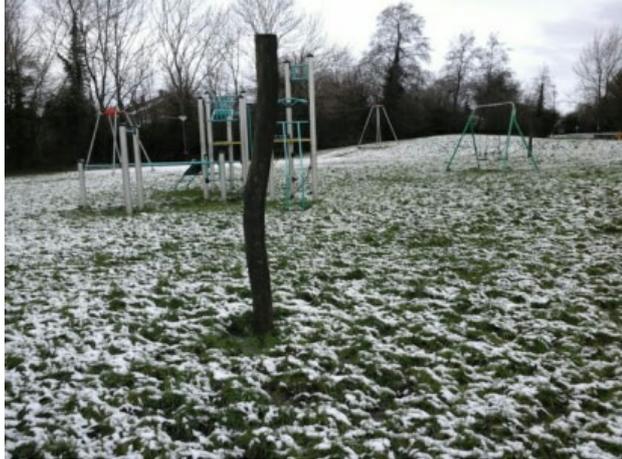
Item: Ancillary Items - Posts
Manufacturer: Not Identified
Surface Type: Grass
Equipment Compliance: N/A
Surface Area Compliance: N/A
Ref/Part Number:
Total Findings: 1

This item is satisfactory - no work required

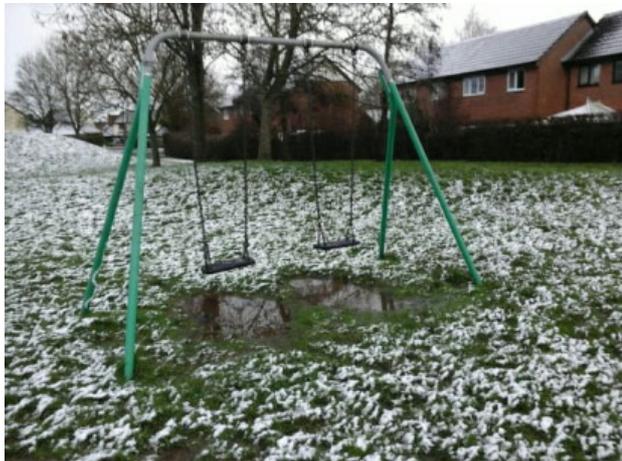
Item: Swings - 1 Bay 2 Seat (Flat)
Manufacturer: Sutcliffe Play Limited
Surface Type: Grass Matrix Tiles
Equipment Compliance: No
Surface Area Compliance: Yes
Ref/Part Number:
Total Findings: 3

The chain openings are in excess of the 8.6mm as recommended by BS EN 1176 - Monitor use and replace with compliant chains during next maintenance cycle.

There is some notable evidence of chain wear - Monitor for any further deterioration and replace when 40% worn

There is some graffiti present - Remove the graffiti

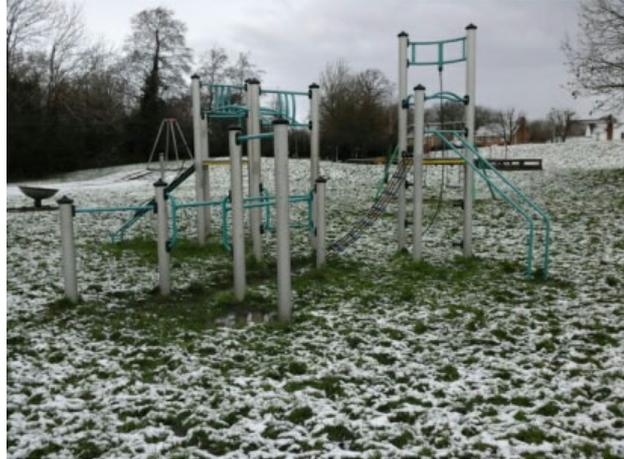
Item: Activity Equipment - Multi Play (Junior)
Manufacturer: Sutcliffe Play Limited
Surface Type: Grass Matrix Tiles
Equipment Compliance: No
Surface Area Compliance: Yes
Ref/Part Number:
Total Findings: 4

The lower net mount forms a hard object within the falling space of the equipment in contravention of the requirements of BS EN 1176 Part 1 - Monitor use

The ropes on this item have been taped and we are unable to fully assess the condition of the rope, ensure no wire strands are broken beneath the tape - Repair or replace as required

The ropes/nets are worn/damaged in places - Monitor for any further deterioration and repair or replace as required

There is some evidence of fire damage to the item - Monitor for any further deterioration and repair as required

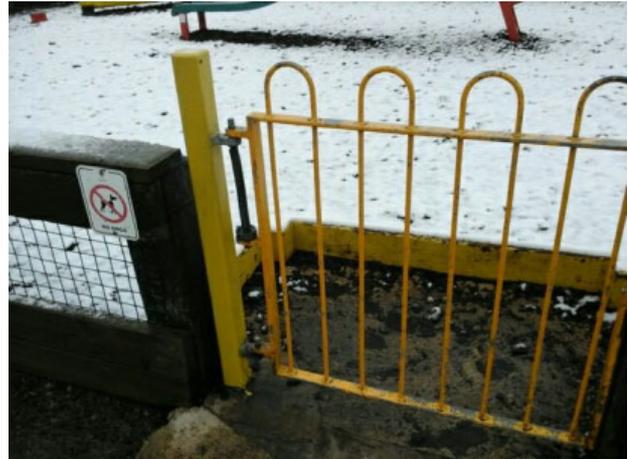
Finding: The gate is closing too quickly (less than 4 seconds)

Action: Take corrective action to ensure that the gate closes in 4-8 seconds

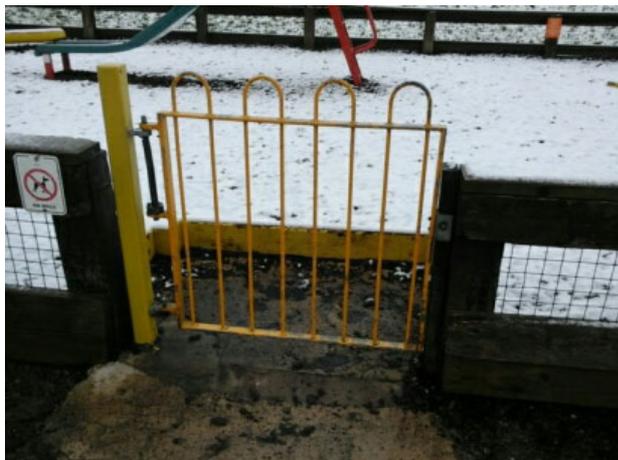
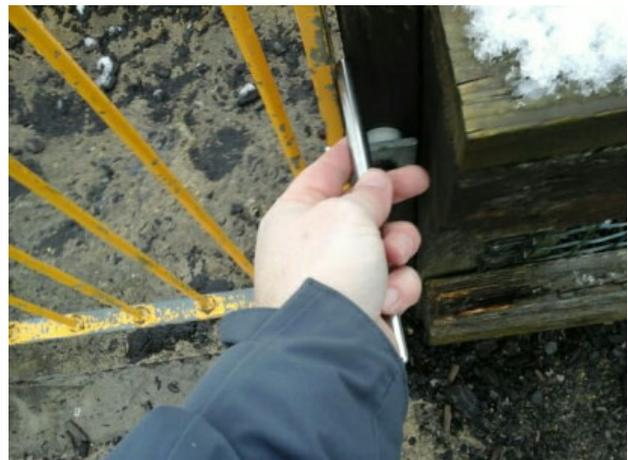
Finding: The opening between the gate and the post is less than 12mm and could trap users fingers

Action: Adjust gate to ensure a 12mm opening all around

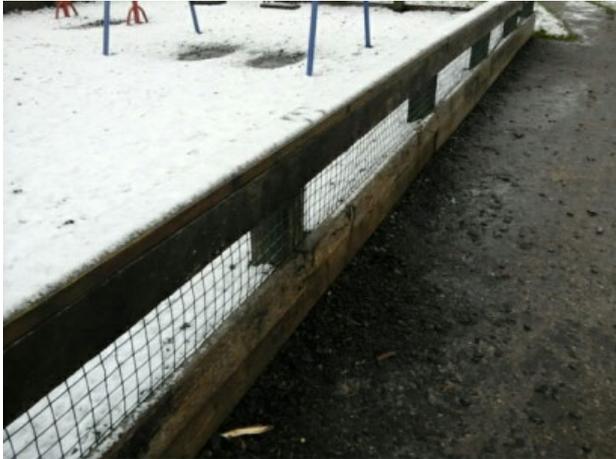
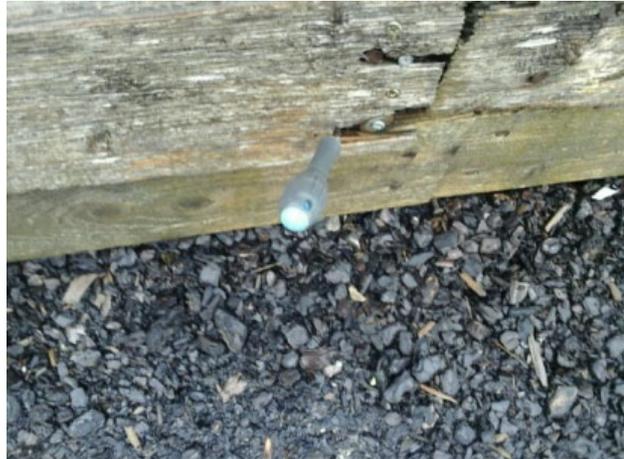
Finding: There are areas or parts of the timber on the structure that have rotted

Action: Replace all affected timbers

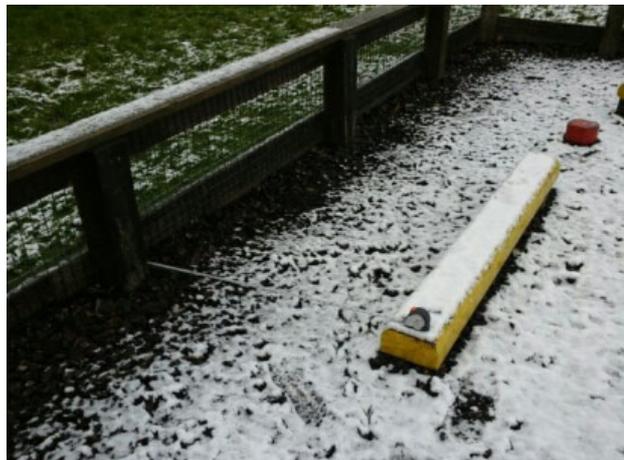
Finding: The fence forms a hard object within the falling space of the equipment in contravention of the requirements of BS EN 1176 Part 1

Action: Monitor use

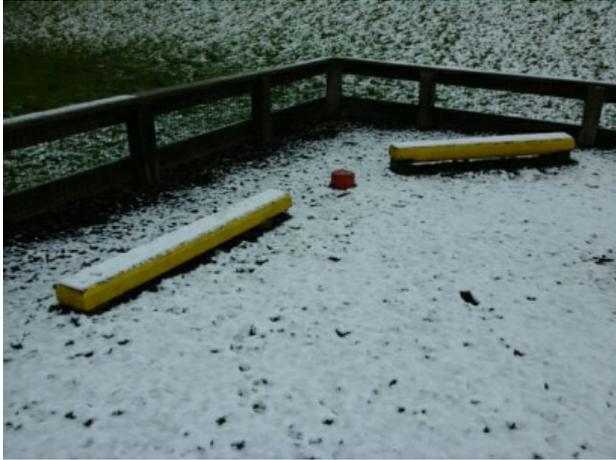
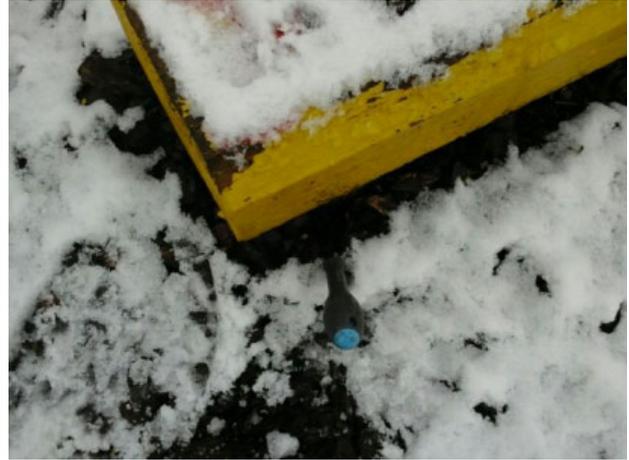
Finding: There is some evidence of rot in the timber

Action: Monitor for any further deterioration and replace as required

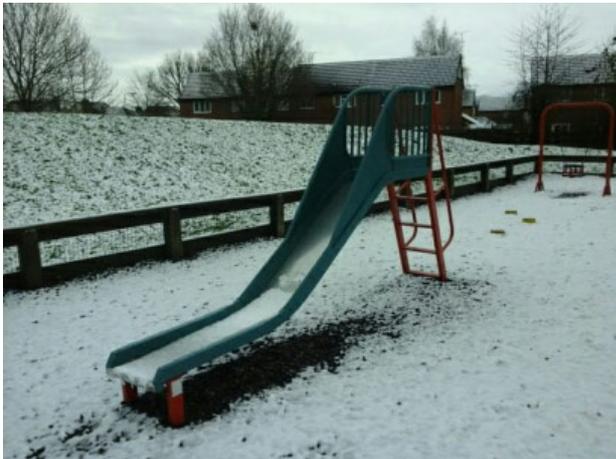
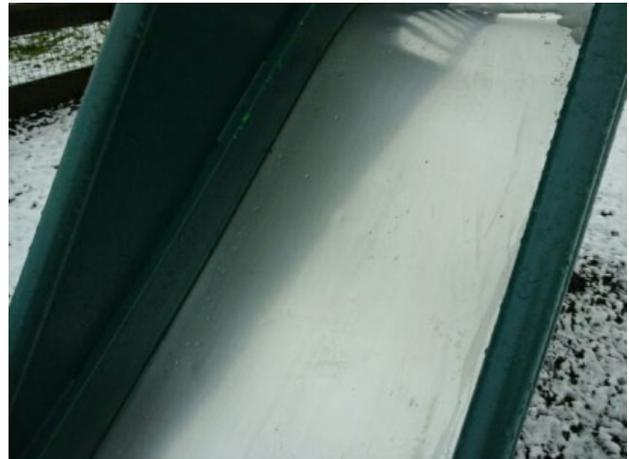
Finding: There are a number of dents in the slide surface

Action: Monitor for any further deterioration and repair as required

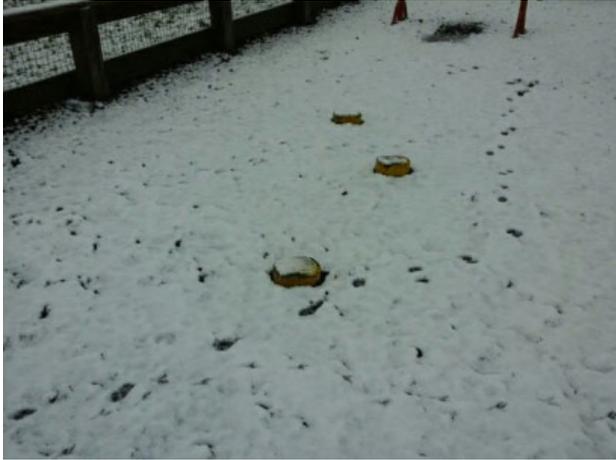
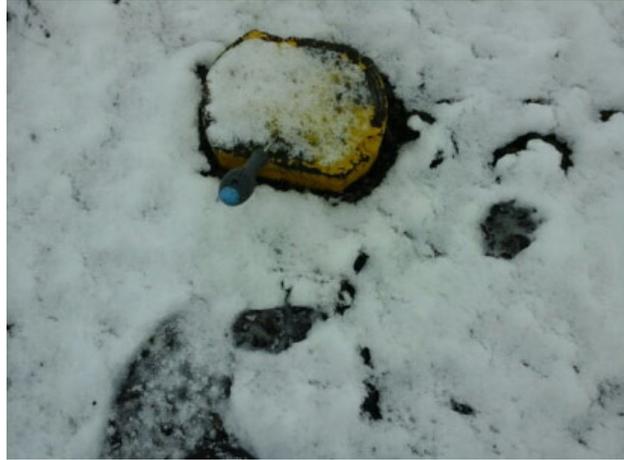
Finding: There is some evidence of rot in the timber

Action: Monitor for any further deterioration and replace as required

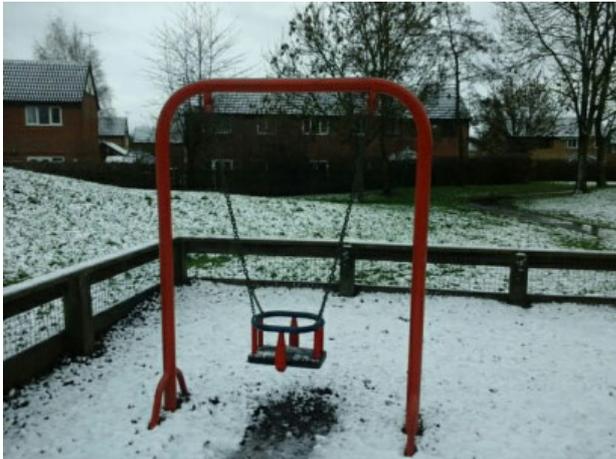
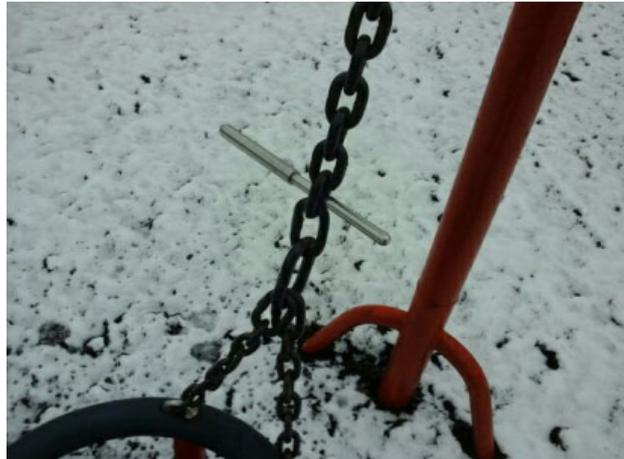
Finding: The chain openings are in excess of the 8.6mm as recommended by BS EN 1176

Action: Monitor use

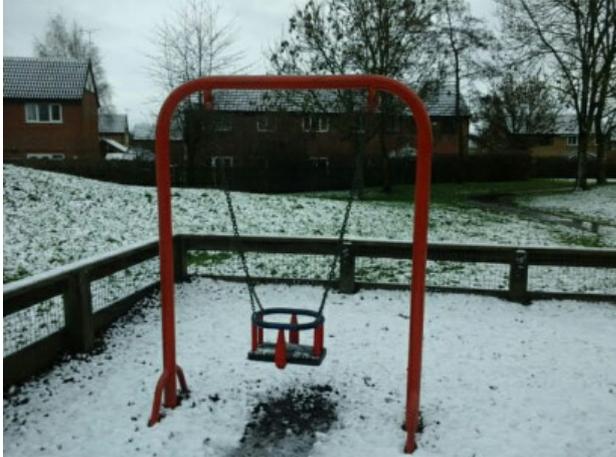
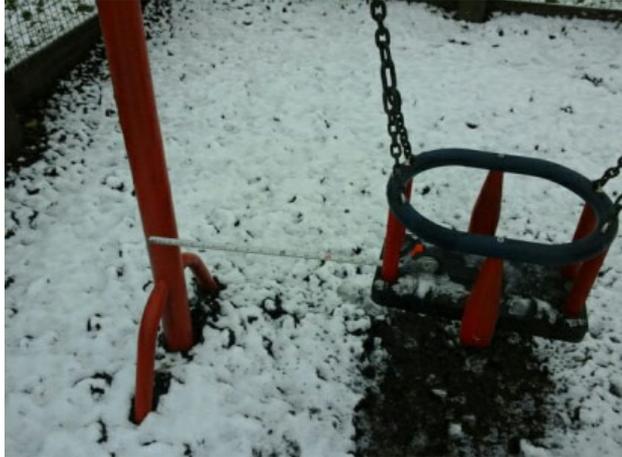
Finding: The seats are too close to the frame as defined in BS EN 1176 Part 2; this is a low risk failure and no remedial action is required
Action: Monitor use

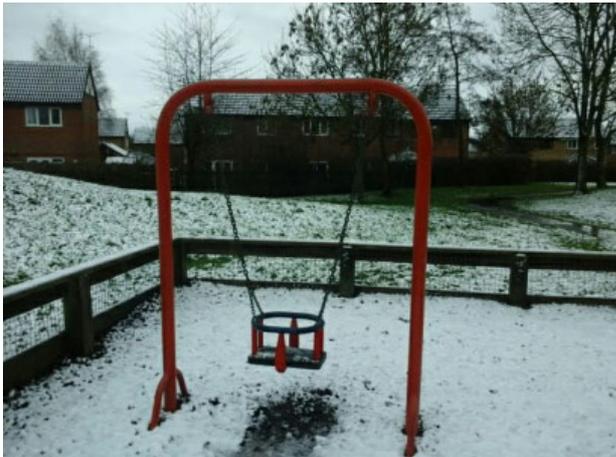
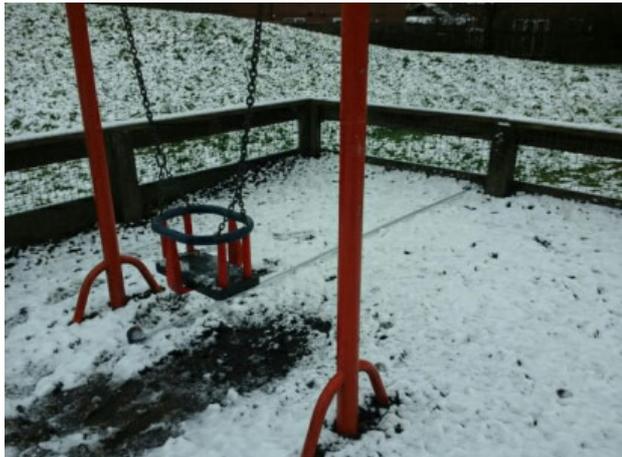
Finding: The surfacing dimensions do not meet with the requirements of the current applicable standard
Action: We consider this to be a low risk finding and no remedial action is recommended - monitor use

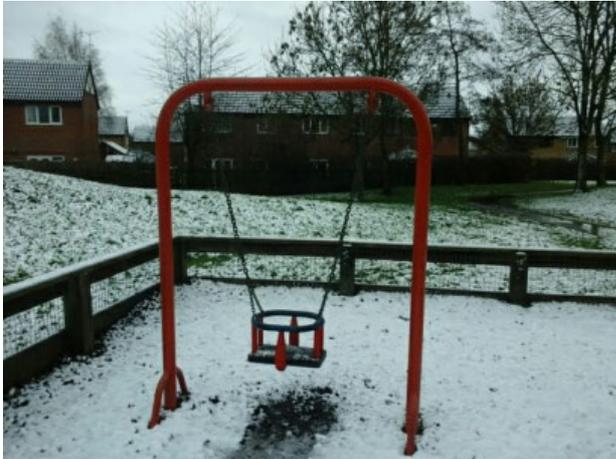
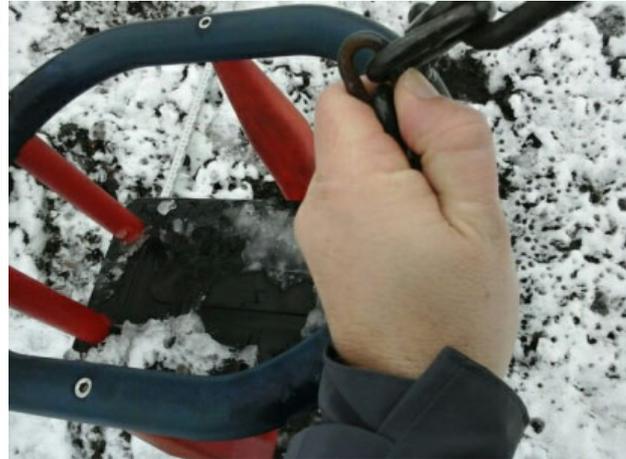
Finding: There is some notable evidence of chain wear

Action: Monitor for any further deterioration and replace when 40% worn

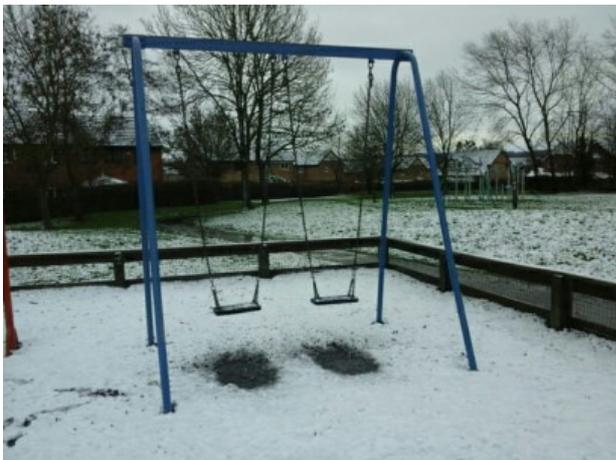
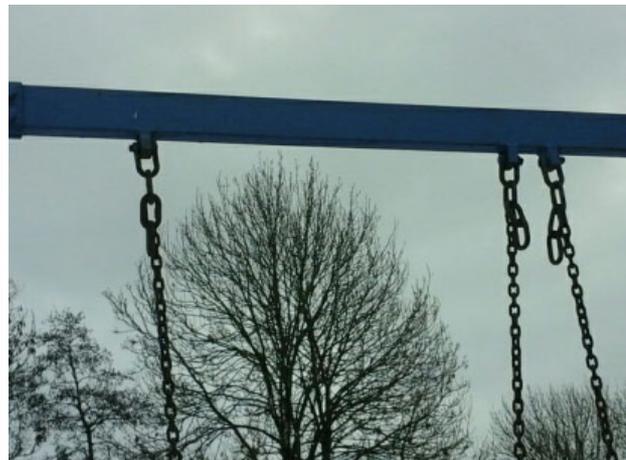
Finding: The bushes are showing signs of wear

Action: Monitor for any further deterioration and replace as required

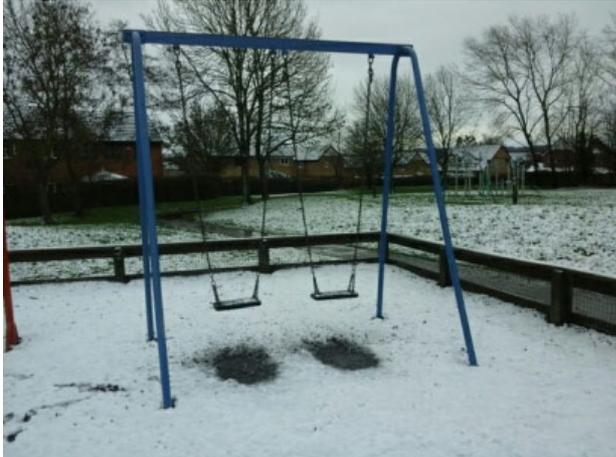
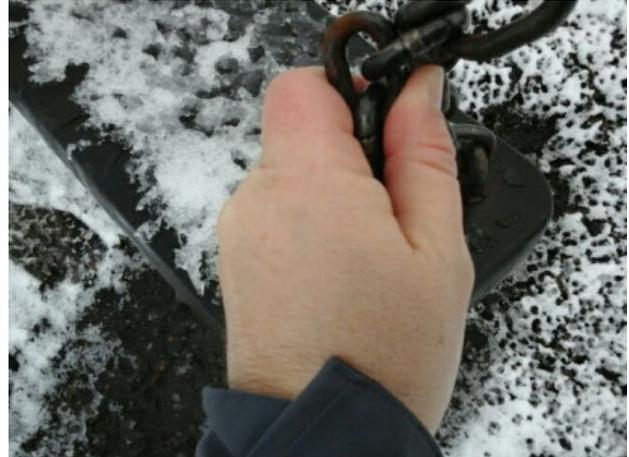
Finding: There is some notable evidence of chain wear

Action: Monitor for any further deterioration and replace when 40% worn

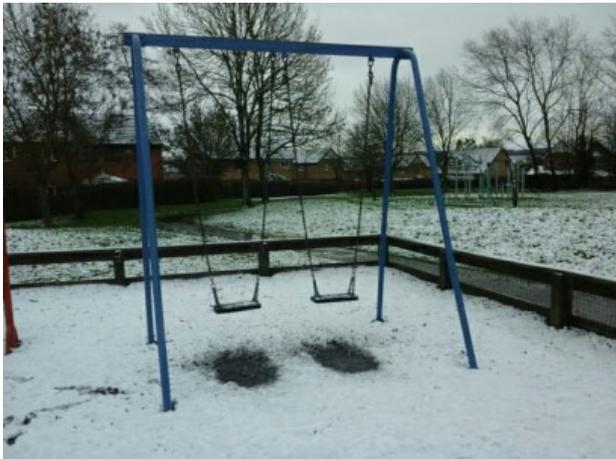
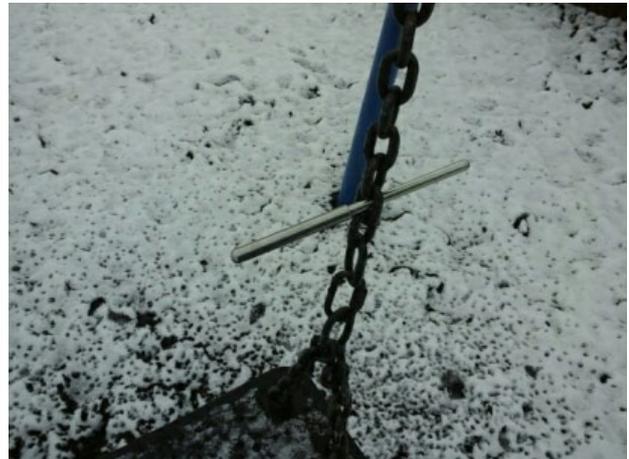
Finding: The chain openings are in excess of the 8.6mm as recommended by BS EN 1176

Action: Monitor use and replace with compliant chains during next maintenance cycle.

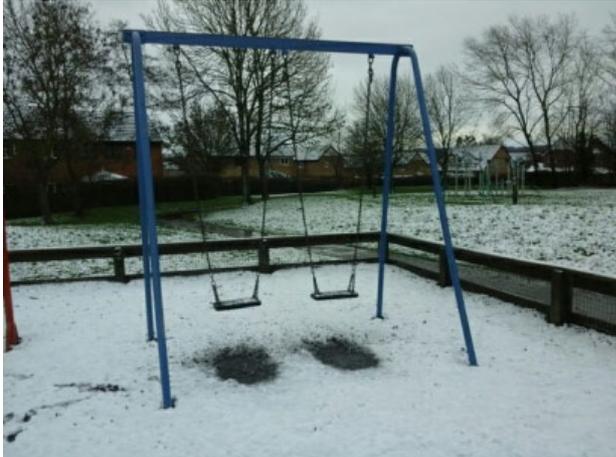
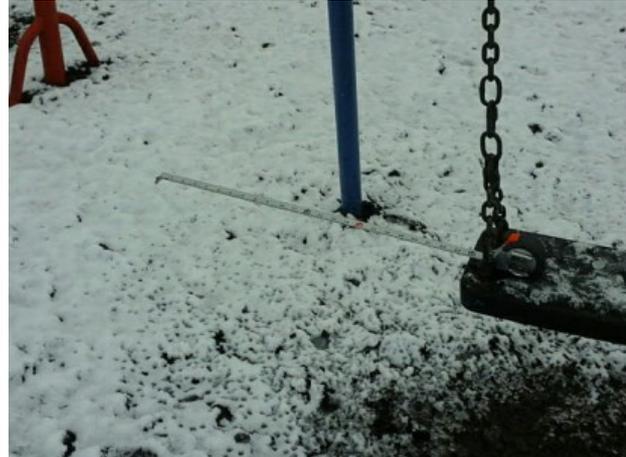
Finding: The seats are too close to the frame as defined in BS EN 1176 Part 2; this is a low risk failure and no remedial action is required

Action: Monitor use

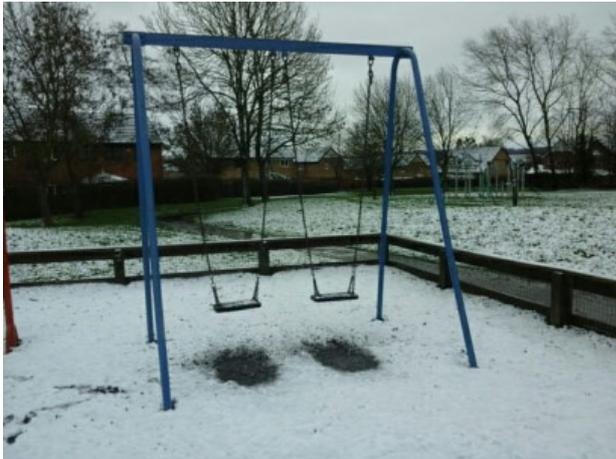
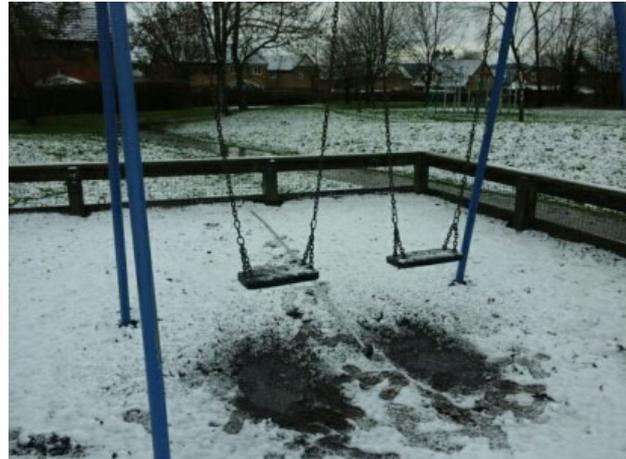
Finding: The surfacing dimensions do not meet with the requirements of the current applicable standard

Action: We consider this to be a low risk finding and no remedial action is recommended - monitor use

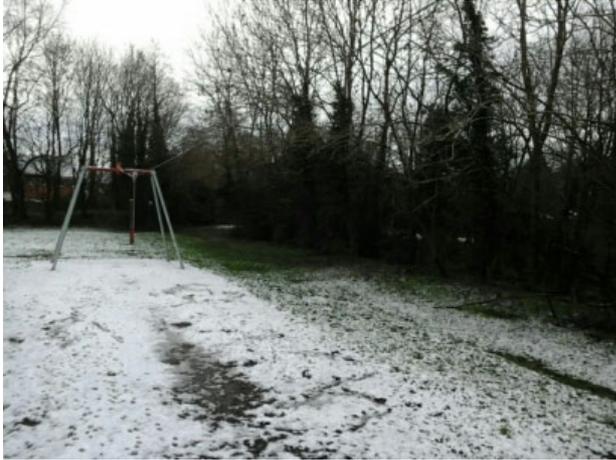
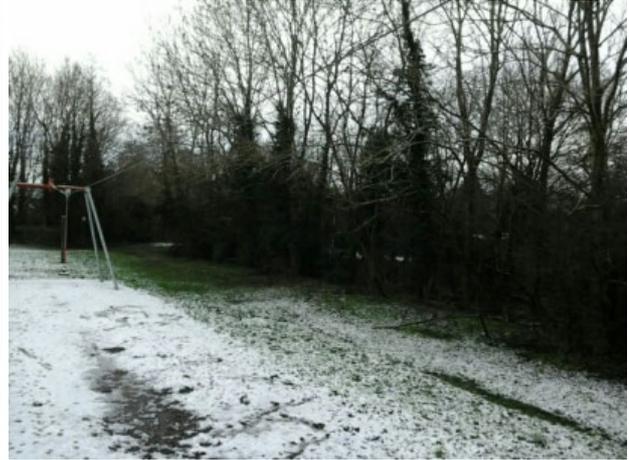
Finding: We recommend that the main cable is removed from the cableway at least once every 2 years to inspect for damage or internal rusting, this will help to ensure the continued safe use of the equipment

Action: Remove and inspect cable every 24 months

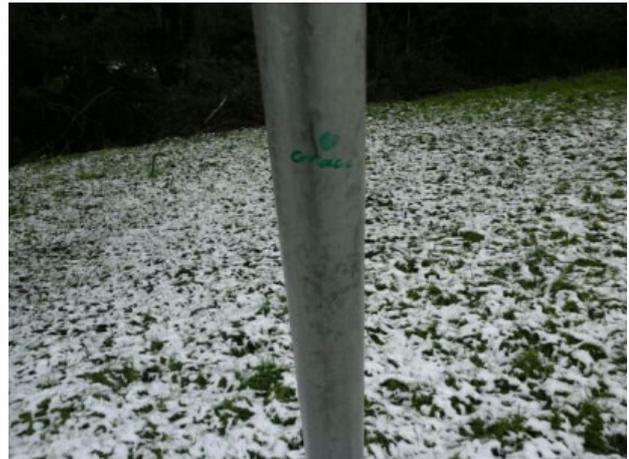
Finding: There is some graffiti present

Action: Remove the graffiti

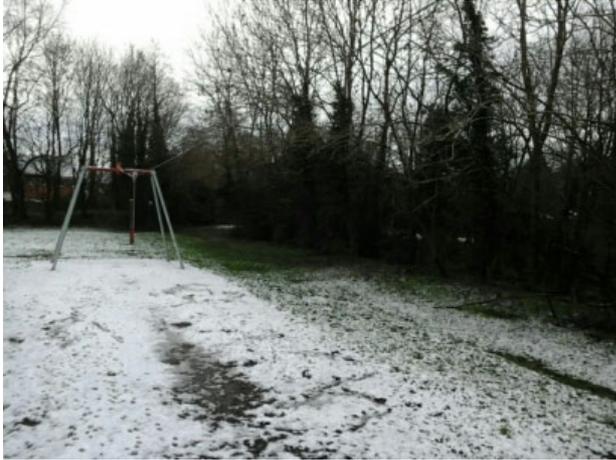
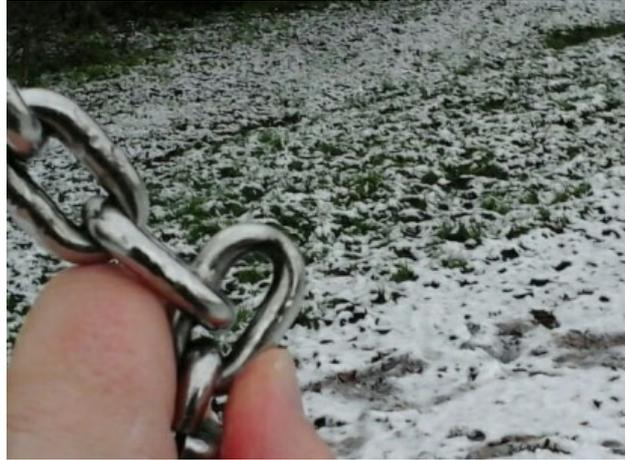
Finding: There is some chain wear

Action: Monitor for any further deterioration and replace when 40% worn

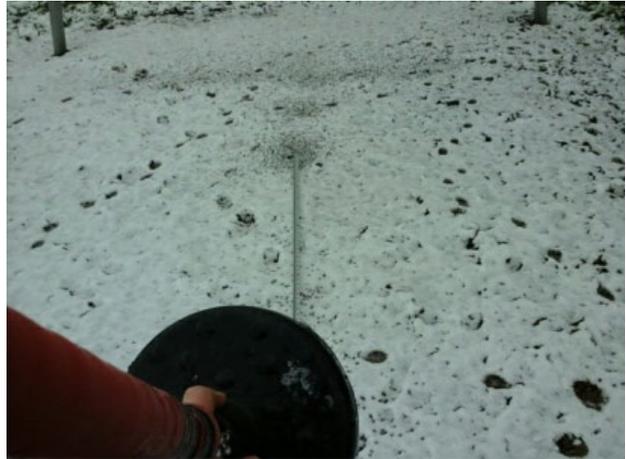
Finding: The seat is less than 2.0 metres from the post when extended at 45 degrees at the end of the area of travel

Action: Adjust the cable stop position to ensure the minimum distance is maintained

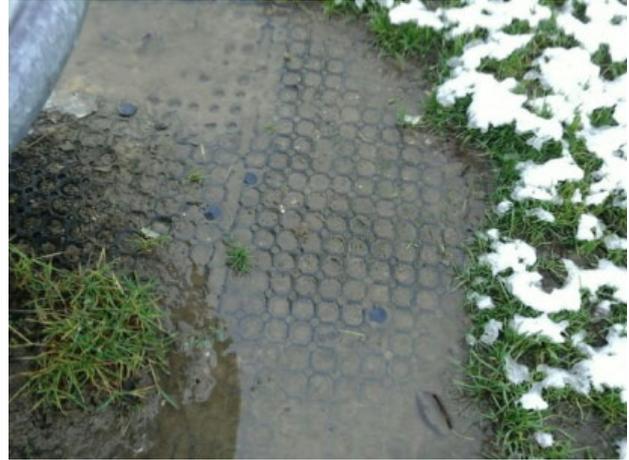
Finding: Fixing Pins have been installed in the impact areas of the grass mats

Action: Remove pins from impact areas

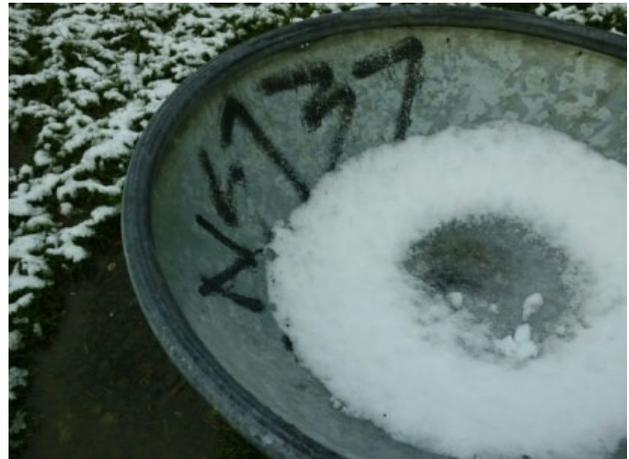
Finding: There is some graffiti present

Action: Remove the graffiti

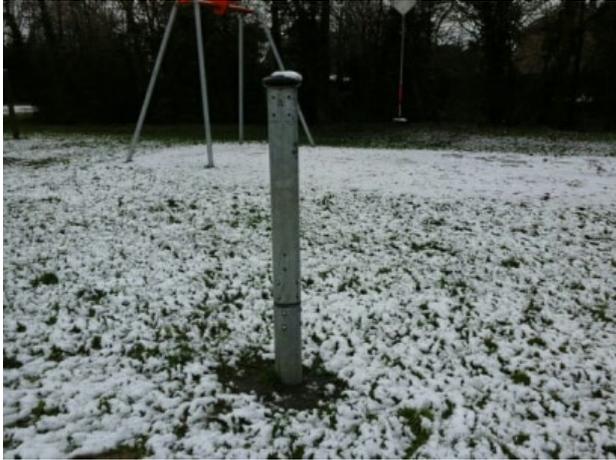
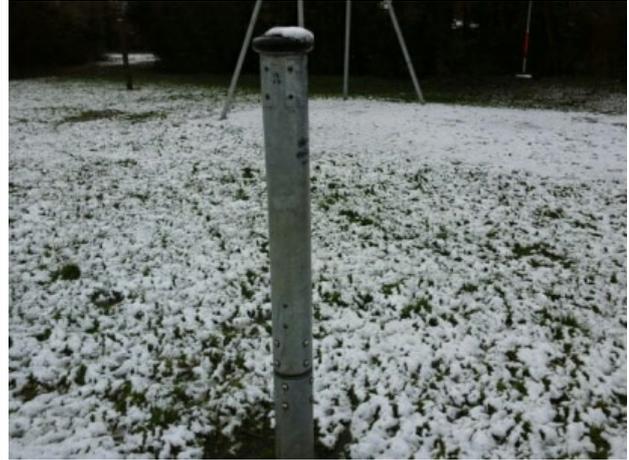
Finding: The item has missing component(s)

Action: Consider replacing missing components

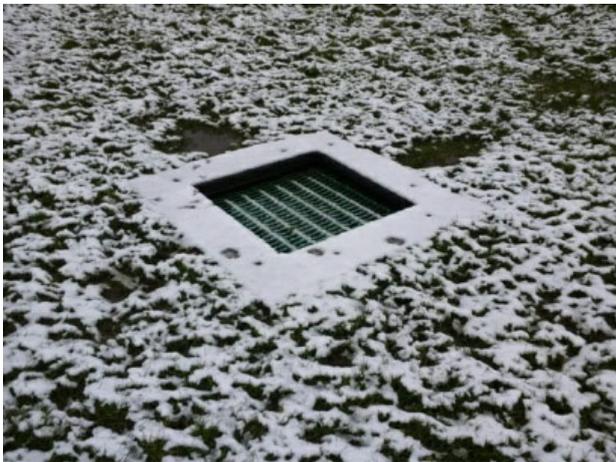
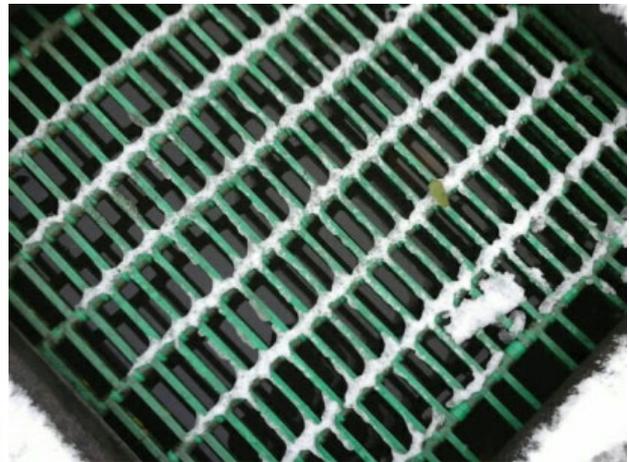
Finding: There is water evident under the trampoline bed

Action: Ensure that water is removed and that adequate drainage has been provided

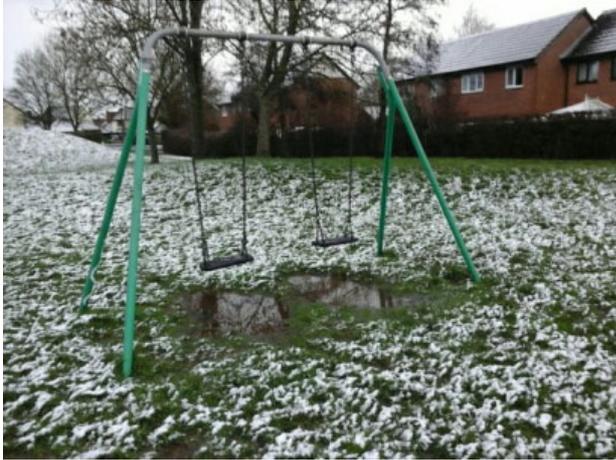
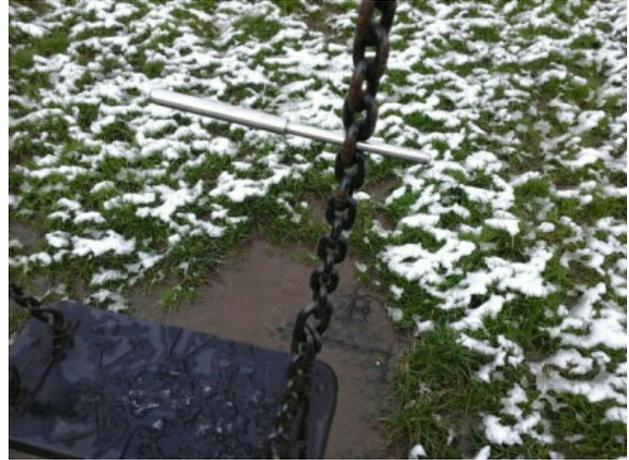
Finding: The chain openings are in excess of the 8.6mm as recommended by BS EN 1176

Action: Monitor use and replace with compliant chains during next maintenance cycle.

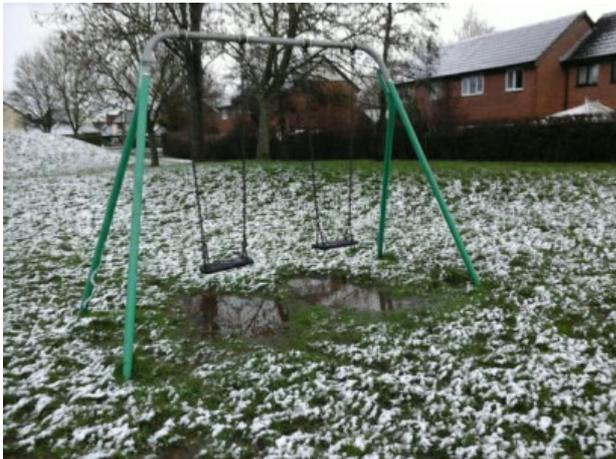
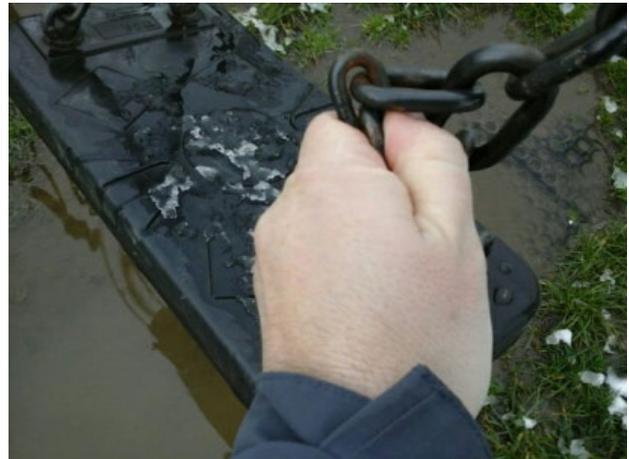
Finding: There is some notable evidence of chain wear

Action: Monitor for any further deterioration and replace when 40% worn

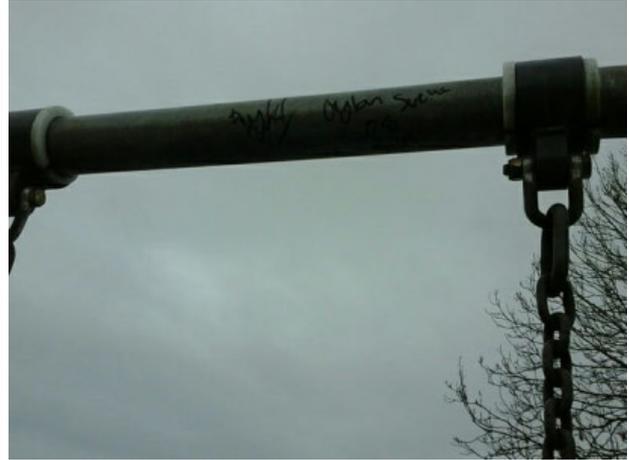
Finding: There is some graffiti present

Action: Remove the graffiti

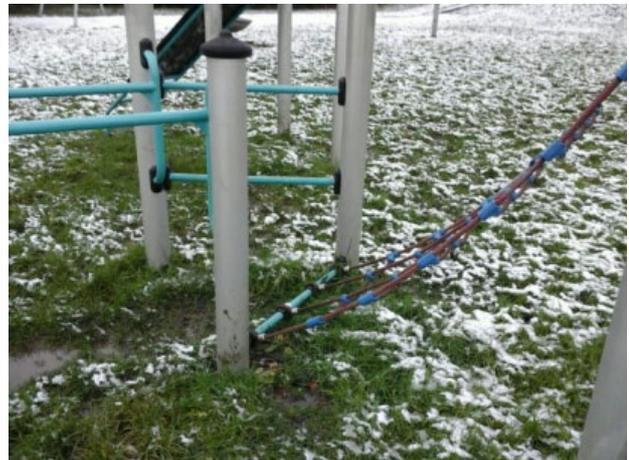
Finding: The lower net mount forms a hard object within the falling space of the equipment in contravention of the requirements of BS EN 1176 Part 1

Action: Monitor use

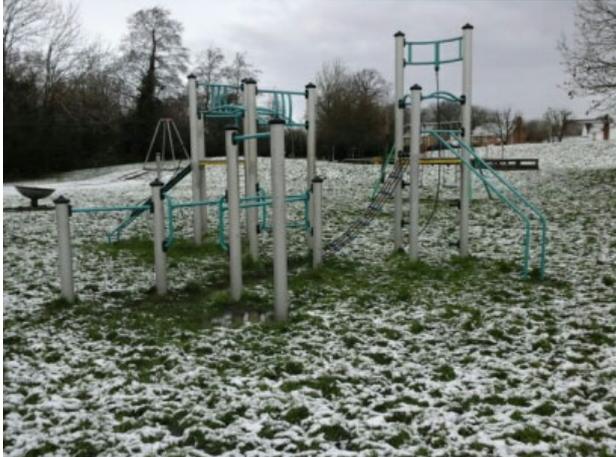
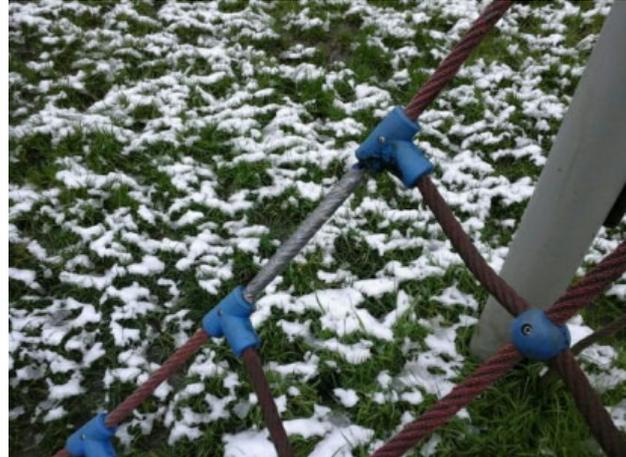
Finding: The ropes on this item have been taped and we are unable to fully assess the condition of the rope, ensure no wire strands are broken beneath the tape

Action: Repair or replace as required

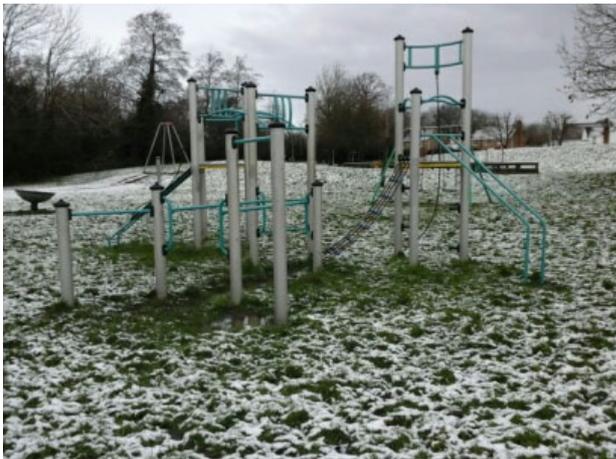
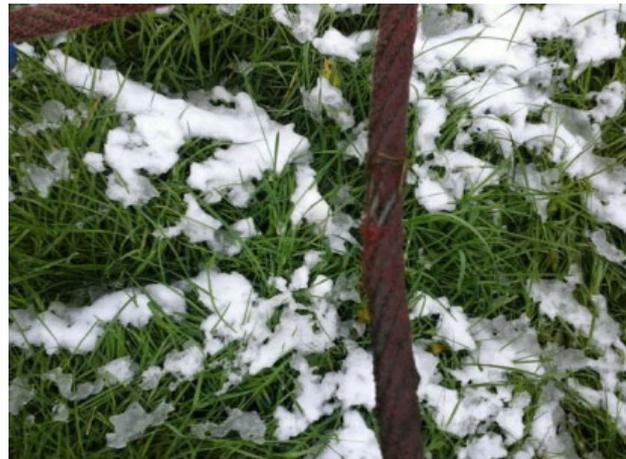
Finding: The ropes/nets are worn/damaged in places

Action: Monitor for any further deterioration and repair or replace as required

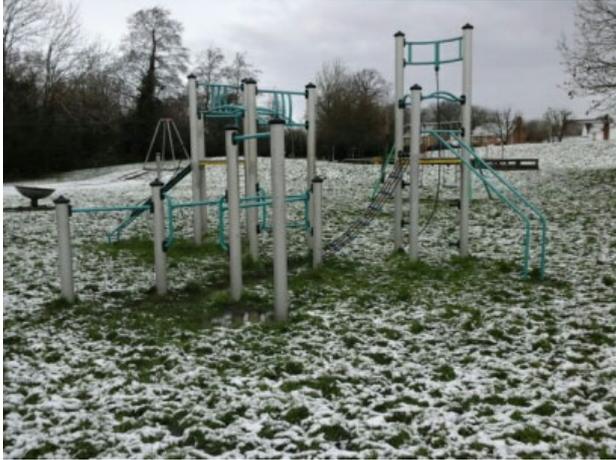
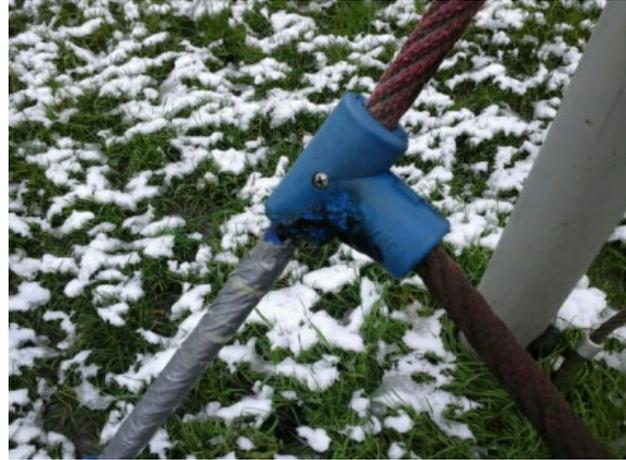
Finding: There is some evidence of fire damage to the item

Action: Monitor for any further deterioration and repair as required
