## Proposed Public Open Space, Kerrier Way, Camborne

### Report details

**Date:** 11.08.2023

**Our Ref:** GEO1740158135

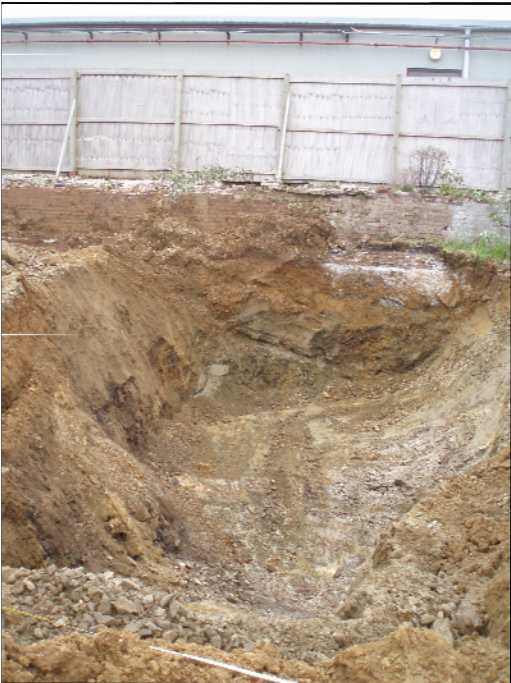
#### ***“Feature 1 (Plate 1)***

*Feature 1 was intersected close to the north eastern corner of the site. Excavations revealed a probable early backfilled exploratory pit, which had a base at approximately 2.9 metres below the stripped surface, at an elevation of 107.3 metres. The maximum dimensions of the feature were 11.9 metres by 3.2 metres. The feature was excavated within moderately strong, slightly weathered, tabular/laminar, orange/buff/black, structured shale with a low clay matrix. This feature was infilled with a lean mix concrete (Plate 2).*

PLATE 1: Showing feature 1, early exploratory pit with a base.

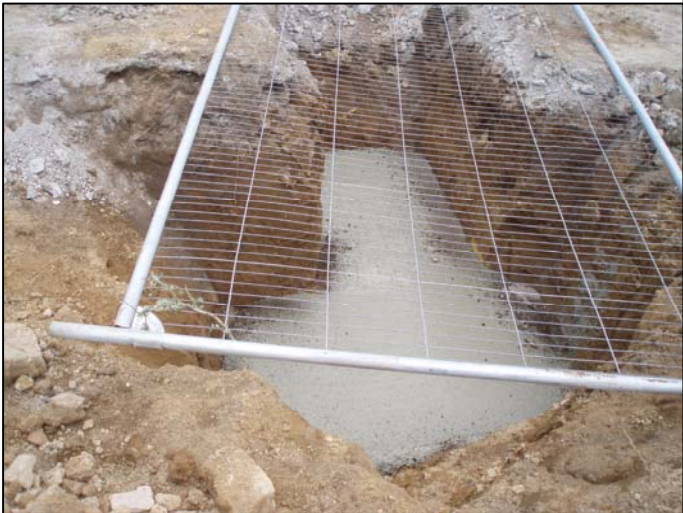
PLATE 2: Feature 1 secured.

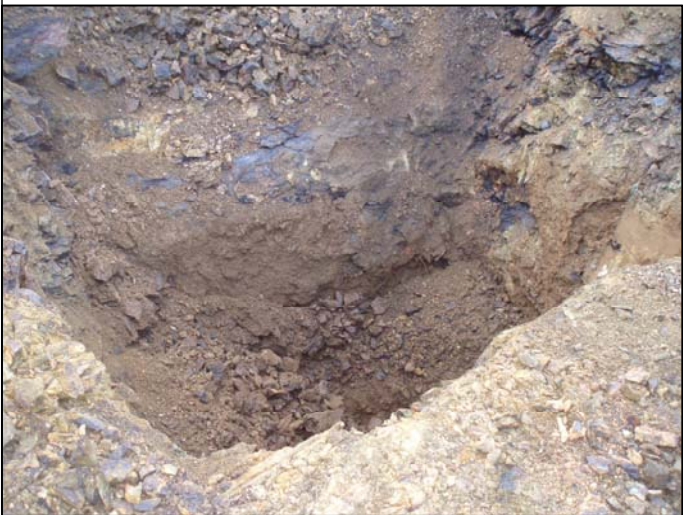
#### ***Feature 2 (Plate 3)***

*Feature 2 was intersected close to the western boundary of the site. Excavations revealed a backfilled exploratory pit, which had a base at approximately 1.1 metres below the stripped surface, at an elevation of 109.35 metres. The dimensions of the exploratory pit were approximately 5.5 metres by 1.5 metres. The sides and the base of the exploratory pit were within a natural, firm, buff, gravelly clay with altered fragments of shale.*

PLATE 3: Showing feature 2, an early exploratory pit.

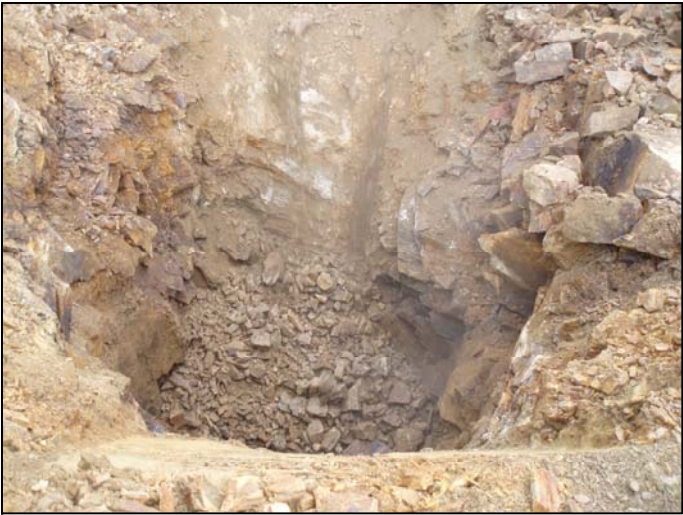
#### ***Feature 3 (Plate 4)***

*Feature 3 was intersected close to the northern boundary of the site. Excavations revealed a backfilled exploratory pit, which had a base at approximately 0.7 metres below the stripped surface, at an elevation of 110.06 metres. The dimensions of the exploratory pit were approximately 2.5 metres by 2.1 metres. The sides and the base of the exploratory pit were within a natural, firm, buff, gravelly clay with altered fragments of Shale.*

PLATE 4: Showing feature 3, an early exploratory pit.

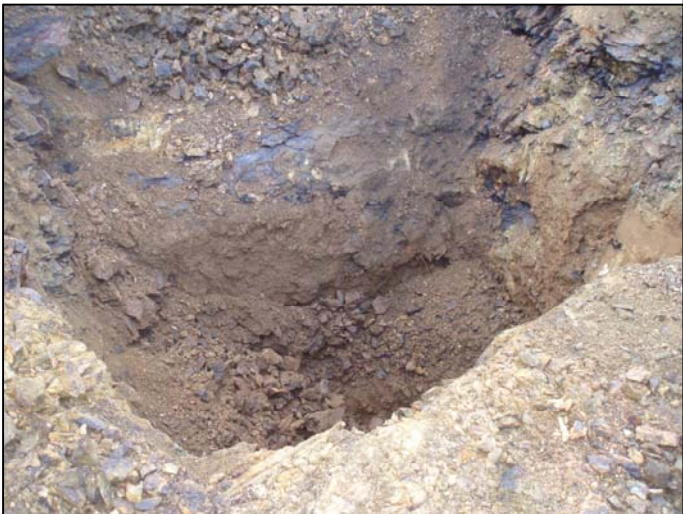
#### ***Feature 4 (Plate 5)***

*Feature 4 was intersected close to the northern boundary of the site. Excavations revealed a backfilled exploratory pit, which had a base at approximately 1.6 metres below the stripped surface, at an elevation of 108.85 metres. The dimensions of the exploratory pit were*

*approximately 4.0 metres by 2.1 metres. The sides and the base of the exploratory pit were within a natural, firm, buff, gravelly clay with altered fragments of shale.*

PLATE 5: Showing feature 4, an early exploratory pit.

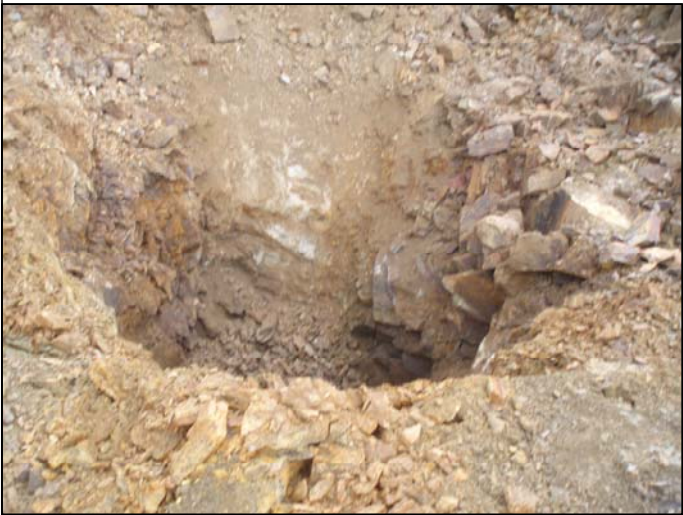
### **Feature 5 (Plate 6)**

*Feature 5 was intersected close to the northern part of the site. Excavations revealed a backfilled exploratory pit, which had a base at approximately 0.6 metres below the stripped surface, at an elevation of 109.33 metres. The dimensions of the exploratory pit were approximately 2.2 metres by 2.2 metres. The sides and the base of the exploratory pit were within a natural, firm, buff, gravelly clay with fragments of altered shale.*

PLATE 6: Showing feature 5, an early exploratory pit.

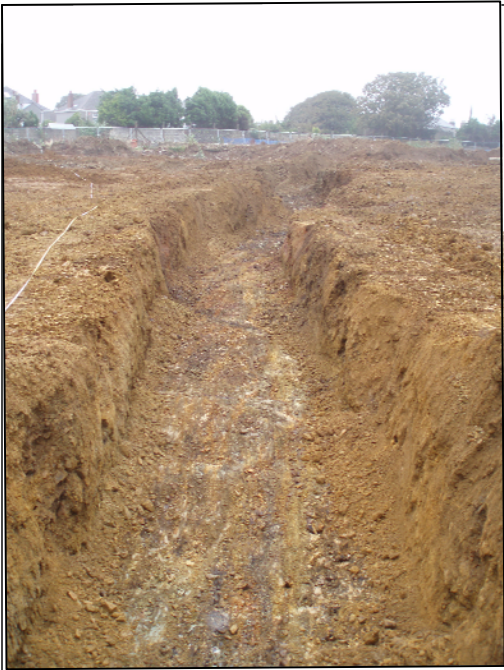
### **Feature 6 (Plates 7 & 8)**

*Feature 6 was intersected towards the western part of the site, trending in a NE/SW Direction. Excavations revealed a shallow backfilled trench feature over a mineralised vein which had a maximum base at 2.0 metres below the stripped surface, at the lowest elevation of 108.72 metres. The vein itself measured 44.8 metres in length and had a maximum width of 2.0 metres. The vein was mainly black in colour with some red patches. The sides were within moderately strong, buff shale. The vein may be associated with the outcrop of the recorded lode.*

PLATE 7: Showing surface/ lode working still intact, can see black vein, in centre of trench.

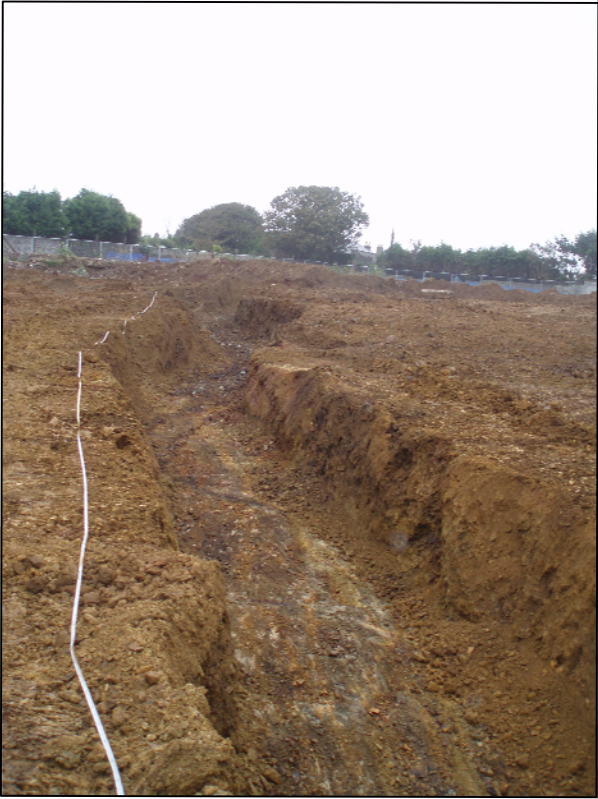
PLATE 8: Sinuous lode outcrop.
