Our ref: 16088
18th August 2016

***Re: Martech Report 16088
Neville House, Corby
Additional Concrete Investigations & Testing***

Neville House, Corby – Additional Concrete Testing Site Photographs

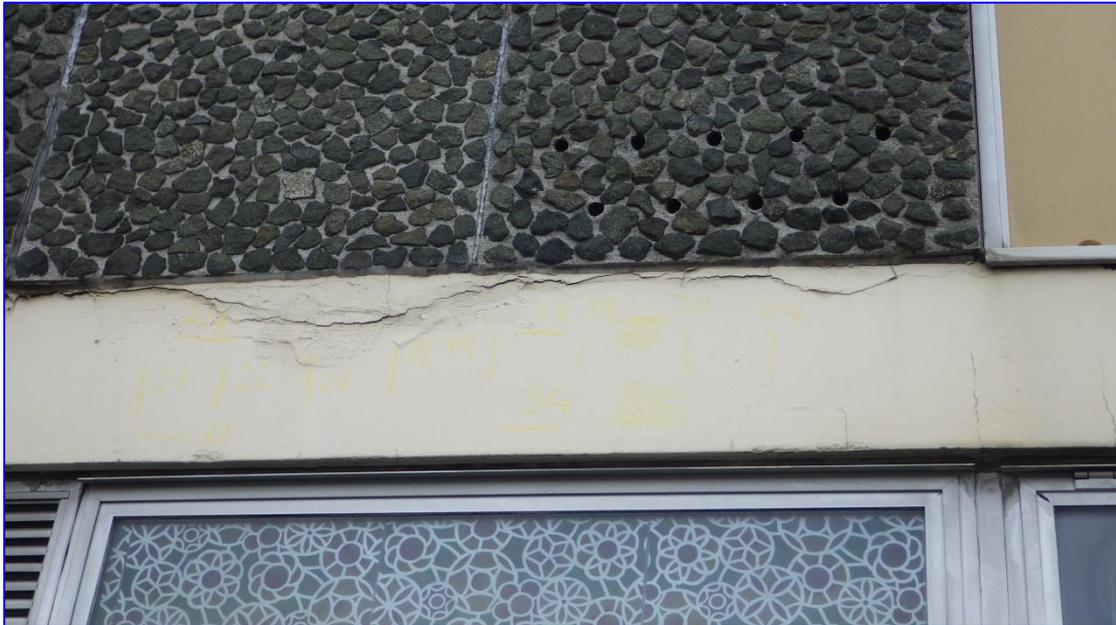
Photograph 1: General view of Test Area 41 (TA41) to a 3rd floor beam.

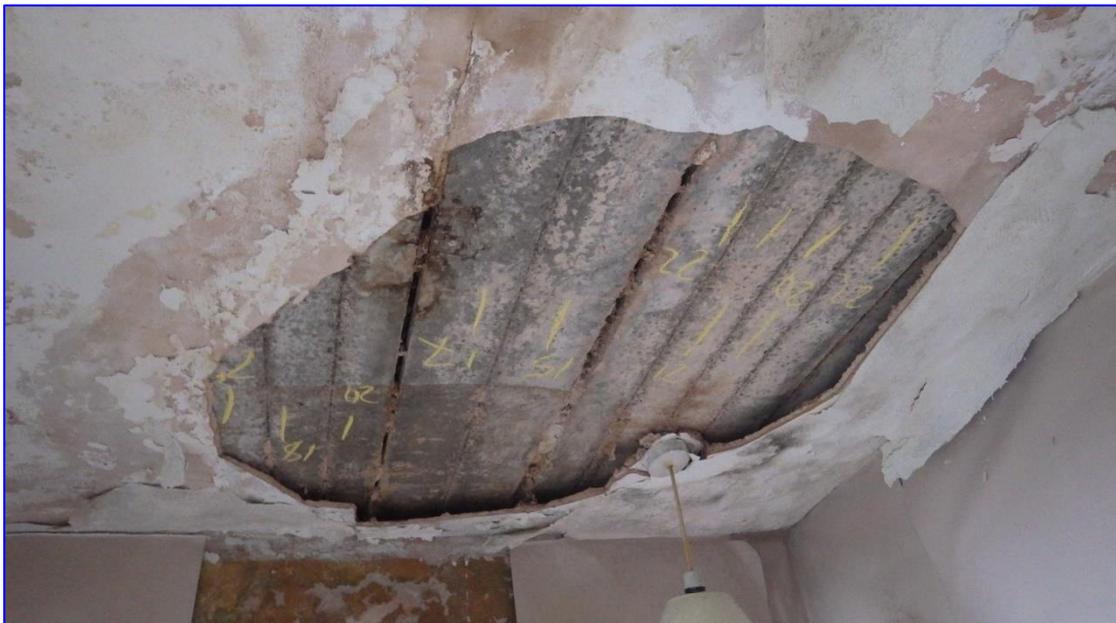
Photograph 2: General view of TA44 to roof plank soffits.

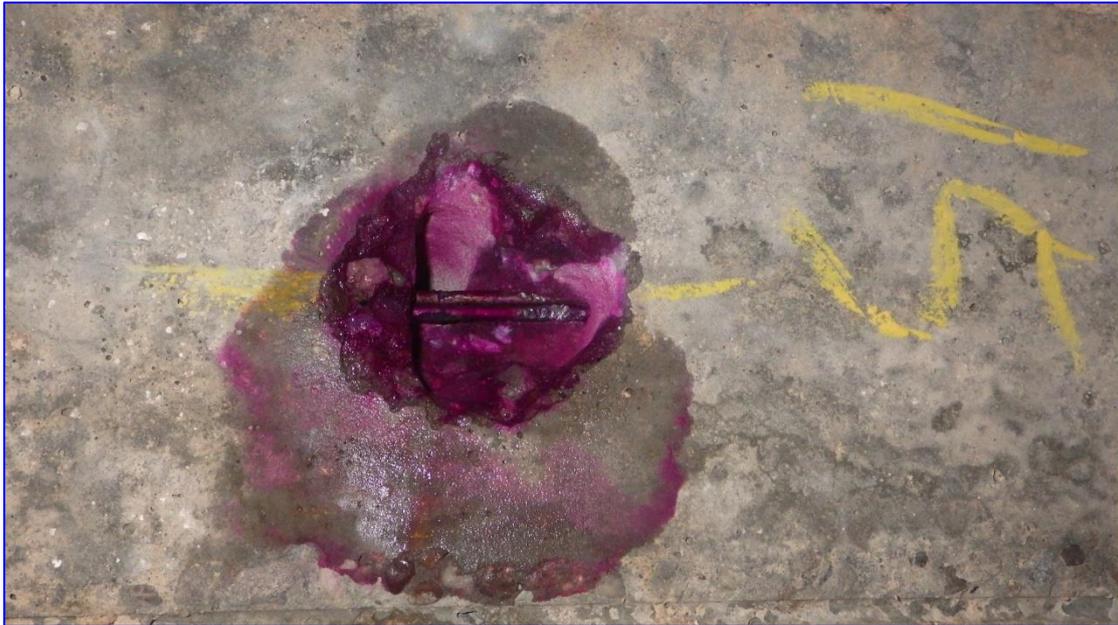
Photograph 3: Breakout and sample location at TA44. The pink colour is a result of a carbonation test also undertaken – indicating low carbonation.

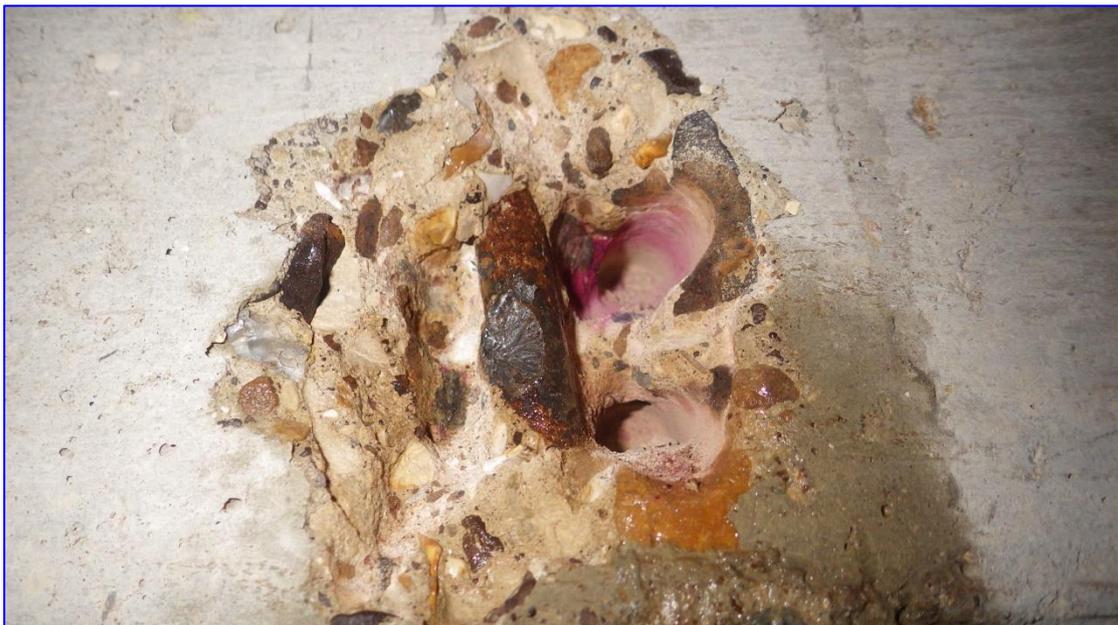
The cement content results ranged from 9.2% to 24.4% at this visit. The lowest of 9.2% was from the roof main beam at TA48, about 1m further along from TA9. The result was not as low as before but still indicative of a lower level of cement to this element. Three of the other four results were fairly consistent (from 13.3% to 15.2% (the accepted norm is 14%) and one result was high (24.4%).

The other test results (cover and carbonation) were comparable to those previously obtained. In fact the carbonation results were often lower and so will lower the mean carbonation results. A breakout at TA48, 1m along from TA9, revealed a bar with surface corrosion in carbonated concrete.

Photograph 4: Breakout / sample location at TA48, roof main beam (approximately 1m from original TA9) revealing a bar with surface corrosion in carbonated concrete.

The findings should be assessed by the Structural Engineer.

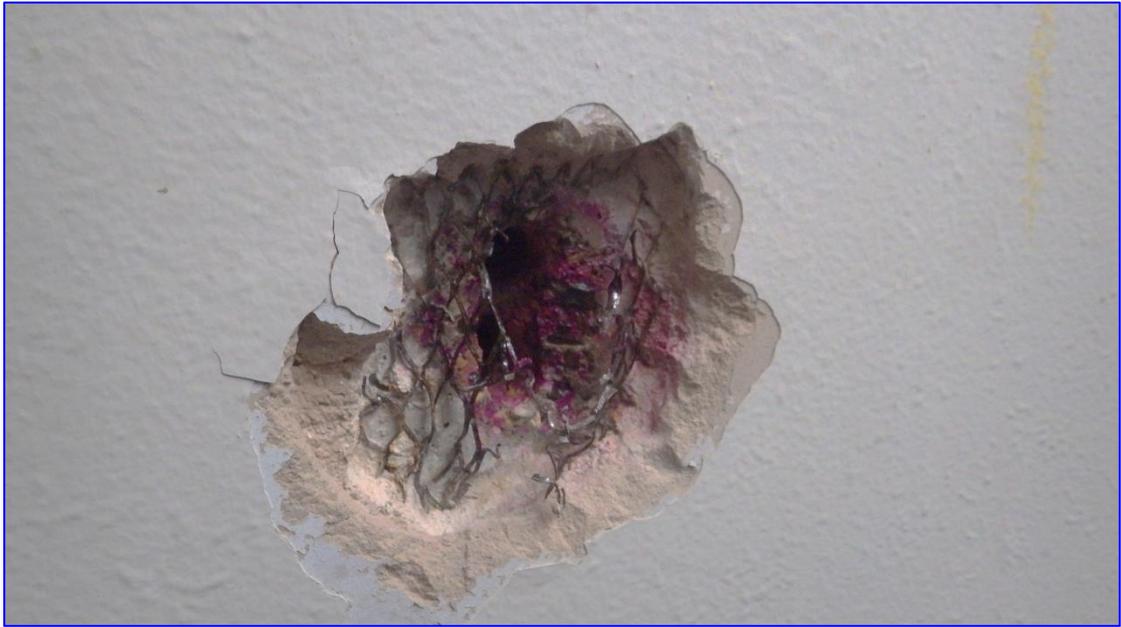
Photograph 5: Sample location at TA49, 1st floor column. Render over eml over the concrete.

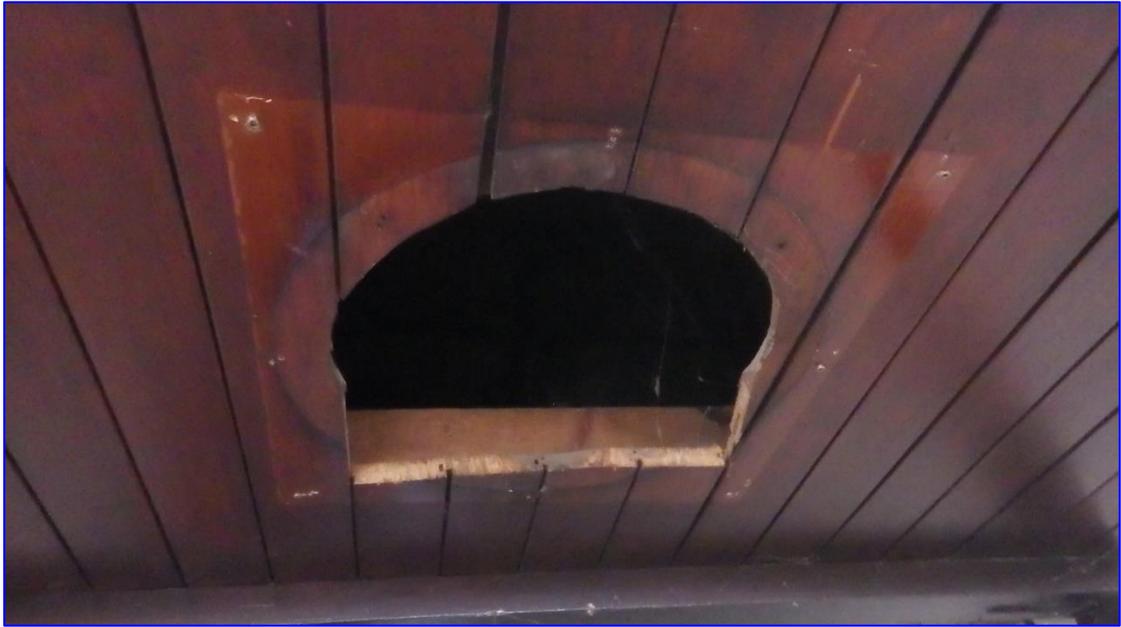
Photograph 8: View of timber cladding over soffit in lobby and existing hole through.

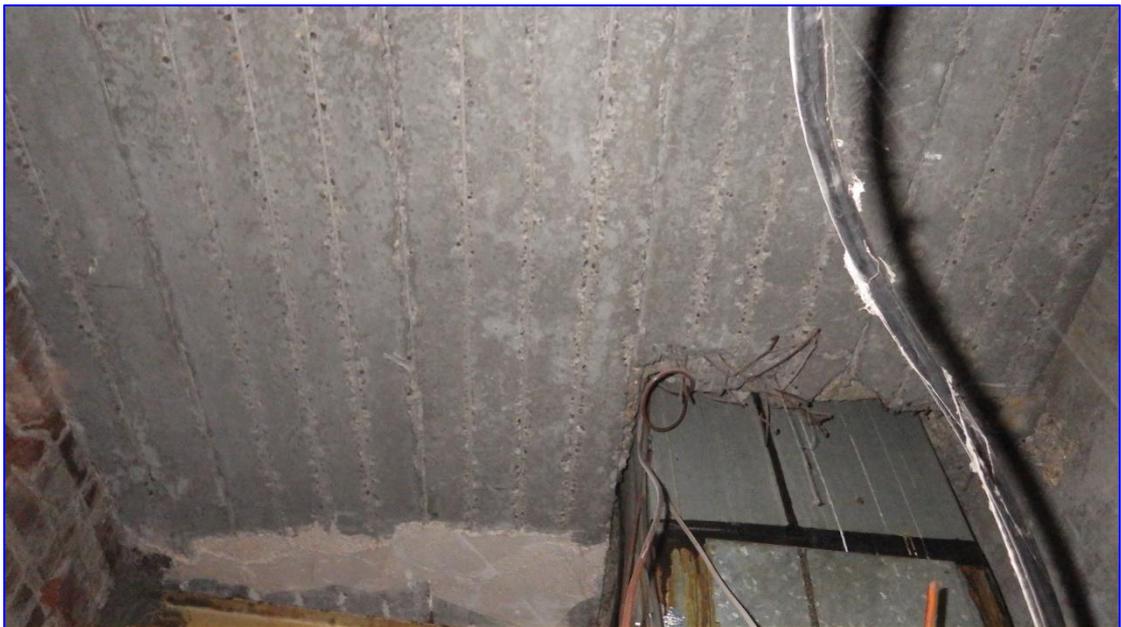
Photograph 9: General view of section of floor plank soffit in lobby, hidden by timber cladding.

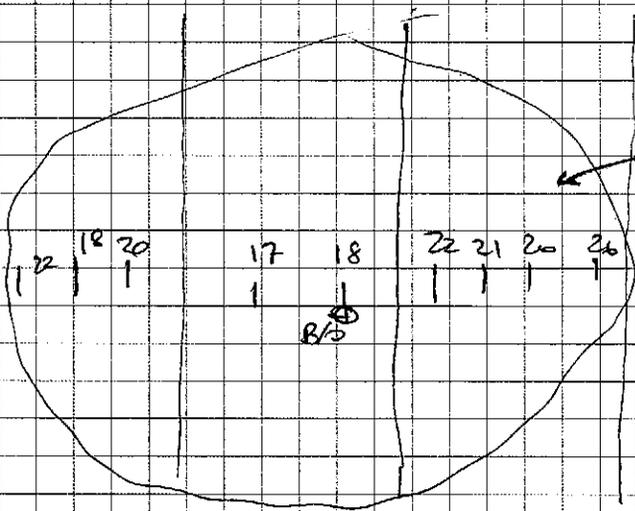
TA44 Roof Soffit

MISSING RENDER

B/O 2x 3mm plain bars c/c
 c/c 18 & 20
 c/c < 5.

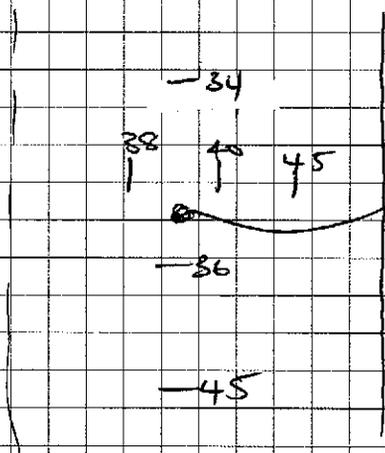
TA46 3rd floor WALL

c/s < 5
 10mm render

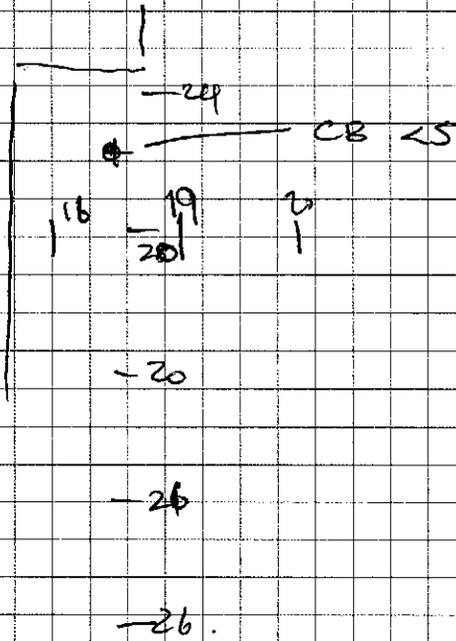
TASO 1st floor split

BRICKWORK WITH 25mm RENDER
