**16-0159**

**A SUMMARY DOCUMENT OF INITIAL STRUCTURAL  
INVESTIGATIONS INTO INSITU CONCRETE FRAME TO  
UPPER FLOORS**

**NEVILLE HOUSE,  
GEORGE STREET  
CORBY NN17 1QD**

**CORBY BOROUGH COUNCIL**

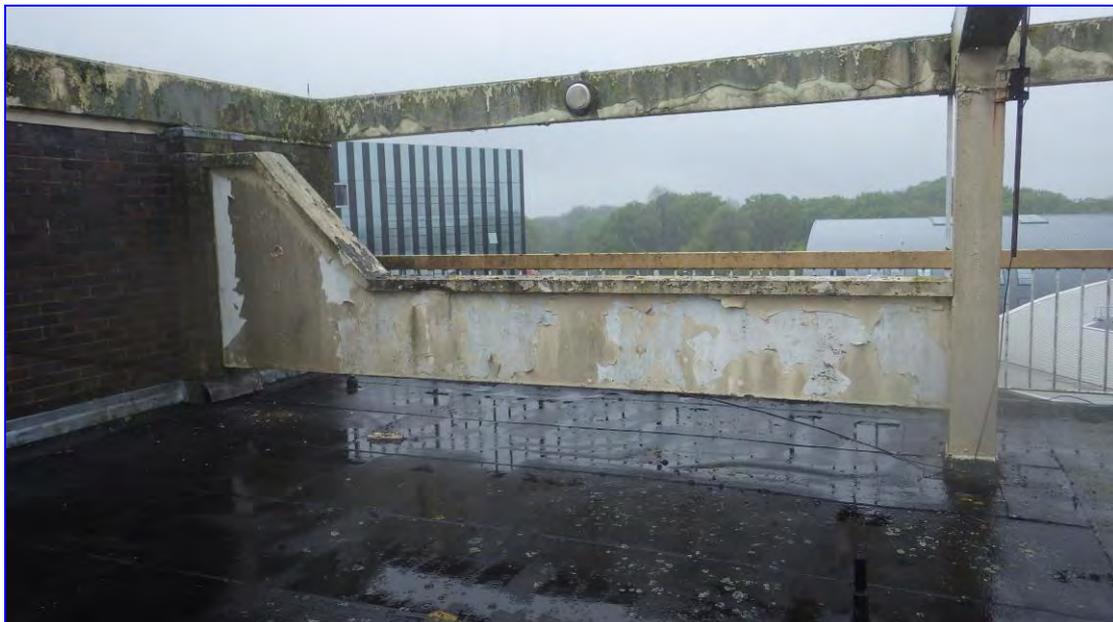
Photograph 8: General view at roof level. Note deteriorated coatings apparent to the concrete elements. Note coping detail to support beam (see photograph 10).

At some time during the life of the structure a protective coating system has been applied. This has failed and in conjunction with other remedial works and will need to be replaced to ensure the future serviceability of the structure.

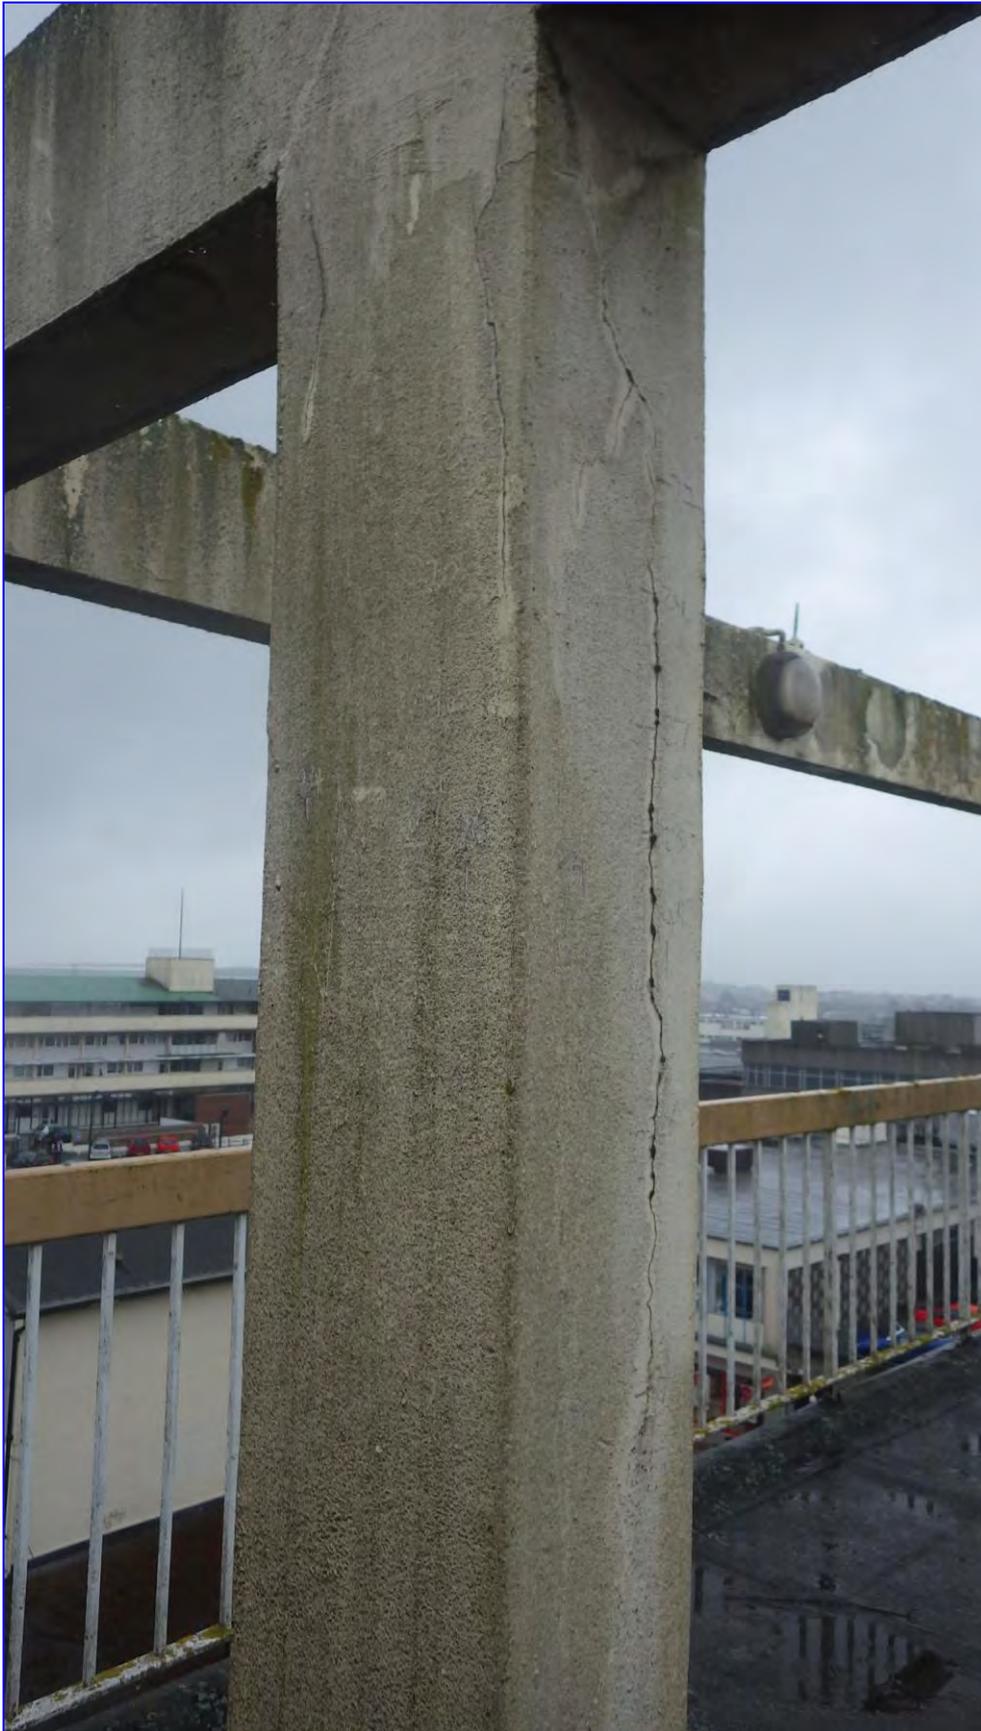
Photograph 9: Cracking / spalling to a roof level column (TA19).

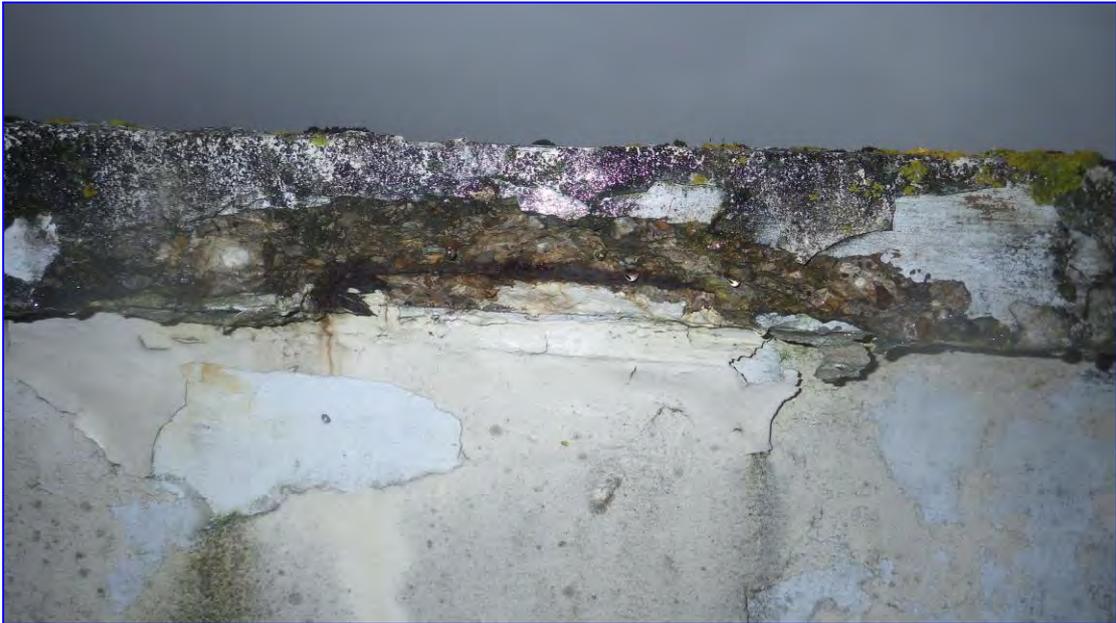
Photograph 10: A spall to the coping detail on the support beam (as per photograph 8).

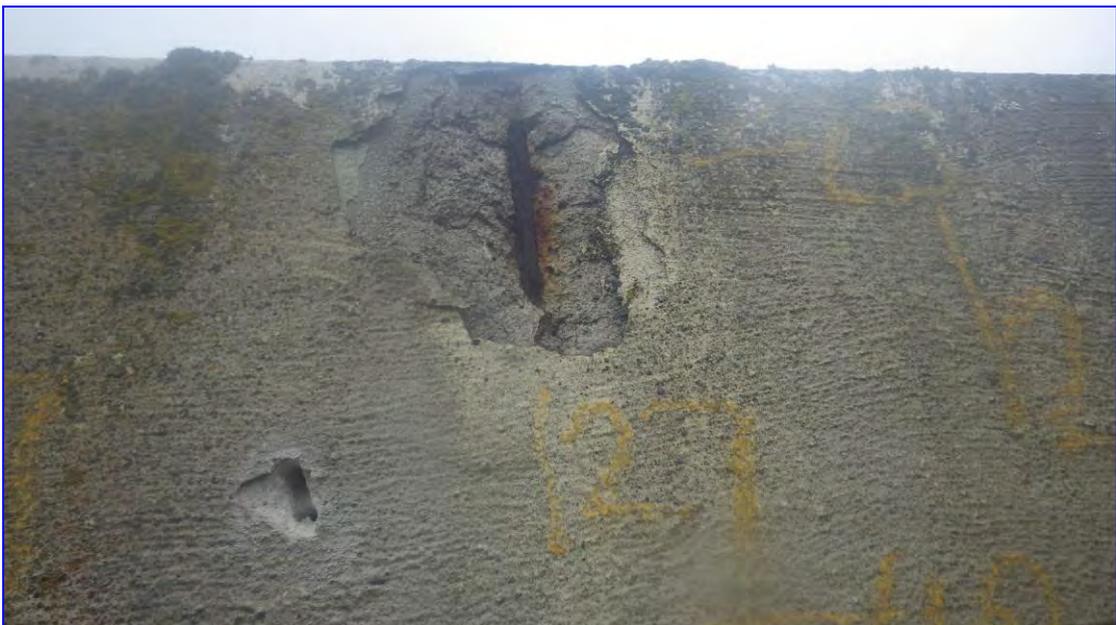
Photograph 11: A spall to a roof beam face (TA24).

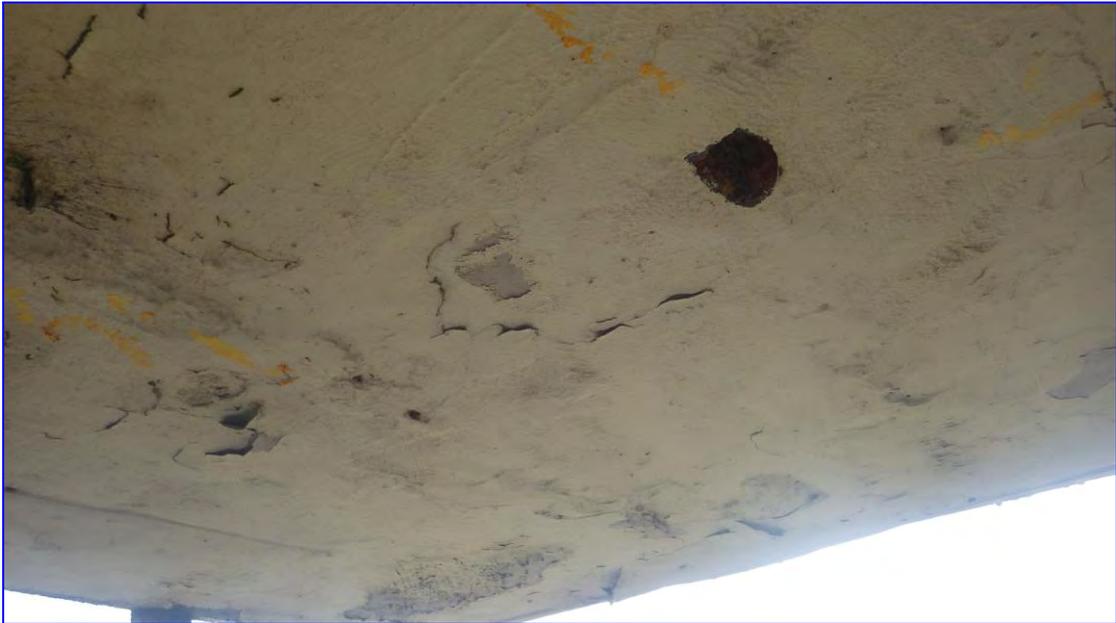
Photograph 12: A couple of spalls and deteriorated coating to a balcony soffit (TA28), east elevation.

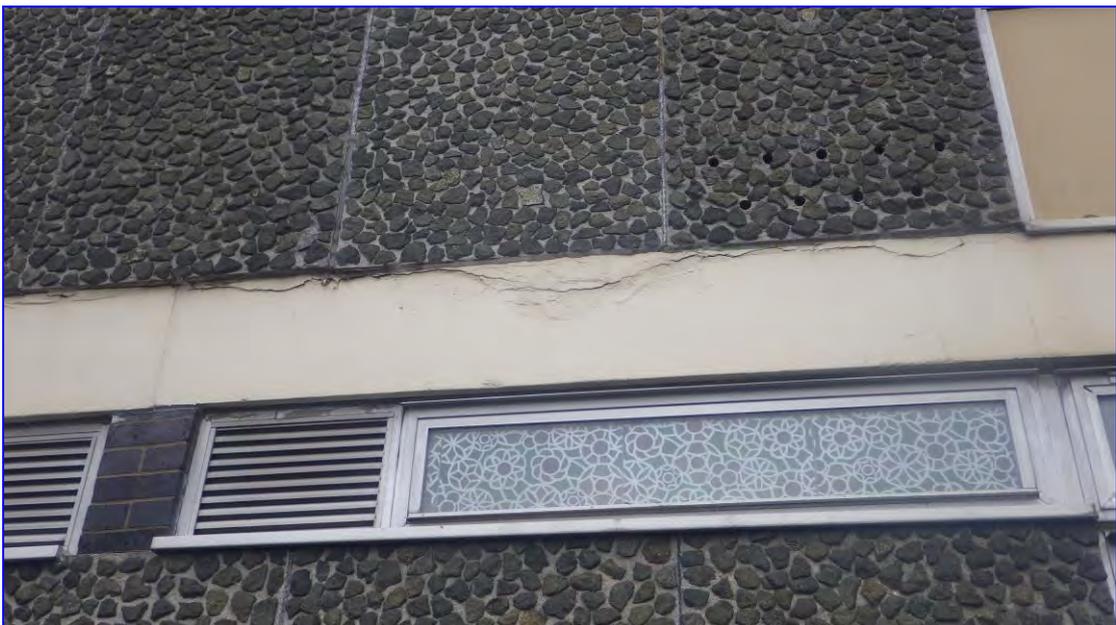
Photograph 13: Spalling to a floor beam, west elevation.

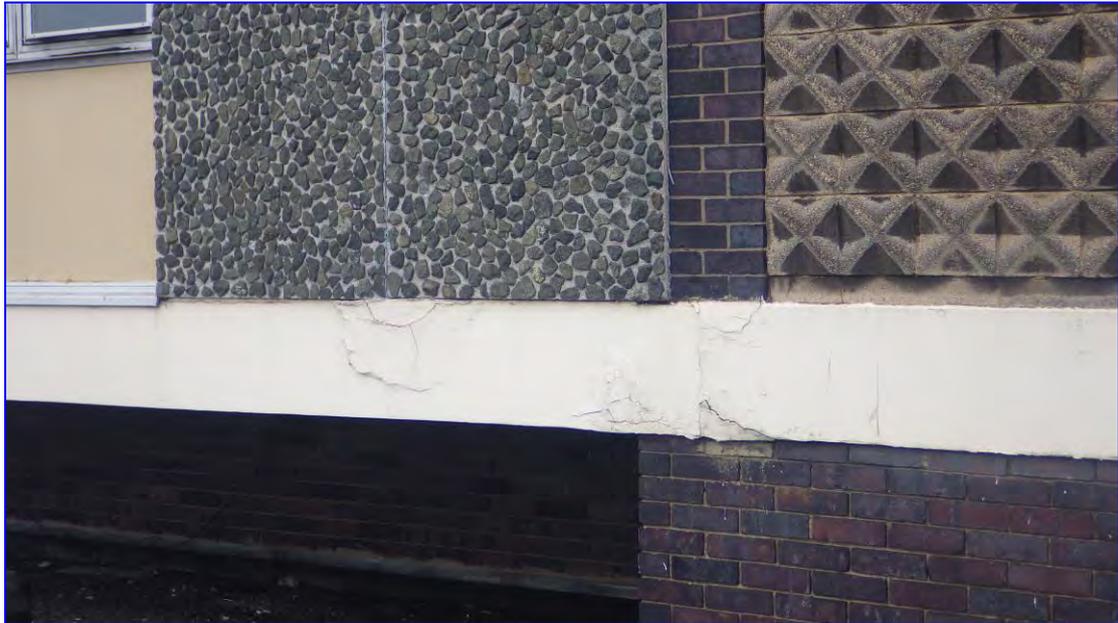
Photograph 14: Spalling to another floor beam, west elevation.

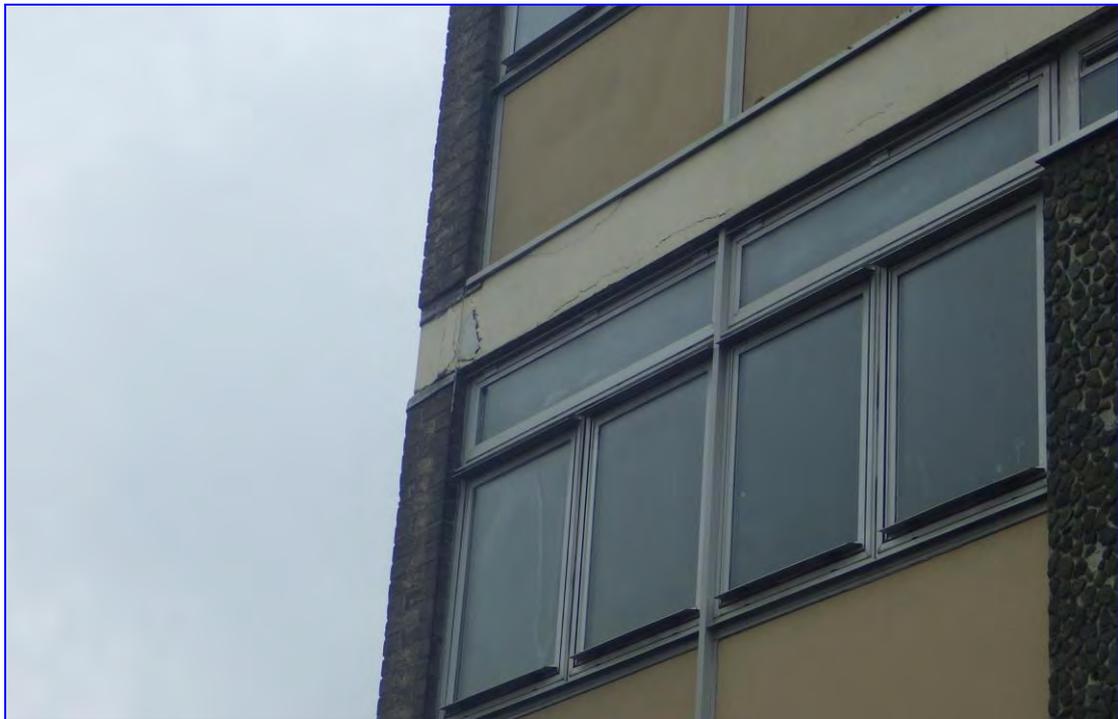
Photograph 15: Another example of spalling to a floor beam, west elevation.

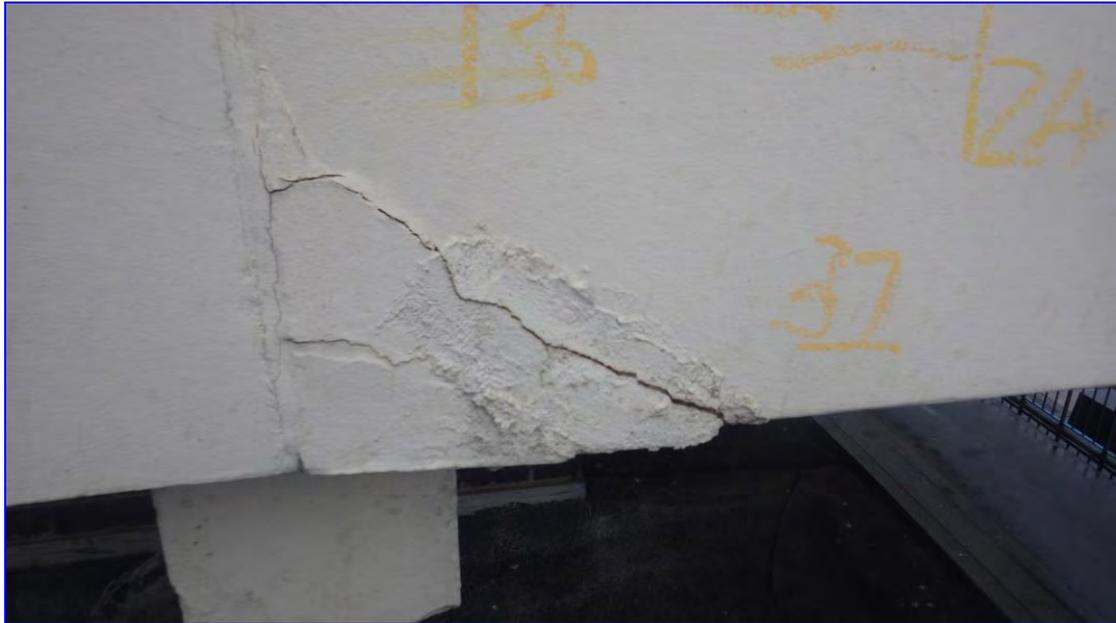
Photograph 16: A larger spall / failed previous repair to a floor beam (2<sup>nd</sup> floor, TA31).

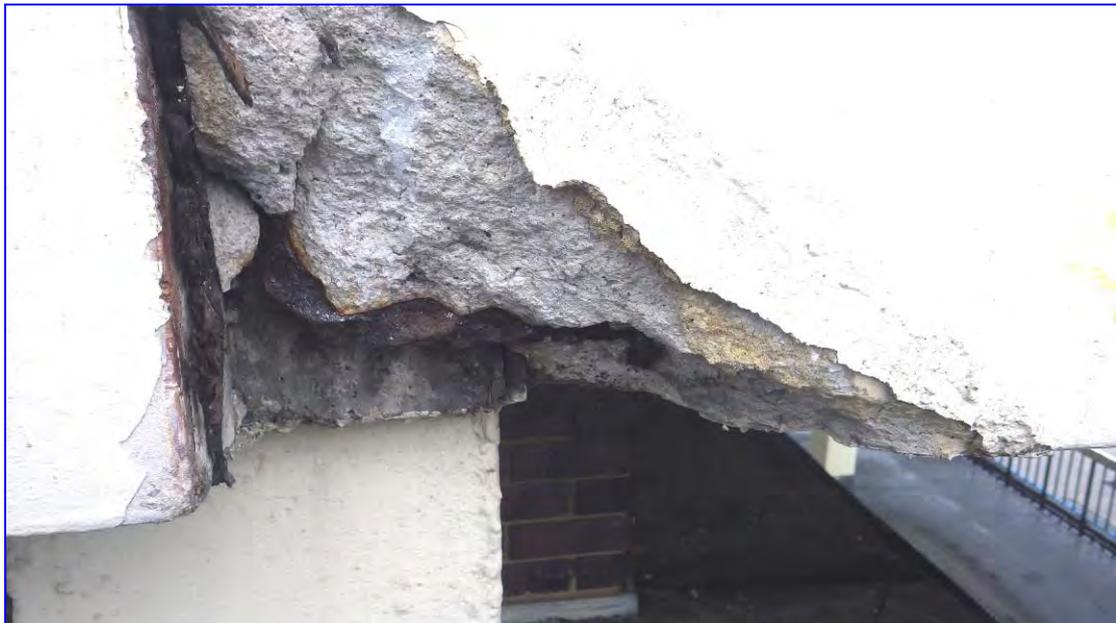
Photograph 17: As p16 after failed section removed. Note corroded reinforcement, one bar being at low original cover.

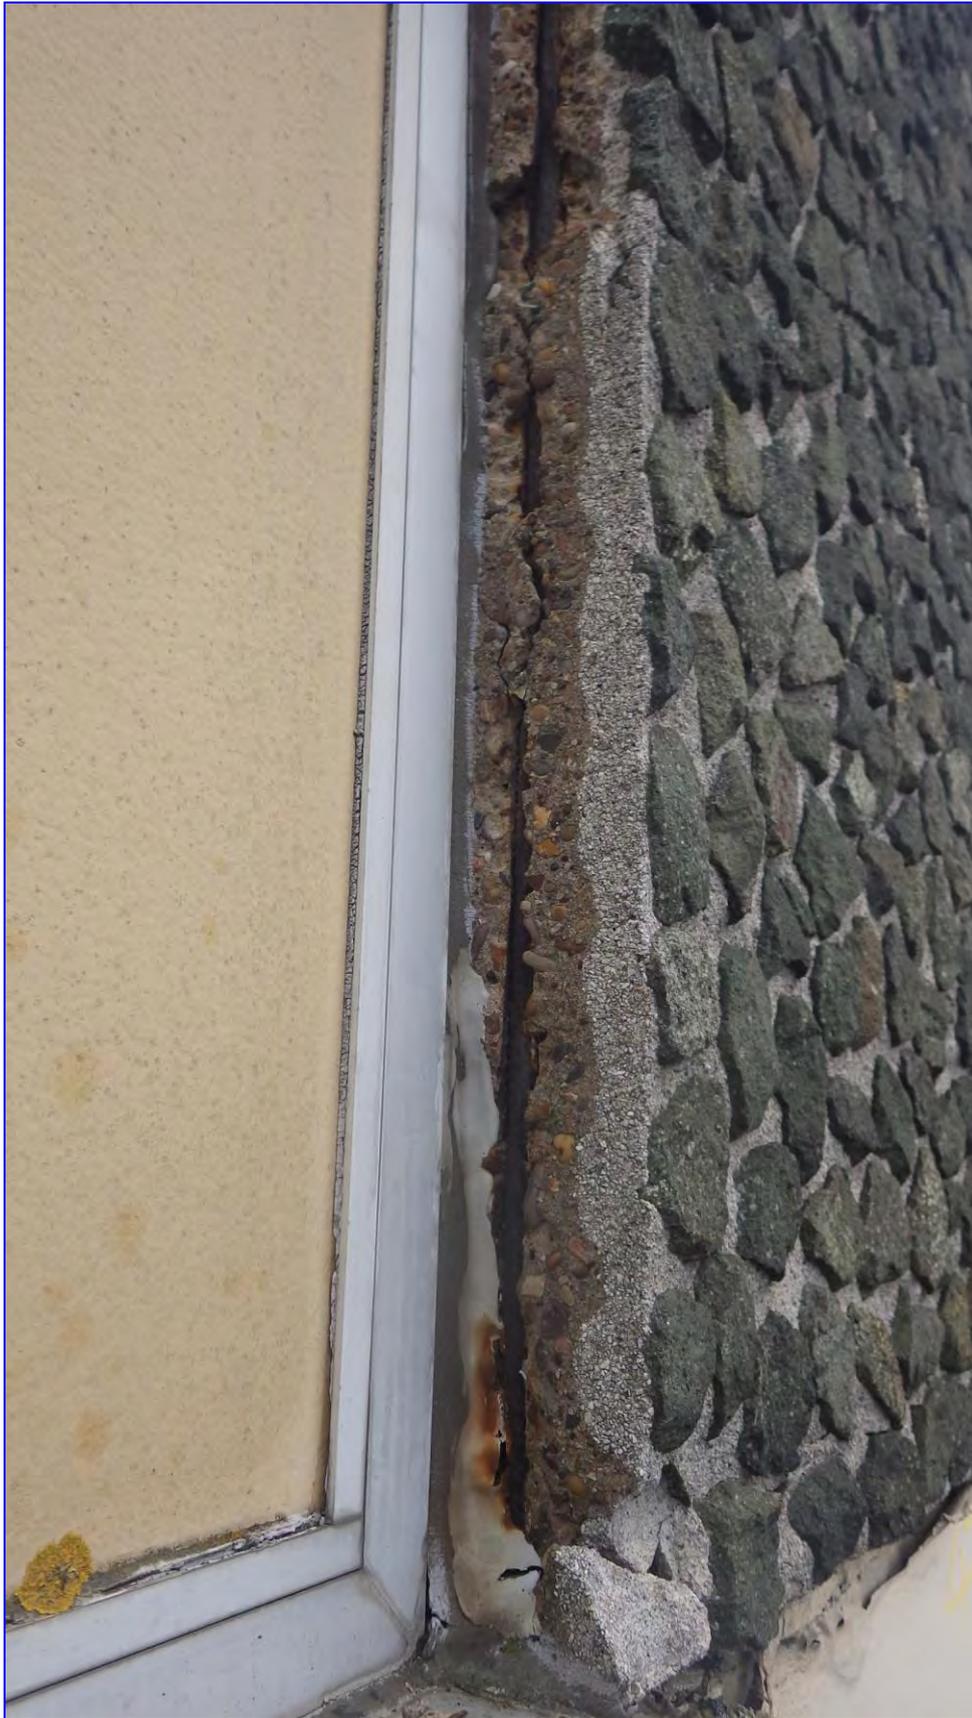
Photograph 18: A spall to the edge of an exposed aggregate panel, west elevation (TA32). Note exposed corroded bar at low minimal original cover.

The main corrosion issue appears to be with the external aggregate panels. We understand that these are to be potentially removed and replaced with a light weight panel system during the proposed refurbishment works. From a structural perspective the replacement of the panels with lightweight cladding should not be an issue, provided that the replacement lightweight panel imposes less load than the aggregate panel.

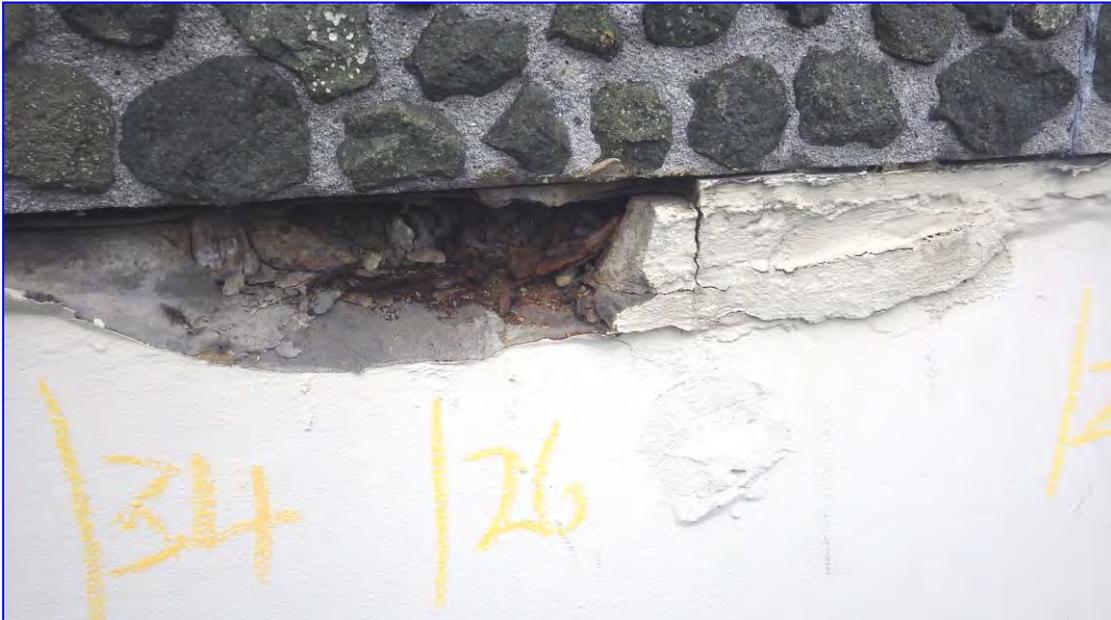
Photograph 19: A spall/failed previous repair to a floor beam (TA33). The bar had a total loss of section.

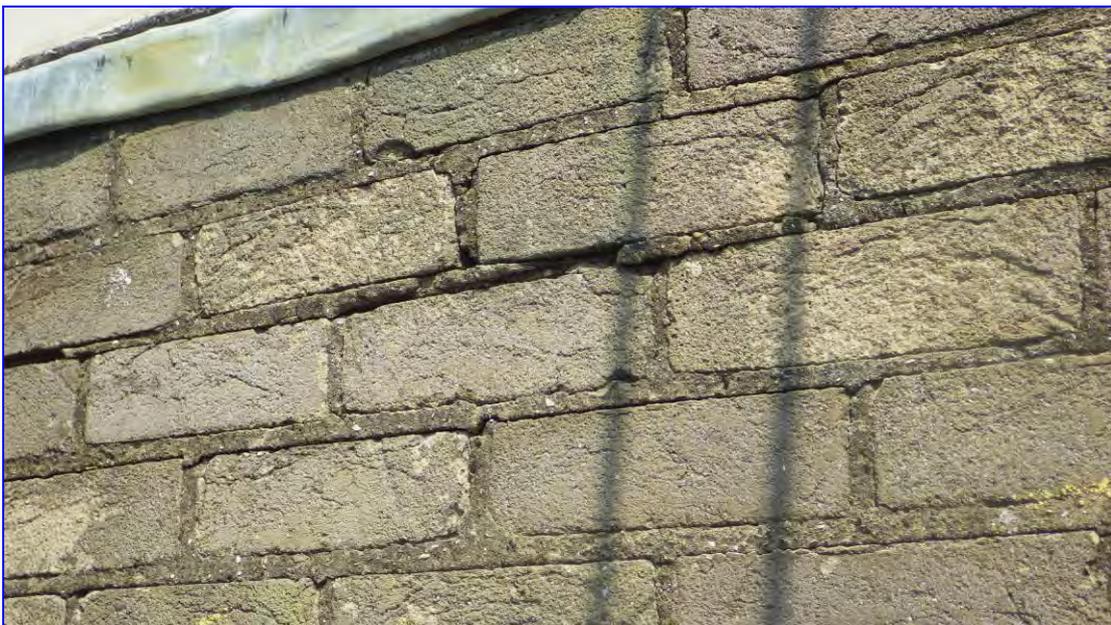
The ties to the masonry panels appear to be in a good condition when considering the age of the building. We suspect that the loss of mortar to the joints is due to weathering and the age of the building. The mortar debris noted in the cavity, on both the ties and damp proof courses (DPC's), is probably from the construction. Varying levels of insulation were noted in the cavity. If the masonry is to be retained during the proposed refurbishment works then consideration should be given to adding insulation (blown type) and the repointing as necessary to the joints.

Photograph 20: The brickwork mortar joints were poor / deteriorated in places as shown here at BWK 8, 3<sup>rd</sup> floor, south gable.

- 6) Where brickwork is retained it should be repointed and insulation should be added to the walls as necessary. Additional ties may also be required.
- 7) The handrails rails to the balconies and roof terrace should be replaced.

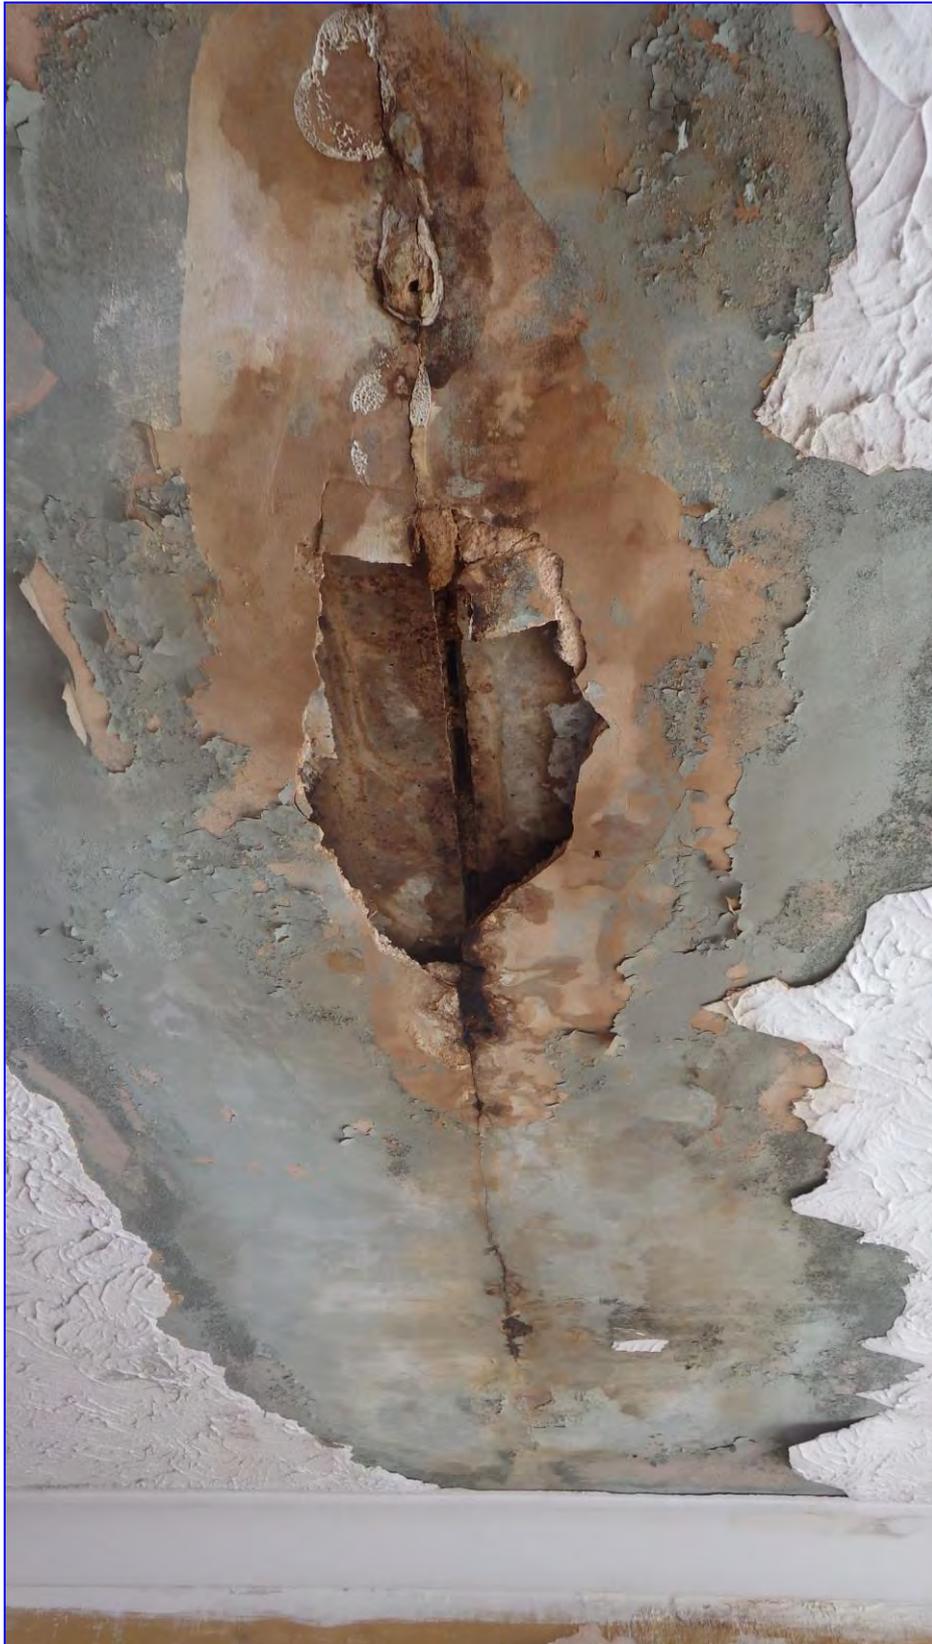
Internally water ingress was noted at the fourth floor from the flat roof above. It is assumed that this is due to the failure of the roof covering. The roof covering will need replacing during the proposed refurbishment works. In addition and although not part of our brief, consideration should be given to replacing and upgrading the insulation to the roof. It is suspect that although no spalling was noted, there is risk of corrosion to the reinforcement to precast concrete planks. Therefore further investigations and potentially remedial works will need to be carried out during the proposed refurbishment works/roof replacement.

Photograph 21: An example of leakage and associated deterioration seen in places internally. This photograph is at TA2, roof slab soffit, and where the plaster has fallen away a joint between precast planks is apparent.

- 3) The roof covering and associated insulation should be replaced during the proposed refurbishment works. The opportunity should be taken to inspect both the insitu concrete frame and precast concrete units for evidence of corrosion. Remedial works may be required.

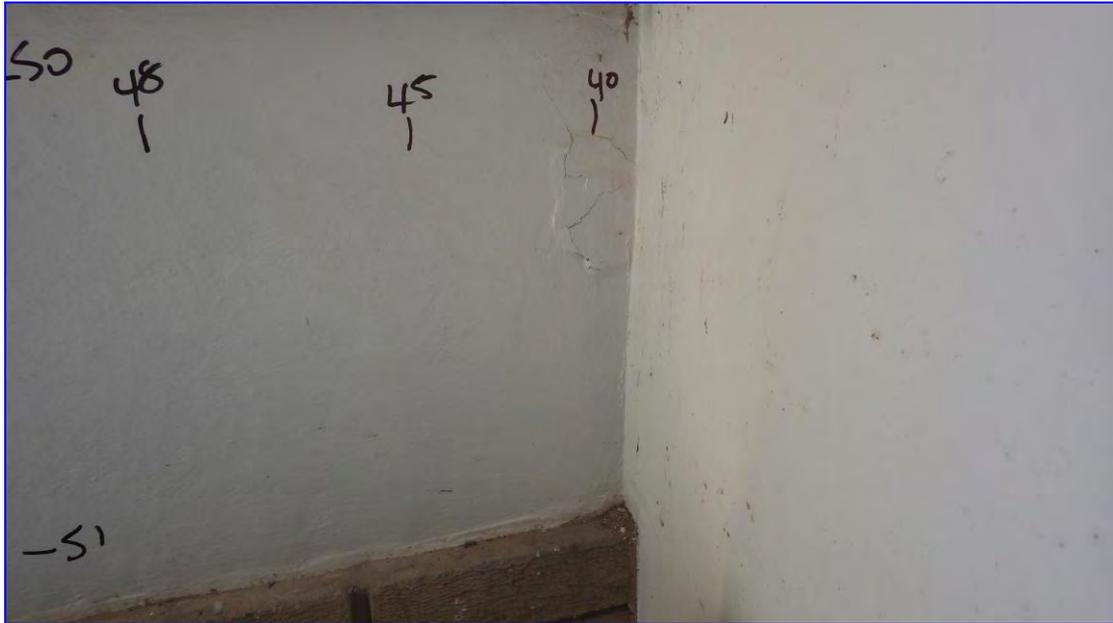
Photograph 22: A spall noted internally to a 3<sup>rd</sup> floor beam (on the east elevation) seen at a stair landing.

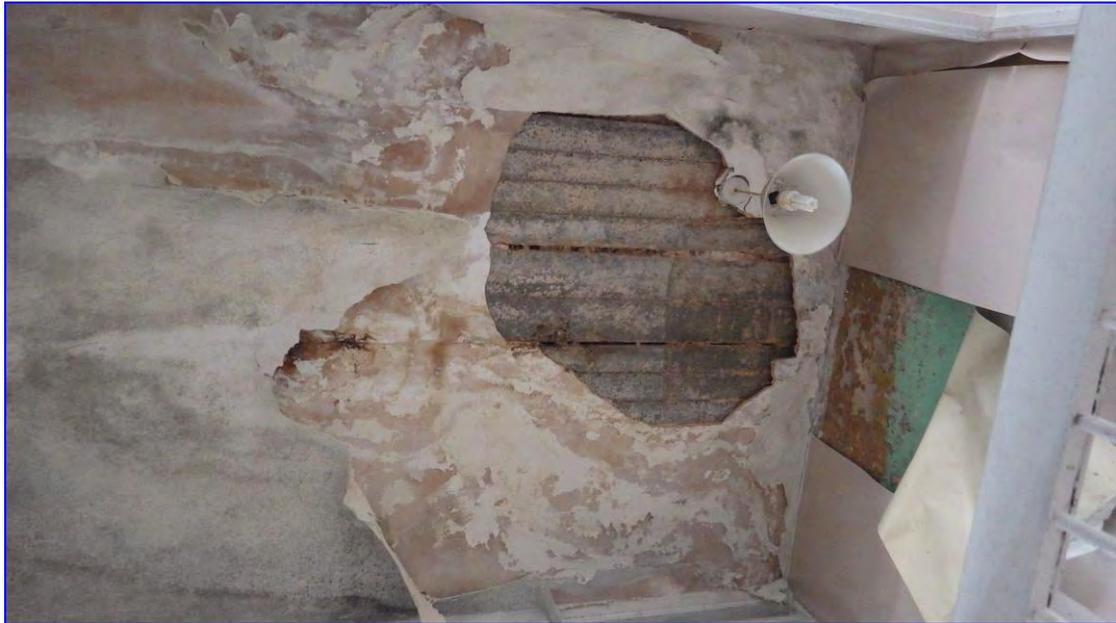
Photograph 24: Leakage damage noted in flat 12, roof slab soffit – not planks are visible as a result.

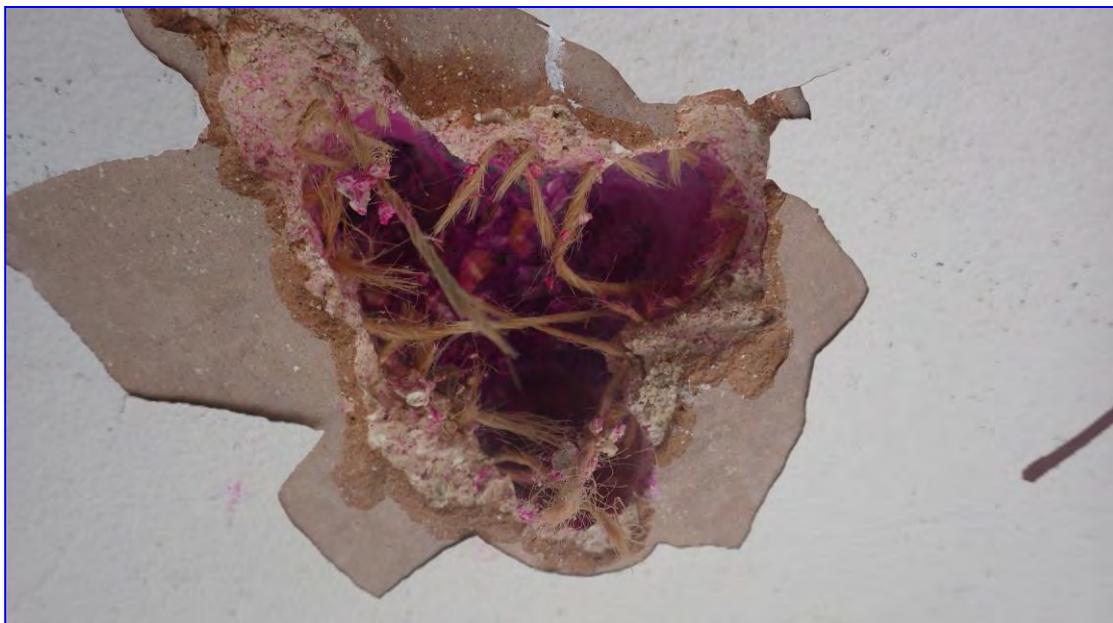
Photograph 26: The sample / carbonation test at TA1, 4<sup>th</sup> floor soffit, revealing a render reinforced with a string covering the concrete.

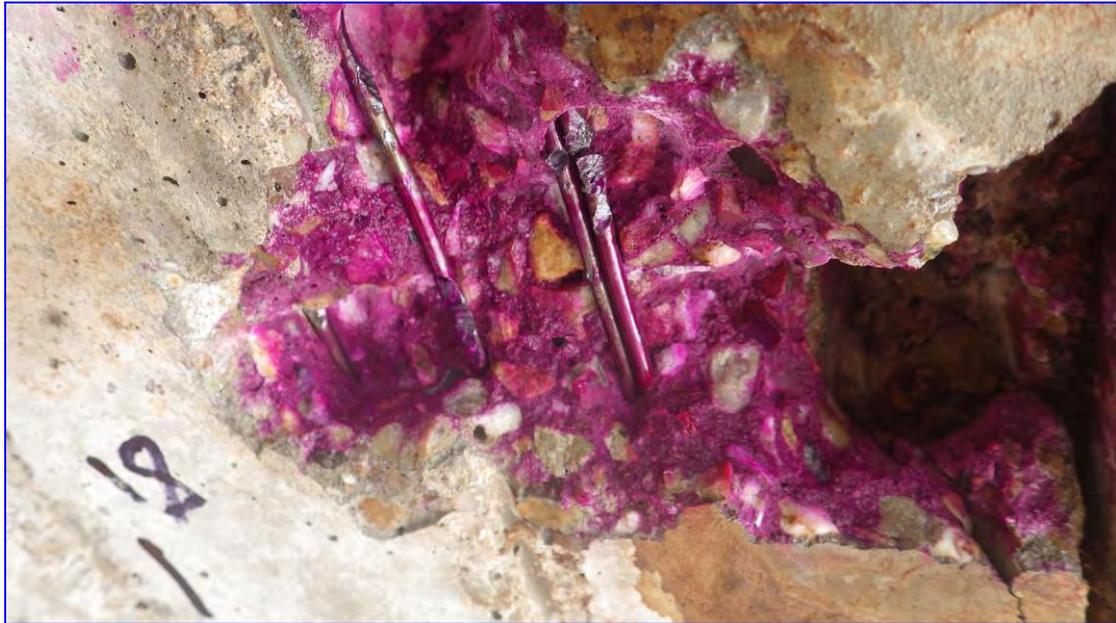
Photograph 27: The breakout at TA2, roof slab soffit, revealing wire/small bar diameter reinforcement in a precast plank (in good condition).

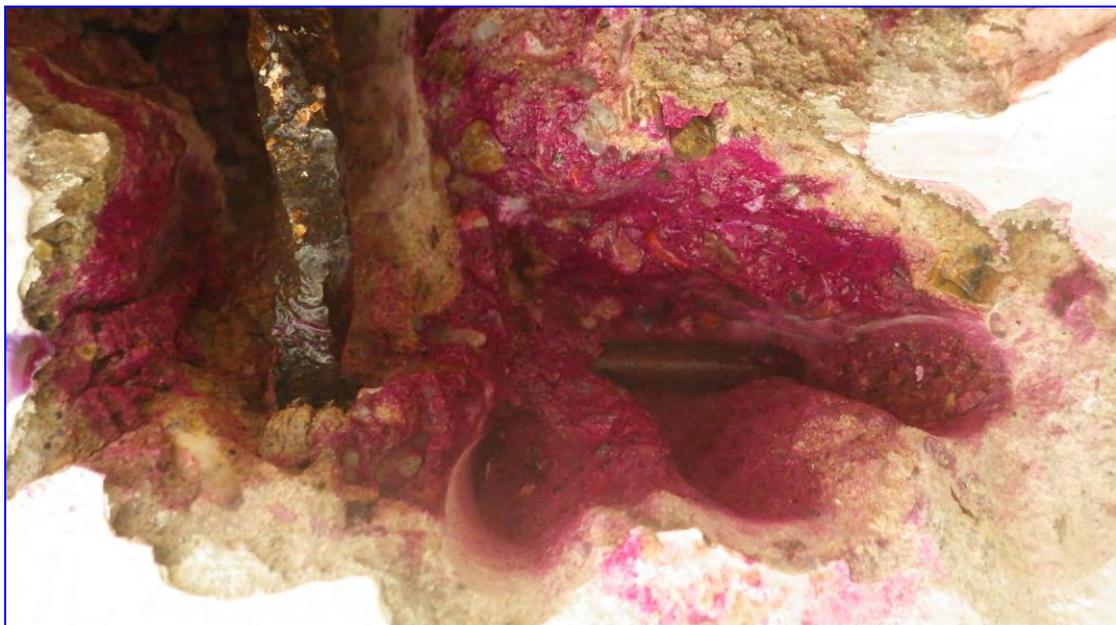
Photograph 28: The breakout at TA5, 3<sup>rd</sup> floor beam, revealing surface corrosion to a bar (vertical) in carbonated concrete, whilst the bar at deeper cover in alkaline concrete was clean and passive.

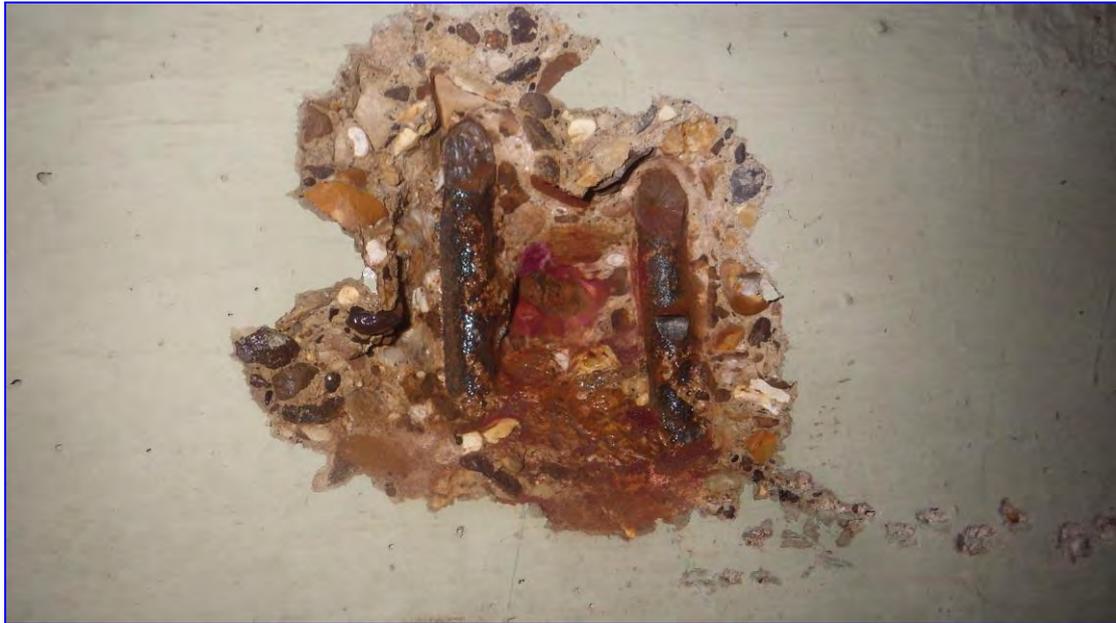
The cement content results varied widely. One sample (to a beam, location TA9) was very low. This is of concern and we would therefore recommend that further tests are carried out to assess whether this is local issue or a wide spread issue.

Photograph 29: The breakout at TA9, roof main beam, revealing bars with slight/surface corrosion in carbonated concrete.

- 1) For health and safety reasons further "safety surveys" and removal of all loose material be carried out on a regular basis.
- 2) Further cement tests are to be carried out to assess if there is an inherent weakness to the beam at test area TA9.

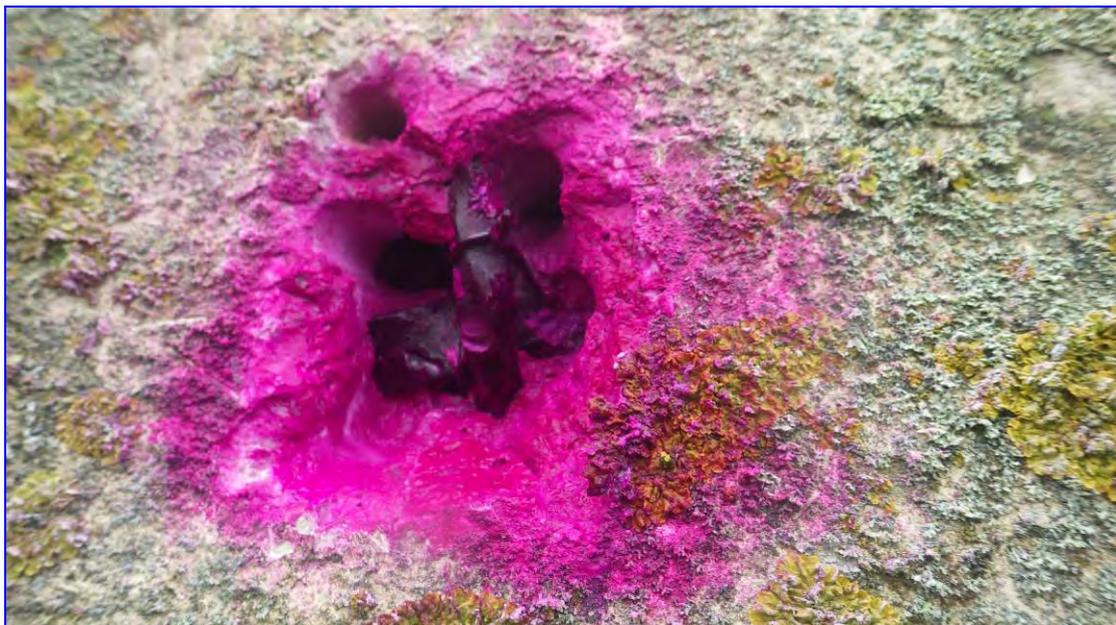
Photograph 30: The breakout at TA22, roof beam (external) revealing clean and passive reinforcement in alkaline concrete.

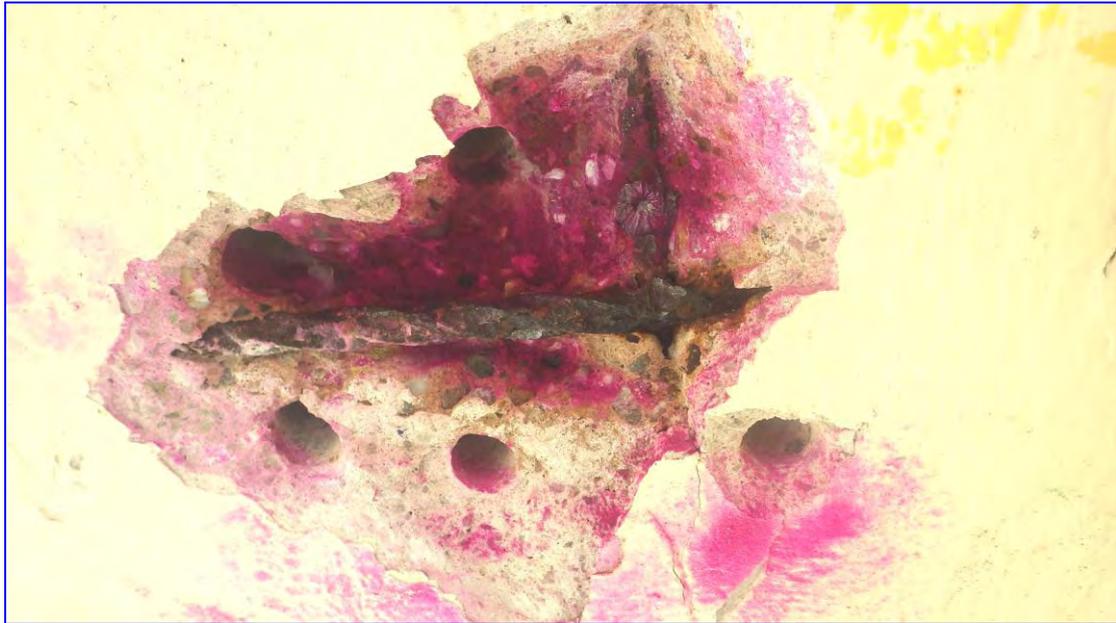
Photograph 31: The breakout at TA28, 2<sup>nd</sup> floor balcony soffit, revealing a bar at low cover in carbonated concrete with surface corrosion. The deeper bar was generally clean and passive.

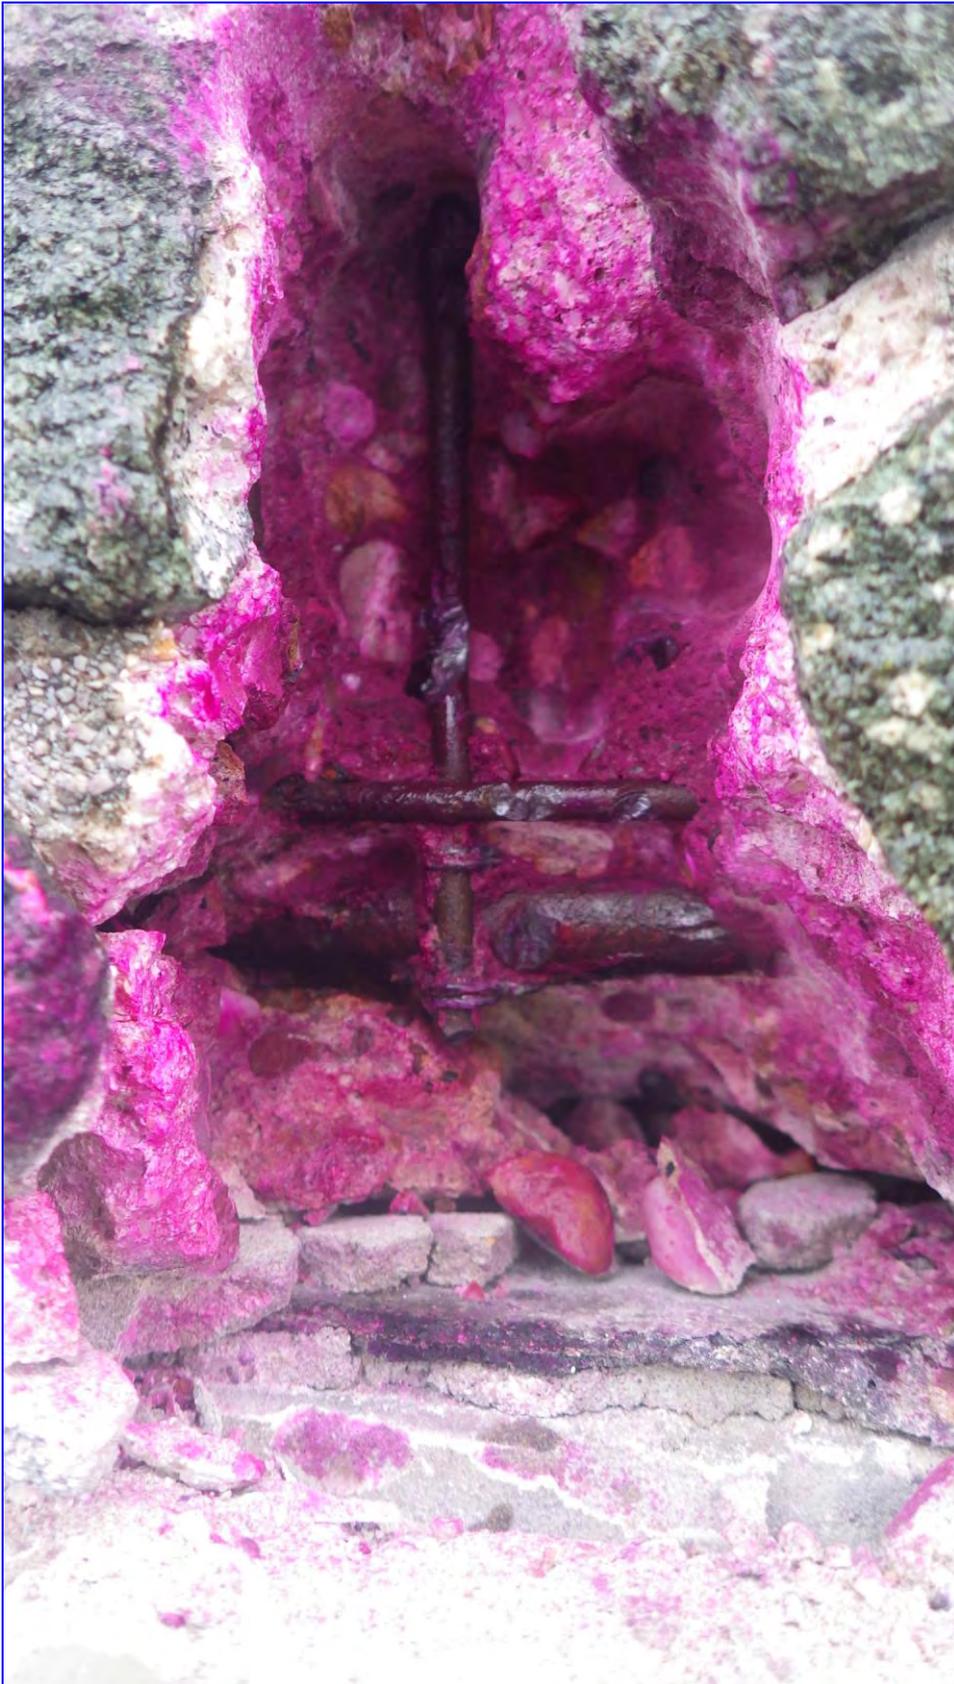
Photograph 32: The breakout at TA32, exposed aggregate panel, revealing clean and passive reinforcement in alkaline concrete.

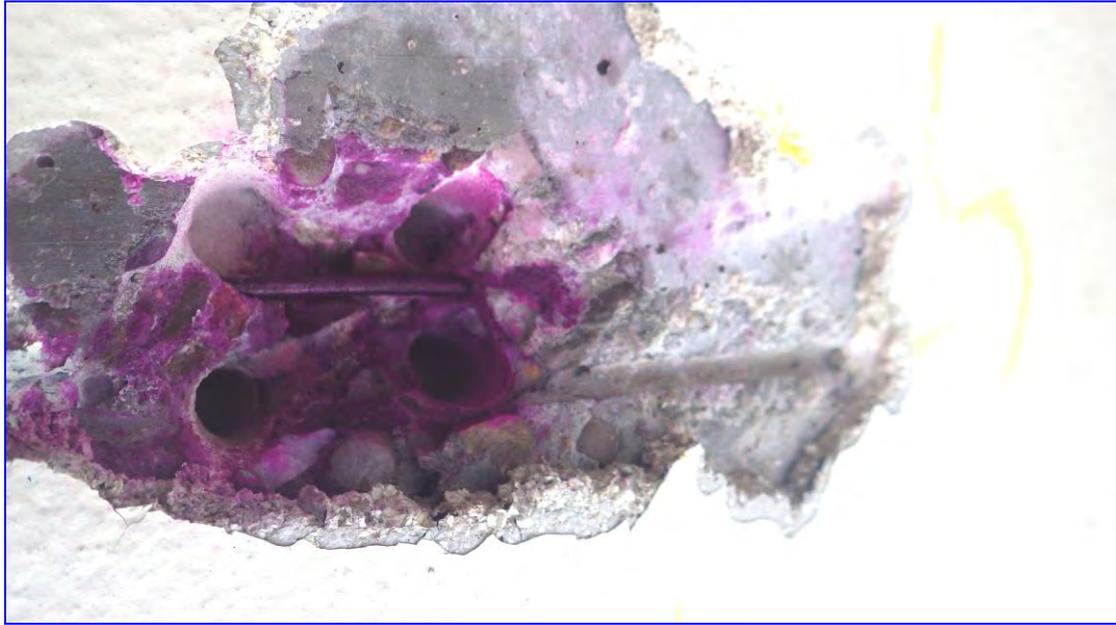
Photograph 33: The breakout at TA35, 2<sup>nd</sup> floor soffit (external) revealing another small diameter bar/wire (in a plank) in a clean and passive condition.

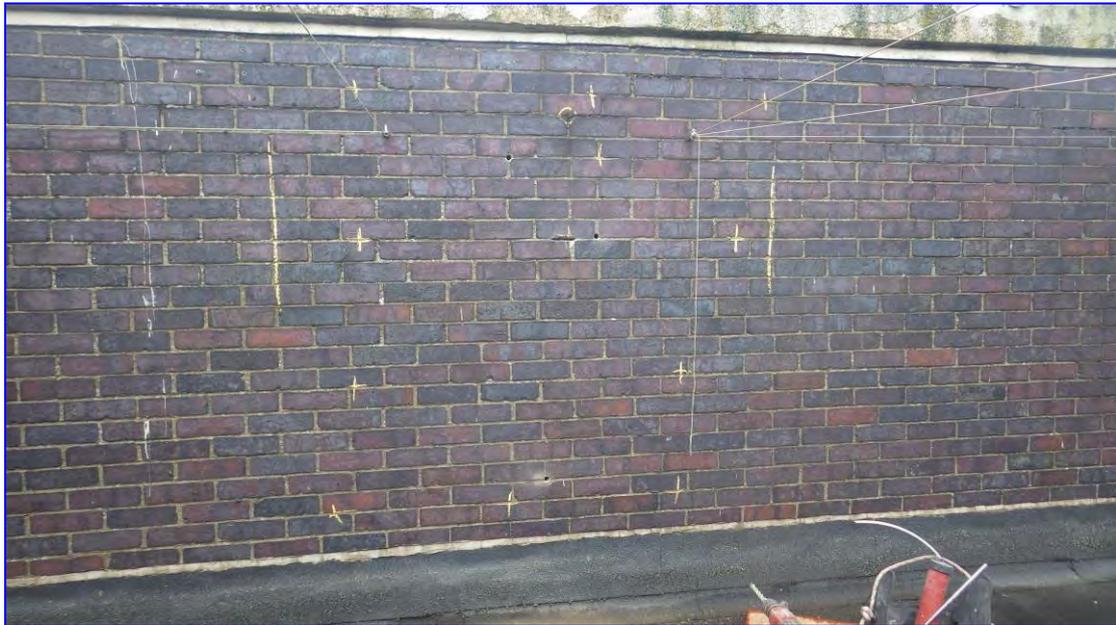
Testing to the roof level north gable end wall (at BWK 1) confirmed it to be a cavity wall with brick inner and outer leafs. The cavity was 75mm wide where inspected and there were mortar protrusions in the cavity but it was clear. The cavity tray was covered in mortar debris. The leafs are tied with flat twisted galvanised wall ties in a rough diamond pattern. The ties had some debris on them and no corrosion was seen.

Photograph 34: General view of the brickwork at BWK1 with wall tie locations marked in yellow chalk.
