**16-0159**

**A SUMMARY DOCUMENT OF INITIAL STRUCTURAL  
INVESTIGATIONS INTO INSITU CONCRETE FRAME TO  
UPPER FLOORS**

**NEVILLE HOUSE,  
GEORGE STREET  
CORBY NN17 1QD**

**CORBY BOROUGH COUNCIL**

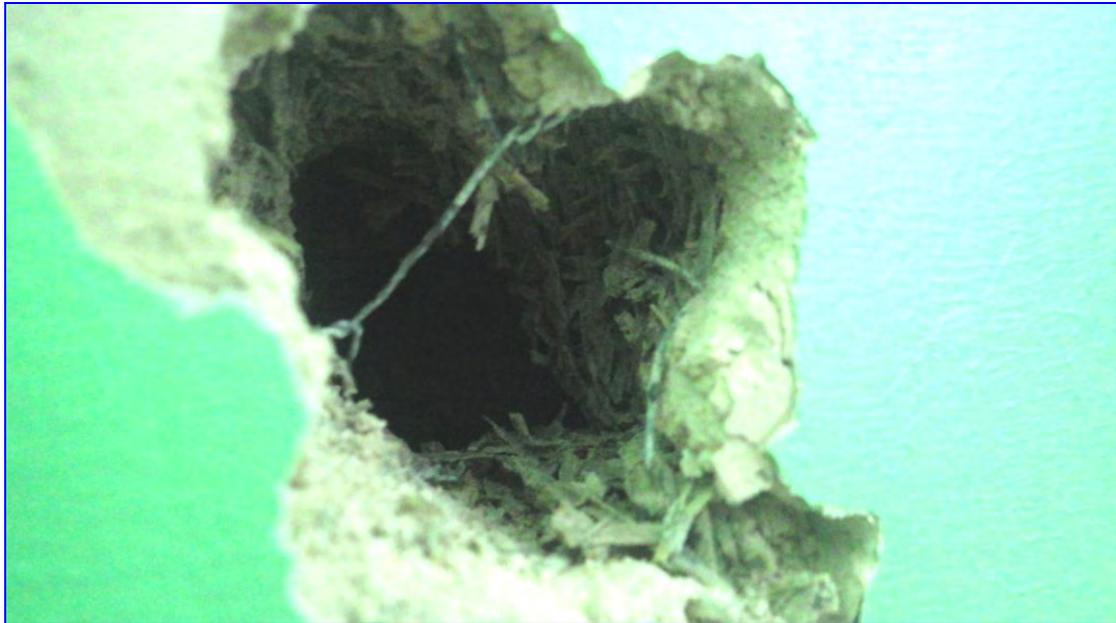
At BWK 3, 3<sup>rd</sup> floor west elevation, the wall was found to be an aggregate panel with a cavity behind (70mm wide) and an inner of woodwool which was internally plastered. Spalling concrete and bars at originally low cover were seen in the cavity to the rear of the aggregate panel.

Photograph 35: Hole made at BWK3 revealing woodwool inner, plastered over.

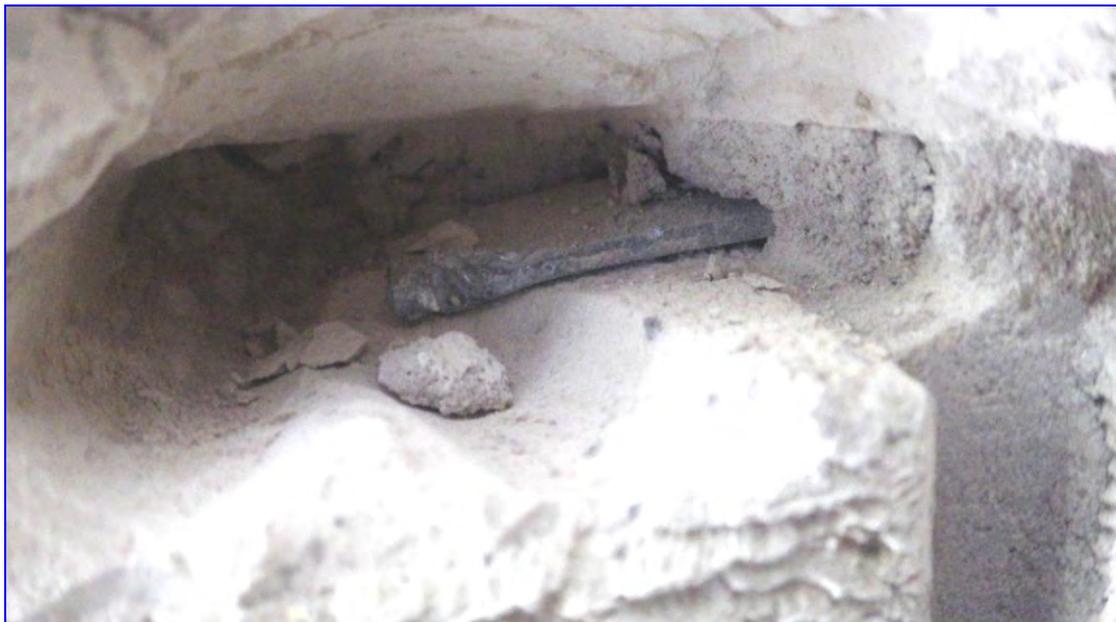
At BWK 4, 3<sup>rd</sup> floor, east elevation, the wall was found to be a cavity wall with brickwork inner and outer leafs. The wall had regular wall ties of the flat galvanised type. The cavity was some 60mm wide and had cavity wall insulation. The wall tie presence was confirmed by a small breakout internally.

Photograph 36: Breakout at BWK4 revealing clean flat end of a tie.

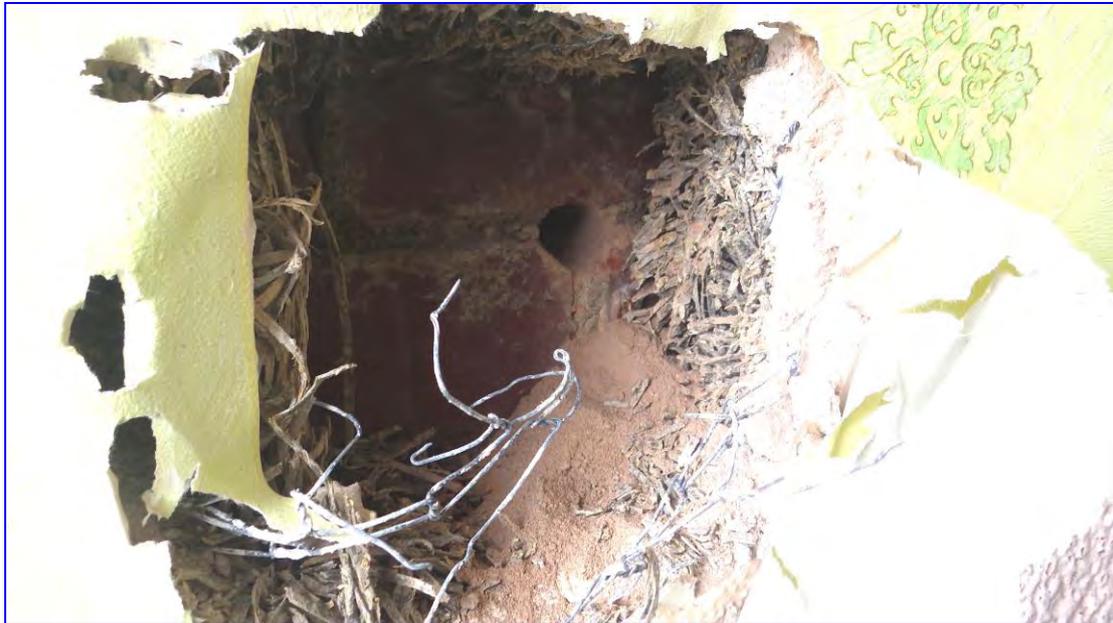
To the north gable at BWK 5, 3<sup>rd</sup> floor, the wall was confirmed as being of brickwork inner and outer leaves with a 75mm clear cavity and flat twisted ties (with no corrosion seen). On the inner (dwelling side) face the wall was covered with woodwool over which plaster was applied.

Photograph 37: Breakout at BWK5 from inside showing render over woodwool over brickwork.

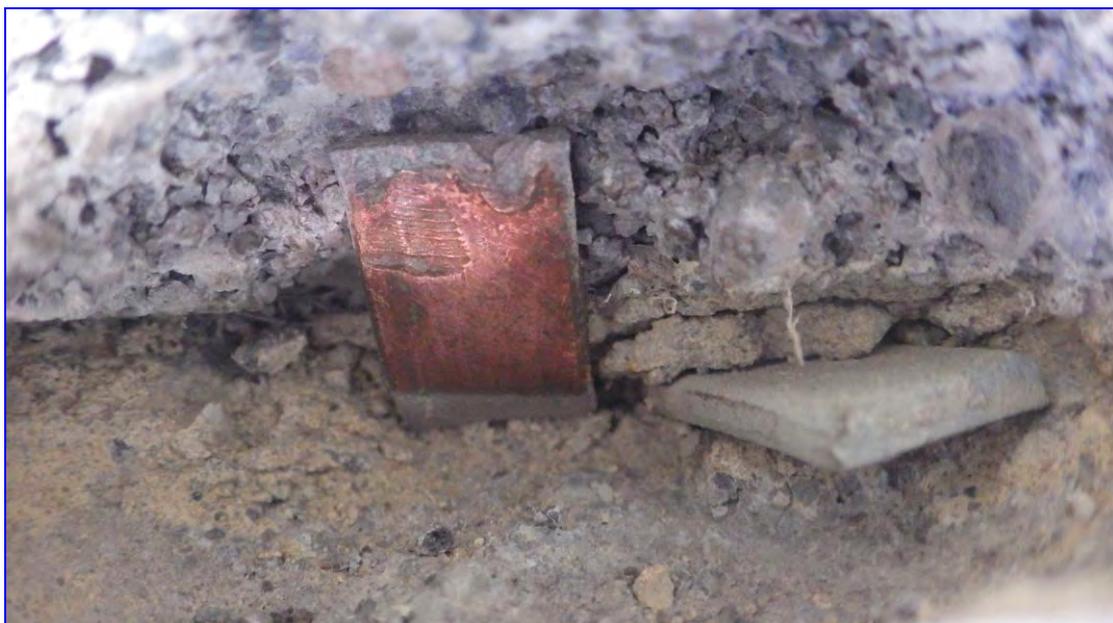
Testing at BWK9, 10 and 13 (2<sup>nd</sup>, 3<sup>rd</sup> and 4<sup>th</sup> floor) of the blocks on the west elevation – as per BWK 2 – found similar detailing to BWK 2.

Photograph 38: Breakout at BWK9 revealing end of phosphor bronze tie.

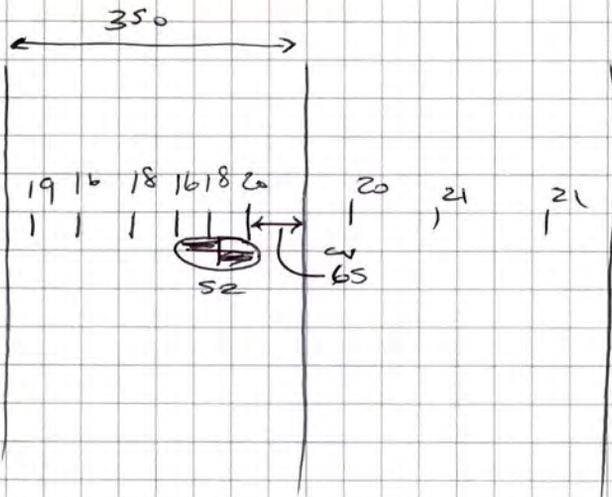
TA2. Roof Soffit

10mm render - failing at joint from leakage

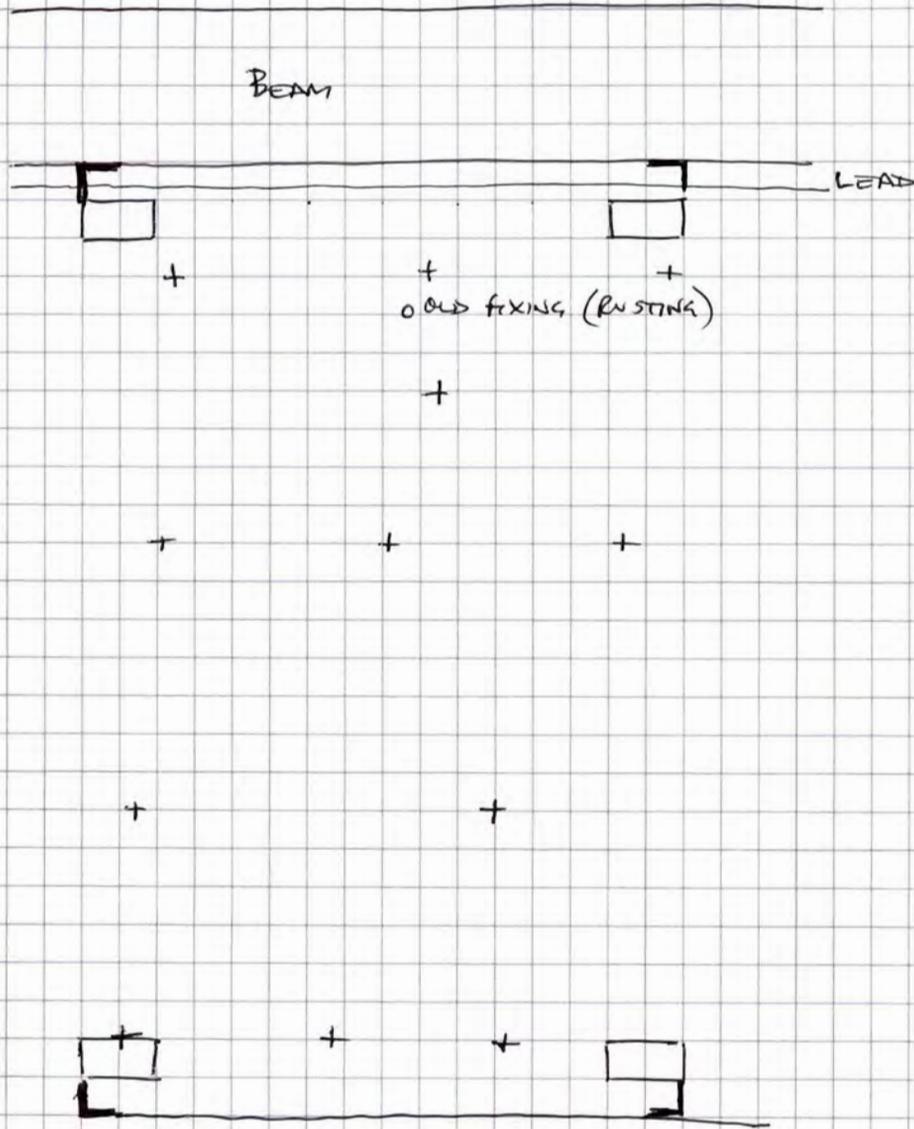
BWk 1. Roof PARAPET WALL (INT)

BRICKWORK INNER & OUTER. STRETCHER BOND.  
 MORTAR OK. SLIGHT MORTAR PROTRUSIONS.  
 CAVITY CLEAN, DEBRIS IN CAVITY TRAY  
 CAVITY 75MM WIDE  
 12<sup>Nº</sup> TIES SEEN FLAT TWIST  
 GALVANISED, N<sup>º</sup> CORROSION, SOME DEBRIS ON THEM.  
 EMBEDMENT GOOD.

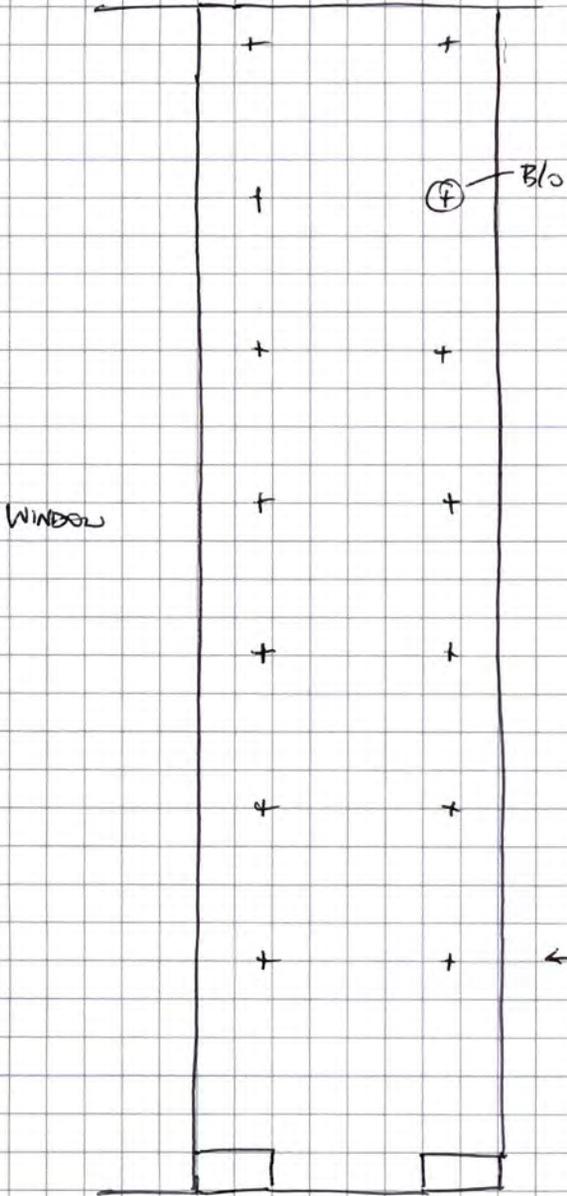
## BANK 4. 3<sup>RD</sup> floor BANK WALL (INT)

14<sup>Nº</sup> TIES DETECTED.

B/o FLAT GALVANISED TIE  
NO CORROSION.

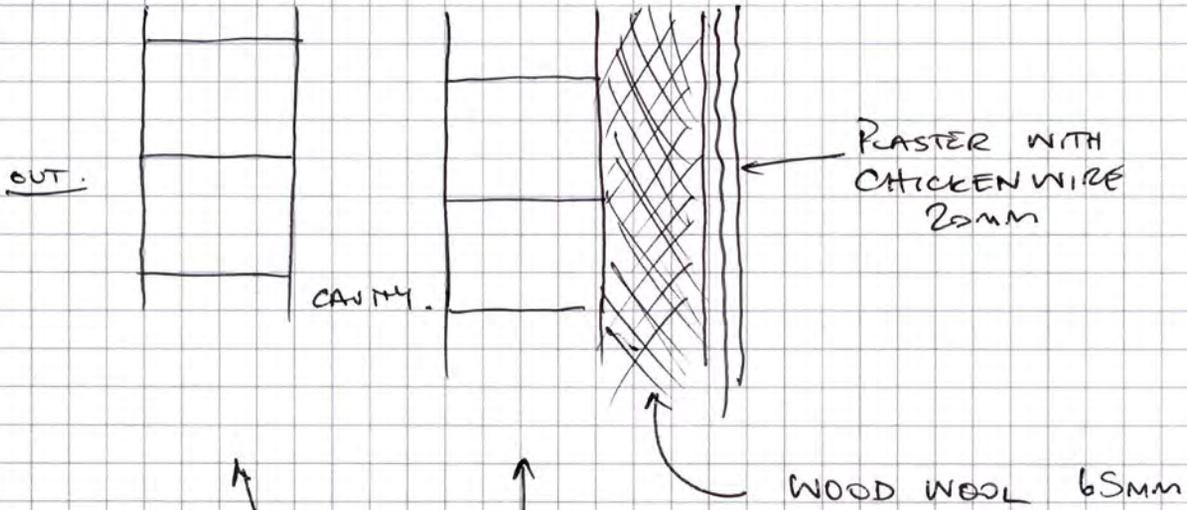
## BWK 5. 3RD floor WALL (INT)

BACKWORK INNER & OUTER.  
SLIGHT MORTAR PROTRUSIONS IN CAVITY.  
CAVITY CLEAN 75MM WIDE  
FLAT TWIST TIES SEEN - NO CORROSION  
CALANISED. SLIGHT DEBRIS ON THEM.

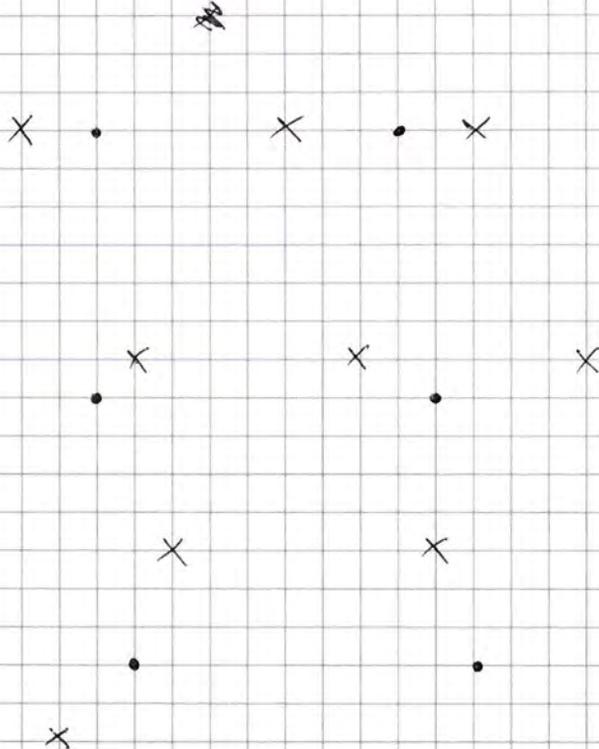
BWK 6.

- AREA SURVEYED FROM INNER SIDE (ROOF)
- SLICE OUTER, SLICE INNER
- 9 NO GIMS FLAT TIGHT TIES
- EMBEDMENT OK, NO CORROSION
- SOME MARGINAL SNOTS ON TIES
- SS IN CAVITY, SMALL AMOUNT OF MATERIAL PROTRUSION
- SOME DEBRIS COVERING CAVITY TRAY

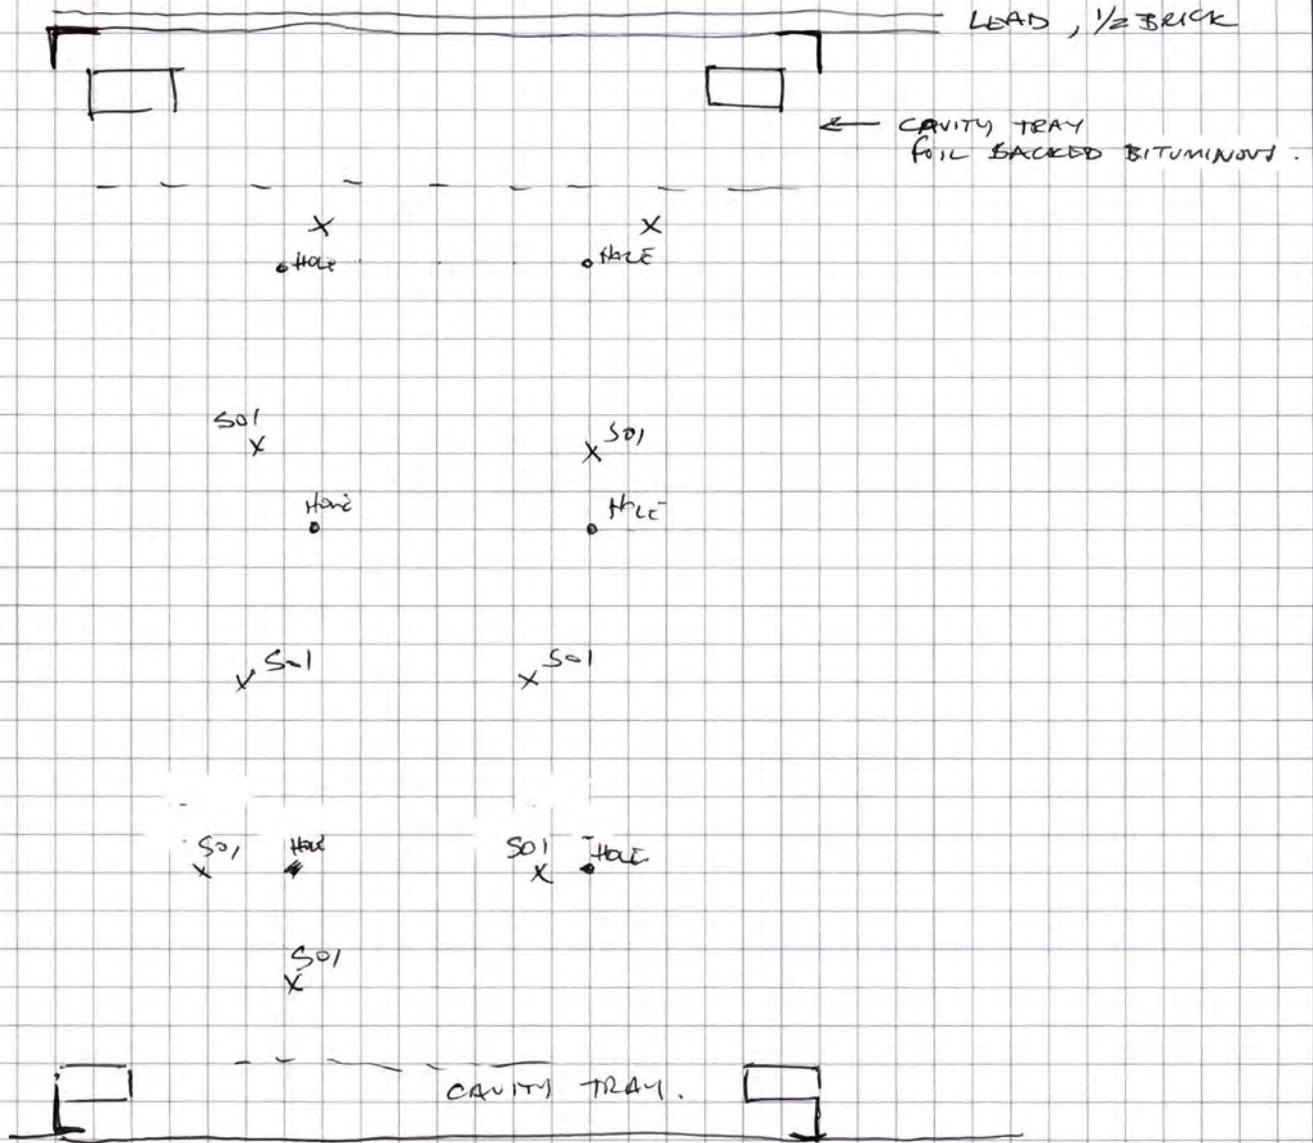
BWK 7 4th floor wall

BRICKWORK INNER  
 BRICKWORK OUTER  
 STRETCHED BOND  
 53mm CAVITY

9 NR GSM TIES FLAT TWIST  
 NO CORROSION SOME MORTAR DEBRIS  
 POOR EMBELEMNT SCEN TO INTERNAL LEAF  
 DEBRIS IN CAVITY

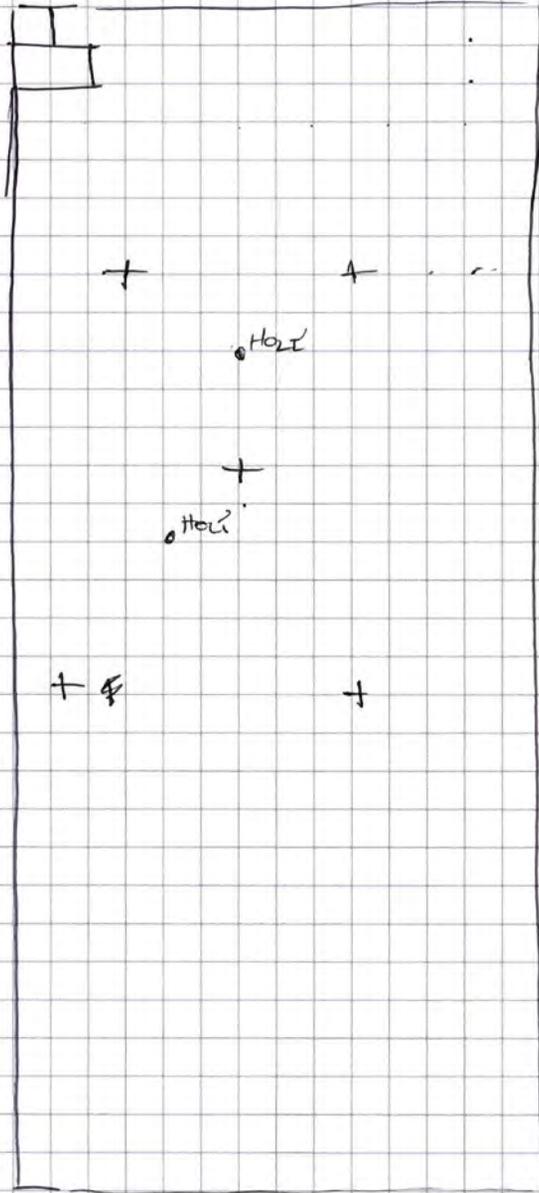
BWK 10 4th floor wall (INT)

BLOCK OUTER  
BRICKWORK INNER OR.

5/2 PHOSPHOR BRASS TIES.  
NO CORROSION, SLIGHT  
MORTAR PROTRUSIONS
