Client: Corby Borough Council
10 Fleming Road,
Earlstrees Industrial Estate,
Corby,
Northamptonshire,
NN17 4SW

Report Reference: SY/13/05/081

Report on Survey of Asbestos Materials at

Grosvenor House
Corby
Northamptonshire

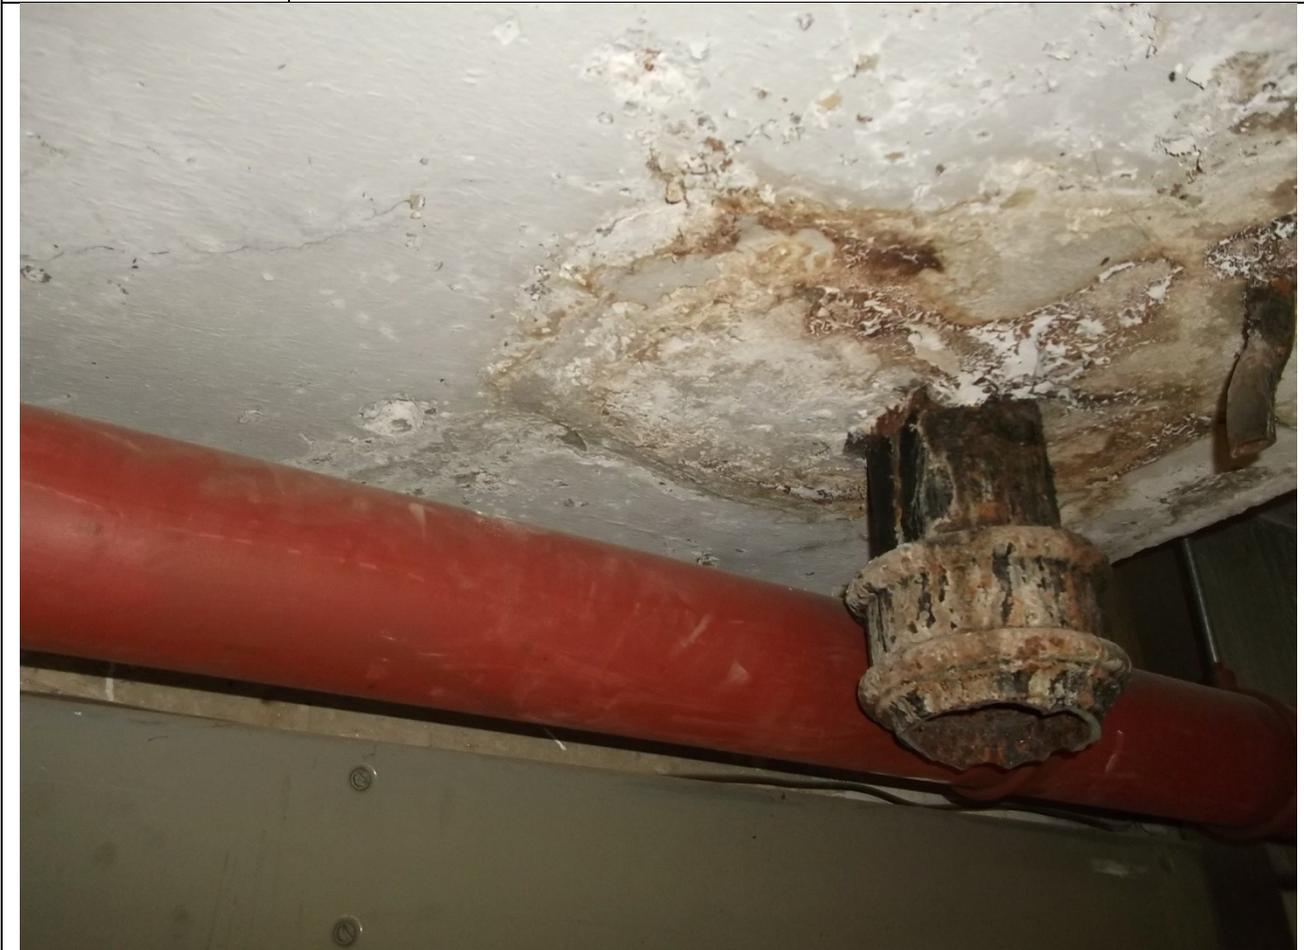
Photo 2 –	B.08 - Store
Sample Location –	Insulation residue to concrete –13/4/B/19/DS15
Analysis Result –	Amosite Chrysotile

Location	B.08 Store, B.09 Corridor, B.10 Boiler room
Items and Content	Insulation residues and debris to walls, concrete and pipe penetrations, containing Amosite and Chrysotile
Recommendation	<p>These materials are in poor condition and unsealed, with significant damage apparent. These materials should be completely removed at the earlier opportunity. Any works on this material should only be undertaken by a licensed asbestos removal contractor working under the guidance of a safe working procedure and in accordance with the requirements of The Control of Asbestos Regulations, 2012 and Schedule 3 of The Hazardous Waste Regulations 2005 (amended 2009).</p> <p>14 Days Notification must be given to The Health and Safety Executive prior to any works being carried out to these materials.</p>

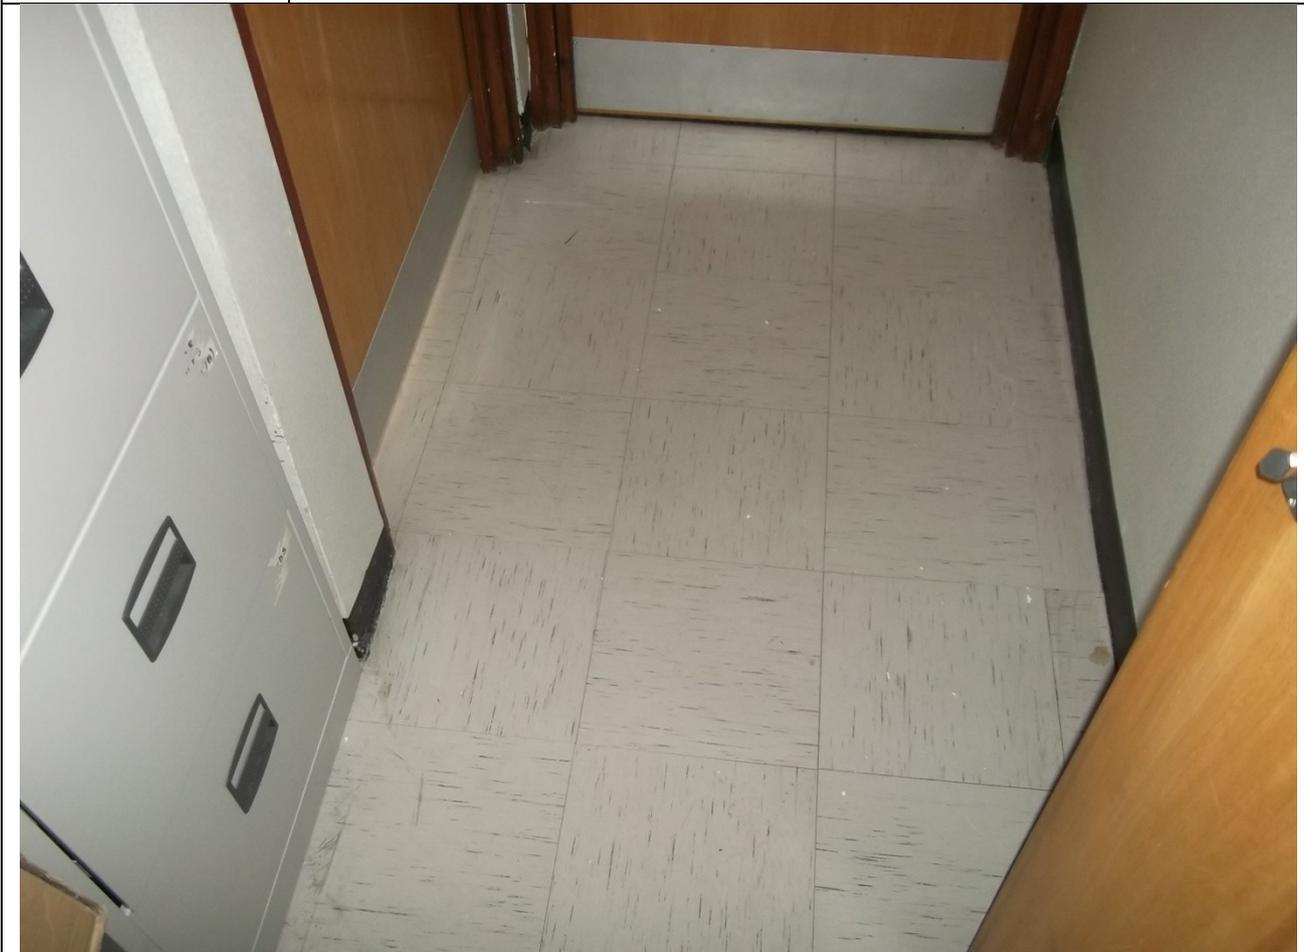
Photo 12 –	4.06 Lobby
Sample Location –	Vinyl floor tiles with bitumen adhesive (asbestos present within bitumen layer) – 13/4/B/10/CW10
Analysis Result –	Chrysotile

Location	Rear stairwell, 4.06 Lobby, 5.08 Lobby, 6.05 kitchenette
Items and Content	Bitumen adhesive beneath vinyl floor tiles and vinyl stair nosings, containing Chrysotile
Recommendation	<p>These materials should be labelled to indicate their asbestos content and regularly re-inspected to ensure their good condition is maintained. If these materials are considered likely to be disturbed by any future works they should be completely removed prior to any such disturbance. Any works on these materials should only be carried out by suitably trained and equipped personnel, working under the guidance of a safe working procedure and in accordance with the requirements of The Control of Asbestos at Work Regulations 2012 and Schedule 3 of The Hazardous Waste Regulations 2005 (amended 2009).</p>
