**Campbell Park Parish Council**

**Former Springfield Public House  
Springfield Boulevard  
Milton Keynes  
MK6 3JS**

**Asbestos Survey Report Following a Refurbishment Survey in  
Accordance with HSG264**

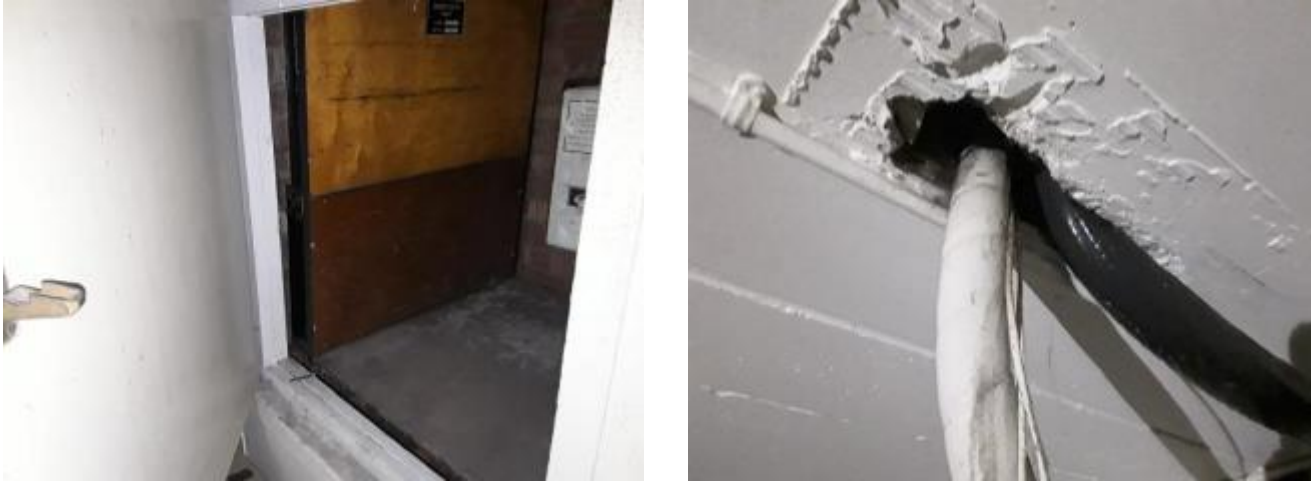
Survey ID	2	Sample No.	N/A
Floor	Basement	Area	Floor, Walls and Ceiling
Room	B.01	Item	General View

Action	N/A	Priority	N/A	Notifiable	N/A	Licensable	N/A
<b>Comments/Recommendations</b>  General Observations – Dumb Waiter with Timber Carriage, Service Penetrations Through The Concrete Ceiling

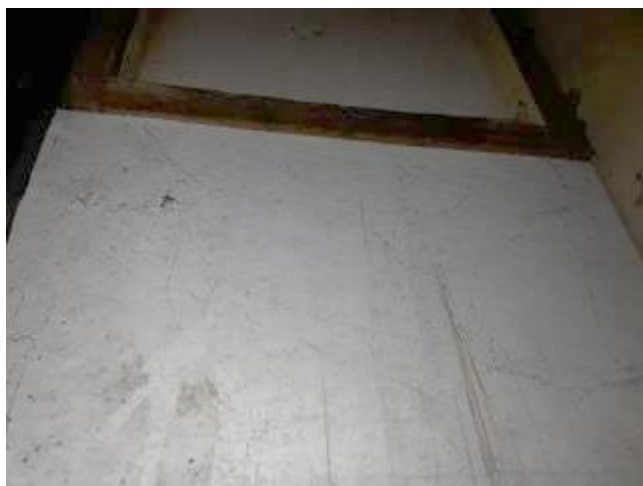
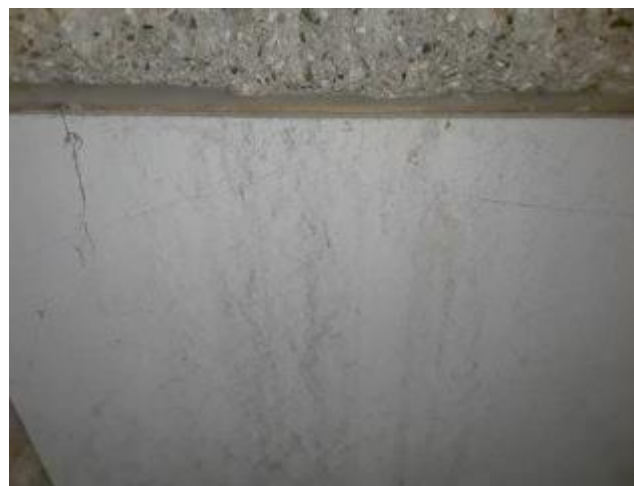
Survey ID	3	Sample No.	S002
Floor	Basement	Area	Walls
Room	B.01	Item	Lining to Dumb Waiter Shaft

Material Assessment		Score			Score
Material	Insulating Board	2	Surface Treatment	Unsealed AIB or encapsulated lagging and sprays	2
Extent of Damage	Low Damage	1	Asbestos Type	Amosite	2
Identification	SAMPLED		Material Assessment Total	Medium	7
				Quantity	3 m <sup>2</sup>

Comments/Recommendations
TO BE REMOVED BY A LICENSED CONTRACTOR AND DISPOSED OF AS HAZARDOUS WASTE, ALL IN ACCORDANCE WITH CURRENT ASBESTOS LEGISLATION/REGULATIONS

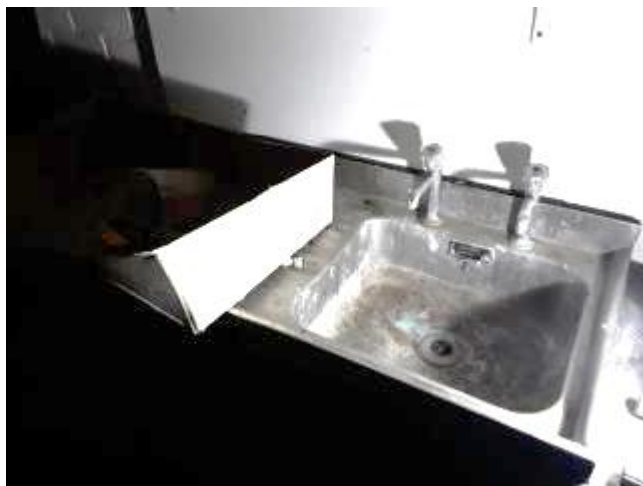
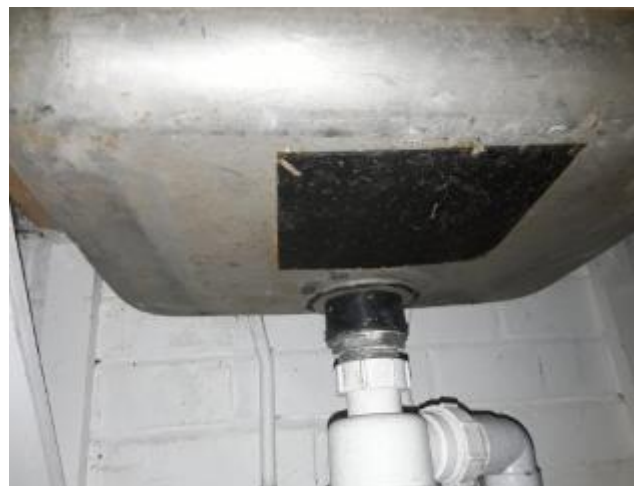
<b>Survey ID</b>	9	<b>Sample No.</b>	S004
<b>Floor</b>	Basement	<b>Area</b>	Sink
<b>Room</b>	B.03	<b>Item</b>	Sink Pad

<u>Material Assessment</u>		Score			Score
Material	N/A	N/A	Surface Treatment	N/A	N/A
Extent of Damage	N/A	N/A	Asbestos Type	None Detected	N/A
Identification	SAMPLED		Material Assessment Total	N/A	N/A
				Quantity	N/A

<b>Action</b>	N/A	<b>Priority</b>	N/A	<b>Notifiable</b>	N/A	<b>Licensable</b>	N/A
<b>Comments/Recommendations</b>							
NO FURTHER ACTION REQUIRED

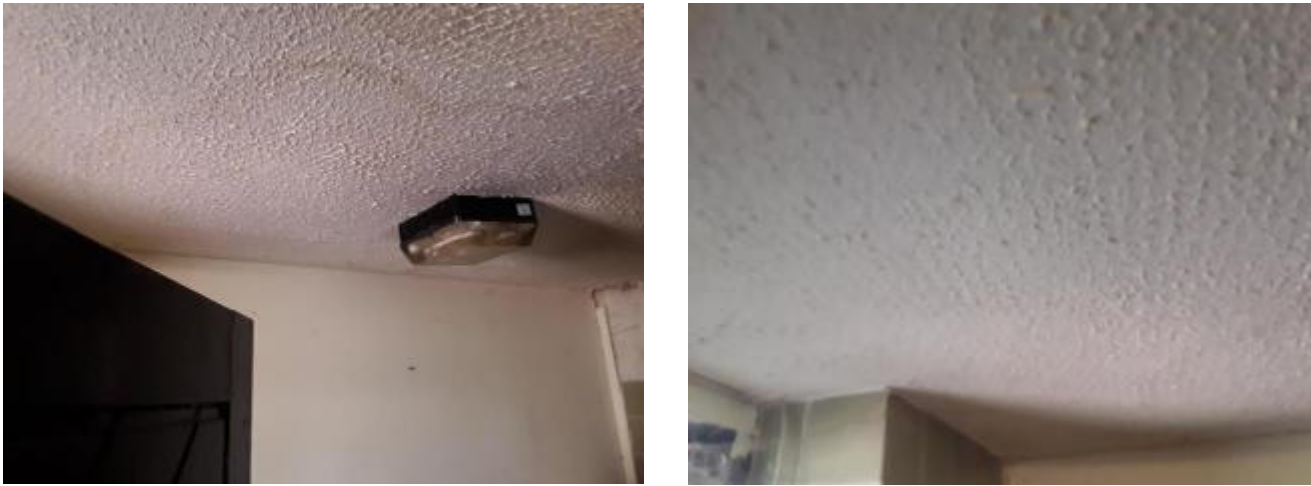
<b>Survey ID</b>	13	<b>Sample No.</b>	As S005
<b>Floor</b>	Ground Floor	<b>Area</b>	Ceiling
<b>Room</b>	G.02	<b>Item</b>	Textured Coating

<u>Material Assessment</u>		Score			Score
Material	Textured Coating	1	Surface Treatment	Composite materials containing asbestos	0
Extent of Damage	Low Damage	1	Asbestos Type	Chrysotile	1
Identification	STRONGLY PRESUMED		Material Assessment Total	Very Low	3
				Quantity	3 m²

<b>Action</b>	Remove	<b>Priority</b>	As soon as possible	<b>Notifiable</b>	No	<b>Licensable</b>	No
<b>Comments/Recommendations</b>							
TO BE REMOVED BY A COMPETENT CONTRACTOR AND DISPOSED OF AS HAZARDOUS WASTE, ALL IN ACCORDANCE WITH CURRENT ASBESTOS LEGISLATION/REGULATIONS

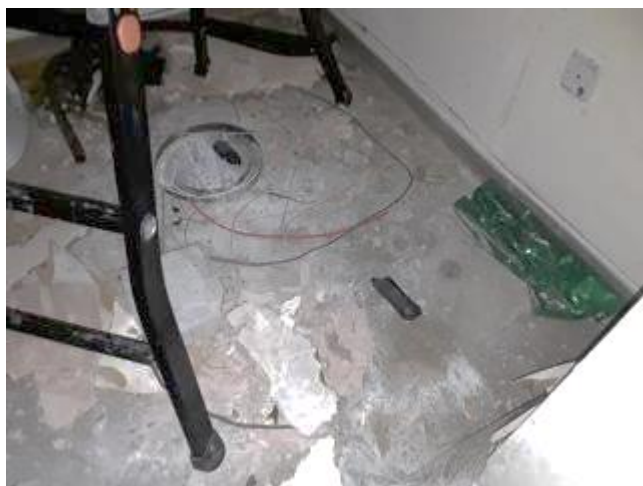
<b>Survey ID</b>	16	<b>Sample No.</b>	As S005
<b>Floor</b>	Ground Floor	<b>Area</b>	Floor
<b>Room</b>	G.03	<b>Item</b>	Textured Coating Debris

<u>Material Assessment</u>		Score			Score
Material	Textured Coating	1	Surface Treatment	Composite materials containing asbestos	0
Extent of Damage	High Damage	3	Asbestos Type	Chrysotile	1
Identification	STRONGLY PRESUMED		Material Assessment Total	Low	5
				Quantity	5 m²

<b>Comments/Recommendations</b>
TO BE REMOVED BY A COMPETENT CONTRACTOR AND DISPOSED OF AS HAZARDOUS WASTE, ALL IN ACCORDANCE WITH CURRENT ASBESTOS LEGISLATION/REGULATIONS
