# Mechanical Services Report

Public Toilet Block – Warminster Road, Westbury, BA13 3PE

Prepared for: Information and Refurbishment Recommendations

Date: Tuesday 30<sup>th</sup> September 2025

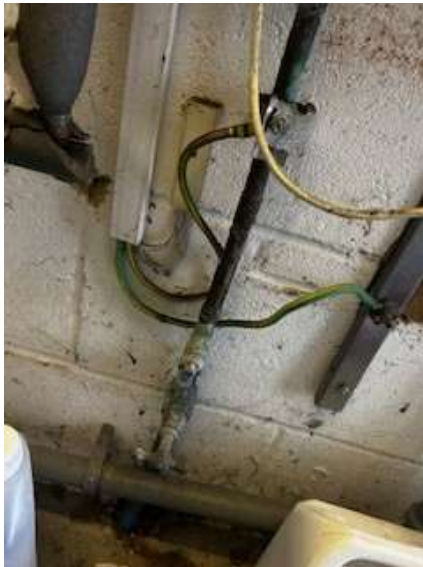
Ref 1.

Incoming 20mm MDPE mains supply observed. No double check valve (DCV) or backflow prevention device(s) installed. This presents a compliance issue under the Water Supply (Water Fittings) Regulations 1999.

[Photo(s) Ref. 1 Incoming mains pipework]

Recommendation: Install appropriate DCV.

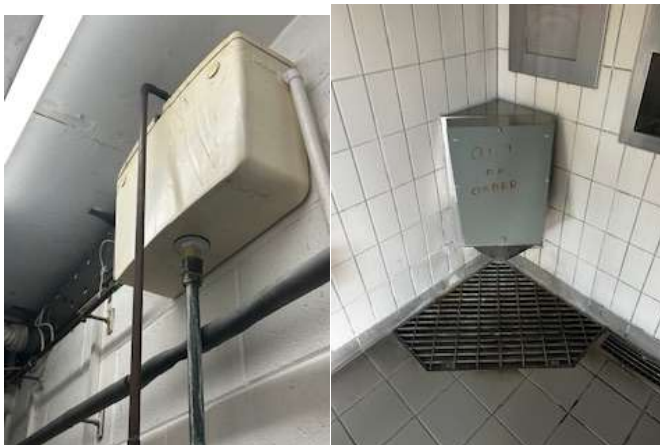
Ref 2.

The Urinal is fed from a high-level cistern located within the service corridor although this appears to be isolated, and the urinal has been covered with sheet metal preventing use. Recommendation: Replace all necessary ancillaries, including flush pipes, waste connections, and sensor controls, to restore full functionality. Consider upgrading to water-efficient sensor-operated flushing systems to improve hygiene and reduce water consumption.

[Photo(s) Ref. 2 Urinal]

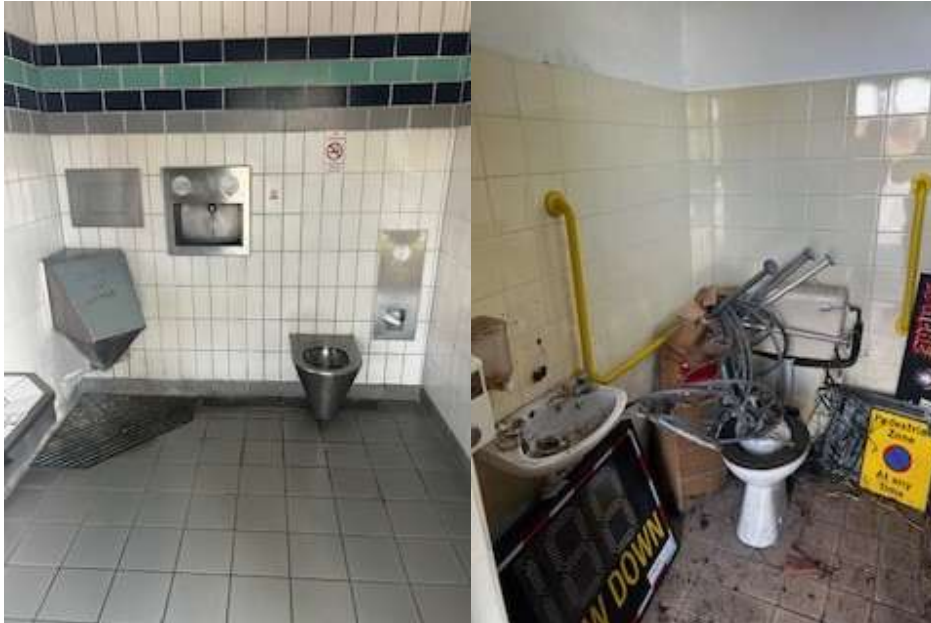
Ref 3.

All sanitaryware and fittings show significant signs of age. Retrofit repairs and mismatched fittings are evident. Microwave sensor flush controls and automatic taps are outdated. The DDA-compliant WC located on the right-hand side of the south elevation has been disconnected from all services, although the sanitaryware remains in place. The fixtures are in poor condition and are considered outdated. Additionally, all redundant pipework has been left in situ within the storeroom adjacent to the DDA WC. The intended use of this DDA facility is unclear, as it does not appear to have been intended for public use, given the presence of vitreous China.

[Photo(s) Ref. 3 Sanitaryware]

Recommendation: Replace all sanitaryware and sensor controls. Seek advice for intended use.

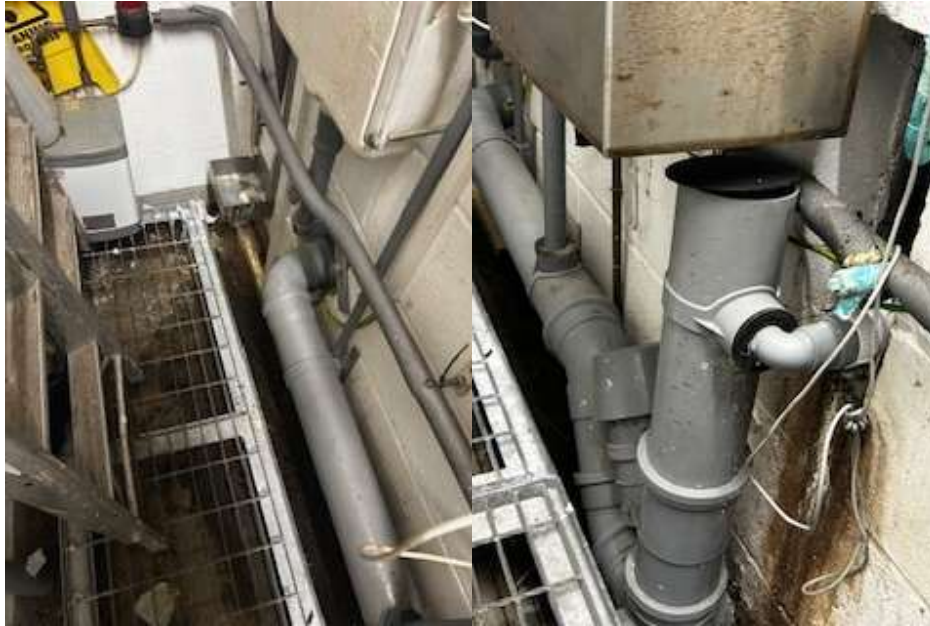
Ref 4.

Waste pipework lacks access points and has retrofit repairs/modifications. There is no provision currently installed for venting the system i.e. roof outlet/ AAV (Automatic Air Admittance Valve). An AAV appears to have been used previously, however this has been removed leaving the space susceptible to foul odours.

[Photo Ref. 4 – Waste pipework]

Recommendation: Replace with proper rodding access install AAV or Vent Stack to atmosphere.

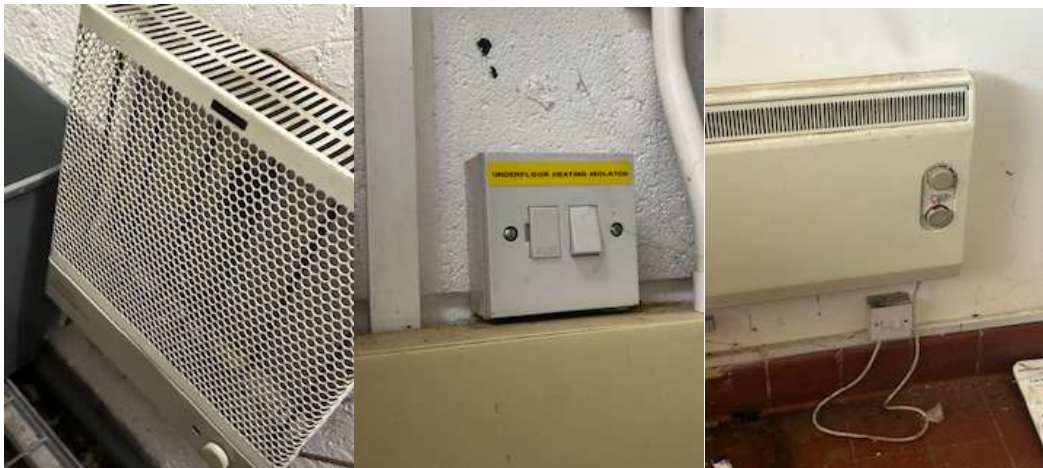
Ref 5.

Electric underfloor heating and wall mounted heaters present but dated.

[Photo(s) Ref. 5 Heating]

Recommendation: Replace controls and heaters.

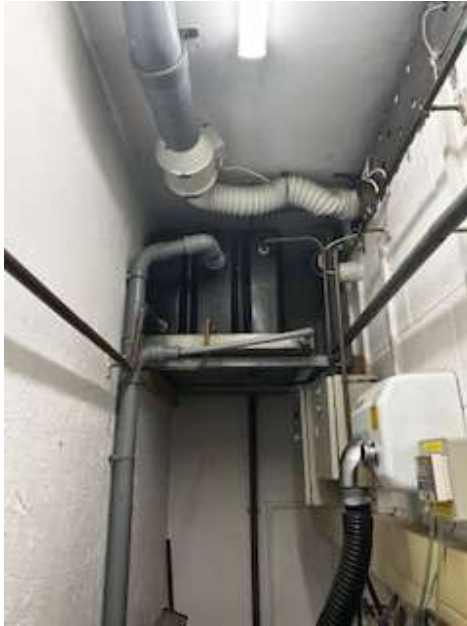
Ref 6.

Fans and ductwork are dated and installed with excess flex.

[Photo(s) Ref. 6 – Ventilation]

Recommendation: Replace with efficient inline fans with rigid ducting

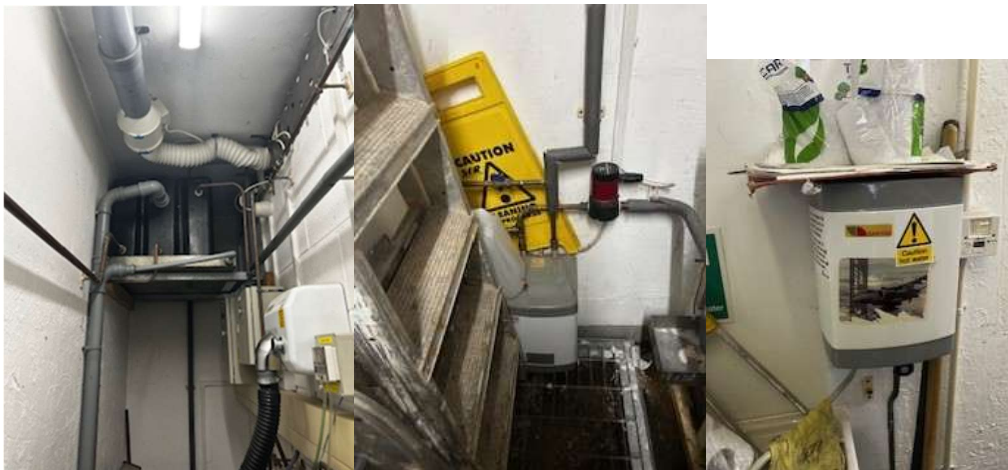
Ref 7.

The mains cold water runs along the corridor and rises to high level where it serves a cold-water storage cistern. From here, cold water is distributed down to serve the WC cisterns. A 10-litre electric water heater is located beneath the cold-water storage tank, also fed from the cold water down service, and provides hot water to the hand wash facilities in each restroom. A hot water recirculating pump is present; this appears to be a newly installed pump.

[Photo(s) Ref. 7 Cold water cistern and heater]

Recommendation: Replace the cold-water storage cistern and water heater with a modern, efficient mains-fed hot water solution. Options include point-of-use instantaneous heaters for each restroom or a centralised storage water heater with recirculation pump.

Installation of Thermostatic control of hot water to each hand wash unit to prevent accidental scalding.

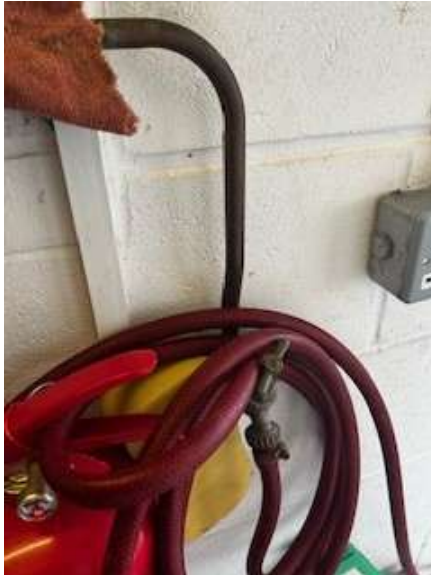
Ref 8.

Mains cold water also serves the cleaner's sink within the service corridor. A 6-litre point-of-use over-sink water heater provides hot water. A bib tap with hose is also present. Whilst not in use, the hose should be disconnected to prevent backflow contamination.

[Photo(s) Ref. 8 Cleaner's sink and bib tap]

Recommendation: Provide dedicated hose storage and consider installing a Cat 5 mini booster set depending on intended use. Replacement cleaners sink and new hot water plant.

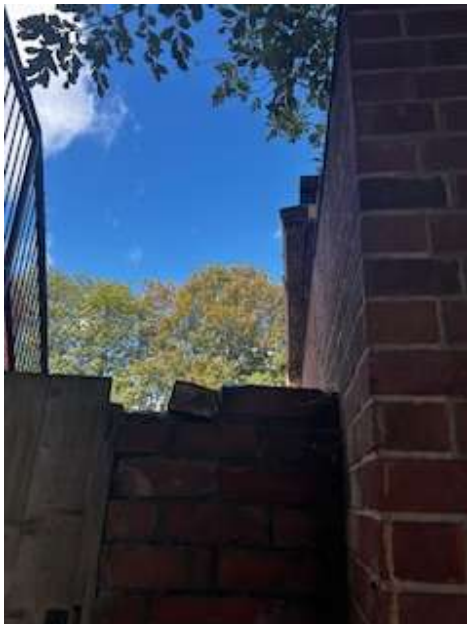
Ref 9.

Rainwater goods are installed on the North elevation. Guttering appears to be of metal construction and shows signs of corrosion and paint finish is blistered along the entire length.

[Photo Ref. 9 Guttering]

Recommendation: Replace guttering and downpipes.

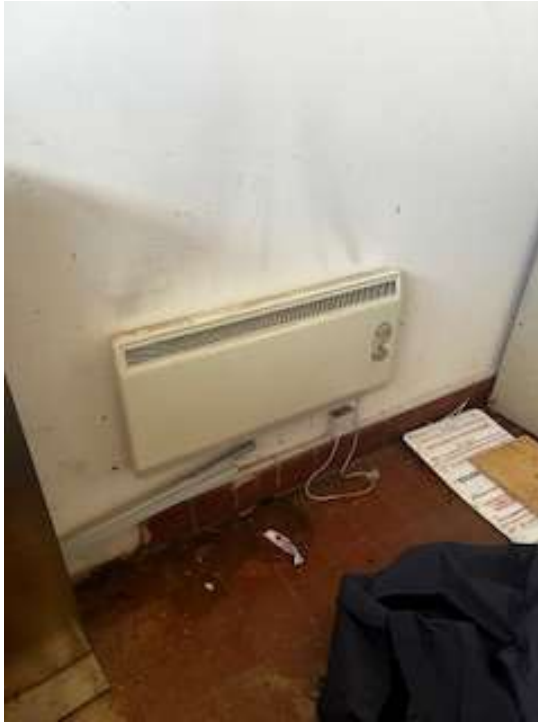
The storeroom located on the south elevation of the building contains an electric wall heater with an integrated thermostat, which is also showing signs of age and wear.

Recommendation: Replace wall mounted heater with modern alternative. [Photo(s) Ref 10. Electric Radiator]
