Asbestos Management Survey

Committee of Management
Pamber Heath Memorial Hall
Pamber Heath Road
Pamber Heath
Tadley
Hampshire
RG26 3TQ

Report Number: **J019534**

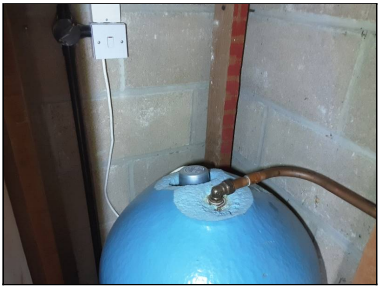
Survey Date:	Lead Surveyor	Survey Type	Floor	Analysis
	22 Jun 2021	Craig Excell	Management Survey	Ground Floor	Chrysotile (1)
	Building	Room	Item	Quantity	
	Pamper Heath Memorial Hall, Pamper Heath Road, Pamper Heath, Tadley	Electrical Room G01	Gasket to cylinder - unable to sample without causing significant damage Cylinder	1no.	
	Sample No (S,SP,P,As)	Product Type	Surface Treatment	Condition	Accessibility
	Visual (P)	Asbestos Textiles/Paper (2)	Surface Sealed (1)	Low Damage (1)	Usually inaccessible or unlikely to be disturbed (0)

Normal Occupancy	Score	Likelihood of disturbance	Score	Exposure Potential	Score	Maintenance Activity	Score
Main type of activity	1	Location	2	Number of occupants	0	Type of Maintenance	0
		Accessibility	0	Frequency of use	0	Frequency of maintenance	0
		Amount	0	Average Time	0		
Average Score	1	Average Score	1	Average Score	0	Average Score	0
Average of Priority	2						
Material Assessment Score	5						
Recommendation	D - No Attention Required, Label

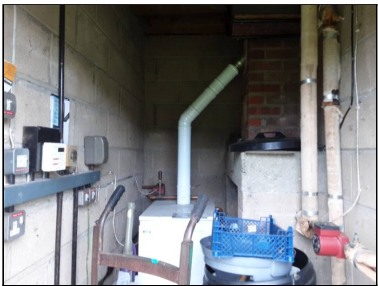
Survey Date:	Lead Surveyor	Survey Type	Floor	Analysis
	22 Jun 2021	Craig Excell	Management Survey	Ground Floor	N/A
	Building	Room	Item	Quantity	
	Pamper Heath Memorial Hall, Pamper Heath Road, Pamper Heath, Tadley	Boiler Room G02	No suspect materials found	N/A	N/A
	Sample No (S,SP,P,As)	Product Type	Surface Treatment	Condition	Accessibility
	Visual (P)	N/A	N/A	N/A	N/A

Normal Occupancy	Score	Likelihood of disturbance	Score	Exposure Potential	Score	Maintenance Activity	Score
Main type of activity	N/A	Location	N/A	Number of occupants	N/A	Type of Maintenance	N/A
		Accessibility	N/A	Frequency of use	N/A	Frequency of maintenance	N/A
		Amount	N/A	Average Time	N/A		
Average Score	N/A	Average Score	N/A	Average Score	N/A	Average Score	N/A
Average of Priority	N/A						
Material Assessment Score	N/A						
Recommendation	No further action required

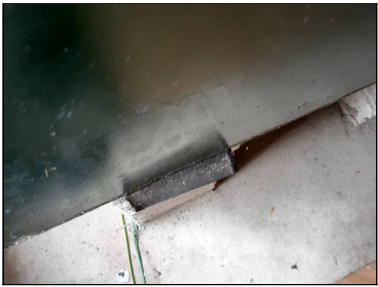
Survey Date:	Lead Surveyor	Survey Type	Floor	Analysis
	22 Jun 2021	Craig Excell	Management Survey	Ground Floor	No Asbestos Detected
	Building	Room	Item	Quantity	
	Pamper Heath Memorial Hall, Pamper Heath Road, Pamper Heath, Tadley	Oil Tank Room G03	Packer below tank Tank	Small amounts	
	Sample No (S,SP,P,As)	Product Type	Surface Treatment	Condition	Accessibility
	CE000497 (S)	N/A	N/A	N/A	N/A

Normal Occupancy	Score	Likelihood of disturbance	Score	Exposure Potential	Score	Maintenance Activity	Score
Main type of activity	N/A	Location	N/A	Number of occupants	N/A	Type of Maintenance	N/A
		Accessibility	N/A	Frequency of use	N/A	Frequency of maintenance	N/A
		Amount	N/A	Average Time	N/A		
Average Score	N/A	Average Score	N/A	Average Score	N/A	Average Score	N/A
Average of Priority	N/A						
Material Assessment Score	N/A						
Recommendation	No further action required

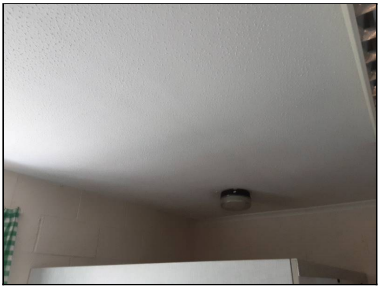
Survey Date:	Lead Surveyor	Survey Type	Floor	Analysis
	22 Jun 2021	Craig Excell	Management Survey	Ground Floor	Chrysotile (1)
	Building	Room	Item	Quantity	
	Pamper Heath Memorial Hall, Pamper Heath Road, Pamper Heath, Tadley	Female W.C. G04	Textured coating to ceiling Ceiling	8-10m ²	
	Sample No (S,SP,P,As)	Product Type	Surface Treatment	Condition	Accessibility
	CE000498 (S)	Textured Coating (1)	Surface Sealed (1)	Low Damage (1)	Occasionally likely to be disturbed (1)

Normal Occupancy	Score	Likelihood of disturbance	Score	Exposure Potential	Score	Maintenance Activity	Score
Main type of activity	1	Location	2	Number of occupants	1	Type of Maintenance	0
		Accessibility	1	Frequency of use	3	Frequency of maintenance	0
Average Score		Amount	1	Average Time	0	Average Score	
	1	Average Score	2	Average Score	2		0
Average of Priority	5						
Material Assessment Score	4						
Recommendation	D - No Attention Required, Label

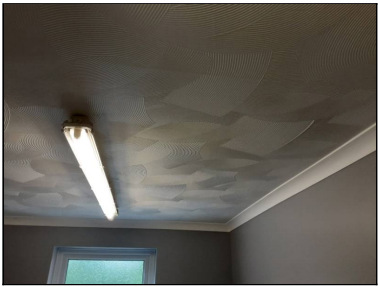
Survey Date:	Lead Surveyor	Survey Type	Floor	Analysis
	22 Jun 2021	Craig Excell	Management Survey	Ground Floor	Chrysotile (1)
	Building	Room	Item	Quantity	
	Pamper Heath Memorial Hall, Pamper Heath Road, Pamper Heath, Tadley	Kitchen G05	Textured coating to ceiling Ceiling	12-14m ²	
	Sample No (S,SP,P,As)	Product Type	Surface Treatment	Condition	Accessibility
	CE000499 (S)	Textured Coating (1)	Surface Sealed (1)	Low Damage (1)	Occasionally likely to be disturbed (1)

Normal Occupancy	Score	Likelihood of disturbance	Score	Exposure Potential	Score	Maintenance Activity	Score
Main type of activity	1	Location	2	Number of occupants	1	Type of Maintenance	0
		Accessibility	1	Frequency of use	3	Frequency of maintenance	0
Average Score		Amount	1	Average Time	1		
	1	Average Score	2	Average Score	2		Average Score
Average of Priority	5						
Material Assessment Score	4						
Recommendation	D - No Attention Required, Label

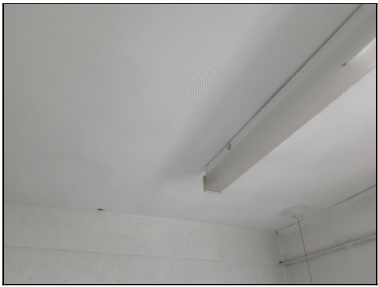
Survey Date:	Lead Surveyor	Survey Type	Floor	Analysis
	22 Jun 2021	Craig Excell	Management Survey	Ground Floor	Chrysotile (1)
	Building	Room	Item	Quantity	
	Pamper Heath Memorial Hall, Pamper Heath Road, Pamper Heath, Tadley	Disabled W.C. G06	Textured coating to ceiling Ceiling	4-6m ²	
	Sample No (S,SP,P,As)	Product Type	Surface Treatment	Condition	Accessibility
	As CE000499 (SP)	Textured Coating (1)	Surface Sealed (1)	Low Damage (1)	Occasionally likely to be disturbed (1)

Normal Occupancy	Score	Likelihood of disturbance	Score	Exposure Potential	Score	Maintenance Activity	Score
Main type of activity	1	Location	2	Number of occupants	1	Type of Maintenance	0
		Accessibility	1	Frequency of use	3	Frequency of maintenance	0
Average Score		Amount	1	Average Time	0		
	1	Average Score	2	Average Score	2		Average Score
Average of Priority	5						
Material Assessment Score	4						
Recommendation	D - No Attention Required, Label

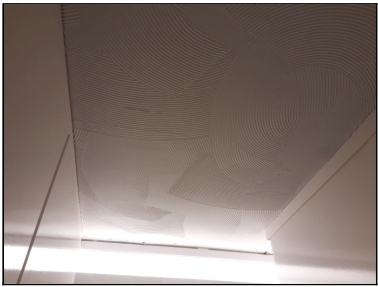
Survey Date:	Lead Surveyor	Survey Type	Floor	Analysis
	22 Jun 2021	Craig Excell	Management Survey	Ground Floor	Chrysotile (1)
	Building	Room	Item	Quantity	
	Pamper Heath Memorial Hall, Pamper Heath Road, Pamper Heath, Tadley	Store G07	Textured coating to ceiling Ceiling	4-6m ²	
	Sample No (S,SP,P,As)	Product Type	Surface Treatment	Condition	Accessibility
	As CE000499 (SP)	Textured Coating (1)	Surface Sealed (1)	Low Damage (1)	Occasionally likely to be disturbed (1)

Normal Occupancy	Score	Likelihood of disturbance	Score	Exposure Potential	Score	Maintenance Activity	Score
Main type of activity	1	Location	2	Number of occupants	1	Type of Maintenance	0
		Accessibility	1	Frequency of use	3	Frequency of maintenance	0
Average Score		Amount	1	Average Time	0		
	1	Average Score	2	Average Score	2		Average Score
Average of Priority	5						
Material Assessment Score	4						
Recommendation	D - No Attention Required, Label

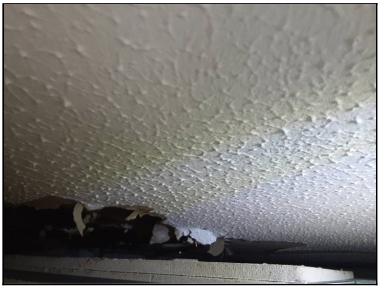
Survey Date:	Lead Surveyor	Survey Type	Floor	Analysis
	22 Jun 2021	Craig Excell	Management Survey	Ground Floor	Chrysotile (1)
	Building	Room	Item	Quantity	
	Pamper Heath Memorial Hall, Pamper Heath Road, Pamper Heath, Tadley	Male W.C. G08	Textured coating to ceiling Ceiling	12-14m ²	
	Sample No (S,SP,P,As)	Product Type	Surface Treatment	Condition	Accessibility
	As CE000498 (SP)	Textured Coating (1)	Surface Sealed (1)	Low Damage (1)	Occasionally likely to be disturbed (1)

Normal Occupancy	Score	Likelihood of disturbance	Score	Exposure Potential	Score	Maintenance Activity	Score
Main type of activity	1	Location	2	Number of occupants	1	Type of Maintenance	0
		Accessibility	1	Frequency of use	3	Frequency of maintenance	0
Average Score		Amount	1	Average Time	0		
	1	Average Score	2	Average Score	2		Average Score
Average of Priority	5						
Material Assessment Score	4						
Recommendation	D - No Attention Required, Label

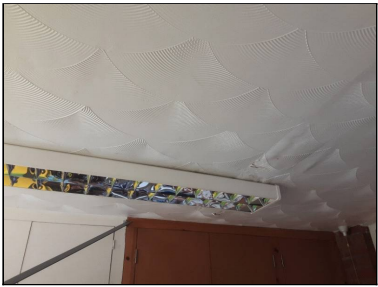
Survey Date:	Lead Surveyor	Survey Type	Floor	Analysis
	22 Jun 2021	Craig Excell	Management Survey	Ground Floor	Chrysotile (1)
	Building	Room	Item	Quantity	
	Pamper Heath Memorial Hall, Pamper Heath Road, Pamper Heath, Tadley	Committee Room G09	Textured coating to ceiling Ceiling	14-16m ²	
	Sample No (S,SP,P,As)	Product Type	Surface Treatment	Condition	Accessibility
	CE000500 (S)	Textured Coating (1)	Surface Sealed (1)	Low Damage (1)	Occasionally likely to be disturbed (1)

Normal Occupancy	Score	Likelihood of disturbance	Score	Exposure Potential	Score	Maintenance Activity	Score
Main type of activity	1	Location	2	Number of occupants	1	Type of Maintenance	0
		Accessibility	1	Frequency of use	3	Frequency of maintenance	0
Average Score		Amount	2	Average Time	1		
	1	Average Score	2	Average Score	2		Average Score
Average of Priority	5						
Material Assessment Score	4						
Recommendation	D - No Attention Required, Label

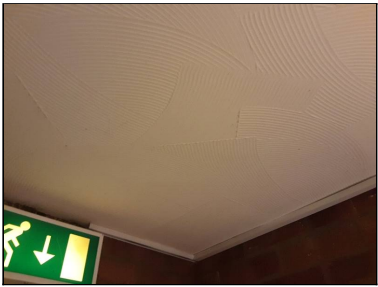
Survey Date:	Lead Surveyor	Survey Type	Floor	Analysis
	22 Jun 2021	Craig Excell	Management Survey	Ground Floor	Chrysotile (1)
	Building	Room	Item	Quantity	
	Pamper Heath Memorial Hall, Pamper Heath Road, Pamper Heath, Tadley	Circulation G10	Textured coating to ceiling Ceiling	4-6m ²	
	Sample No (S,SP,P,As)	Product Type	Surface Treatment	Condition	Accessibility
	As CE000500 (SP)	Textured Coating (1)	Surface Sealed (1)	Low Damage (1)	Occasionally likely to be disturbed (1)

Normal Occupancy	Score	Likelihood of disturbance	Score	Exposure Potential	Score	Maintenance Activity	Score
Main type of activity	1	Location	2	Number of occupants	1	Type of Maintenance	0
		Accessibility	1	Frequency of use	3	Frequency of maintenance	0
Average Score		Amount	1	Average Time	0		
	1	Average Score	2	Average Score	2		Average Score
Average of Priority	5						
Material Assessment Score	4						
Recommendation	D - No Attention Required, Label

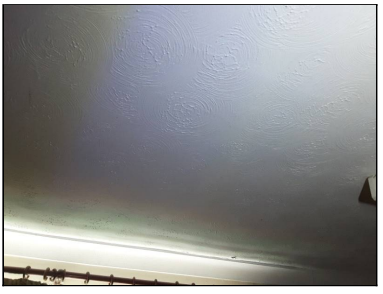
Survey Date:	Lead Surveyor	Survey Type	Floor	Analysis
	22 Jun 2021	Craig Excell	Management Survey	Ground Floor	No Asbestos Detected
	Building	Room	Item	Quantity	
	Pamper Heath Memorial Hall, Pamper Heath Road, Pamper Heath, Tadley	Small Hall G11	Textured coating to ceiling Ceiling	28-30m ²	
	Sample No (S,SP,P,As)	Product Type	Surface Treatment	Condition	Accessibility
	CE000501 (S)	N/A	N/A	N/A	N/A

Normal Occupancy	Score	Likelihood of disturbance	Score	Exposure Potential	Score	Maintenance Activity	Score
Main type of activity	N/A	Location	N/A	Number of occupants	N/A	Type of Maintenance	N/A
		Accessibility	N/A	Frequency of use	N/A	Frequency of maintenance	N/A
Average Score		Amount	N/A	Average Time	N/A	Average Score	
	N/A	Average Score	N/A	Average Score	N/A		N/A
Average of Priority	N/A						
Material Assessment Score	N/A						
Recommendation	No further action required

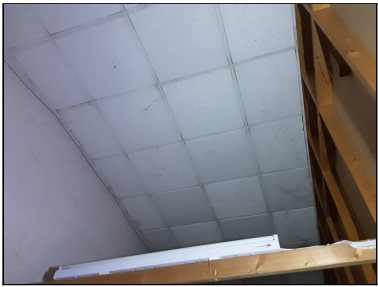
Survey Date:	Lead Surveyor	Survey Type	Floor	Analysis
	22 Jun 2021	Craig Excell	Management Survey	Ground Floor	N/A
	Building	Room	Item	Quantity	
	Pamper Heath Memorial Hall, Pamper Heath Road, Pamper Heath, Tadley	Store G12	No access above suspended ceiling tiles due to height restrictions	N/A	
	Sample No (S,SP,P,As)	Product Type	Surface Treatment	Condition	Accessibility
	Visual (P)	N/A	N/A	N/A	N/A

Normal Occupancy	Score	Likelihood of disturbance	Score	Exposure Potential	Score	Maintenance Activity	Score
Main type of activity	N/A	Location	N/A	Number of occupants	N/A	Type of Maintenance	N/A
		Accessibility	N/A	Frequency of use	N/A	Frequency of maintenance	N/A
Average Score		Amount	N/A	Average Time	N/A	Average Score	
	N/A	Average Score	N/A	Average Score	N/A		N/A
Average of Priority	N/A						
Material Assessment Score	N/A						
Recommendation	Inspection Required

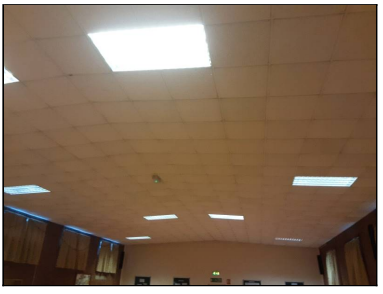
Survey Date:	Lead Surveyor	Survey Type	Floor	Analysis
	22 Jun 2021	Craig Excell	Management Survey	Ground Floor	N/A
	Building	Room	Item	Quantity	
	Pamper Heath Memorial Hall, Pamper Heath Road, Pamper Heath, Tadley	Main hall G13	No access above suspended ceiling tiles due to height restrictions	N/A	
	Sample No (S,SP,P,As)	Product Type	Surface Treatment	Condition	Accessibility
	Visual (P)	N/A	N/A	N/A	N/A

Normal Occupancy	Score	Likelihood of disturbance	Score	Exposure Potential	Score	Maintenance Activity	Score
Main type of activity	N/A	Location	N/A	Number of occupants	N/A	Type of Maintenance	N/A
		Accessibility	N/A	Frequency of use	N/A	Frequency of maintenance	N/A
Average Score		Amount	N/A	Average Time	N/A	Average Score	
	N/A	Average Score	N/A	Average Score	N/A		N/A
Average of Priority	N/A						
Material Assessment Score	N/A						
Recommendation	Inspection Required

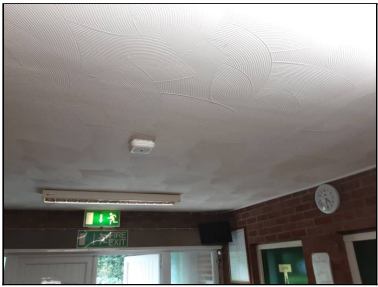
Survey Date:	Lead Surveyor	Survey Type	Floor	Analysis
	22 Jun 2021	Craig Excell	Management Survey	Ground Floor	Chrysotile (1)
	Building	Room	Item	Quantity	
	Pamper Heath Memorial Hall, Pamper Heath Road, Pamper Heath, Tadley	Circulation G14	Textured coating to ceiling Ceiling	22-24m ²	
	Sample No (S,SP,P,As)	Product Type	Surface Treatment	Condition	Accessibility
	As CE000500 (SP)	Textured Coating (1)	Surface Sealed (1)	Low Damage (1)	Occasionally likely to be disturbed (1)

Normal Occupancy	Score	Likelihood of disturbance	Score	Exposure Potential	Score	Maintenance Activity	Score
Main type of activity	1	Location	2	Number of occupants	1	Type of Maintenance	0
		Accessibility	1	Frequency of use	3	Frequency of maintenance	0
Average Score		Amount	1	Average Time	0		
	1	Average Score	2	Average Score	2		Average Score
Average of Priority	5						
Material Assessment Score	4						
Recommendation	D - No Attention Required, Label

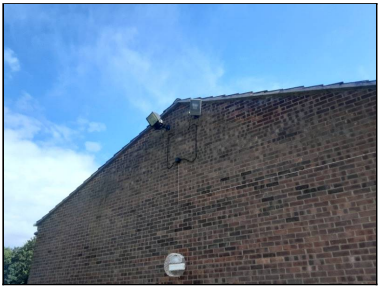
Survey Date:	Lead Surveyor	Survey Type	Floor	Analysis
	22 Jun 2021	Craig Excell	Management Survey	External	Chrysotile (1)
	Building	Room	Item	Quantity	
	Pamper Heath Memorial Hall, Pamper Heath Road, Pamper Heath, Tadley	External E01	Undercloaking to roof edge - unable to reach to sample Roof	22-24m	
	Sample No (S,SP,P,As)	Product Type	Surface Treatment	Condition	Accessibility
	Visual (P)	Asbestos Cement (1)	Surface Sealed (1)	Low Damage (1)	Usually inaccessible or unlikely to be disturbed (0)

Normal Occupancy	Score	Likelihood of disturbance	Score	Exposure Potential	Score	Maintenance Activity	Score
Main type of activity	1	Location	0	Number of occupants	0	Type of Maintenance	0
		Accessibility	0	Frequency of use	0	Frequency of maintenance	0
Average Score		Amount	2	Average Time	0	Average Score	
	1	Average Score	1	Average Score	0		0
Average of Priority	2						
Material Assessment Score	4						
Recommendation	D - No Attention Required, Label

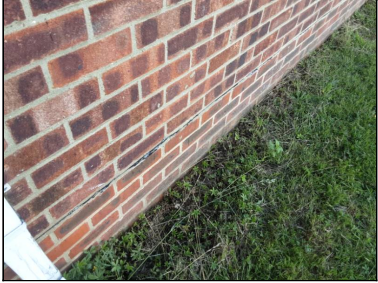
Survey Date:	Lead Surveyor	Survey Type	Floor	Analysis
	22 Jun 2021	Craig Excell	Management Survey	External	Chrysotile (1)
	Building	Room	Item	Quantity	
	Pamper Heath Memorial Hall, Pamper Heath Road, Pamper Heath, Tadley	External E01	Damp proof course Wall	Throughout	
	Sample No (S,SP,P,As)	Product Type	Surface Treatment	Condition	Accessibility
	CE000502 (S)	Reinforced Composite (1)	Completely Sealed (0)	Low Damage (1)	Usually inaccessible or unlikely to be disturbed (0)

Normal Occupancy	Score	Likelihood of disturbance	Score	Exposure Potential	Score	Maintenance Activity	Score
Main type of activity	1	Location	0	Number of occupants	0	Type of Maintenance	0
		Accessibility	0	Frequency of use	0	Frequency of maintenance	0
Average Score		Amount	3	Average Time	0		
	1	Average Score	1	Average Score	0		Average Score
Average of Priority	2						
Material Assessment Score	3						
Recommendation	D - No Attention Required, Label
