TASK NO.	TASK/DESCRIPTION	NOTES
H2	HULL AND STRUCTURE – EXTERNAL DECKS AND ASSOCIATED FITTINGS	
H2.16	<p><b>Vehicle Deck</b></p>

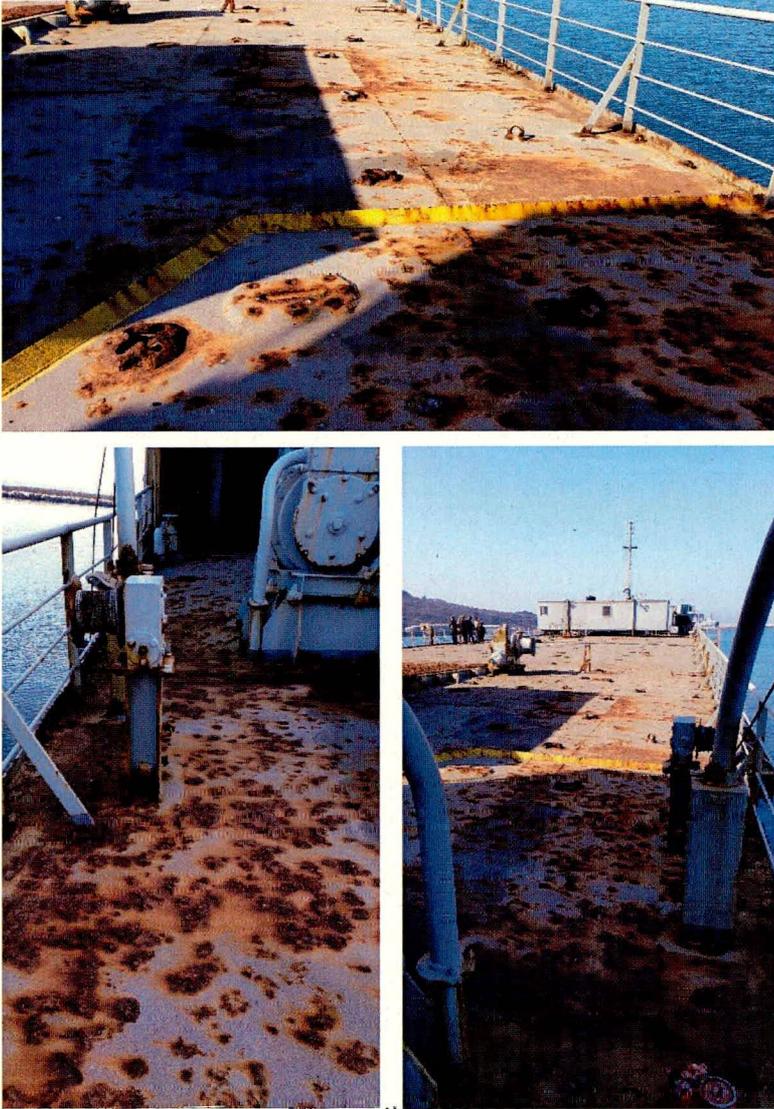
<p>The vehicle deck has breakdown of paint coatings throughout with active corrosion evident, particularly at the aft end either side of the vehicle ramp. The total area both sides of the vehicle ramp to have <b>REPRESERVATION</b> carried out, and the remainder of the vehicle deck patch repair <b>REPRESERVATION</b>.</p> <p>ALLOW for 250m<sup>2</sup> <b>REPRESERVATION</b>.</p>	<p>IAW Paint scheme -General 12 and Annex B refer.</p> <p>To be completed in conjunction with H2.01, H2.02, H2.09, H2.10, H2.18, H3.01 and 3.02.</p>

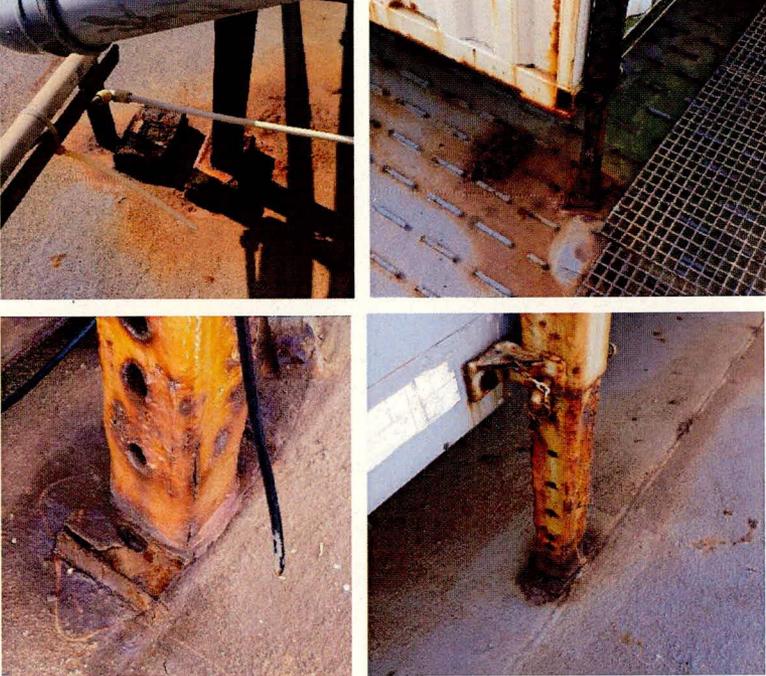
</div> <p data-bbox="400 1155 1246 1294">Current Office and toilet block support legs are not securely fixed to deck (welds suffering active corrosion). Following removal of existing facilities, hold-down points to be welded to deck to facilitate securing of new office and toilet block facilities. Total deck area beneath existing fit to be assessed and REPRESENTED accordingly.</p> <p data-bbox="400 1312 1070 1368">ALLOW for 8 in number securing points. ALLOW for 80m<sup>2</sup> REPRESENTATION.</p>	<p data-bbox="1249 416 1450 584">Hotwork Required – Appropriate precautions to be taken iaw General 8.4.</p> <p data-bbox="1249 618 1450 730">IAW Paint scheme -General 12 and Annex B refer.</p> <p data-bbox="1249 763 1450 875">To be completed in conjunction with H2.17 and H9.02.</p>
