Name:	Marlbrook Cadbury's Section SE	Number:	BS9001
Eastings:	351144	Northings:	253932
Route Crossed:		Route Carried:	HEREFORD ROAD
In or near an area of interest	of ecological		
Description:			
Location Map:		NEWTON BETT	A417

Works Required				
Work Type:	Safety Barrier Works	Reference:	SA2000138	
Works Identified by:	Steve Beresford (BTCS Ltd)	Date:	27-03-2020	
Work Description:	Retension System, update brackets and adjuster assemblies.			
Risk Likelihood:	2	Risk Consequence:	9	
Risk Overall Score:		,	18

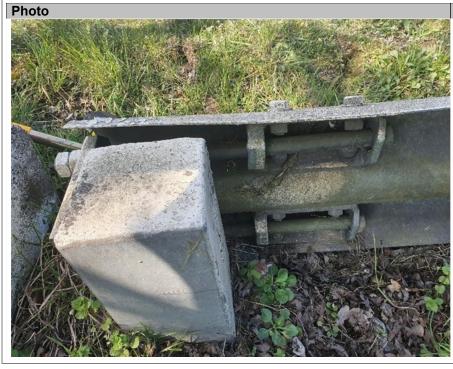
Photo Description
End Tension assembly

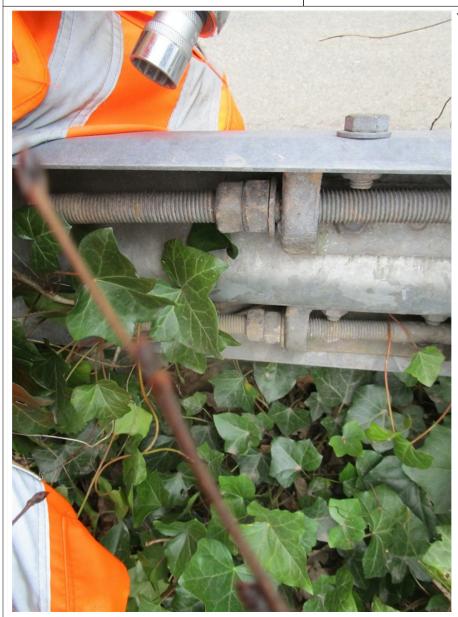
Tensioning Assembly

Works Required				
Work Type:	Safety Barrier Works	Reference:	SA2000177	
Works Identified by:	Steve Beresford (BTCS Ltd)	Date:	01-04-2020	
Work Description:	Re-tension system, Install extra adjuster assembly due to length of system.			
Risk Likelihood:	2	Risk Consequence:	9	
Risk Overall S	Risk Overall Score: 18			
Photo Description			Photo Description

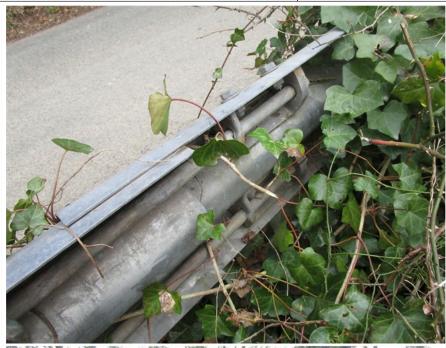
Tensioning assembly

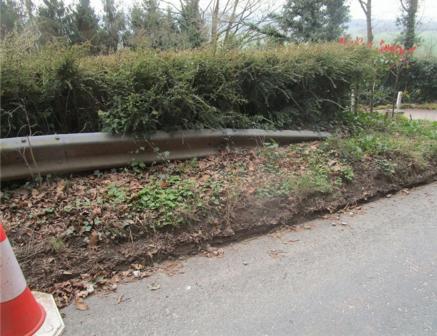
End terminal anchorage.

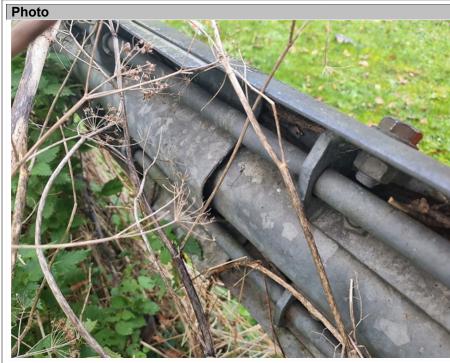
Photo Description
Tension assembly.

Works Required				
Work Type:	Safety Barrier Works	Reference:	SA2000135	
Works Identified by:	Steve Beresford (BTCS Ltd)	Date:	27-03-2020	
Work Description:	Re-tensioning of System.			
Risk Likelihood:	2	Risk Consequence:	9	
Risk Overall Score:			18

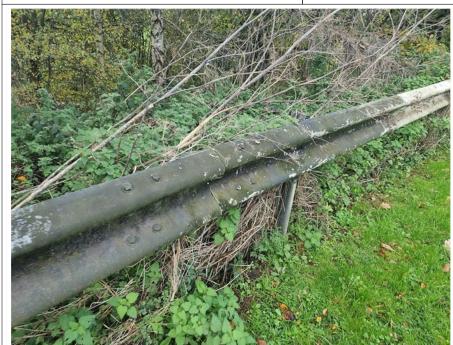
Front face of barrier at tension assembly.

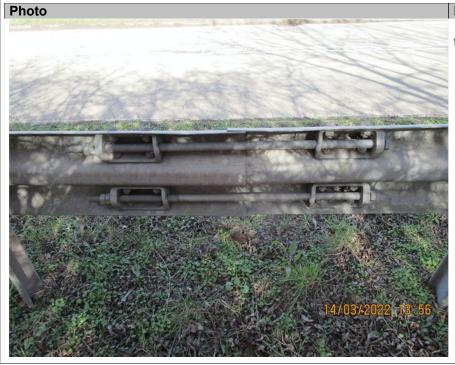
Photo Description
Uphill tension assembly

Works Required				
Work Type:	Safety Barrier Works	Reference:	SA1900226	
Works Identified by:	Nick Davies	Date:	15-11-2019	
Work Description:	Re-tension of System.			
Risk Likelihood:	2	Risk Consequence:	9	
Risk Overall Score: 18		8

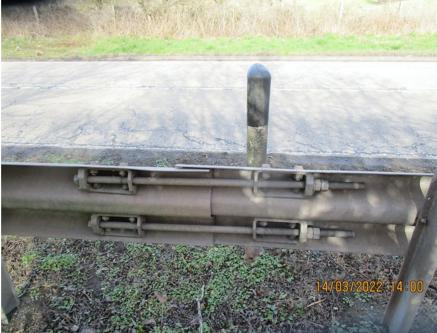
Downhill tension assembly.

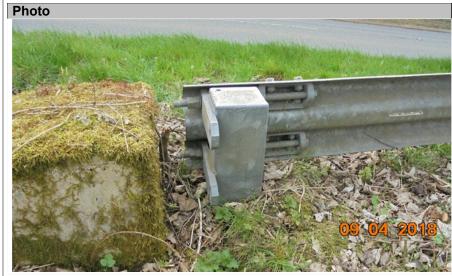
Photo Description
Departure Assembly

Works Required				
Work Type:	Safety Barrier Works	Reference:	SA2000154	
Works Identified by:	Steve Beresford (BTCS Ltd)	Date:	30-03-2020	
Work Description:	Re-tensioning of System.			
Estimated Cost:				
Risk Likelihood:	2	Risk Consequence:	9	
Risk Overall So	Risk Overall Score: 18		8

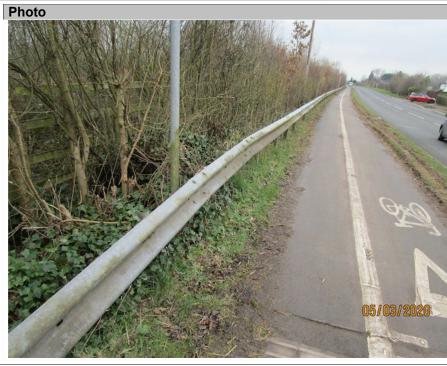
Photo Description
View from Approach
end.

Works Required				
Work Type:	Safety Barrier Works	Reference:	RO1800375	
Works Identified by:	Nick Davies	Date:	23-04-2018	
Work Description:	Retension system			
Estimated Cost:				
Risk Likelihood:	2	Risk Consequence:	9	
Risk Overall S	core:	18

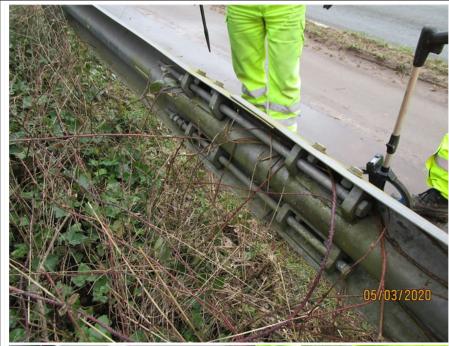
Tension assembly nearest approach end.

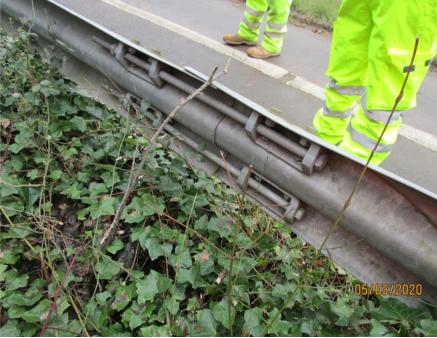
Tension assembly nearest Departure end.

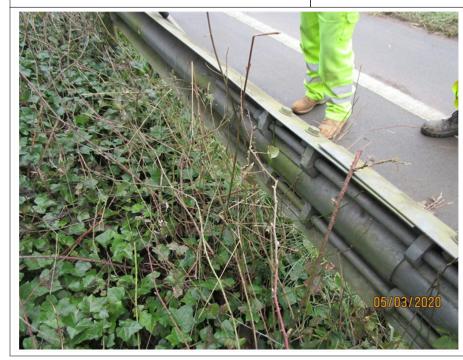
Middle tension assembly.

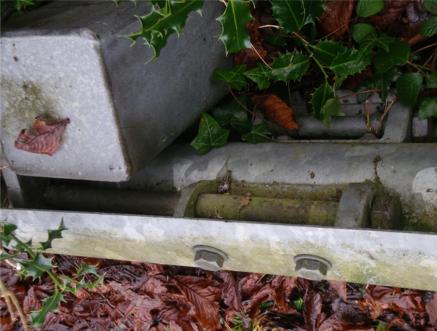
Historic end tension assembly

Works Required			
Work Type:	Routine Maintenance	Reference:	MS2300351
Works Identified by:	James Powell	Date:	06-09-2023
Work Description:	Re-tension system		
Risk Likelihood:	2	Risk Consequence:	9
Risk Overall Score:		18

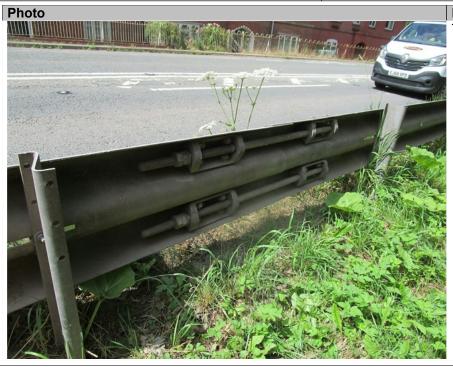
Photo Description
Tensioning bolts

Works Require	ed		
Work Type:	Safety Barrier Works	Reference:	SB2400018
Works Identified by:	Chris Wright	Date:	17-04-2024
Work Description:	Re-tensioning of Barrier		
Risk Likelihood:	2	Risk Consequence:	9
Risk Overall S	core:	•	18

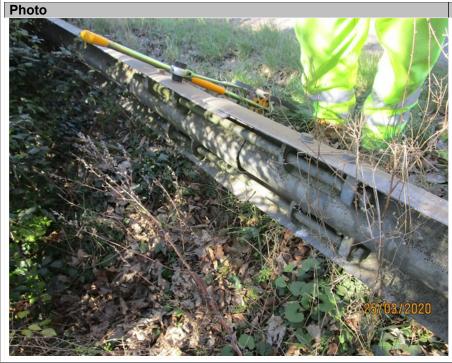
Photo Description
3rd
Tension Assembly

Works Required			
Work Type:	Safety Barrier Works	Reference:	SA2000127
Works Identified by:	Steve Beresford (BTCS Ltd)	Date:	25-03-2020
Work Description:	3 x adjuster assemblies require retensioning, 1 post needs replacing, Departure anchorage needs replacing/repair.		
	Priority:	В	
Risk Likelihood:	2	Risk Consequence:	9
Risk Overall Score:		18

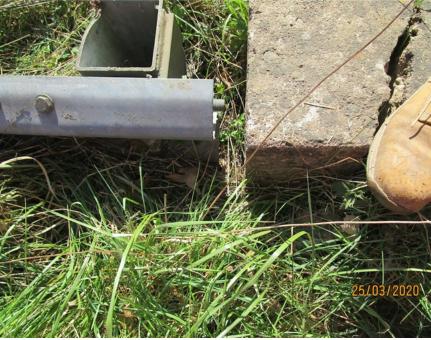
Departure assembly and damaged concrete anchor

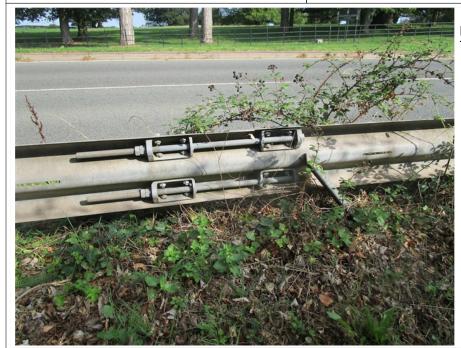
Damaged post next to Tension Assembly

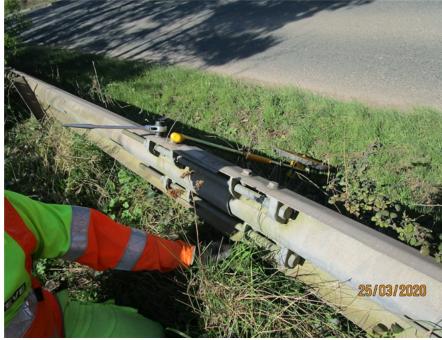
1st Tension Assembly

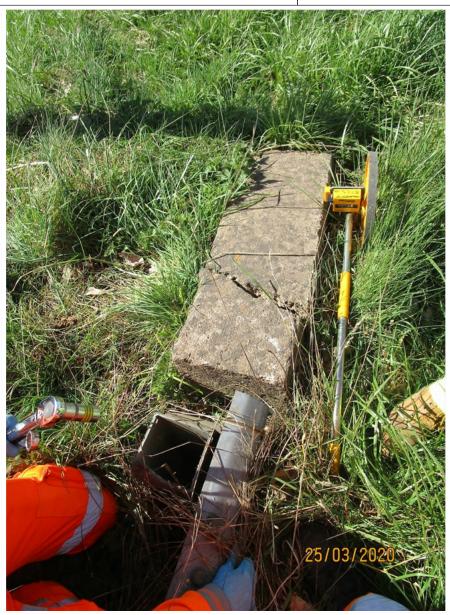
Departure assembly and damaged concrete anchor
