Asbestos Refurbishment Survey Report

Job Ref No: **517299**, Account Ref No: **23189**, Contract Ref No: **79256**

Brown Law, Bedburn, Hamsterley, Bishop Auckland DL13 3NP

Title: Pre refurbishment survey prior to replacement of roof, roofline and wall render., **Including:** Localised, **Excluding:** All other areas

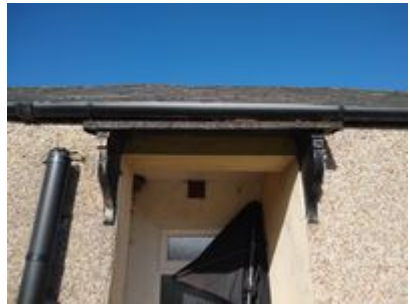
Building	Level	Location	Item / Product Examined	Sample No.	Material Description	Fibre Type	Material Score	Extent	Risk Level Assessment	Initial Control Recommendation	Photograph
Brown Law	9	999/externals	Felt covering to rear canopy	517299-3	Asbestos-containing bituminous felt	Chrysotile	3	1 Sqm.	R3	Remove if likely to be disturbed by proposed works
