CHURCH OF ST. JOHN THE EVANGELIST, SLIMBRIDGE

CONDITION REPORT ON 22 LISTED CHURCHYARD
MONUMENTS, WITH PROPOSALS

CENTRELINE ARCHITECTURAL SCULPTURE

APRIL 2022

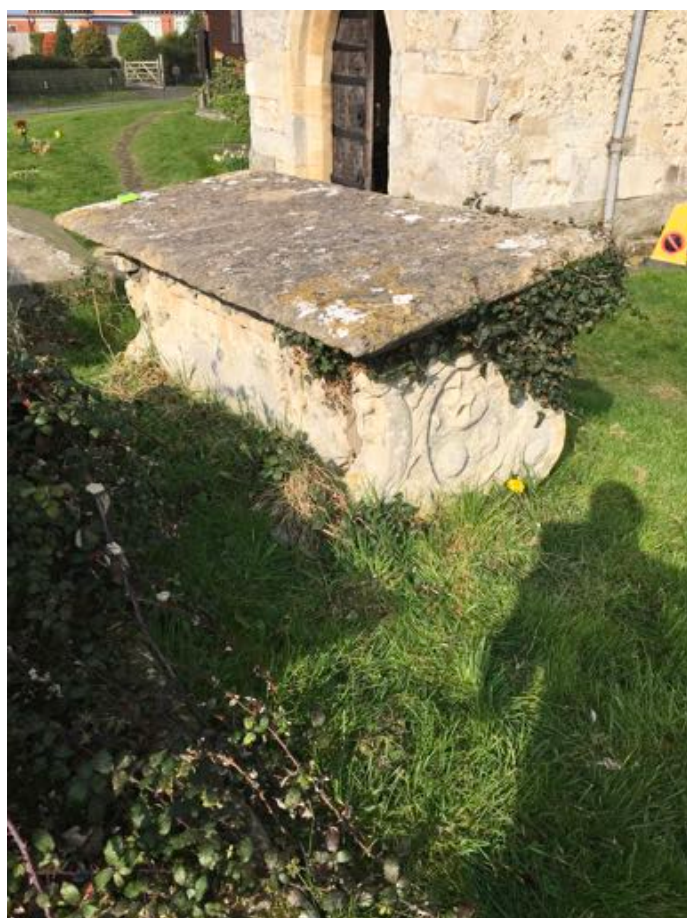
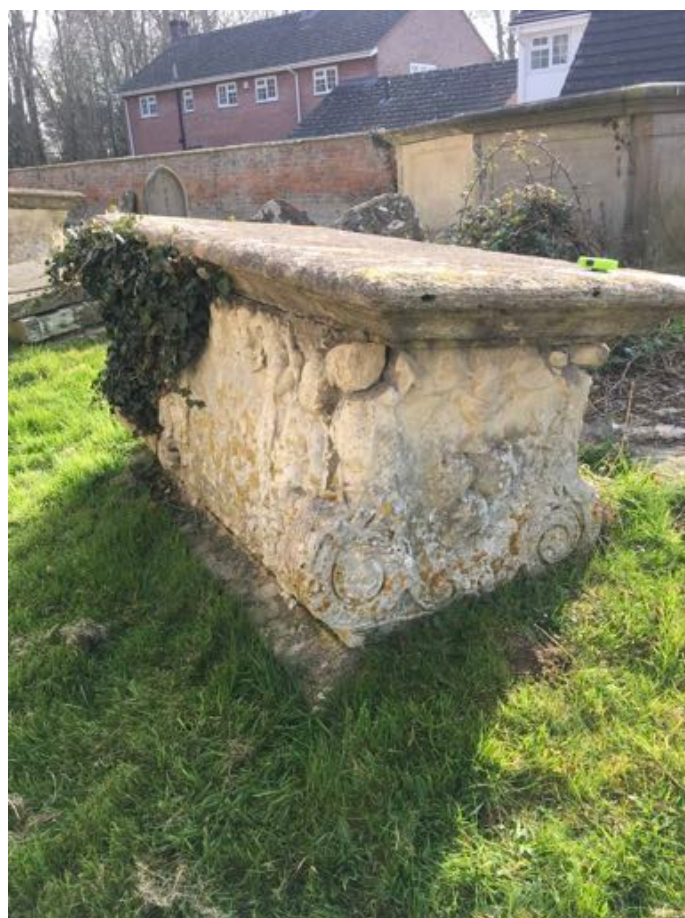
Previous interventions: Untidy cement pointing repairs under the top, especially on the south side, suspect iron cramps have been removed.

Condition of structure Slight lean to south, evidence of rusting iron cramp damage on all four top corners which has been badly 'repaired' with random stones and neat cement.

Condition of surface Ivy growth on north east corner, contour scaling and surface erosion.

Cause of deterioration Rusting iron cramps which previously held the four sides together at the top.

Proposals Apply biocide to kill the ivy growth and then gradually peel the dead stems away as the plant loses its hold.
Lift top
Remove any remaining iron cramps, dismantle sides and two lyre ends, dismantle and remove plinth.
Resest monument on a Limecrete foundation.
Reassemble monument replacing all iron cramps with stainless steel set in lead.
Rebuild and repoint with lime mortar, picking out any remaining cement pointing. Lime grout and fill the still-attached contour scaling.
Mortar repair top scrolls of west lyre end, retaining scroll fragments.
Fill fine cracks with lime grout.

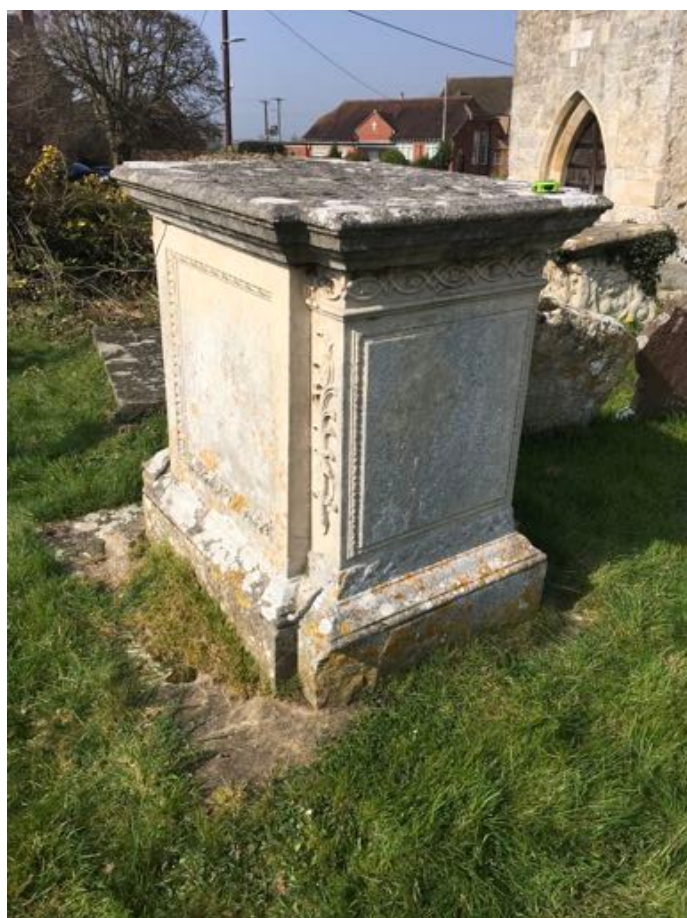
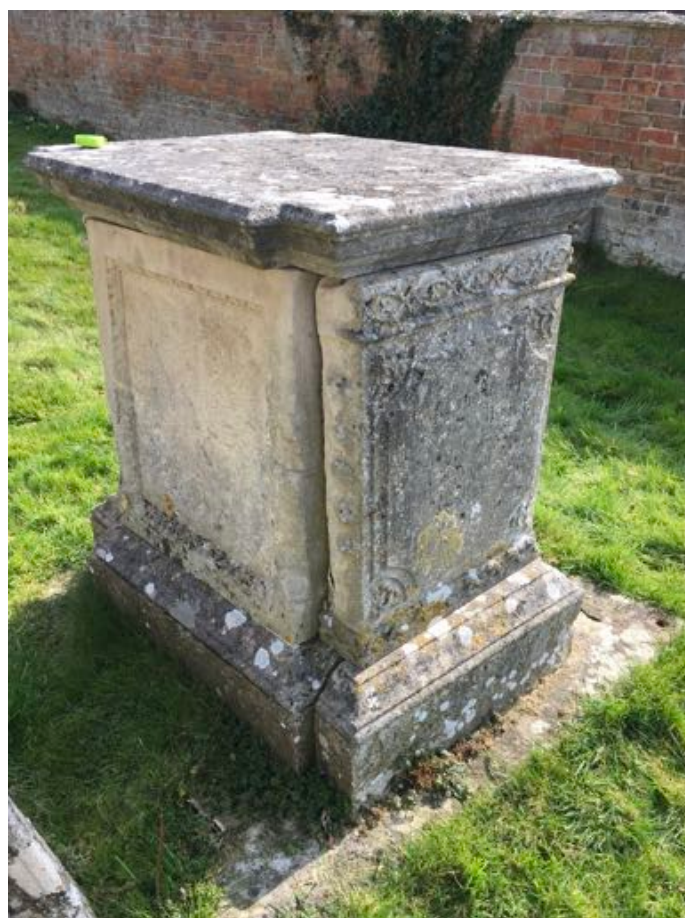
Condition of structure Leaning slightly to the south east, dislocated by ivy growth which has been removed. Rusting iron cramps have lifted the top, spalling on south west corner probably caused by ivy growth. Vertical and diagonal cracking on south side of east end. Cracks in north panel, west side.

Condition of surface Surface erosion, contour scaling on west panel and lichen growth.

Cause of deterioration Rusting iron cramps, ivy growth and subsidence distorting and opening the joints.

Rebuild, pin loose fragments back at top of south side and pin across north panel.

Remove remains of rusting iron cramps and replace with stainless steel set in lead.

Replace top and repoint all with lime mortar.

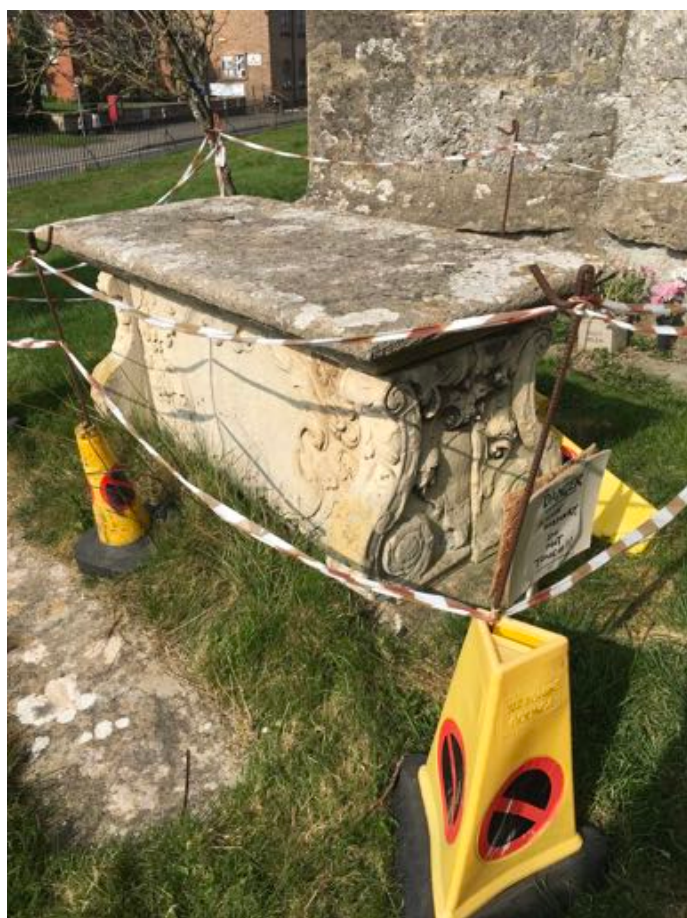
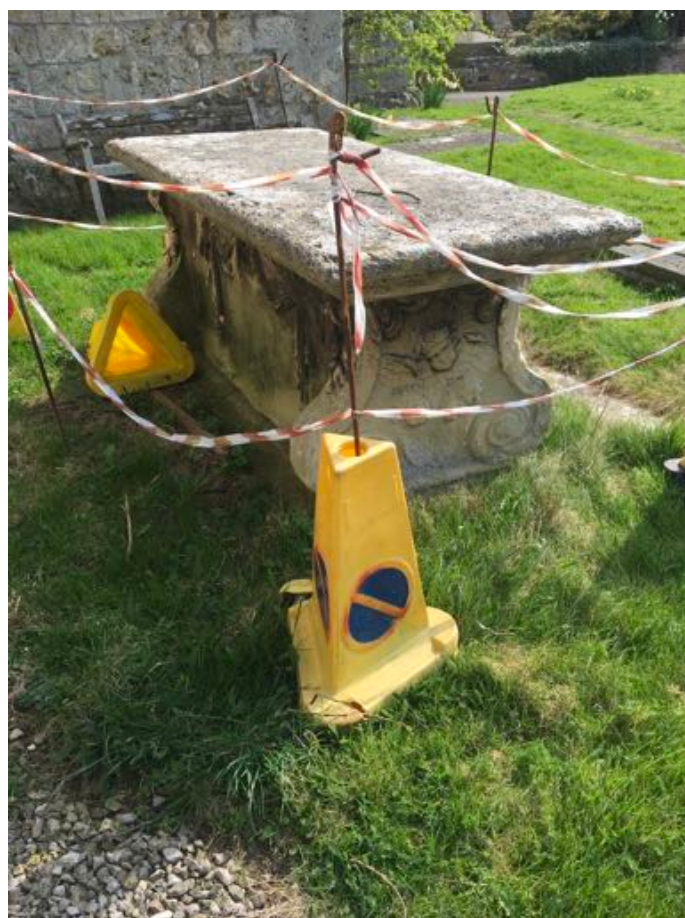
Condition of structure The whole monument has a very slight lean to the south but the top has been displaced to the west with the overhang being 200mm on the west with only 90mm overhanging the east lyre end. The main structural defect is that the east lyre end has split vertically down the middle. The corner cramps are rusted and broken which has resulted in the north east half of the lyre end being completely loose and liable to fall. The west lyre end has twisted, possibly when the top was pushed to the east. The south inscription panel has its top left corner broken, probably by the expansion of a rusting iron cramp in that top corner.

Condition of surface Sulphation on lyre ends.

Cause of deterioration Rusting iron cramps, dislodged top, split lyre end.

Lift top
Carefully remove the east lyre end and using stainless steel dowels pin the two halves back together.
Pin the top corner of the south panel back in place
Realign the west lyre end and using stainless steel cramps set in lead rebuild the monument
Replace top in correct alignment west-east
Repoint monument using a matching lime mortar
Consider removing built up sulphation by a poultice
Carefully remove the build up of grass and soil from around the plinth

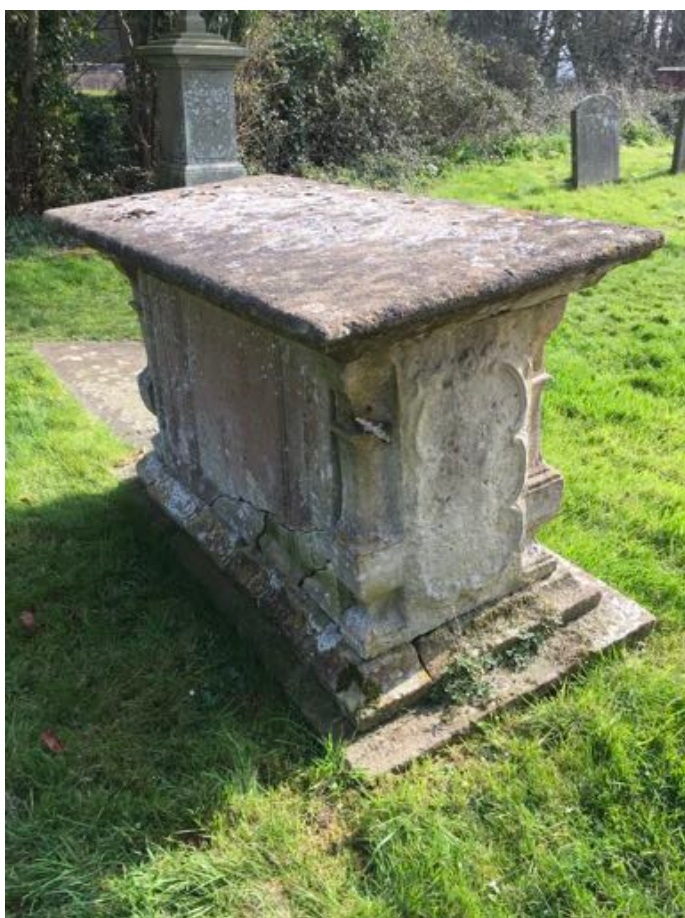
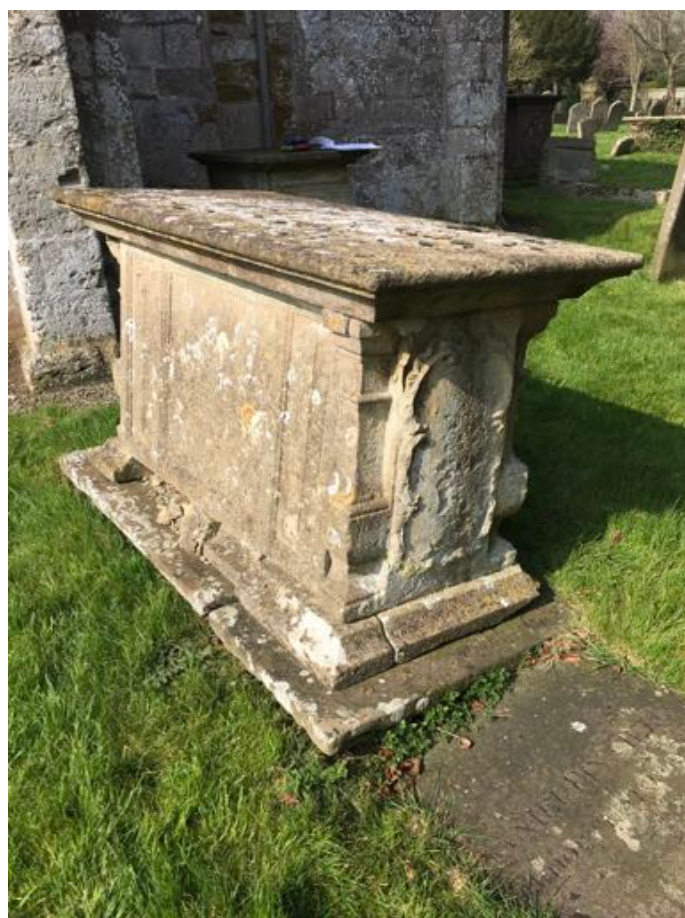
Previous interventions: Early indent repairs on south and also east and west panels.

Condition of structure This monument is in a dangerous condition, leaning to the north with all its rusting iron cramps failed. It could easily be pushed over and needs fencing to protect the public. Broken fragment on north panel. Plinth completely deteriorated on the south side.

Condition of surface A fossilised branch/root, now missing from the stone of the north west corner, has been filled with lime putty. Contour scaling on east panel. Lichen growth.

Cause of deterioration Rusting iron cramps, subsidence, ivy growth jacking the panels apart, salts and frost damage.

Pin with stainless steel set in epoxy resin and lime mortar repair.

Replace top and repoint with lime mortar.

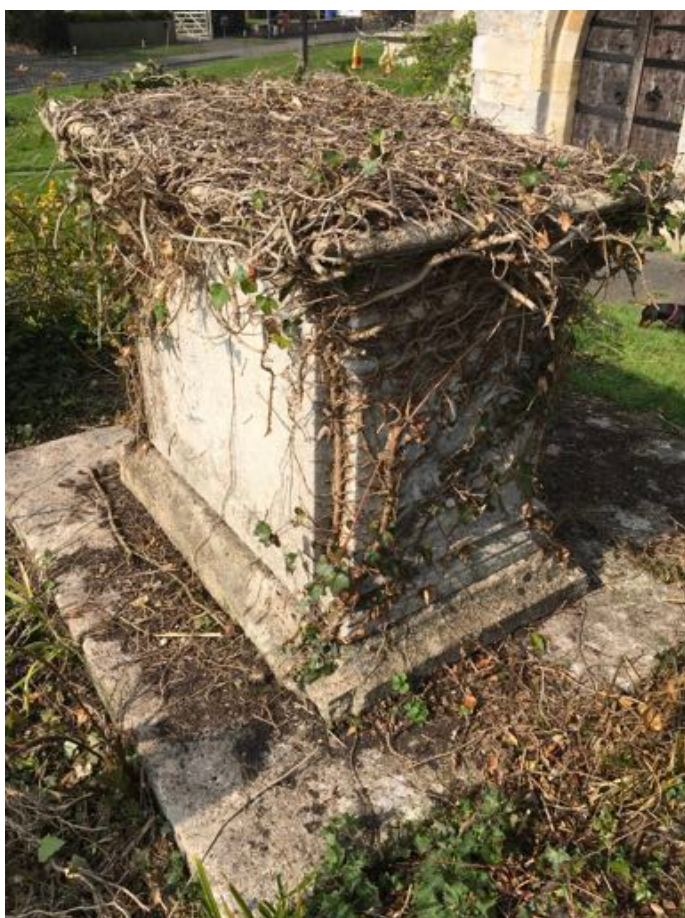
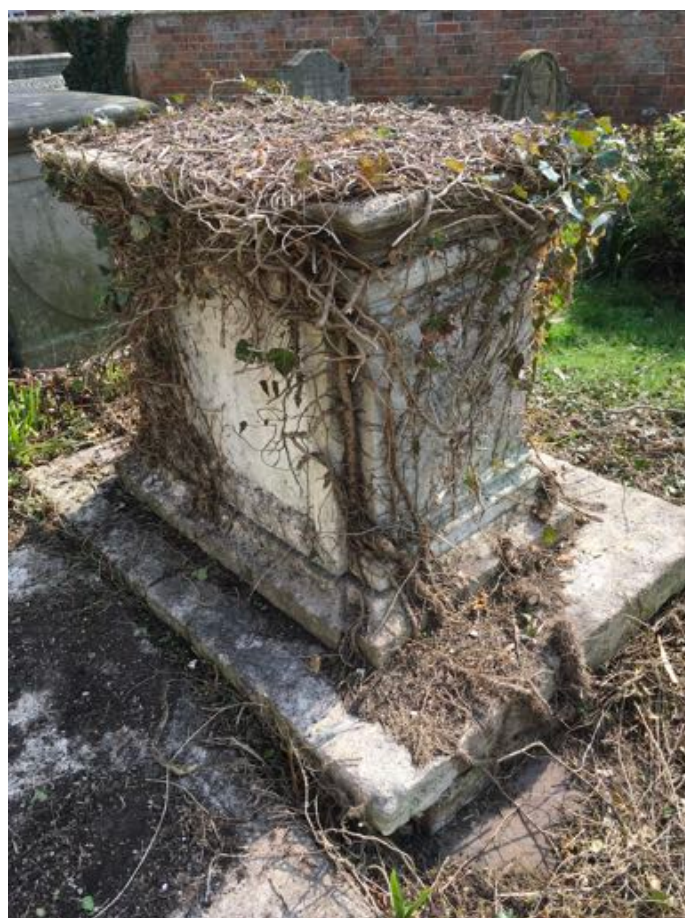
Condition of structure This tomb has been badly affected by ivy growth which has prised the tomb apart.

Condition of surface The weathering and surface erosion is as expected for a monument of this date.

Cause of deterioration The damage has been caused by unchecked ivy growth and the decay of the rusting iron cramps which once held the sides together.

Using a suitable biocide, reduce the vigour of the ivy and carefully peel the stems away when it loosens.

Remove rusting iron cramps and the ivy roots from inside the tomb.

Reassemble sides on the plinth using stainless steel cramps set in lead and lime mortar point the whole including the lower slabs.

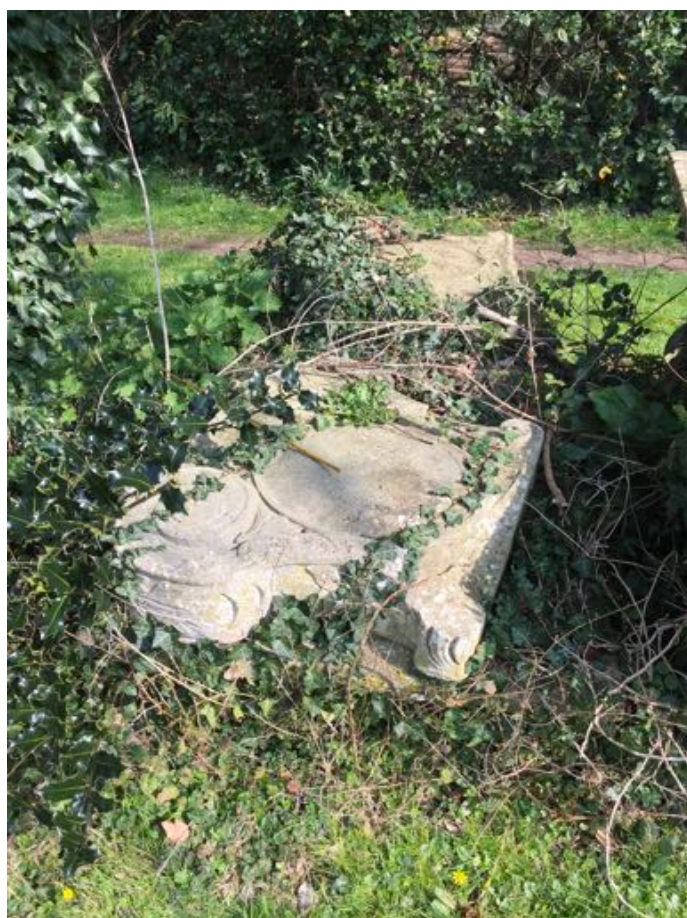
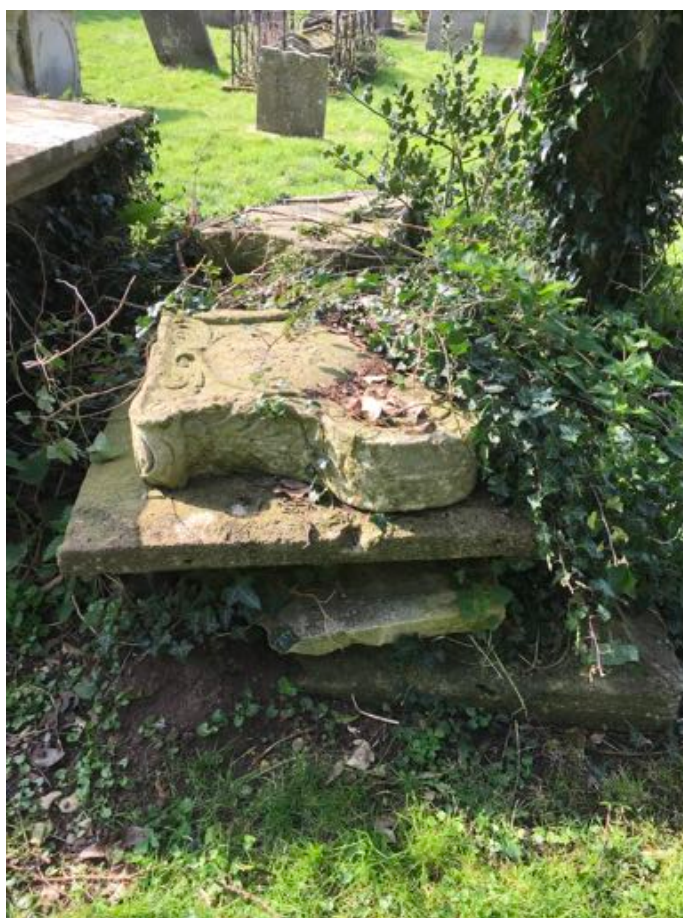
Condition of structure Only the lyre ends could be assessed, the main panels are stacked underneath and their condition is unknown. One of the lyre ends is broken and top corner missing due to spalling caused by a rusting iron cramp.

Condition of surface The surface is weathered but only as much as expected for the date.

Cause of deterioration Rusting iron cramps have probably failed completely making the structure unsafe and a decision has been made to stack the parts ready for future reassembly.

Lift parts for inspection for cracks and damage.

Reassemble on the original site using all available original stone using stainless steel cramps set in lead.

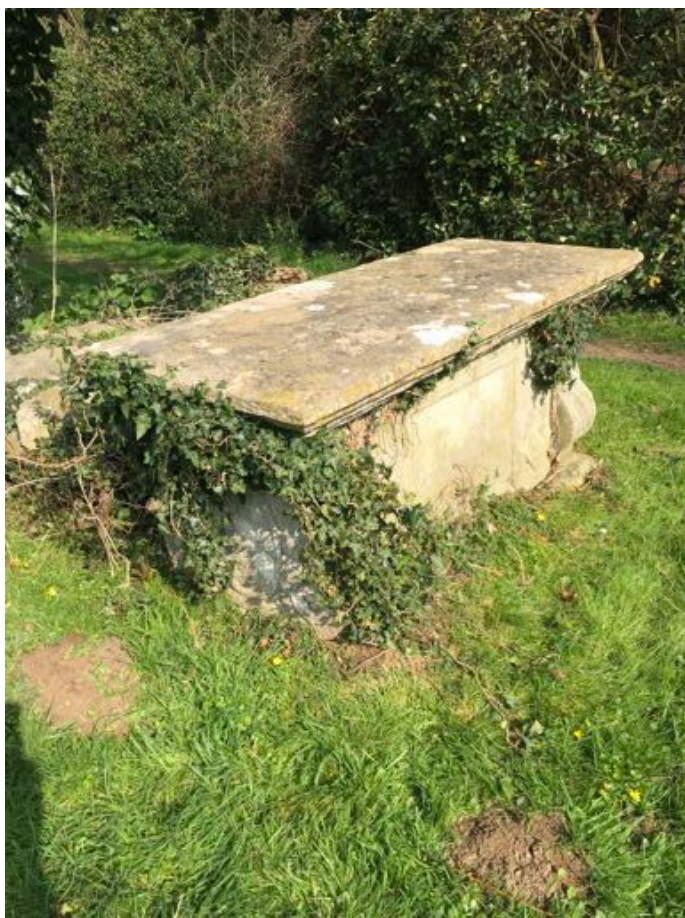
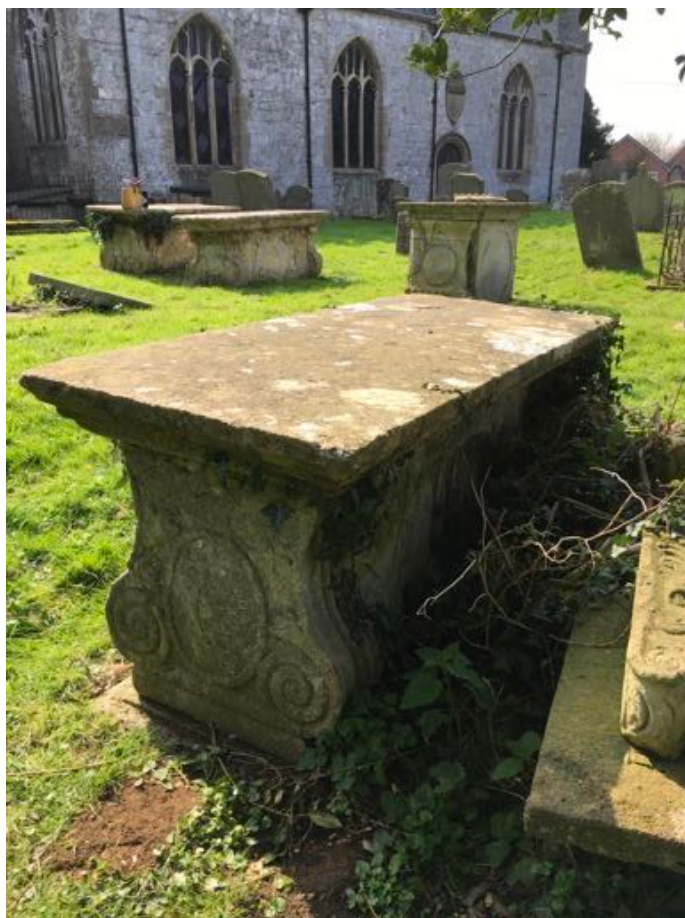
Condition of structure Ivy is growing through many of the joints and is lifting the top, possibly in conjunction with rusting iron cramps.

Condition of surface Reasonable condition for the age of the monument, no scaling or flaking but the growth of both lichen and ivy is a problem.

Cause of deterioration Ivy and lichen growth and rusting iron cramps.

Reassemble all with stainless steel cramps set in lead and lime mortar point the whole including the lower slabs.

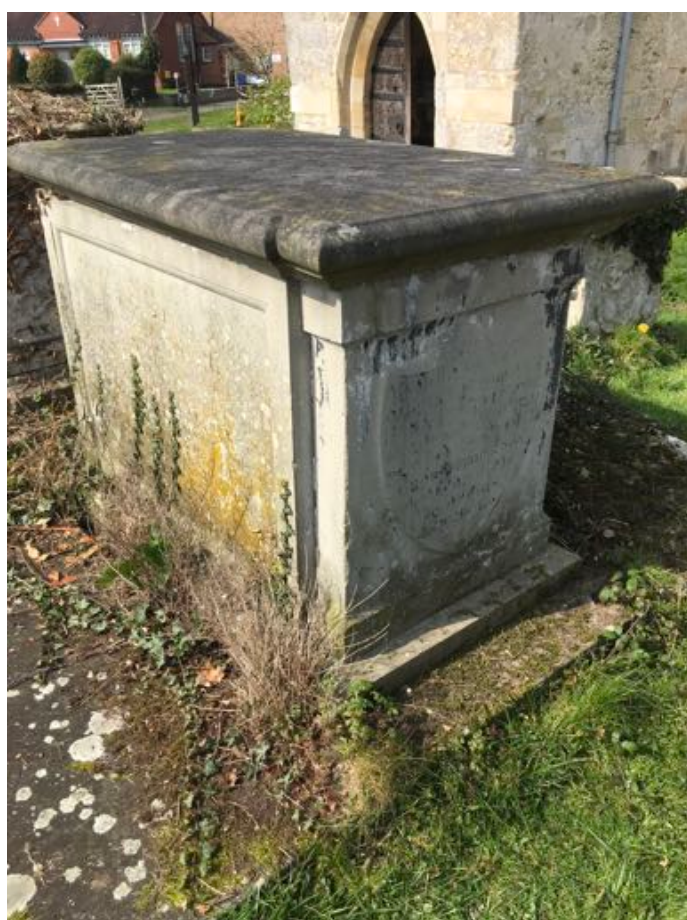
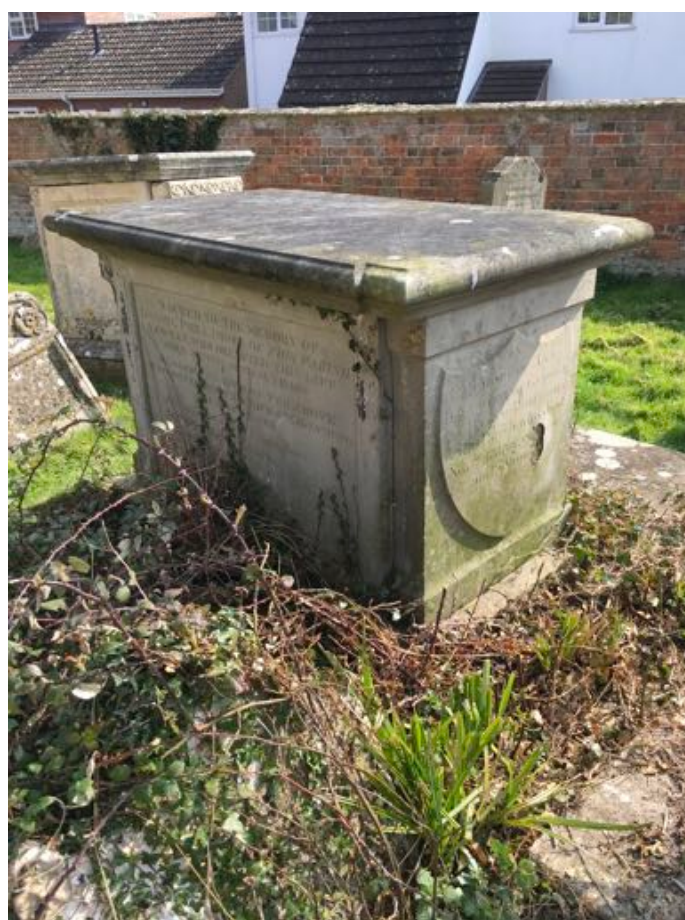
Condition of structure Iron cramp damage to SW corner and top dislocated to NW exposing a rusting iron cramp. Some open joints.

Condition of surface The top surface of the monument is very nicely tooled and has weathered slightly. There are small patches of delamination on all sides. There are traces of limewash and it is possible that the whole may have been black originally.

Cause of deterioration Rusting iron cramps have caused damage as has unchecked ivy growth.

Remove rusting iron cramps. Replace with Stainless steel set in lead.

Replace top.

Repoint all open or cracked joints with matching lime mortar and fill delaminating areas with matching lime mortar to avoid water traps.

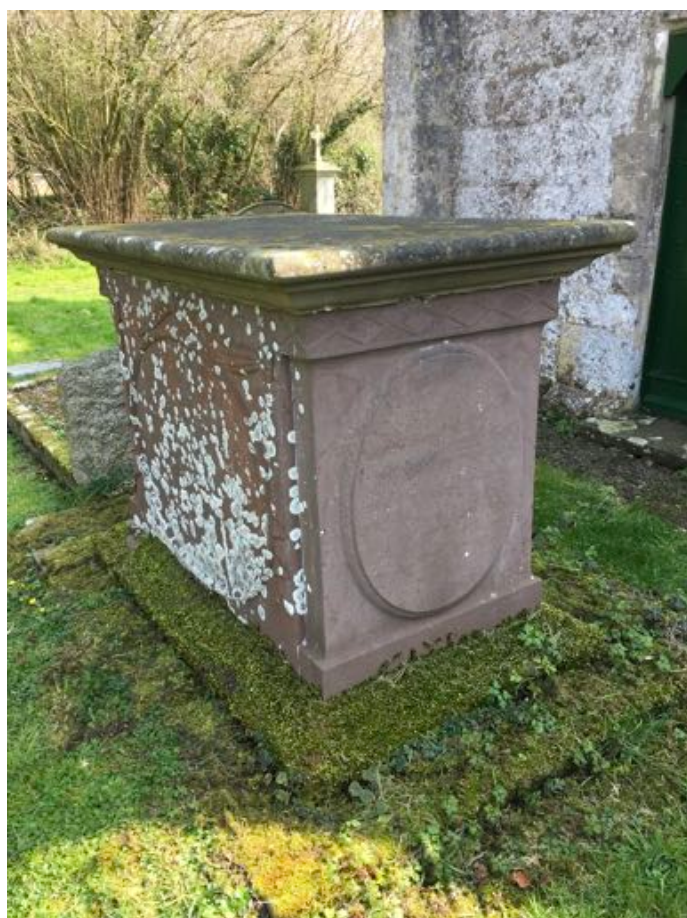
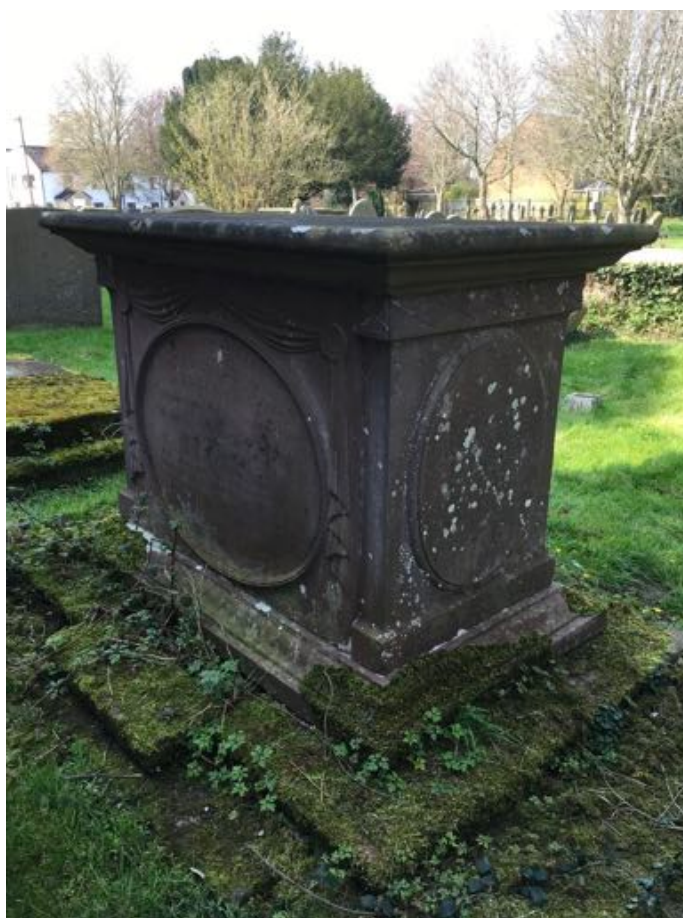
Condition of structure Dislocated slab on south side on upper course of the base.

Condition of surface Delamination in small localised areas, strong licheb growth on the north side of the monument. There are traces of limewash.

Cause of deterioration There is a build up of the ground level on the north side and the dislodged slab of the base has :
bramble growing out of it. There is also a quantity of moss growing on the monument.

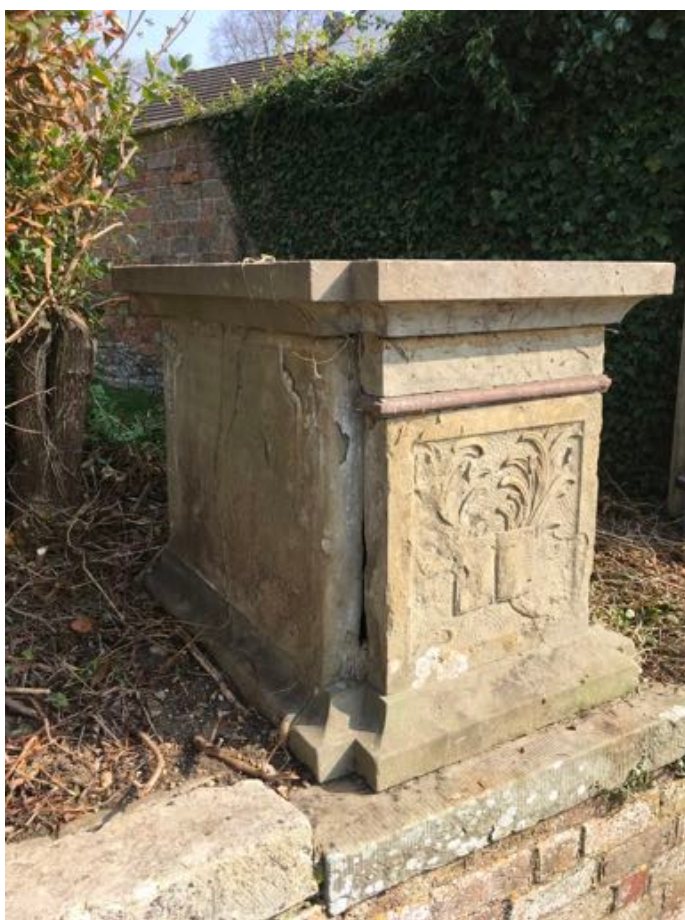
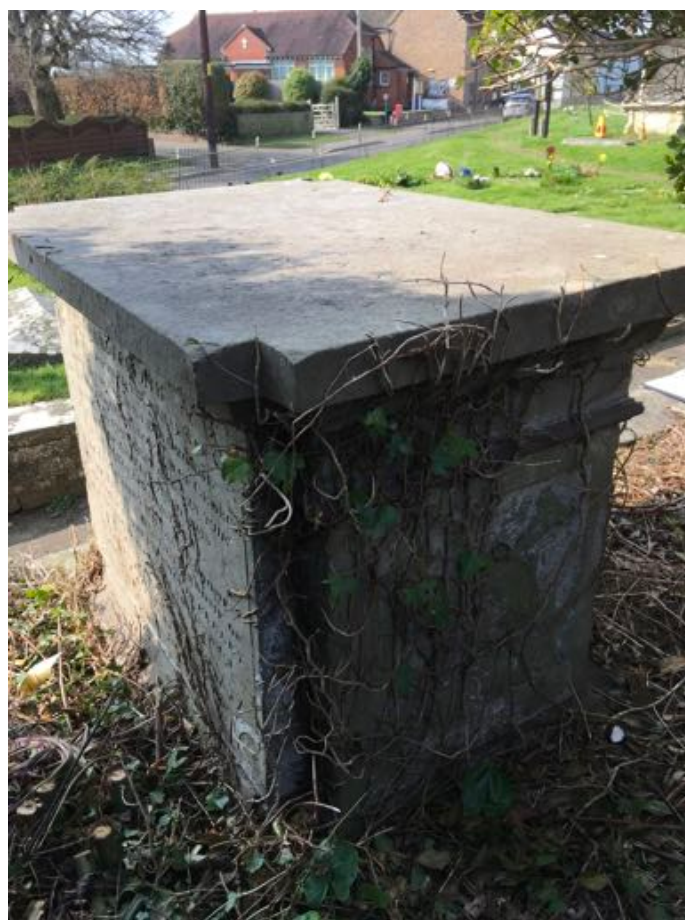
Name George Watts, 1783 Number 1305805 What3Words gurgling.iceberg.fuel
location

Previous interventions: Very poor sand and cement pointing at the west end, presumably to fill the gap caused by ivy growth.

Condition of structure The joints are fairly tight and apart from a crack in the architrave at the east end the monument is in quite good structural condition.

Condition of surface Delamination of the surface on the north, south and west with a small area on the east end.

Cause of deterioration Excessive ivy growth in the past and salts accumulated in the surface.

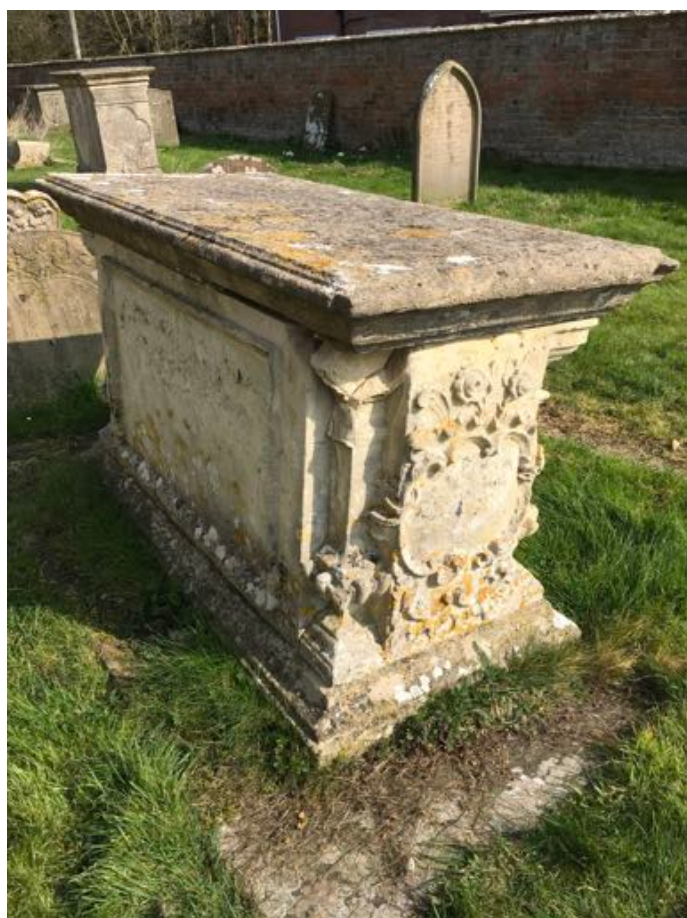
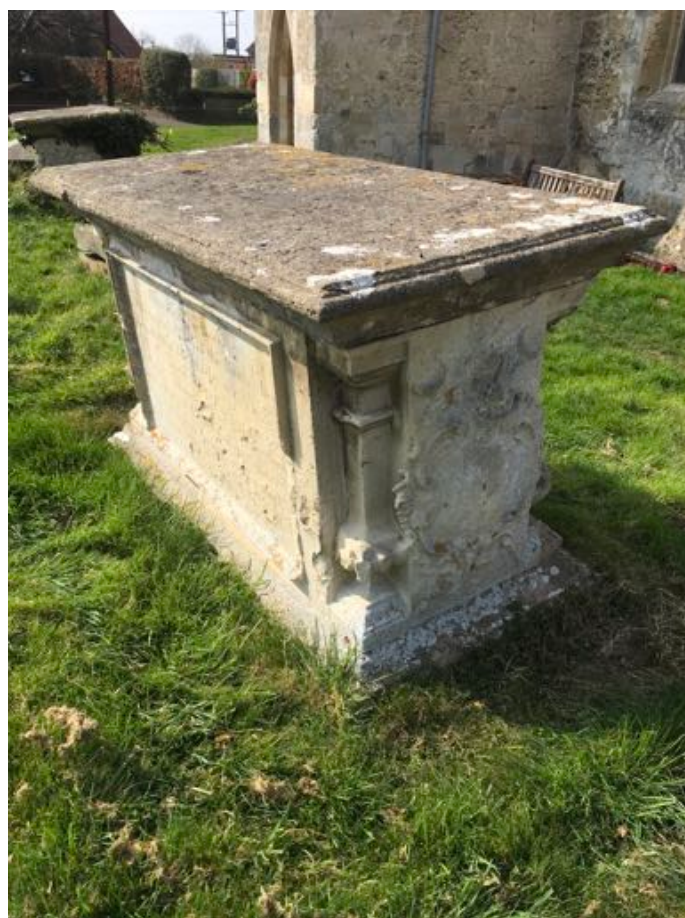
Condition of structure The monument is leaning to the south and rusting iron cramps are lifting the top and damaging the sides on the south, east and west. There is also evidence of the base subsiding.

NB The structure is unsafe and could collapse.

Condition of surface There is extensive delamination to all sides. Lichen growth is also a problem. There are traces of old limewash on the east and west ends.

Cause of deterioration Subsidence and rusting iron cramps are the main causes of deterioration.

Pin across cracks and mortar repair damaged stone at corners

Reassemble with new stainless steel cramps set in lead.

Replace top.

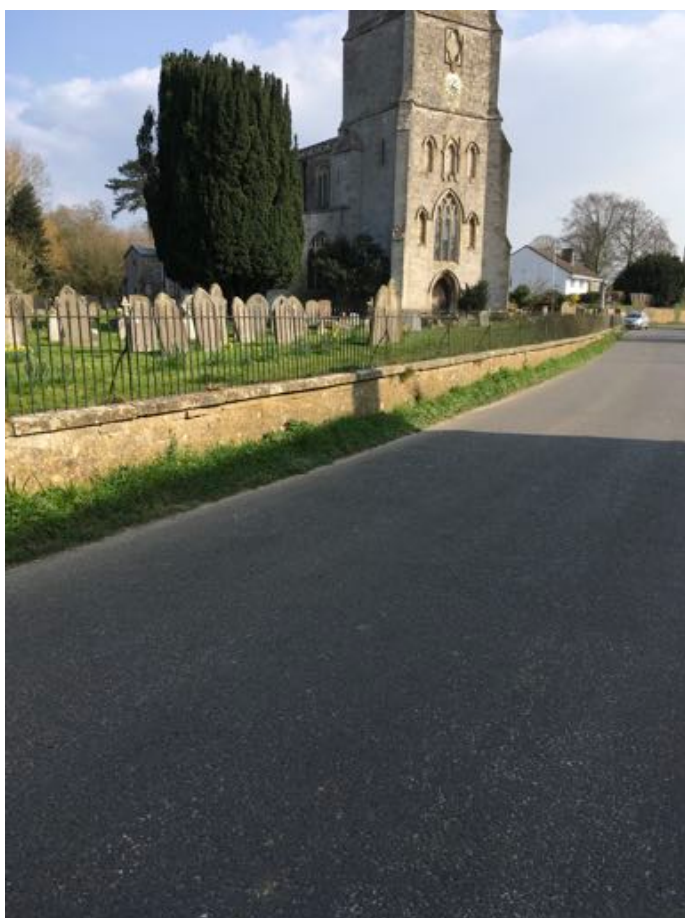
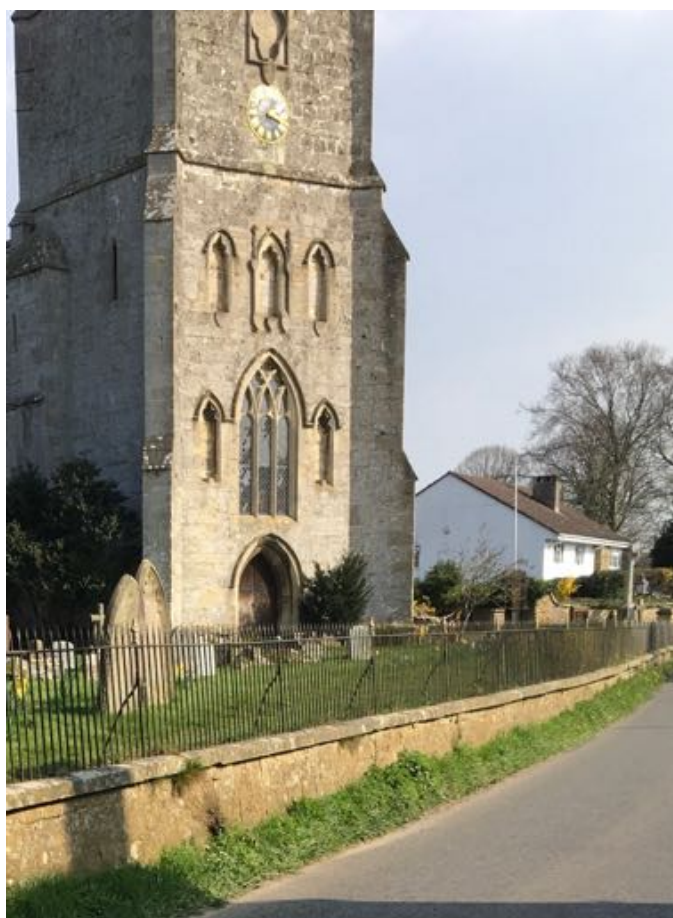
Name Boundary Wall & Railings Number 1340548 What3Words starred.encrusted.brush location

Condition of structure The railings are mostly in a rusty condition with a few bent and others missing with some missing their rail heads. The large majority are intact however and the wall supporting them needs some stone replacement in parts but is otherwise in a reasonable structural condition.

Condition of surface The paint is peeling away from the rails and rust is showing through and the rail head also need repainting.
The surface of the wall below has some plant growth in the joints.

Cause of deterioration The railings have not been painted recently and the iron is beginning to rust, the wall has been pointed with cement in places which traps the water in the stone.

All the railings should be rubbed down and new matching rail heads sourced to replace the few missing.

Repaint all after applying a rust preventative primer/undercoat. Repaint the rail heads.

Repoint all open and cracked joints in the retaining wall and in the coping using lime mortar.

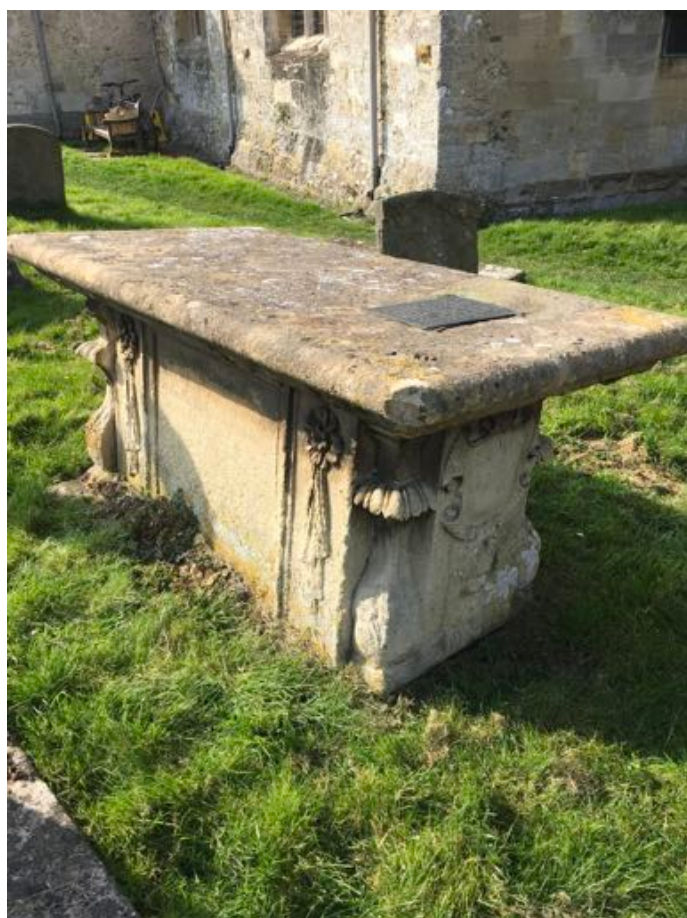
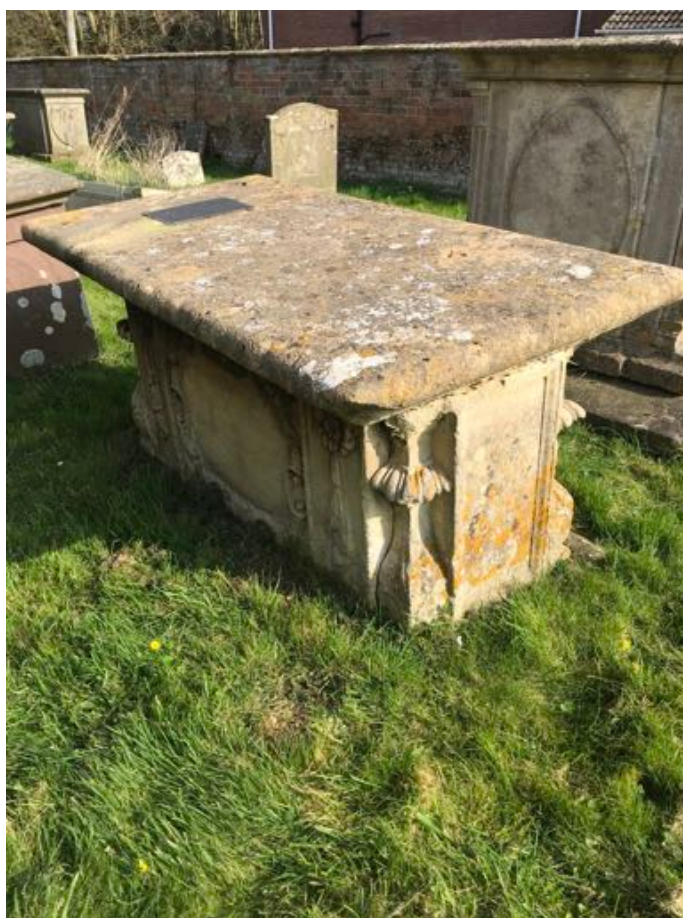
Condition of structure The monument is leaning to the north, there are open joints in the structure, signs of failed rusting iron cramps and spalling probably caused by this on the south west corner. The east end is slightly dislocated to the north.

Condition of surface The limestone is weathered and there is a sulphated crust and crypto-florescence under the top on the south side.

Cause of deterioration Rusting iron cramp failure and subsidence.

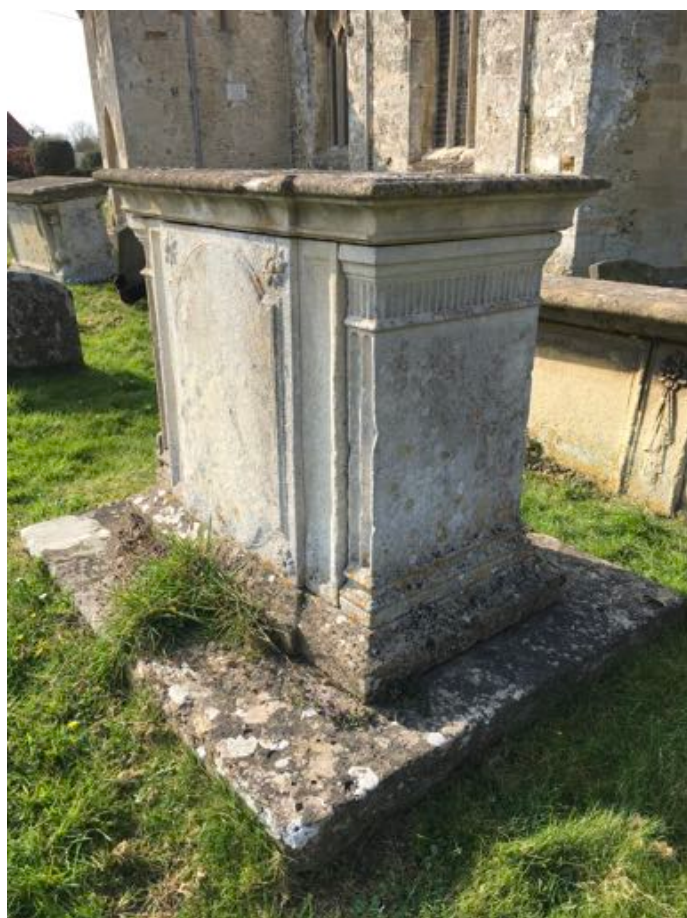
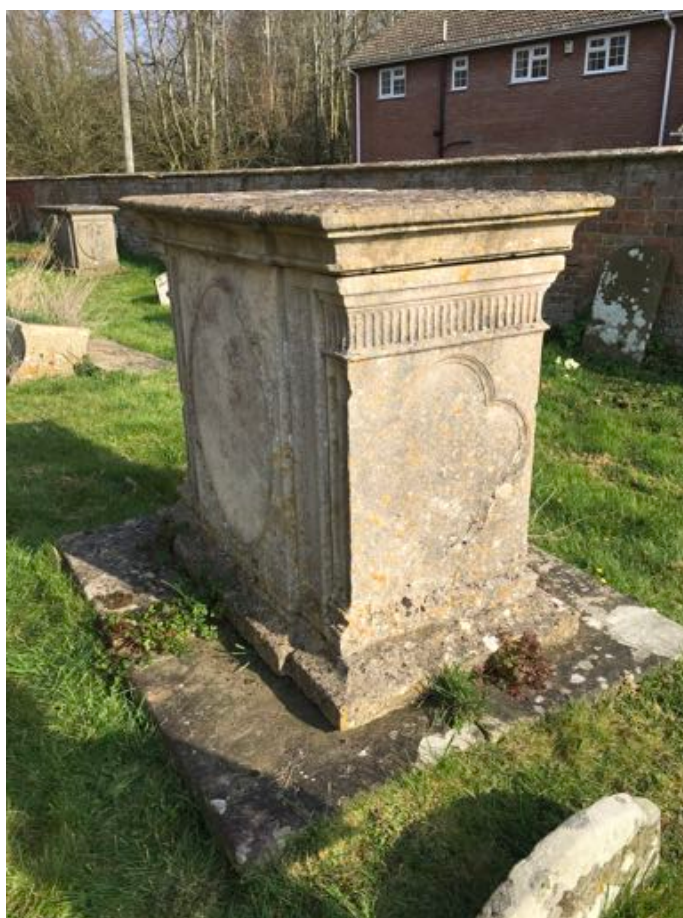
Condition of structure Plant growth in the joints of both the plinth and base will eventually damage the structure, there are open joints around the monument and rusting iron cramps are jacking the top up.

Condition of surface Frost damage to the west and the expected amount of surface damage and decay for the date.

Cause of deterioration Rusting iron cramps and the action of the weather, wetting and drying cycles.

Proposals
Carefully remove the plant growth from around the base and plinth.
Lift the top.
Replace the rusting iron cramps with stainless steel set in lead.
Bed the top back on with lime mortar.
Repoint all open or cracked joints.
Grout and mortar fill the frost damage on the west panel.

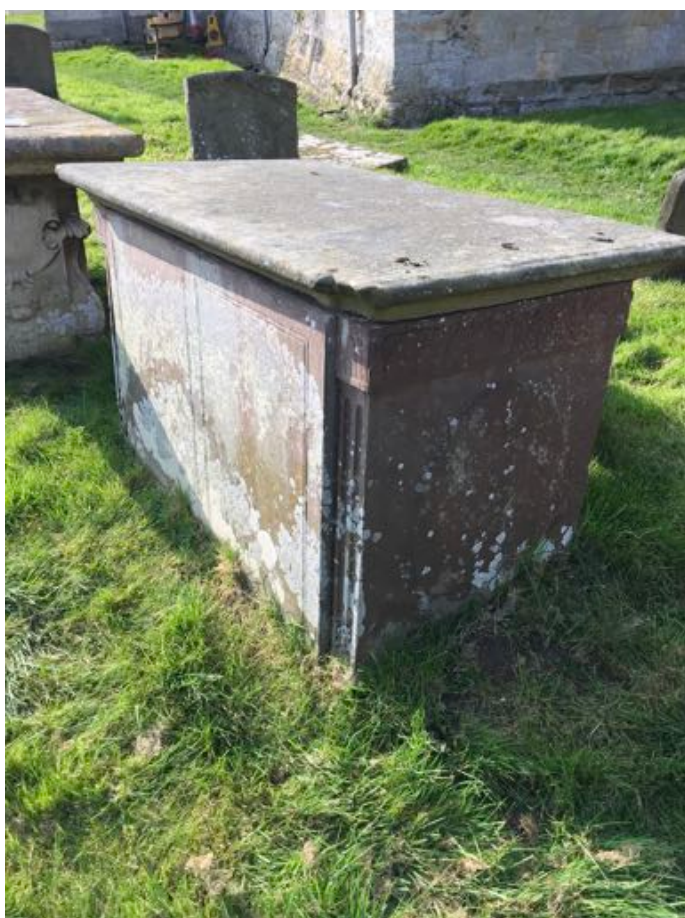
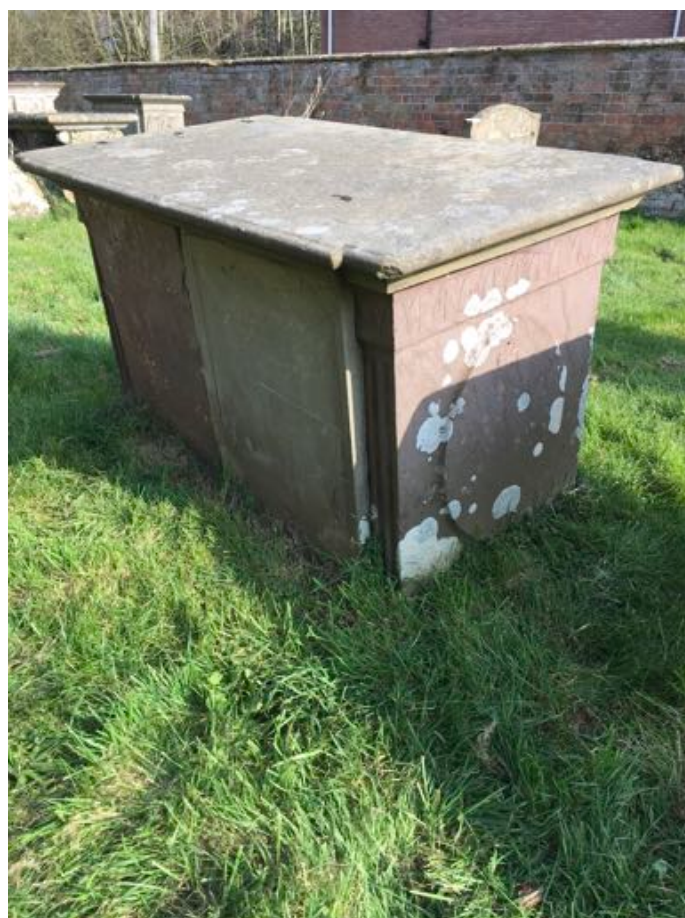
Condition of structure The top is loose and can be rocked quite easily. The monument is leaning to the north and the sides are dislocated on the north, east and west.

Condition of surface The frieze is delaminating.

Cause of deterioration Subsidence and rusting iron cramps.

Dismantle the sides and remove the rusting iron cramps

Reassemble the monument with stainless steel cramps set in lead.
