CHURCH OF ST. JOHN THE EVANGELIST, SLIMBRIDGE

CONDITION REPORT ON 22 LISTED CHURCHYARD
MONUMENTS, WITH PROPOSALS

CENTRELINE ARCHITECTURAL SCULPTURE

APRIL 2022

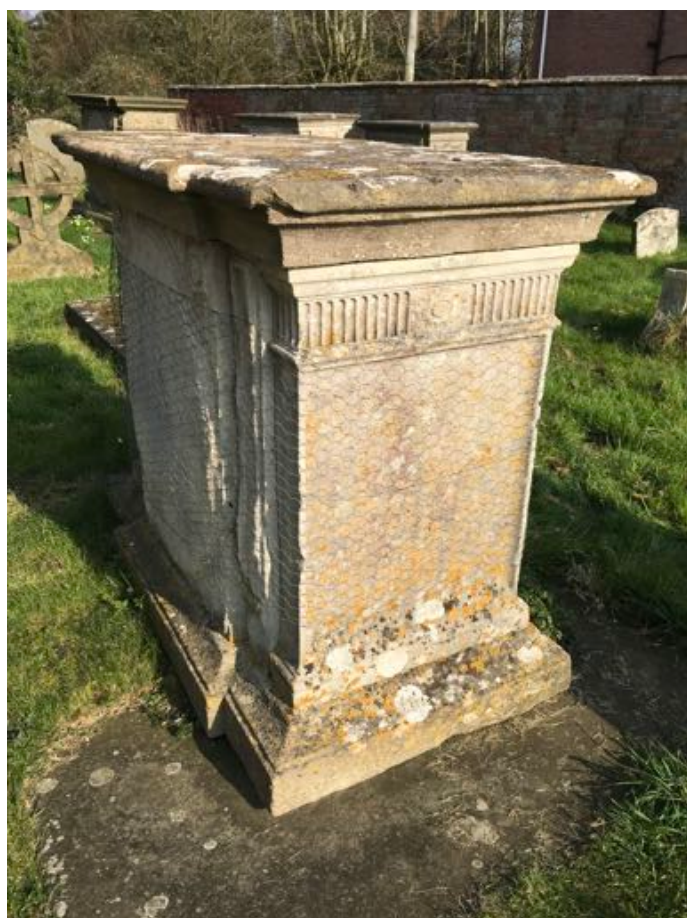
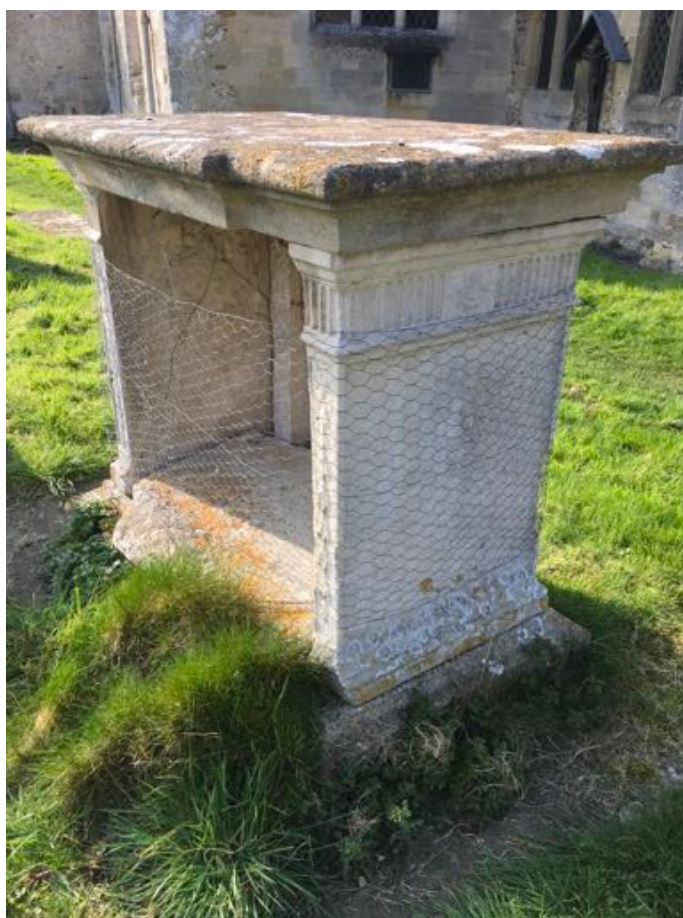
Condition of structure The failure of the iron cramps have allowed the south side to be dismantled after it became loose.

Condition of surface There is a small amount of contour scaling to the north side.

Cause of deterioration Rusting iron cramps.

Remove remaining rusting iron cramps.

Replace cramps with stainless steel set in lead.

Replace top and point all joints with matching lime mortar.

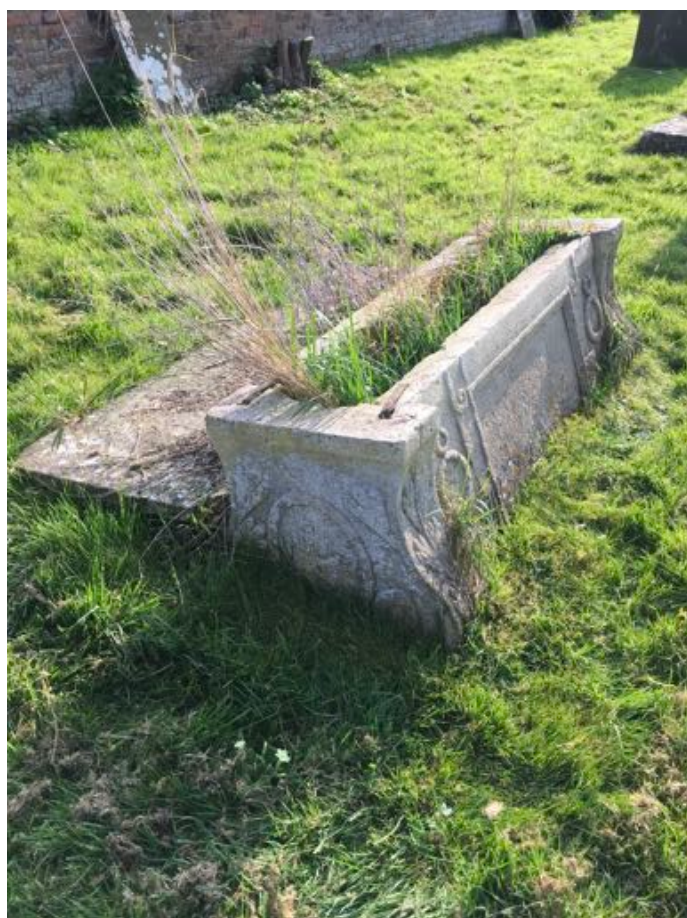
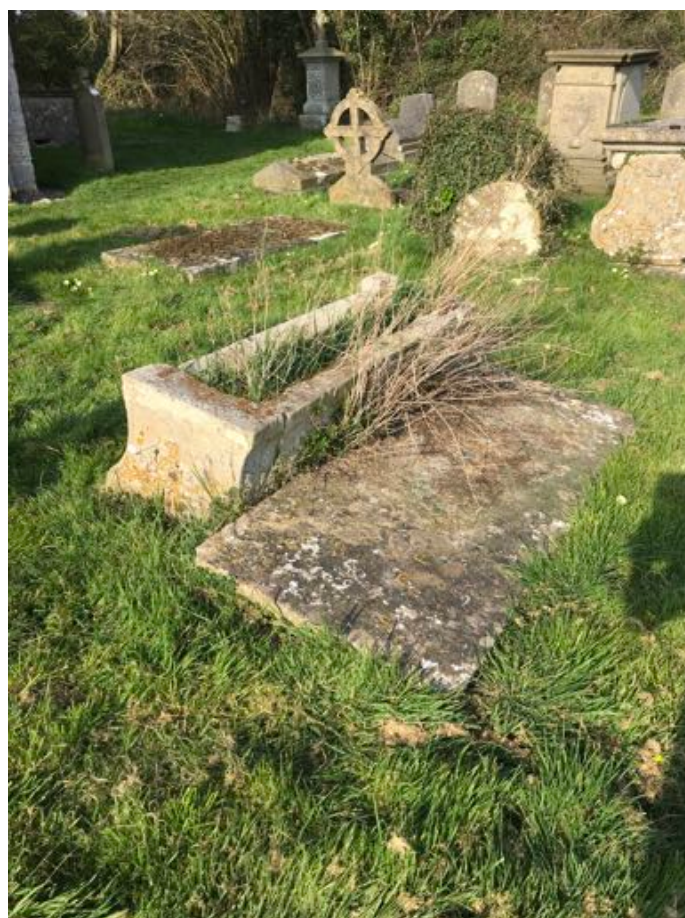
Condition of structure The tomb is subsiding to the south, the iron cramps are missing on the west but remain in place on the east. Strong plant growth inside the monument now the top has been removed.

Condition of surface The surface is as expected for the age of the monument.

Cause of deterioration Failure of rusting iron cramps and subsidence.

- Dismantle the sides of the monument
- Remove any vegetation growing within the space.
- Relevel the base on a shallow foundation of limecrete.
- Replace iron cramps with stainless steel set in lead.
- Rebed the top and point all joints with a matching lime mortar.

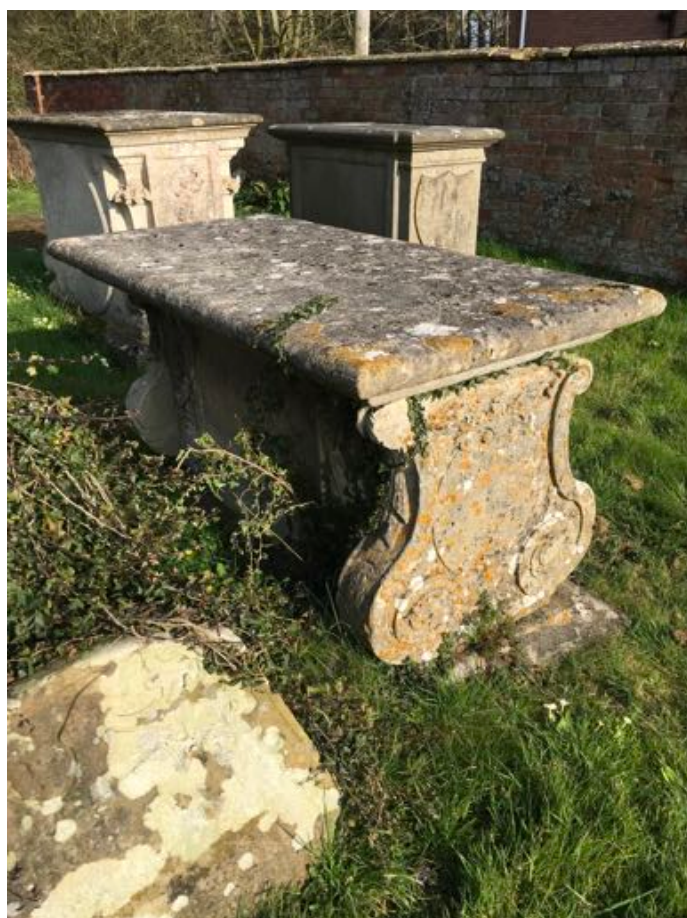
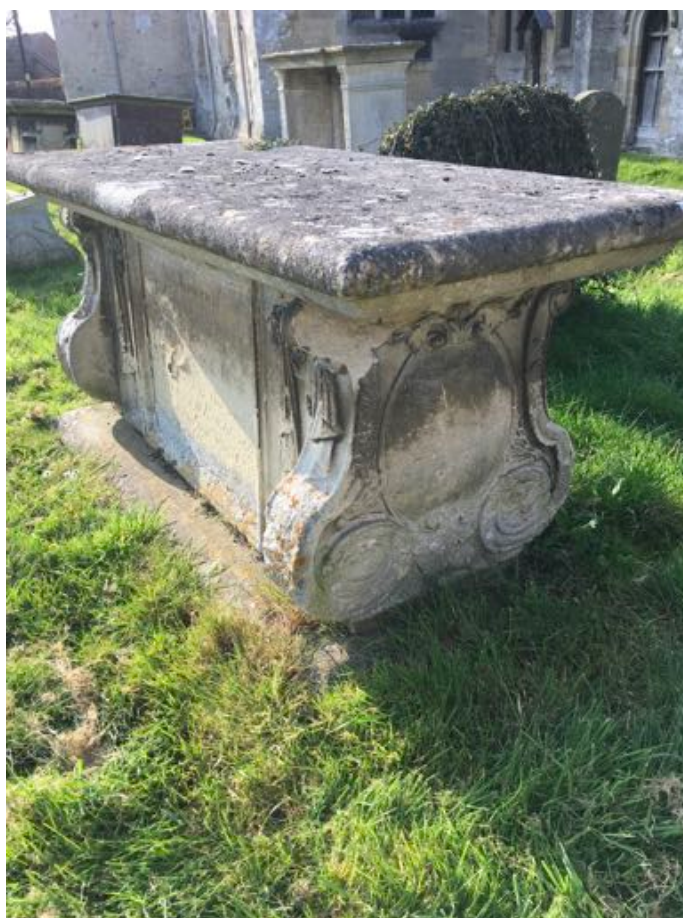
Condition of structure Slight lean to NE, rusting iron cramps on the north west loose / broken corner on the inscription panel. Large missing spall on SE corner. Open joints and the top is jacked up by stems of plants.

Condition of surface Contour scaling in the middle of the south side and also some on the north panel., smaller amount on the east end. There are the remains of black paint in the lettering on the north side.

Cause of deterioration Rusting iron cramps and the encroachment by vegetation.

Rebuild monument replacing the rusting iron cramps with stainless steel set in lead.

Replace top and point using a matching lime mortar.

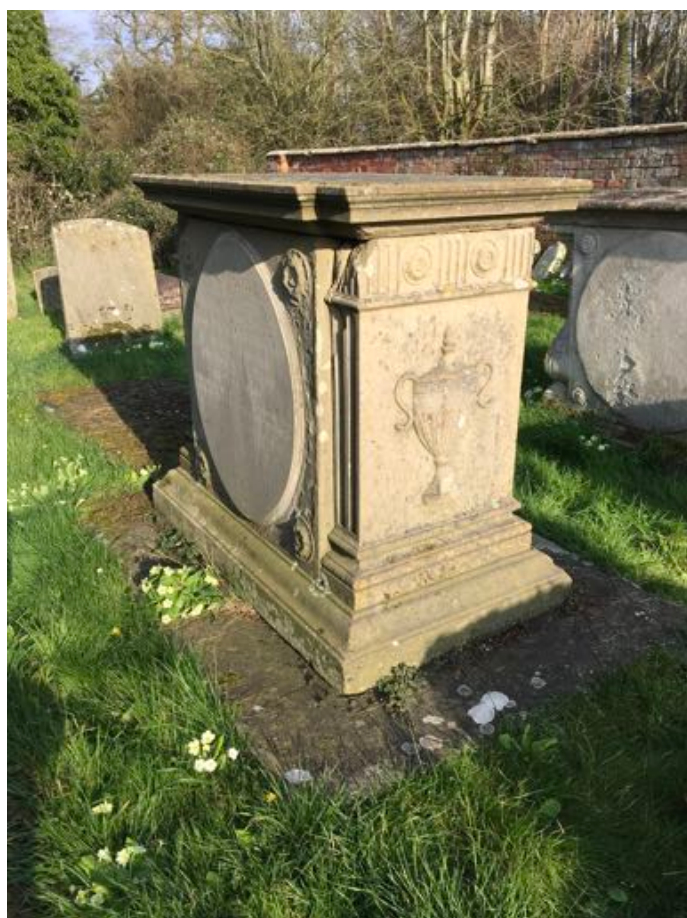
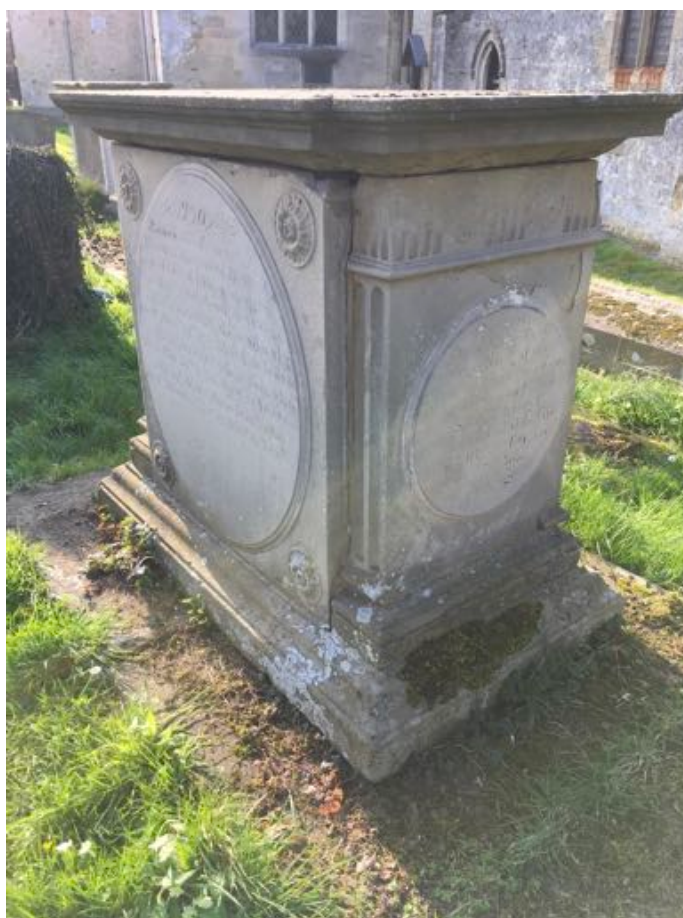
Condition of structure Cramp spalls on all four corners due to rusting iron cramps. The north and south panels could fall outwards as they are not being held securely.

Condition of surface Delamination all round the monument.

Cause of deterioration The rusting iron cramps have jacked the top up.

Remove the remains of the rusting iron cramps.

Replace the cramps in stainless steel set in lead pinning back the spalls.

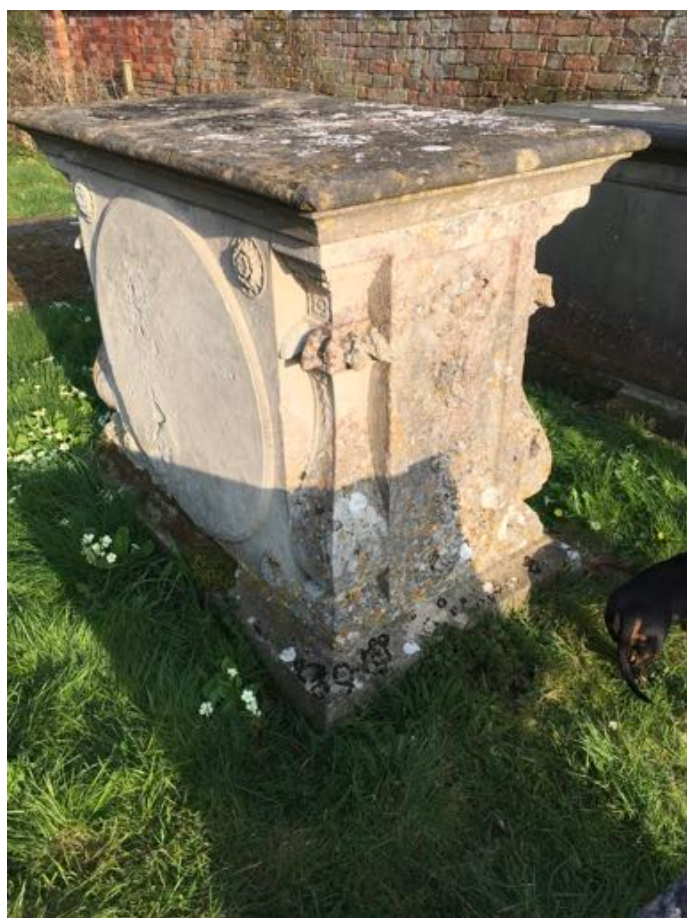
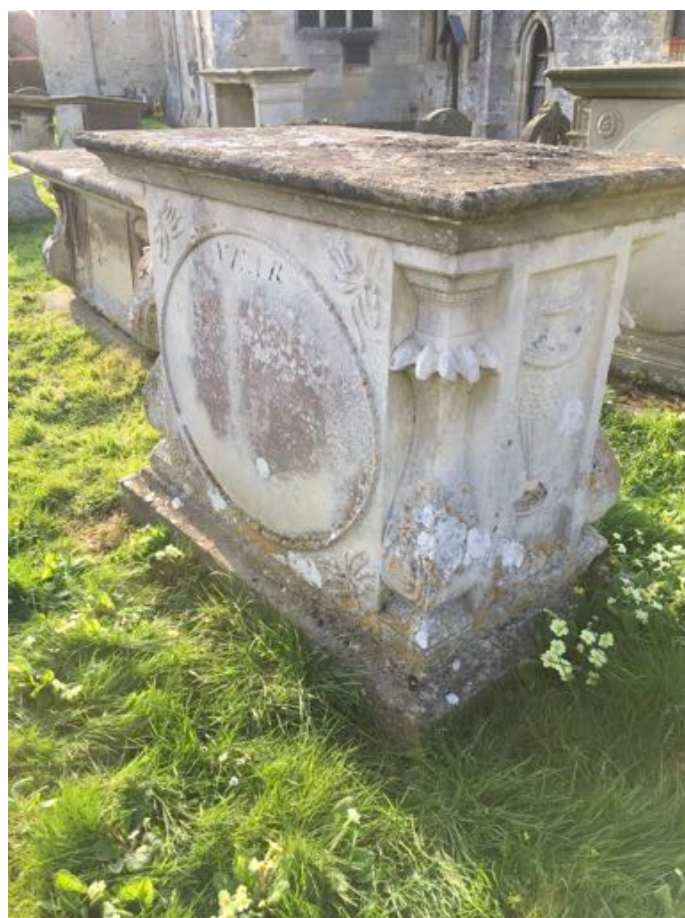
Previous interventions: Old iron cramp set across crack in top. Cement pointing.
