| Project name :<br><b>Ramsgate Town Council - Old Fire St</b> | Project Number : | Contact : | Date :<br><b>07/10/2022</b> |

Client: **Ramsgate Town Council**  
Contact Name:  
Department:  
Road: **The Custom House, Harbour Parade**  
Town: **Ramsgate**  
County: **Kent, CT11 8LP**  
Telephone:  
Fax:  
Mobile:  
E-mail:

Site: **Radford House**  
Contact Name:  
Department:  
Road: **18-20 Effingham Street**  
Town: **Ramsgate**  
County: **Kent, CT11 9AT**  
Telephone:  
Fax:  
Mobile:  
E-mail:

Contractor **BP Drains Ltd**  
Contact Name:  
Department:  
Road: **Unit 11 Invicta Way**  
Town: **Ramsgate**  
County: **Kent, CT12 5FD**  
Telephone: **01843 293040**  
Fax:  
Mobile:  
E-mail: **[office@bpd rainsoutheast.co.uk](mailto:office@bpd rainsoutheast.co.uk)**

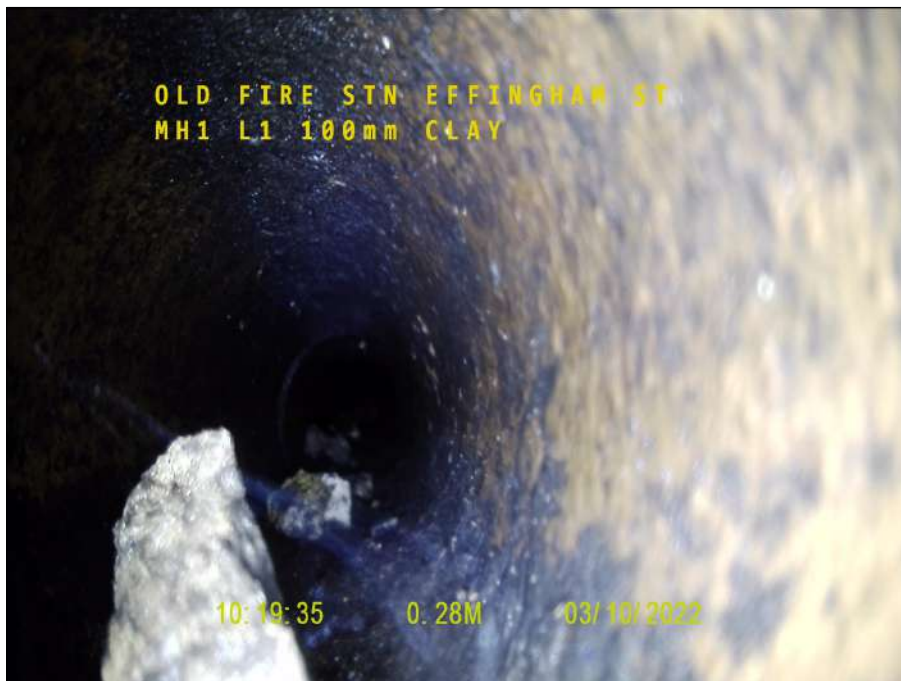
Photo: 1\_1\_4\_A.jpg  
0.28m, Settled deposits, coarse, 10% cross-sectional area loss, Start

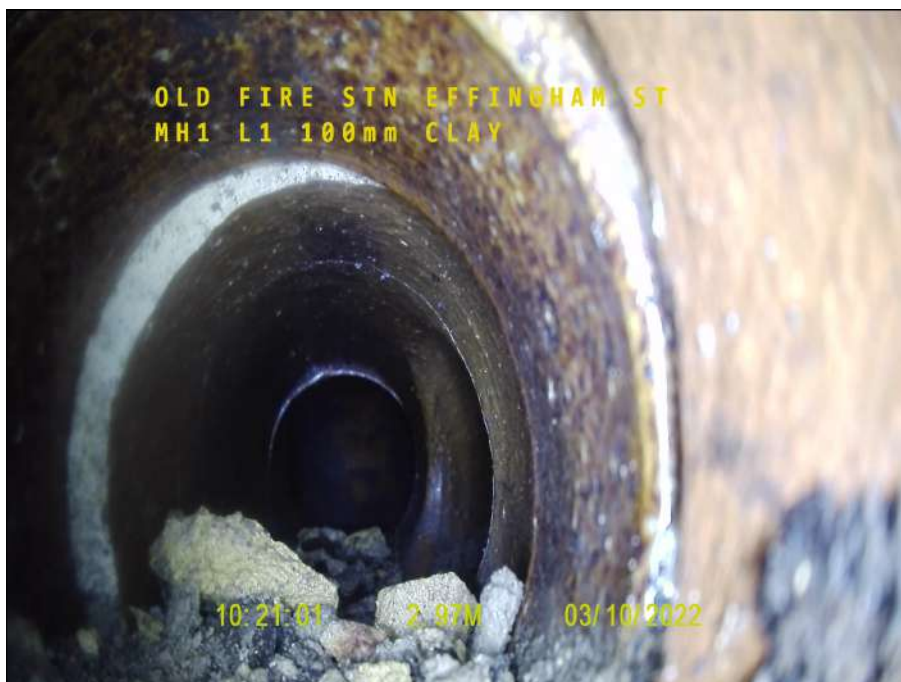
Photo: 1\_1\_7\_A.jpg  
3.07m, Joint displaced, medium

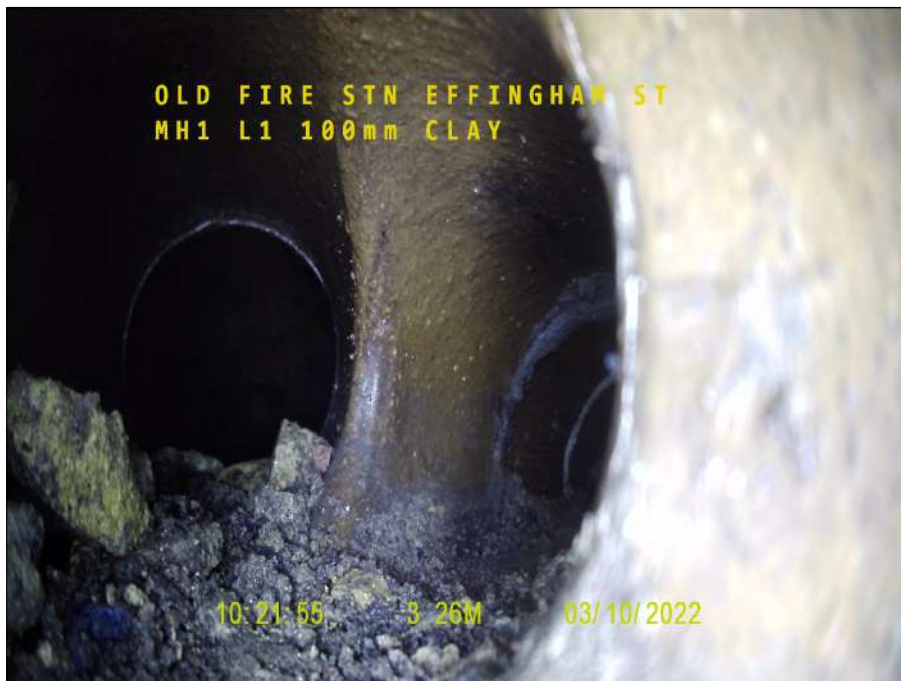
Photo: 1\_1\_10\_A.jpg

3.2m, Survey abandoned - Camera caught on debris at junction

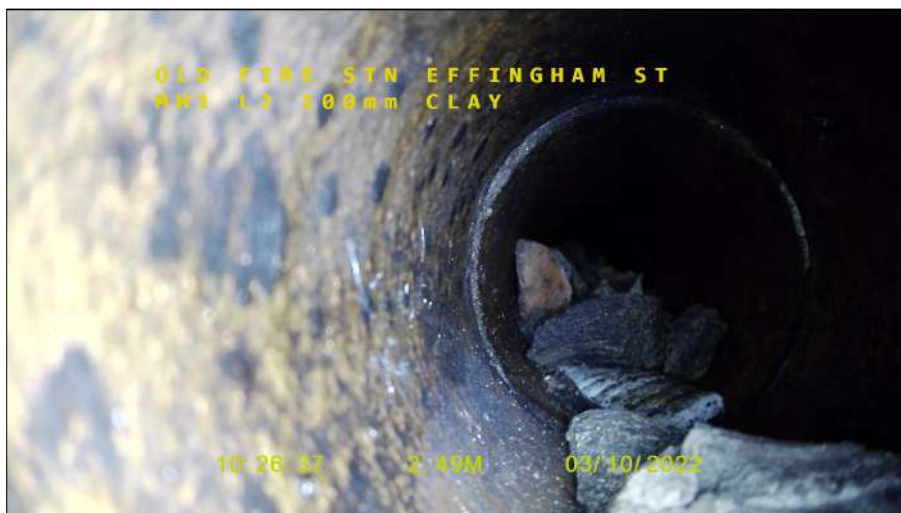
Photo: 3\_3\_13\_A.jpg

2.49m, Settled deposits, coarse, 10% cross-sectional area loss

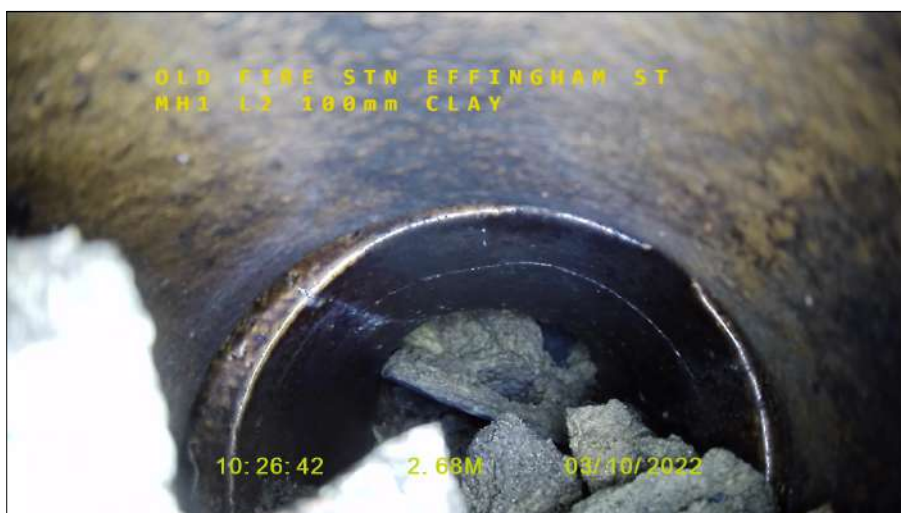
Photo: 3\_3\_16\_A.jpg

2.68m, Crack, circumferential at joint, from 10 to 3 o'clock

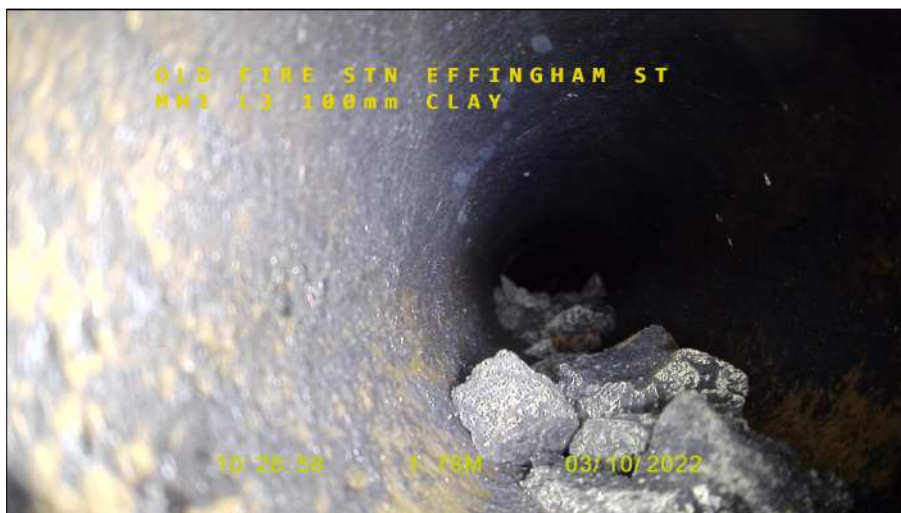
Photo: 4\_4\_19\_A.jpg

1.78m, Settled deposits, coarse, 15% cross-sectional area loss, Start

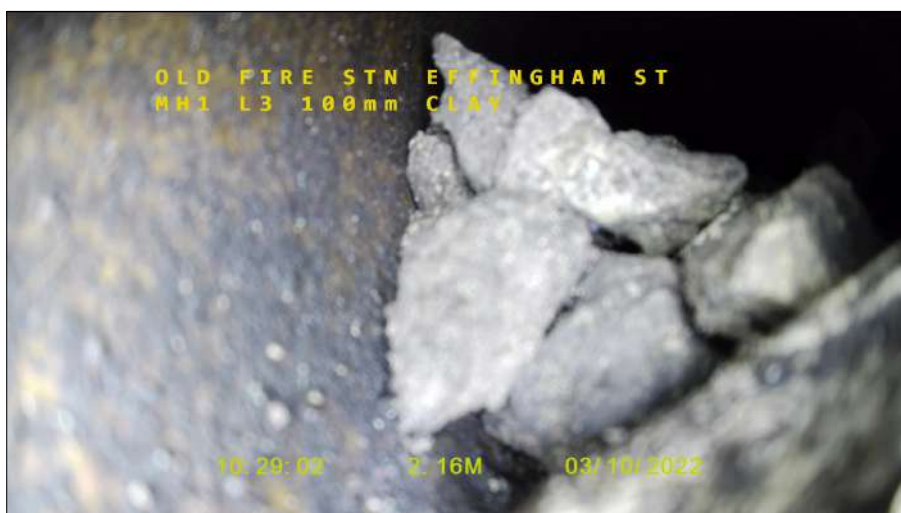
Photo: 4\_4\_21\_A.jpg

2.26m, Survey abandoned - Pipe blocked by debris

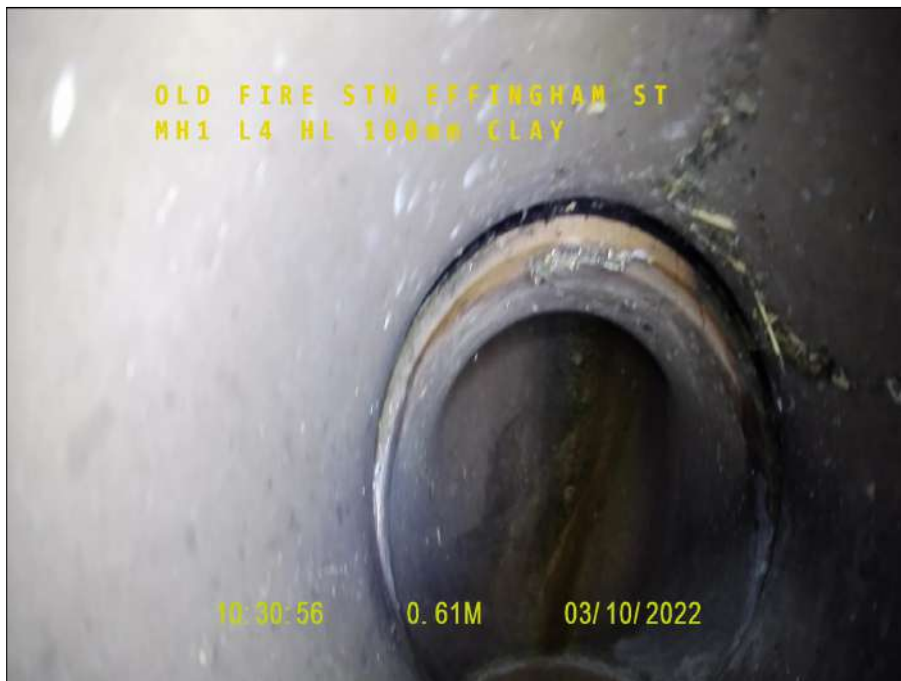
Photo: 5\_5\_24\_A.jpg  
 0.61m, Joint displaced, medium

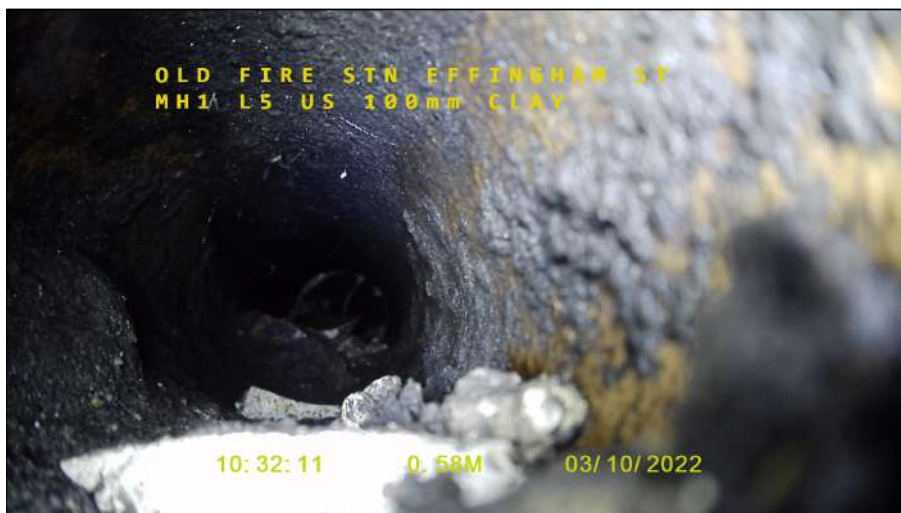
Photo: 6\_6\_29\_A.jpg

0m, Settled deposits, fine, 15% cross-sectional area loss, Start

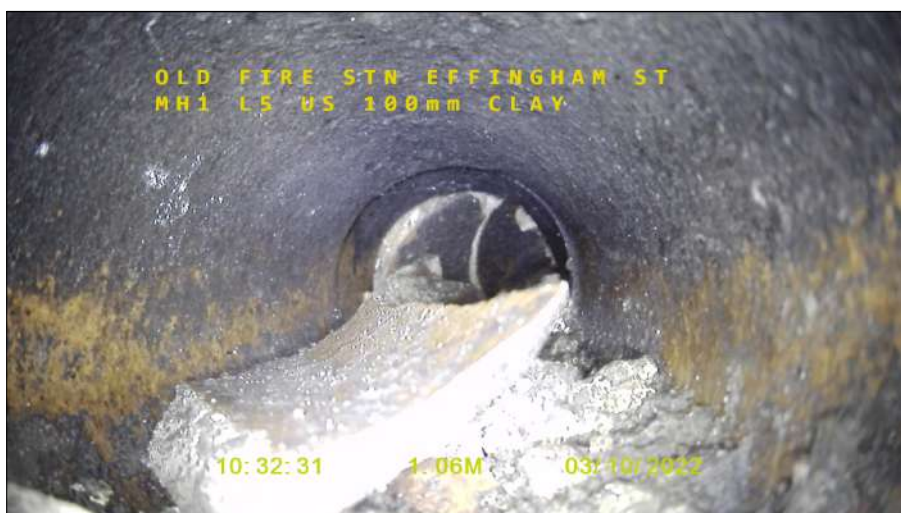
Photo: 6\_6\_30\_A.jpg

1.06m, Settled deposits, coarse, 10% cross-sectional area loss

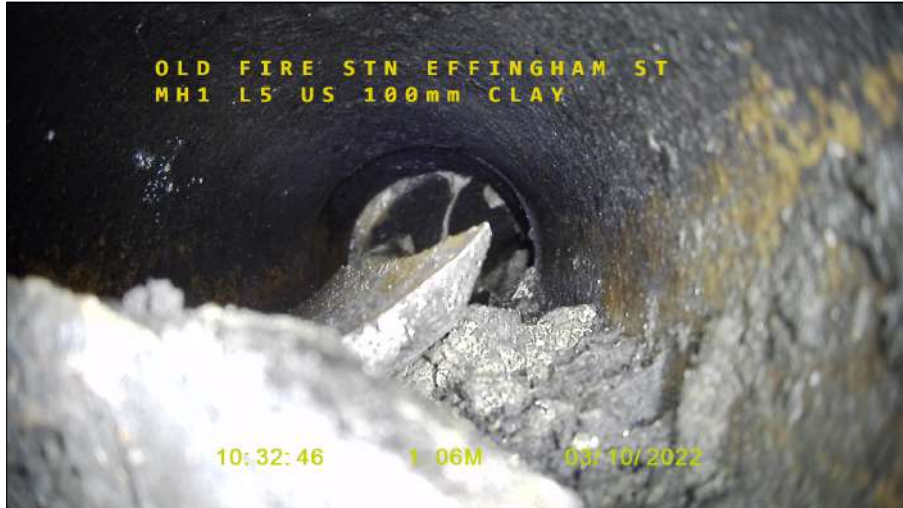
Photo: 6\_6\_32\_A.jpg

1.06m, Survey abandoned - Pipe blocked by debris

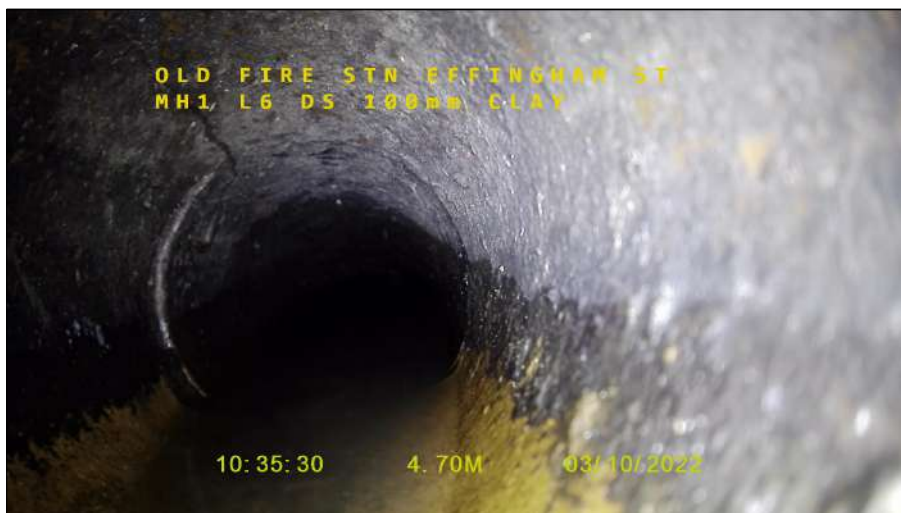
Photo: 7\_7\_35\_A.jpg

4.7m, Water level, 10% of the vertical dimension

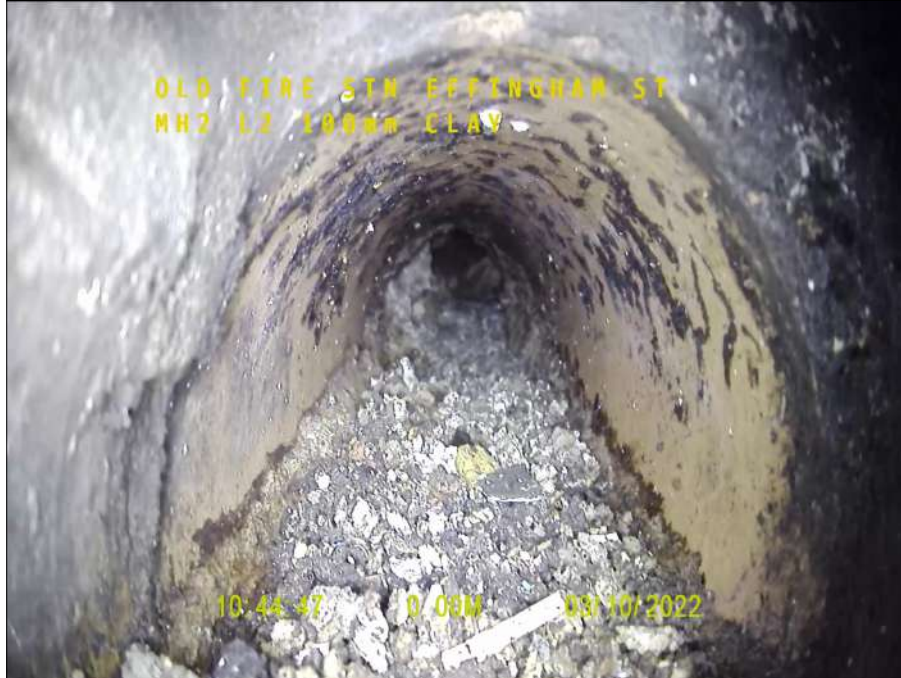
Photo: 9\_9\_45\_A.jpg

0m, Settled deposits, coarse, 15% cross-sectional area loss, Start

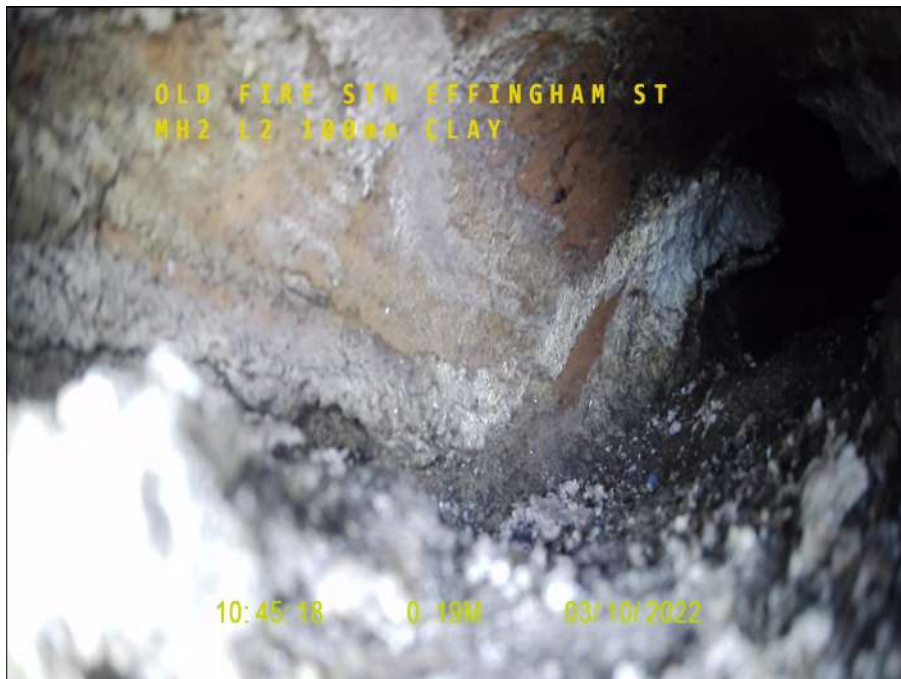
Photo: 9\_9\_48\_A.jpg

0.19m, Survey abandoned - Pipe blocked by debris

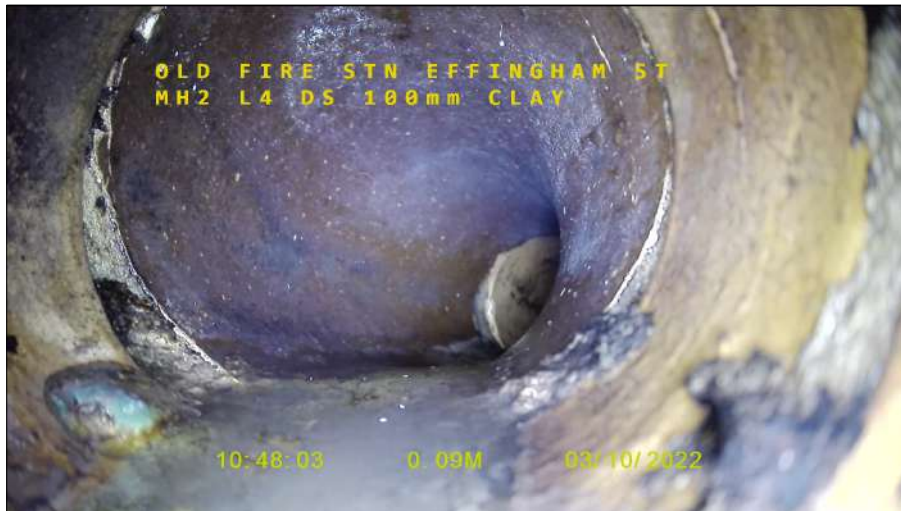
Photo: 11\_11\_54\_A.jpg  
 0.1m, Joint displaced, medium

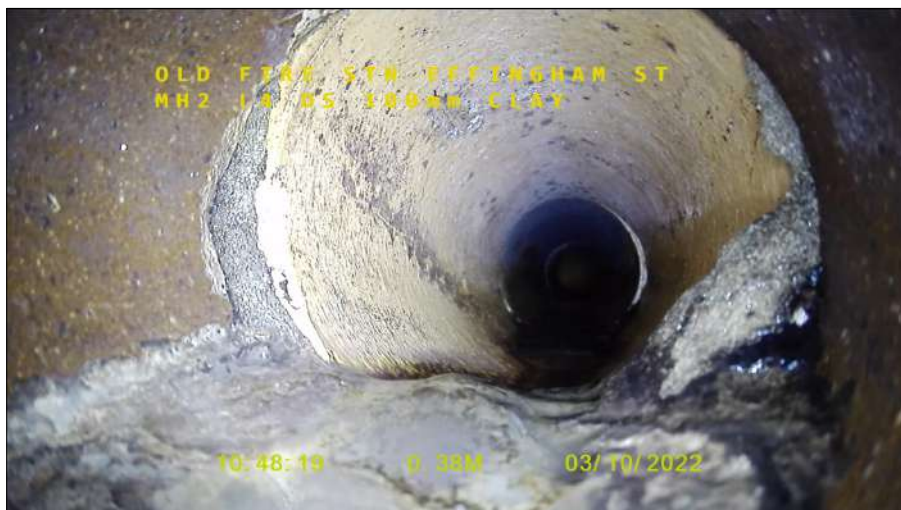
Photo: 11\_11\_57\_A.jpg  
 0.28m, Settled deposits, hard or compacted at joint, 10% cross-sectional area loss

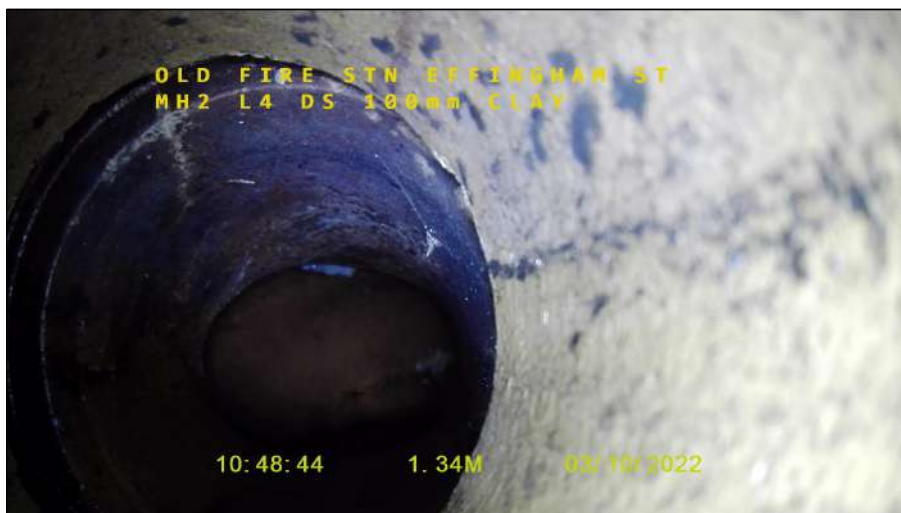
Photo: 11\_11\_59\_A.jpg  
1.34m, Joint displaced, medium

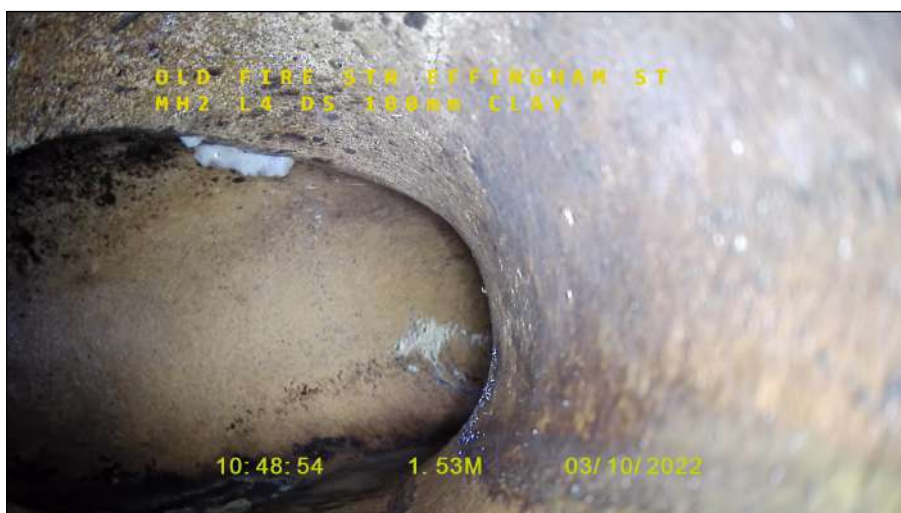
Photo: 11\_11\_60\_A.jpg  
1.53m, General remark - Enters into another line

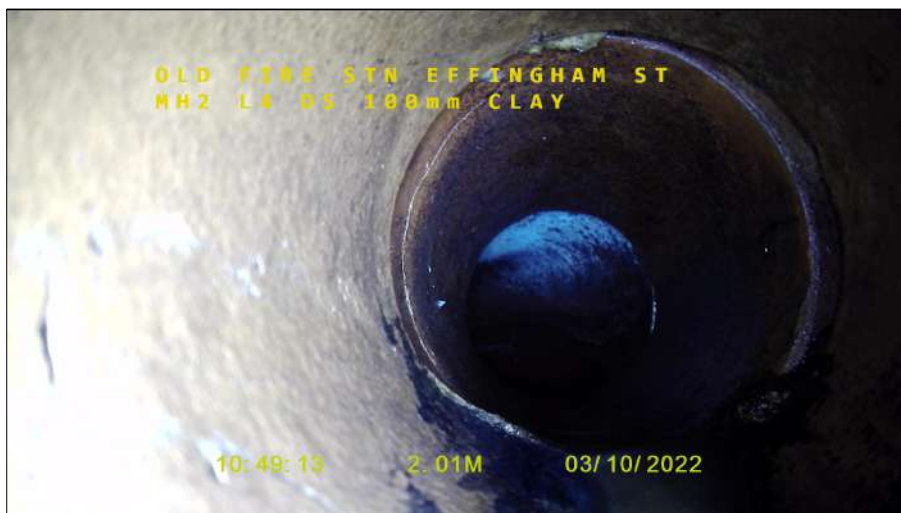
Photo: 11\_11\_61\_A.jpg  
2.01m, Crack, circumferential at joint, from 7 to 12 o'clock

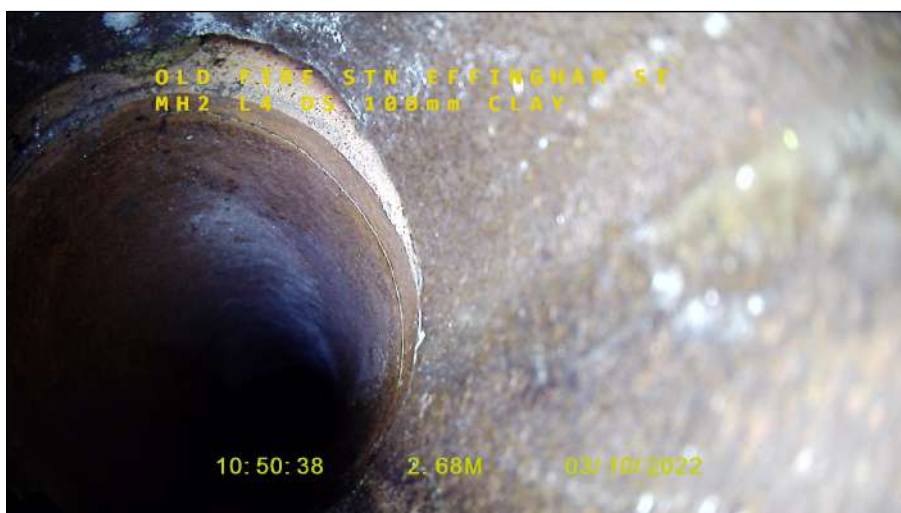
Photo: 11\_11\_63\_A.jpg  
2.68m, Joint displaced, medium

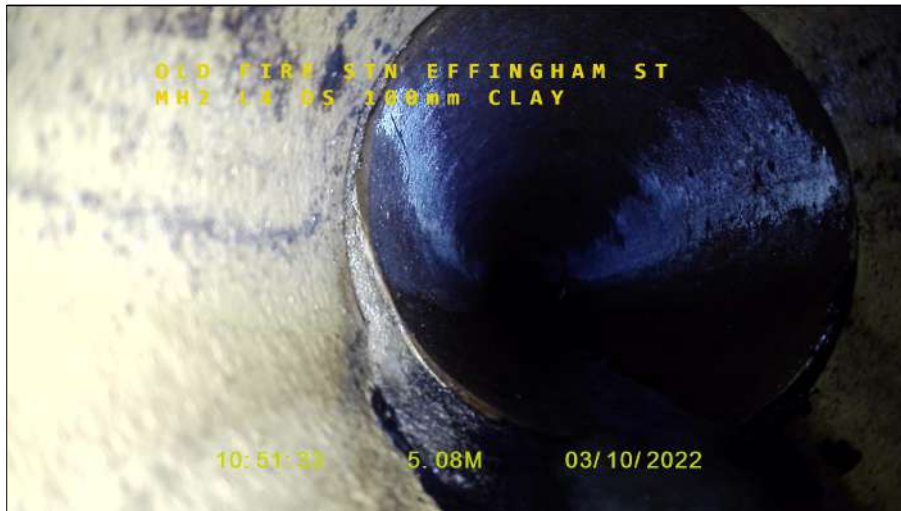
Photo: 11\_11\_68\_A.jpg  
5.08m, Joint displaced, medium

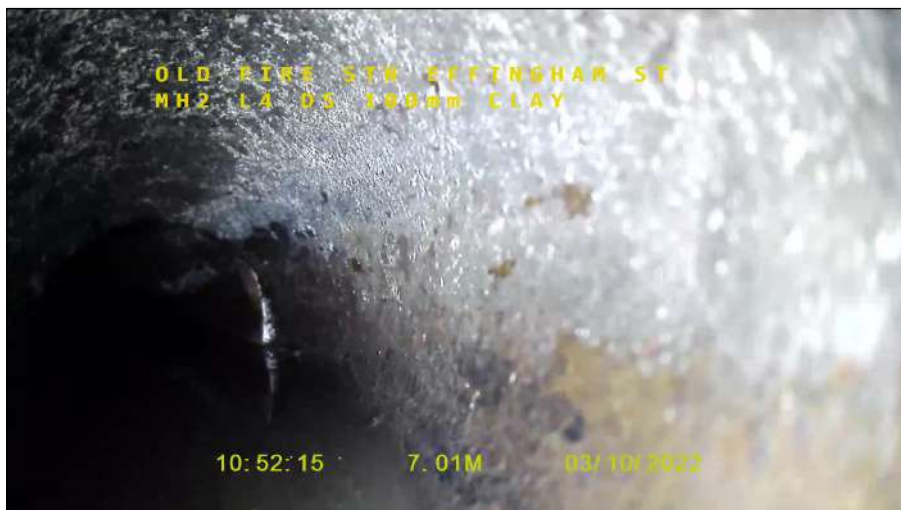
Photo: 11\_11\_71\_A.jpg  
7.01m, Water level, 30% of the vertical dimension

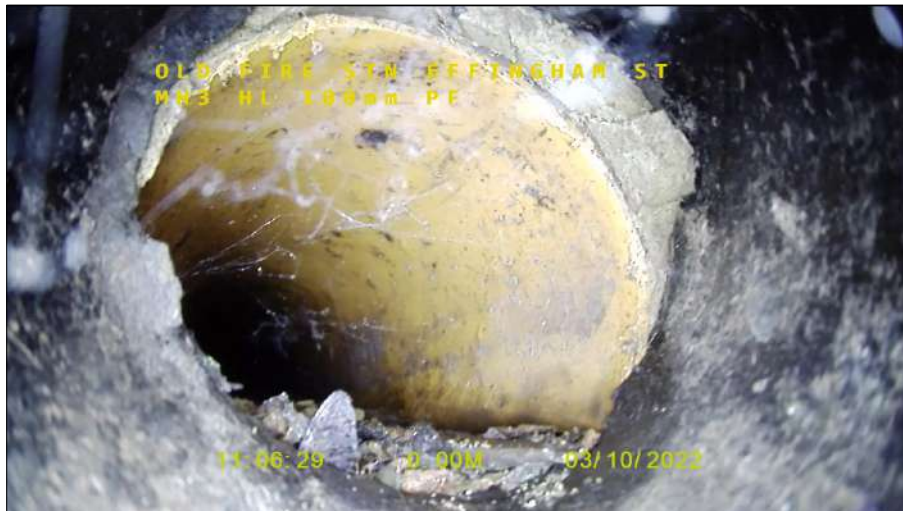
Photo: 12\_12\_79\_A.jpg  
 0.2m, Joint displaced, large

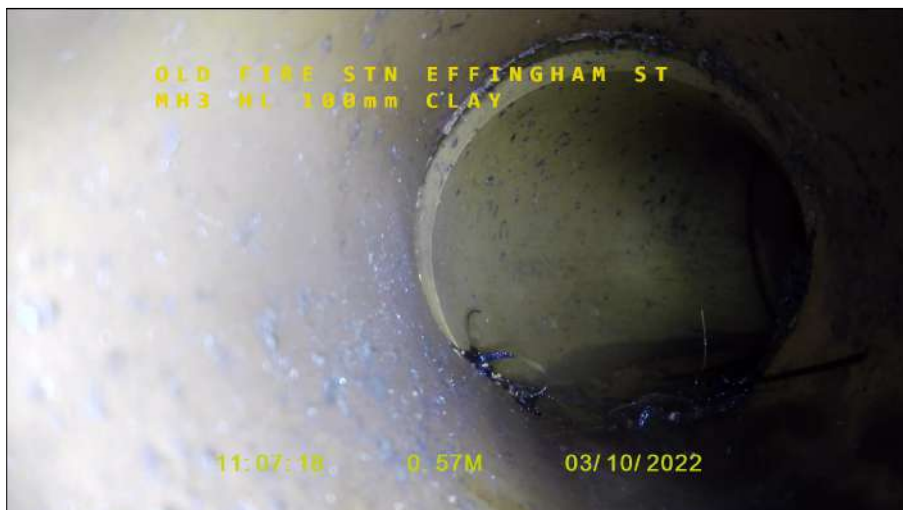
Photo: 12\_12\_83\_A.jpg  
 0.67m, Roots, fine at joint

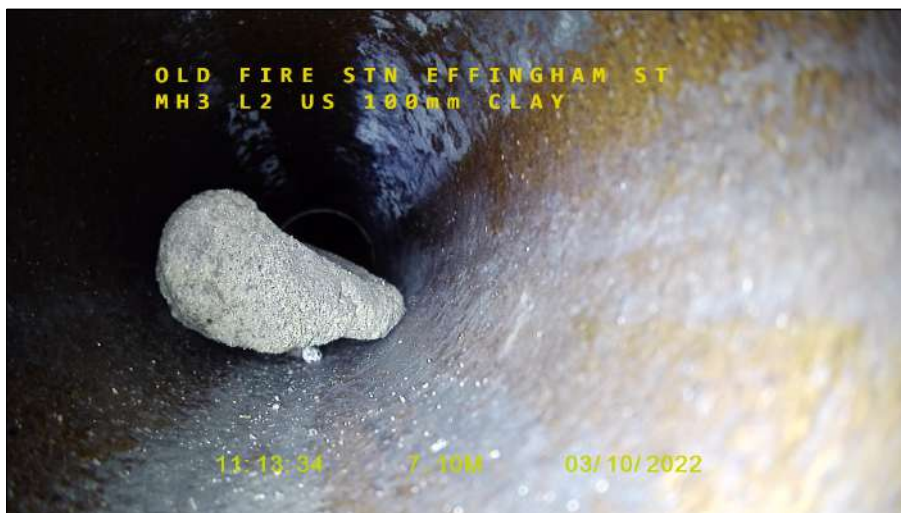
Photo: 13\_13\_90\_A.jpg  
7.01m, Settled deposits, coarse, 30% cross-sectional area loss

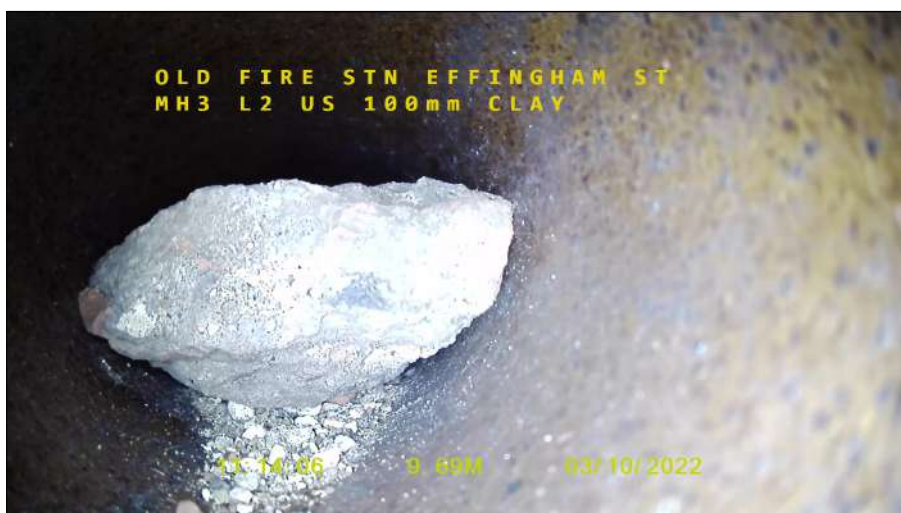
Photo: 13\_13\_91\_A.jpg  
9.09m, Settled deposits, coarse, 50% cross-sectional area loss

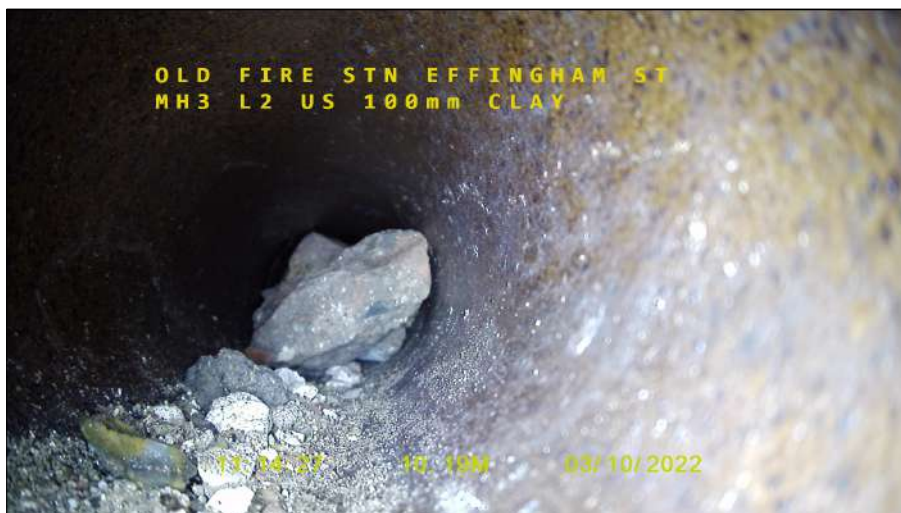
Photo: 13\_13\_92\_A.jpg

10.19m, Survey abandoned - Blocked by debris

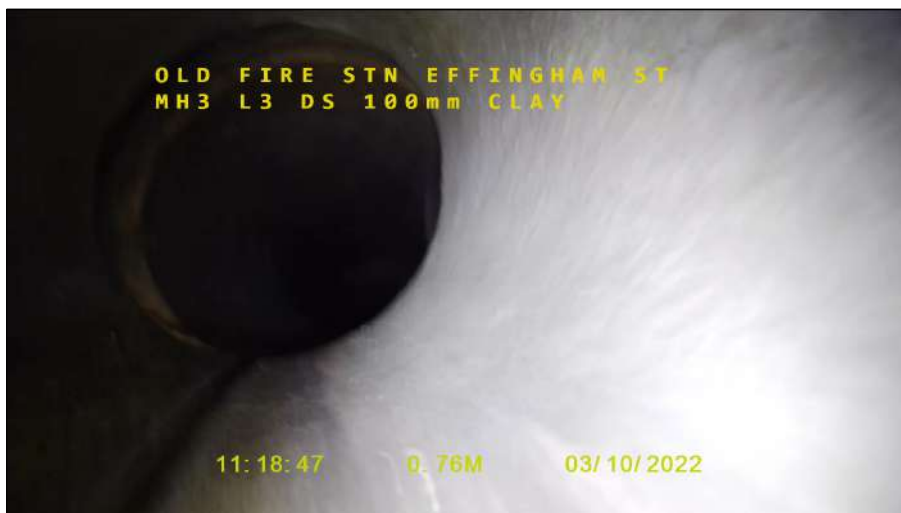
Photo: 14\_14\_96\_A.jpg  
0.96m, Joint displaced, medium

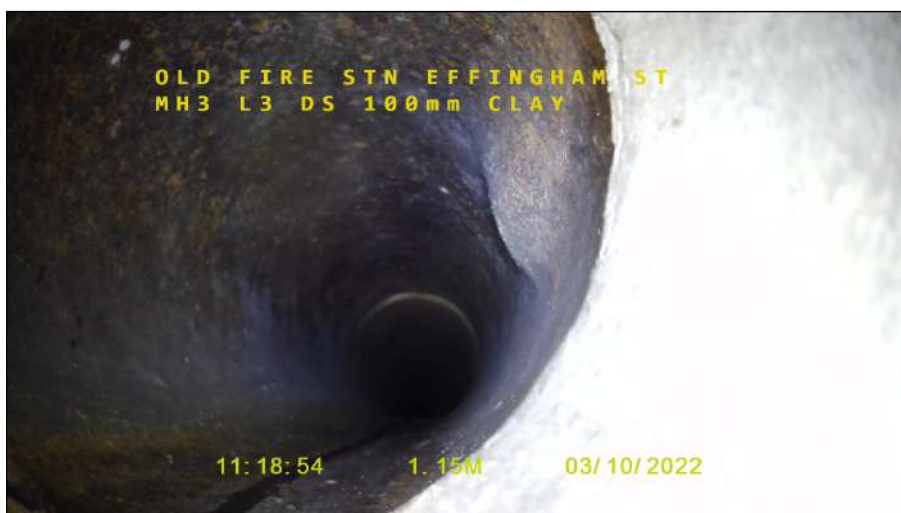
Photo: 14\_14\_97\_A.jpg  
1.15m, Deformed sewer/drain, 5%
