**National Asset Delivery  
Technical Surveys and Testing**

**570127**

**M5 J11-J10 Northbound MP81/7**

**CCTV Survey**

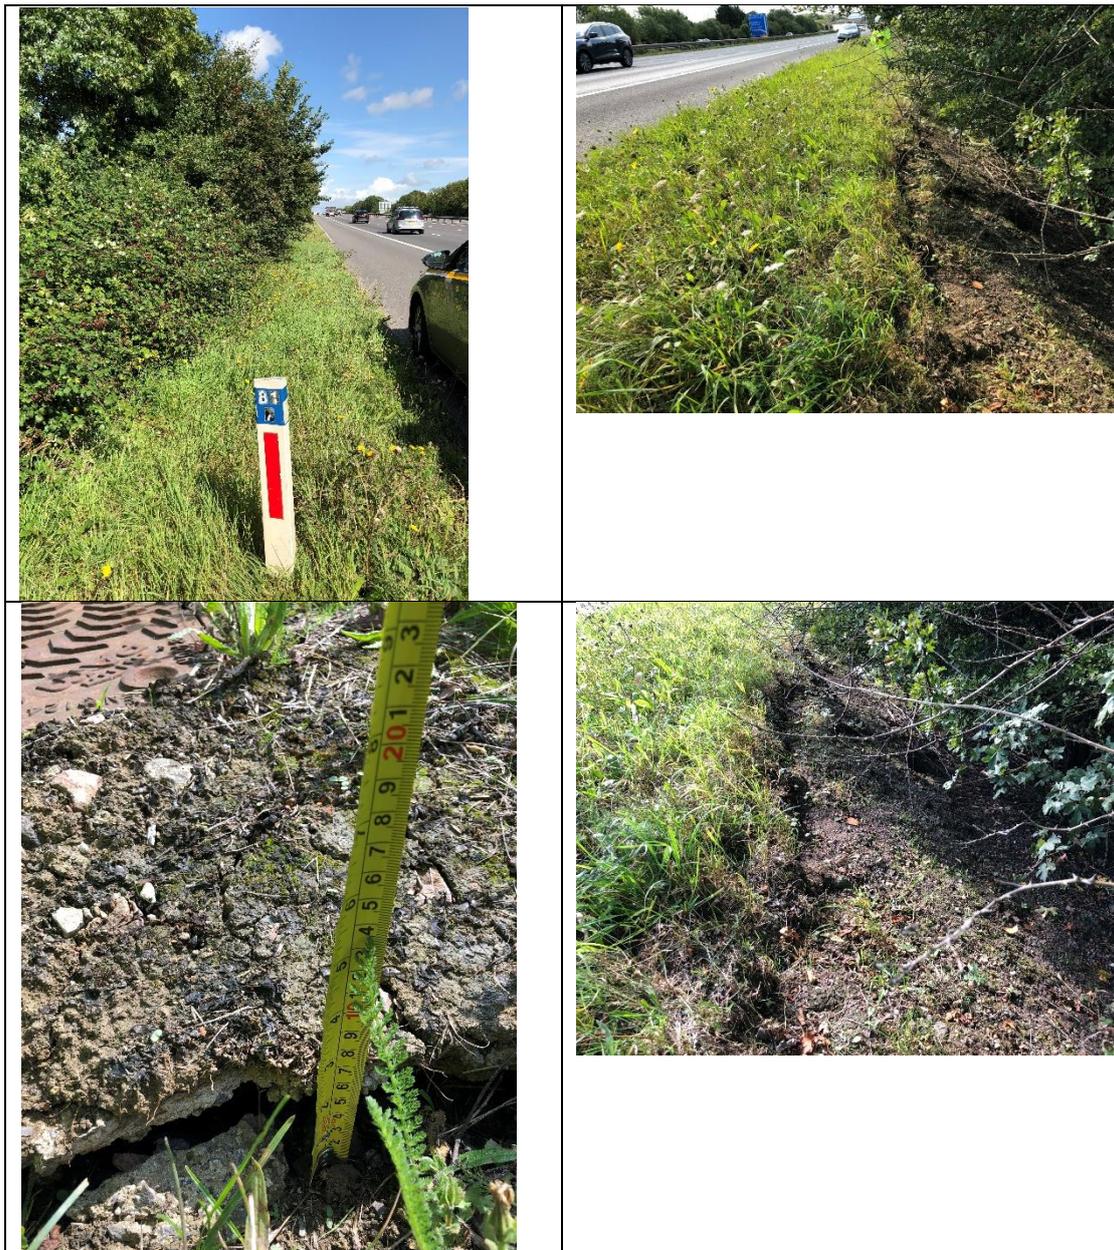
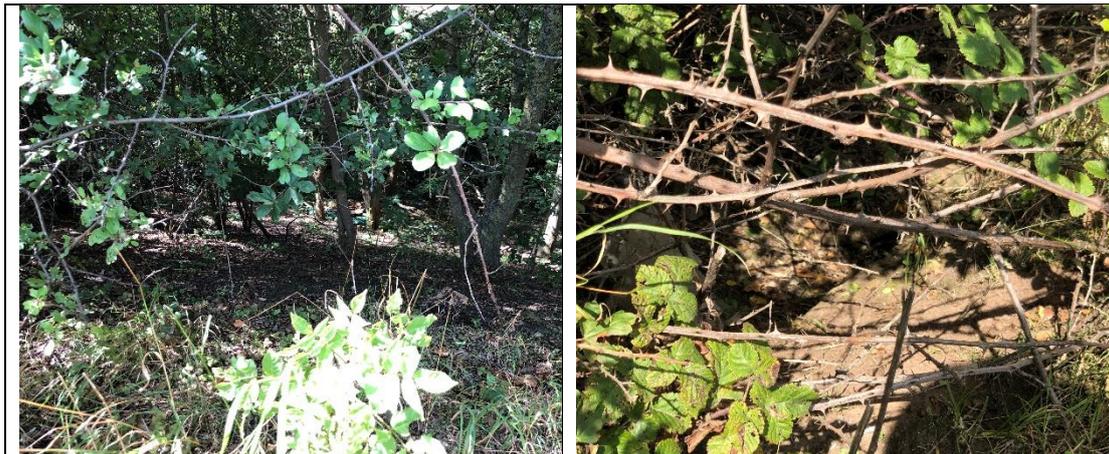
The M5 MP81/7 scheme is located on the northbound embankment of the M5 to the west of Cheltenham at approximate National Grid co-ordinates 389647, 222079. Repairs to an embankment defect (soil slip, bulge and tension crack ) are required, extending from 389650, 222067 to 389651, 222090.

Photographs taken in 2019 are presented below.

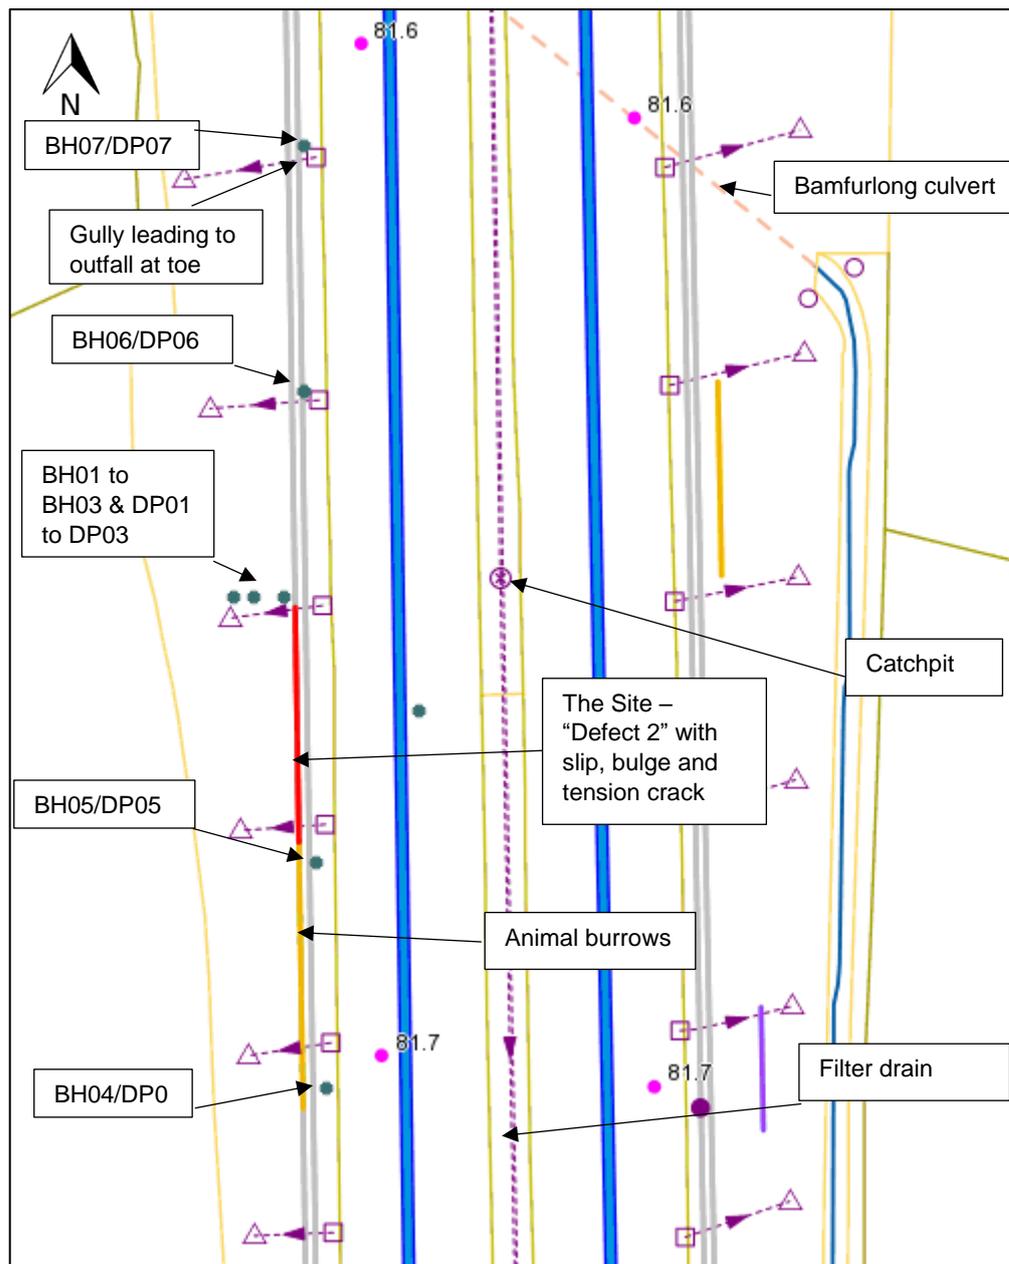
Figure 1: Site details

An extract from HAGDMS showing the location of the site identified as “Defect 2”, drainage and historic boreholes is given in Figure 1.
