Market House Site Layout

CLIENT: Rose-of-Wyke Town Council
PROJECT: Market House
TITLE: South Elevation External Stone Repairs 1 of 2
SCALE: 1:15
DATE: 05/07/22
SHEETING: A1
REF: NW CAB
JOB/DRAWING NUMBER: 1 046 Town Street, Rose-of-Wyke, Notts NG20 9HT
Tel: 01909 280870
Fax: 01909 280870
Email: info@hawkesedwards.com
CIPD: 026

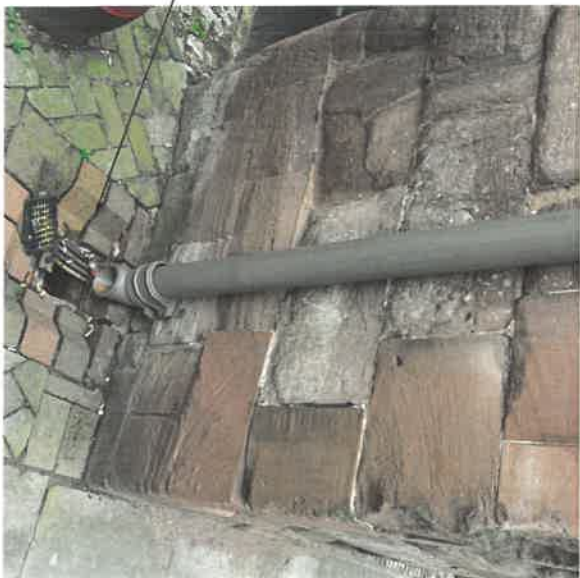
South west corner

Existing condition of South West Corner.

Rake out and deepack and repoint thin horizontal mortar joint under base of corner stone

Rake out and repoint to open defective vertical joints, mainly to corner stones and the base of bottom course.

Rake out and deep pack open joints to modern brickwork surround to gully. Allow for replacement iron gully grille

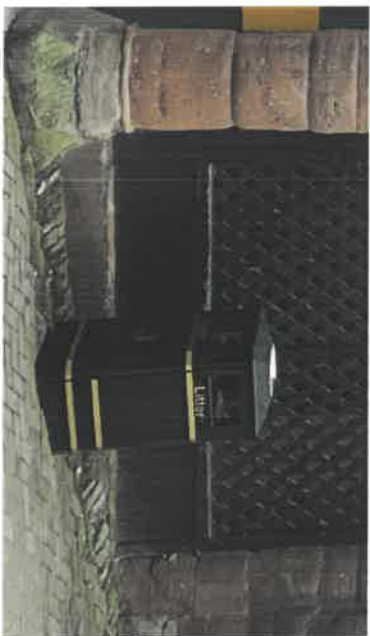
Lower 2 base stones to half column 7b are ending heavily on surface. Gently brush back loose friable stone back to a sound hard crust. Allow for minor pointing to this area as directed by the architect.

Current condition of lower stones to column 7b.

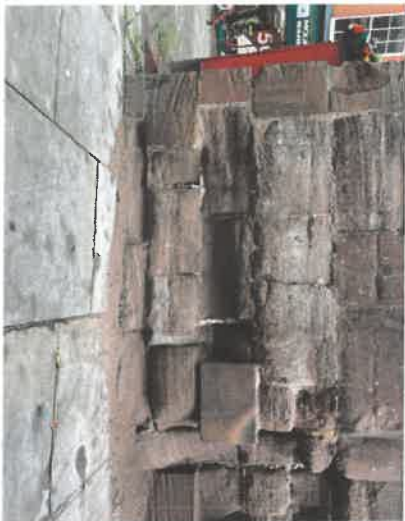
Area of stone corresponding to drawing
Current condition of existing lower left wall to the south west corner.

Gentily brush loose delaminated stone from the exposed face back to a sound surface.
Refer to dng' 850-017

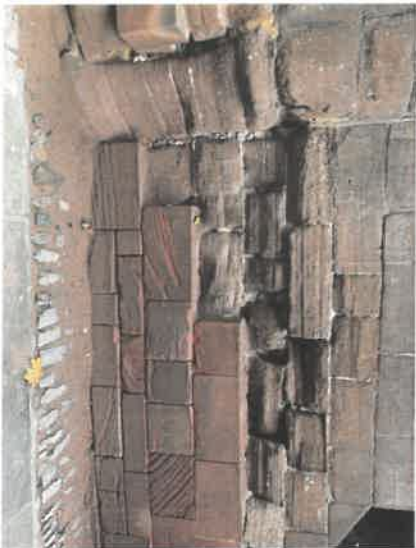
Current condition of south west corner adjacent to half column 8a

A degree of further investigation is necessary to determine how deep the stone sections are, and what building material is present as the structure core.

The stones are severely eroded, especially the two lower large stone sections to the half column referred to as (Col 8a).

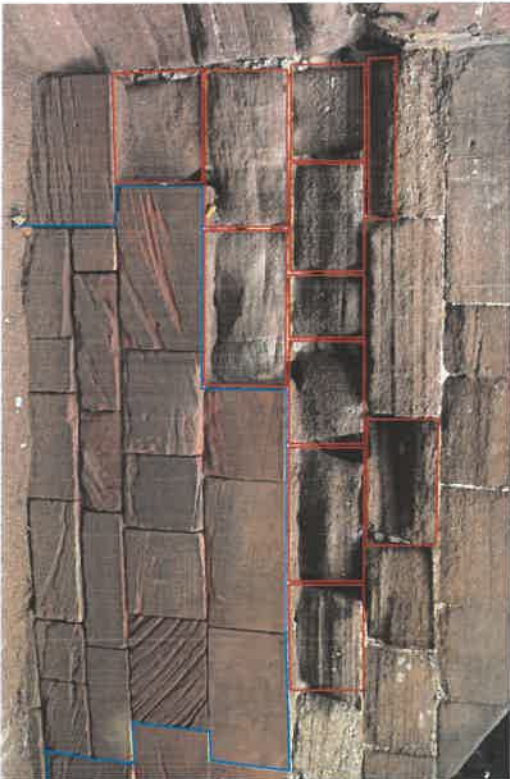
The area below outlined in BLUE represents earlier previous attempts at stone replacement and for unknown reasons the lime mortar has failed and desintegrated.

The identified red outlined blocks indicated above require replacing in part or whole, each stone to be treated on an individual basis. As stones are exposed, visual inspections can determine extent of replacement. Ashlar stone replacements of a minimum depth of 150mm.

Allow for filling in large voids which may be present behind the outer stone. Architect to advise as works uncover and progress.

Ideally this area should be carefully removed and rebuilt using the same stone blocks. Report this area in line with the specification and above stone replacements. Refer to drawing 560-018

Outer line of best preserved existing stone section to upper column 8a
Replacement stones below to line through to above.

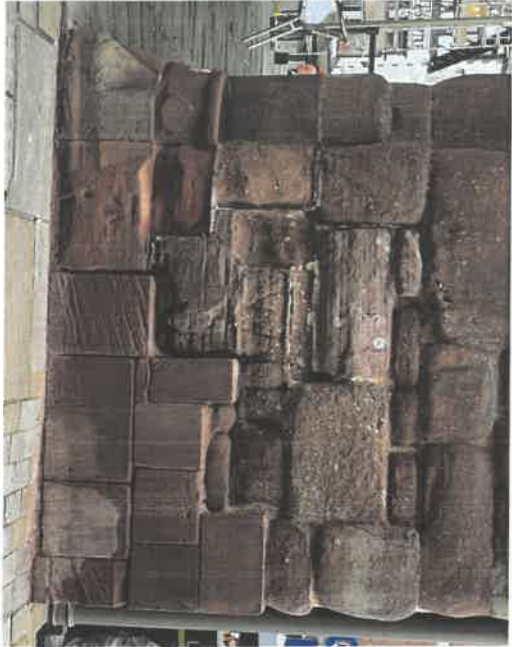
Area of existing stonework to South Elevation requiring sensitive repointing. Lower previously replaced newer stone joints to be carefully packed tight with approved lime mortar.

Existing Photographic Record of the east end of the lower stone to the South Elevation

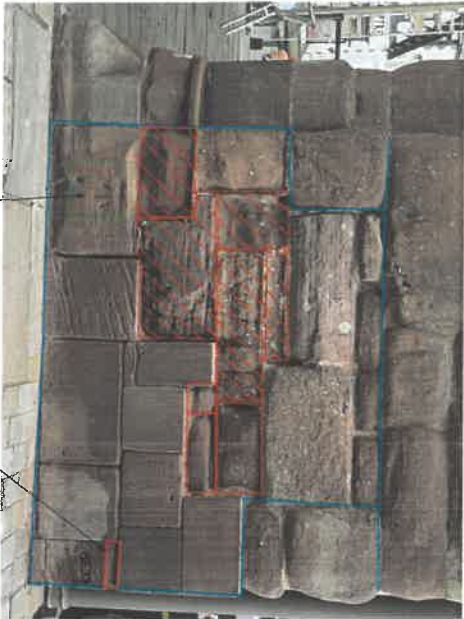
Hatched recessed stone blocks are questionable and if left will advance the decay of adjacent stones.

In order to uniform the stone and protect the lower block edges. Recommend refacing hatched blocks with 150mm deep ashlars at the heavier eroded areas. Introducing red clay tile creasing where possible to preserve more of the historic fabric. The Conservation Architect to advise and direct exact intervention on site.

Apply sensitive plastic mortar repair to the top eroded section of the corner block S33. Mortar repair to match host stone in colour, texture and finish.

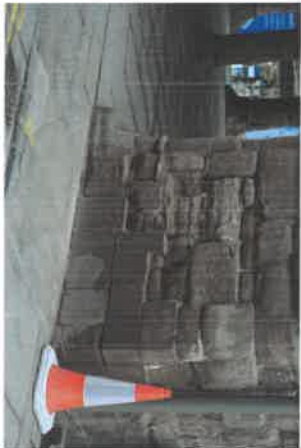
South east corner shown above demonstrating its close proximity to the adjacent highway. A likely contributory factor to the lower stone and mortar erosion.
