TASK NO.	TASK/DESCRIPTION	NOTES
H1.03	<p data-bbox="379 331 1241 360">H1 HULL AND STRUCTURE - VESSEL MOVEMENT AND BERTHING</p> <p data-bbox="408 389 943 418"><b>Return of Vessel to Permanent Mooring</b></p> <p data-bbox="408 439 1241 551">The vessel is to be moved from alongside Refit location to the permanent mooring berth within Portland Harbour. This move has to be undertaken "cold" and the Contractor is responsible for the provision of tugs/workboats, personnel and pilotage to facilitate the move.</p>	<p data-bbox="1249 365 1455 618">Custody of the Vessel will not be transferred from the Contractor until this evolution has been successfully completed.</p>

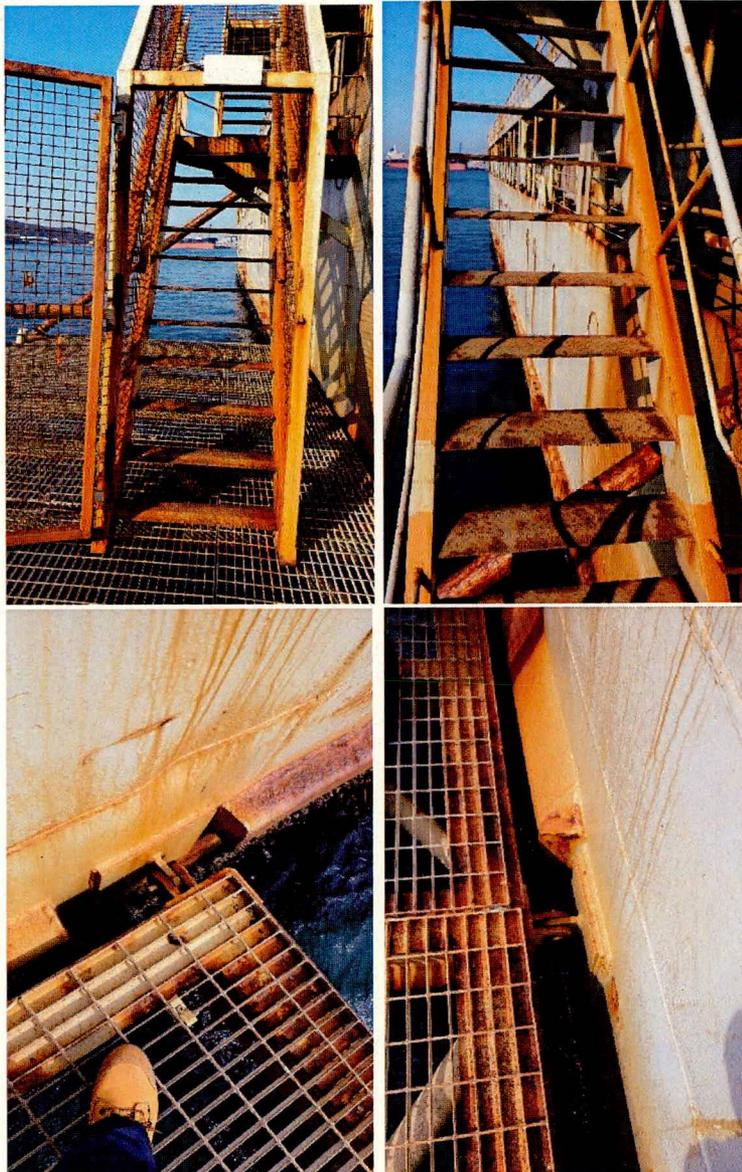
Port and stbd access platforms and pin joints anchorings to hull are extensively suffering from paint coating breakdown and active corrosion. Stbd has sustained storm damage (platform plates recovered by Quest Marine, may be refitted before RPSD). Both port and stbd platforms and stern platform to be REMOVED by contractor prior to moving to Refit berthing. Both port and stbd platforms require RE-FURBISHED and REPRESENTED. All platforms to be refitted when Vessel returned to permanent mooring on completion of alongside work.

Allow for 150m<sup>2</sup>

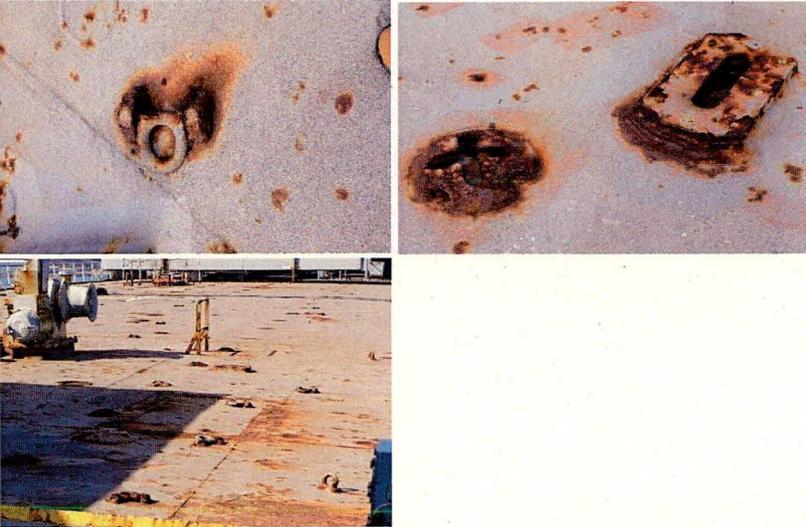
TASK NO.	TASK/DESCRIPTION	NOTES
H2.01	<p data-bbox="400 416 746 450"><b>Redundant Deck Fittings.</b></p>

<p data-bbox="400 1003 1206 1115">Numerous vehicle deck deck fittings are excessively corroded. As no longer required, they are to be removed and any areas of corroded plate cropped out and weld inserts fitted, REPRESENT effected areas. ALLOW for 50 in number fittings. ALLOW for 30m<sup>2</sup> REPRESENTATION</p>	<p data-bbox="1246 416 1453 589">Hotwork Required – Appropriate precautions to be taken iaw General 8.4.</p> <p data-bbox="1246 618 1453 730">IAW Paint scheme -General 12 and Annex B refer.</p>
