Feasibility Report

In respect of:
Former Fire Station, Frankwell Street,
Tywyn, LL36 9EW

On behalf of:
Maritime and Coastguard Agency

August 2023

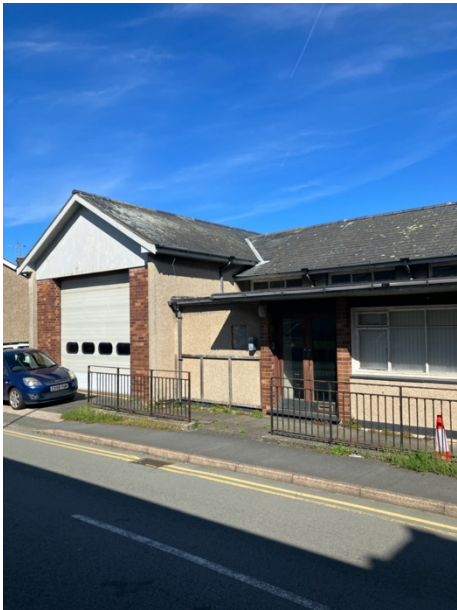
A photograph showing the front elevation of a single-story house. The house has a grey gabled roof, a white garage door, and a brick chimney. A blue car is parked on the street in front of the house. The sky is clear blue.	Front Elevation
2.

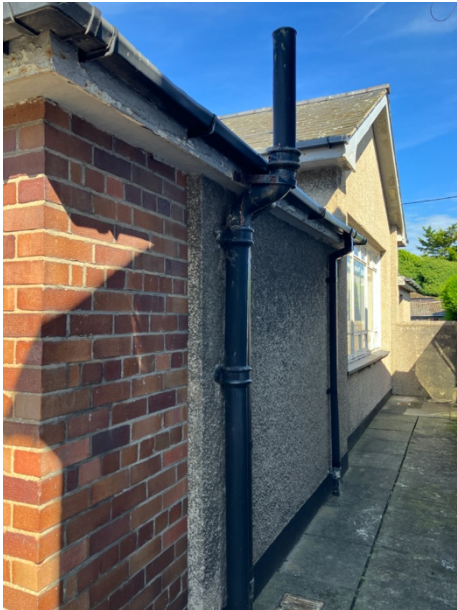
A photograph showing the right-hand side elevation of the house. It features a brick wall on the left, a grey textured wall on the right, and a black downspout running vertically. A window is visible on the right side. The sky is clear blue.	Right Hand Side Elevation

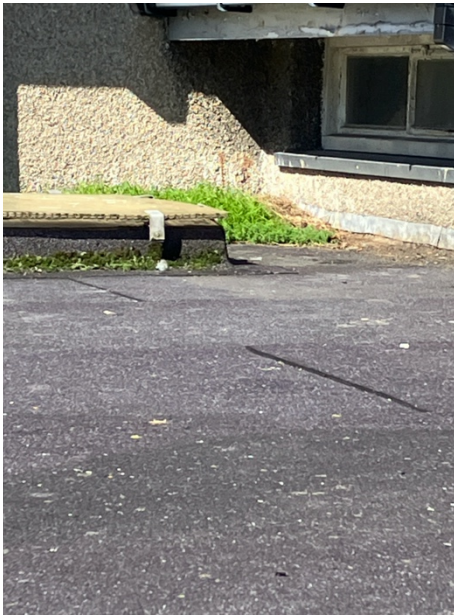
- 5.5 One roof light at the front was noted to have been replaced with a non matching repair, and although sound may require further attention.
- 5.6 Gutters and downpipes are sound but dated and UV degraded. These will require periodic overhaul and clearing. An original cast iron Soil Vent Pipe is in poor decorative order and subject to corrosion. This will require replacement.

Typical Flat Roof [Front] – noting mismatch roof light repair
6.

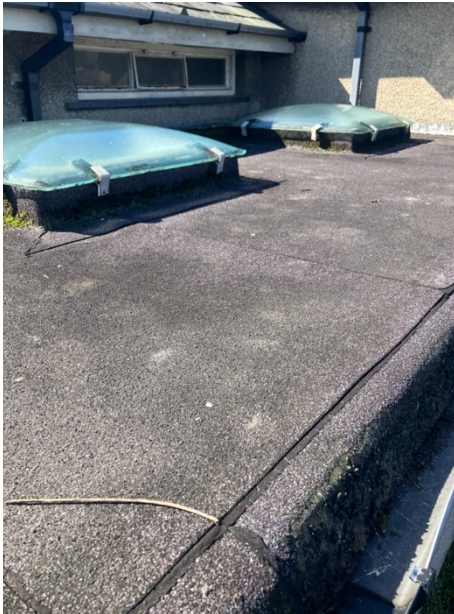
- 5.3 Roof level joinery is in poor decorative order, whilst soffits are believed contain asbestos.
- 5.4 The felt finish is sound although dated and considered to be at the end of its life expectancy. The finish is likely to need replacing within the lifespan of a typical commercial lease.

Typical Flat Roof [Rear]

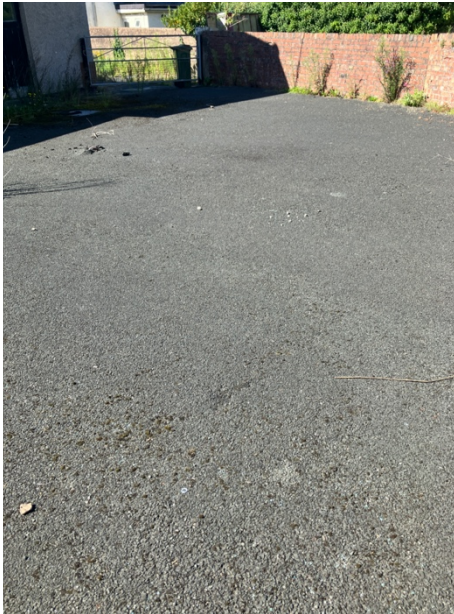
- 5.10 The rear yard is subject to vegetation growth and some isolated surface damage that requires remediation. The right hand concrete hardstanding is cracked and requires repair, whilst there is vegetation growth and uneven pavings along the front where the metal railings are in very poor decorative order.

Rear Yard

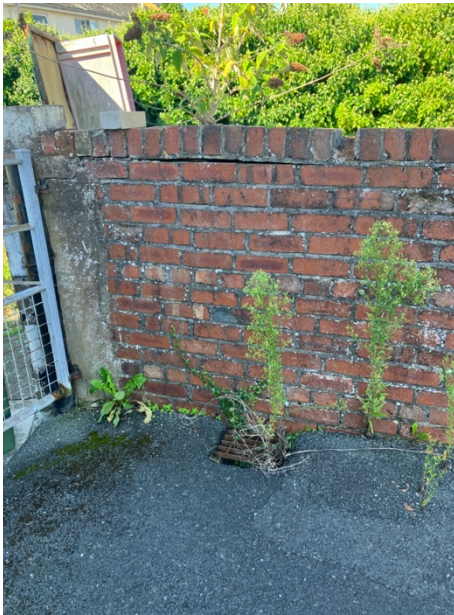
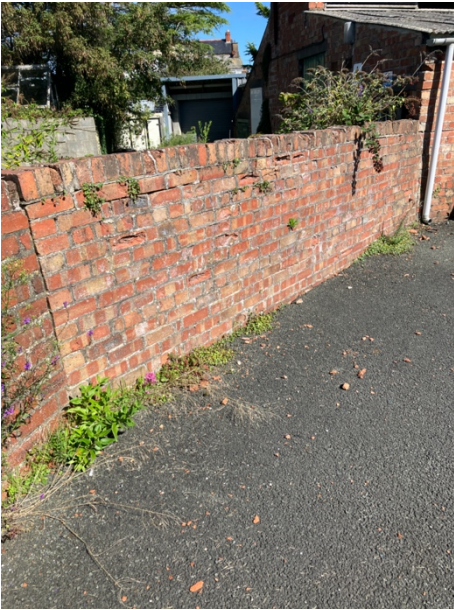
- 5.11 The brick boundary wall enclosing the rear, where the ownership requires clarification, is in very poor condition and requires repair/rebuilding.

Rear Boundary Wall – poor condition
10.

Rear Boundary Wall – poor condition

- 1.9 The ownership of the rear brick boundary wall needs to be established as it requires significant repairs. Clarification is also required as to the full extent of liability for the boundaries and shared drive.

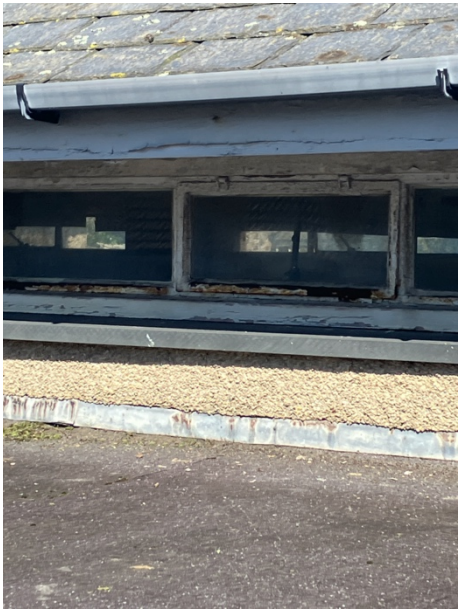
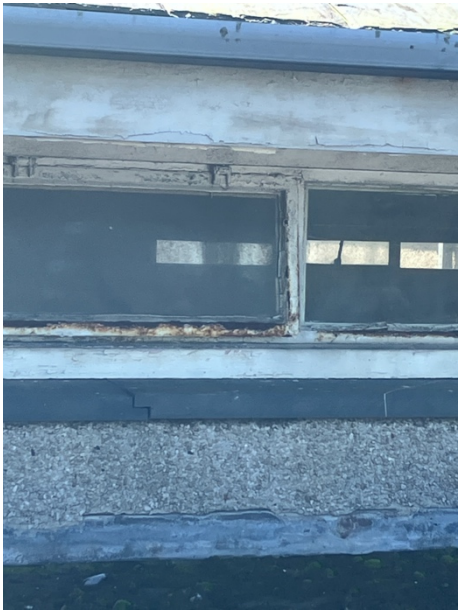
- 5.7 The render is considered to be in reasonable order with only minor isolated pockets of defect.
- 5.8 All metal windows and timber subframes are in very poor decorative order, with corrosion noted to sections of the metal casements. Numerous glazed panels were noted to be cracked and or broken.

Poor external decoration and corroding metal window frame
12.

Poor external decoration and corroding metal window frame

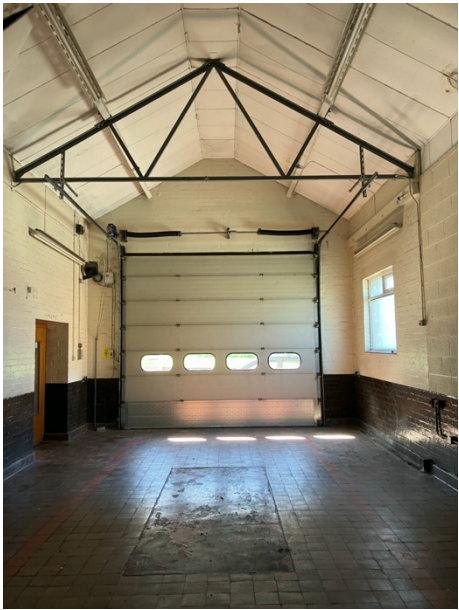
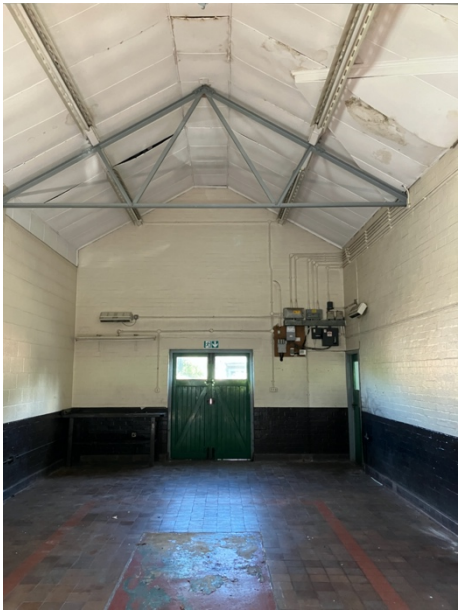
Garage
14.

Garage

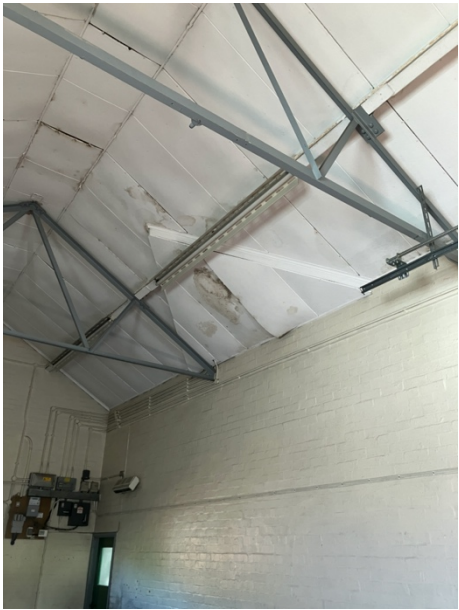
Defective linings to Garage roof soffit
16.

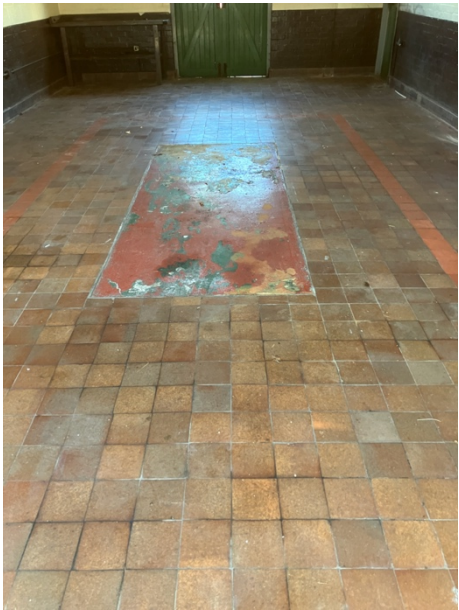
Garage Floor

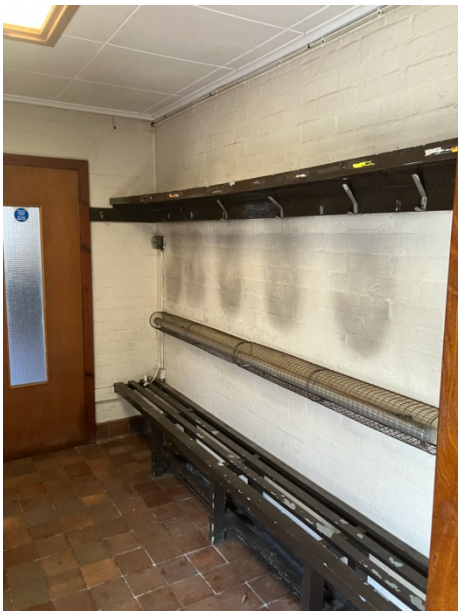
Kit Room
18.

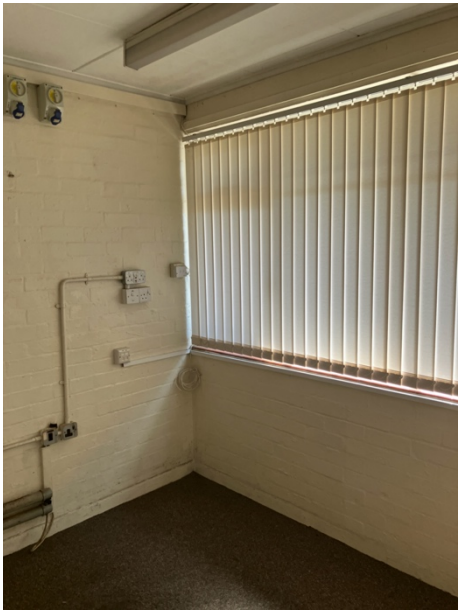
Office

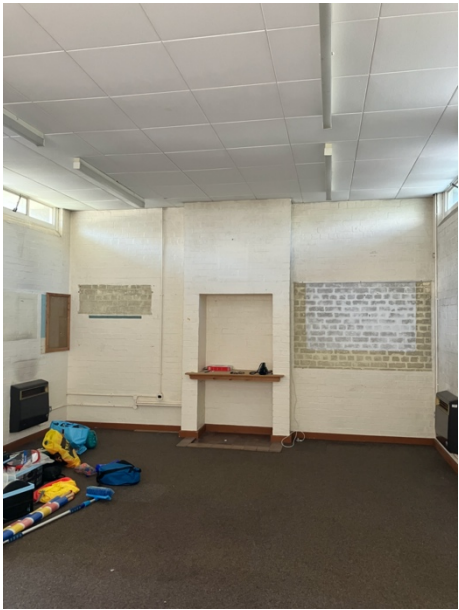
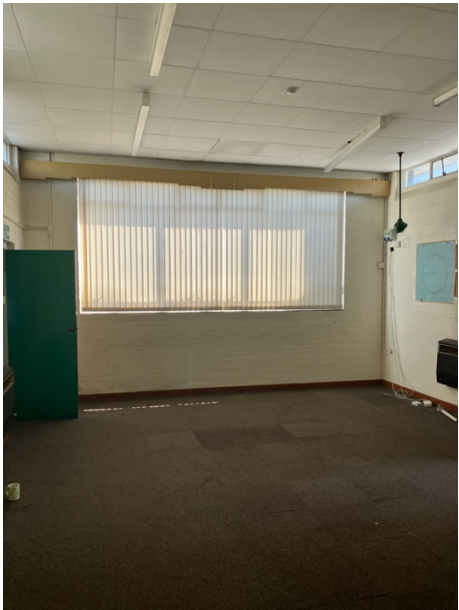
Training Hall
20.

Training Hall

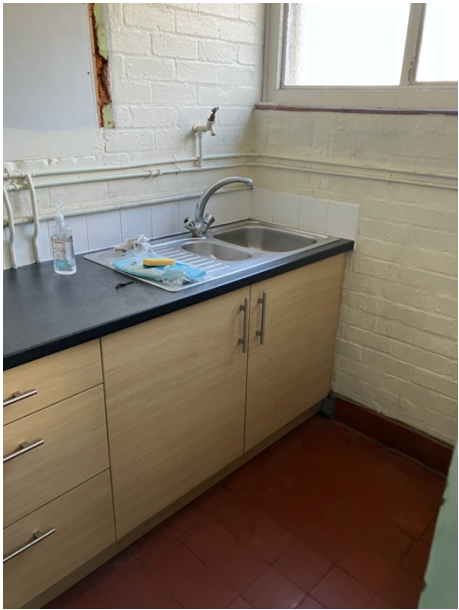
Kitchen
22.

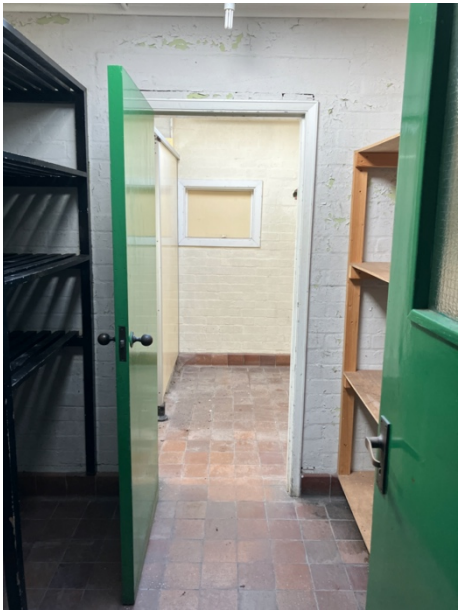
Store Room

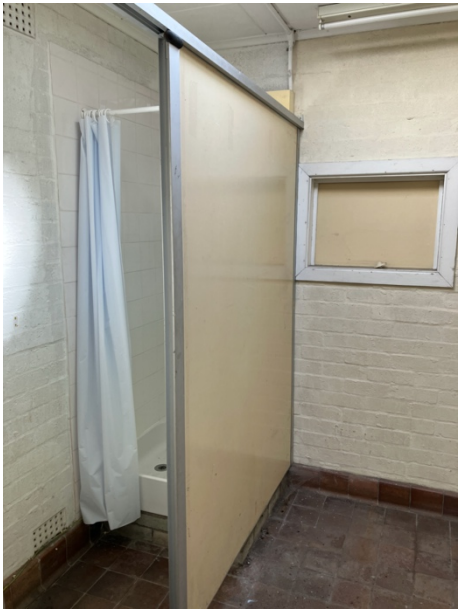
- 5.13 The electrical installation is dated and considered to be well below current NICIEC regulations. A comprehensive overhaul is considered necessary which would include a complete rewire of the power, lighting and heating circuits.
- 5.14 The WC and shower facilities are dated and require upgrade.
- 5.15 With the exception of a single emergency light fitting in the office, the property is devoid of any fire precautions.

Shower
24.

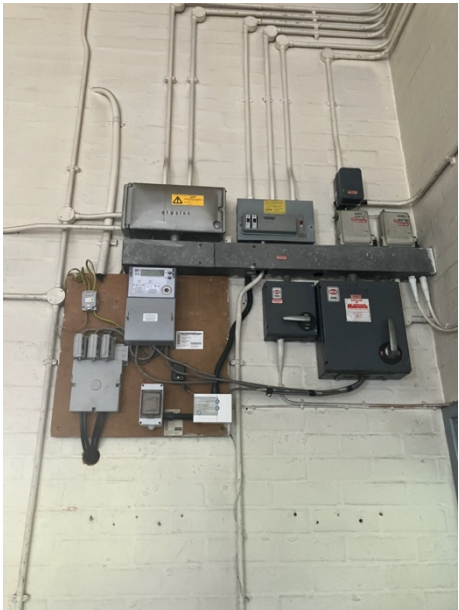
- 8.1 As advised above, the property is served by an existing 3phase electrical supply. The lighting, power and heating installations are all dated and considered to be below current regulations and standards.
- 8.2 A complete rewire of the property is considered necessary.
- 8.3 The property is further devoid of any fire precautions. A fire alarm and emergency lighting are considered as being required.

Incoming electric supply and fuse boards
